Middle Fork – South Fork of the New River Watershed Plan

Watauga County, North Carolina

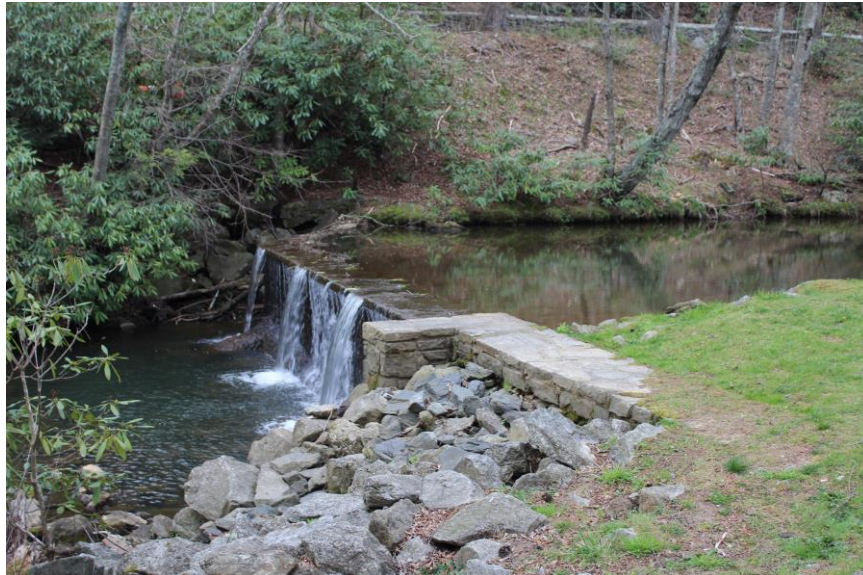
The impoundment of water by dams affects a number of ecological aspects of the Middle Fork. Several impoundments are likely increasing the water temperature in excess of natural conditions. Elevated temperatures influences aquatic organisms which are adapted to particular ranges of temperature. Changes in water temperature regimes can cause considerable changes to growth and developmental rates, reproductive fitness, pollutant uptake, competitive interactions, and mortality in aquatic ecosystems. As a result, food chains may be compromised. The cascade of factors can result in a substantial loss of biodiversity.

Dam at the at the inflow of the Middle Fork into Chetola Lake

Restoration projects surrounding Chetola Lake are needed to restore ecosystem function. The thermal stress caused by the dam could be repaired by releasing water from the bottom, instead of the top. Combined releases from the top and bottom of dams is considered to be the best practice, since cold bottom-released water is typically lower in temperature during summer, while top released water contains less sediment.

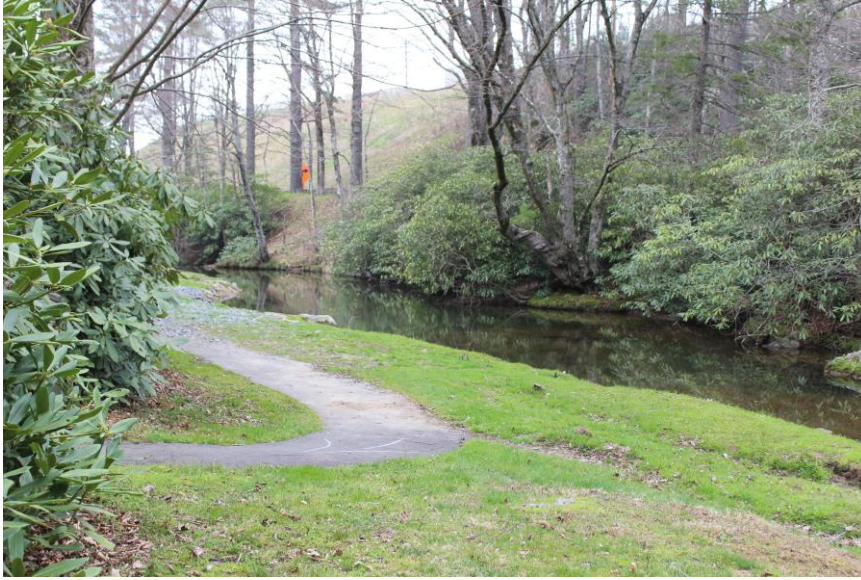
The Middle Fork at the entrance of Chetola Lake. The stream is vegetated on one side and lacks a riparian vegetation the other, however, the backwater created by the dam minimizes bank erosion

In addition, restoration projects in the area around Chetola Lake could indirectly mitigate impacts caused by the dam. A restored riparian buffer can filter pollutants from surface runoff and cool water by partially shading the water surface. The banks of the unnamed tributary connecting Chetola Lake and Bass Lake are eroding due to the lack of a riparian buffer. Water temperature is likely to be elevated. This creek is one of many in need of restoration in the area.

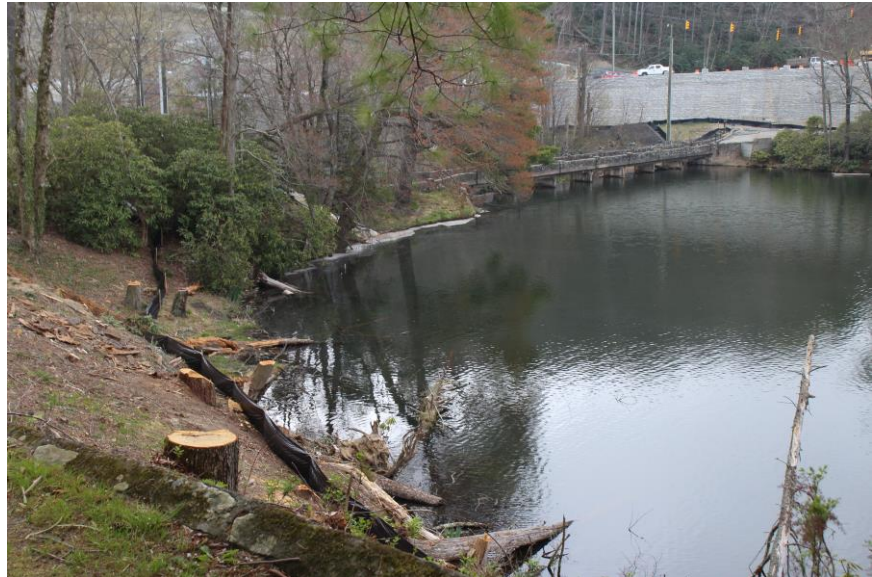
Chetola Lake. The lake is exposed to the sun and has a large surface area, increasing downstream temperature. Most of the land surrounding the lake is not vegetated.

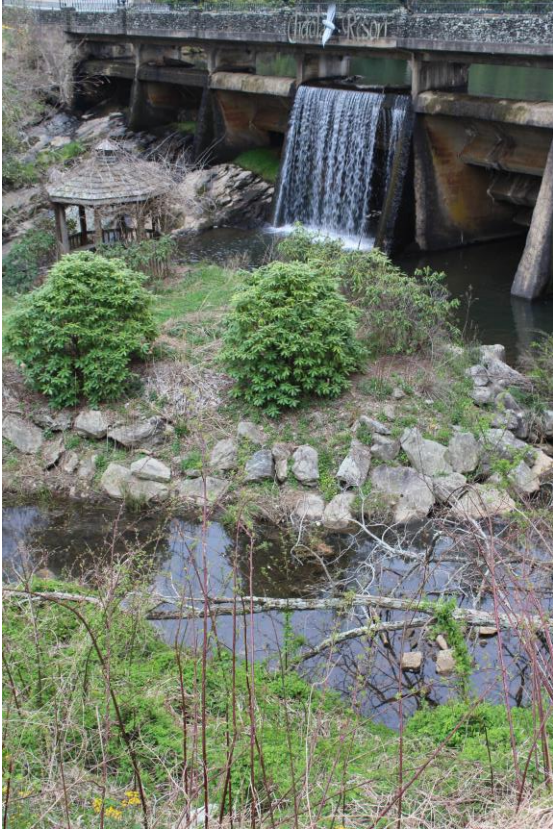
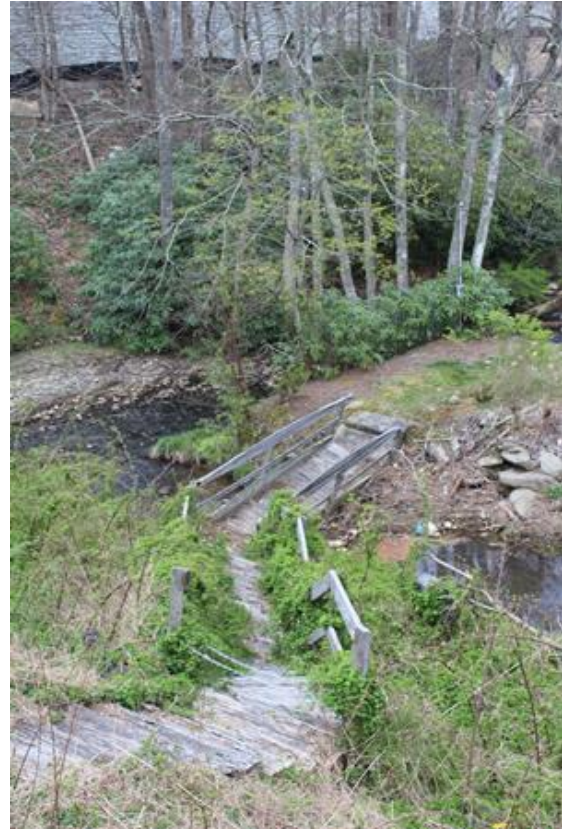
Outflow from Chetola Dam.

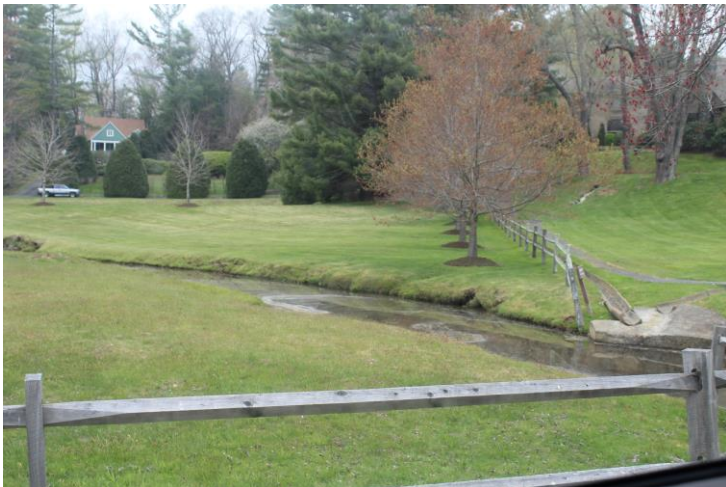
The creek connecting Bass Lake and Chetola Lake lacks a riparian zone immediately above the inflow into the lake. A riparian buffer would decrease water temperature and nutrient/bacteria concentration in the reach.

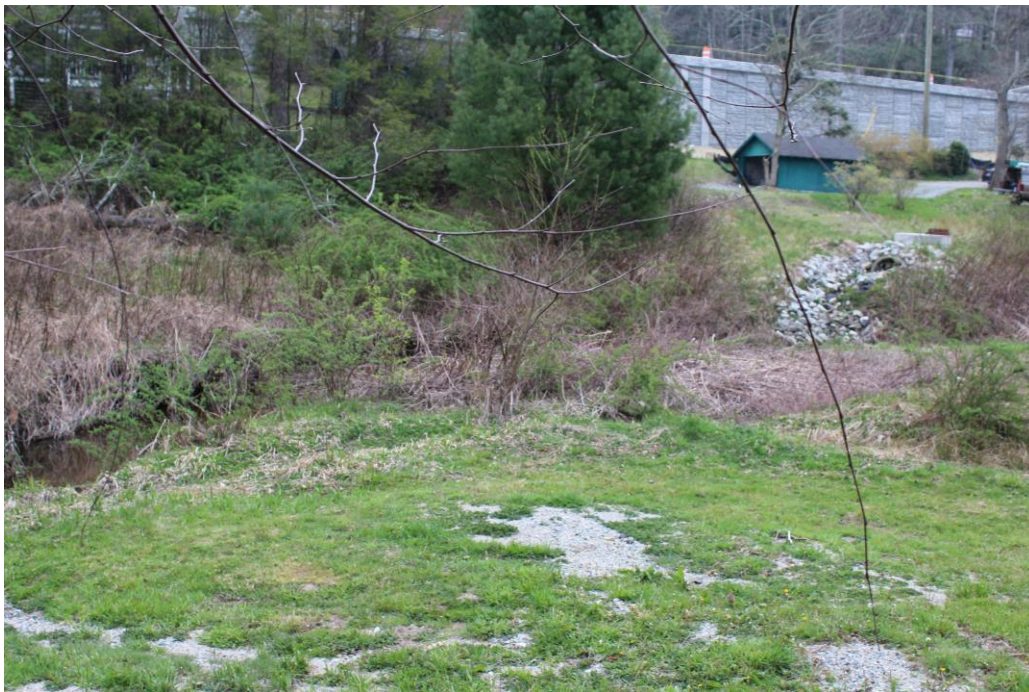
Several reaches have limited riparian vegetation and have experienced erosion and warming within the water column. In particular, a 500 ft reach along US-221 which would benefit from a wider riparian buffer with more native species. A healthy riparian buffer would increase bank stability and protect landowners from continued bank erosion. A buffer would also provide aesthetic value and educational opportunities, especially given the site's central location.

The Middle Fork along US-221 behind Don Caster Outlet. Native woody shrubs would provide shade and bank stability.

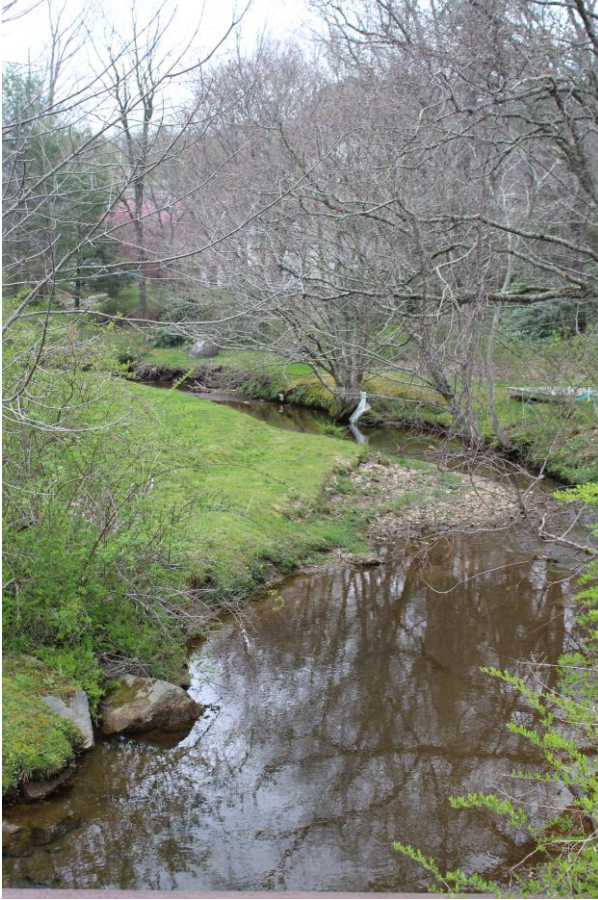
Downstream from Sunset Drive. This reach is in need of a riparian buffer.

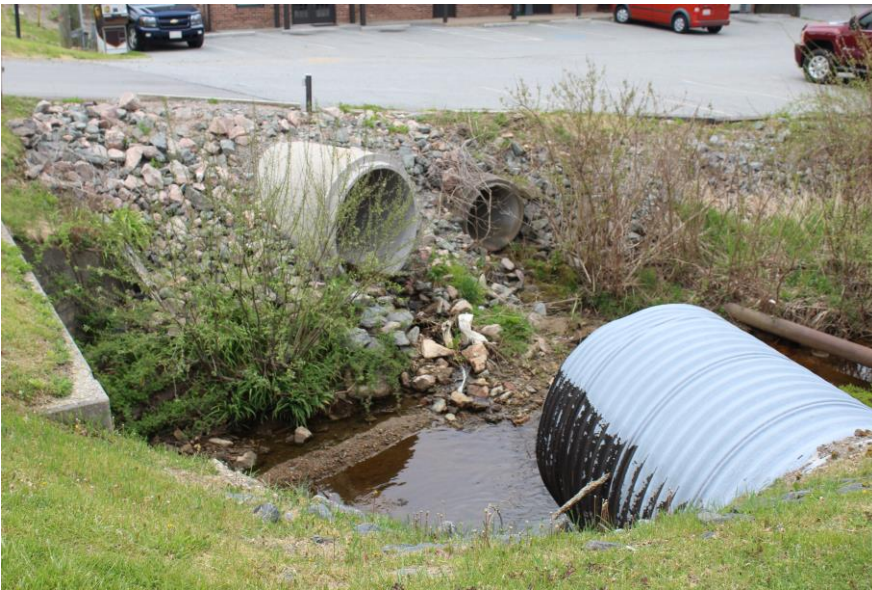
Several of many poorly installed culverts. The area could be improved by the addition of a rain garden, which would slow stormwater, reduce surface runoff, and filter pollutants as runoff infiltrates.

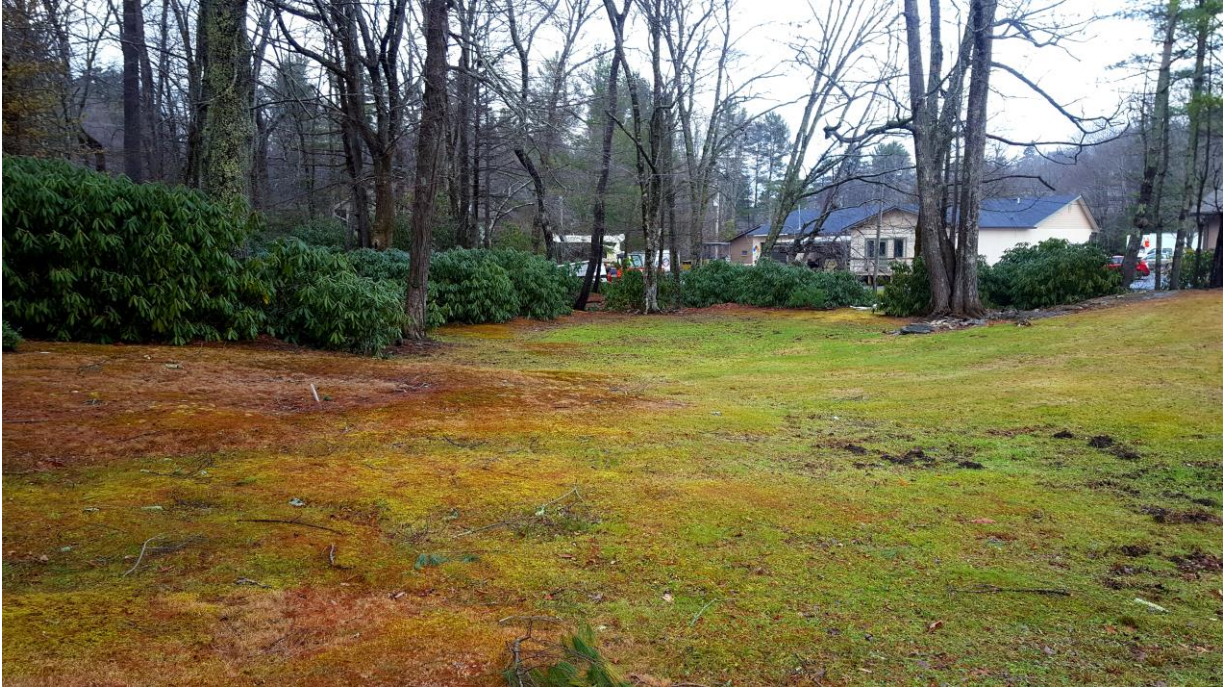
Potential rain garden site along the Middle Fork at Sunset Drive

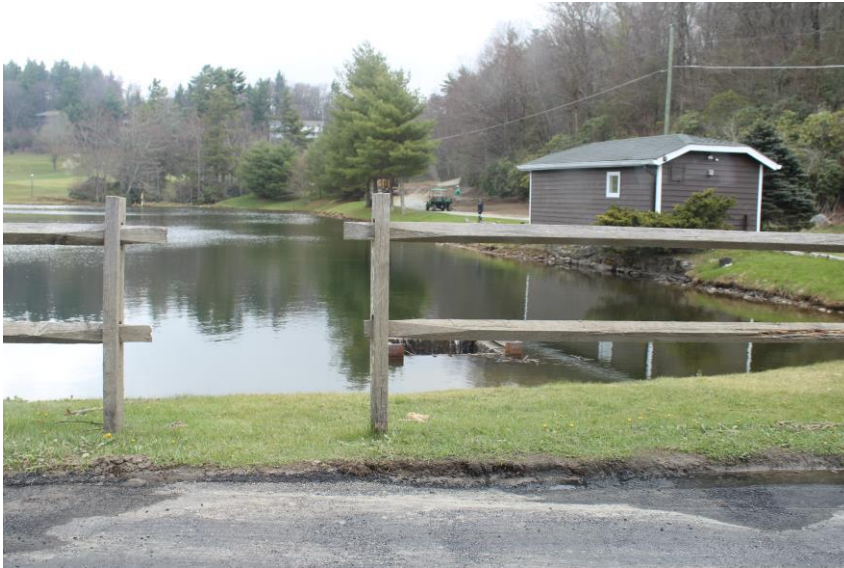
Multiple water impoundments exist on the golf course. Unshaded ponds elevate water temperature.

The headwaters of the Middle Fork connect several impoundments on the Blowing Rock Country Club golf course. The impoundments and the stream both lack riparian vegetation, resulting in elevated water temperature. Additionally, restoration of the stream through the addition of a vegetated riparian corridor would enhance the aesthetic value of the course as well as improve wildlife habitat.

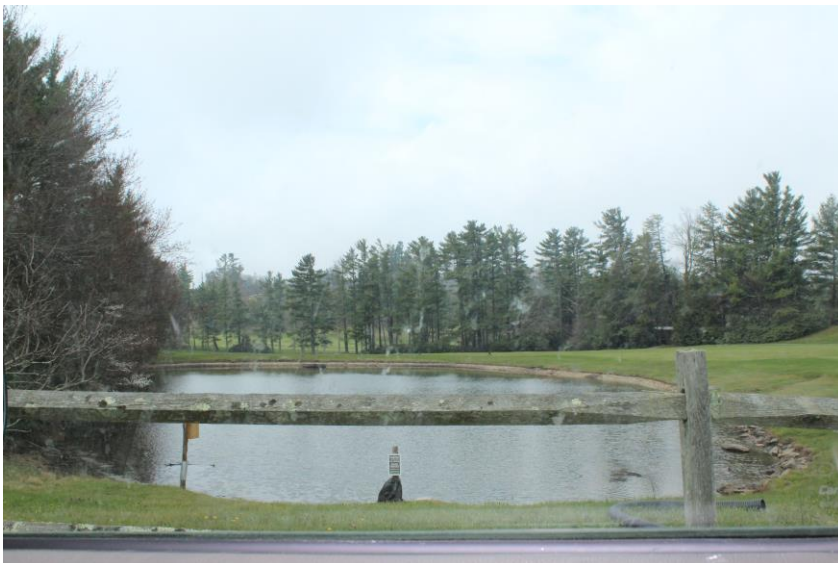
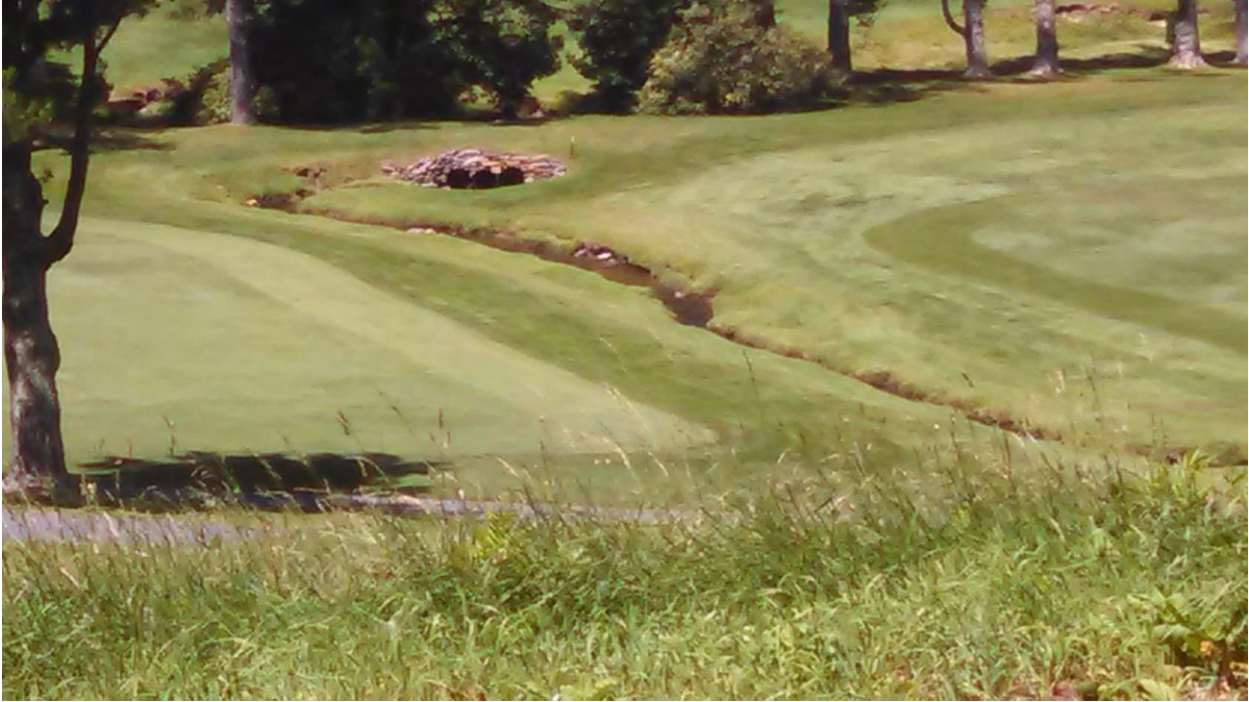
Creek on the Blowing Rock Country Club Golf Course. Streambanks are lacking proper riparian zones and are vulnerable to thermal pollution.

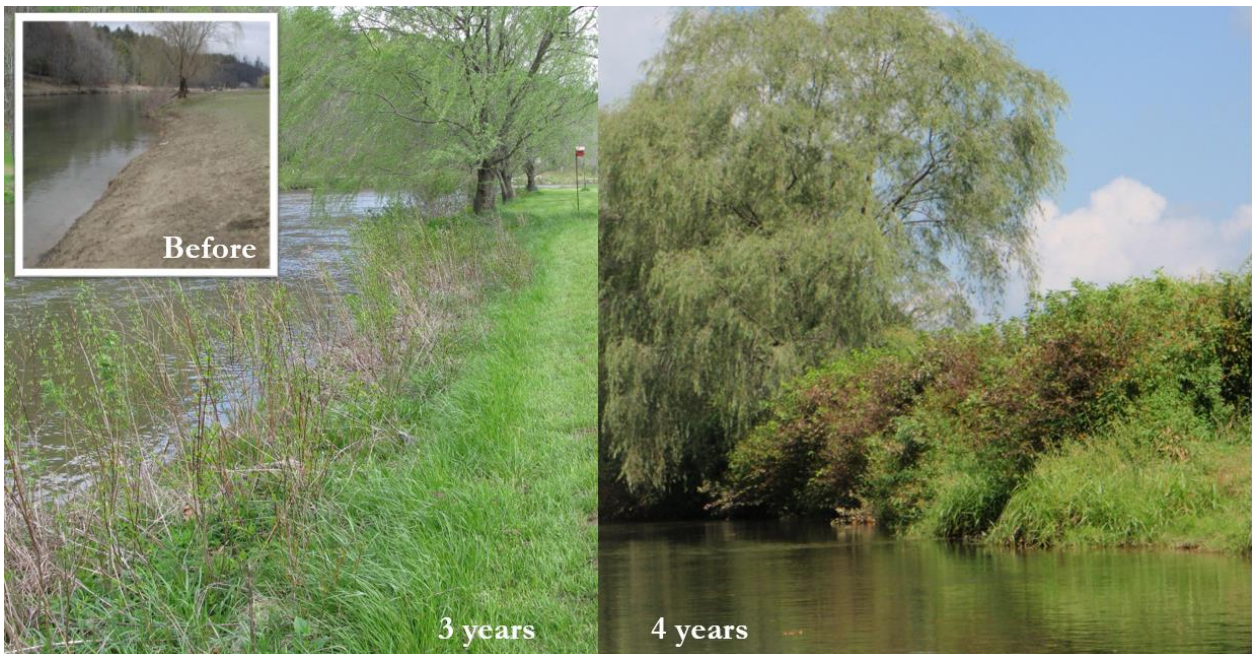
Streambank stabilization accomplished with a native riparian buffer.

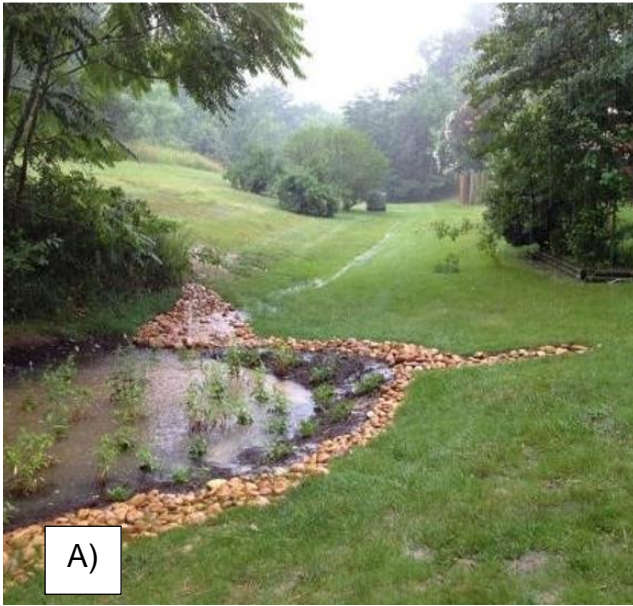
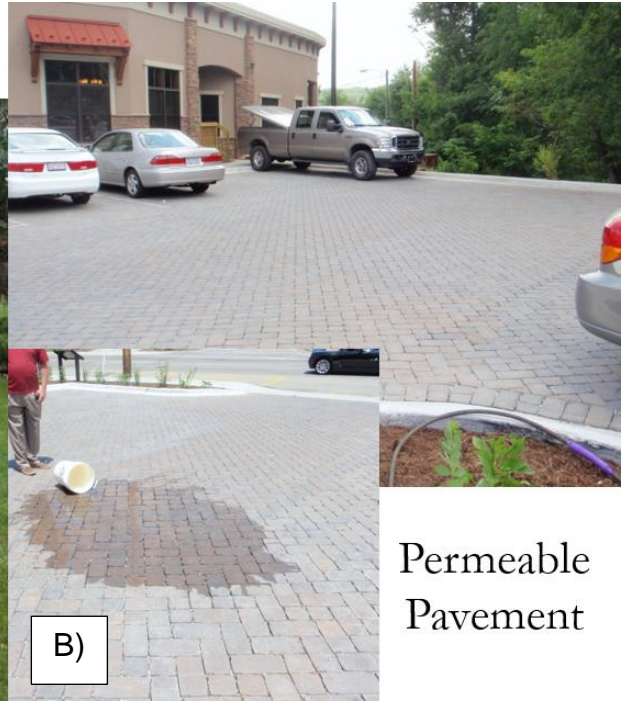
Innovative Stormwater Management in rural and urban areas. A) rain garden in Fairfax, VA. B) Casey & Casey permeable pavement project in Boone, NC.

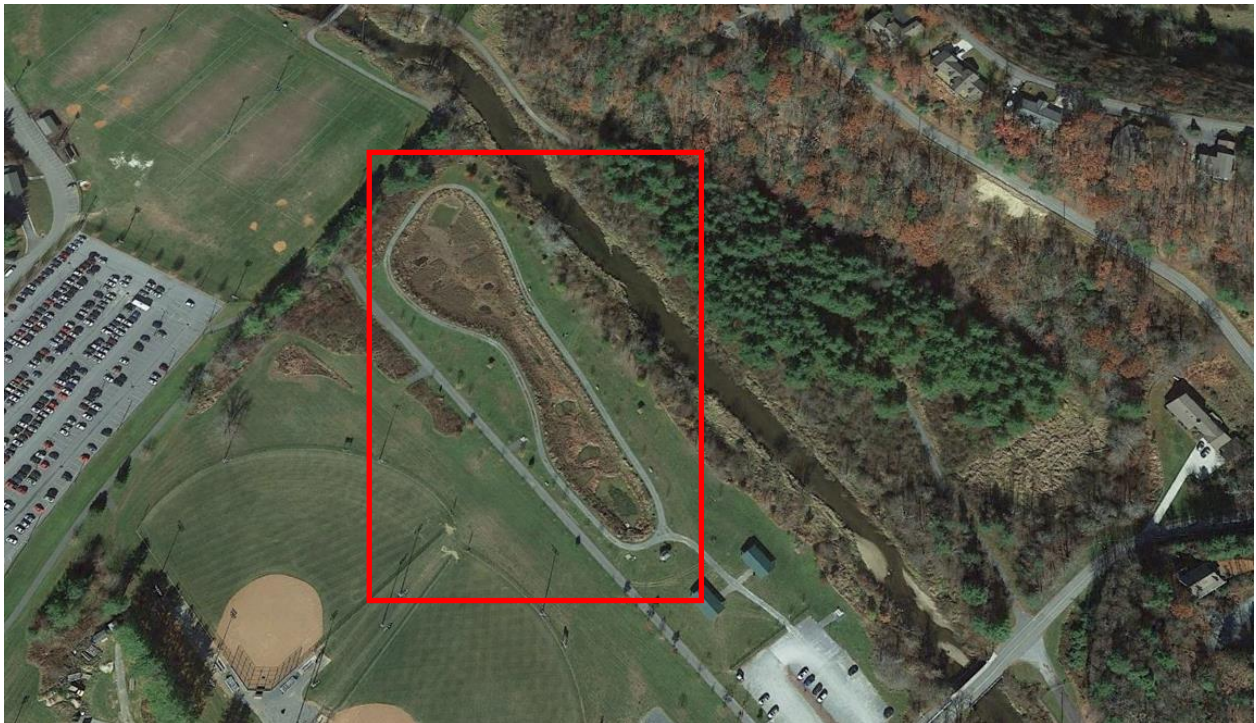
Clawson-Burnley Wetland Park in Boone, NC, designed to capture urban stormwater before it reaches the South Fork New River.
