**A WATERSHED ACTION PLAN  
FOR THE PIGEON RIVER WATERSHED  
OPTIONS FOR IMPROVING OUR WATER  
QUALITY  
HAYWOOD COUNTY, NORTH CAROLINA**

**Haywood Waterways Association's  
Technical Advisory Committee**

This Plan was adopted on March 7, 2002 and is a living document. It is updated as additional strategies develop or new information is obtained. The most recent revision was completed in May, 2014.

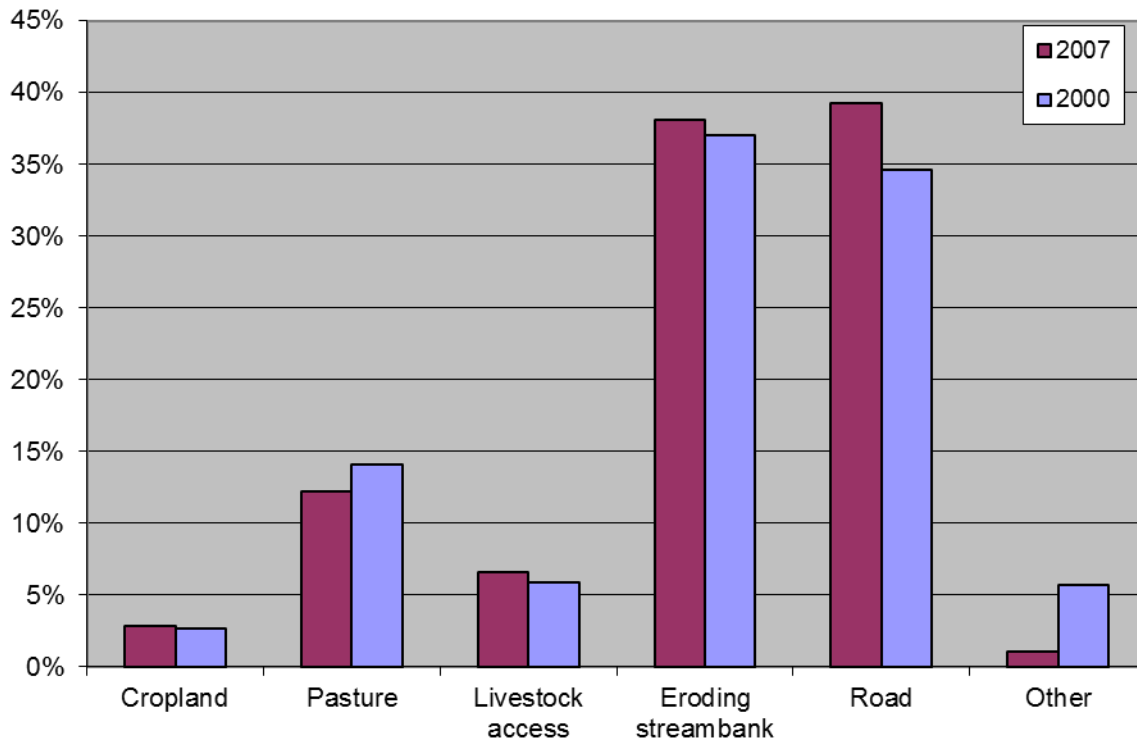
**Figure 10. Primary Sources of Sediment to Streams in the Pigeon River Watershed (source: IPSI)**

There are numerous sources that contribute sediment to area streams. Even undisturbed forestland contributes sediment, albeit at a very low level. While the data is available for all uses, this report focuses on those activities and land uses that contribute the majority of sediment in the Pigeon River Watershed. The two most significant contributors are eroding stream banks and roads. These two sources contribute 73% of the total sediment being deposited in Pigeon River Watershed streams. The third most significant contributor was pastureland (15%) with pastures in fair condition contributing 11% of sediment to streams. The following chart summarizes the primary sources of sediment in the watershed.

Eroding stream banks represent a small percentage of the total mileage of streams in the County. However, every cubic foot of soil that falls off the bank goes directly into the stream. The IPSI data indicates that 6% of the Pigeon River Watershed streams have eroding stream banks. Much of this is concentrated in a few subwatersheds. Analyses of the aerial photographs identified the eroding stream banks along the larger, perennial streams. There are additional eroding stream banks on several small tributaries.

The roads category includes runoff from road surfaces, ditches, and eroding cut and fills slopes. Roads serve a variety of purposes. Many are constructed for residential subdivisions. However, roads are also built as access to individual residences, as well as for forestry, agricultural, and industrial purposes.

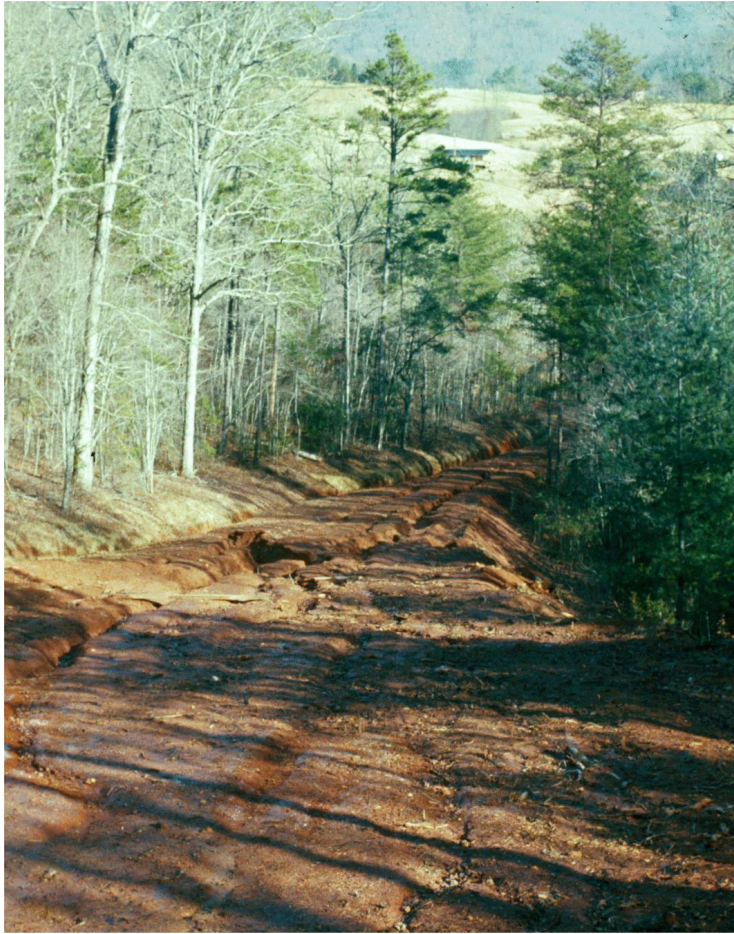
**Figure 11. Severe erosion from an unpaved road**

The impact of the roads on Pigeon River water quality reflects a number of factors. These include whether the road is paved or unpaved. If it is a gravel surface, how good a gravel surface is on the road? A well-graveled road surface will contribute substantially less than one where the protection of the surface material has been worn away. What is the grade on the road? Steep roads are at much greater risk for erosion. Another significant item is the condition of the road ditches. Much of the sediment from roads comes from road ditches, where the storm runoff is concentrated. Are there adequate culverts to avoid long grades where the water can gather force? Have the ditches been vegetated or hardened? Is the stormwater concentrated or dispersed? Have the road banks (cut and fill banks) been vegetated and stabilized? Is the road newly constructed? What type of soil is the road constructed across?

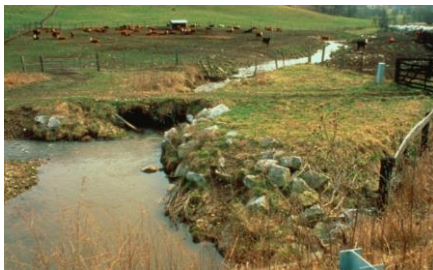
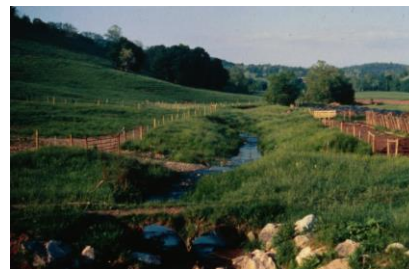
**Figure 21. Agricultural site in Elk Garden, VA before and after pasture and stream BMPs were installed. BMPs were in place for one year.**

Proven conservation techniques called Best Management Practices (BMPs) can be employed to minimize the impact of land-disturbing activities. Some BMPs are simple and inexpensive. Others may require extensive analysis, careful planning, and significant investment. Due to the cost of some land improvements, cash payments are often needed to enable landowner participation. Cost share payments for such things as stream bank repairs, excluding cattle from streams, providing alternate water sources, and revegetating riparian areas are a few examples of direct financial assistance.
