Smith Creek Watershed Restoration Plan

Wake and Franklin Counties
North Carolina

Prepared by WK Dickson & Co., Inc.
616 Colonnade Dr.
Charlotte, NC 28205

December 2015

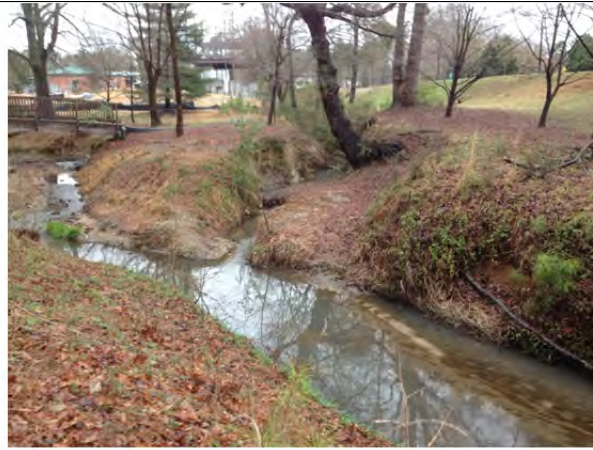
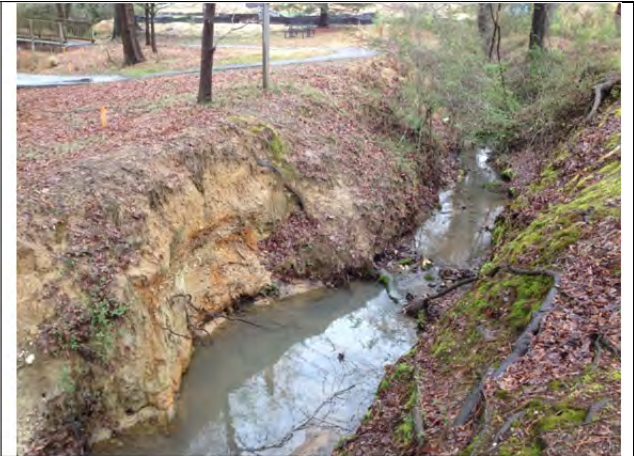
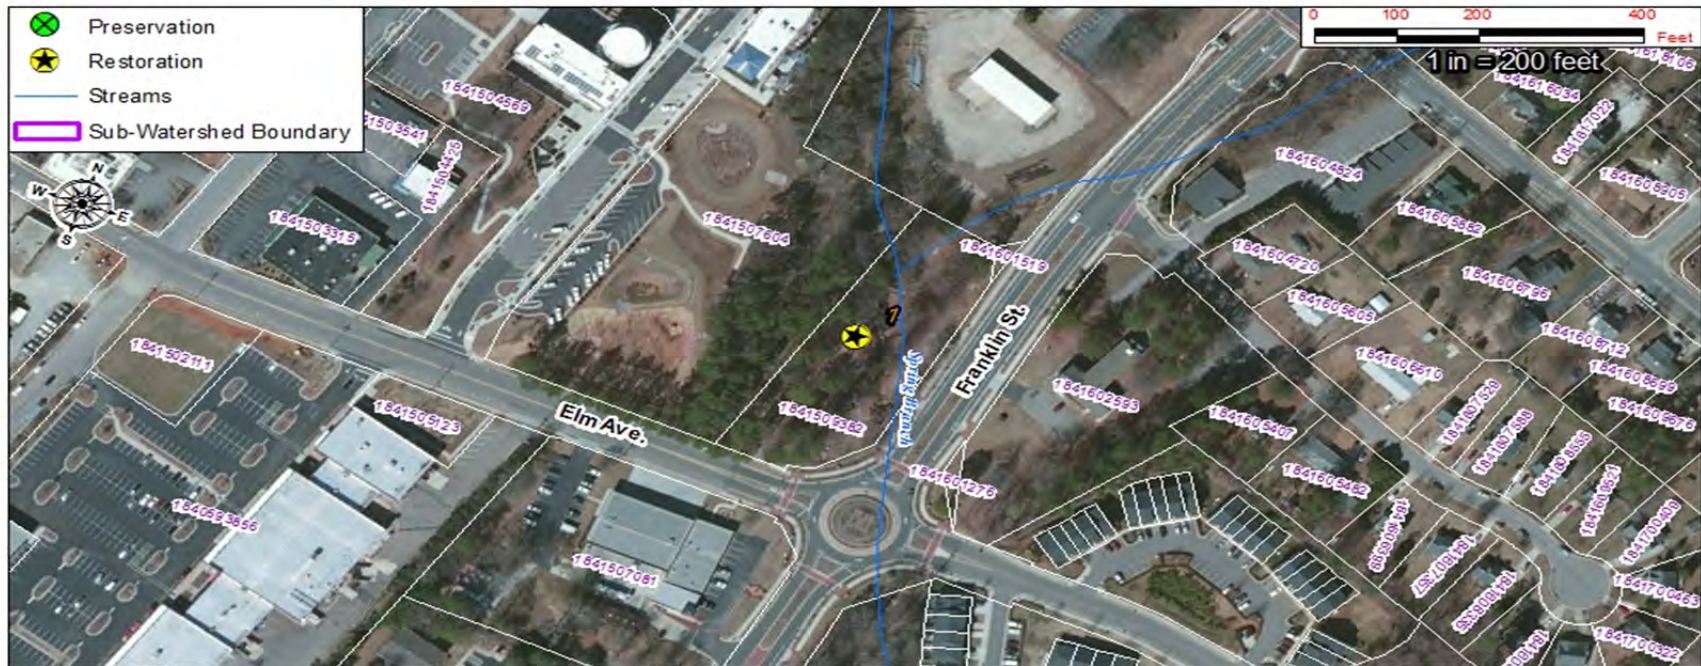
Restoration Priority 1: Miller Park Stream Restoration

Watershed Size (ac)	229
Watershed % Urban	99
Restoration Length (ft)	900
Estimated Cost	\$360,000
Estimated Load Reductions	
Total Nitrogen (lb/yr)	176.20
Total Phosphorous (lb/yr)	67.84
Biological Oxygen Demand (lb/yr)	352.40
Sediment (ton/yr)	95.76

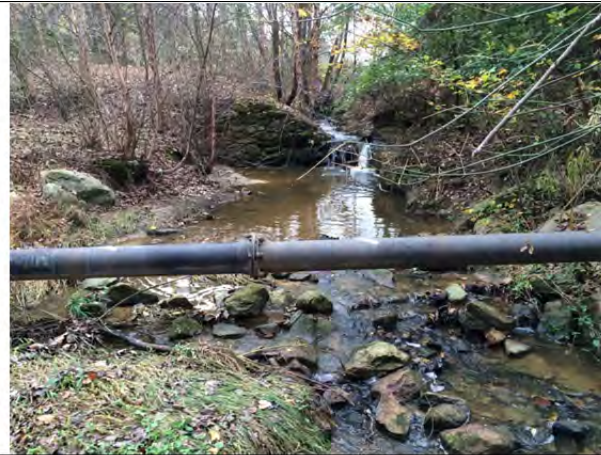
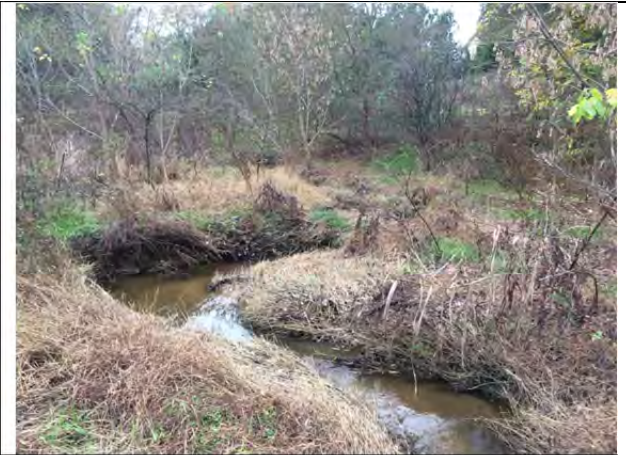
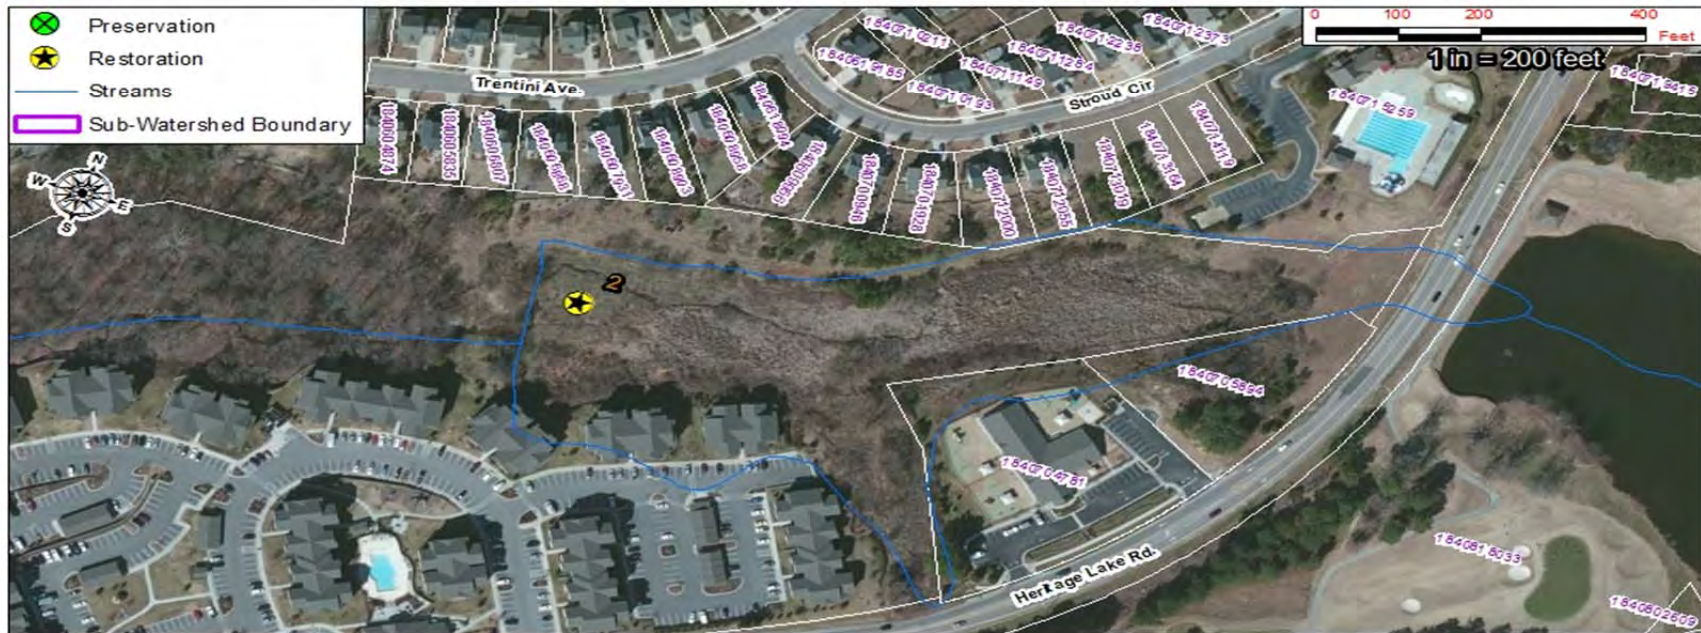
Restoration Priority 2: Hope Lutheran Stream Restoration

Watershed Size (ac)	265
Watershed % Urban	98%
Restoration Length (ft)	1450
Estimated Cost	\$580,000
Estimated Load Reductions	
Total Nitrogen (lb/yr)	141.05
Total Phosphorous (lb/yr)	54.30
Biological Oxygen Demand (lb/yr)	282.10
Sediment (ton/yr)	76.66

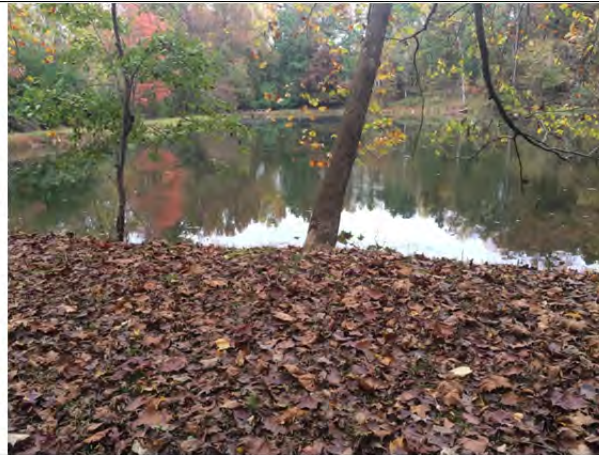
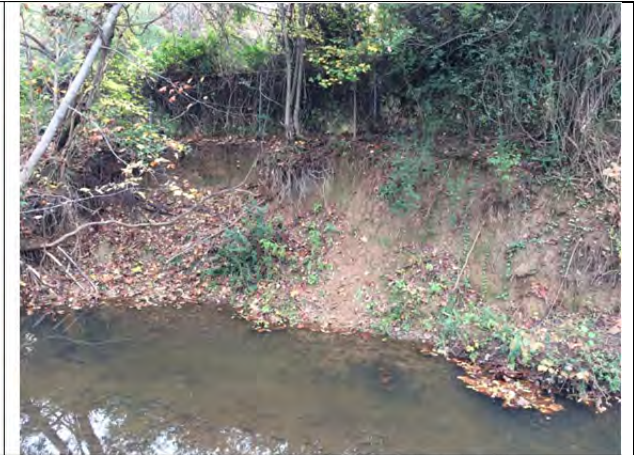
Restoration Priority 3: Joyner Lateral Dam Cut Stream Restoration

Watershed Size (ac)	2207
Watershed % Urban	25%
Restoration Length (ft)	250
Estimated Cost	\$100,000
Estimated Load Reductions	
Total Nitrogen (lb/yr)	91.77
Total Phosphorous (lb/yr)	35.33
Biological Oxygen Demand (lb/yr)	183.54
Sediment (ton/yr)	49.88

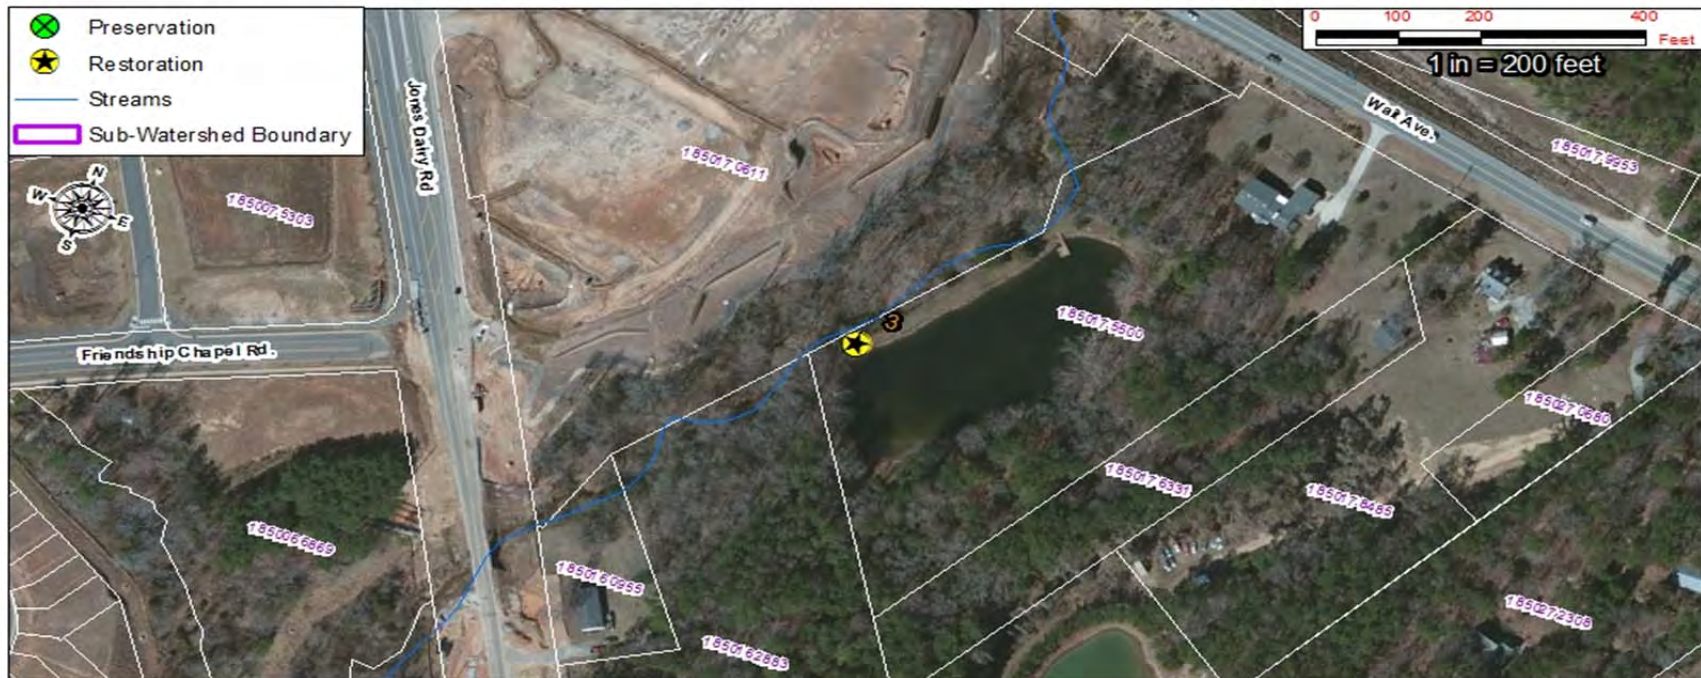
Restoration Priority 4: Dam Failure at Alley Young Park

Watershed Size (ac)	59
Watershed % Urban	92%
Restoration Length (ft)	350
Estimated Cost	\$140,000
Estimated Load Reductions	
Total Nitrogen (lb/yr)	79.23
Total Phosphorous (lb/yr)	30.50
Biological Oxygen Demand (lb/yr)	158.46
Sediment (ton/yr)	43.06

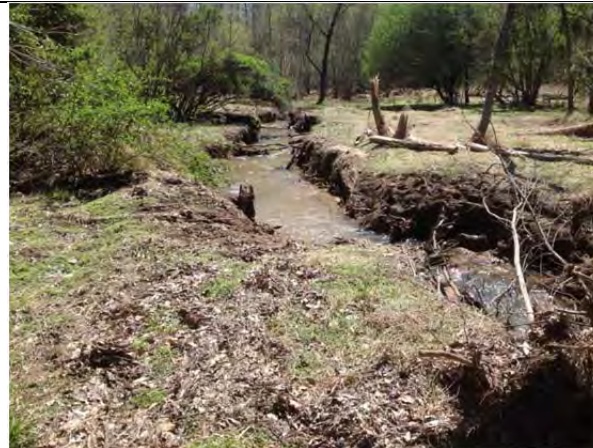
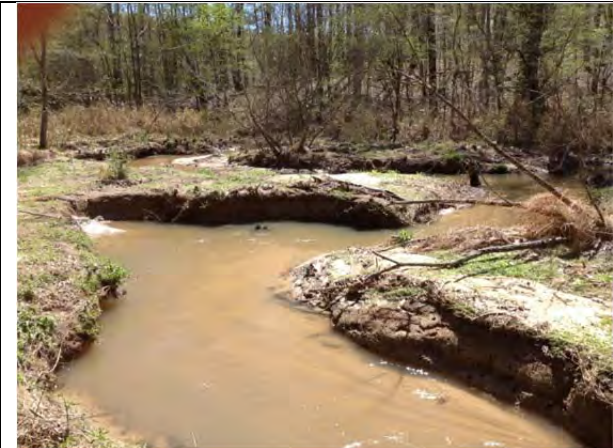
Restoration Priority 5: Traditions Stream Restoration

Watershed Size (ac)	1552
Watershed % Urban	10%
Restoration Length (ft)	1800
Estimated Cost	\$720,000
Estimated Load Reductions	
Total Nitrogen (lb/yr)	71.58
Total Phosphorous (lb/yr)	27.56
Biological Oxygen Demand (lb/yr)	143.16
Sediment (ton/yr)	38.90

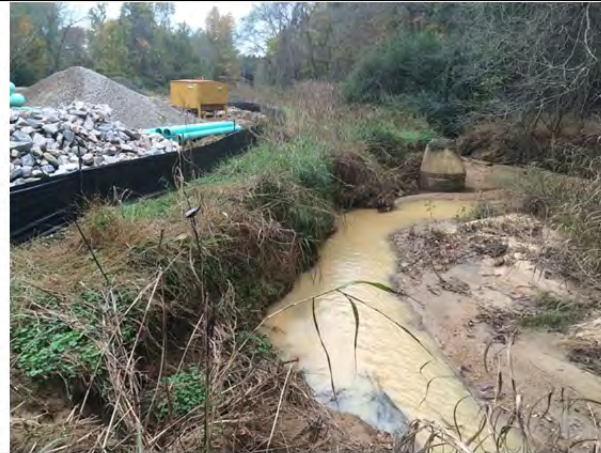
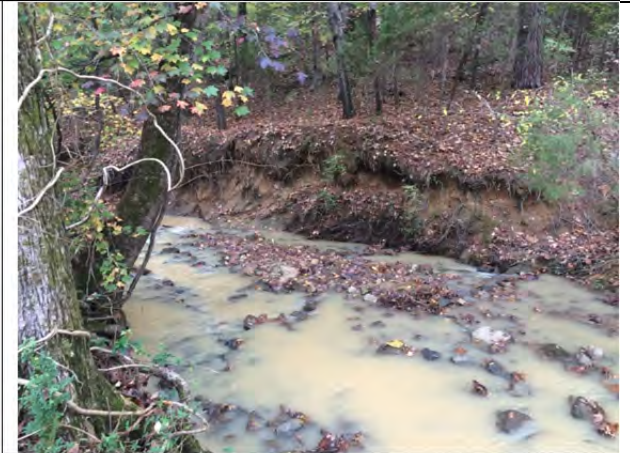
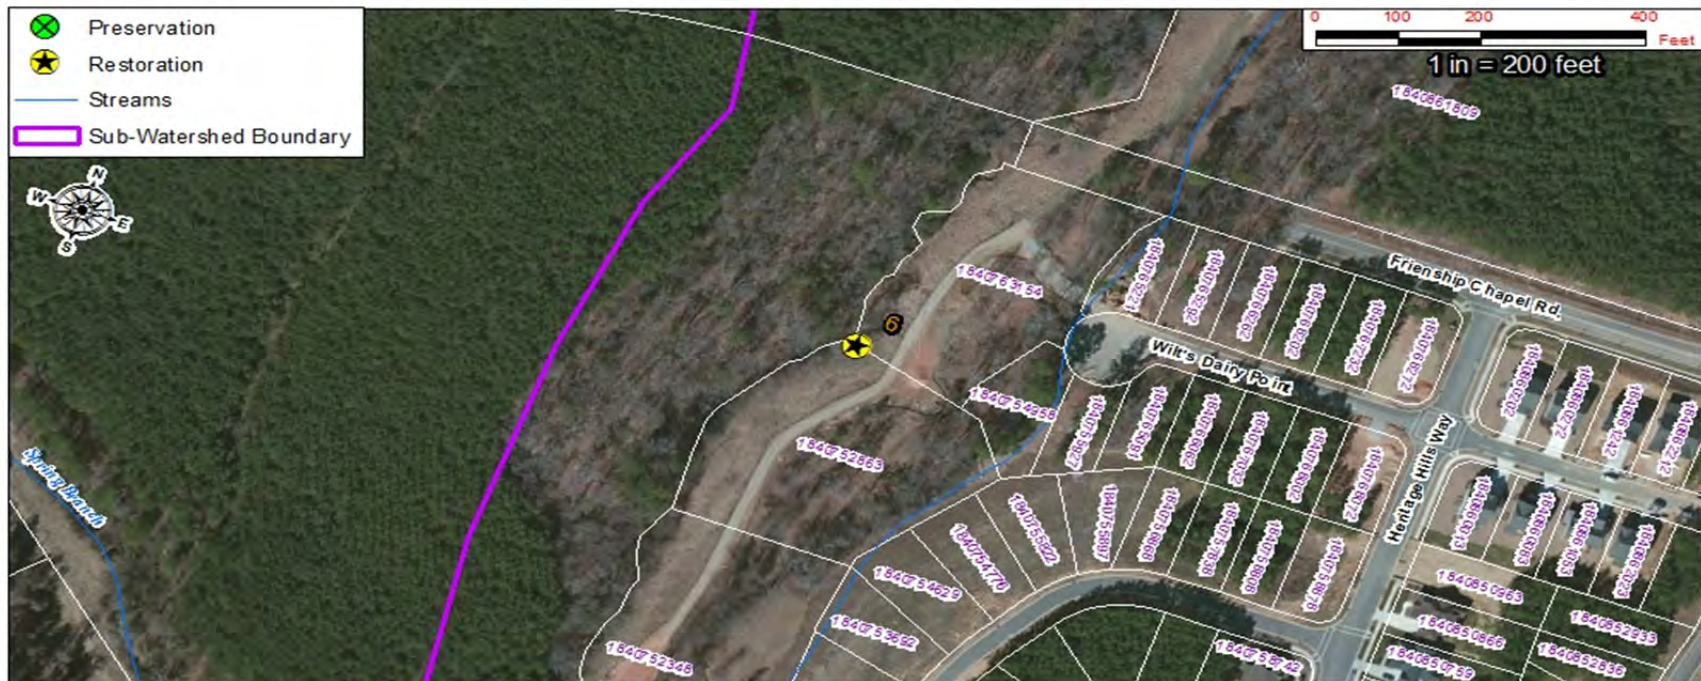
Restoration Priority 6: Dunn Creek Stream Restoration

Watershed Size (ac)	1388
Watershed % Urban	85%
Restoration Length (ft)	450
Estimated Cost	\$180,000
Estimated Load Reductions	
Total Nitrogen (lb/yr)	28.63
Total Phosphorous (lb/yr)	11.02
Biological Oxygen Demand (lb/yr)	57.26
Sediment (ton/yr)	15.56

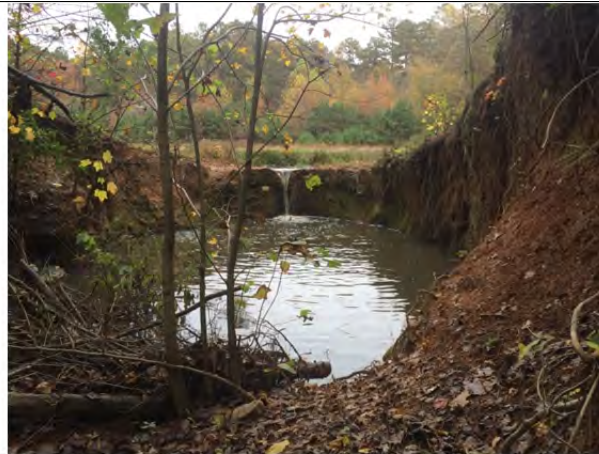
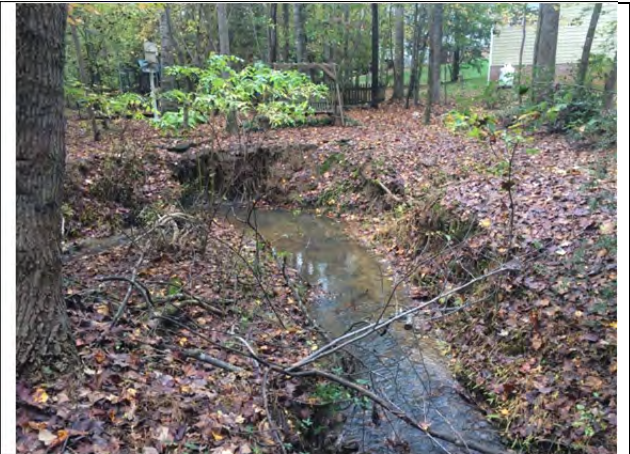
Restoration Priority 7: Sedgfield Park Dam Stream Restoration

Watershed Size (ac)	383
Watershed % Urban	73%
Restoration Length (ft)	75
Estimated Cost	\$30,000
Estimated Load Reductions	
Total Nitrogen (lb/yr)	11.93
Total Phosphorous (lb/yr)	4.59
Biological Oxygen Demand (lb/yr)	23.86
Sediment (ton/yr)	6.48

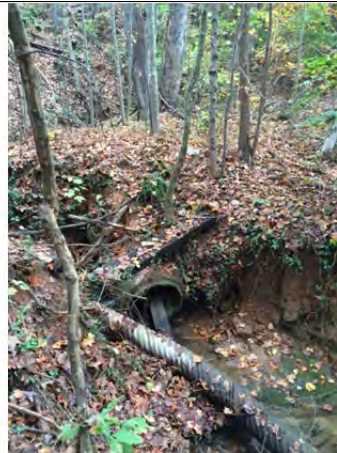
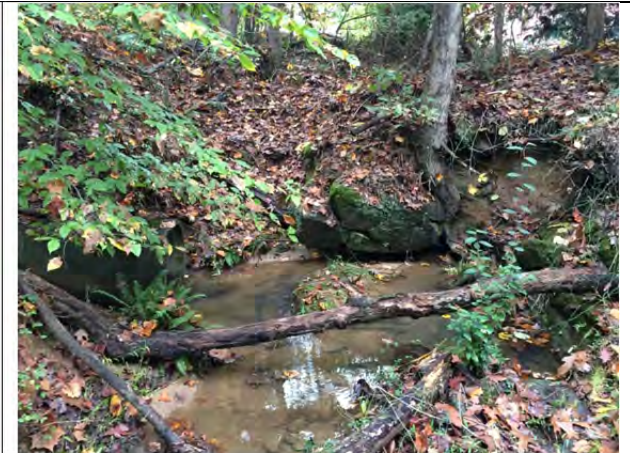
Restoration Priority 8: Thales Academy RR Stream Restoration

Watershed Size (ac)	75
Watershed % Urban	100%
Restoration Length (ft)	200
Estimated Cost	\$80,000
Estimated Load Reductions	
Total Nitrogen (lb/yr)	9.54
Total Phosphorous (lb/yr)	3.67
Biological Oxygen Demand (lb/yr)	19.09
Sediment (ton/yr)	5.19

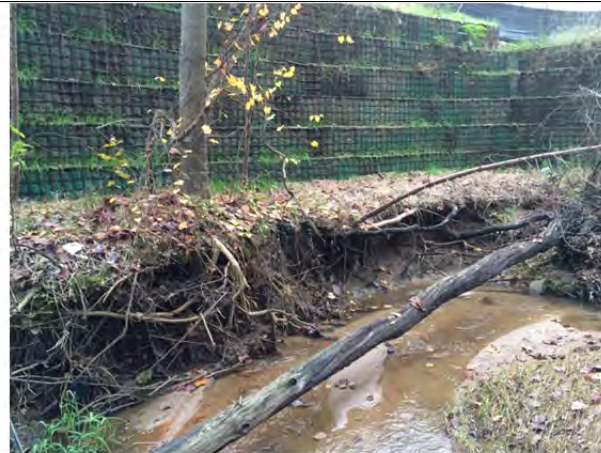
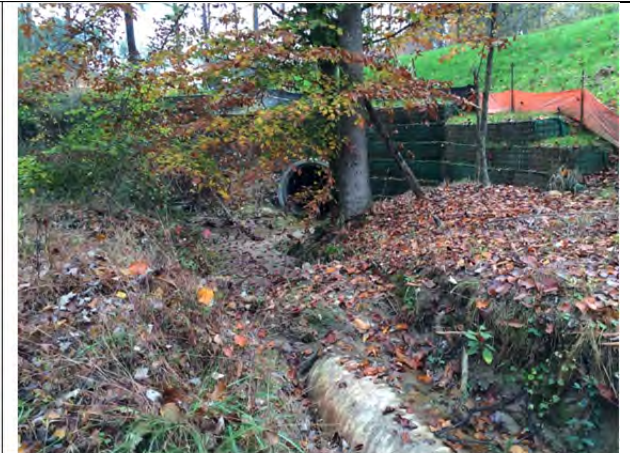
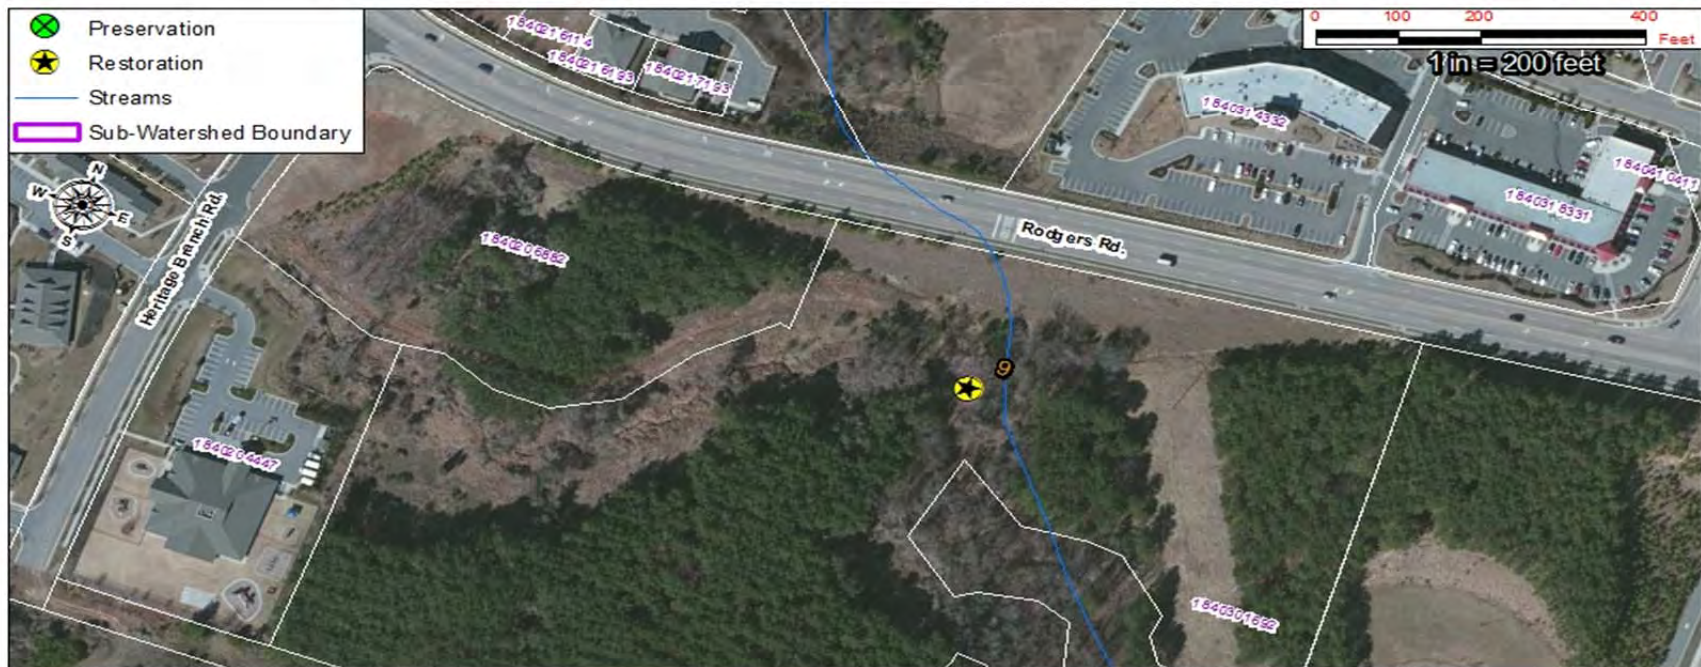
Restoration Priority 9: Heritage Middle School Stream Restoration

Watershed Size (ac)	228
Watershed % Urban	100%
Restoration Length (ft)	350
Estimated Cost	\$140,000
Estimated Load Reductions	
Total Nitrogen (lb/yr)	8.14
Total Phosphorous (lb/yr)	3.13
Biological Oxygen Demand (lb/yr)	16.27
Sediment (ton/yr)	4.42

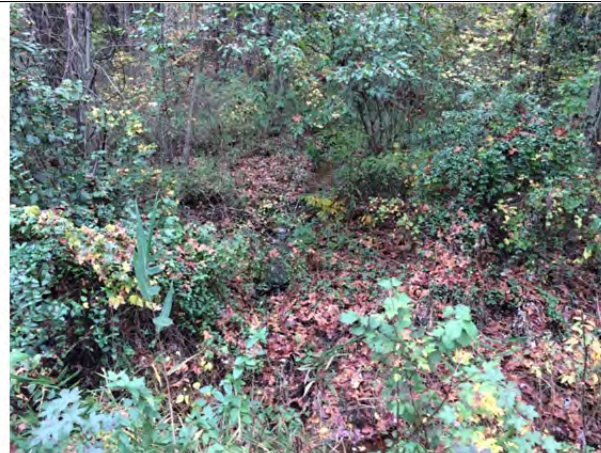
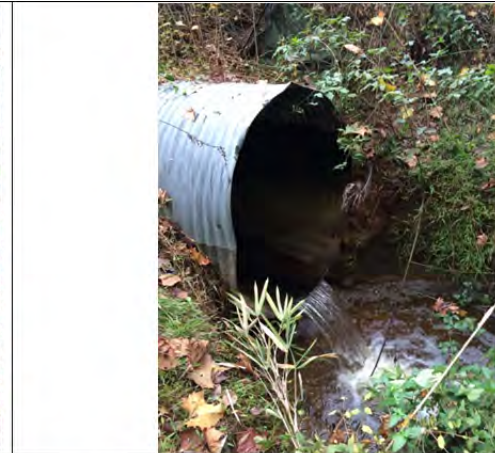
Restoration Priority 10: Franklin Academy Perched Culvert

Watershed Size (ac)	288
Watershed % Urban	75%
Restoration Length (ft)	30
Estimated Cost	\$12,000
Estimated Load Reductions	
Total Nitrogen (lb/yr)	2.39
Total Phosphorous (lb/yr)	0.92
Biological Oxygen Demand (lb/yr)	4.77
Sediment (ton/yr)	1.30

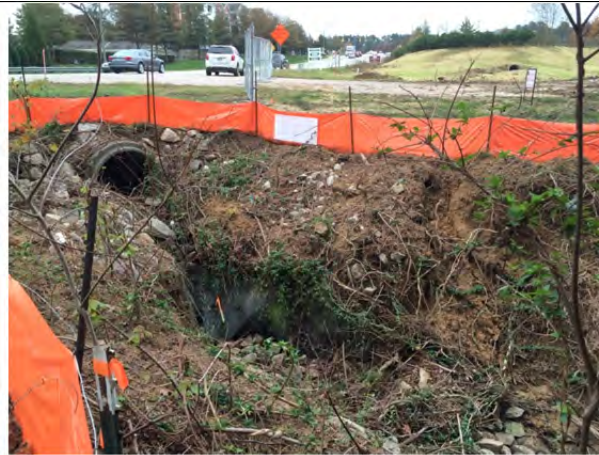
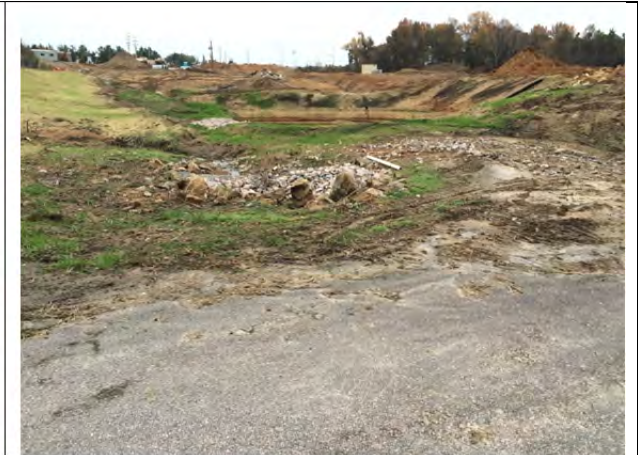
Restoration Priority 11: Rogers Rd. Culvert Stream Restoration

Watershed Size (ac)	46
Watershed % Urban	95%
Restoration Length (ft)	50
Estimated Cost	\$20,000
Estimated Load Reductions	
Total Nitrogen (lb/yr)	2.39
Total Phosphorous (lb/yr)	0.92
Biological Oxygen Demand (lb/yr)	4.77
Sediment (ton/yr)	1.30

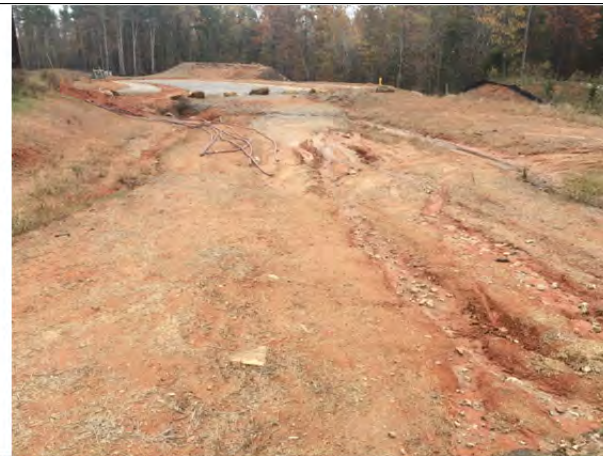
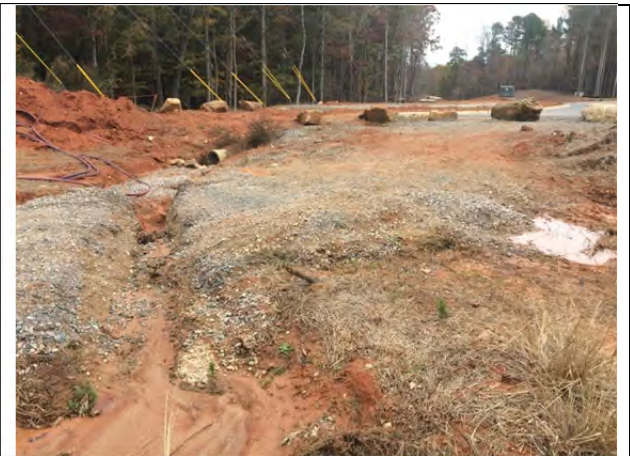
Restoration Priority 12: Erosion at Royal Mill Ave Gully Restoration

Watershed Size (ac)	18
Watershed % Urban	100%
Restoration Length (ft)	100
Estimated Cost	\$20,000
Estimated Load Reductions	
Total Nitrogen (lb/yr)	1.32
Total Phosphorous (lb/yr)	0.60
Biological Oxygen Demand (lb/yr)	18.06
Sediment (ton/yr)	0.20

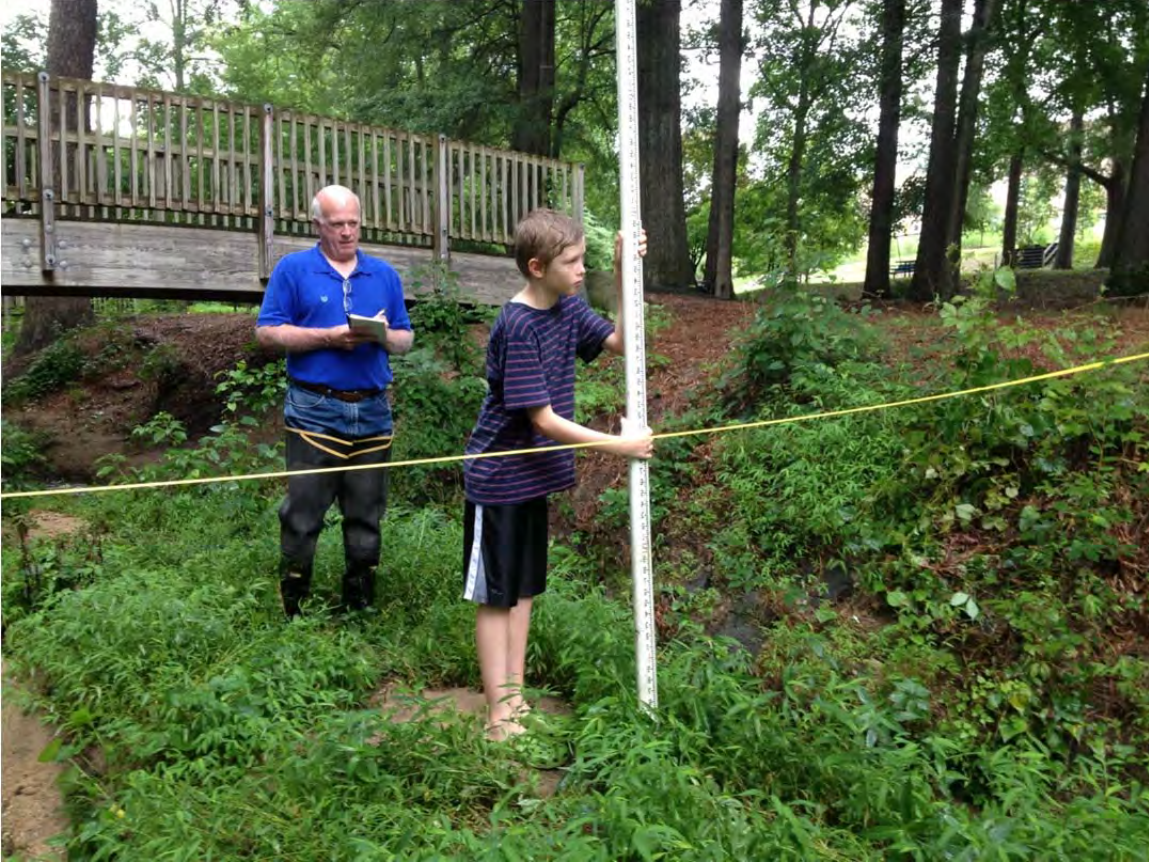
Geomorphologic data collection

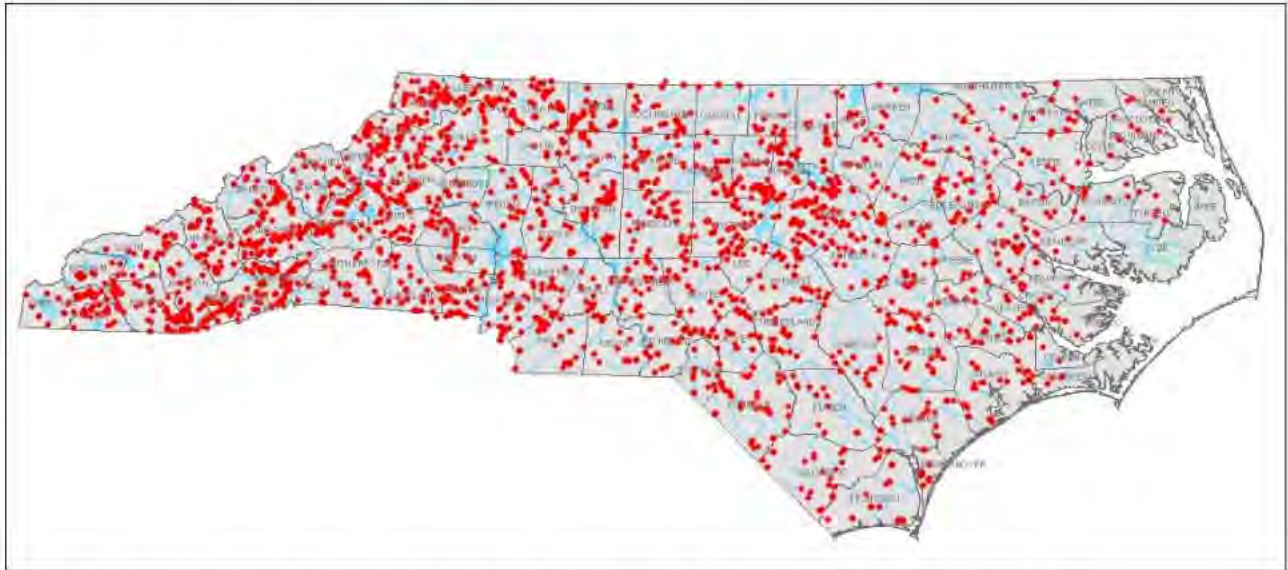
Figure A5.1 Benthic Macroinvertebrate Community Assessment Sites: 2005-2010.

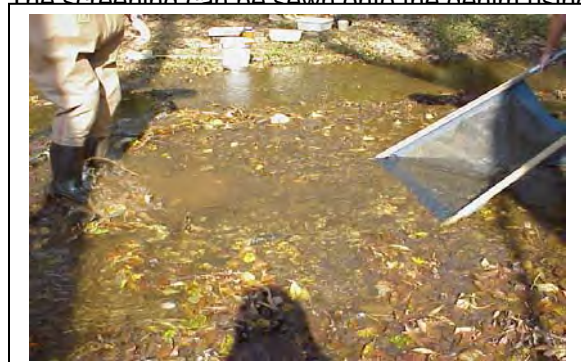
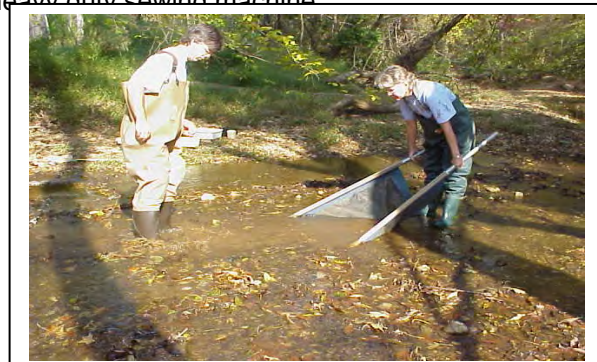
A kick net is an easily constructed and versatile sampling device. It consists of a double layer of flexible nylon door or window screening held in place between two halves of a wooden pole using wood screws. The screening is reinforced with denim along all edges and has lead weights sewn into the bottom edge. The screening can be sewn onto the denim using a heavy duty sewing machine.

The net is positioned upright on the stream bed, while the area upstream is physically disrupted using feet and/or hands. The debris and organisms in the kick net are then washed down into a sieve bucket with a US Standard No. 30 mesh (0.600 mm opening) bottom, and larger leaves and debris are removed. DWQ biologists have found that this technique gives very consistent results. If too coarse a mesh is used for the kick net, many animals will not be retained. If too fine a mesh is employed, the net clogs easily and washout becomes a problem. The double layer of screening works well in this respect.

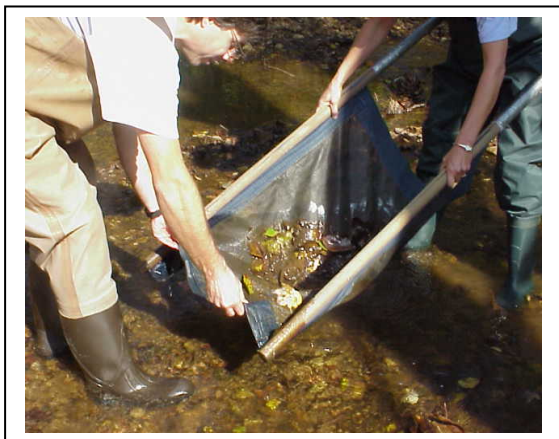
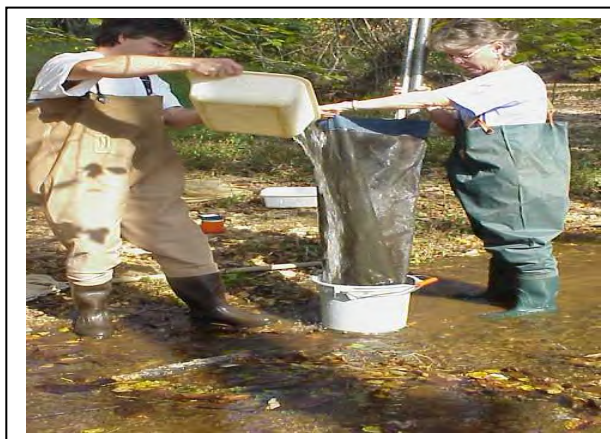
Two kicks are taken from riffle areas. The two samples should be collected from areas of differing current speed. In very small streams, or in sandy areas lacking riffles, kicks should be taken from root masses, snags, or bank areas. All types of benthic macroinvertebrates are collected by this sampling device, but emphasis is placed on Ephemeroptera, Plecoptera and Trichoptera.

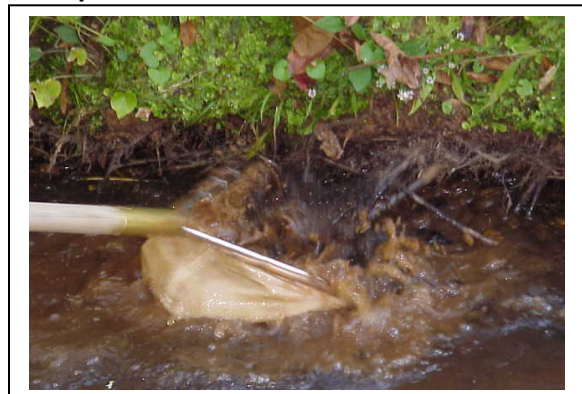
Sweep Net

A long-handled triangular sweep net is another versatile sampling device. Three samples are taken by physically disrupting an area and then vigorously sweeping through the disturbed area. Sweeps are usually taken from bank areas, including mud banks and root masses, and macrophyte beds. Bank samples are particularly important for the collection of "edge" species which prefer low current environments. Look for Chironomini (red chironomids), Oligochaeta, Odonata, mobile cased Trichoptera, *Sialis*, Crustacea, and certain Ephemeroptera. A sweep net also can be used to sample gravel riffle areas where stone-cased Trichoptera may be abundant.

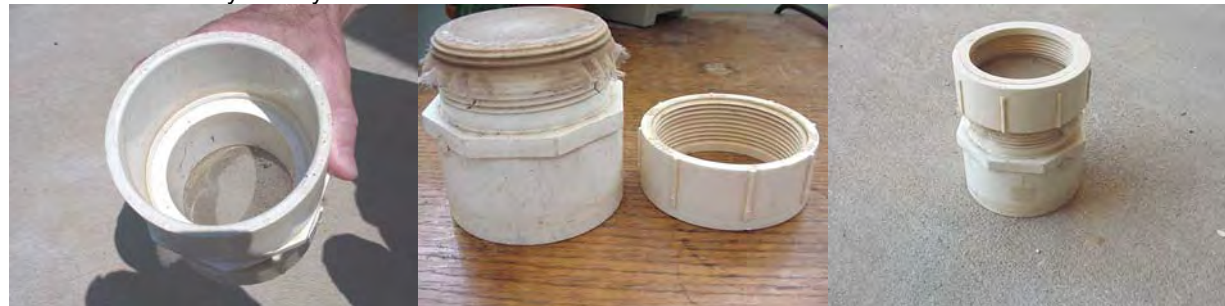
Fine-Mesh Sampler

Since the kick and sweep nets utilize a relatively coarse mesh size, an alternate sampling technique was devised to sample the smaller invertebrates (especially the Chironomidae). The resulting sampler is known as a "chironomid-getter". Fine nitex mesh (300 microns) is placed between four inch PVC pipe fittings that are designed to screw together. The exact dimensions are not critical, but the cylinder should be able to fit inside another container, usually a slightly larger, round plastic container. This device can be used in a variety of ways.

The simplest technique is to wash down rocks or logs in a large plastic tub partially filled with water. Rocks are selected which have visible growths of periphyton, *Podostemum*, or moss. Any large

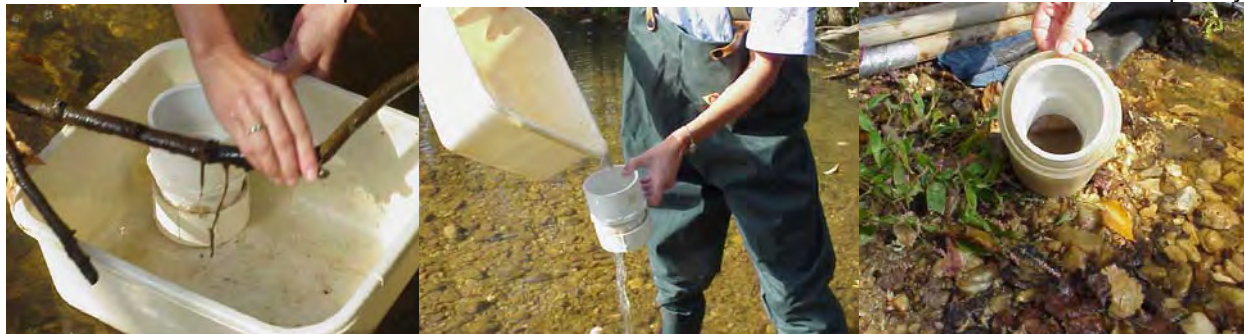
particulate material (leaves, etc.) is washed down and discarded. A single composite sample can be made from several (usually 10-15) rocks and/or logs. The material remaining in the tub is poured through the fine mesh sampler and the water allowed to drain out completely.

The residue is preserved in 95% ethanol. This is accomplished by placing the fine mesh sampler into another container (6 cup size round plastic food storage container works well) which is half filled with alcohol.

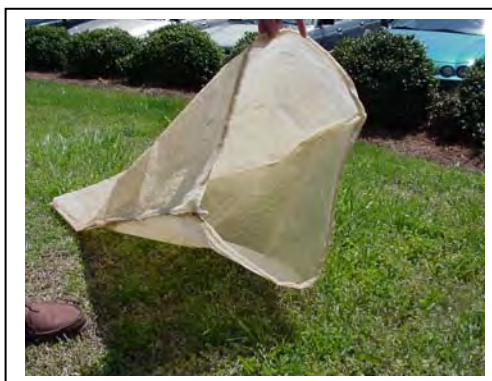
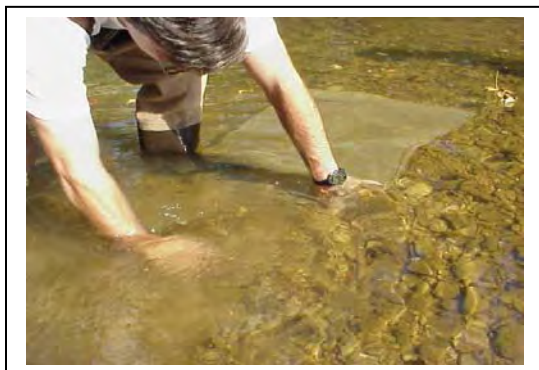
Sand Sample

Sandy habitats often contain a distinct fauna, but extraction of this fauna by means of dredge-type sampling can be tedious. Sandy substrates (in areas with definite flow, if possible) are sampled with a large bag constructed of fine mesh (300 microns) nitex netting. It can be quickly constructed from a one meter square piece of netting, folded in half and sewn together on the opposite side and the bottom. This bag is employed like a Surber sampler, but the lack of a rigid frame allows for easy storage when folded.

The bag is held (open) near the

substrate with the left foot holding the bag on the sand, and the sand is vigorously disturbed by the collector's other hand or foot. The material collected (a lot of sand and a few organisms) is emptied into a large plastic container half-filled with water. A "stir and pour" elutriation technique is used in conjunction with the fine mesh sampler. After field preservation, the elutriate is picked, looking especially for small Chironomidae (*Cryptochironomus*, *Robackia*, *Rheosmittia*, *Harnischia* group, *Polypedilum*), oligochaetes, and Baetidae. The remaining sand can be picked quickly for large or heavy

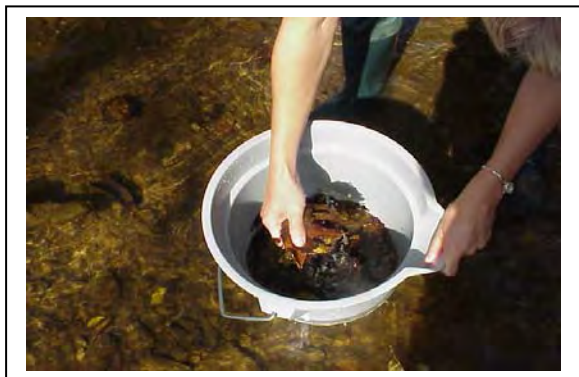
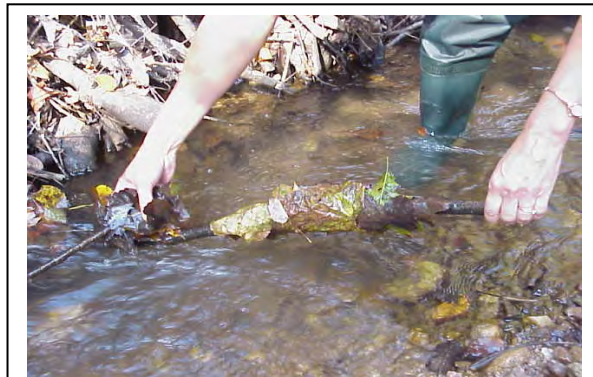
Leaf-packs, sticks and small logs are washed down in a sieve bucket with a U.S. Standard No. 30 sieve (0.600 mm openings) bottom, and then discarded. Generally, three to four leaf packs are collected from rocks or snags in fast current areas. The best leaf packs consist of older leaves (not freshly fallen) that have begun to decay. Piles of leaves in pool areas should not be collected. Leaf-pack and small log

samples are particularly useful in large sandy rivers. In such habitats, many of the species are confined to "snags" (Benke et al. 1984, Neuswanger et al. 1982). Look for "shredders", especially Tipulidae, Plecoptera, and Trichoptera.

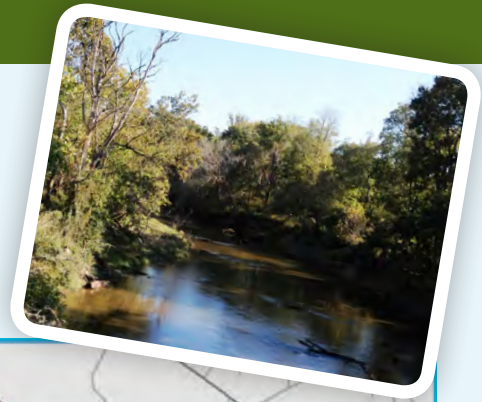
Stream sections for adoption in Wake Forest

The map below shows the different sections of streams in the Adopt-A-Stream program. When signing up, you may indicate your preference for a specific section.
