Assessment Report: Biological Impairment in the Clayroot Swamp Watershed

Neuse River Basin
Pitt County, NC

North Carolina Division of Water Quality
February 2004

Collaborative Assessment for Watersheds and Streams (CAWS) Project
Funded by EPA 104(b)(3) Grant #CP984724-99

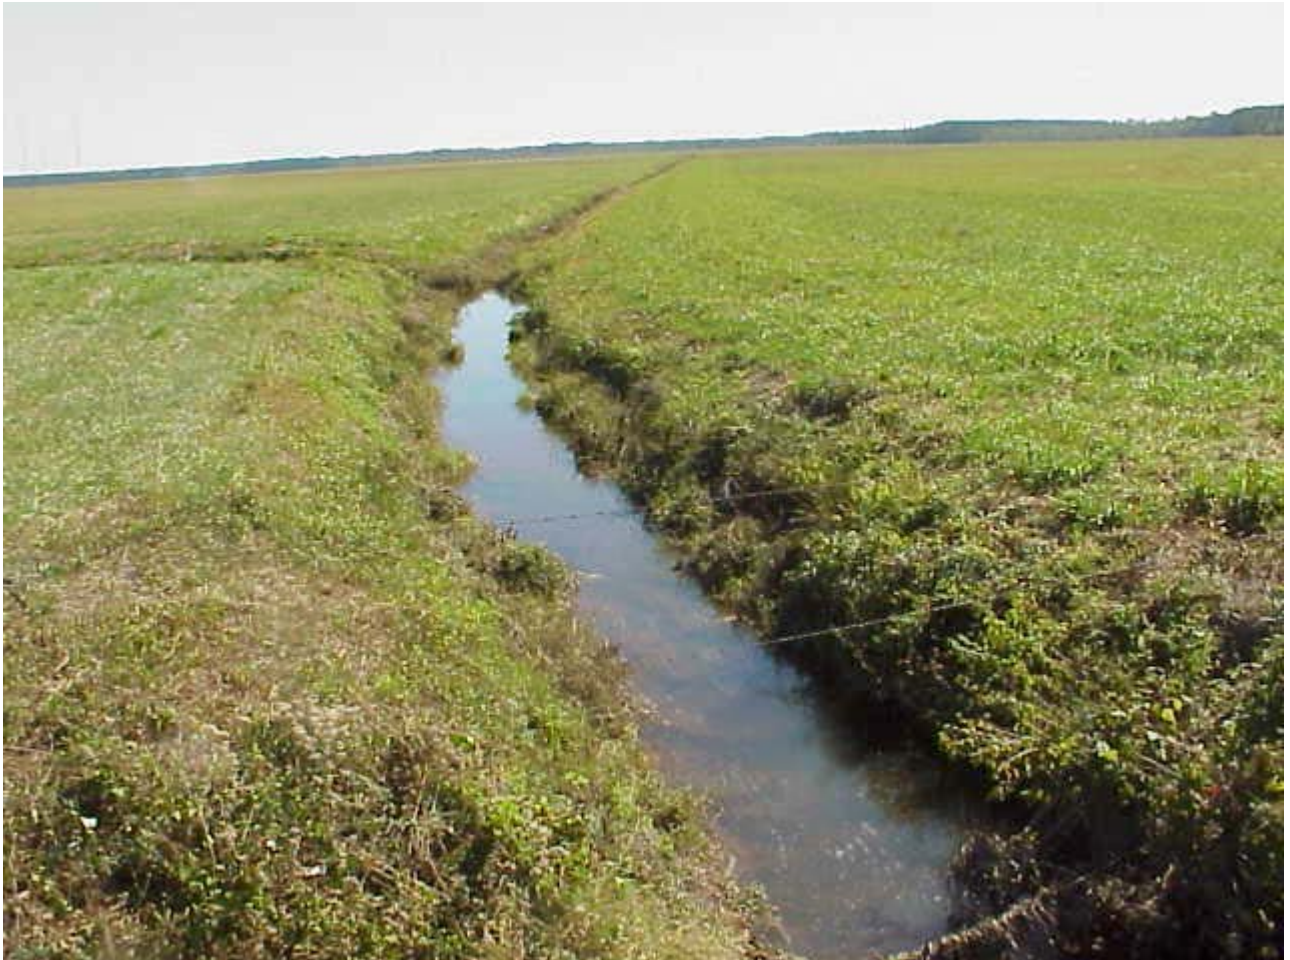
Fig. 1. Clayroot Swamp near headwaters showing channelized streambed .

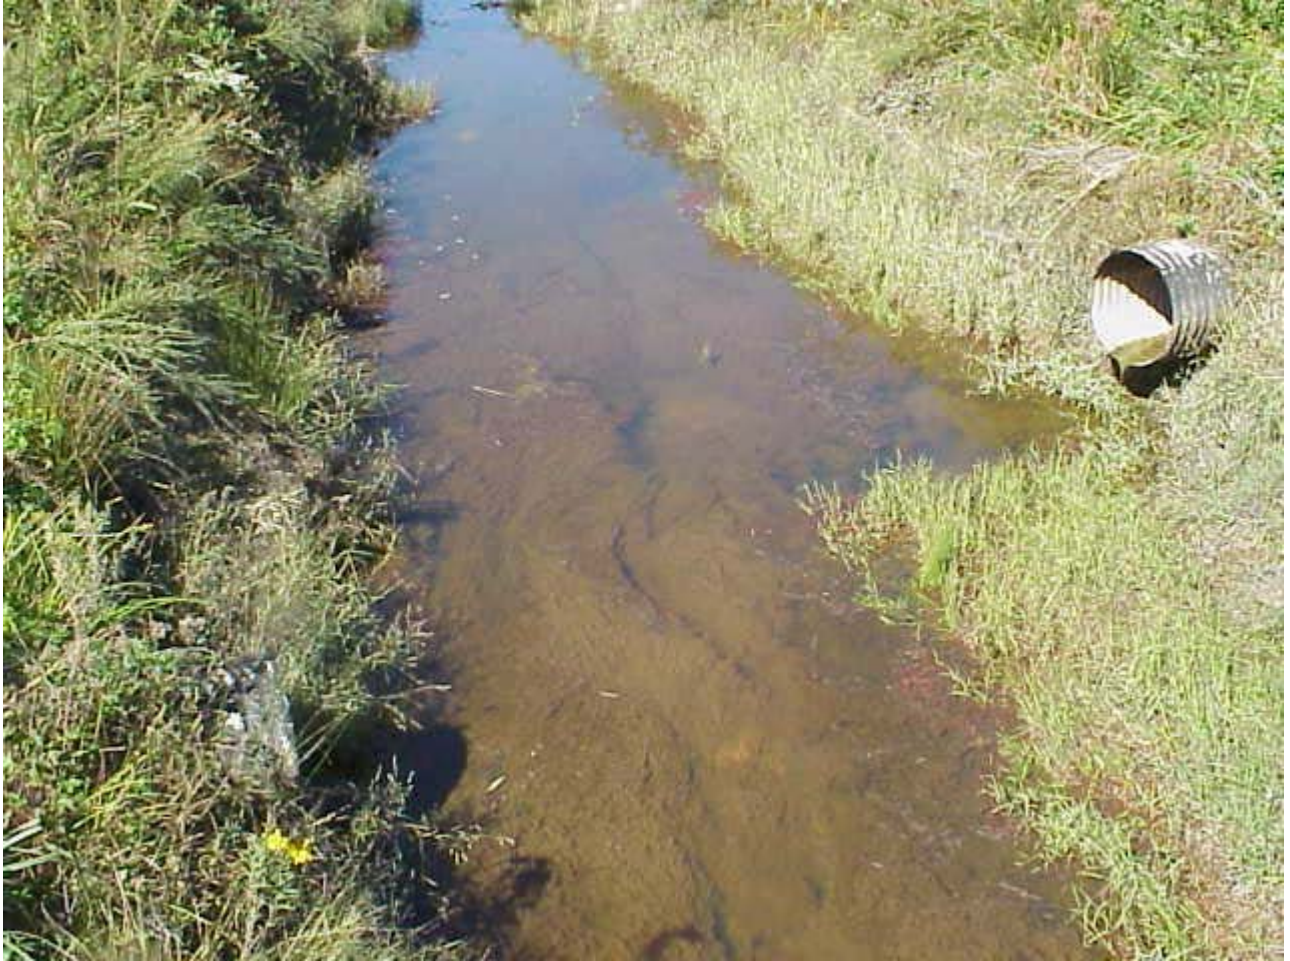
sampling indicated that water appeared to be turbid and nutrient enriched with bottom substrate heavily covered with algae at most sites in the upper watershed. The lower reach of Clayroot Swamp exhibited severe erosion of the sandy banks and increased flow. Presence of the sandy soils in the watershed in combination with existing land use practices resulted in severe erosion and significant sedimentation.

Fig. 2. Clayroot Swamp, upper watershed, channelized, nutrient enriched.

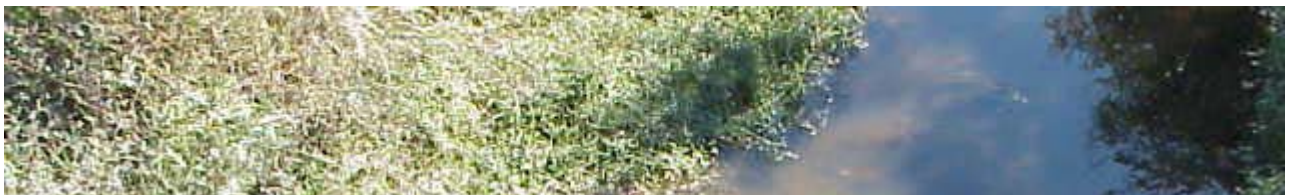
Chemical analyses of the samples collected from Clayroot Swamp provide strong evidence of nutrient enrichment. Concentration of nitrogen and phosphorus is frequently high. Biological indicators such as significant algal growth support this conclusion. Poorly drained sandy soils that dominate the watershed in combination with a network of drainage channels provide ideal conditions for fast delivery of nutrients from agricultural fields to the stream.

Fig. 3. Clayroot Swamp, middle watershed, algal mats.

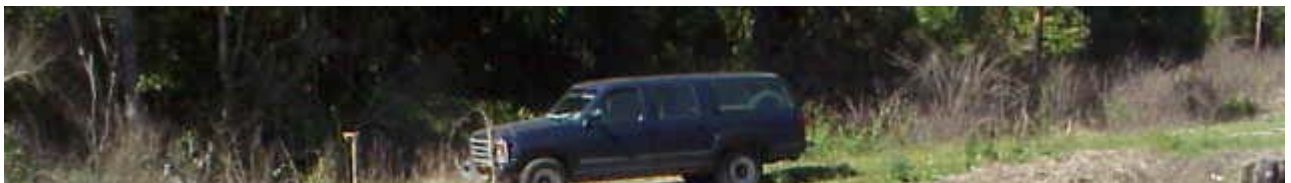
Fig. 4. Clayroot Swamp, lower watershed, sandy bank erosion.

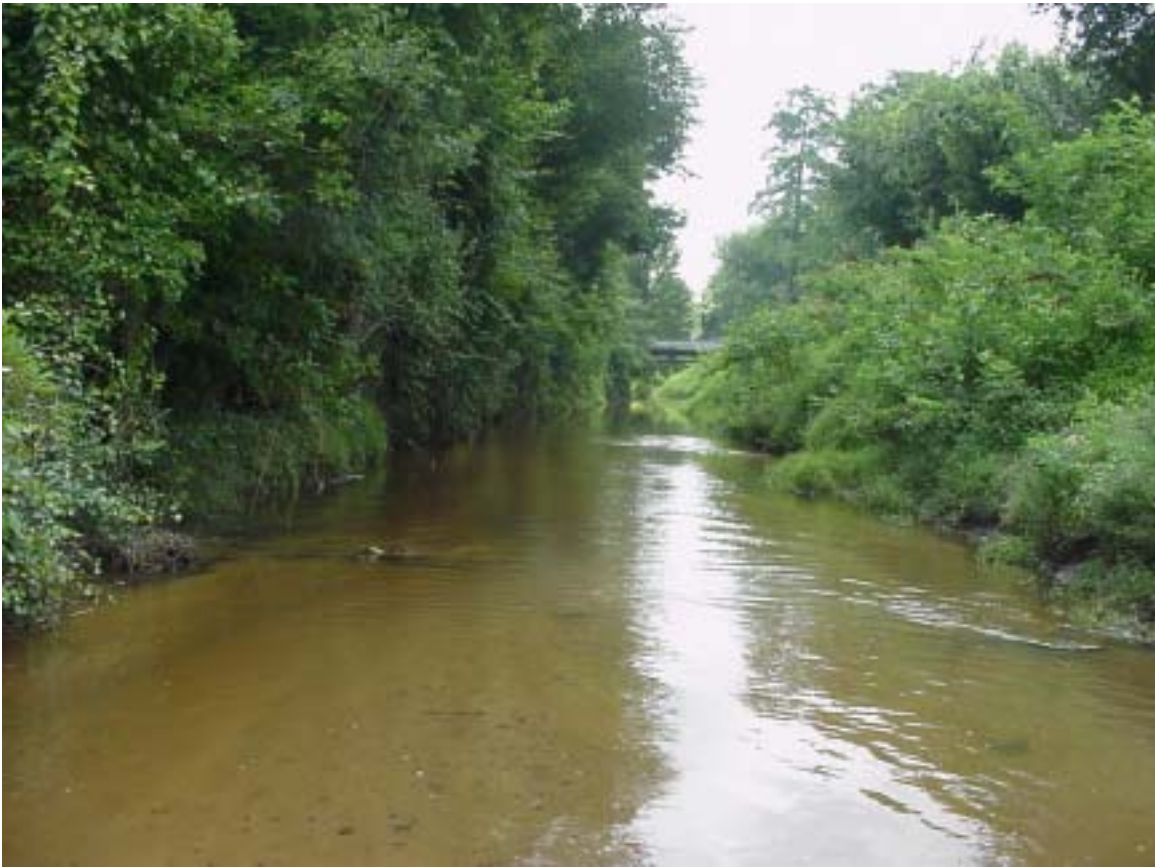
Watershed evaluations conducted over the past 10 years indicate that sedimentation has a serious negative impact in macroinvertebrates of Clayroot Swamp. Constant influx of sand from erosion, and dredging operations covers stream bottom with a layer of sand and fills in pools and riffles. In addition, sand substrate is constantly shifting, which negatively affects recolonization and reproduction of aquatic organisms.

Fig. 6. Clayroot Swamp, lower reach, sedimentation.

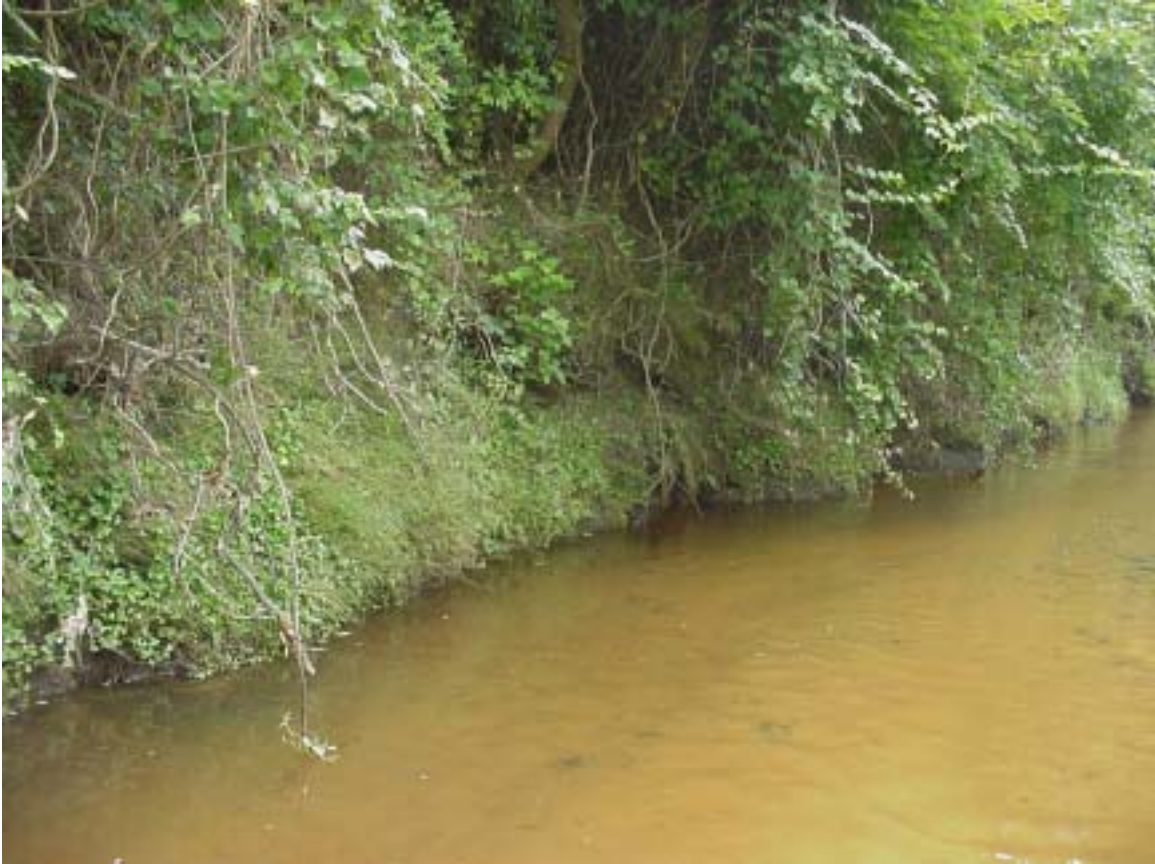
Observation of several reaches of Clayroot Swamp showed that scour is very pervasive, especially in the lower reaches. Networks of ditches quickly deliver stormwater to the stream, which creates conditions that cause pronounced channel incision.

Fig. 7. Clayroot Swamp, lower reach, incision.
