LETTER OF TRANSMITTAL

Remarks: On behalf of the Environmental Bank & Exchange, LLC (EBX), EcoEngineering is submitting
a revised Ezell Mitigation Site Bank Parcel Development Package

Ezell Riparian Buffer & Nutrient Offset Mitigation Site
 GRANVILLE COUNTY, NORTH CAROLINA

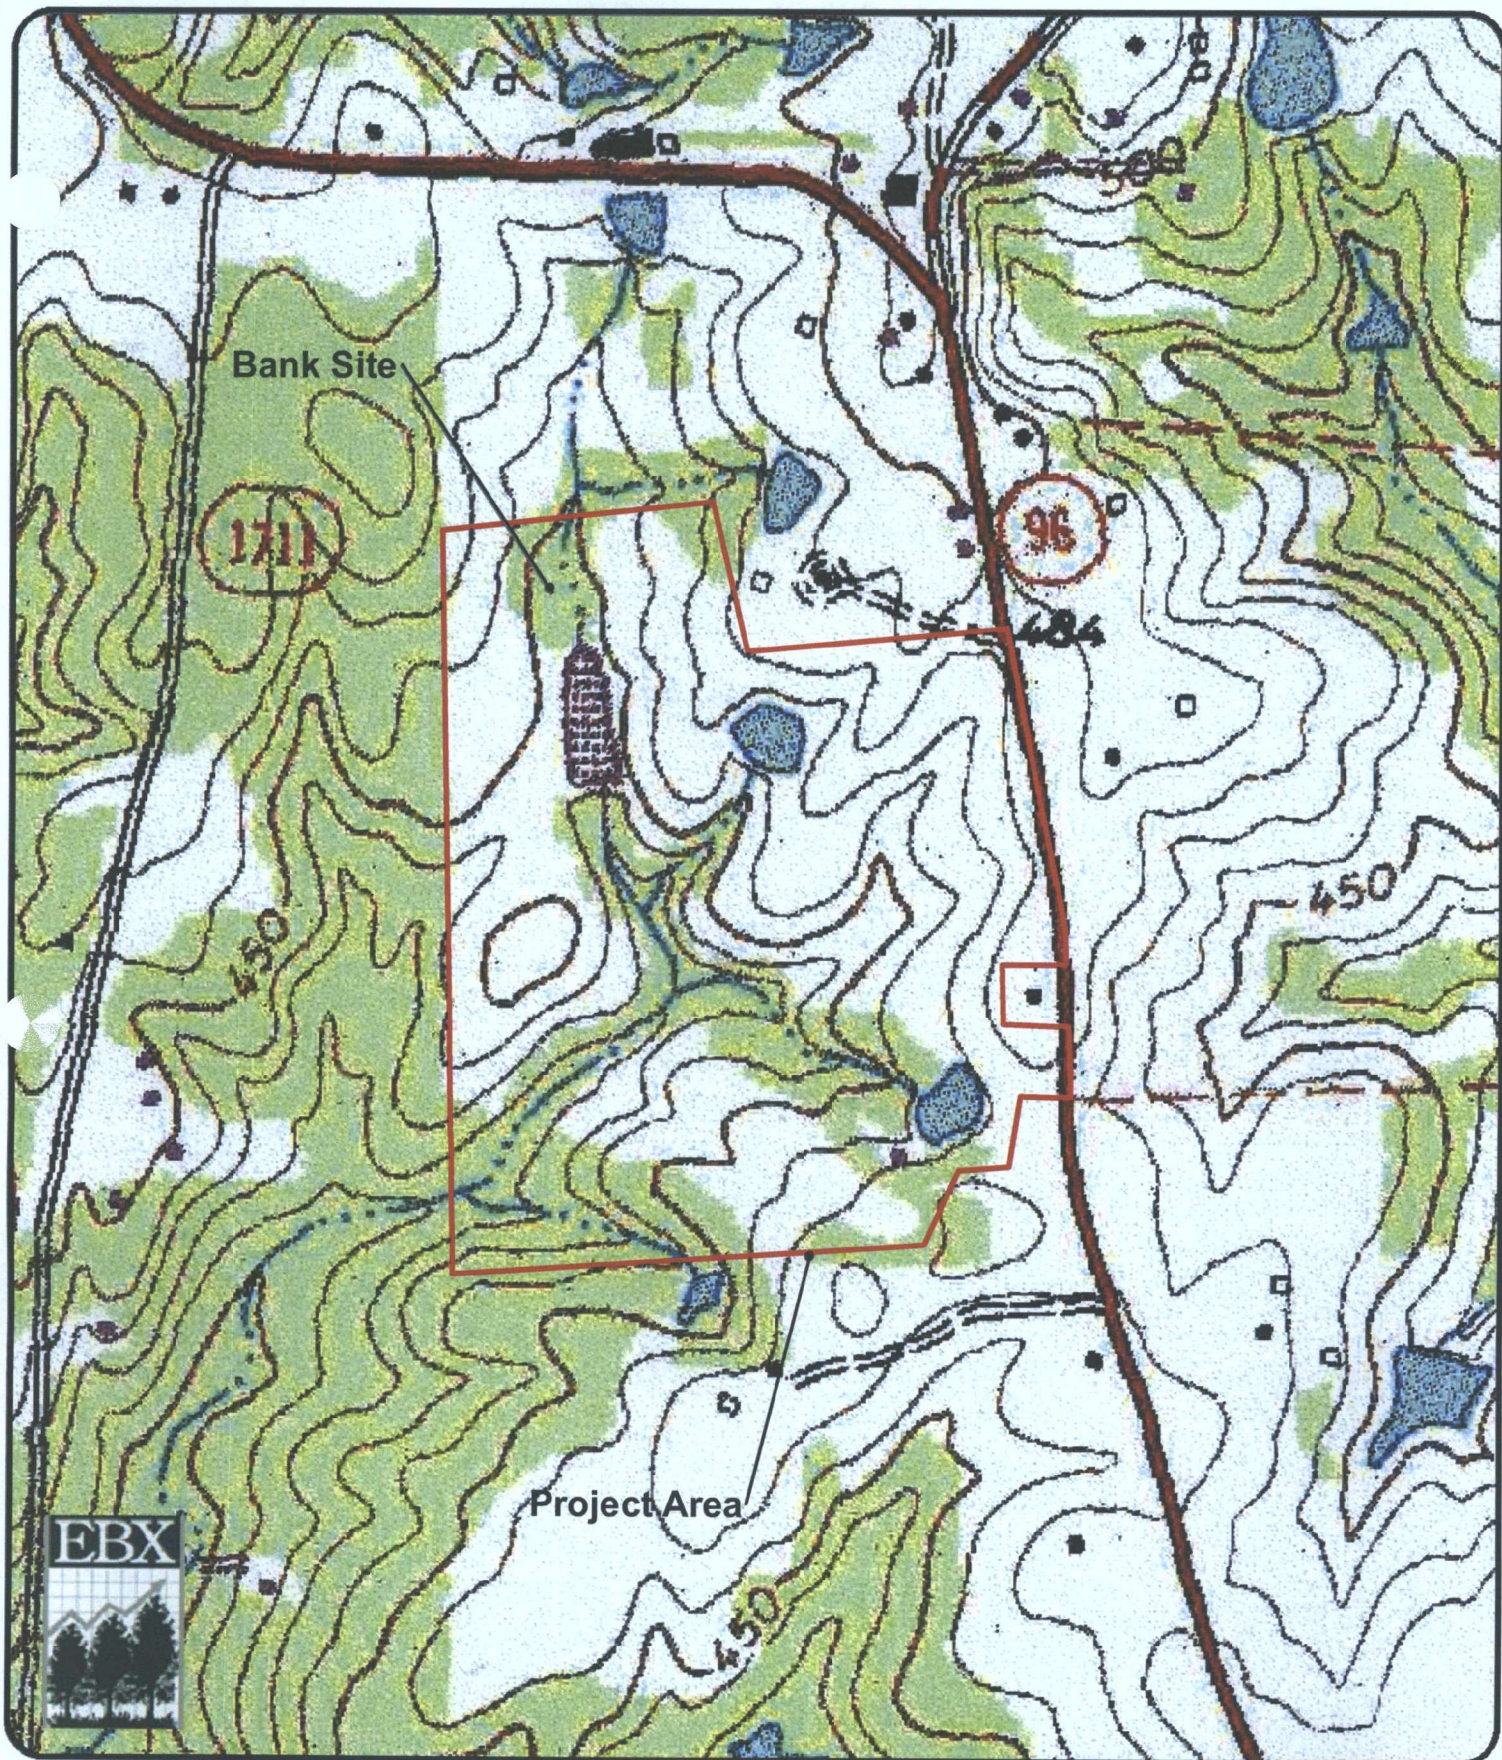
Figure 4

**EZELL BANK SITE
USGS SITE MAP**

Based upon review of the United States Geological Survey (USGS) Grissom, North Carolina Quadrangle, the Site contains low to moderate relief with elevations ranging from \pm 430 feet to \pm 460 feet. The Site has a topographic gradient that generally slopes southwest towards unnamed tributaries to Smith Creek. Surface drainage is generally directed southwest into unnamed tributaries to Smith Creek (**Figure 4**).

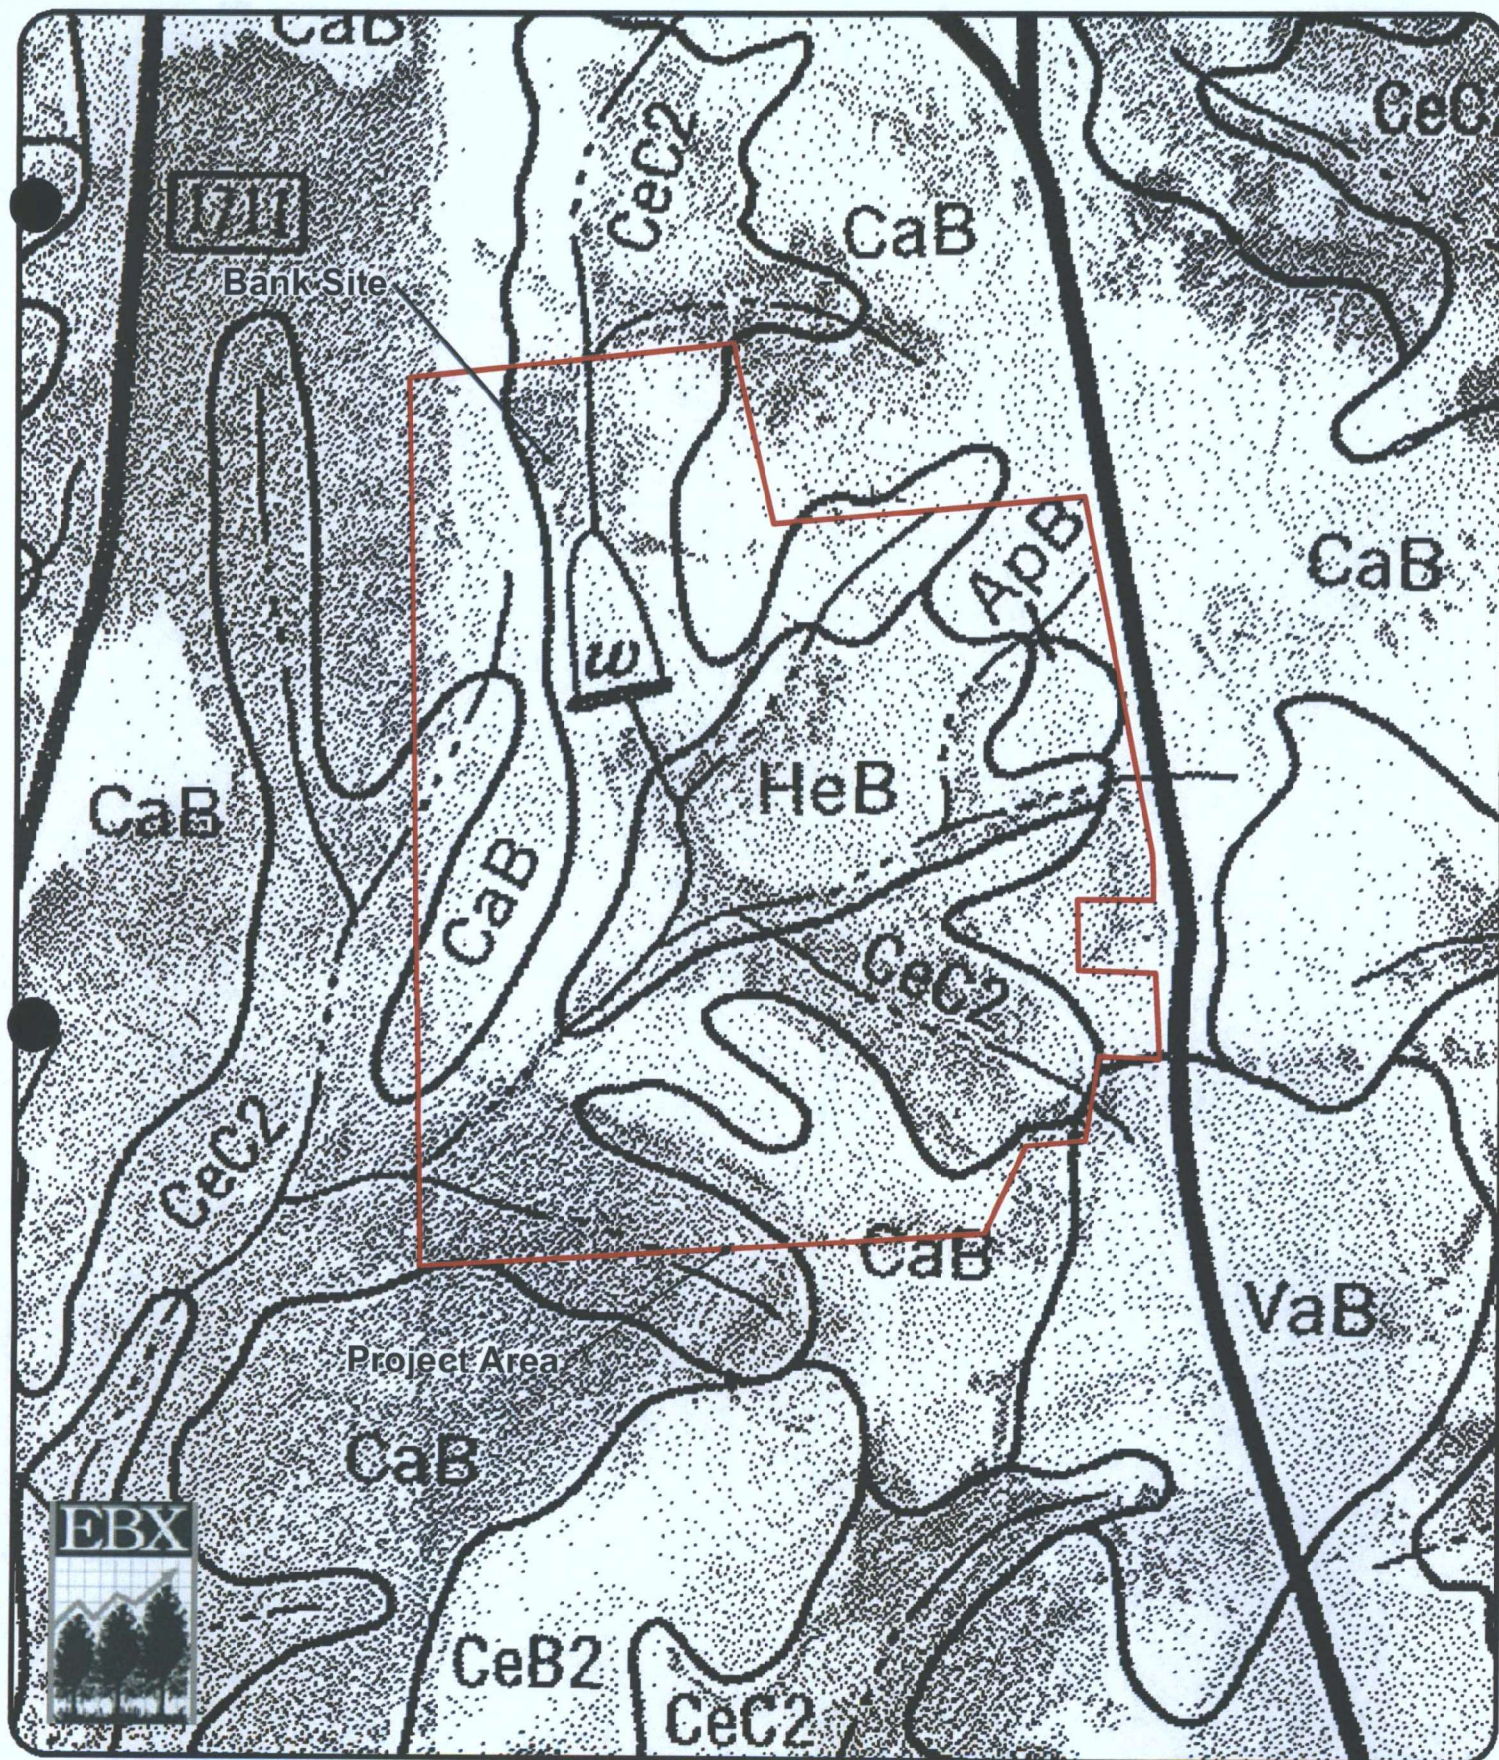
Figure 6

ZONE X

EZELL BANK SITE
FEMA FLOODPLAIN / FLOODWAY MAP

As shown in **Figure 6**, the Site does not contain areas designated by the Federal Emergency Management Association (FEMA) as floodway or 100-year floodplain. Therefore, no floodplain/floodway impacts are anticipated to occur as part of the restoration effort.

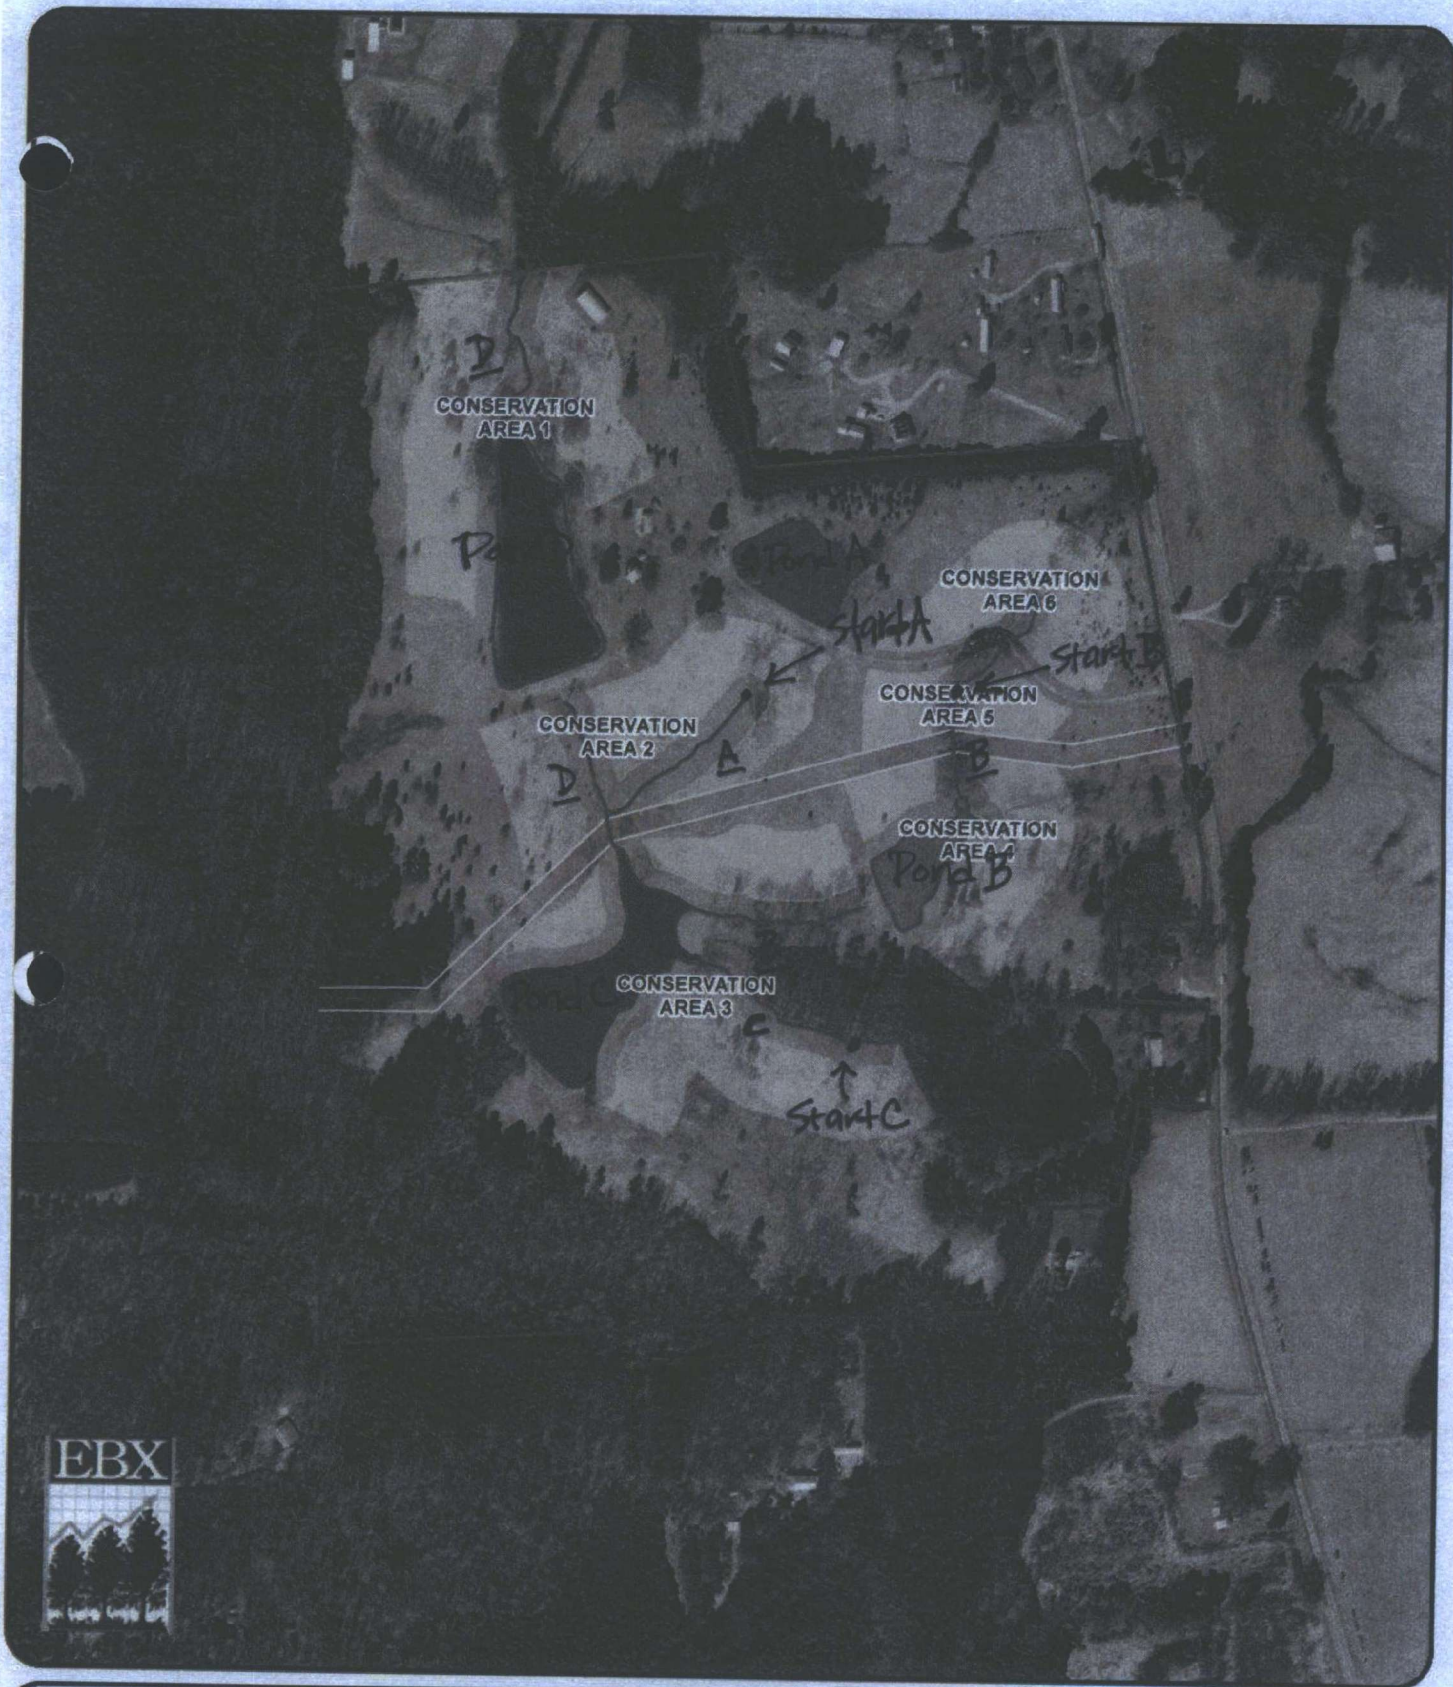
Figure 2A

EZELL BANK SITE
OVERALL PROPOSED NEUSE BUFFER &
NUTRIENT OFFSET RESTORATION AREA

As mentioned in Section 2.2, natural forested areas are limited within many areas of the Site. In addition to cleared or non-forested areas, Neuse Riparian Buffer restoration will also be considered for those forested areas that are within 50 feet of the streams (intermittent or perennial) and ponds, but lacking adequate stem counts. Neuse Riparian Buffer restoration is defined as the process of converting a sparsely woody vegetated area (less than 100 trees per acre that are greater than or equal to five inches diameter at breast height for trees (15A NCAC 02B .0233 (2)(m)) to a forested riparian buffer area (15A NCAC 02B .0242). Nuisance and exotic vegetation are not included in the stem count. The areas proposed for restoration are shown on **Figure 2**. The existing trees and shrubs within the proposed restoration areas within the Site have been surveyed by EcoEngineering and the tree locations are shown on **Figure 2**.

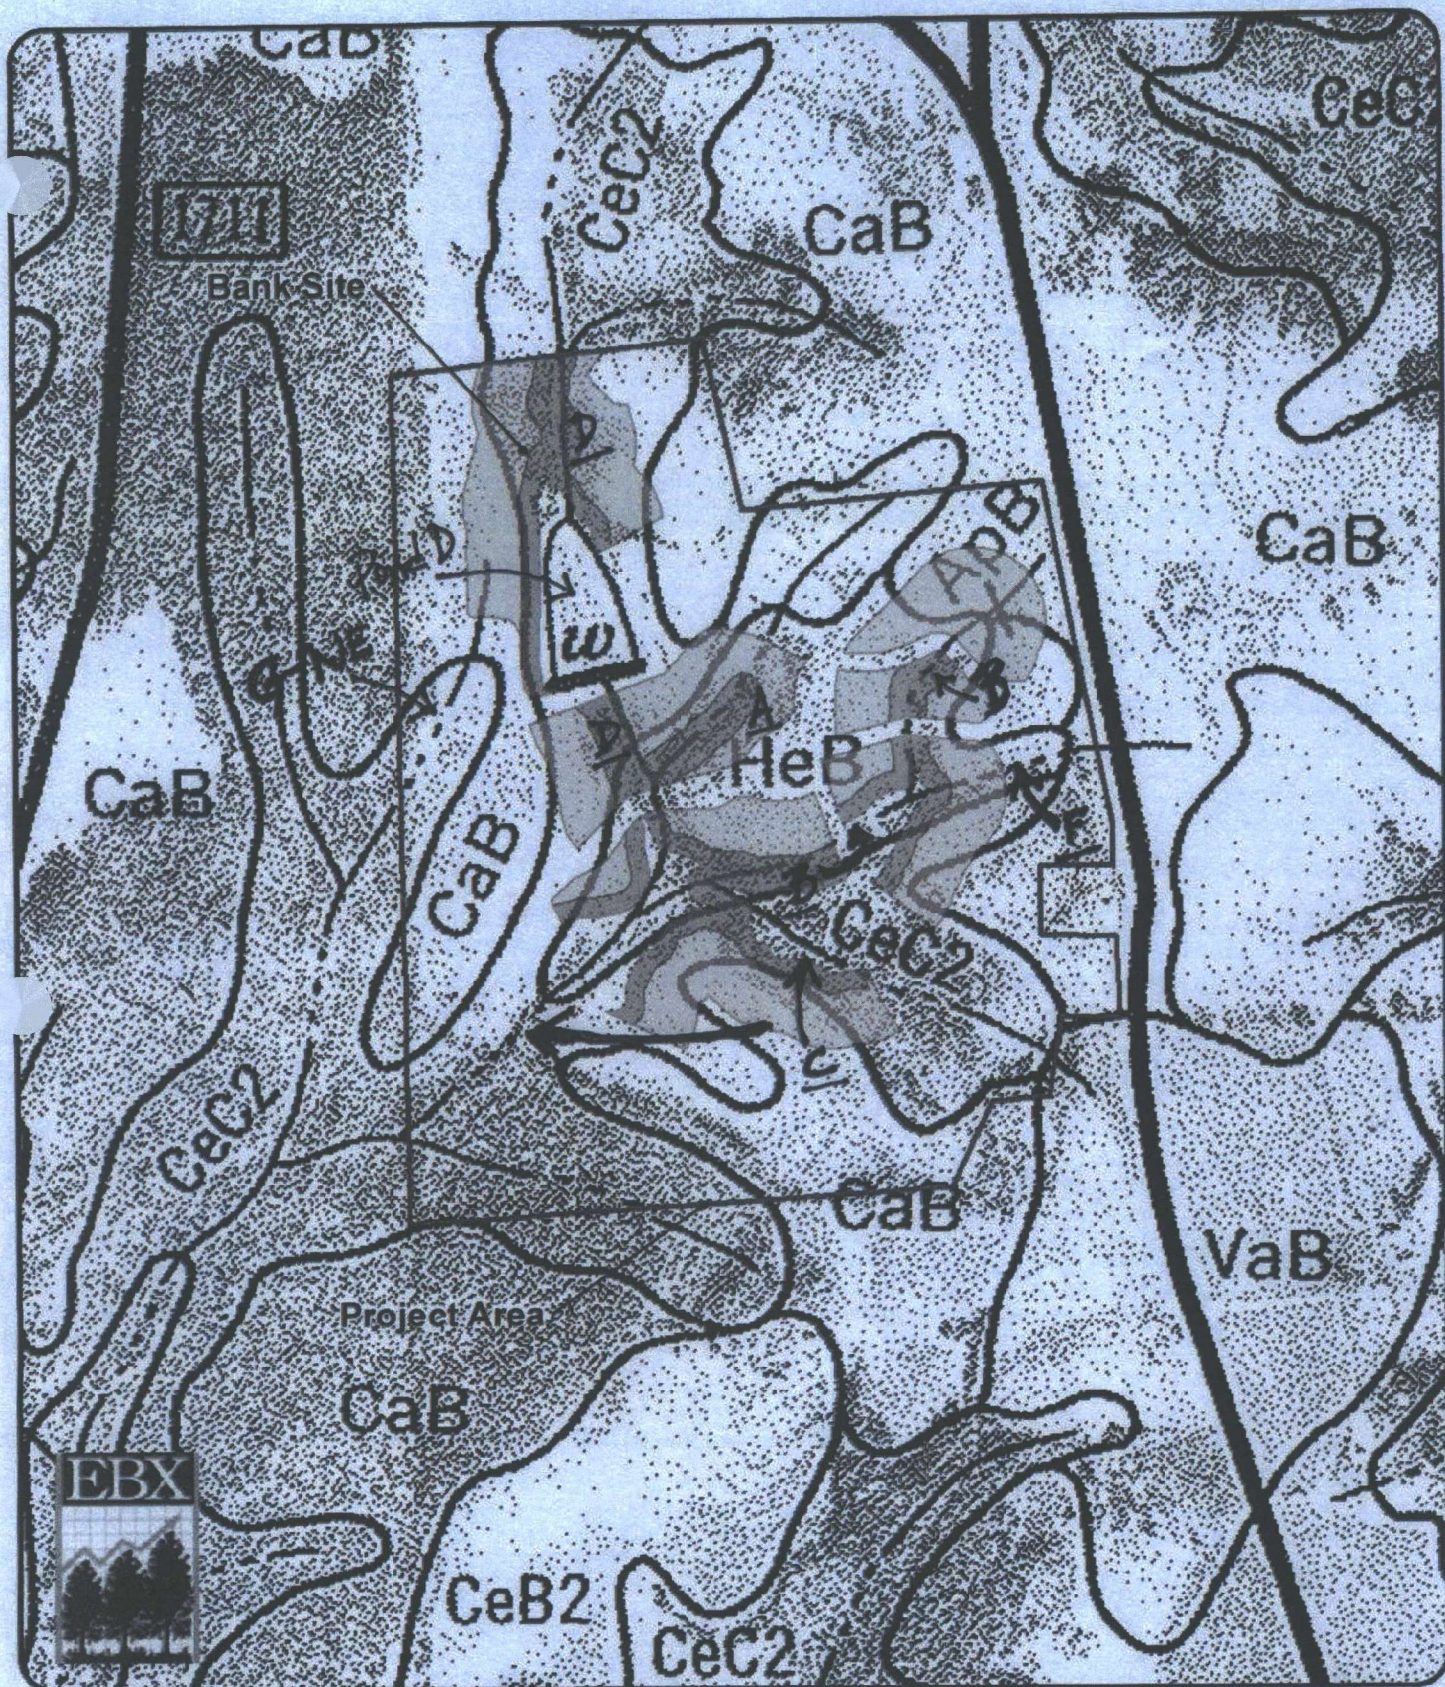
Figure 5

EZELL BANK SITE SOIL SURVEY MAP

The Soil Survey of Granville County, North Carolina (Soil Conservation Service, 1997) lists the soils within the Site as from the Cecil Association. As stated in the soil survey, these soils can be generally classified as gently sloping or moderately sloping well drained soils that have a loamy surface layer and a clayey subsoil. As described by the online USDA NRCS Official Soil Series Descriptions (OSD), the specific soils within the Site are shown on **Figure 5** and are listed, below, in **Table 1**:

Soil Type	Hydrologic Soil Group	General Description
Cecil sandy loam, 2 to 6% slopes (CaB)	HSG B	This well drained soil is on broad to narrow ridges within Piedmont uplands. The permeability is moderate, the available water capacity is high, and the shrink-swell potential is low.
Cecil clay loam, 6 to 10% slopes (CeC2)	HSG B	This well drained soil is located within Piedmont uplands along narrow hill slopes that are strongly sloping. The permeability is moderate, the available water capacity is high, and the shrink-swell potential is low.
Helena sandy loam, 2 to 8% slopes (HeB)	HSG C	This moderately well drained soil is on broad ridges. The permeability is slow, the available water capacity is low, and the shrink-swell potential is high. The seasonal high water table is below a depth of 60 inches, but because of the slow permeability, a perched water table is 12 to 30 inches below the soil surface during wet seasons.

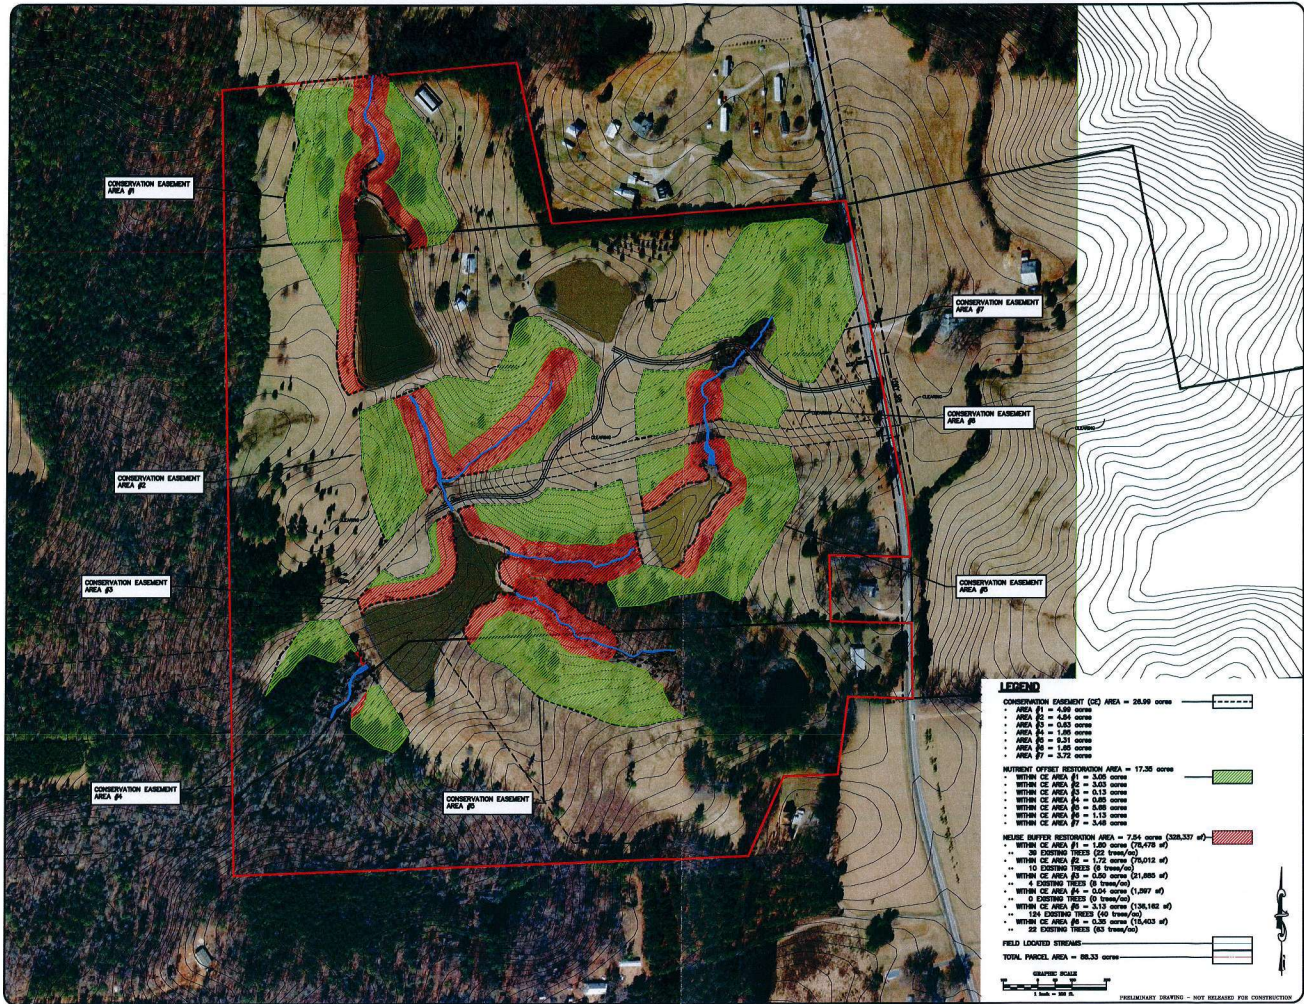
2

OVERALL PROPOSED WETLAND BUFFER & NUTRIENT OFFSET RESTORATION AREAS
