Evans Ballahack Bank Parcel Development Package

GES Tar-Pamlico River Basin Umbrella Mitigation Bank
Greene Environmental Services, LLC
7/17/2013

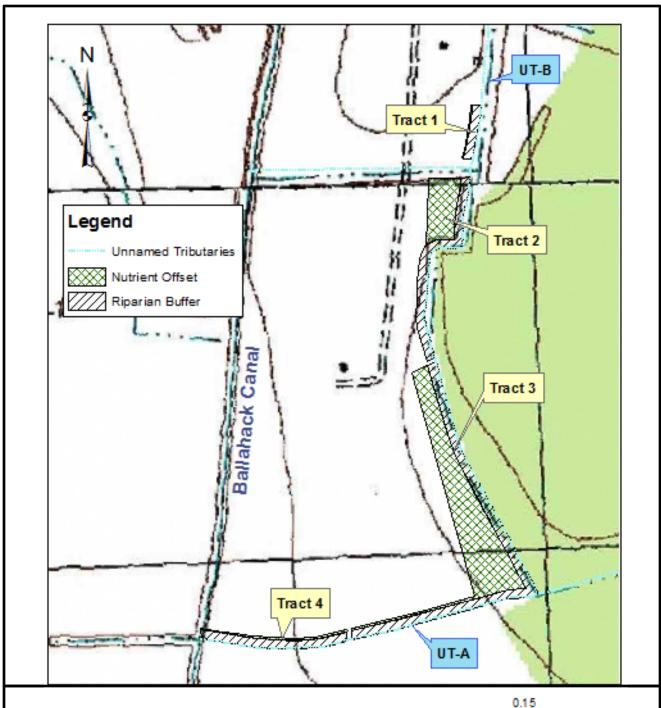
Figure 2 – USGS Topographic Map

Based upon review of the United States Geological Survey (USGS) Conetoe and Speed, North Carolina Quadrangles, the proposed Bank Parcel is located adjacent to the Ballahack canal with elevations ranging from ± 49-feet to ± 53-feet. Topographic relief and surface drainage is generally south and east (Figure 2). The property is located within the Upper Coastal Plain Physiographic Province, within the Southeastern Plains Ecoregion (more specifically the Southeastern Floodplains and Low Terraces subtype). The Southern floodplain forest subtype predominantly includes primarily bottomland hardwood forest and cypress-gum swamp vegetative communities

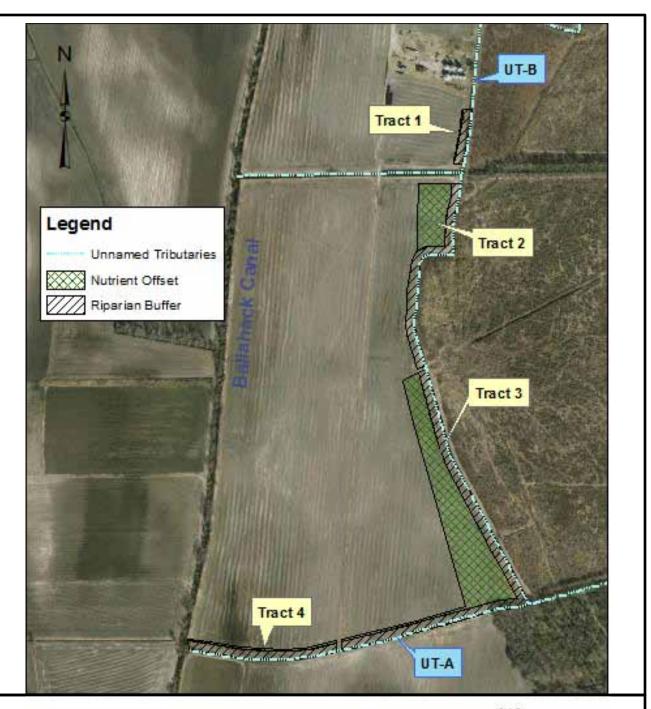
Figure 3 – Aerial Map

The entire Evans Ballahack Bank Parcel was planted in soybeans during the 2012 growing season (Figure 3). However, crop production was poor on approximately two-thirds of the project area during that time due to high soil saturation. Consequently, much of the zone within 50 feet of the stream and within the proposed nutrient offset buffer was colonized by annual grasses (*Poa* spp.), sedges (*Eleocharis* sp., *Caryx* spp.) and other herbaceous species including horse nettle (*Solanum carolinense*), amaranth (*Amaranthus* sp.), purslane (*Portulaca* sp.), ironweed (*Veronia* sp.) and blue dayflower (*Commelina* sp.).

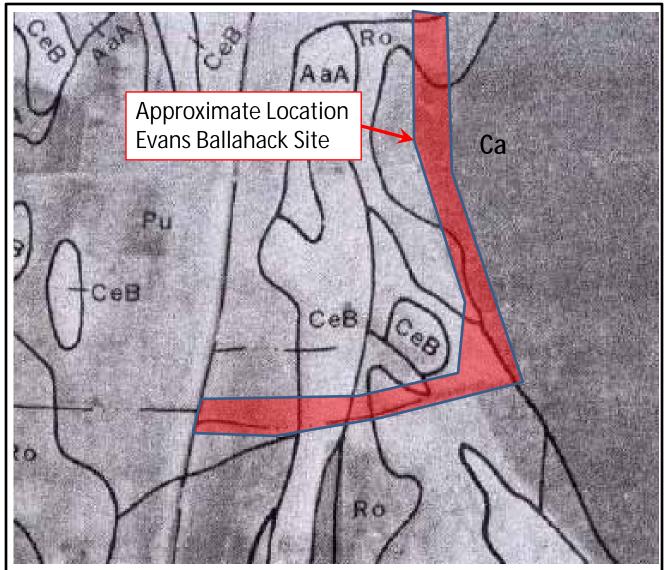
Figure 4 – Soils Map

The Soil Survey of Edgecombe County, North Carolina (Soil Conservation Service, 1979) lists the soils within the property as from the Wehadkee-Congaree Association. These soils are primarily located in "broad areas along streams". As described by the online USDA NRCS Official Soil Series Descriptions (OSD), the specific soils within the project area (Figure 4) are shown below in Table 1:

AaA: Altavista fine sandy loam

Ca: Cape Fear loam

Pu: Portsmouth fine sandy loam

Ba: Ballahack fine sandy loam

CeB: Conetoe loamy sand

Ro: Roanoke Ioam

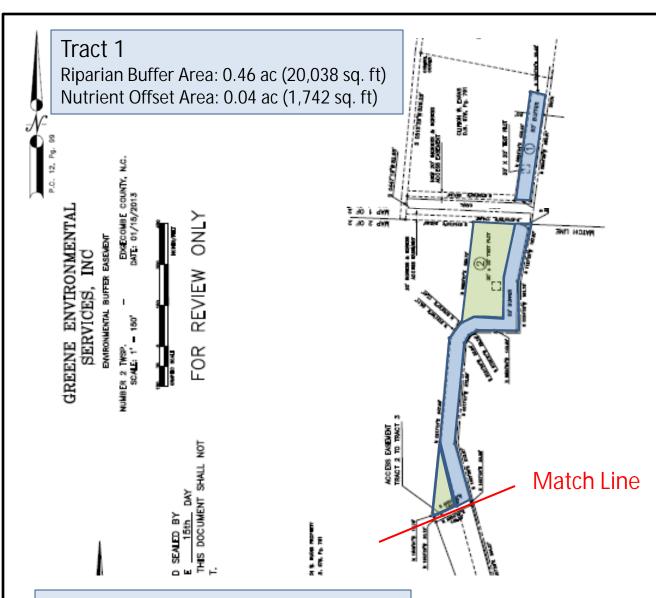
Figure 5a – Survey Excerpt

Riparian Buffer Area: 1.26 acres (54,886 sq. ft) Nutrient Offset Area: 1.56 ac (67,954 sq. ft)

Tar-Pamlico Buffer Area

Nutrient Offset Area

Bareroot seedlings of character trees (Table 3), live stakes of locally obtained woody species and containerized plants were planted in March 2013 within the proposed conservation easement area (Figures 5a & 5b). "Character Trees" are defined as planted or volunteer species identified from a survey of local vegetation on less degraded sections of the specified stream and from reference literature that details native species. Bareroot seedlings were purchased from Claridge Nursery (NC DFR) in Goldsboro, NC and live stakes were obtained adjacent to the site. Mowing and other vegetation management practices may be implemented during the initial years of tree establishment on the site to prevent the establishment of invasive species that will attempt to out-compete the planted native vegetation.

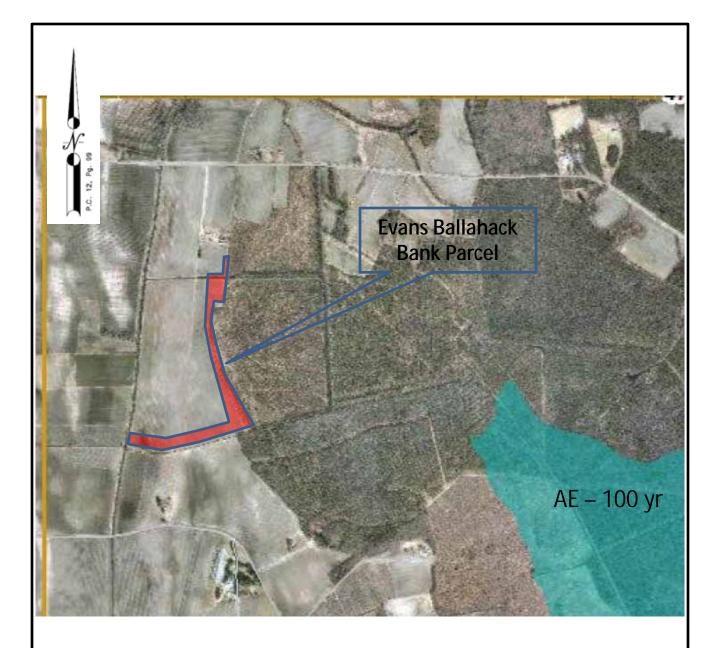
Figure 6 – FEMA Floodplain/ Floodway Mapping

As shown in Figure 6, the Evans Ballahack Bank Parcel does not contain areas designated by Federal Emergency Management Association (FEMA) as floodway or 100-year flood boundary. Therefore, no floodplain or floodway impacts are anticipated.

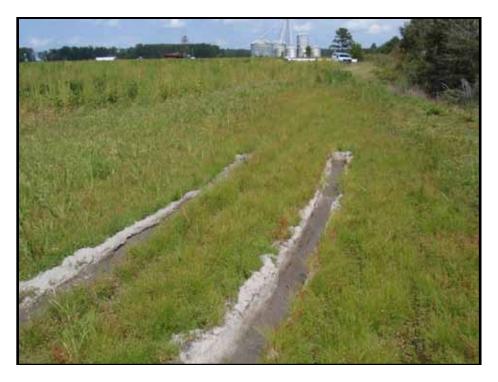
Photograph 3. View to north along UT-B (Tract 2); note ruts in poorly drained soils and crop failure.

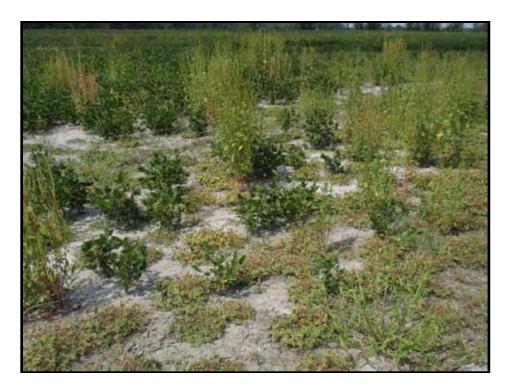
Photograph 5. Minimal soybean crop establishment within proposed buffer (Tract 3).

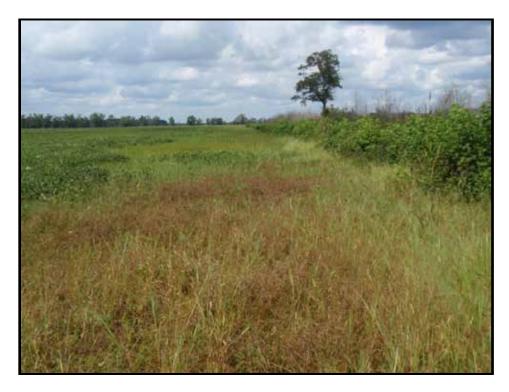
Photograph 6. Southern end of UT-B, note crop failure within proposed project area.

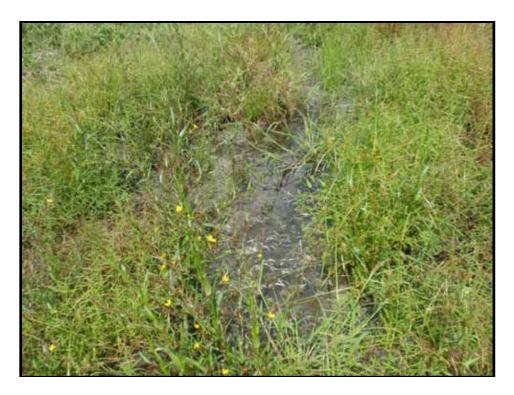
Photograph 7. Standing water in poorly drained soil within propossed buffer at south end of UT-B.

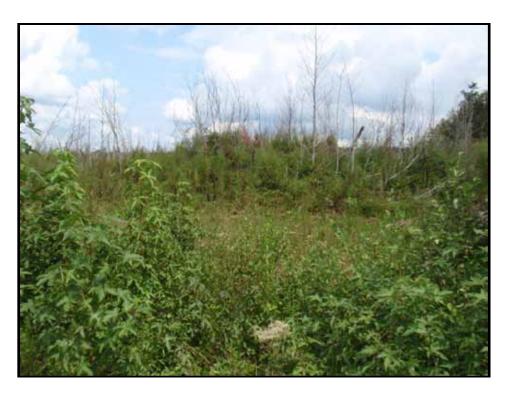
Photograph 13. Land use on opposite side of stream along UT-B; early succession vegetation in cut-over with standing dead woody vegetation killed by herbicide application 1-2 years prior.

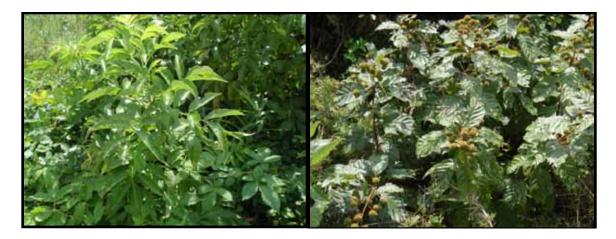
Photograph 16. Shrub species growing in stream channel that can be used for live stakes in proposed project site; left: elderberry (*Sambucus canadensis*), right: buttonbush (*Cephalanthus occidentalis*).
