2003 Monitoring Report for the Miller et al. Mitigation Site on Meat Camp Creek, Watauga County

North Carolina Department of Transportation Stream Mitigation Program

Transportation Improvement Project R-529

December 2003

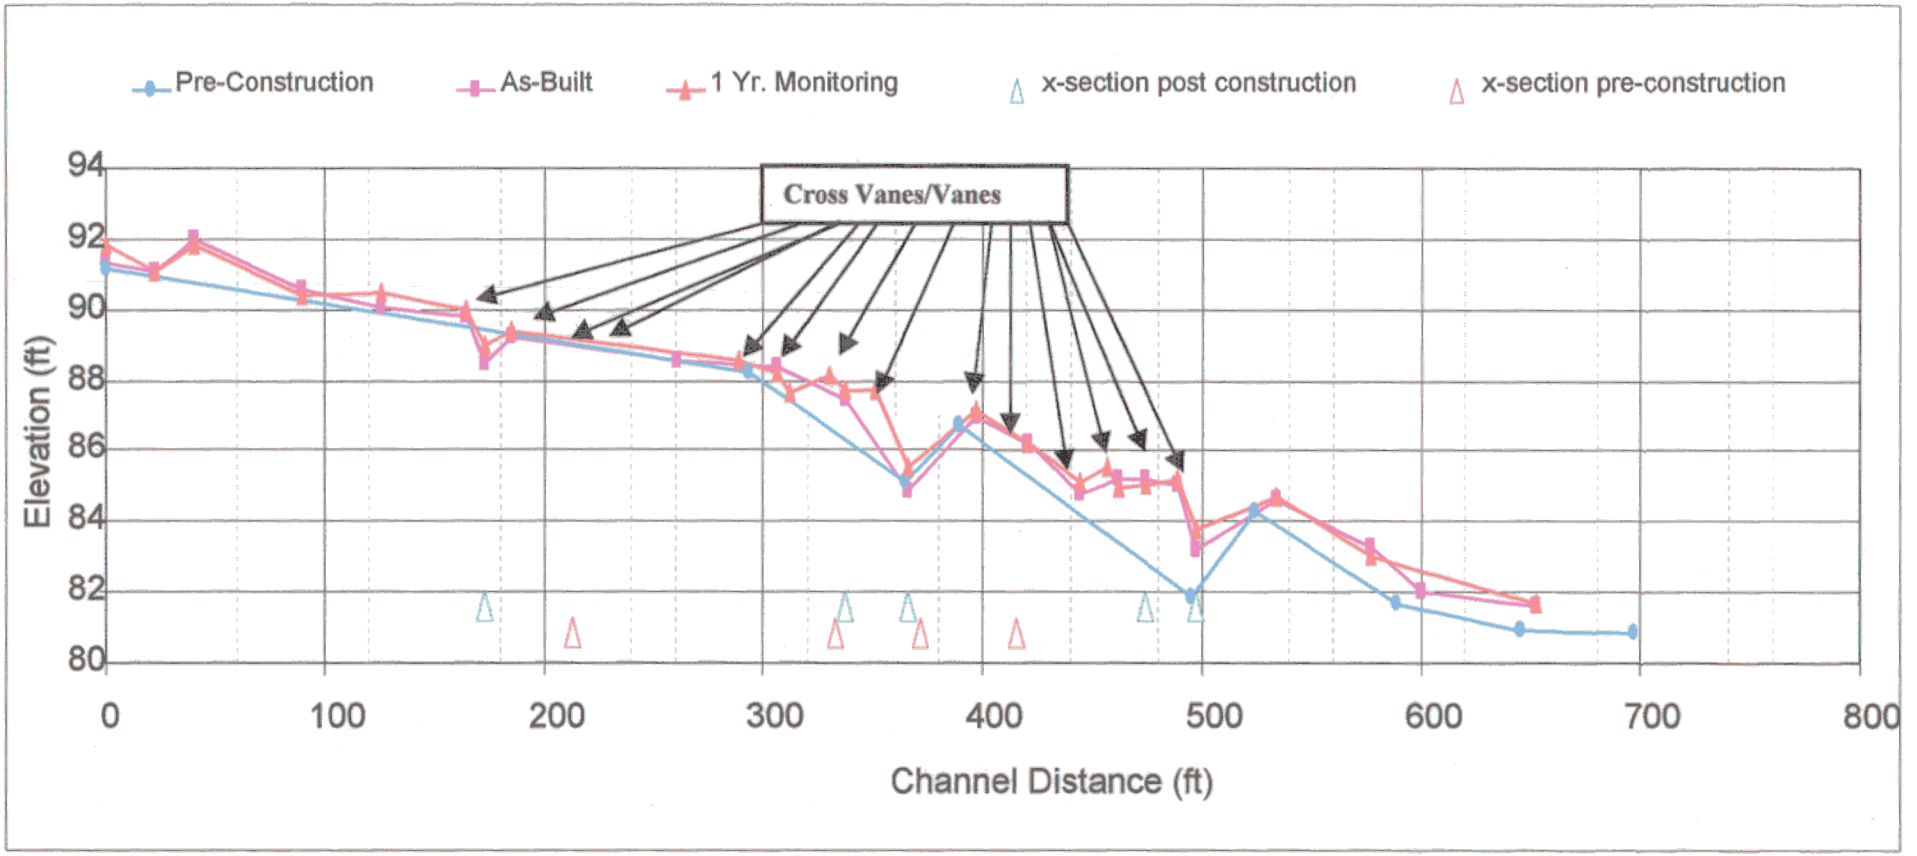
FIGURE 2. Longitudinal profile comparisons at the Miller et al. mitigation site on Meat Camp Creek mitigation site, Watauga County, October 2003.

The first year monitoring survey was completed on October 21, 2003 and included longitudinal profile, pebble count, and five channel cross-sections. The longitudinal profile has remained stable since the as-built survey (Figure 2). A total of 14 structures (2 rock weirs, 11 rock vanes and one log vane) were constructed (Table 1) with approximate locations shown on the longitudinal profile (Figure 2). The pre-construction and post construction riffle D-50's were 45 mm and 46.6 mm (coarse gravel) (Mickey and Hining 2003), respectively. The monitoring pebble count D-50 was 37.2 mm (Figure 3). While the monitoring D-50 was slightly smaller than the post and as-built D-50, it is still in the coarse gravel range. The five cross-sections have remained stable since construction and have experienced very little change since the as-built survey (Figures 4.1-4.5).

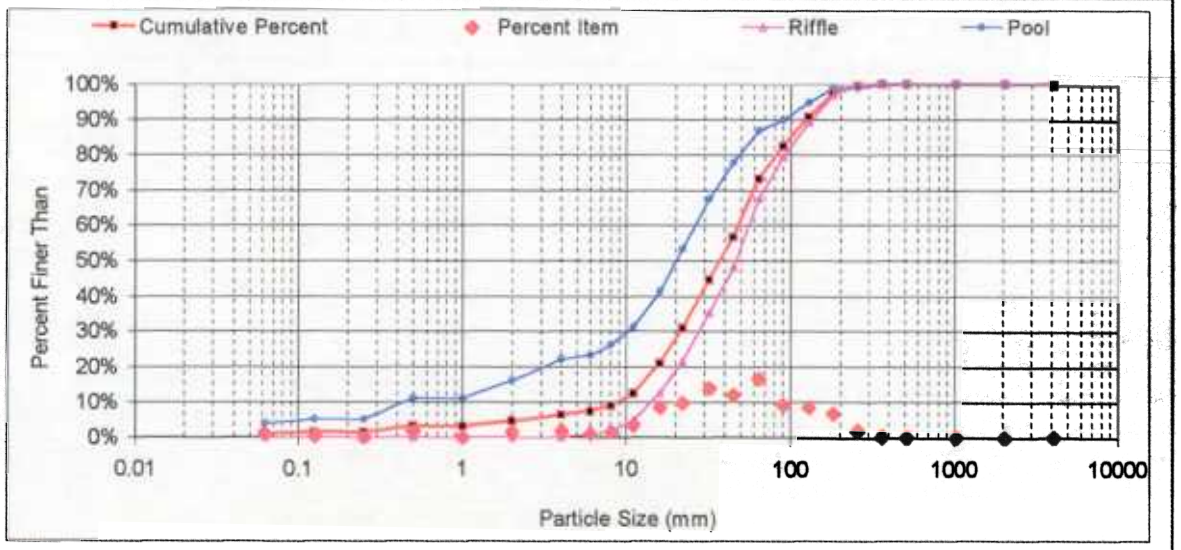
FIGURE 3. Pebble count summary at the Miller et al. mitigation site on Meat Camp Creek, Watauga County, October 2003.

Size percent less than (mm)					
D16	D35	D50	D84	D95	
12.801	24.62	37.2	96	158

Percent by substrate type					
silt/clay	sand	gravel	cobble	boulder	bedrock
1%	4%	69%	26%	0%	0%
