UT to Clarke Creek
Annual Final Monitoring Report

EEP # 92500
DENR Contract # 005363
USACE Action ID # SAW-2010-00471
DWR Project # 11-0409
SCO # 09-07763-01
DLR (Land Quality) Project # MECK-2012-034

Monitoring Report Year 1 of 5
Mecklenburg County, North Carolina

UT to Clarke Creek Stream and Wetland Restoration
EEP Project #92500

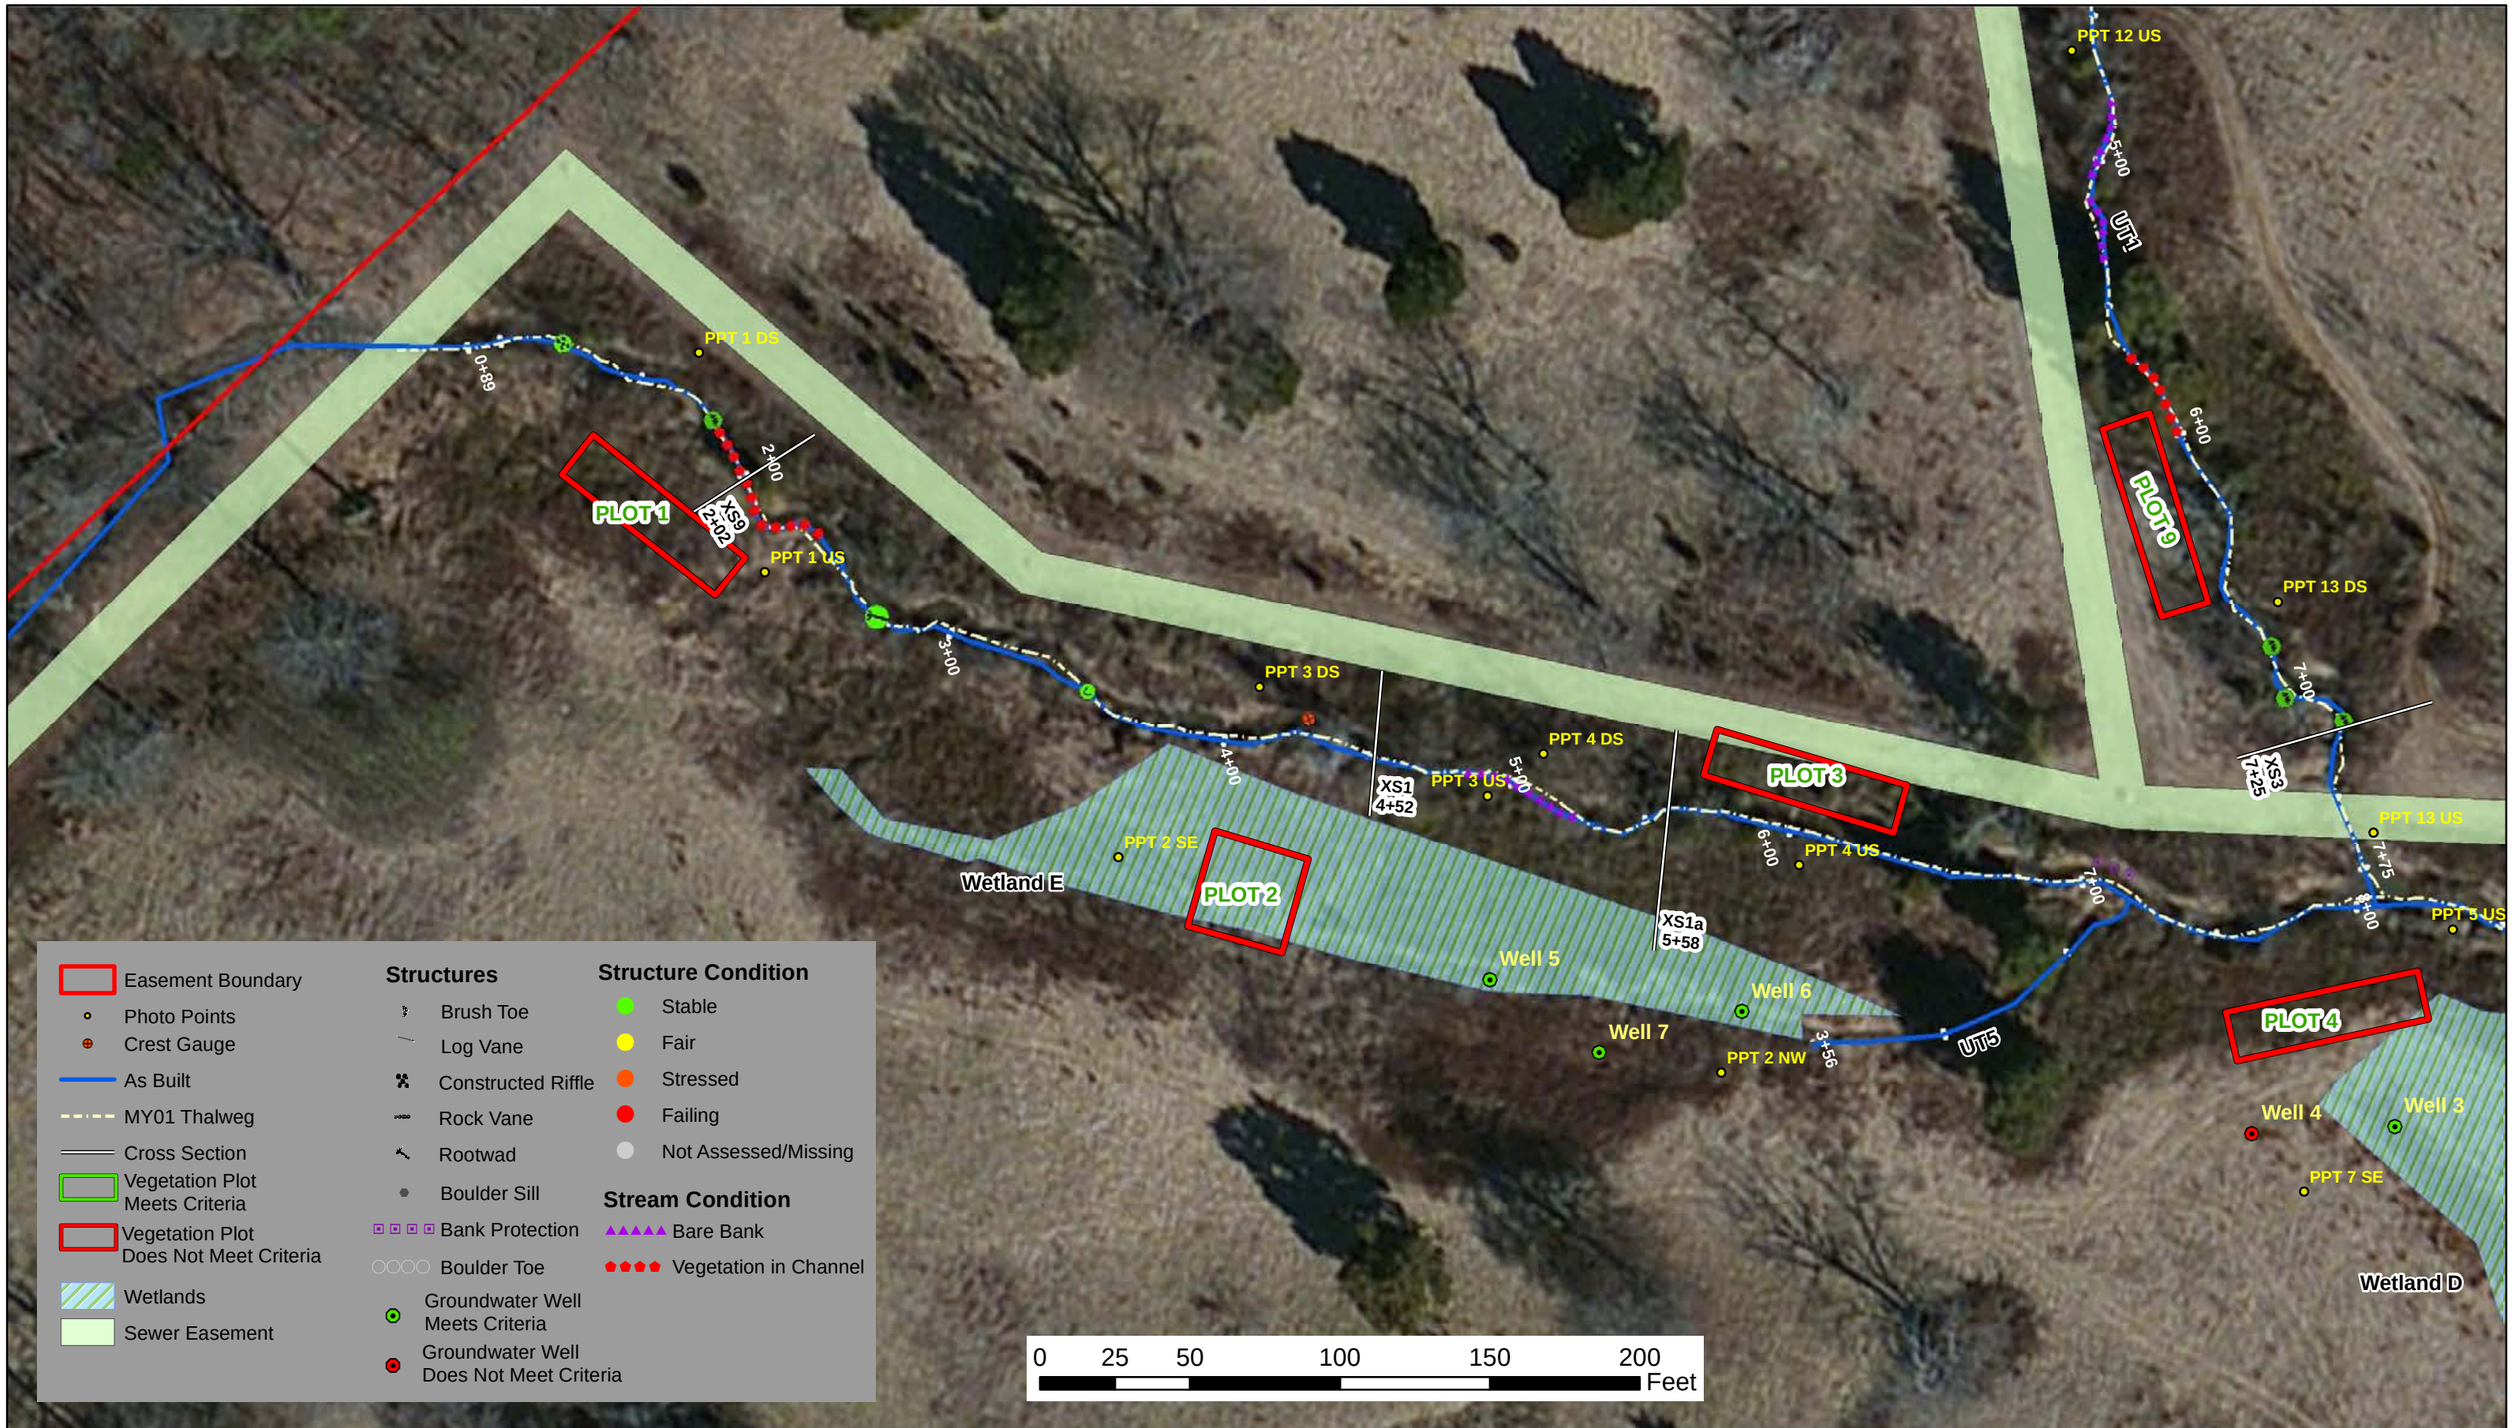
Current Conditions Plan View - UT to Clarke Creek above Confluence

On UT to Clarke Creek, one area of notable bare bank was noted between Stations 4+84 and 5+24. This area was lacking significant woody and herbaceous vegetation. Vegetation was also found growing in the channel between Station 1+75 and 2+34. This vegetation trapped smaller particles in cross section 9 which lead to the smaller particle size collected for the pebble count. Cross section 1A had a similar particle size to baseline data.

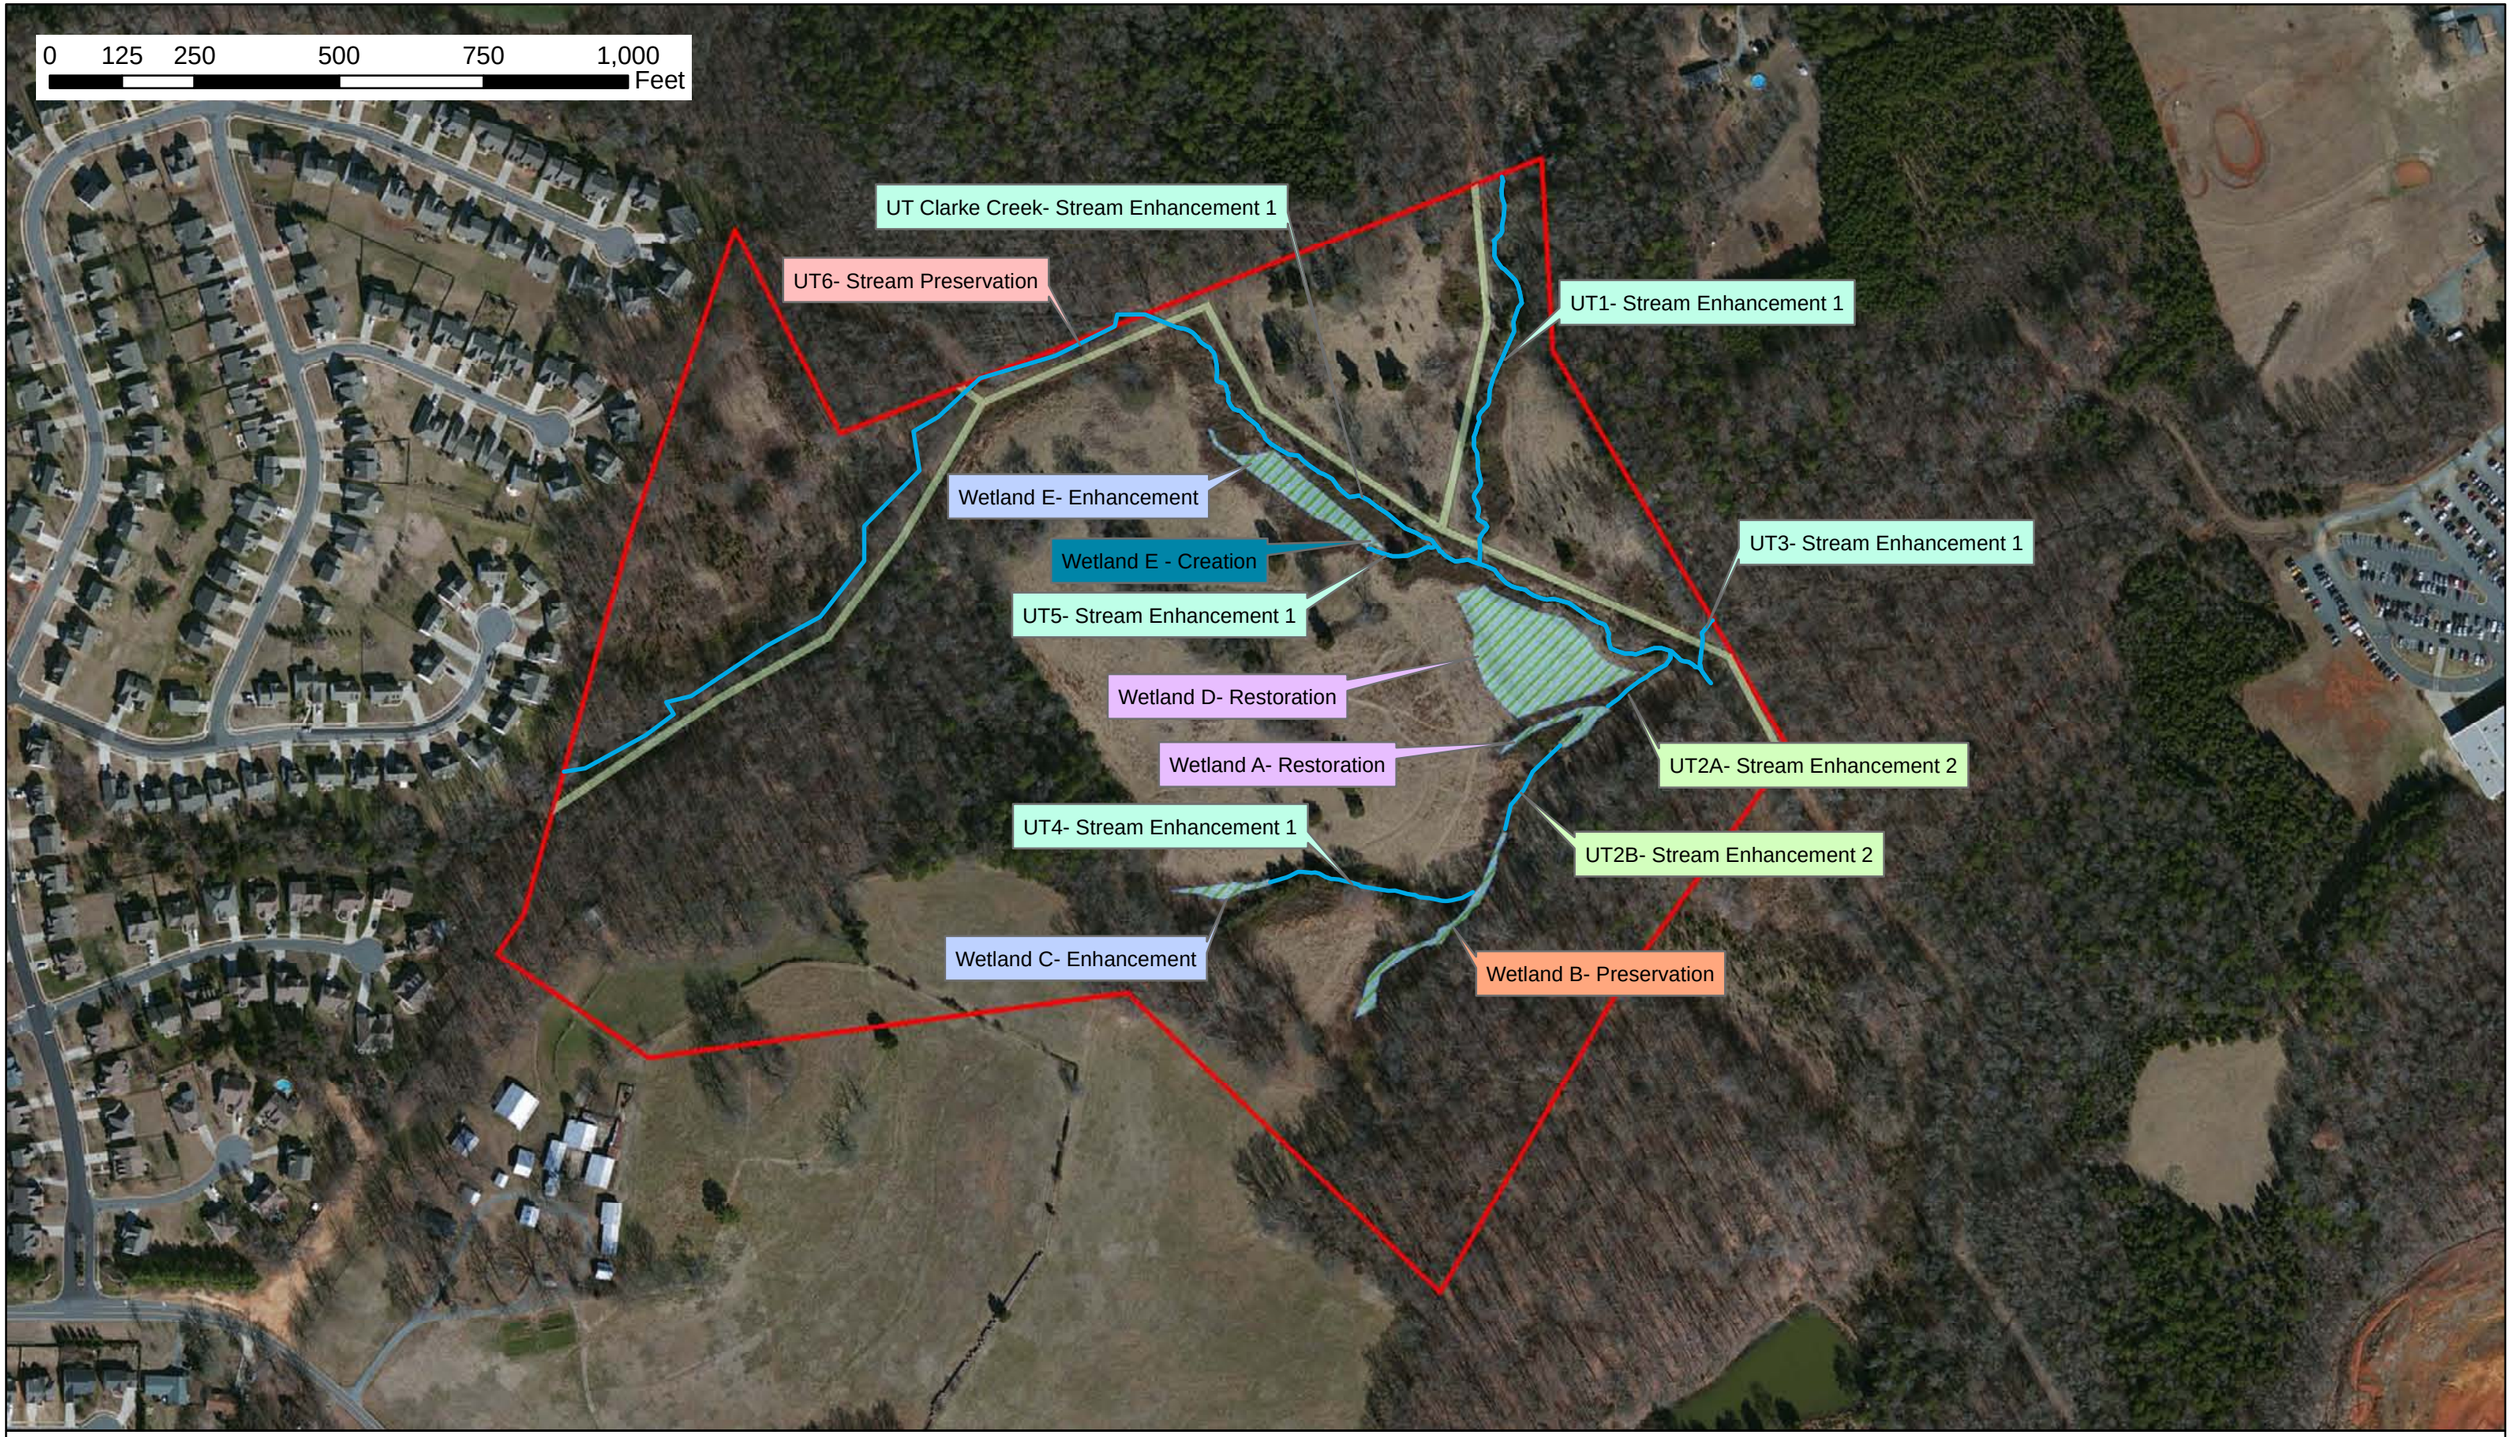
Current Conditions Plan View - UT 1

Reach UT1 had one area of bare bank between Stations 4+78 to 5+37. This area was lacking significant woody and herbaceous vegetation. Three instances of vegetation in the channel were noted between Stations 1+12 to 1+69, 1+96 to 2+66, and 5+70 to 6+00. This vegetation trapped smaller particles in cross sections 4 and 5 leading to smaller particle sizes collected for the pebble counts. Particle size in cross section 6 increased from baseline data, while cross section 8 had a decrease in particle size.

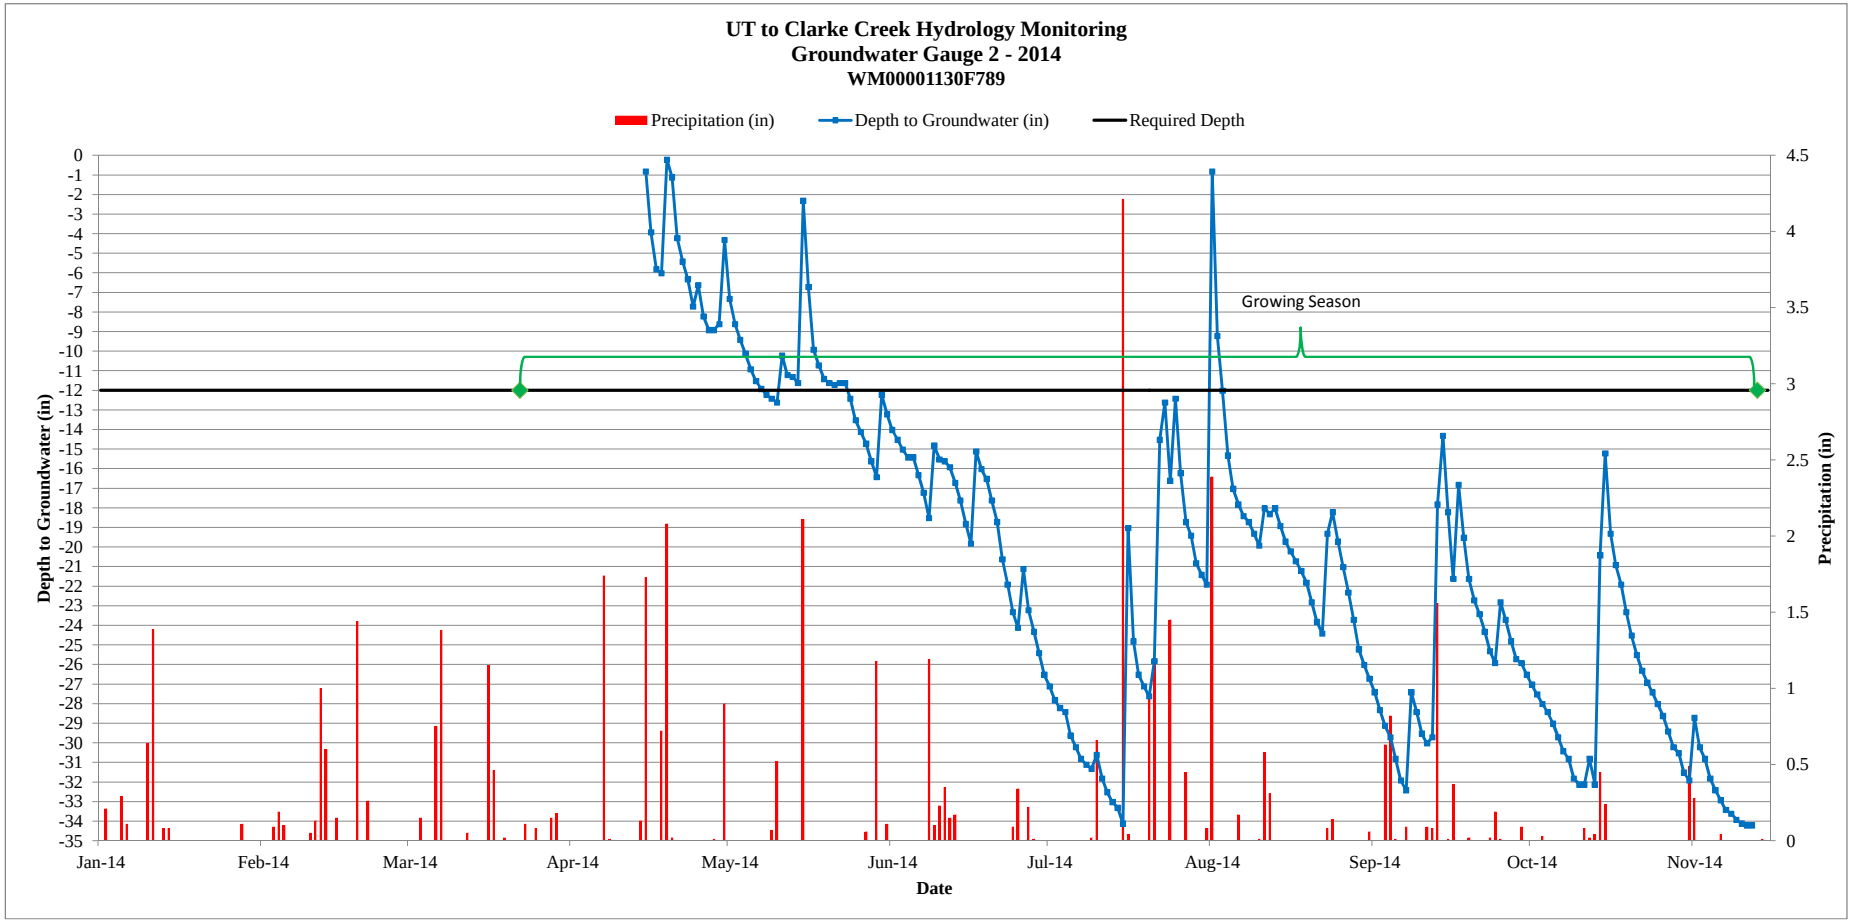
UT to Clarke Creek Hydrology Monitoring
Groundwater Gauge 2 - 2014
WM00001130F789
Precipitation (in)
Depth to Groundwater (in)
Required Depth
Growing Season
Depth to Groundwater (in)
Precipitation (in)
Date
Jan-14
Feb-14
Mar-14
Apr-14
May-14
Jun-14
Jul-14
Aug-14
Sep-14
Oct-14
Nov-14

Wells 1, 3, 5, 6, and 7 met the hydrology success criteria for monitoring year 1. Wells 2 and 8 did not meet the success criteria. Although well 8 is within Wetland D, it was installed along the wetland line. This could explain why it did not meet the hydrology criteria.
