# **Report on Slope Stability Related to the Jackson County Airport**

**North Carolina Geological Survey  
Division of Land Resources  
Department of Environment and Natural Resources**

**February 23, 2006**

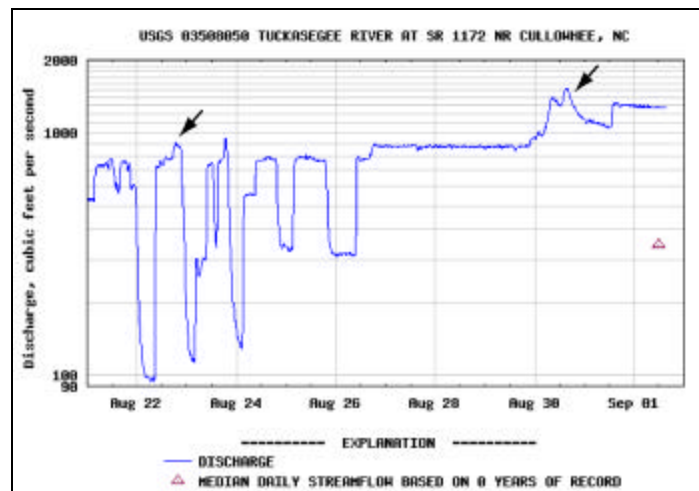
**Figure 3.** Stream flow hydrograph for the Tuckasegee River near Cullowhee. August 22, 2005 peak discharge (arrow left) indicates an increase in stream flow attributed to the storm event that day. Major fluctuations in discharge between August 22 and August 26 resulted from lowering of lake levels above the dam upstream in preparation for the remnants of Hurricane Katrina on August 30 (arrow right) (USGS, 2005).
