Investigation of the Peeks Creek Debris Flow of September 2004 and Its Relationship to Landslide Hazard Mapping in Macon County, North Carolina

Investigation of the Peaks Creek Debris Flow of September 2004 and Its Relationship to Landslide Hazard Mapping in Macon County, North Carolina

Rebecca Latham, Rick Wooten, Anne Witt, Ken Gillon, Tommy Douglas,
Stephen Fuemmeler and Jennifer Bauer
North Carolina Geological Survey, Swannanoa, North Carolina

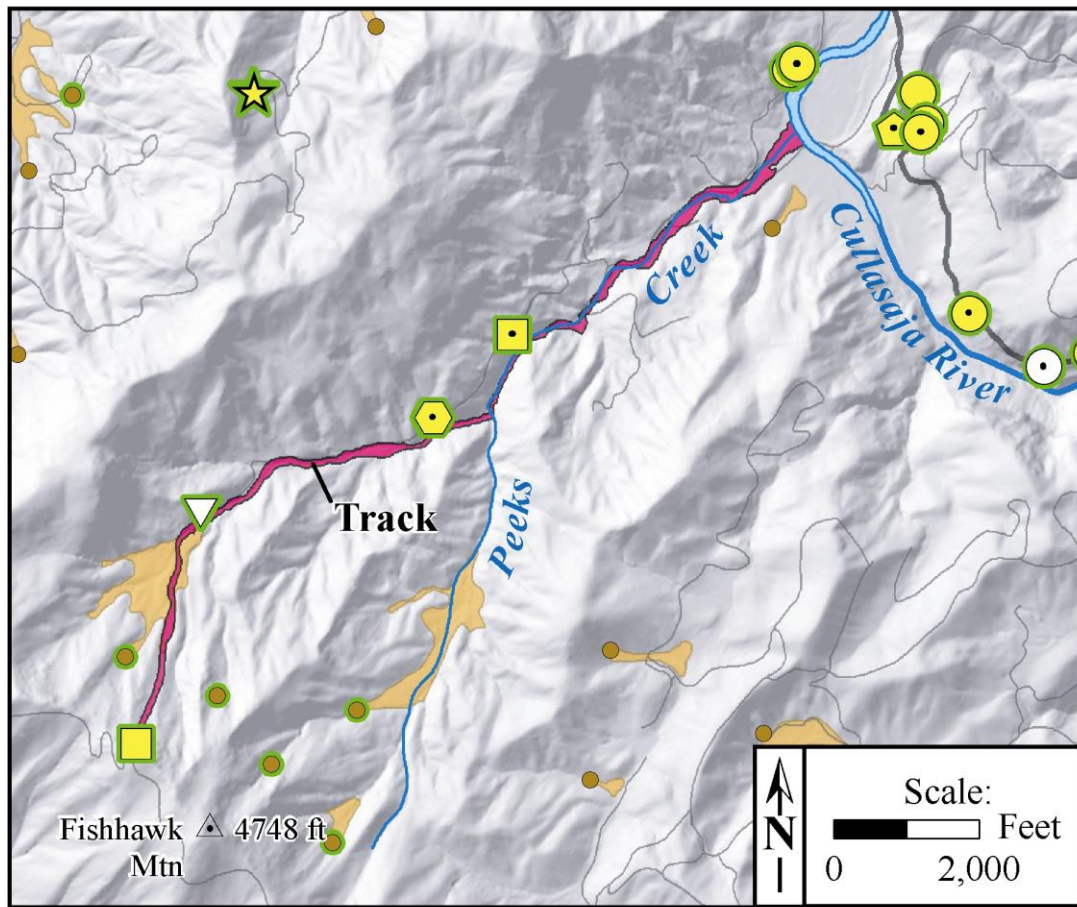
The Slope Movements and Slope Movement Deposits Map shows the locations of past slope movements (landslides). Figure 7 shows the portion of this map in the area of the Peaks Creek failure. Multiple vintages of aerial and orthophotography in conjunction with 6-meter pixel resolution LiDAR digital elevation model (DEM) were used to identify potential failure locations. Once identified, staff members field checked the slope movements using handheld global positioning systems (GPS). The failures were classified according to Cruden and Varnes (1996), and detailed information was collected at each failure including location data, soil and/or rock properties, ground and surface water conditions and geomorphic setting. In Macon County, 56% of the slope movements initiated on modified slopes while 40% occurred on natural slopes.

Figure 7. Excerpt of slope movements and slope movement deposits map of Macon County, North Carolina (sheet 1, Wooten, *et al.*, 2006) showing the area near the September 16, 2004, Peaks Creek debris flow (track shown in pink). Map base is a LiDAR hillshade DEM.

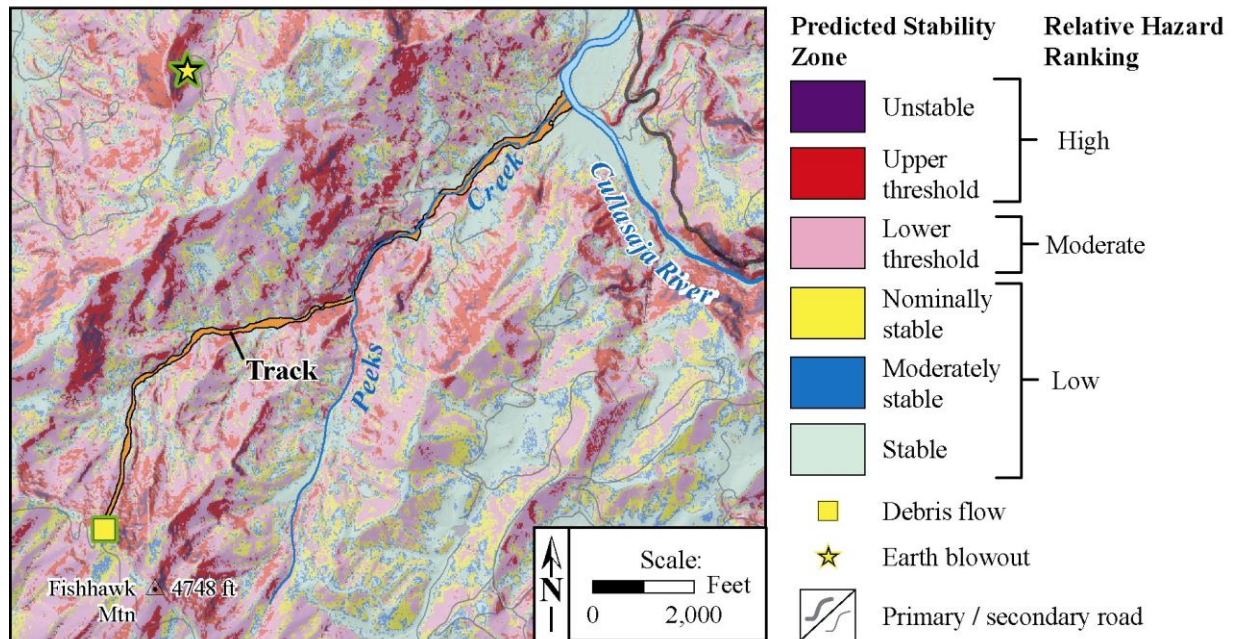
The output of the model is a color-coded map based on the six stability classes ranging from stable to unstable (figure 9). Along with the stability class ranking comes statistics as well as a factor of safety ranking. The NCGS combined some of the categories into a relative hazards ranking for debris flows/slides. Using this classification, 11% of the county falls into the high hazard category. For more details on parameter selection and model calibration see Witt *et al.* (2007) and sheet 2 of Wooten *et al.* (2006).

Figure 9. Excerpt of the stability index map of Macon County (sheet 2, Wooten, *et al.*, 2006) showing the relative stability zones in the vicinity of the Peeks Creek debris flow (track in orange). Map base is a hillshade LiDAR DEM.

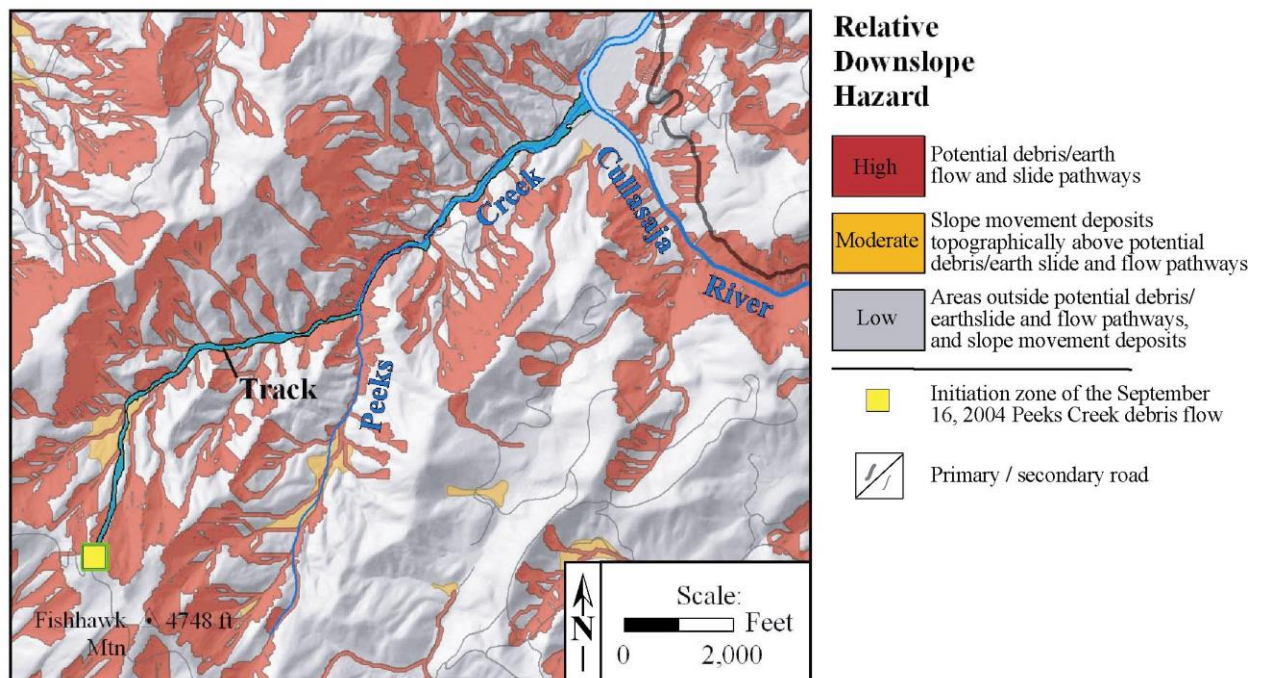
The downslope hazard map shows locations potentially in the path of a debris slide/flow that initiates in one of the SINMAP high hazard zones (figure 10). ArcGISTM was used to generate flow paths originating from the SINMAP high hazard zones. These flow paths were extended downslope until they reached a three-degree slope, the angle at which most observed debris flows tend to terminate, with a width of 65 feet, the average width of observed tracks. The flow paths were augmented with information collected about actual, observed track widths and lengths, and where known, this information was used rather than the computer generated flow path.

Figure 10. Excerpt of the downslope hazard map of Macon County, North Carolina for shallow translational slope movements (sheet 3, Wooten, *et al.*, 2006) showing the area in the vicinity of the September 16, 2004, Peeks Creek debris flow (track in blue). Map base is a hillshade LiDAR DEM.

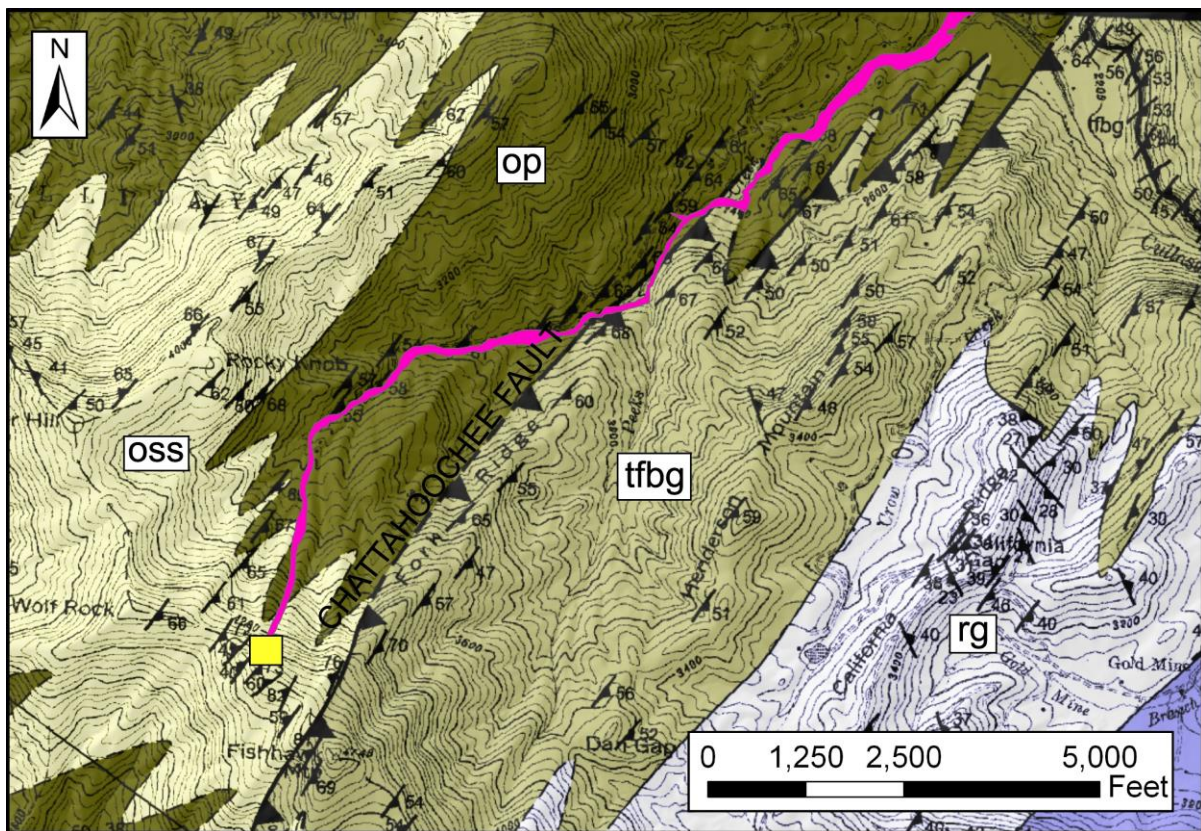
The Peaks Creek debris flow initiated in the Middle to Late Proterozoic metagraywacke and minor biotite-muscovite schist of the Otto Formation (figure 11) (Lamb, 2001). Two tonalite-trondhjemite dikes (figure 12) cross cut the metagraywacke in the source area of the debris flow. An exfoliation fracture oriented $283\text{--}322^{\circ}/35\text{--}56^{\circ}$ NE defines the plane of failure in the headscarp. The debris flow then traveled through the biotite-muscovite schist dominated portion of the Otto Formation as well as the biotite gneiss and metagraywacke of the Tallulah Falls Formation. Multiple pegmatites are exposed along the track as well as amphibolites and minor metaconglomerates. Rock outcrops in the debris flow channel are freshly exposed (visually fresh state as defined by the Unified Rock Classification System (Williamson, 1984)). Foliation strikes northeast to southwest and dips $80\text{--}90^{\circ}$ southeast to $40\text{--}90^{\circ}$ northwest. Mesoscopic folds and ptygmatic veins are exposed along the whole length of the debris flow track.

Figure 11. Geologic map of the Peaks Creek slide area (from Lamb, 2001). Initiation zone indicated by yellow square, and track is outlined in pink. **Otto Fmn.:** **op** - biotite muscovite schist with minor metagraywacke, **oss** – metagraywacke with minor schist. **Tallulah Falls Fmn.:** **tfbg** - biotite gneiss and metagraywacke. **Rabun Granodiorite:** **rg** - megacrystic granodiorite.

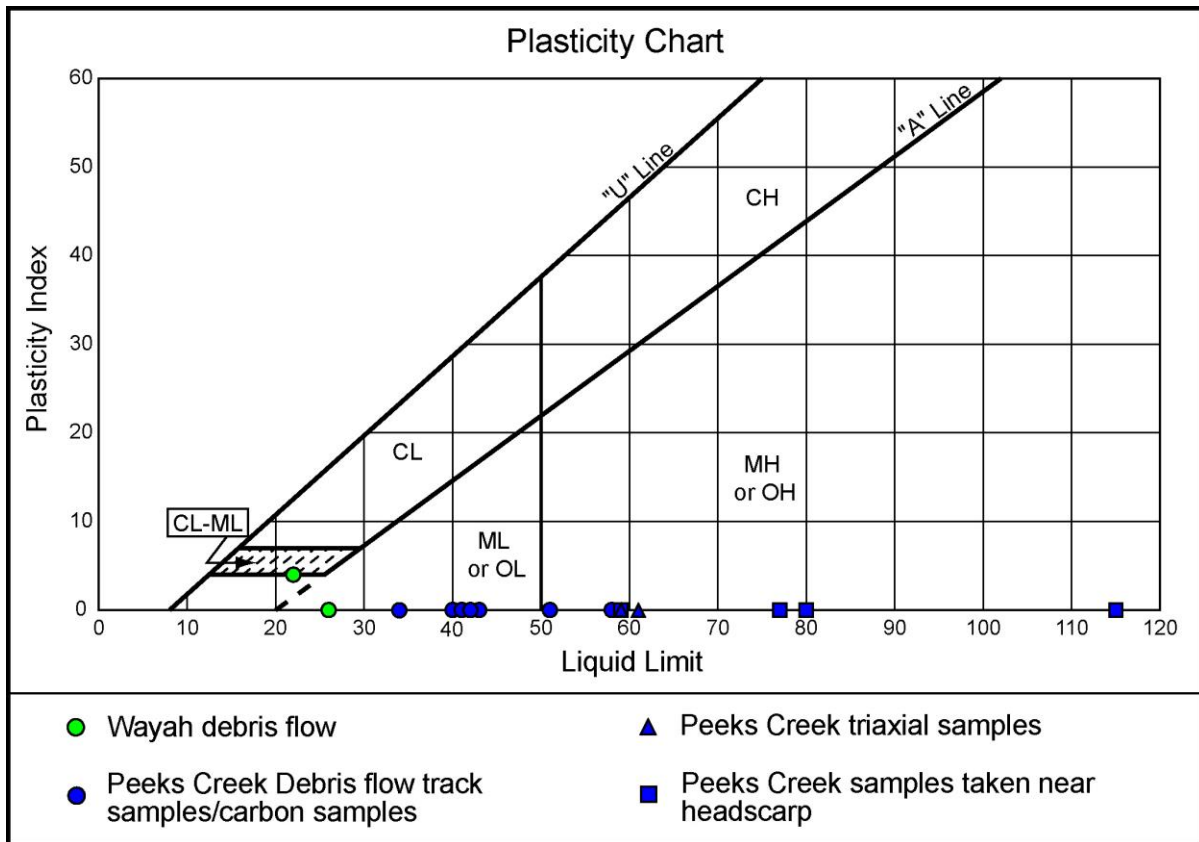
Surficial deposits vary along the length of the debris flow track. The USDA Soil Survey Map of Macon County (1996) defines the soil in the headscarp as the Cleveland-Chestnut-Rock outcrop complex which is comprised of sandy loam to cobbly sandy loam approximately 17-36 inches thick. Four soil samples were collected from the initiation zone (figure 13) for gradation, Atterberg, and triaxial tests. Results of the soil tests (figure 14) indicate that these samples are non-plastic, organic silty sand with low clay contents. The

Figure 14. Test results for the fine-grained portion (passing #200 sieve) of soils from two different debris flows in Macon County. The Peek's Creek soils have no measurable plastic limit while having high to very high liquid limit values.

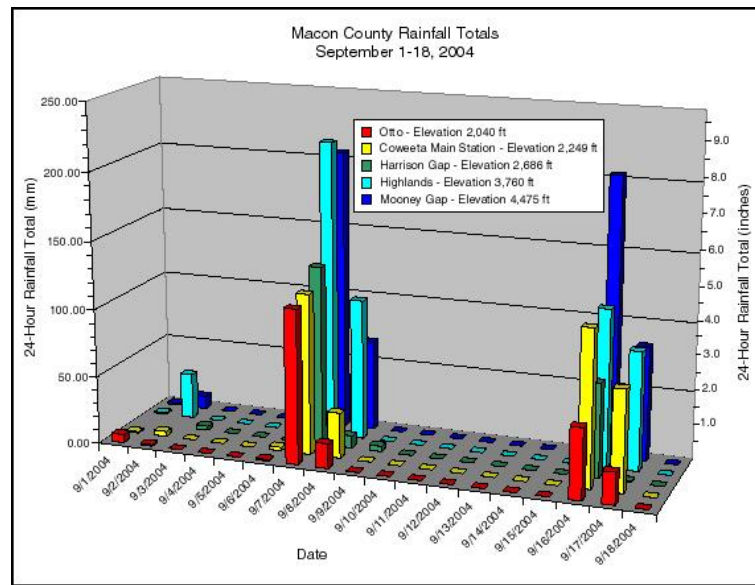
Elevation plays a role in precipitation amounts. Figure 17 shows a plot of precipitation versus time during the September hurricanes and rainfall measurements at various elevations throughout Macon County. The high elevation gauges recorded much higher precipitation amounts than the low elevation gauges, indicating that rainfall was higher at the initiation zone for the Peaks Creek debris flow (elevation 4,420 feet) than at the lower elevation rainfall gauges.

Figure 17. Rainfall totals collected from rain gauges at various elevations in Macon County over an 18-day period. Data from the U.S. Forest Service Coweeta Hydrologic Laboratory and the Integrated Flood Observation and Warning System.

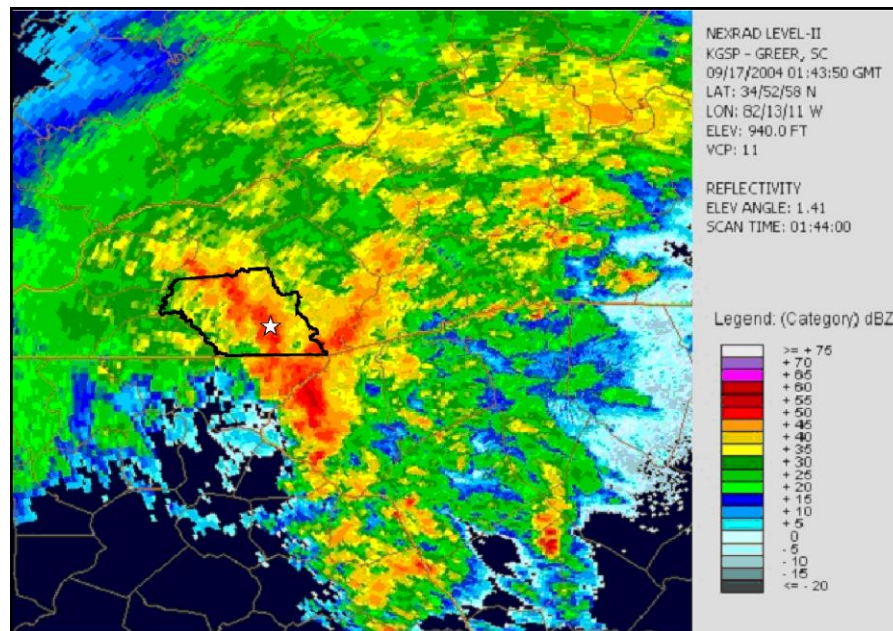
The National Weather Service (NWS) indicated that a spiral rain band within Ivan that contained intervals of deep vertical convection in thunderstorms that produced heavy rainfall. (figure 18) passed over Fishhawk Mountain at 9:48 p.m., approximately 20 minutes before the debris flow reportedly hit the Peaks Creek Community (Wooten *et al*, 2007).

Figure 18. KGSP WSR-88D 1.4° radar scan from the National Weather Service in Greer, SC showing heavy precipitation in spiral rain band crossing Macon County at 9:44 p.m. Precipitation intensity increases as reflectivity (dBZ) transitions from blue to red. The Peaks Creek debris flow indicated by the white star occurred at about 10:10 p.m. (from Wooten, 2007).

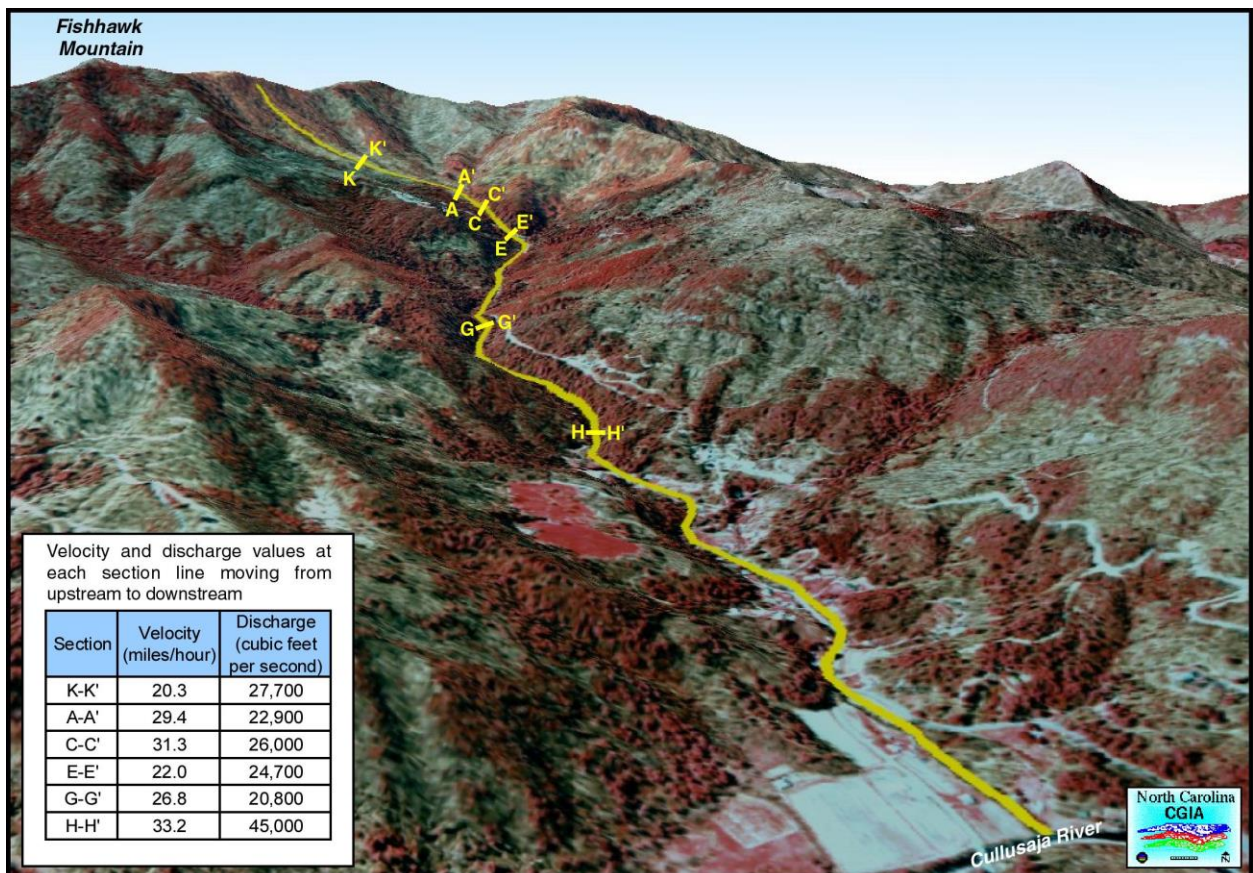
Estimates of velocity and discharge were calculated at six points along the debris flow track in order to gain a better understanding of why the debris flow was so destructive. According to Chen (1987), debris flows resemble hyperconcentrated stream flow and will bank as they travel around a curve in the channel. An estimate of velocity can be calculated given the radius of curvature of the stream channel, the superelevation angle of the material as it rounds the curve, the stream gradient, and acceleration due to gravity. If velocity is known, discharge can be calculated by multiplying the velocity times the cross-sectional area of the channel at that location (Fetter, 1994). Figure 32 shows the locations of the cross sections measured to calculate velocity and discharge and a table with the estimated values.

Figure 32. 3-D oblique view of a digital elevation model with a 1998 color-infrared digital orthophoto quarter quadrangle (DOQQ) superimposed. Shown are the locations of six cross sections measured by NCGS along the debris flow track to compute velocity and discharge estimates shown in inset table. Debris flow track is shown in yellow.

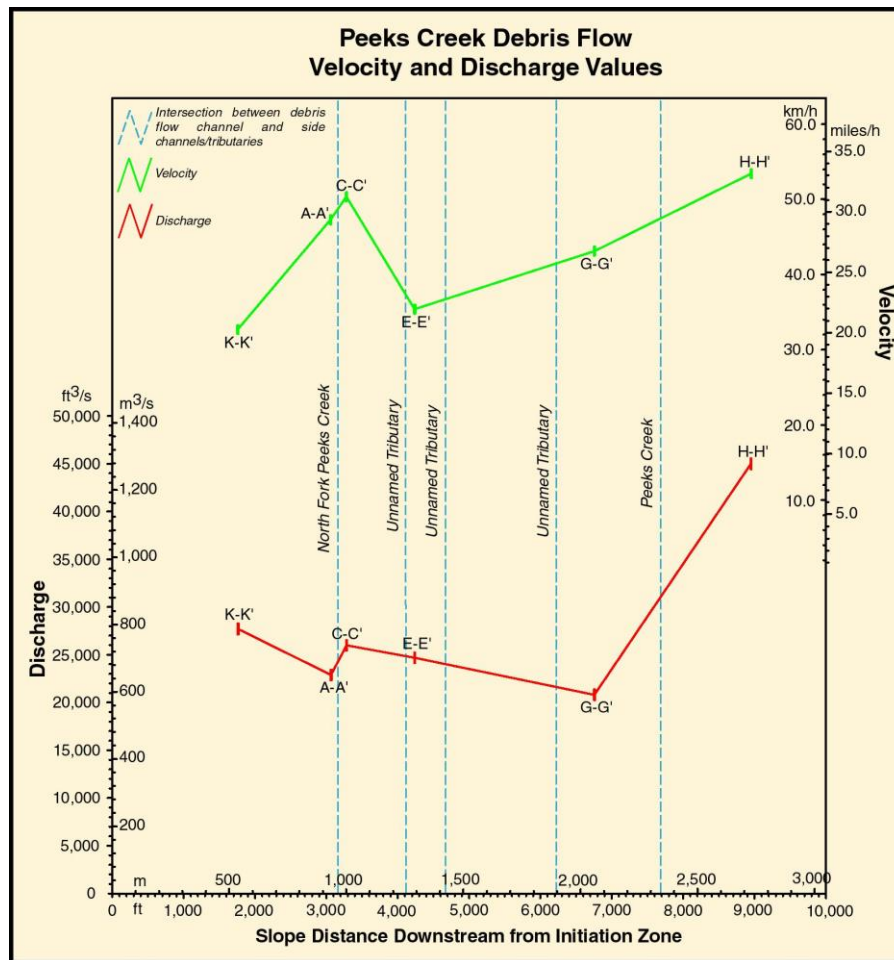
Velocity and discharge values vary along the debris flow track from the initiation zone down to the Peaks Creek community (figure 33). The minimum velocity calculated is 20.3 mph at section K-K', and the maximum velocity calculated is 33.2 mph at section H-H'. The minimum discharge calculated is 20,800 cfs at section G-G', and a conservative value for maximum discharge is 45,000 cfs at section H-H'. In comparison, the Pigeon River caused

Figure 33. Graph showing a plot of velocity (shown at top in green) and discharge (shown at bottom in red) versus slope distance from the initiation zone. Locations of section lines are shown on each line. Blue dashed lines indicate the locations of side channels that may have contributed significant flow to the debris flow.

Fluctuations in velocity can be attributed to variations in the stream channel gradient as well as to contributions of flow from side channels. The debris flow will decelerate along a lower gradient reach and deposit more material. Contribution from side channels could increase the velocity by increasing the flow and reducing the viscosity of the material, depending on the volume of flow in side channels. The main debris flow may have temporarily dammed some side channels, limiting their influence on the velocity of the material. The velocity at section K-K' (20.3 mph) is probably lower due to the relatively smaller amount of water present and its proximity to the initiation zone (i.e., it is just beginning to accelerate). The velocity decreases at E-E' to 22.0 mph, probably from a change in stream gradient, as the channel gradient flattens just upstream from this section line (figure 34). It most likely continued to decrease as evidenced by deposition in this flatter portion of the channel until just upstream of section G-G' (velocity here is 26.8 mph) where the debris flow transitioned into a narrower portion of the channel.

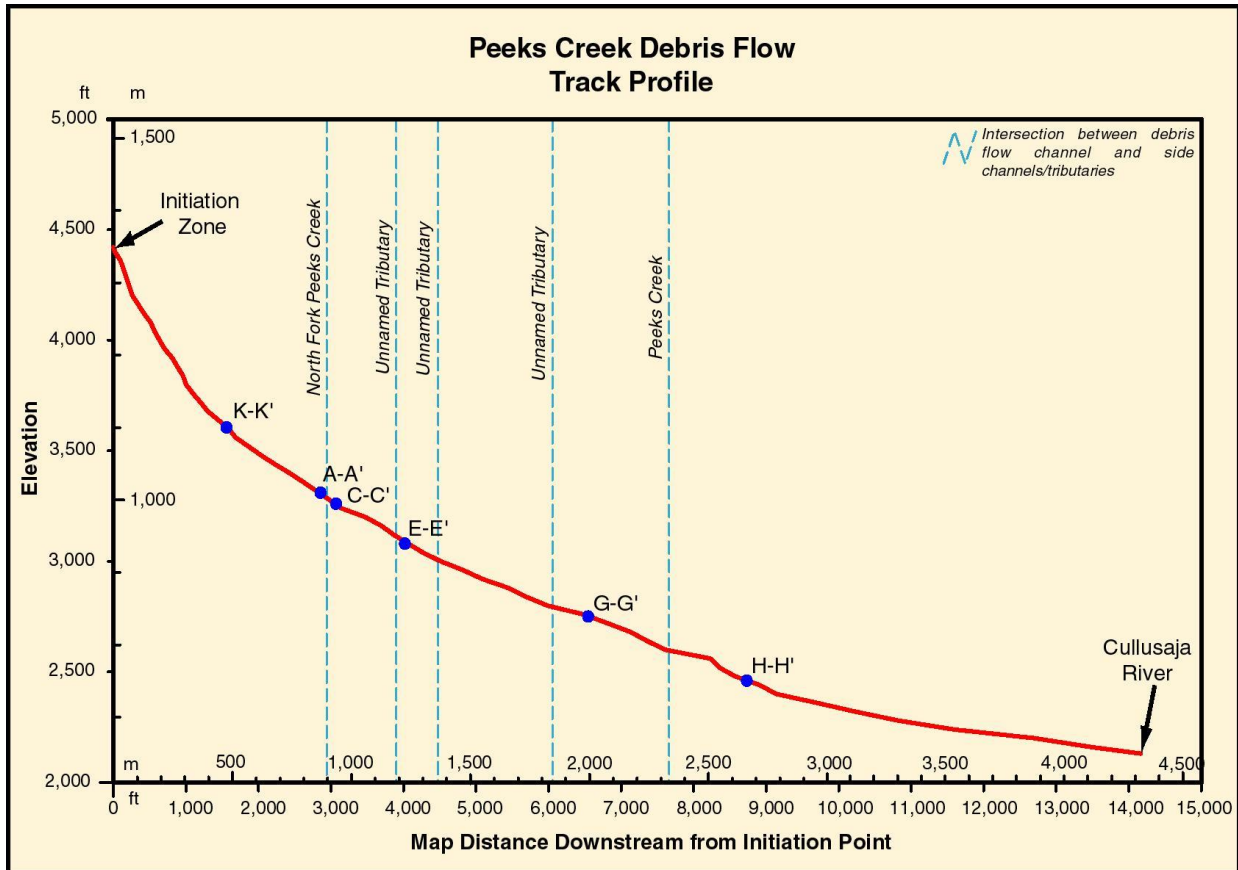
Discharge depends on the calculated cross sectional area of the debris flow and velocity. More scour will take place with higher velocity flow that can increase the cross sectional area. The depth to competent bedrock also dictates the amount of channel scour. Discharge is lowest at section A-A' (22,900 cfs) probably due to a flattening of the channel gradient (figure 34). Discharge increased at section C-C' (26,000 cfs) probably from the North Fork of Peeks Creek contribution. It continues to decrease downslope (minimum value of 20,800 cfs at section G-G') and then increases to a maximum of 45,000 cfs at section H-H' (figure 33). This is most likely due to significant contribution from the main channel of Peeks Creek, the steeper channel gradient, and steeper side slopes that produce greater amounts of runoff that increases the volume of water present.

Figure 34. Graph of the debris flow track profile. Locations of section lines are shown by blue dots. Blue dashed lines indicate the locations of side channels that may have contributed significant flow to the debris flow. This could account for the fluctuations in velocity and discharge estimates. Vertical exaggeration used to show subtle changes in the channel gradient.

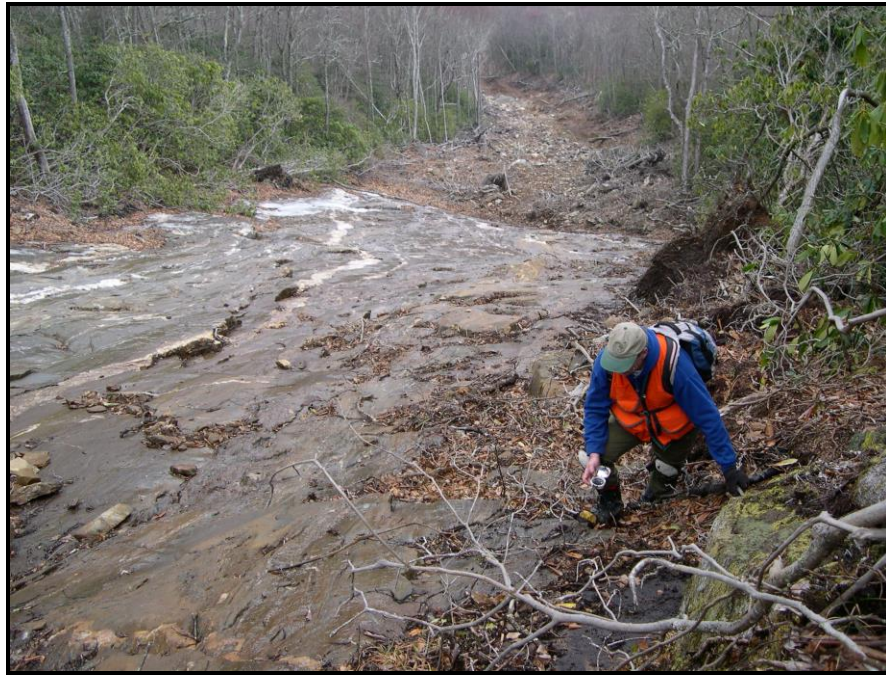
The extreme uphill part of the debris flow track ends at the headscarp where a debris slide initiated the debris flow. Before the slope failure, this area was heavily forested and no bare rock slope was exposed. The footing on the bedrock scar is quite slippery and climbing the rock is not recommended (figure 42).

Figure 42. Ken Gillon of the NCGS working his way up the side of the scar.
