**Report On The May 5-7, 2003 Debris Flows  
on Slopes Underlain by Sulfidic Bedrock of the  
Wehutt, Nantahala and Copper Hill Formations,  
Swain County, North Carolina**

**North Carolina Geological Survey  
Division of Land Resources  
Department of Environment and Natural Resources**

**August 3, 2004**

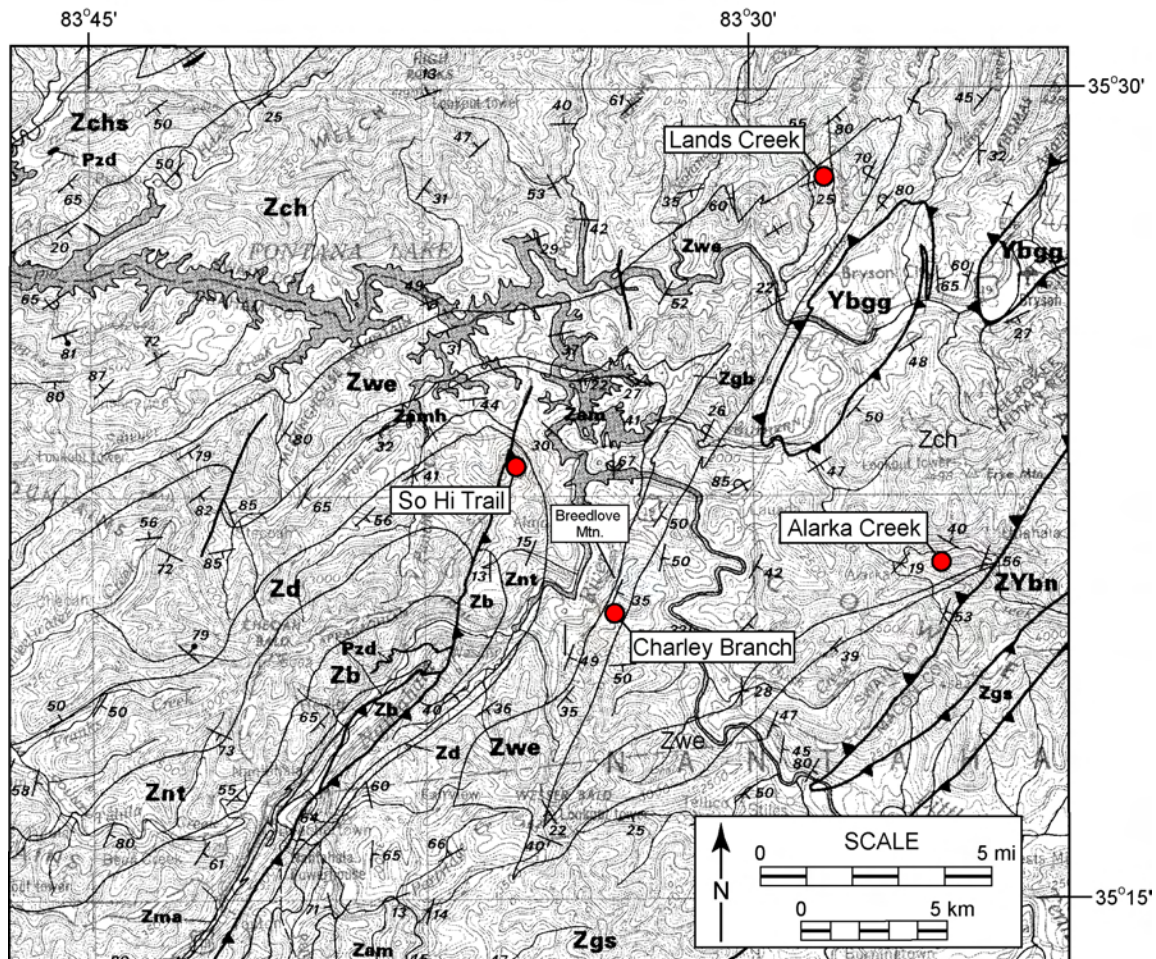
**Figure 1.** Location of debris flow study sites. Locations of the debris flow study sites are shown on a geologic map excerpted from Wiener and Merschat (1992). Most sites studied have multiple debris flows: Alarka Creek - 3 debris flows; Charley Branch - 3 debris flows; Lands Creek - 2 debris flows; and So Hi Trail - 1 debris flow. Geologic formations shown on the map relevant to this study that characteristically contain sulfidic, graphitic schist and pyllite bedrock units are the Wehuty (Zwe) and the Nantahala (Znt) Formations. Localized sulfidic, graphitic schist units also occur in the Copperhill Formation (Zch). The Horse Branch Member of the Hot House Formation (Zamh) characteristically contains dark-gray graphitic and sulfidic mica schist and metasiltstone.

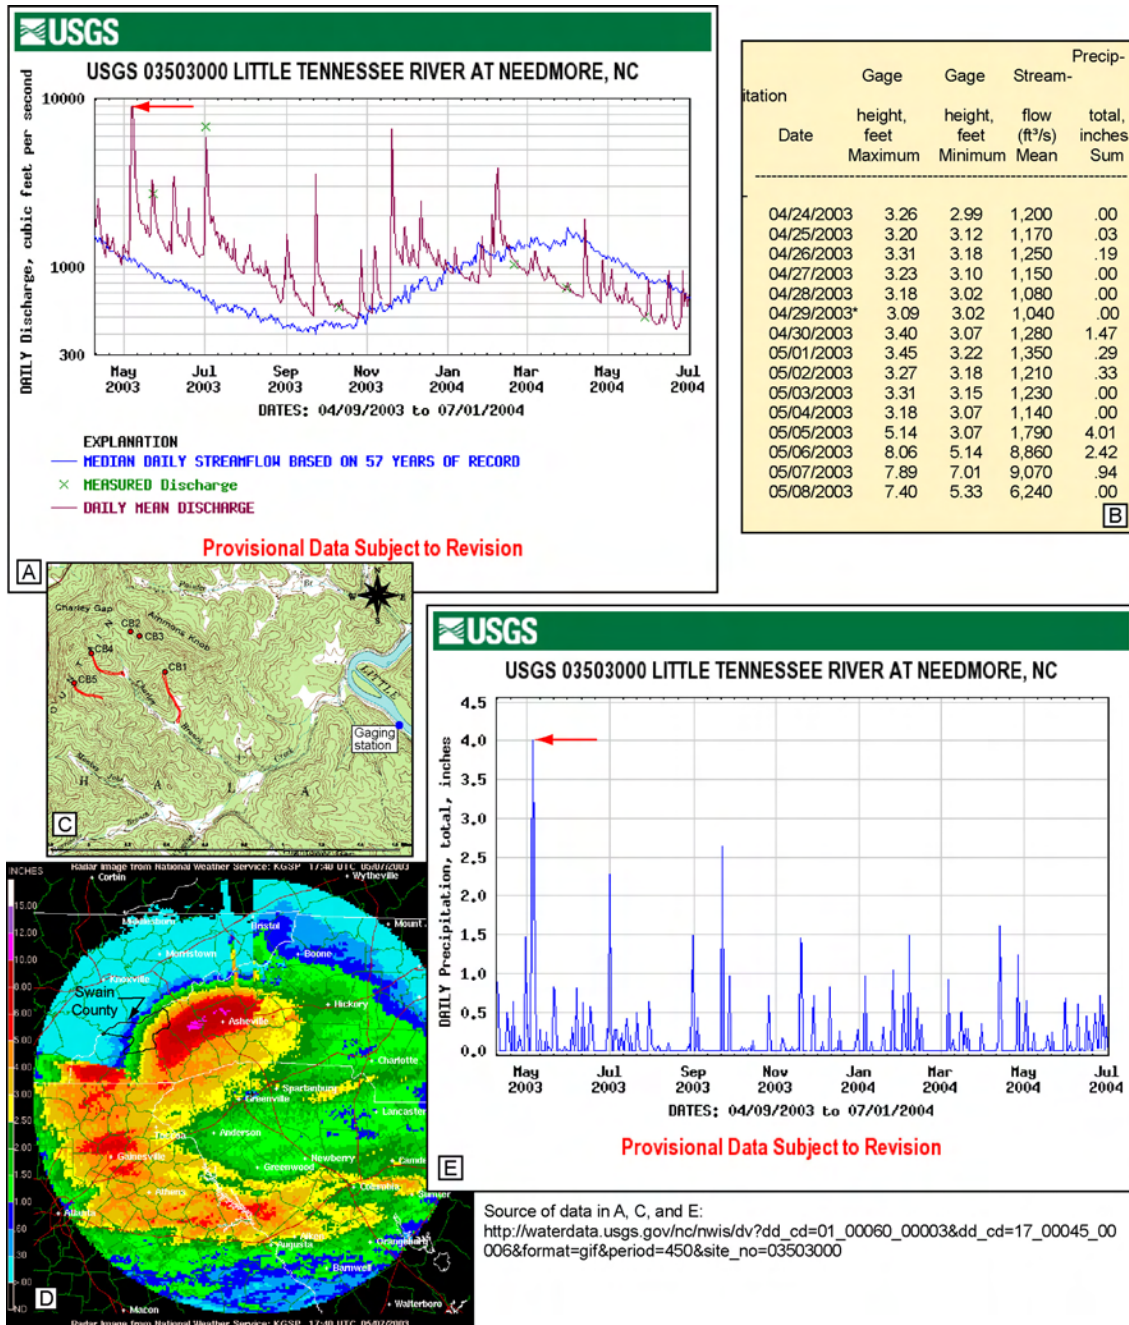
Heavy rains from May 5-7, 2003 triggered the debris flows and other landslides throughout the area. The U.S. Geological Survey gaging station on the Little Tennessee River at Needmore recorded 7.37 inches of rain over the three-day period (fig. 2). Local residents, however, report as much as 15 inches of rain during the same period. Another contributing factor was the 2.09 inches of rain recorded from April 30 to May 2, 2003 that led to higher antecedent moisture conditions prior to the May 5-7 event. The May 5-7 rains resulted in a peak discharge of 9,070 cubic feet per second on the Little Tennessee River at Needmore on May 7, 2003 (fig. 2). The weather radar image shown in figure 2D indicates the regional extent of the rainfall, and that higher rainfall may have occurred east of Swain County.

**Figure 2.** Precipitation and stream discharge associated with the May 5-7, 2003 flooding. A. Stream hydrograph data for the Little Tennessee River at Needmore, NC for late April 2003 through early July 2004. Note that the highest discharge occurred during the May 2003 event (indicated by arrow). B. Summary table of data. Total rainfall recorded for the May 5-7 event was 7.37 inches. C. Location of the USGS gage at Needmore with respect to the Charley Branch area. Gaging station is indicated by blue dot. D. May 7, 2003 radar image showing precipitation estimates for the regionally extensive May storm event. This image indicates that Swain County received anywhere from approximately 0.30-inches of rain in western portions of the county, and up to approximately 6 inches along the eastern county line. E. Plot of precipitation at the Little Tennessee River at Needmore, NC. Again, note spike (indicated by arrow) in precipitation amount during early May 2003.

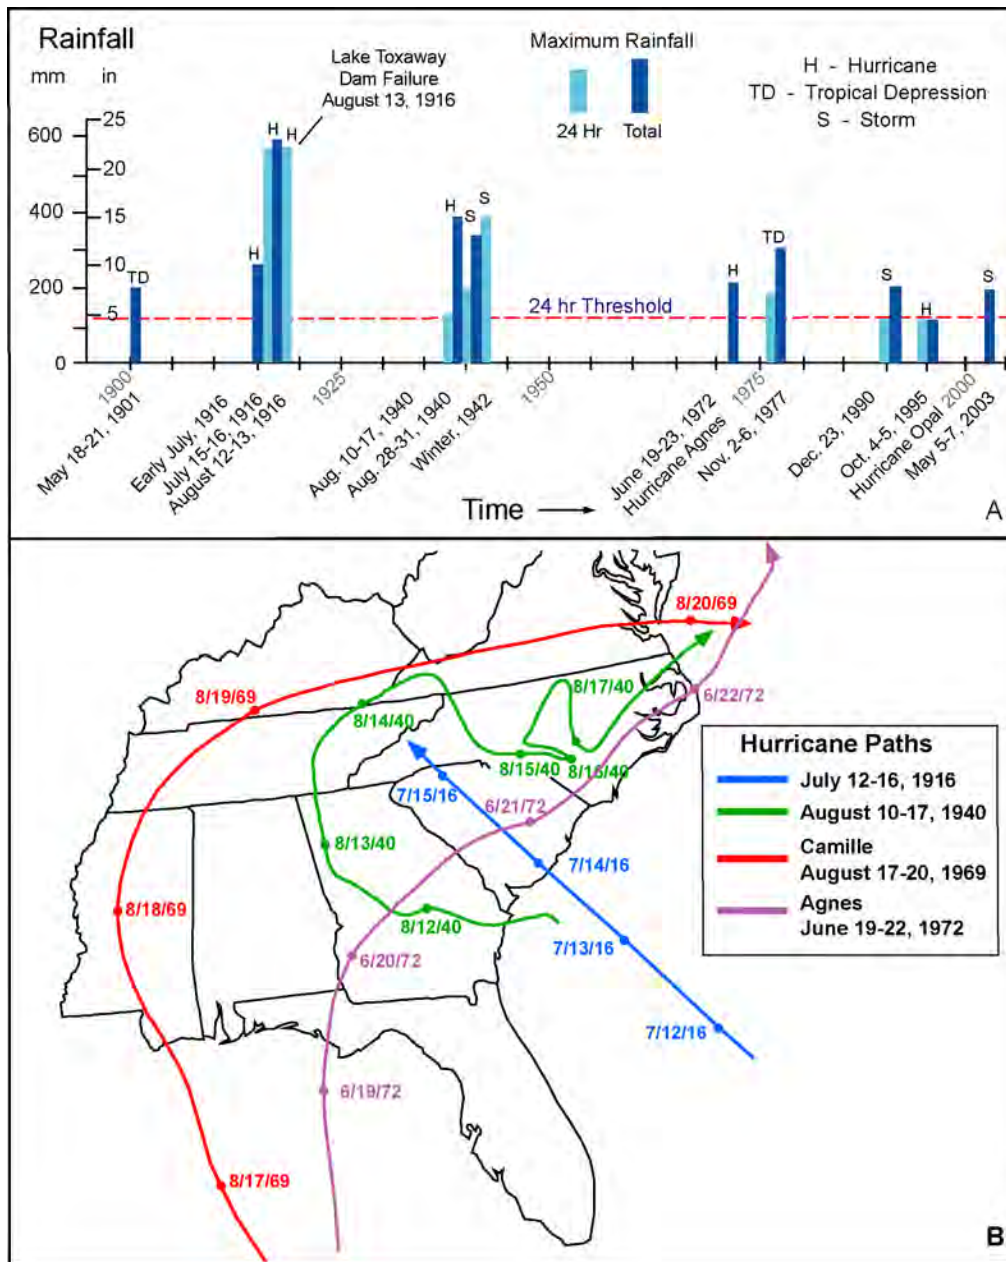
The May 5-7, 2003 rain was a significant flooding and debris flow event; however, the region has experienced much higher rainfalls associated with hurricanes and tropical storms in the past. In 1916 and 1940 some of the hurricanes that tracked over the western North Carolina mountains dumped as much as 15-20 inches of rain in a 24-hour period (fig. 10) causing extensive flooding, landsliding, and loss of life. Should storms of this magnitude track over the mountains in the future, the impacts on developments on steep hillsides, and property down slope, will likely be severe. Tension cracks and scarps observed in fill slopes at the Charley Branch sites CB2 and CB3 suggest that these and similar sites elsewhere may develop into debris flows as a consequence of future heavy rainfalls.

**Figure 10.** A. Chart showing rainfall amounts that triggered debris flow events in western North Carolina. The hurricanes and storms of July-August, 1916, and August 1940 set off hundreds of debris flows. The Lake Toxaway dam, in Transylvania County, failed after two and possibly three hurricanes tracked over the Southern Appalachians within six weeks in July-August, 1916. The rainfall total of 7.4 inches for the May 5-7, 2003 event is the value recorded at the U.S.G.S. gaging station at Needmore on the Little Tennessee River (fig. 2). Rainfall totals associated with this storm may have exceeded 7.4 inches elsewhere in western N.C. The 24-hour threshold line shows the minimum 24-hour rainfall needed to trigger widespread debris flows in the Southern Appalachians as estimated by Eschner and Patric (1982). B. Paths of 20th century hurricanes that caused widespread flooding and major debris flow events in the Southern Appalachians. Major debris flow events occurred in western North Carolina in 1916 and 1940 with loss of life and widespread damage. Heavy rains along with the slow rate of movement of the mid-August 1940 hurricane set off hundreds of debris flows. In 1972, Hurricane Agnes initiated debris flows and debris slides in western North Carolina although the path was to the east. Hurricane Camille triggered hundreds of debris flows in the Blue Ridge Mountains of Virginia causing extensive damage and loss of life in 1969. Map adapted from Scott (1972) and Bailey and others (1975).
