MONITORING YEAR 7 ANNUAL REPORT

AGONY ACRES MITIGATION SITE

Guilford County, NC

DMS Project Number 95716

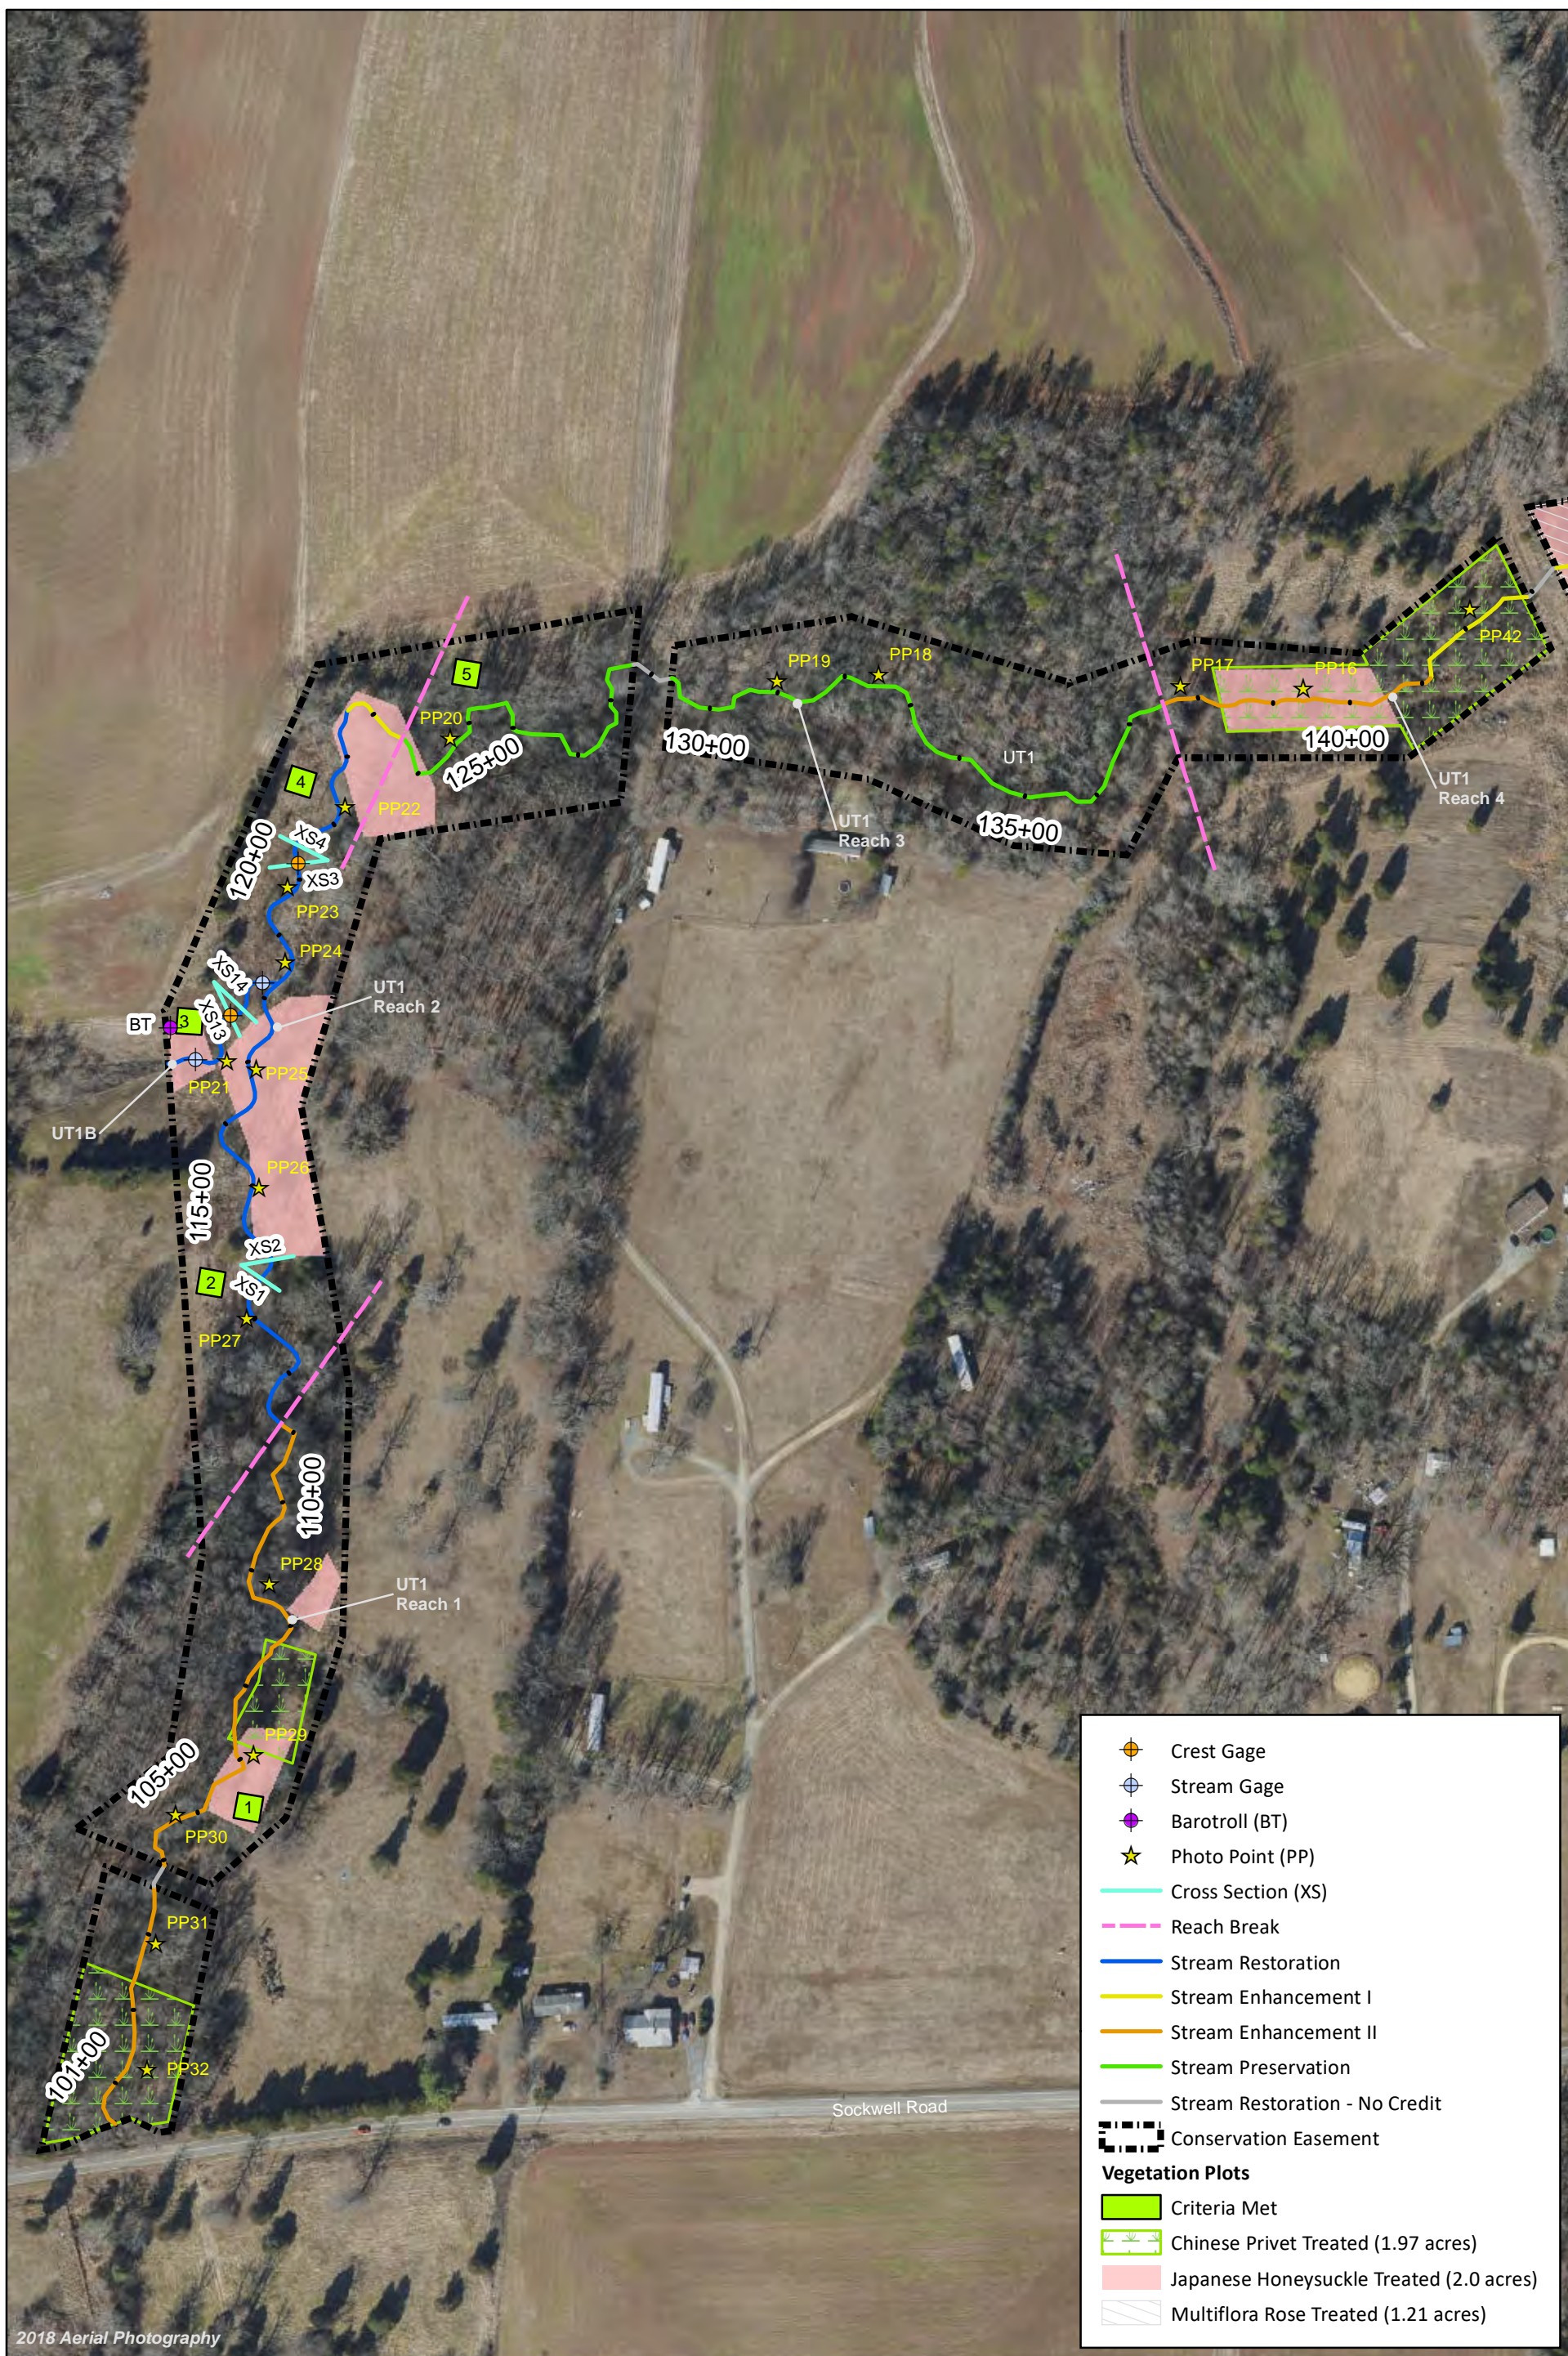
Identifiable populations of Chinese privet (*Ligustrum sinense*), Japanese honeysuckle (*Lonicera japonica*), and multiflora rose (*Rosa multiflora*) were treated along UT1 Reaches 1-5 and UT2 totaling 1.97 acres, 2.0 acres, and 1.21 acres, respectively (Figure 3.1-3.2). Scattered invasive stems were also treated along UT1 Reaches 1-5 and UT2. A total of 0.57 acres of Japanese honeysuckle occurs along UT1A Reach 1 and UT1 Reach 5 which was not treated during MY7 (Figure 3.2).

Beaver activity occurred on UT1 where it approaches the Reedy Fork floodplain (Figure 3.2). Beaver activity was identified in September and removal of three beavers and two dams was completed in early November. Beavers also attempted to inhabit this area during the fall of MY4, MY5, and MY6. Despite temporary damming of the stream and severance of numerous black willow stems during these years, the stream and vegetation community has proven resilient to short-term beaver inhabitation. Stream banks remained stable and no changes to stream geomorphology have been detected through visual observation or cross section surveys (Appendix 4). Primarily black willow trees were affected which appear to have maintained healthy below-ground root mass. Severed black willow stems resprouted vigorously each spring and achieved five to six feet of height growth by the following fall. Photo point 10 is located in the area which has been most substantially impacted by beaver activity over the past four

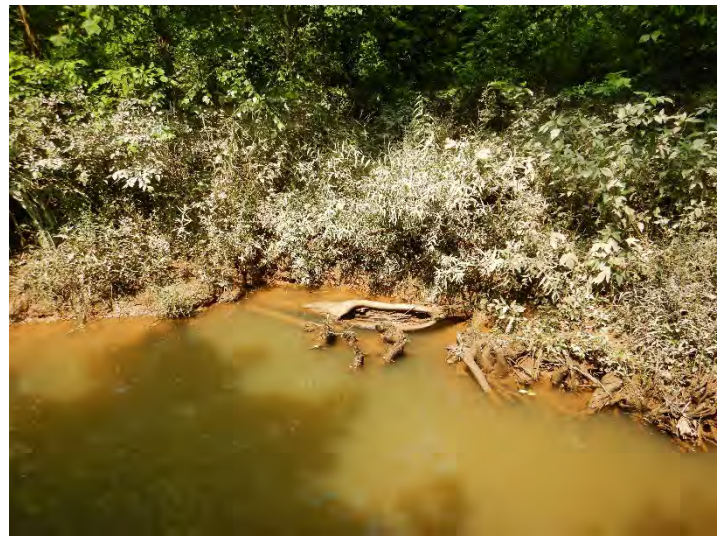
UT1 Isolated Bank Erosion with Vegetative Stabilization – (07/21/2021)
