FINAL
MONITORING REPORT (MY2)

ALLIANCE HEADWATERS MITIGATION SITE

Johnston County, North Carolina

DMS ID No. 97086

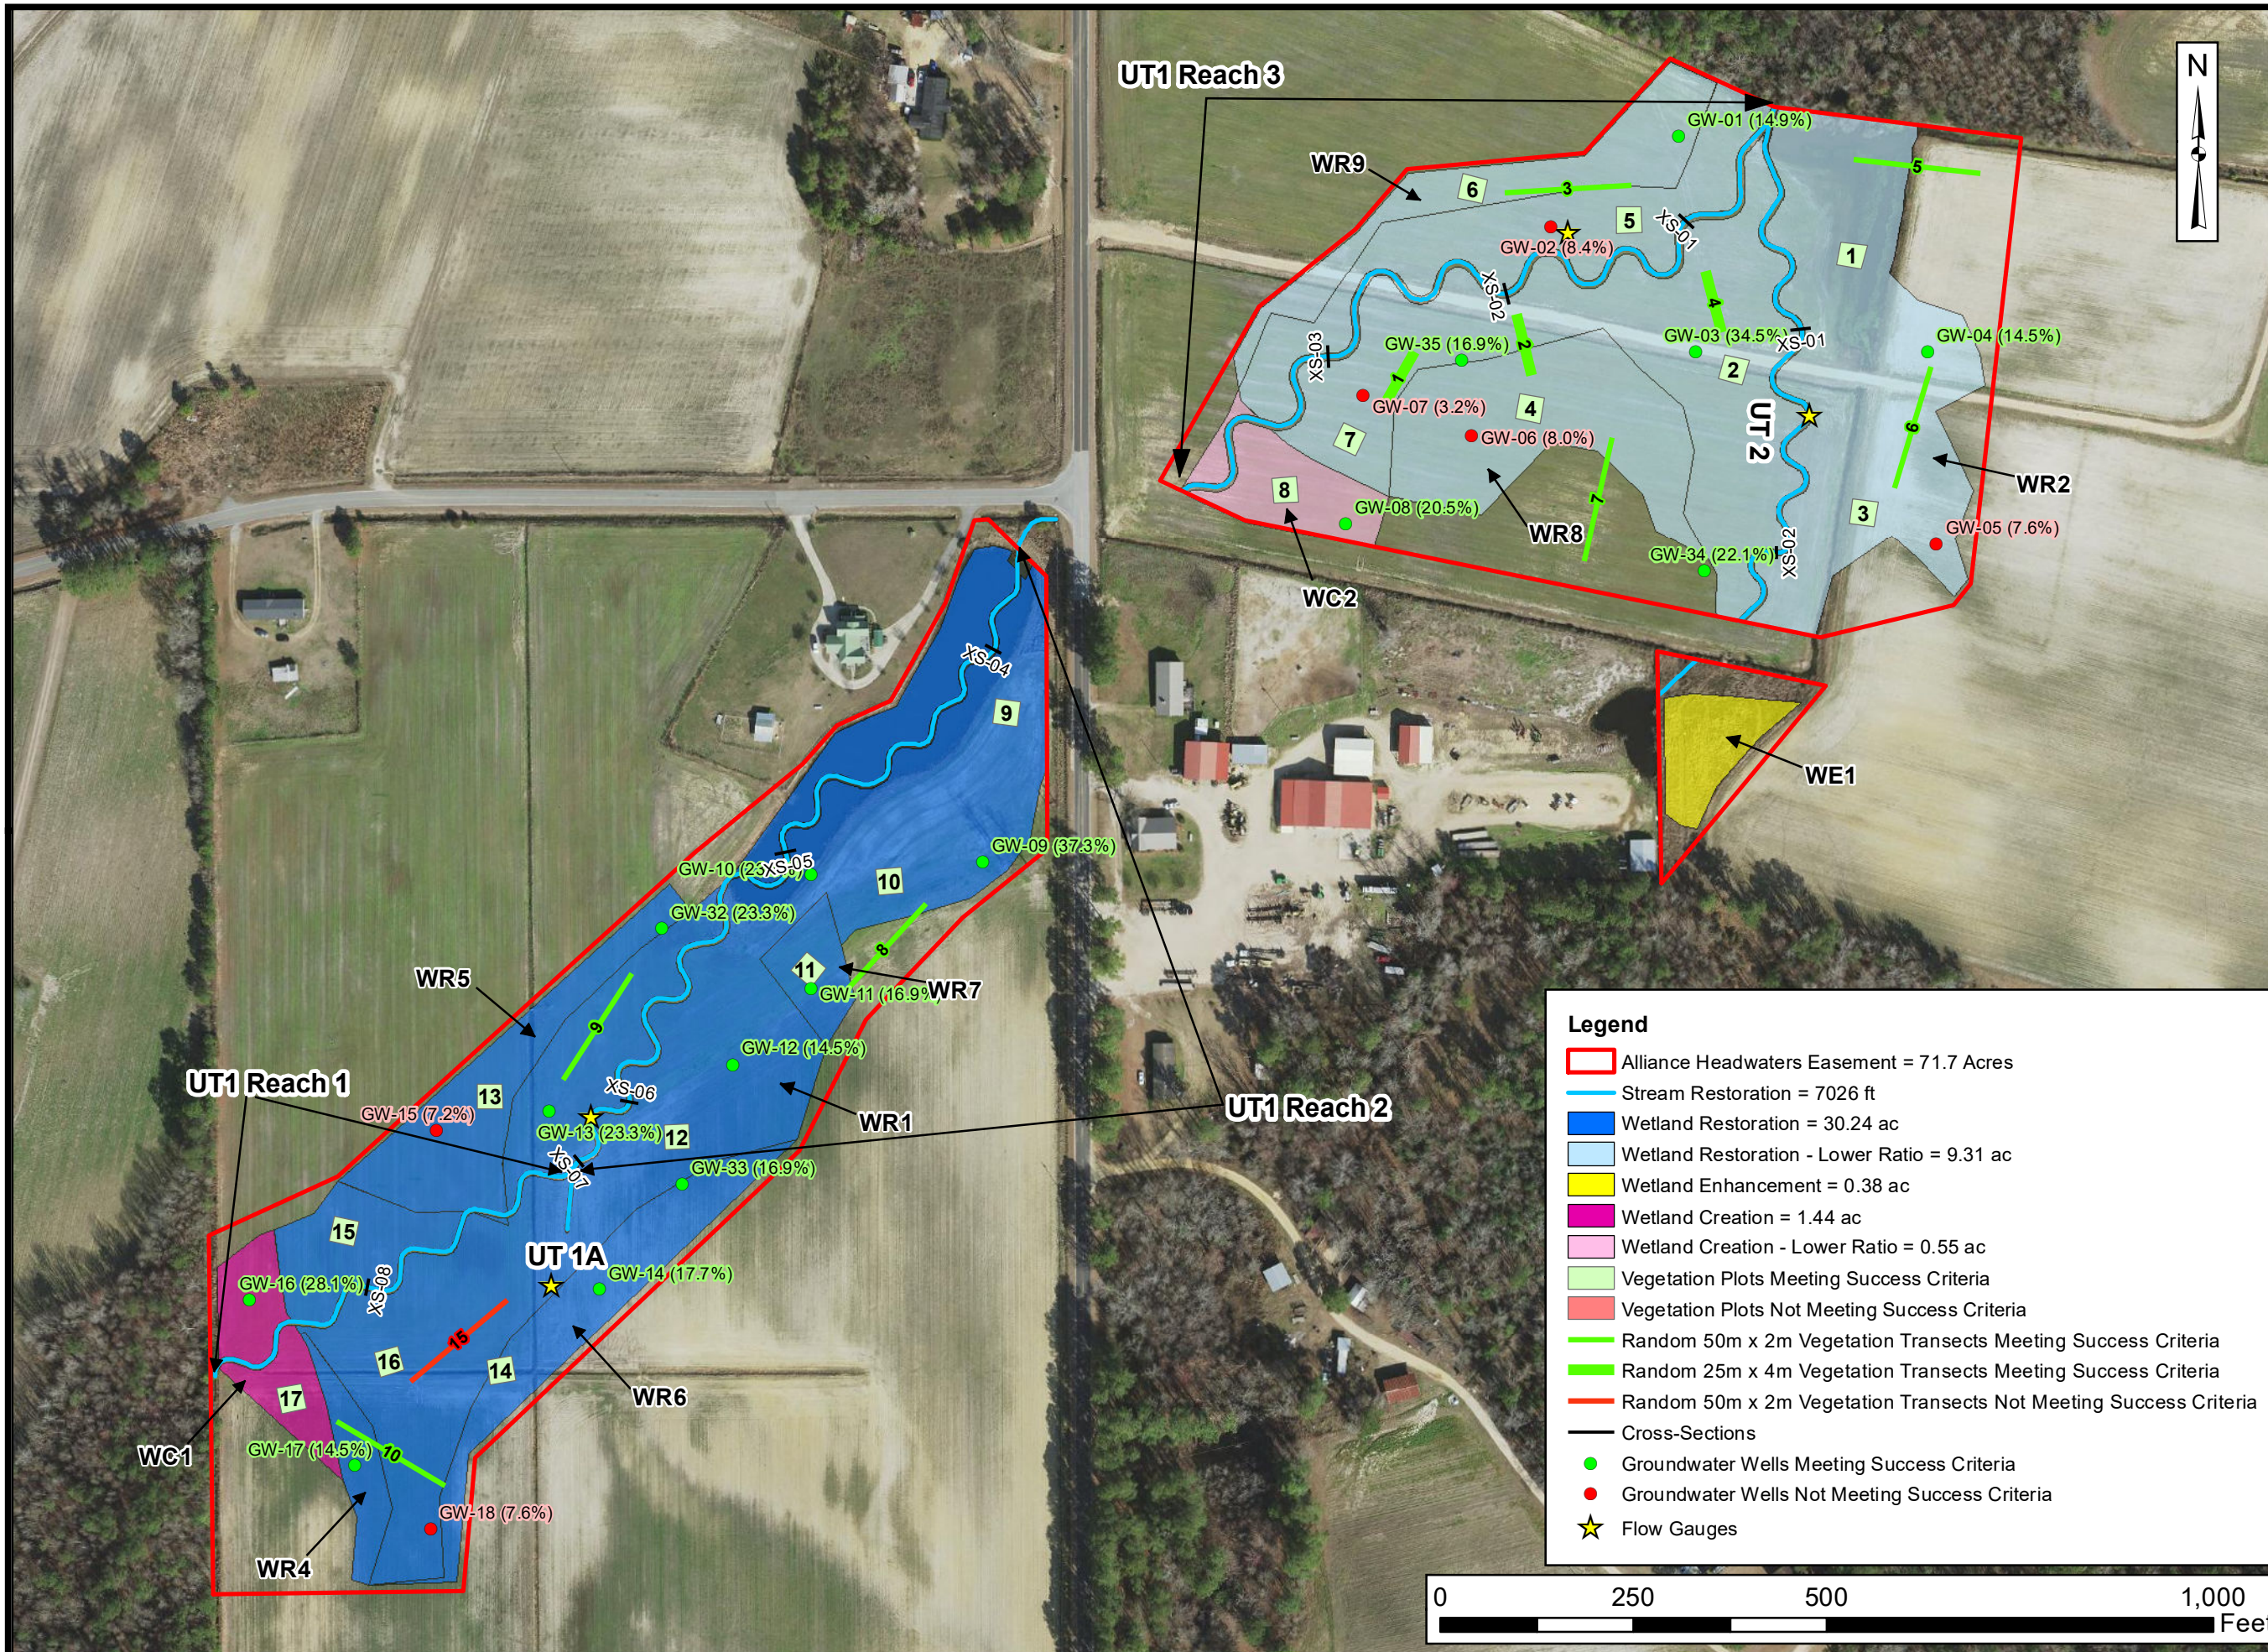
FIGURE 2A

Due to equipment malfunctions and general wetland hydrology failure during Year 1 (2021), the original twenty-nine groundwater gauges were replaced with a standard Onset HOB0 pressure-based water level data loggers in January 2021. Also, six additional wetland gauges were installed in areas of the Site RS felt needed additional data points (near GW19, near vegetation plot 31, near GW 7, at the upstream portion of UT 2, and across UT 1 from GW 11-12). New gauge locations are depicted on Figures 2A-B (Appendix B).
