YEAR 6 (2021) MONITORING REPORT
AYCOCK SPRINGS
STREAM AND WETLAND MITIGATION SITE

ALAMANCE COUNTY, NORTH CAROLINA
DMS PROJECT No. 96312
FULL DELIVERY CONTRACT No. 5791
NCDWR PROJECT No. 20140335
USACE ACTION ID No. SAW-2014-01711

Data Collection – January-October 2021

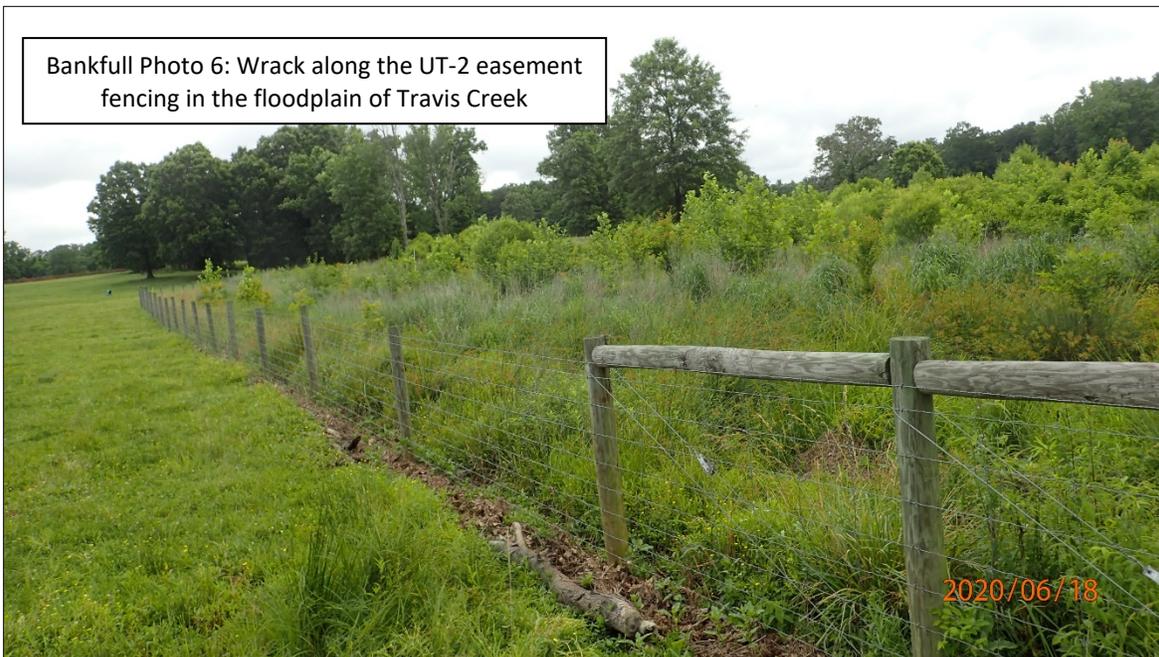
Bankfull Photo 6: Wrack along the UT-2 easement fencing in the floodplain of Travis Creek

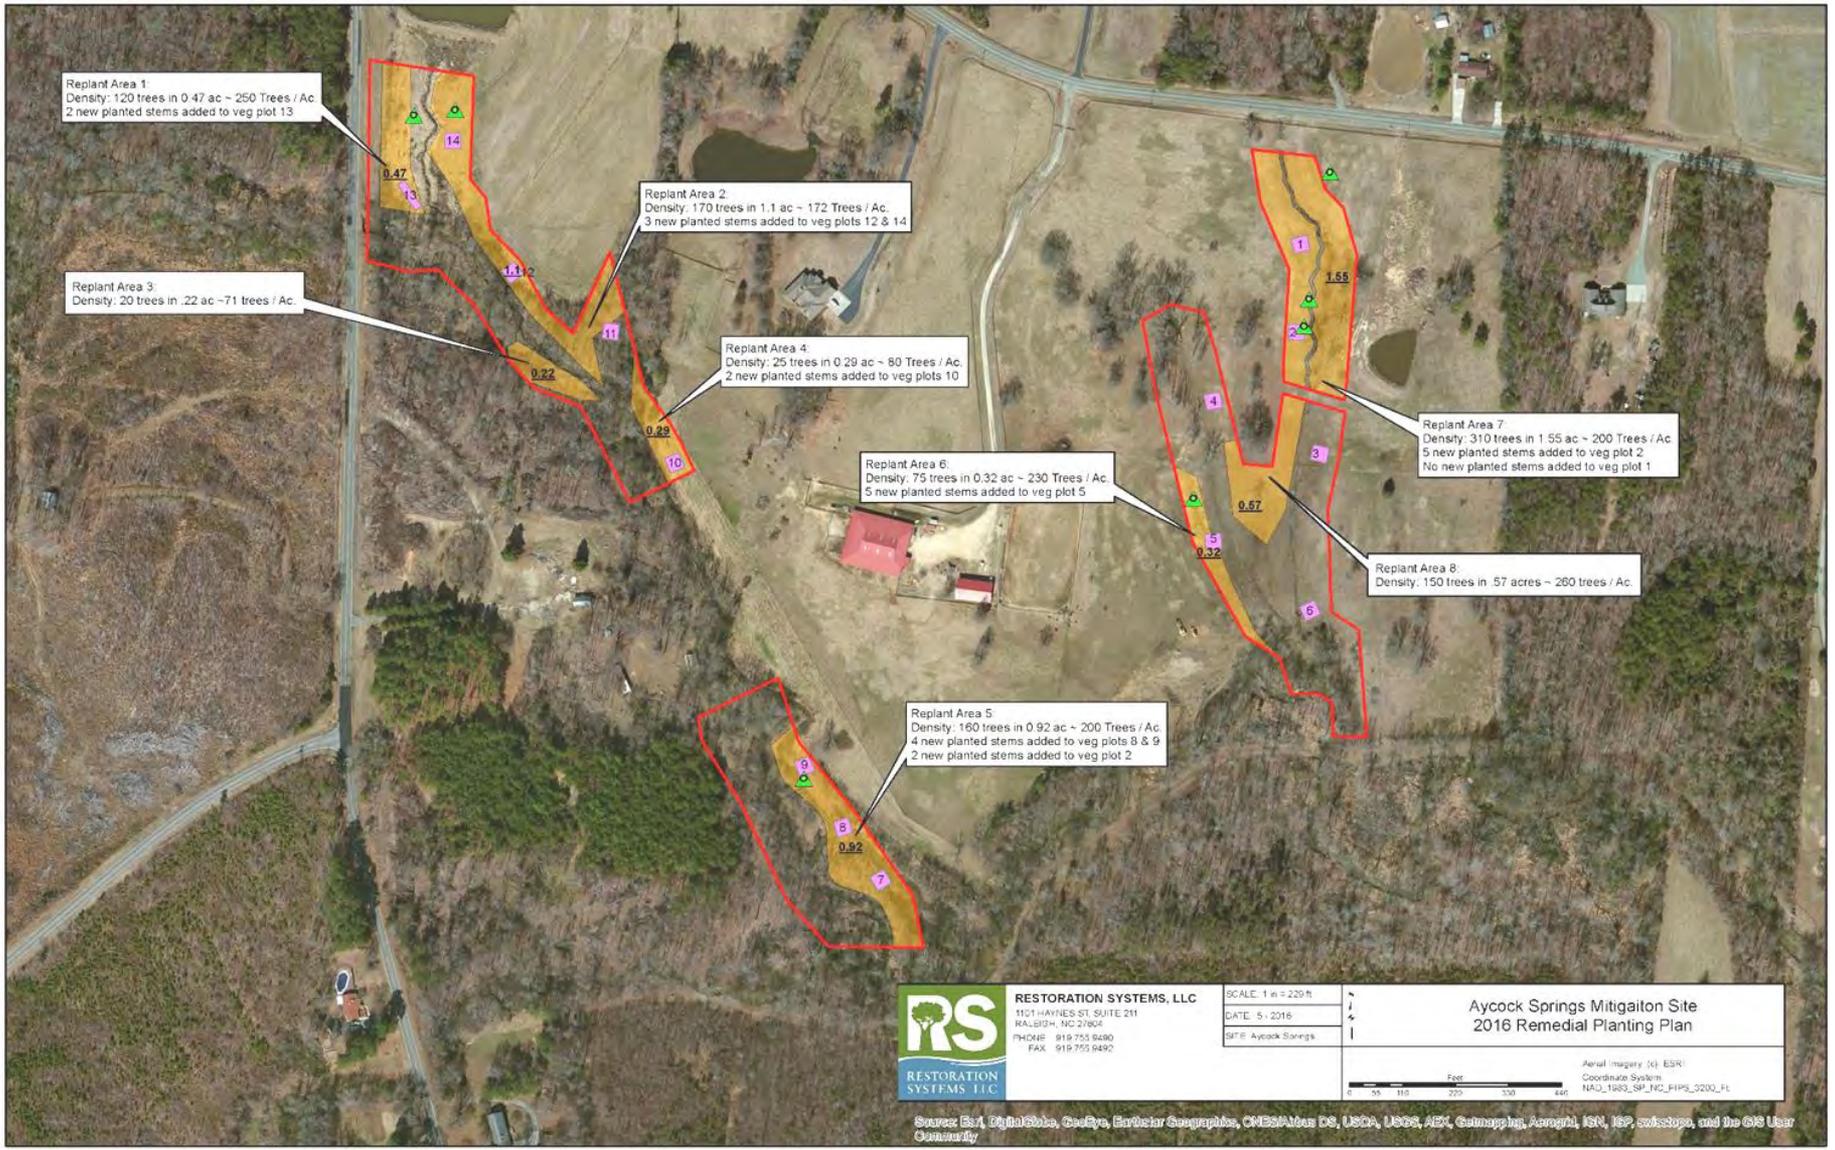
Map of Replant Areas- green dots indicate approximate location of where photos were taken.

Aycock Springs– Remedial Action Plan - Vegetation Update

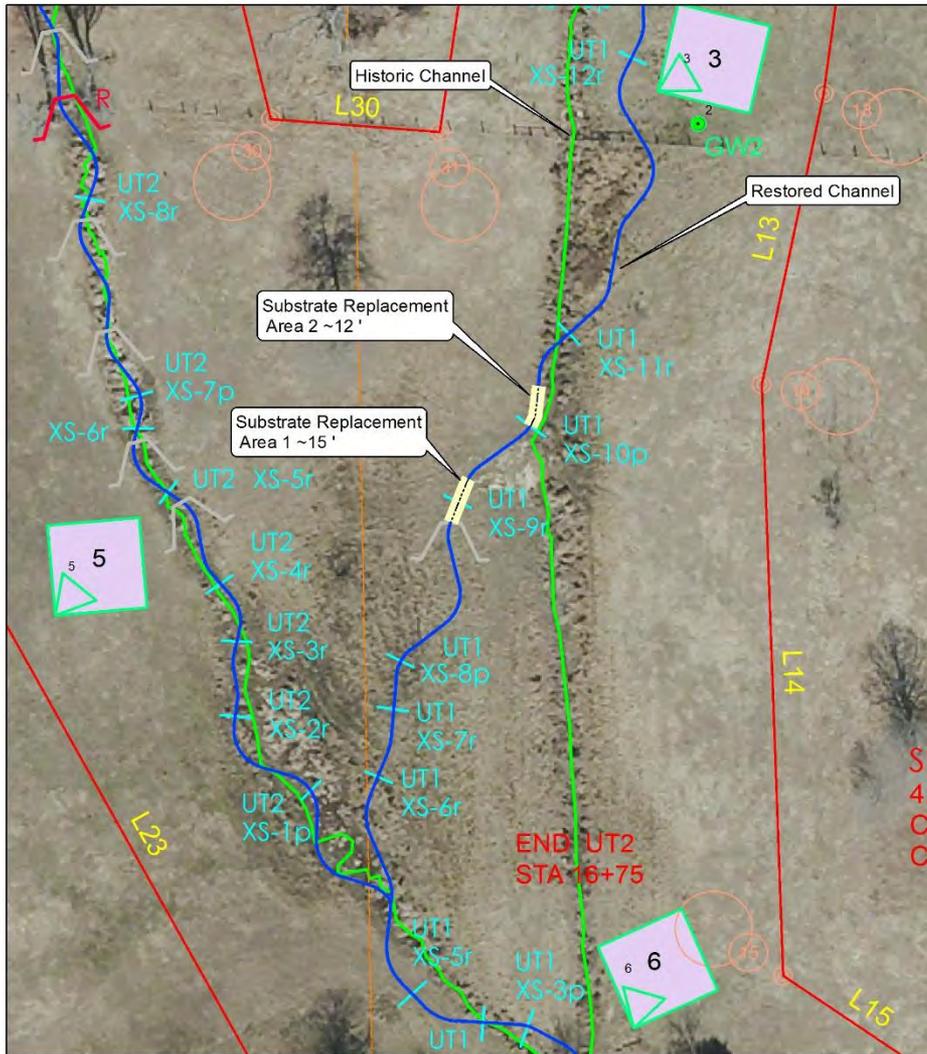
Map of Area – UT 1, XC 9, 10, 11

The year 1 (2016) measurements for cross-sections 9 and 10 on UT-1 showed stream bed erosion compared with as-built data. Stream bed erosion was noted shortly after as-built measurements were taken and were the result of the above mentioned rain events. It was evident bed material used during construction in this area was finer than it should have been. Two riffles showed bed erosion, totaling approximately 50 feet in length (approximately 1 percent of the project length). RS created and implemented a remedial action plan during the winter of 2016/2017 (see Section 3.0 and Appendix E). These repairs appear stable during Year 6 (2021) monitoring, and they will continue to be monitored during subsequent monitoring years.

Aycock Springs-- Remedial Action Plan Substrate Replacement - Update
