MY1 FINAL MONITORING REPORT
Banner Branch Mitigation Project
Stokes County
Roanoke River Basin
CU 03010103

DMS Project # 100080
DMS Contract # 7610 and 7701
DMS RFP # 16-007405
USACE Action ID Number SAW-2018-01760
DWR Project # 18-1154
Calendar Year of Data Collection: 2021

December 29, 2021

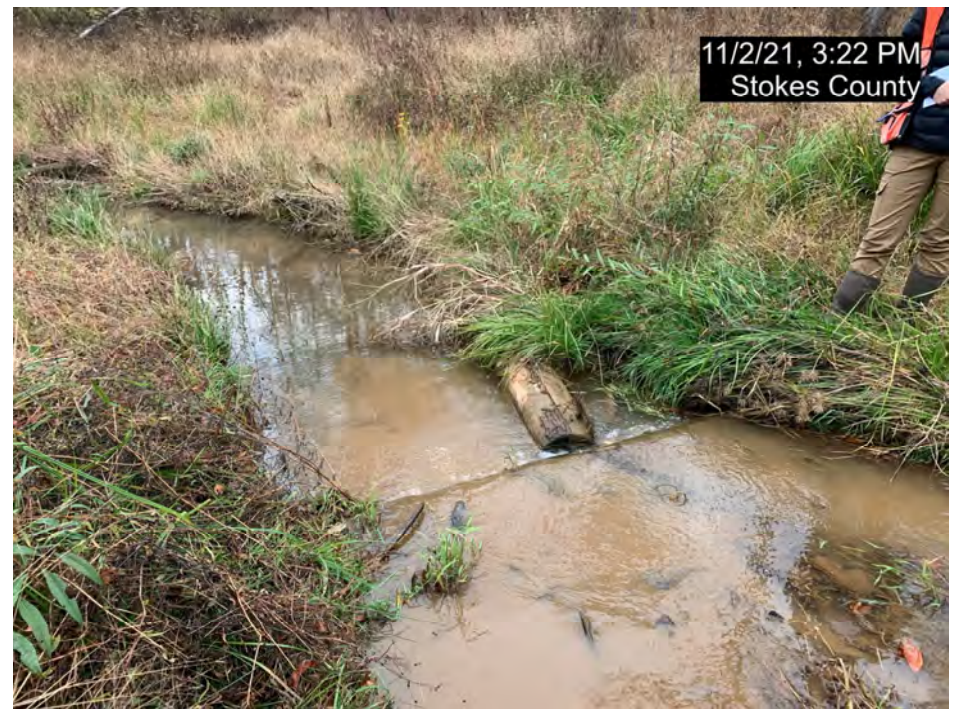
SPA-1 – BB-R1, Piping around rock structure @ STA 44+00 (MY-01)

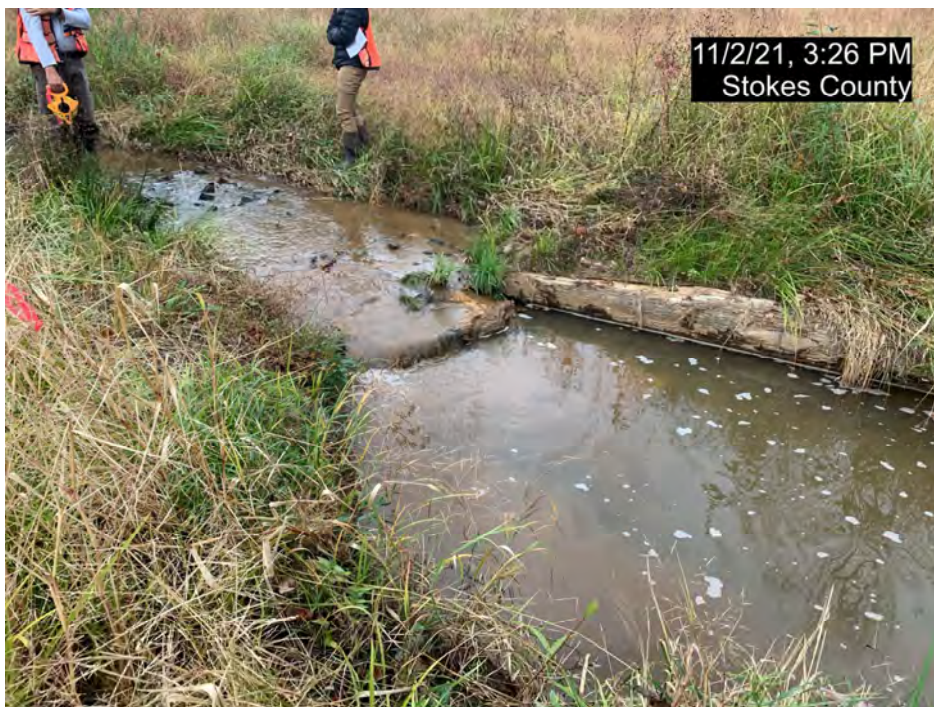
SPA-2 – BB-R3, Erosion around log vane @ STA 70+50 (MY-01)
