# **MONITORING YEAR 3 ANNUAL REPORT**

## **BUCKWATER MITIGATION SITE**

Orange County, NC  
NCDEQ Contract No. 006829  
DMS Project Number 97084  
USACE Action ID Number 2016-00873  
NCDWR Project Number 2016-0406

Data Collection Period: January – November 2021  
Draft Submission Date: November 29, 2021  
Final Submission Date: December 13, 2021

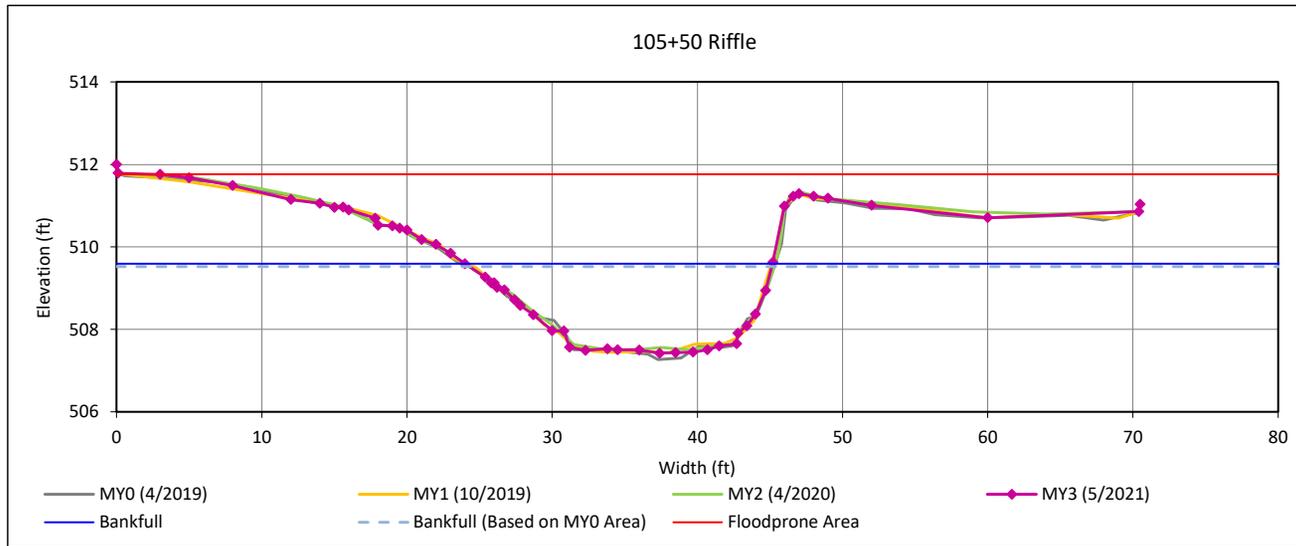
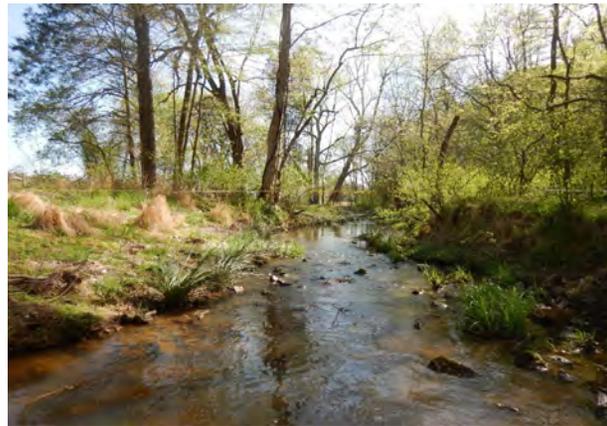
**Cross-Section 1 - Buckwater Creek Reach 2**

33.4	x-section area (ft.sq.)
21.2	width (ft)
1.6	mean depth (ft)
2.2	max depth (ft)
22.4	wetted perimeter (ft)
1.5	hydraulic radius (ft)
13.4	width-depth ratio
200.0	W flood prone area (ft)
9.4	entrenchment ratio
1.0	low bank height ratio

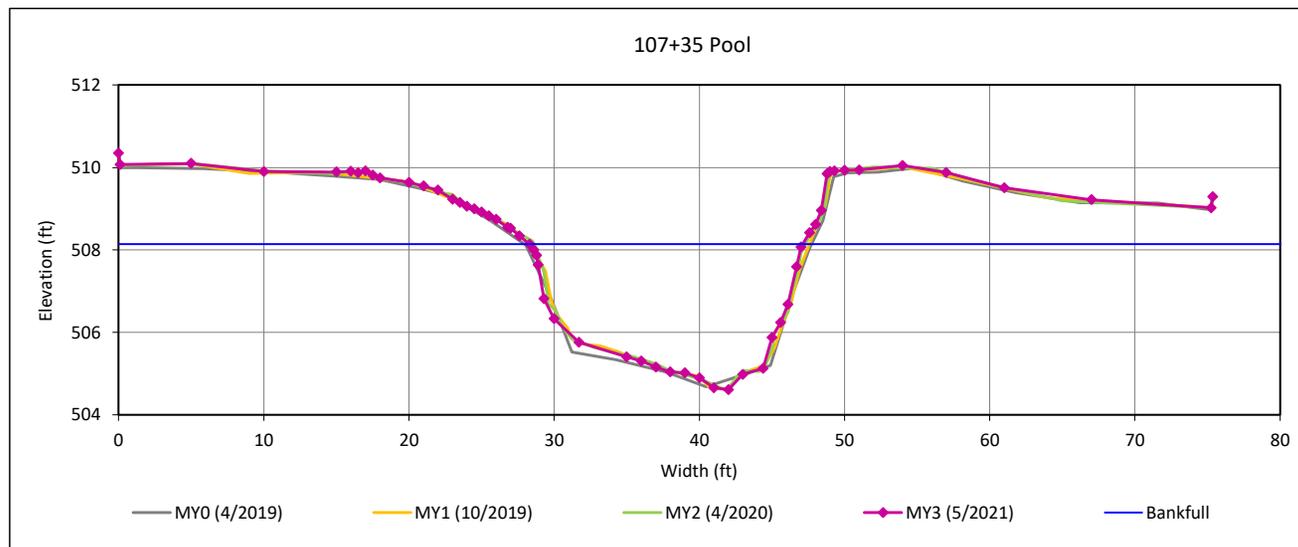
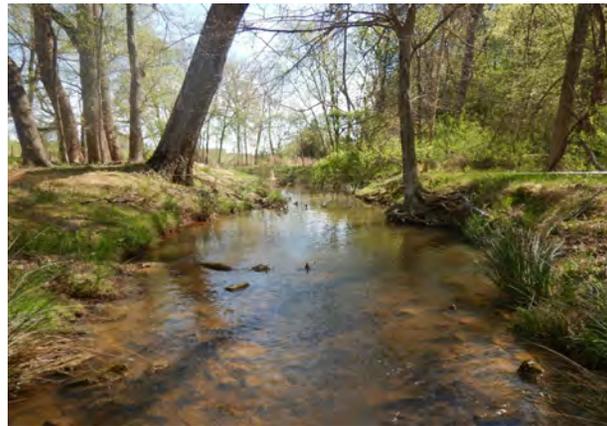
#### Cross-Section 2 - Buckwater Creek Reach 3

47.5	x-section area (ft.sq.)
18.7	width (ft)
2.5	mean depth (ft)
3.5	max depth (ft)
21.2	wetted perimeter (ft)
2.2	hydraulic radius (ft)
7.4	width-depth ratio

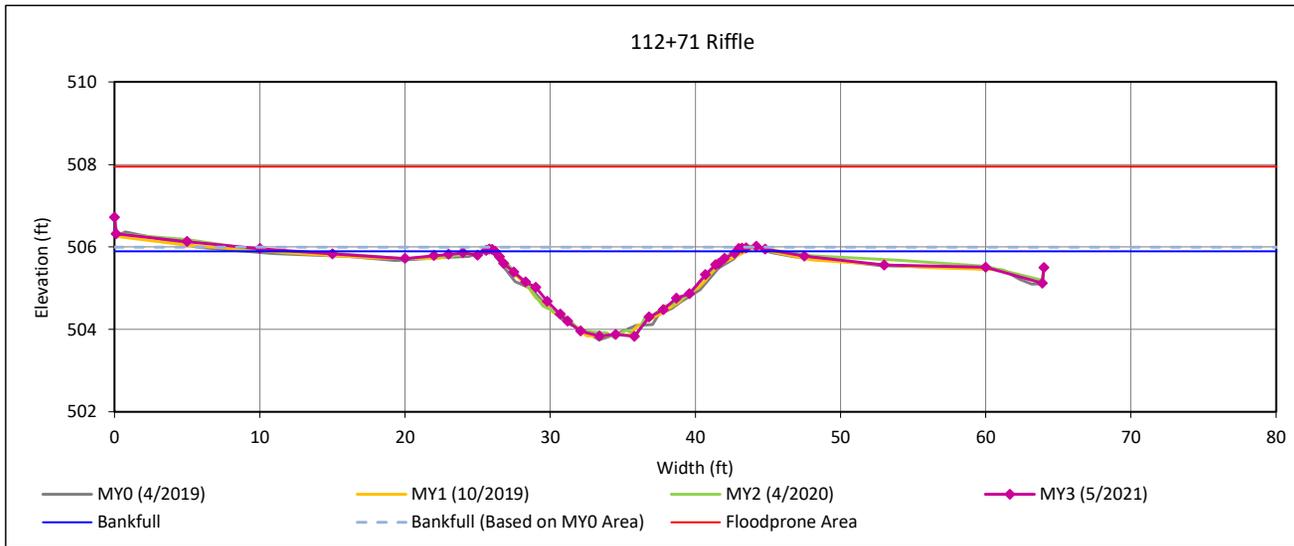
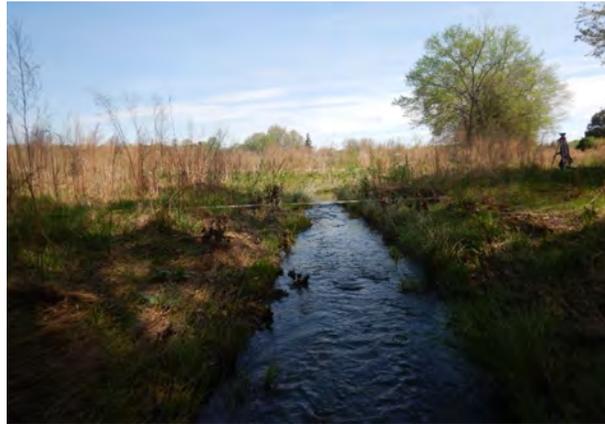
**Cross-Section 4 - Buckwater Creek Reach 4**

20.2	x-section area (ft.sq.)
16.6	width (ft)
1.2	mean depth (ft)
2.1	max depth (ft)
17.3	wetted perimeter (ft)
1.2	hydraulic radius (ft)
13.6	width-depth ratio
150.0	W flood prone area (ft)
9.0	entrenchment ratio
< 1.0	low bank height ratio

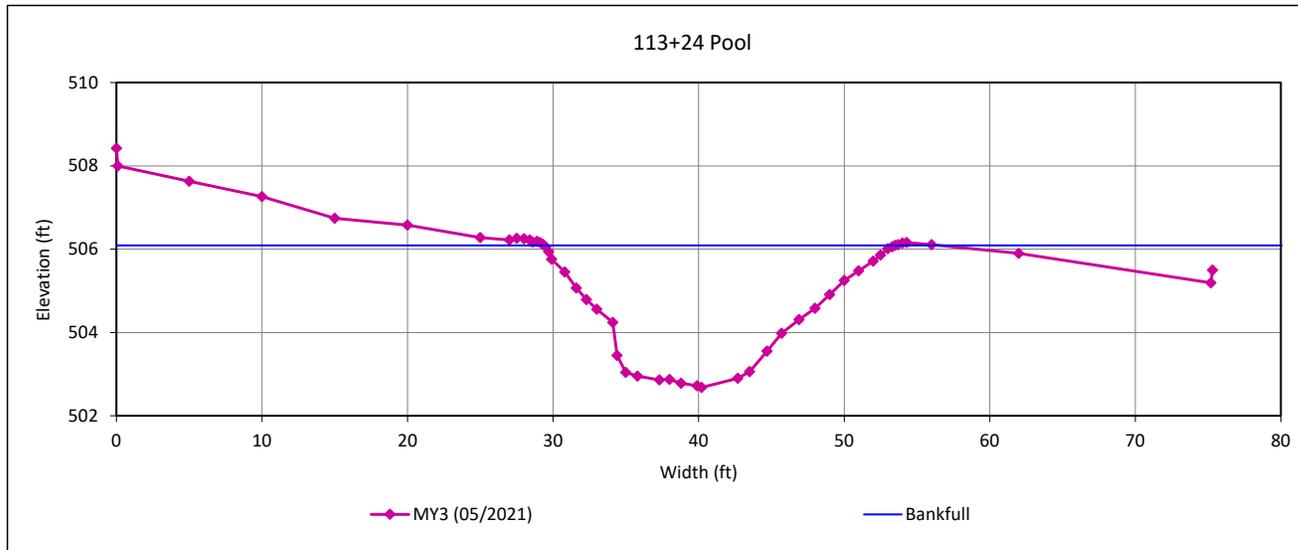
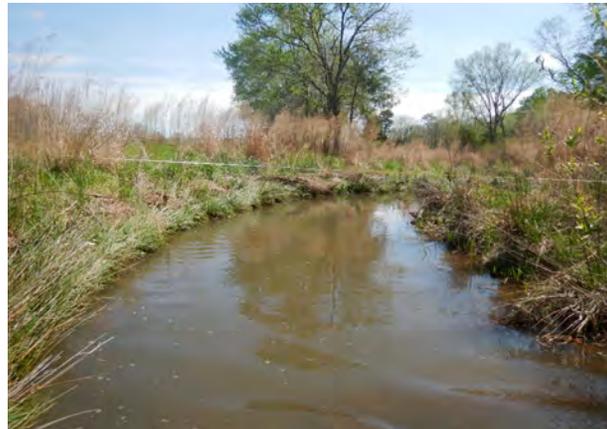
#### Cross-Section 5 - Buckwater Creek Reach 4

48.4	x-section area (ft.sq.)
24.1	width (ft)
2.0	mean depth (ft)
3.4	max depth (ft)
25.7	wetted perimeter (ft)
1.9	hydraulic radius (ft)
12.0	width-depth ratio

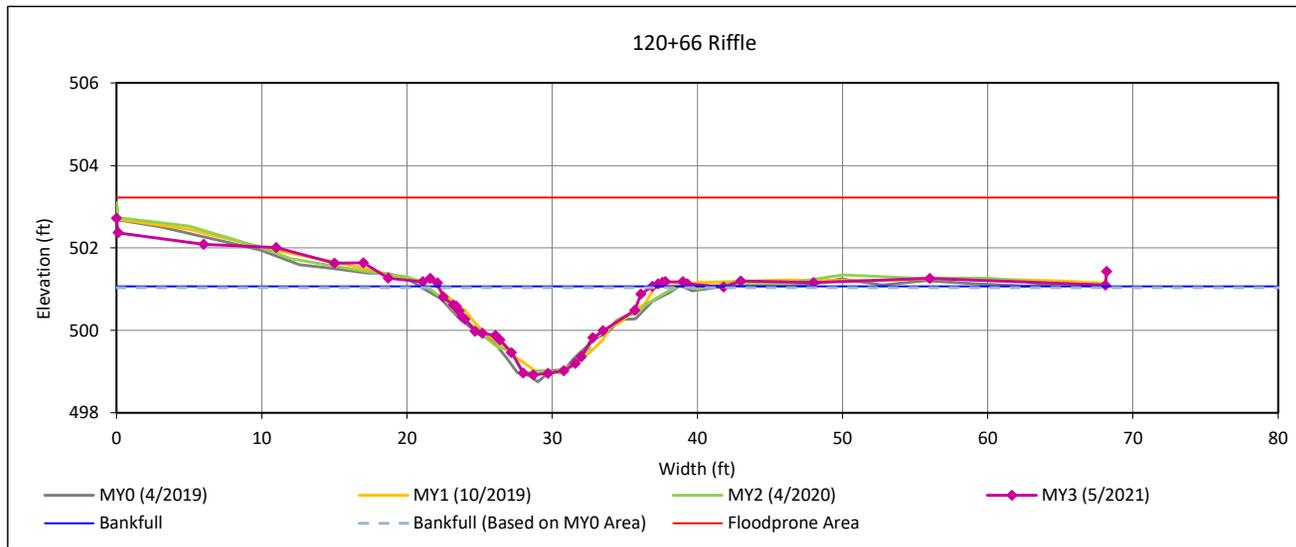
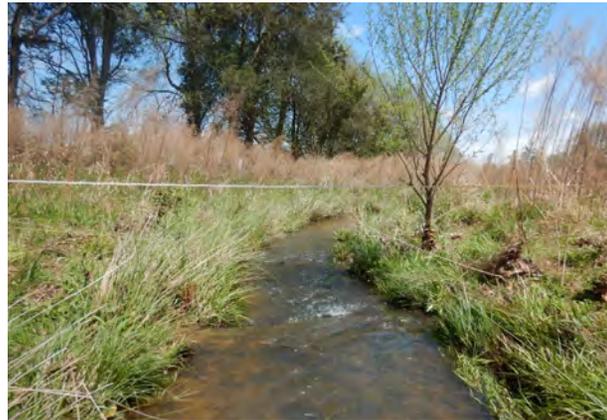
**Cross-Section 6 - Buckwater Creek Reach 4**

18.3	x-section area (ft.sq.)
14.7	width (ft)
1.2	mean depth (ft)
2.2	max depth (ft)
15.6	wetted perimeter (ft)
1.2	hydraulic radius (ft)
11.8	width-depth ratio
200.0	W flood prone area (ft)
13.6	entrenchment ratio
1.0	low bank height ratio

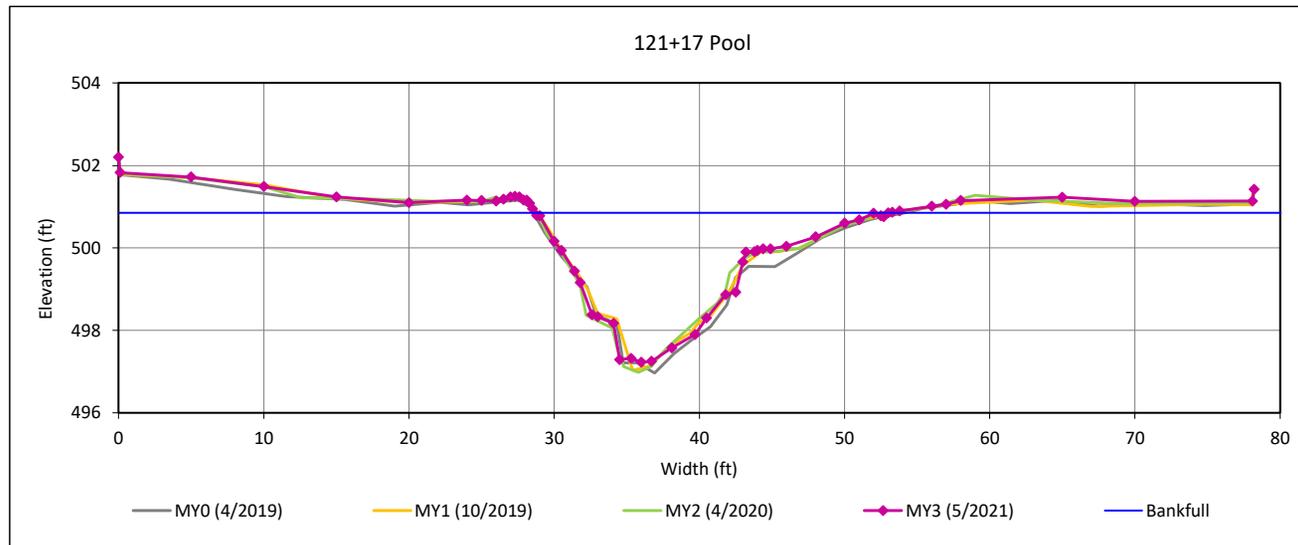
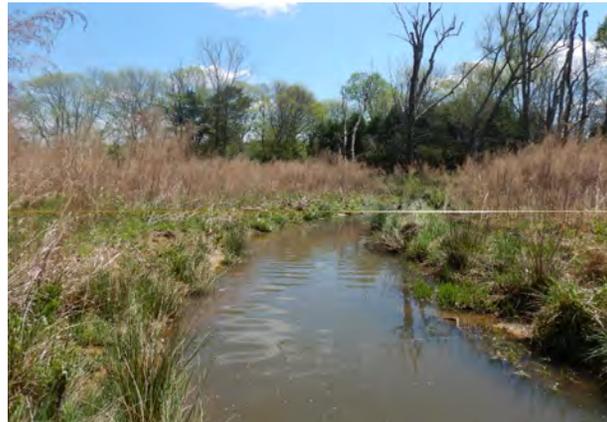
#### Cross-Section 7 - Buckwater Creek Reach 4

39.4	x-section area (ft.sq.)
24.3	width (ft)
1.6	mean depth (ft)
3.6	max depth (ft)
26.5	wetted perimeter (ft)
1.5	hydraulic radius (ft)
15.0	width-depth ratio

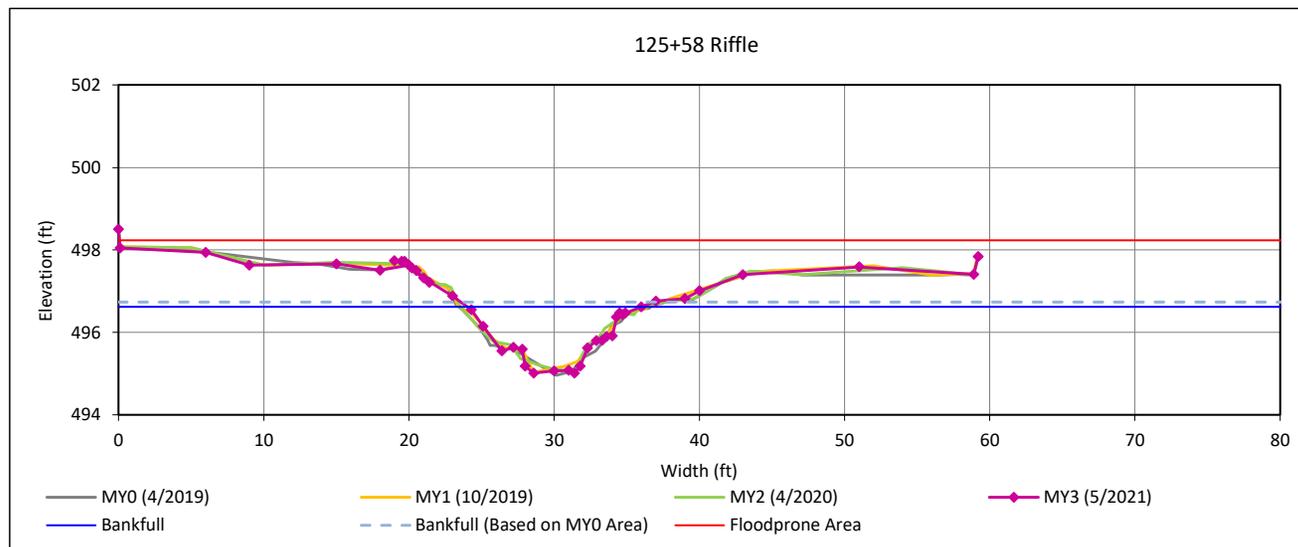
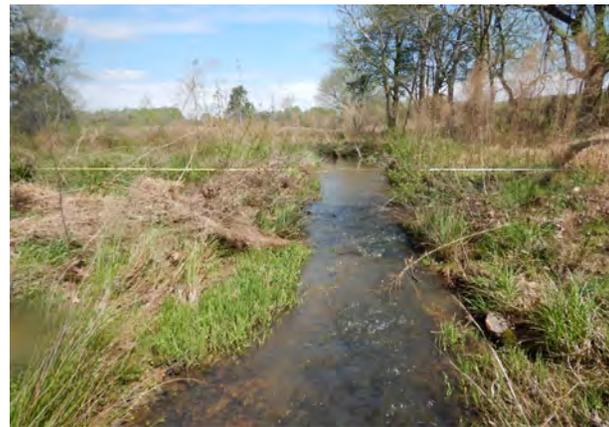
**Cross-Section 8 - Buckwater Creek Reach 4**

11.1	x-section area (ft.sq.)
12.0	width (ft)
0.9	mean depth (ft)
1.6	max depth (ft)
13.0	wetted perimeter (ft)
0.9	hydraulic radius (ft)
12.9	width-depth ratio
200.0	W flood prone area (ft)
16.7	entrenchment ratio
< 1.0	low bank height ratio

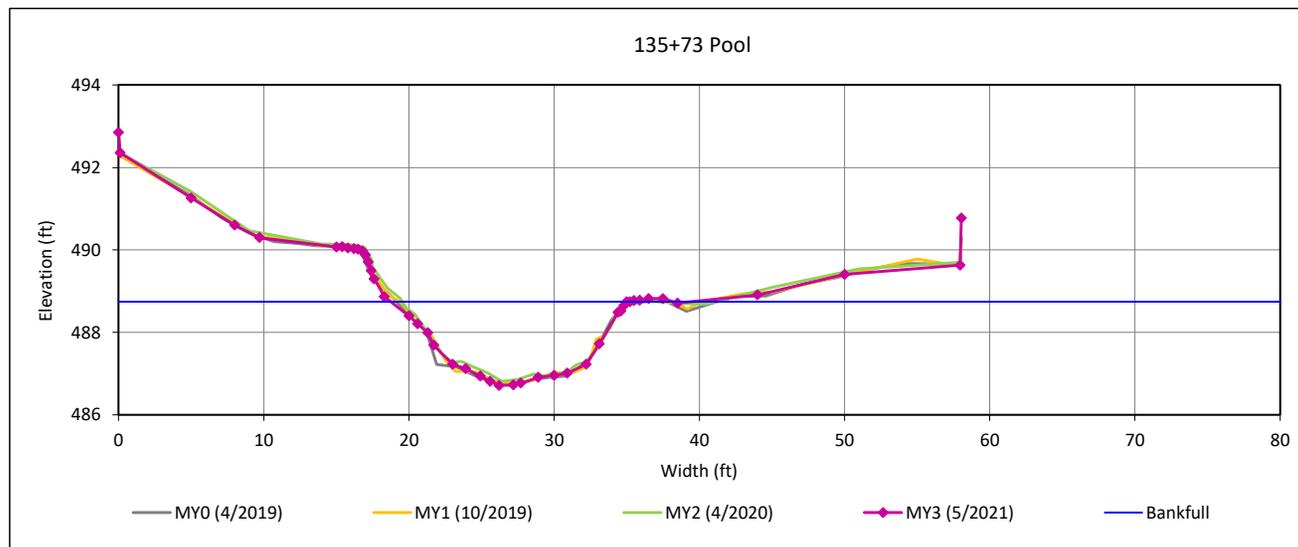
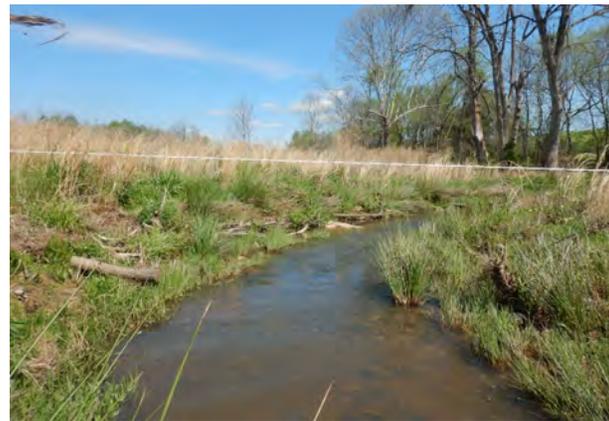
#### Cross-Section 9 - Buckwater Creek Reach 5

21.6	x-section area (ft.sq.)
16.2	width (ft)
1.3	mean depth (ft)
2.0	max depth (ft)
17.0	wetted perimeter (ft)
1.3	hydraulic radius (ft)
12.2	width-depth ratio

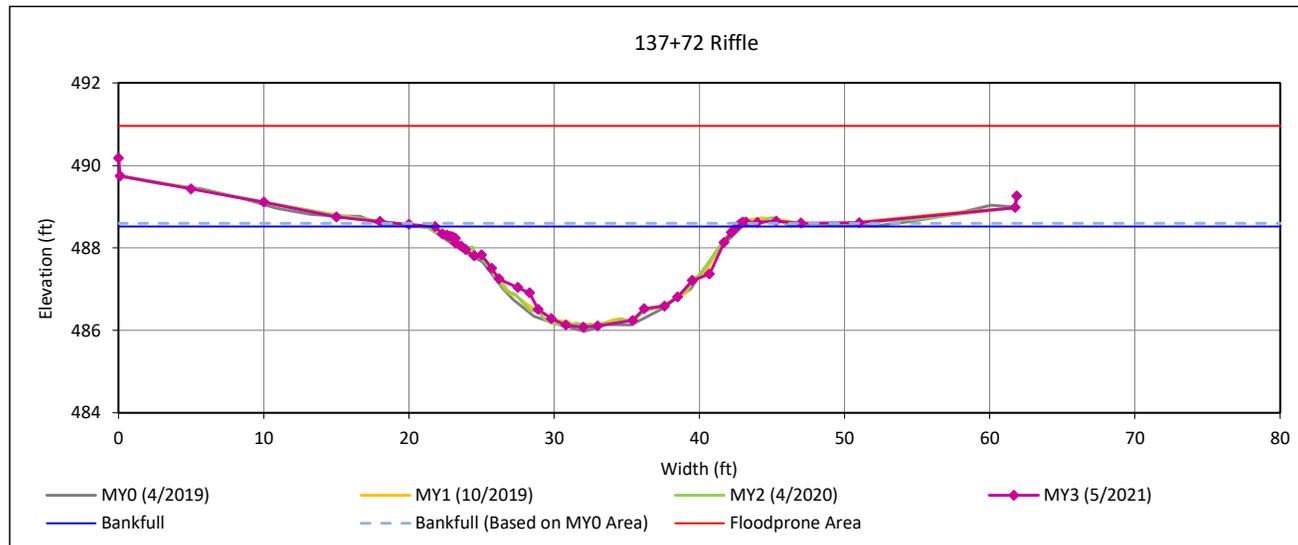
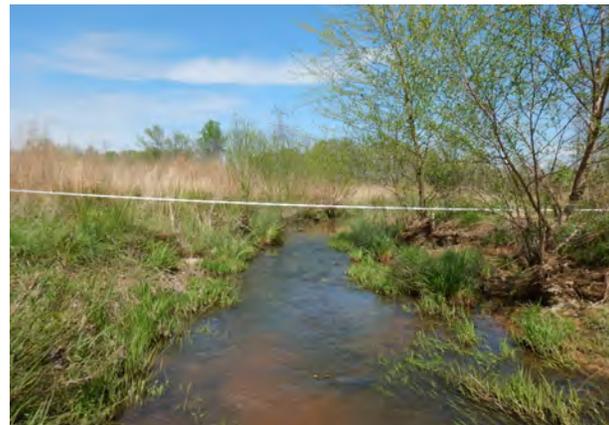
**Cross-Section 10 - Buckwater Creek Reach 5**

31.8	x-section area (ft.sq.)
20.8	width (ft)
1.5	mean depth (ft)
2.4	max depth (ft)
21.8	wetted perimeter (ft)
1.5	hydraulic radius (ft)
13.6	width-depth ratio
200.0	W flood prone area (ft)
9.6	entrenchment ratio
< 1.0	low bank height ratio

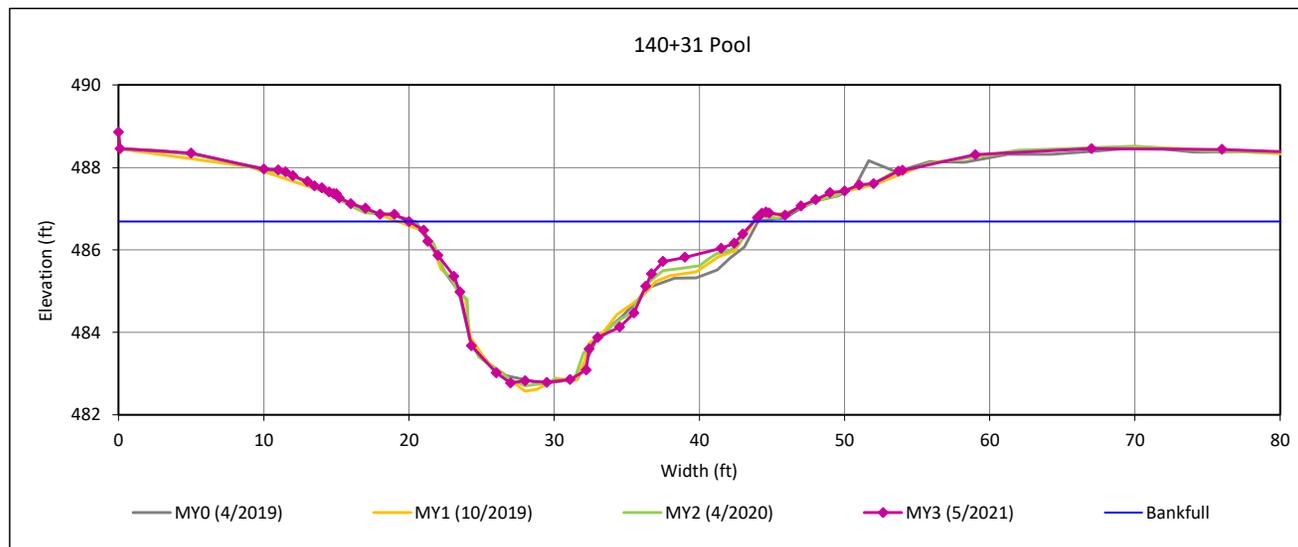
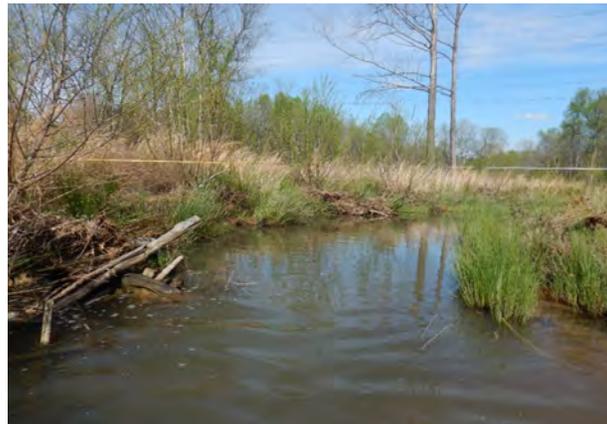
#### Cross-Section 11 - Buckwater Creek Reach 6

49.8	x-section area (ft.sq.)
23.8	width (ft)
2.1	mean depth (ft)
3.9	max depth (ft)
26.1	wetted perimeter (ft)
1.9	hydraulic radius (ft)
11.3	width-depth ratio

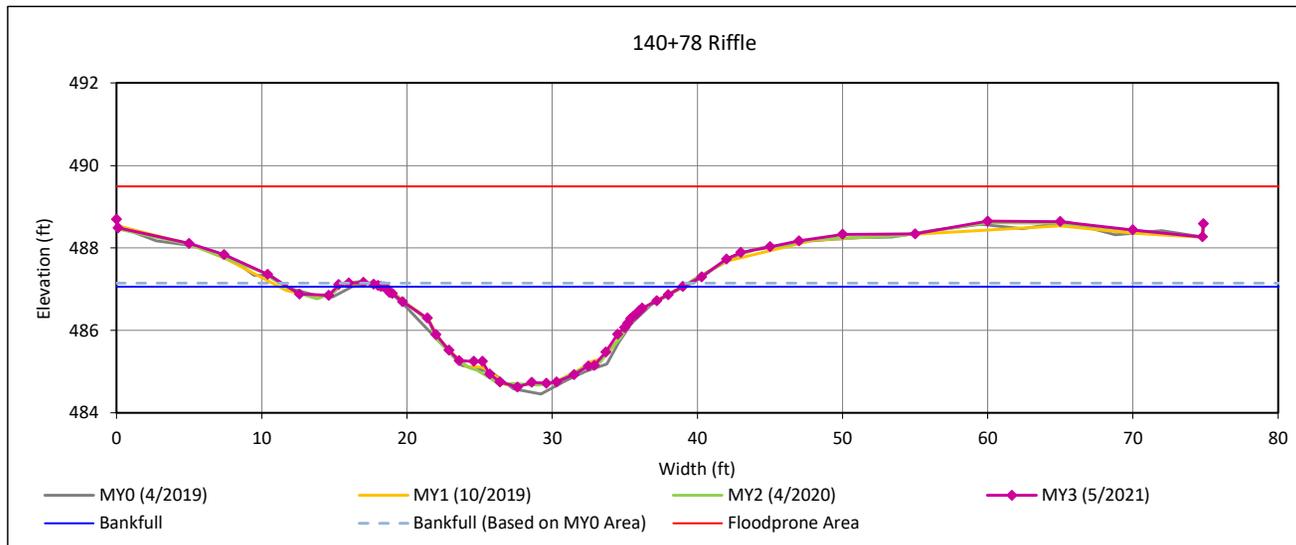
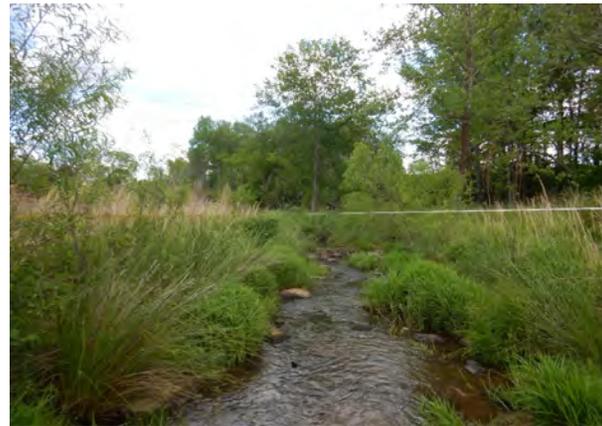
**Cross-Section 12 - Buckwater Creek Reach 6**

28.8	x-section area (ft.sq.)
20.6	width (ft)
1.4	mean depth (ft)
2.4	max depth (ft)
21.4	wetted perimeter (ft)
1.3	hydraulic radius (ft)
14.7	width-depth ratio
200.0	W flood prone area (ft)
9.7	entrenchment ratio
< 1.0	low bank height ratio

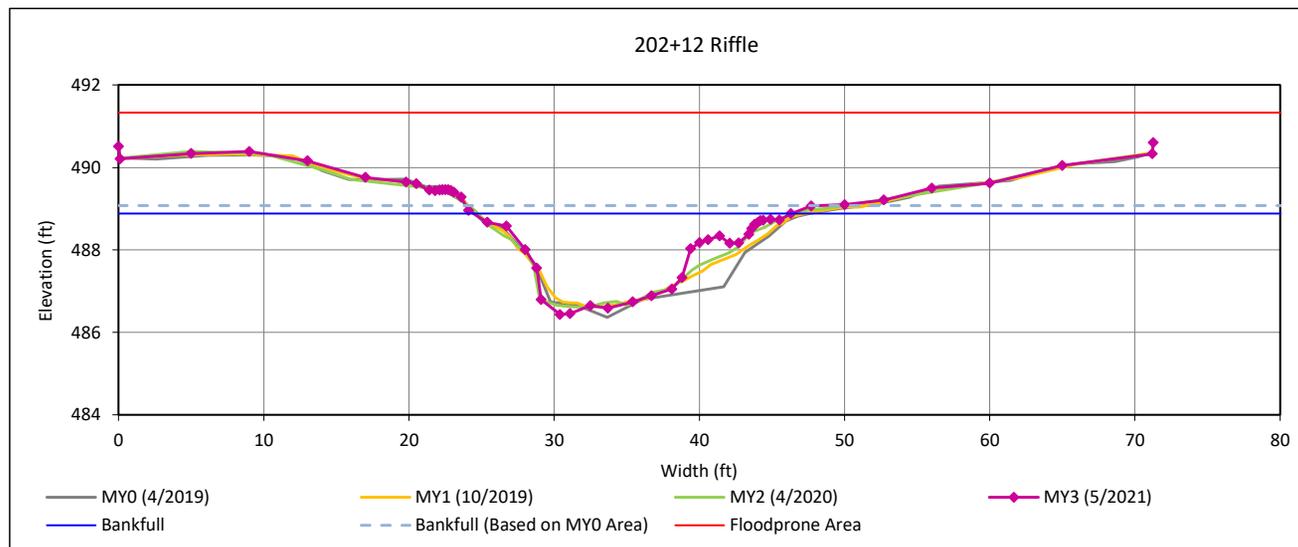
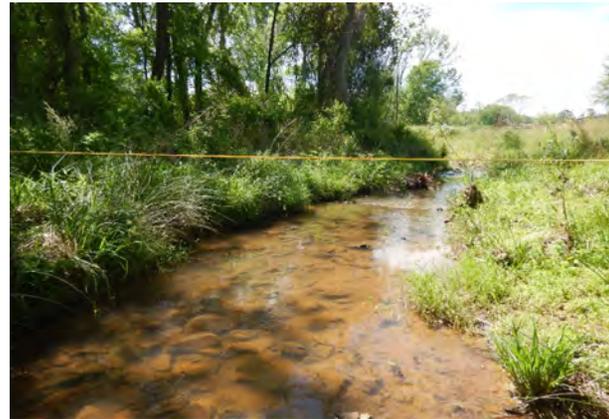
#### Cross-Section 13 - T1 Reach 1

27.3	x-section area (ft.sq.)
21.0	width (ft)
1.3	mean depth (ft)
2.5	max depth (ft)
22.4	wetted perimeter (ft)
1.2	hydraulic radius (ft)
16.2	width-depth ratio
150.0	W flood prone area (ft)
7.1	entrenchment ratio
< 1.0	low bank height ratio

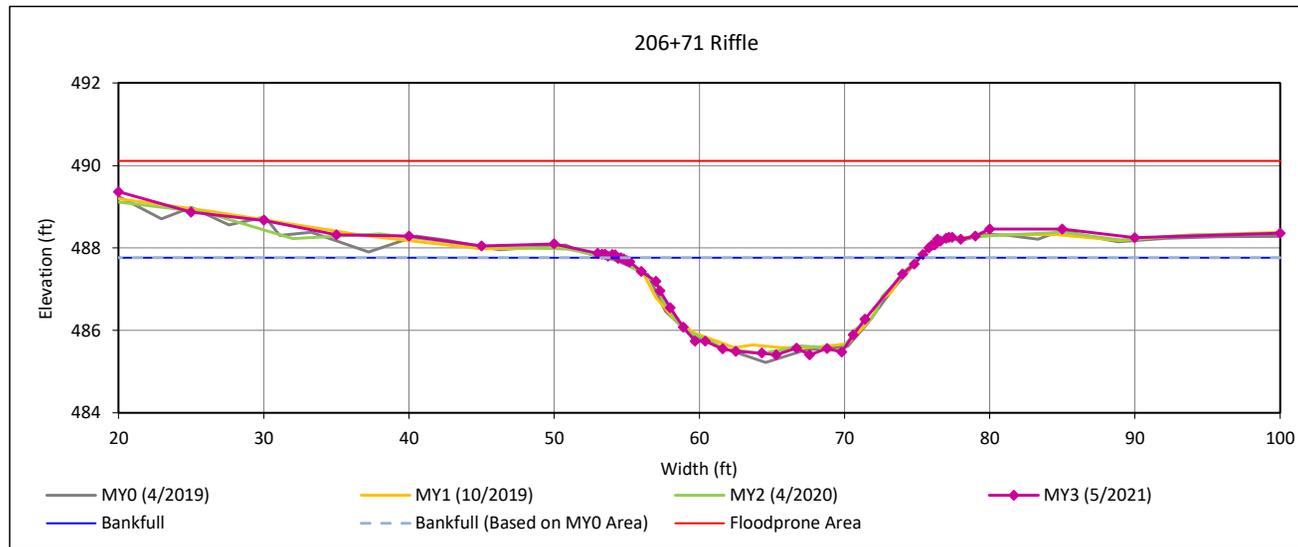
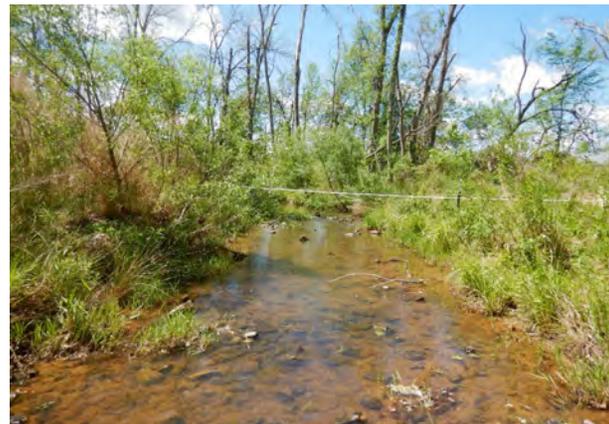
**Cross-Section 14 - T1 Reach 2**

32.6	x-section area (ft.sq.)
20.6	width (ft)
1.6	mean depth (ft)
2.3	max depth (ft)
21.6	wetted perimeter (ft)
1.5	hydraulic radius (ft)
13.0	width-depth ratio
200.0	W flood prone area (ft)
9.7	entrenchment ratio
1.0	low bank height ratio

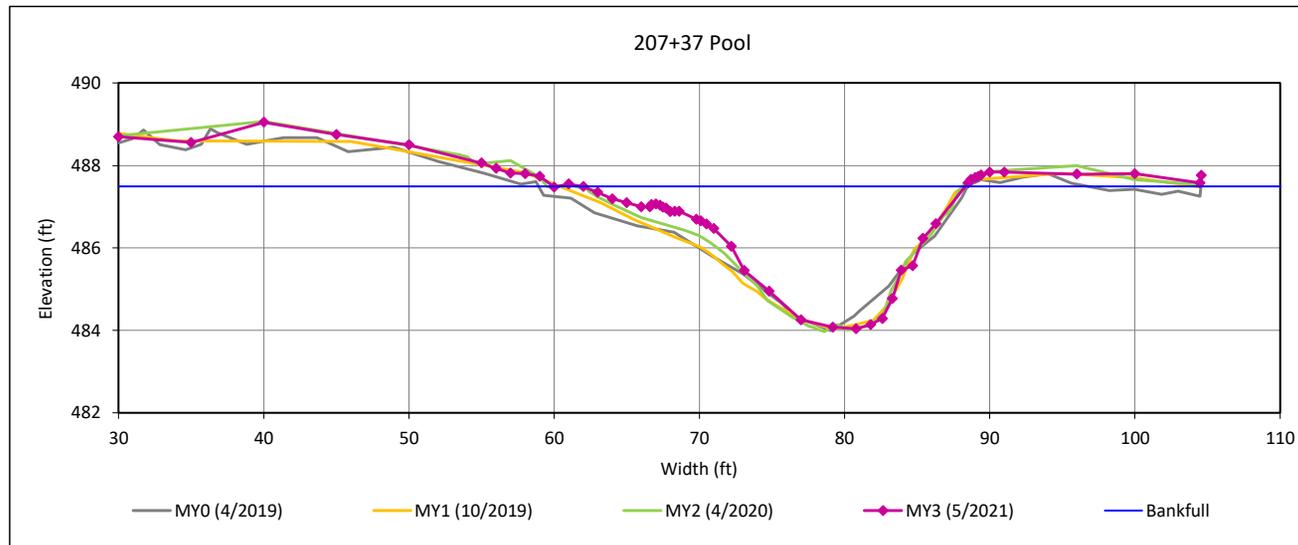
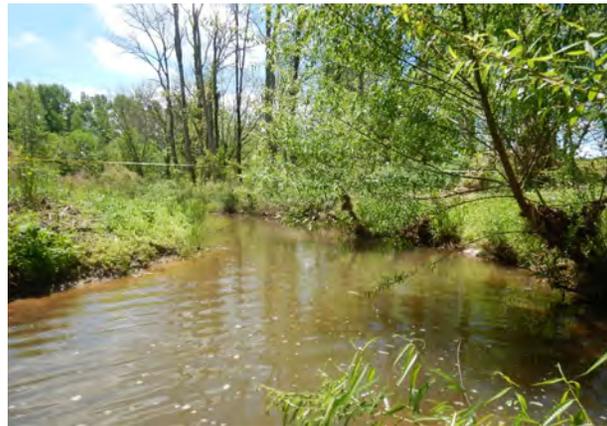
#### Cross-Section 15 - T1 Reach 2

44.5	x-section area (ft.sq.)
26.3	width (ft)
1.7	mean depth (ft)
3.4	max depth (ft)
27.9	wetted perimeter (ft)
1.6	hydraulic radius (ft)
15.6	width-depth ratio

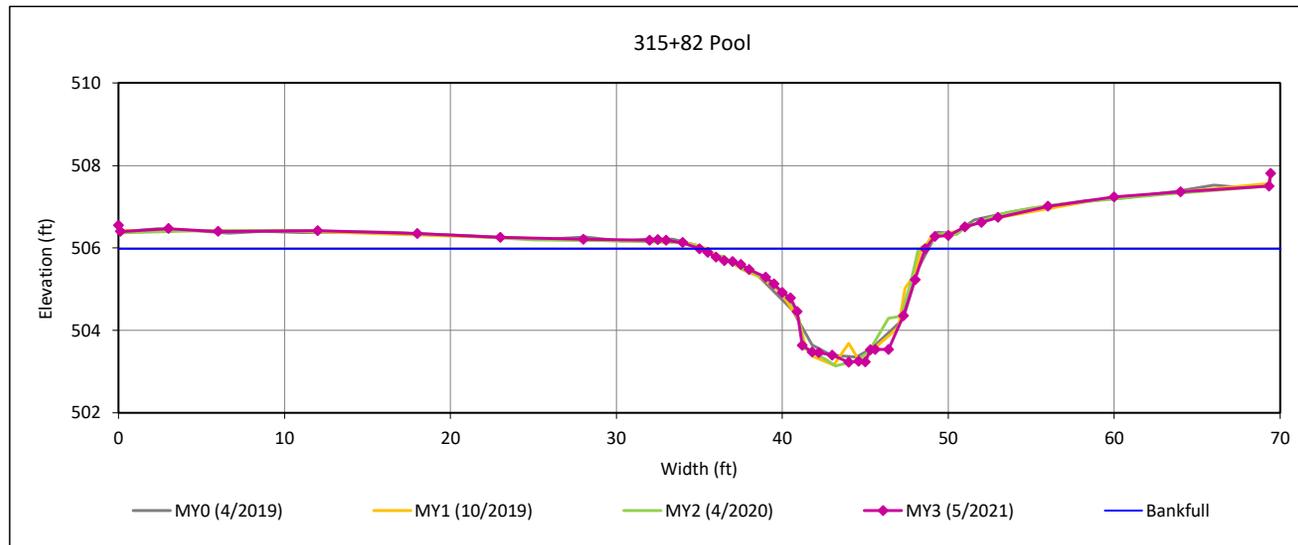
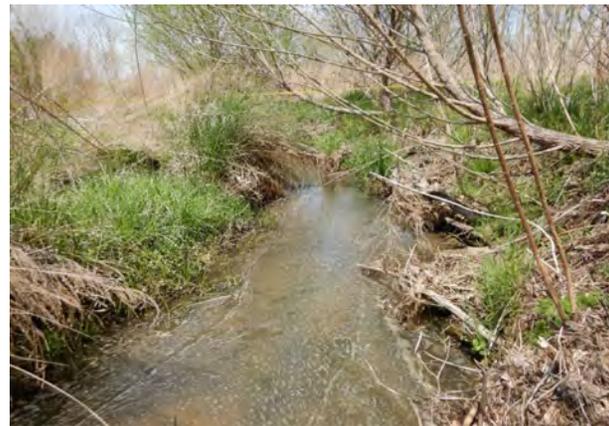
#### Cross-Section 16 - T3 Reach 2

20.1	x-section area (ft.sq.)
13.6	width (ft)
1.5	mean depth (ft)
2.8	max depth (ft)
15.7	wetted perimeter (ft)
1.3	hydraulic radius (ft)
9.2	width-depth ratio

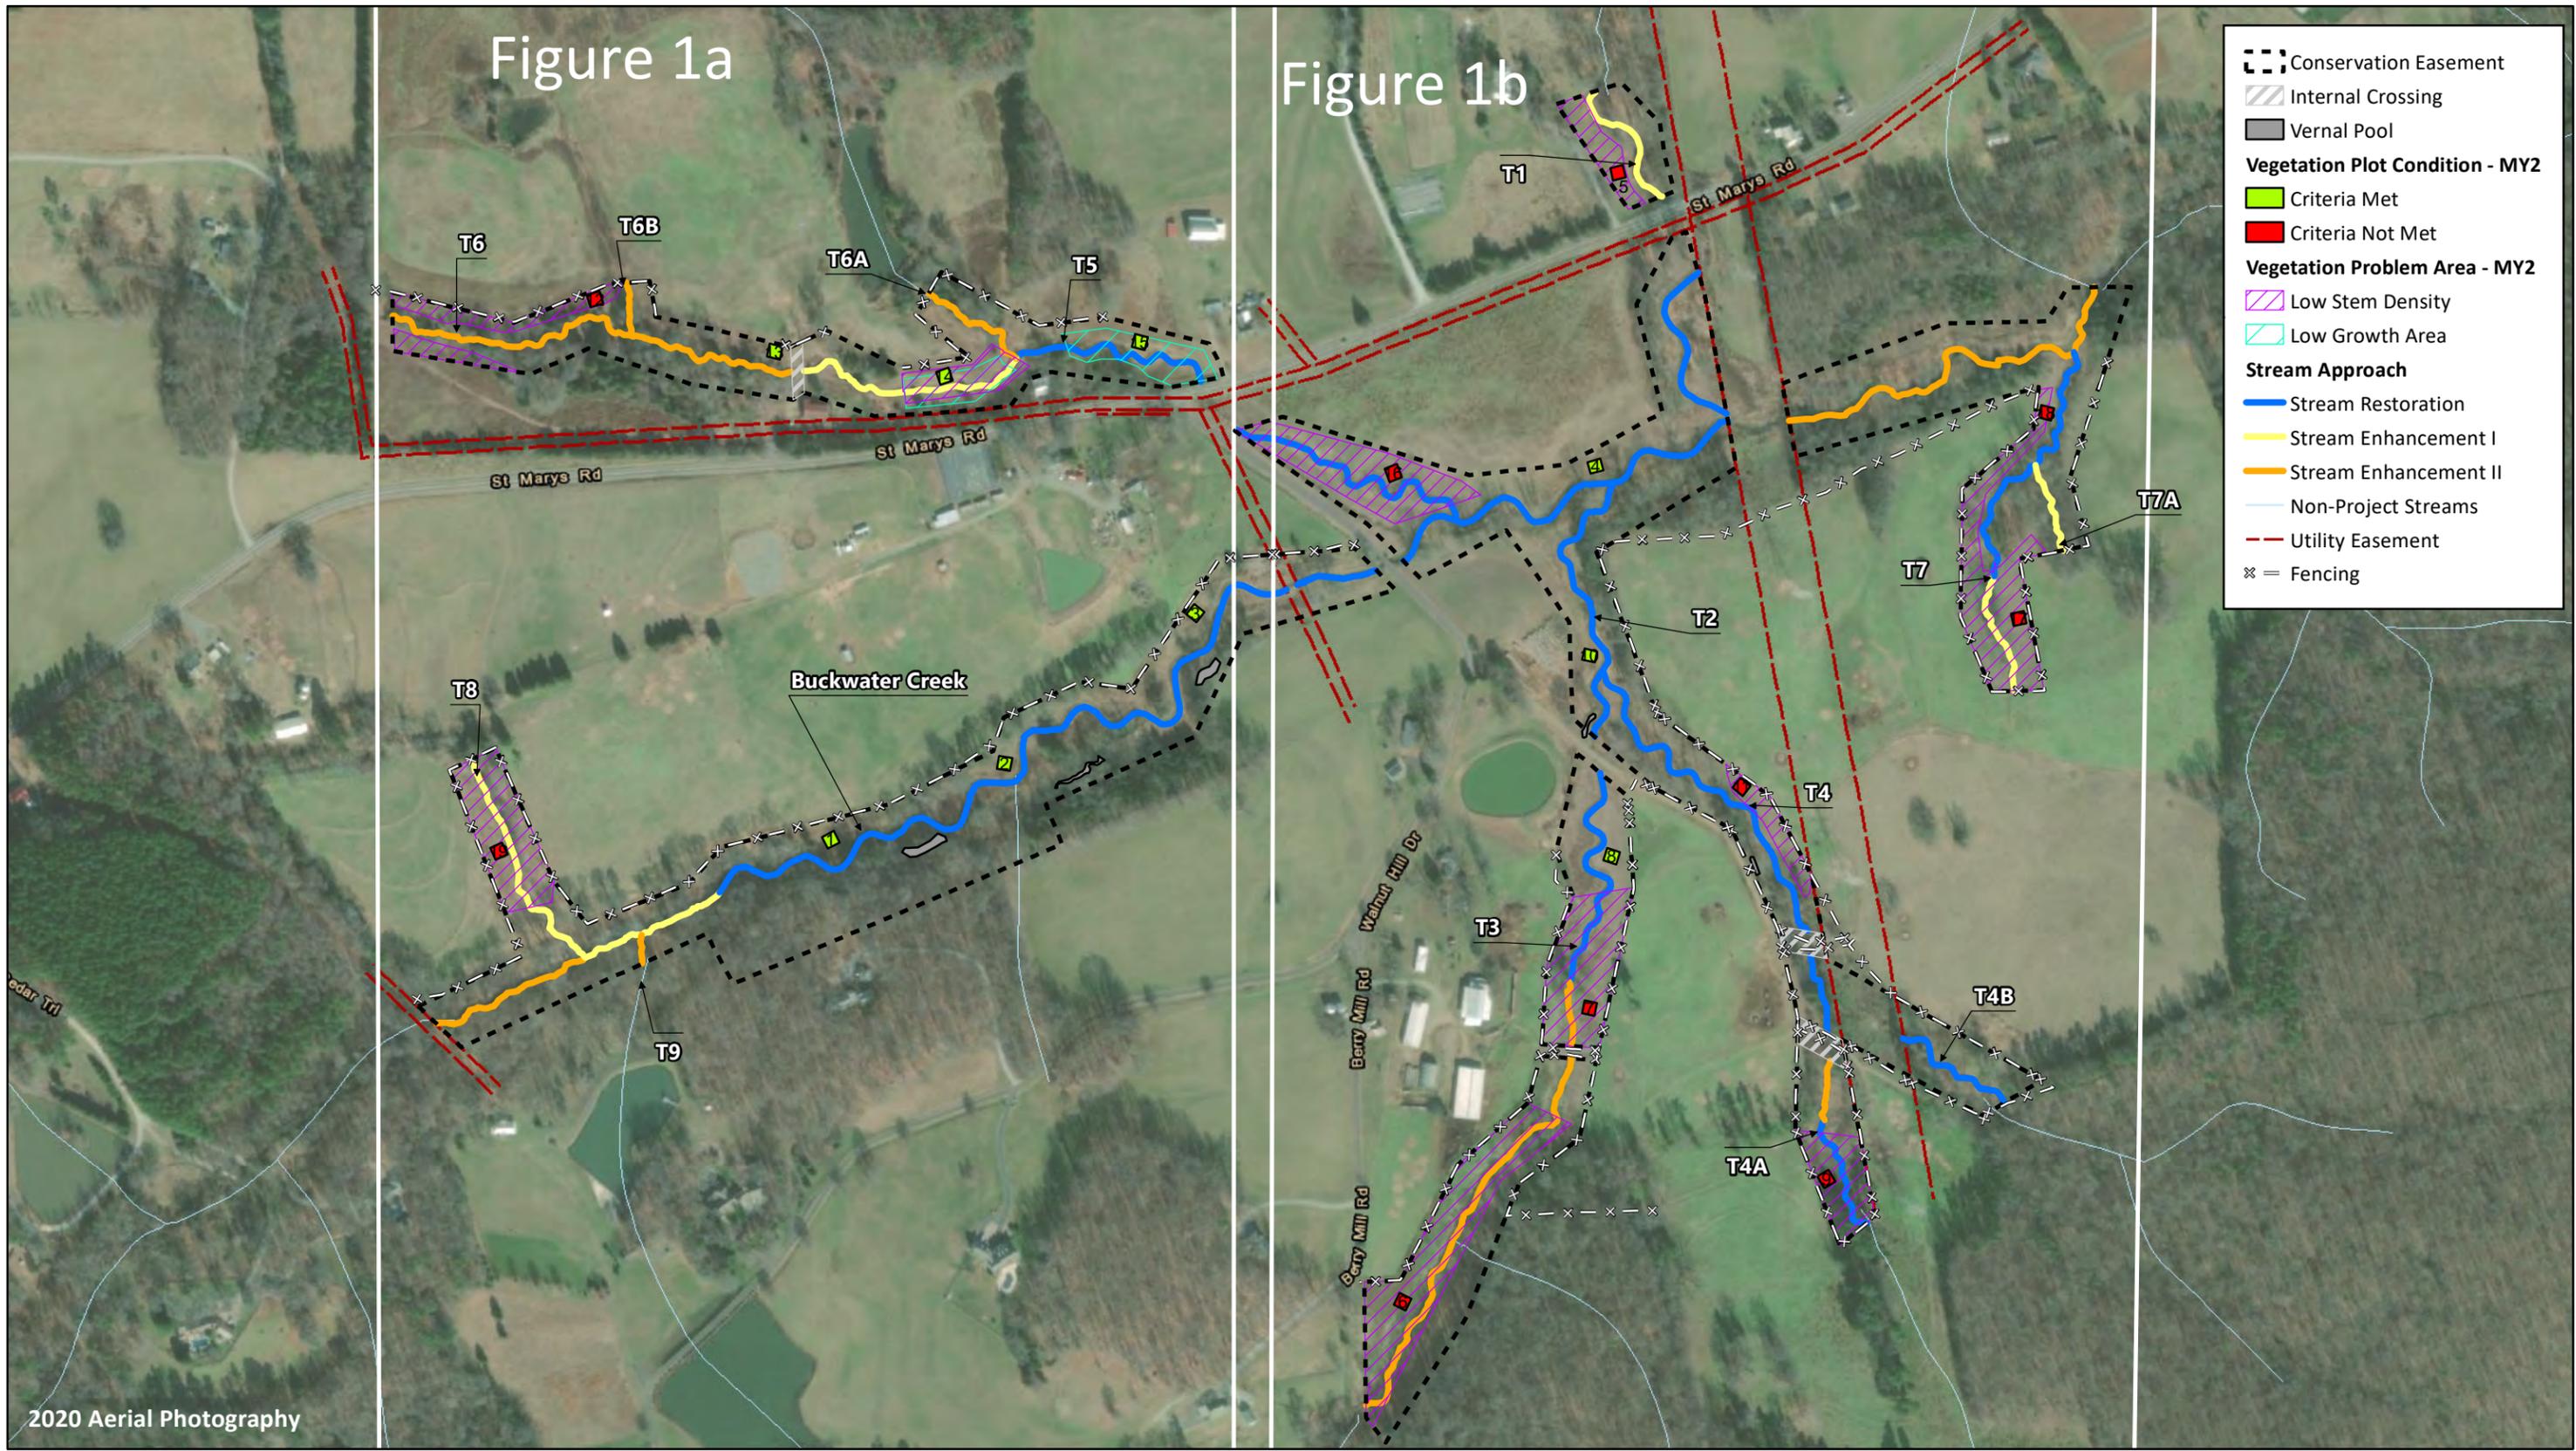
Figure 1. Supplemental Planting Map Key  
 Buckwater Mitigation Site  
 Adaptive Management Plan  
 Neuse River Basin (03020201)  
 Orange County, NC

Following the MY2 vegetative survey, Wildlands surveyed the Site to assess the extent of the tree mortality and explored reasons why mortality was higher in some areas compared to others. After assessing the Site, 10.7-acres were identified for supplemental planting in early winter of 2021. Wildlands believes significant factors for the high mortality rate are competition from dense herbaceous vegetation and drought conditions during the end of the first growing season. The NC Drought Management Advisory Council maintains map archives (<https://www.ncdrought.org/map-archives>) that show abnormally dry and moderate drought conditions during 2019 in the Buckwater area beginning September 17 and ending December 3.

Throughout the 10.7-acres, a mixture of nine species will be planted at a density of 200 to 300 stems per acre (Figures 1, 1a, and 1b). This is 46% of the original planted area. Planted trees will primarily be bare root stock with fewer one-gallon container trees. Species and quantities of trees to be planted are shown in Table 3. Three of the species (hackberry, persimmon, and box elder) are not on the original mitigation plan planting list but we believe they will do well at the site as early successional pioneers. Sycamore are proposed to be planted in select areas that currently have especially low stem densities for the purpose of providing shade for slower growing species. Wildlands proposes to plant sycamore where the vegetation plots report the lowest stem density and where sycamore is not exceeding 25% of the surviving stems. This includes vegetation plots 7, 11, 17, and 18. Immediately after supplemental planting, sycamore stems will not exceed 20% of the surviving stems in any vegetation plot. White oak and hackberry (*Celtis occidentalis*) will be planted only in drier areas primarily at the top of slopes and higher elevations. Any tree added to a vegetation plot will be flagged with a color different from what was used to flag the originally planted trees. The additional trees will not be counted towards success criteria until two growing seasons have passed.
