# **MONITORING YEAR 3 ANNUAL REPORT**

## **BUCKWATER MITIGATION SITE**

Orange County, NC  
NCDEQ Contract No. 006829  
DMS Project Number 97084  
USACE Action ID Number 2016-00873  
NCDWR Project Number 2016-0406

Data Collection Period: January – November 2021  
Draft Submission Date: November 29, 2021  
Final Submission Date: December 13, 2021

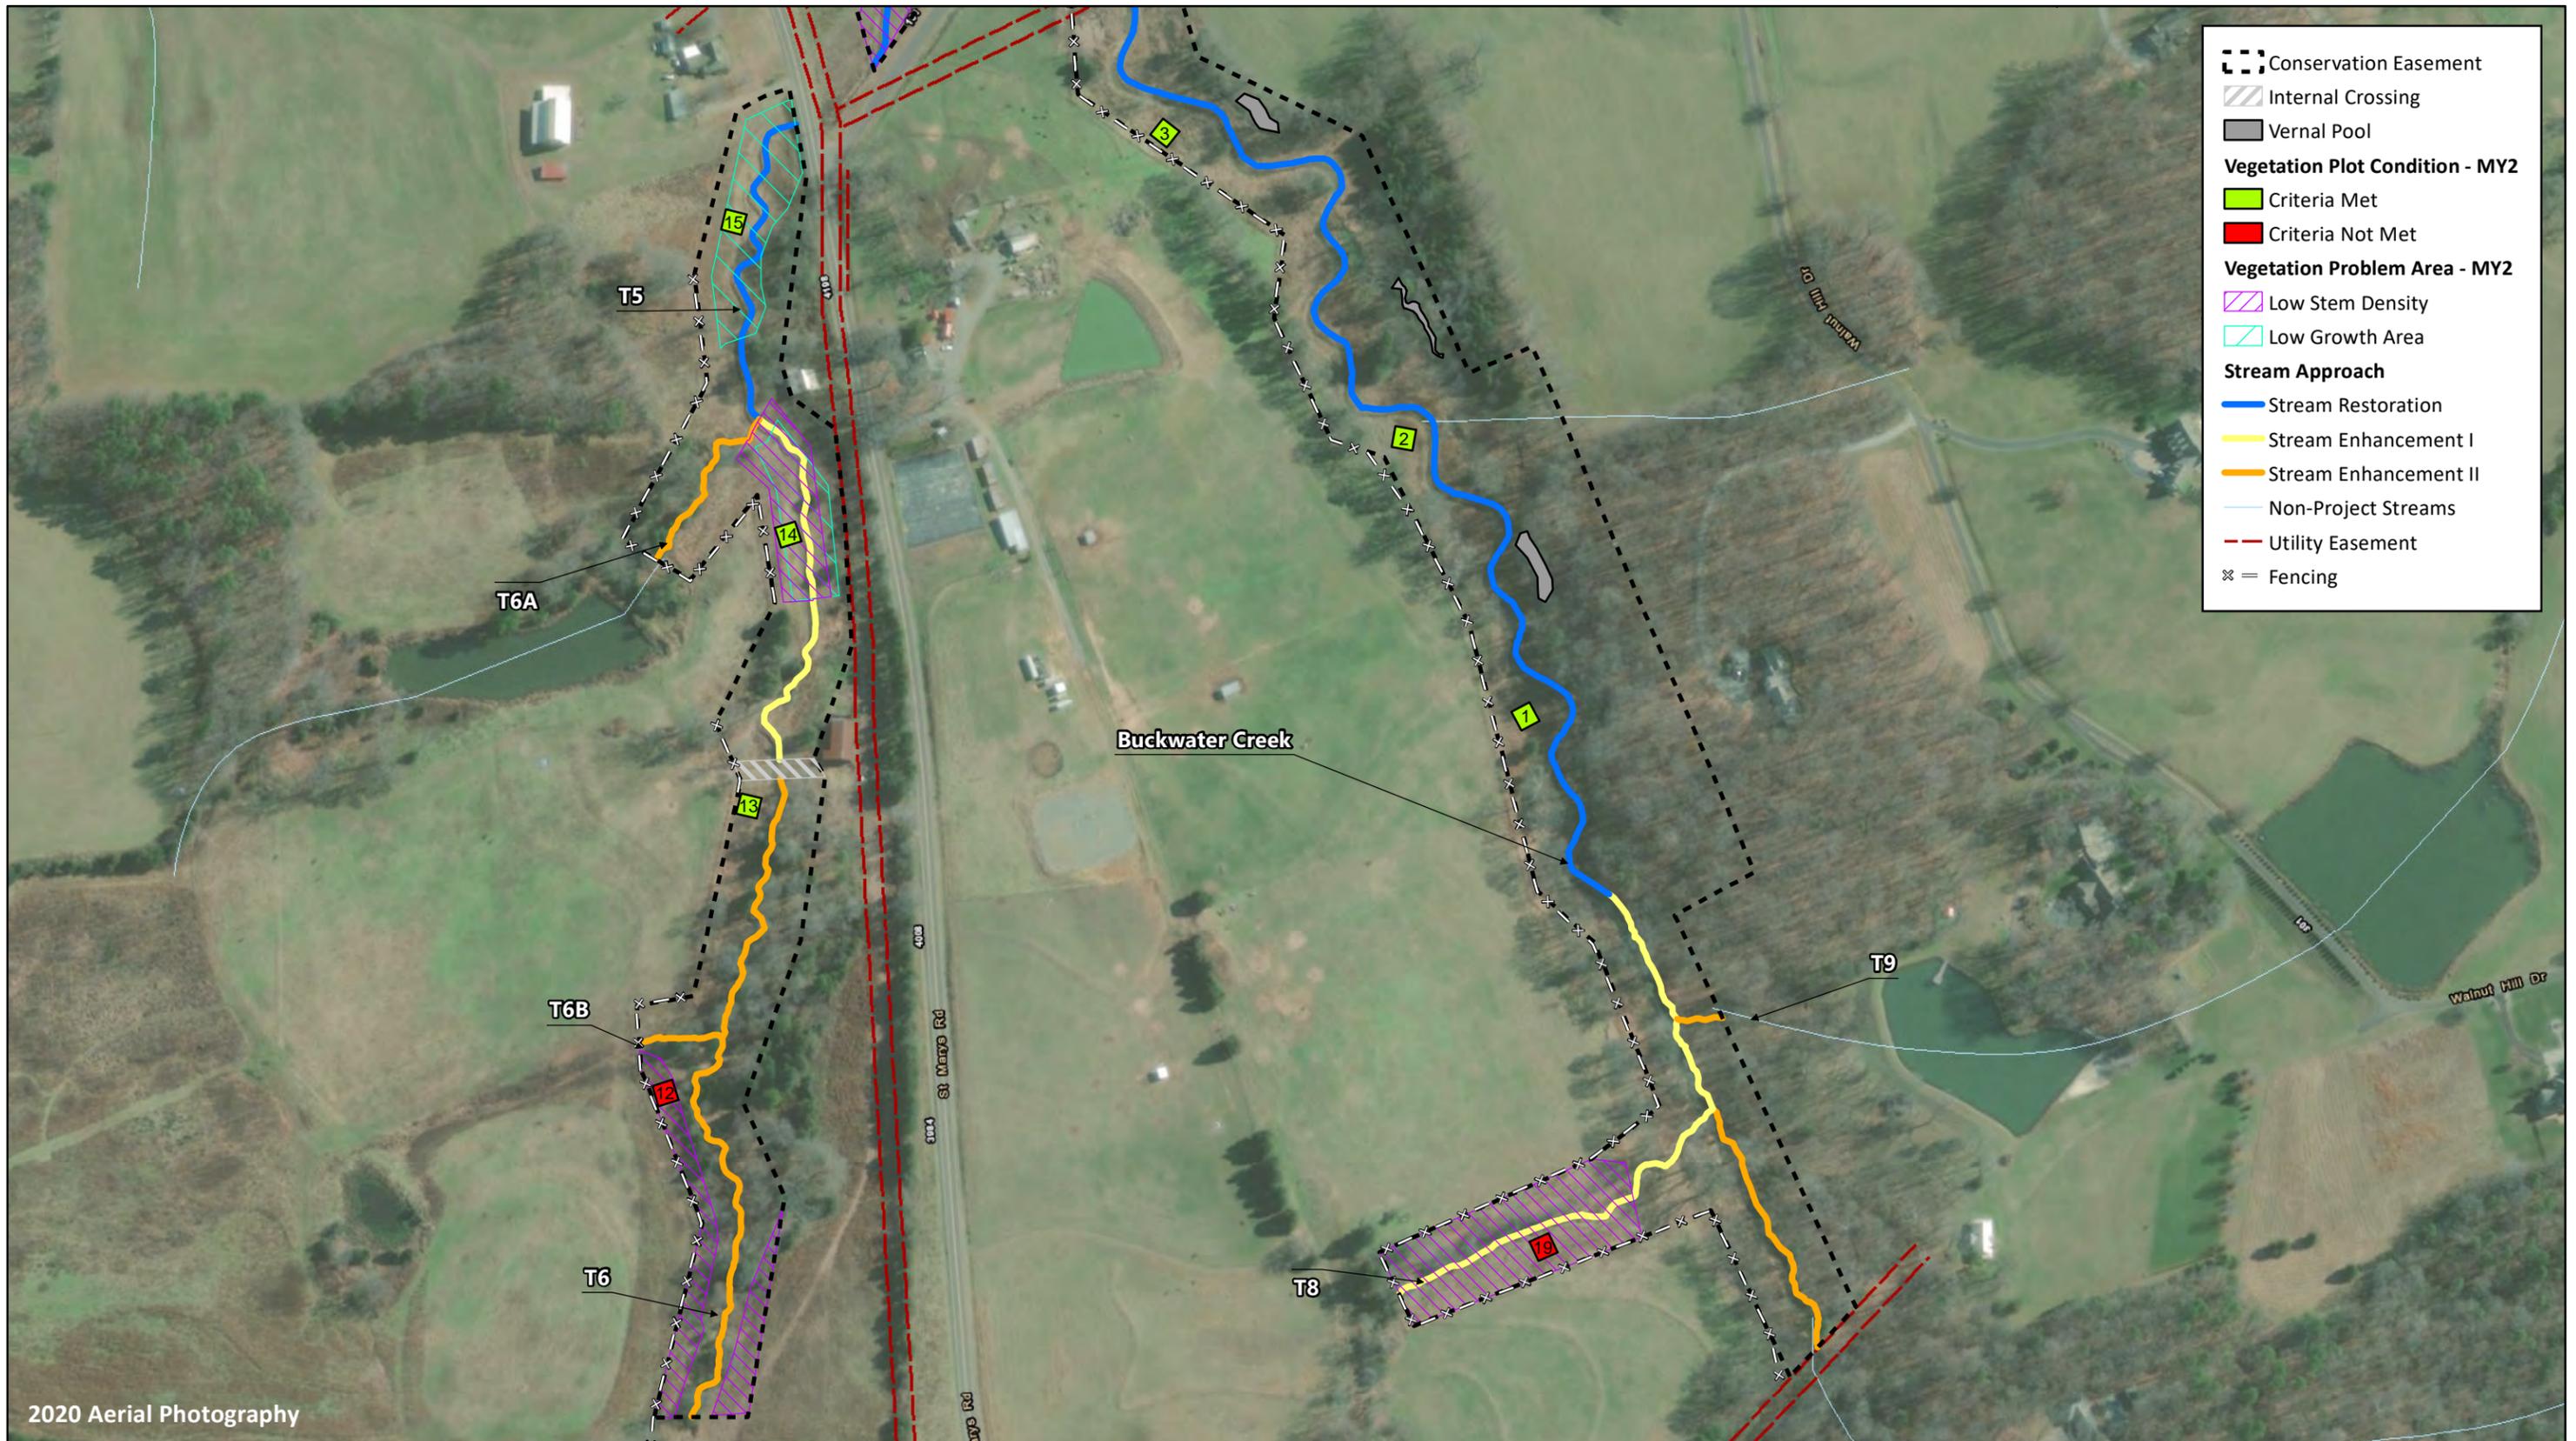
Figure 1a. Supplemental Planting Map  
 Buckwater Mitigation Site  
 Adaptive Management Plan  
 Neuse River Basin (03020201)  
 Orange County, NC

The two low vegetative growth areas totaling 1.4-acres along T5 (upstream of St. Mary's Rd) and T6 (Figure 1a) will be further treated with soil amendments. Grading during construction exposed poor-quality rocky subsoils near the surface. Soil amendments were applied to this area in December 2019 and August 2020 and will continue to be applied during MY3. Soil amendments planned to be added in

MY3 include humic acid, biochar, dried molasses, slow-release fertilizer, rock phosphate, and azomite. Beyond boosting macronutrients in the soil, adding these amendments will improve soil properties and biota. Expected improvements include higher moisture-holding capacity, organic matter, nutrient availability for plants, and saprophytic and mycorrhizal fungal growth. The amendments will be applied to the base of each stem rather than broadcasted on the entire 1.4-acre area.
