MY1 FINAL MONITORING REPORT  
Buffalo Creek Tributaries Mitigation Project  
Johnston County  
Neuse River Basin  
CU 03020201

DMS Project # 100042  
DMS Contract # 7422  
DMS RFP # 16-007279  
USACE Action ID Number: SAW-2018-00425  
DWR Project # 2018-0199 V2  
Calendar Year of Data Collection: 2021

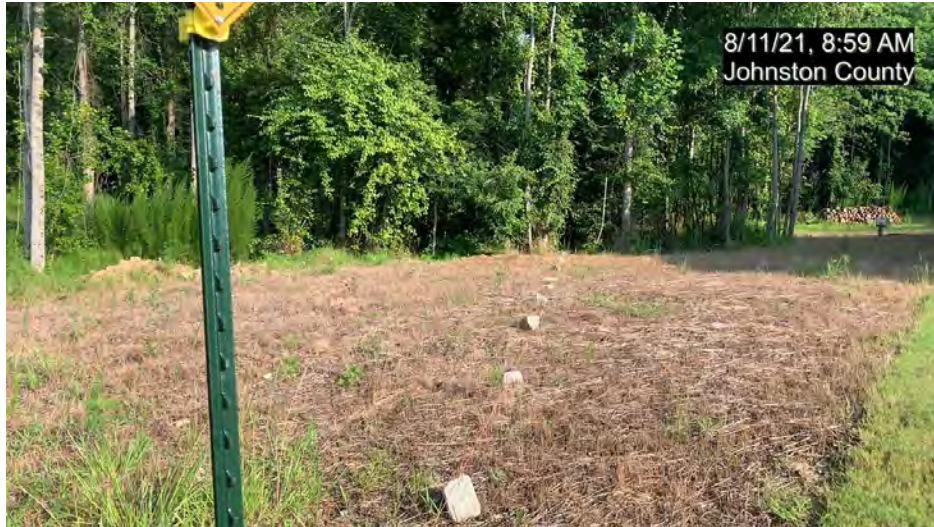
Two encroachments (~0.014 acres) were noted near the southern most culvert crossing on MS-R2. Both are recently sodded/planted grassy areas adjacent to recent home construction. To prevent further encroachment, the homeowners were contacted, and the easement line was more clearly marked. Encroachment planting will occur in early MY2, and actions taken will be documented in the MY2 report.

Encroachment Area 1, MS-R2, Upstream of Culvert (MY-01)

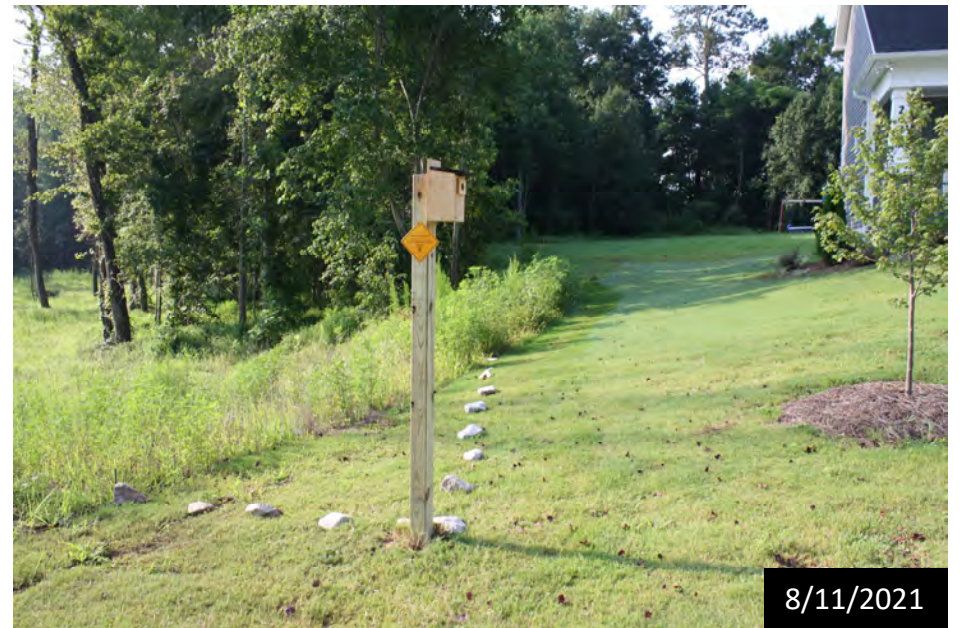
Encroachment Area 2, MS-R2, Downstream of Culvert (MY-01)
