**BEST STREAM AND WETLAND RESTORATION PROJECT
MONITORING REPORT
MONITORING YEAR 7
FINAL**

DUPLIN COUNTY, NORTH CAROLINA
CONTRACT No. 004631 - PROJECT No. 95353
USACE Action ID No. 2012-01384 -NCDWR Project No. 13-0865

RE: Best Stream and Wetland Restoration Project: MY7 Monitoring Report (NCDMS ID 95353)

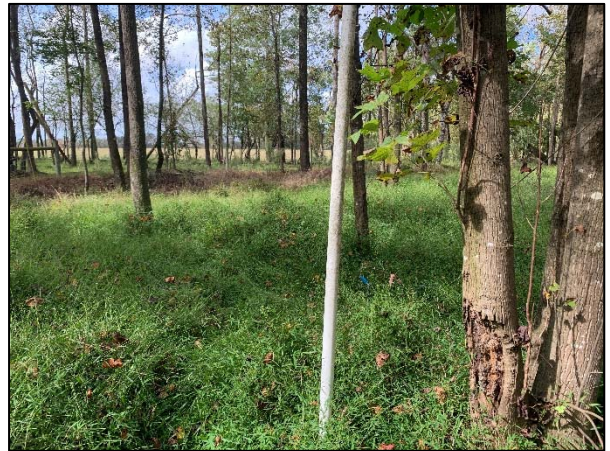
No vegetation problem areas were identified during the Year 7 monitoring period. Previously in MY6, there was a vegetation problem area in and around Vegetation Plot 18 which was documented and mapped on the CCPV as part of the annual monitoring report. This area consisted of a low stem density area (0.28 acres) in and around Vegetation Plot 18. The area in and around VP18 was planted after construction because it was anticipated that the existing forest would die due to the raising and relocation of the stream channel. However, as seen in RVP1 (**Table 9**), the existing forest area meets the vegetation success criteria. RES performed a comprehensive invasive species delineation in October 2021 and treated a number of the invasive species areas in November 2021. The main areas were along tributaries to Muddy Creek outside of wetland areas. Treatments were also performed in December 2021 and January 2022 and totaled approximately 24 acres of basal bark and cut stump treatment (**Figure 3**).
