**MONITORING YEAR 1
ANNUAL REPORT**
Final

BUG HEADWATERS MITIGATION SITE

Wilkes County, NC
Yadkin River Basin
HUC 03040101

DMS Project No. 100084
DMS RFP No. 16-007406
NCDEQ Contract No. 7617
USACE Action ID No. 2018-01788
DWR Project No. 2018-1273

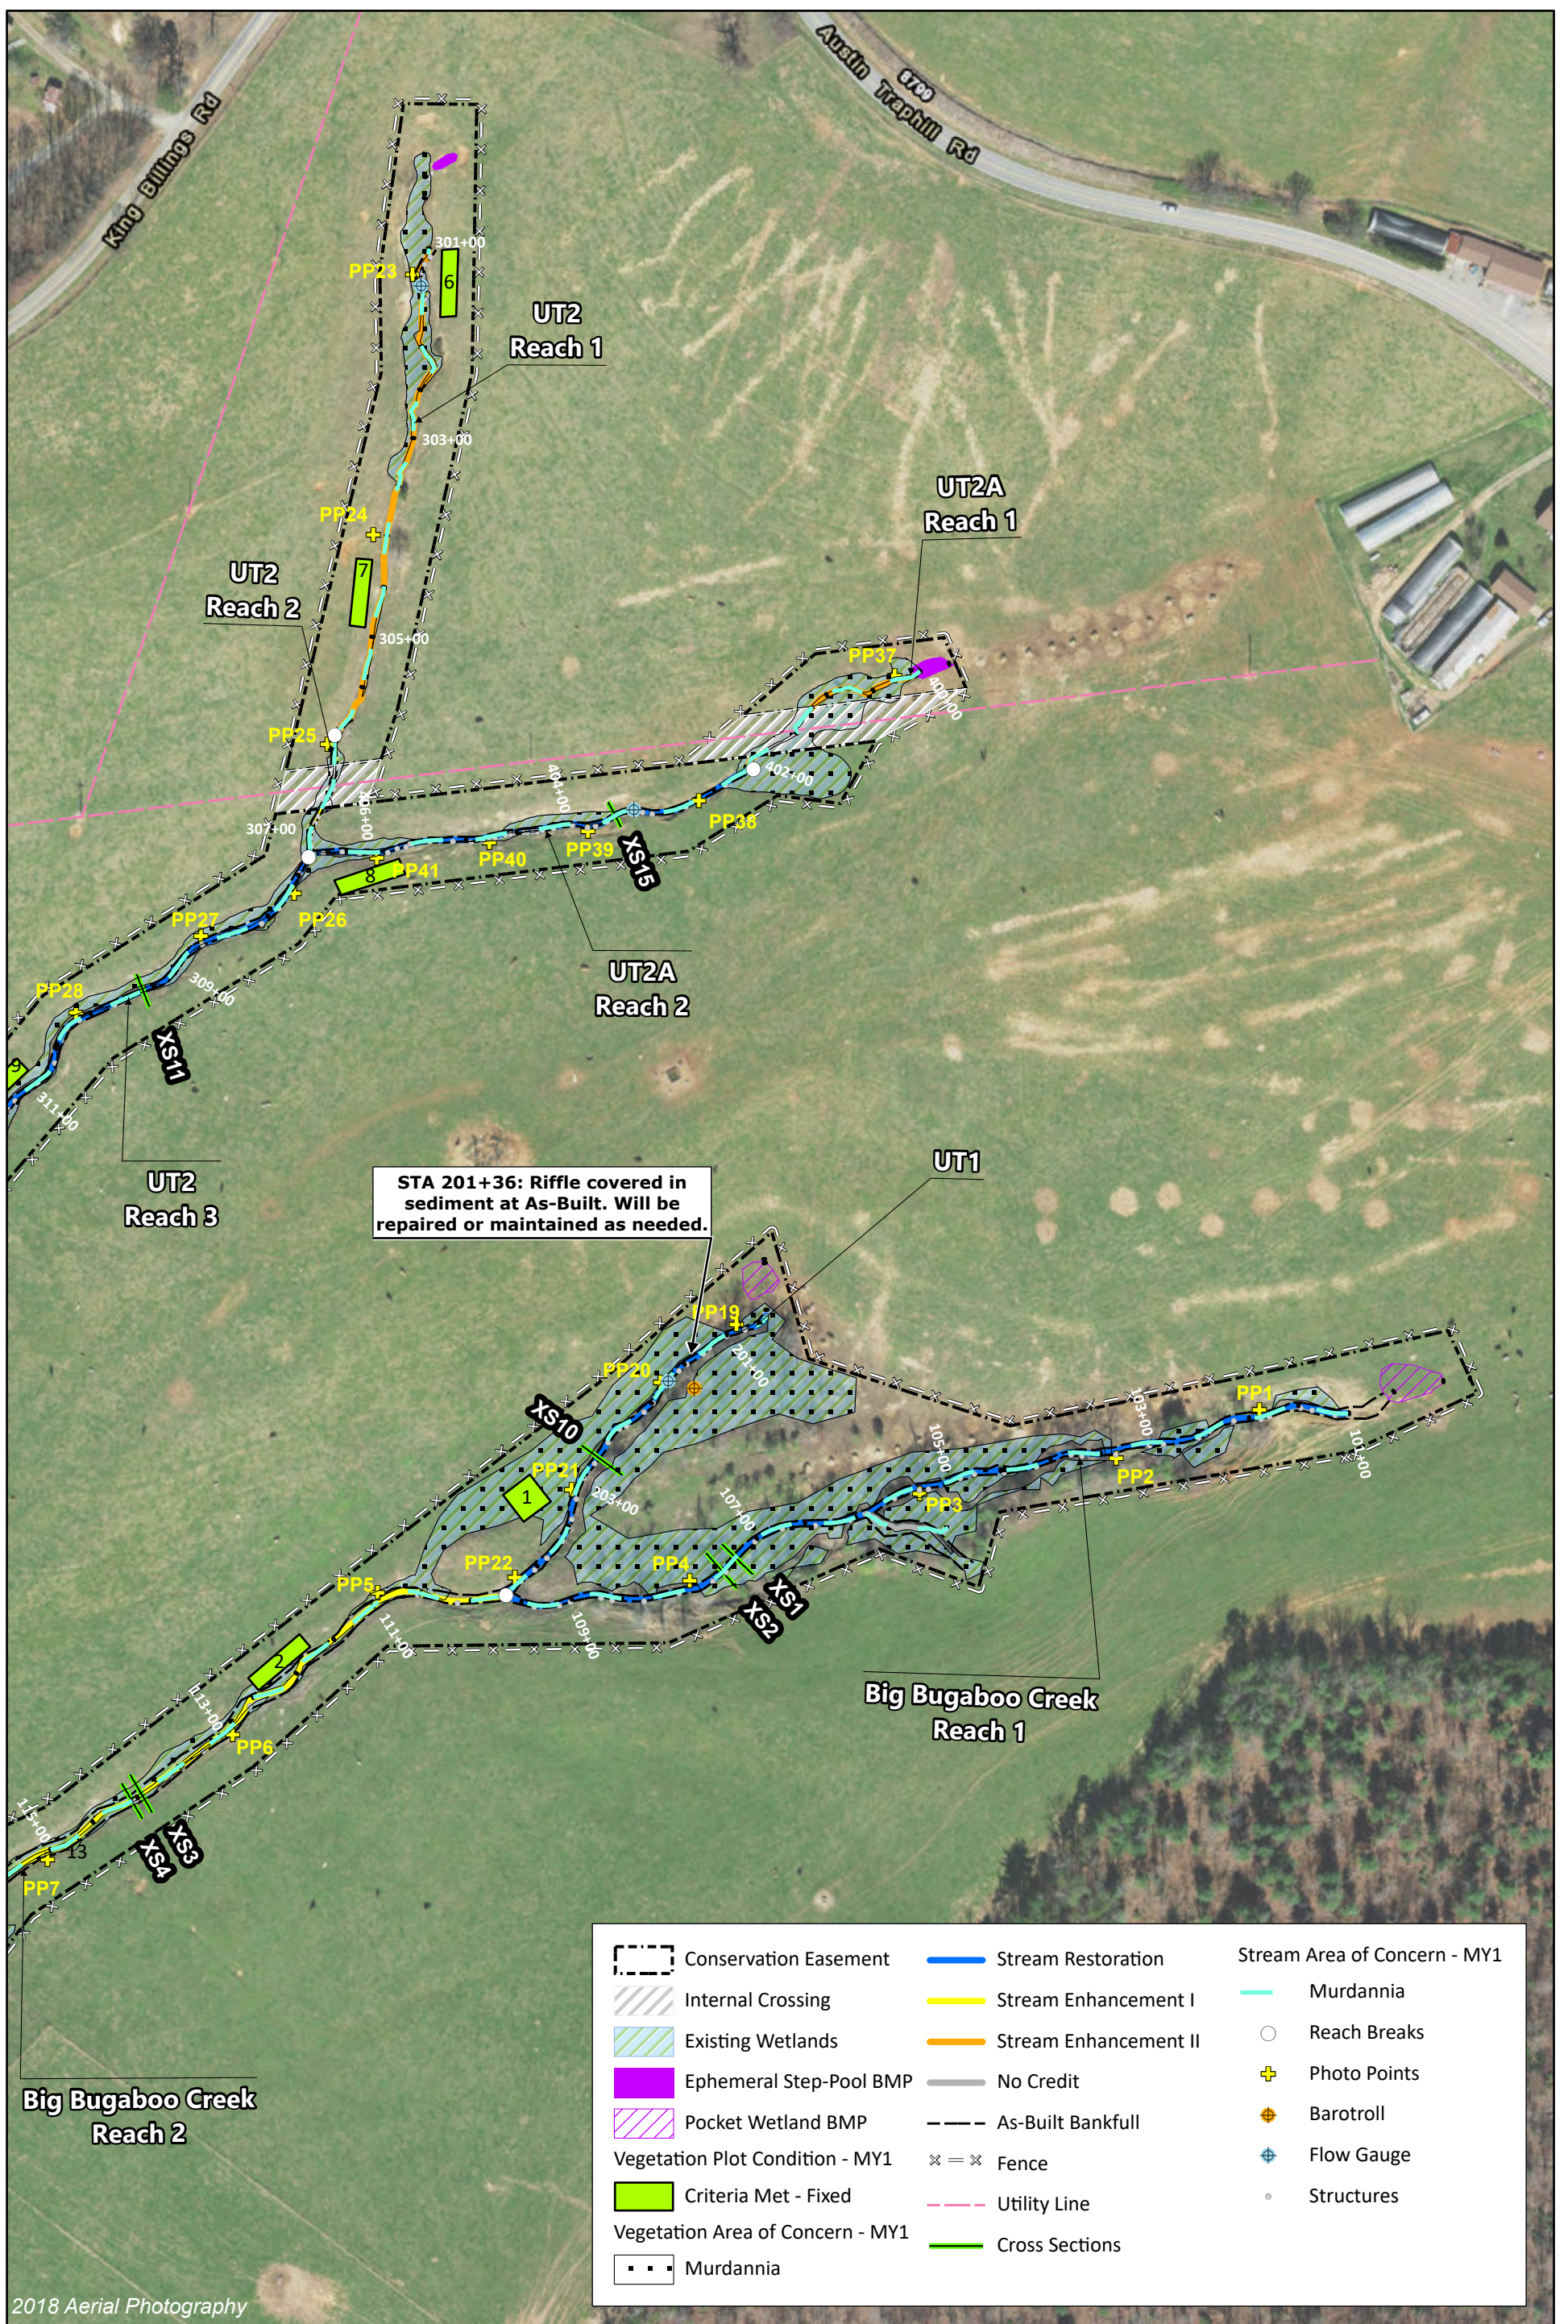
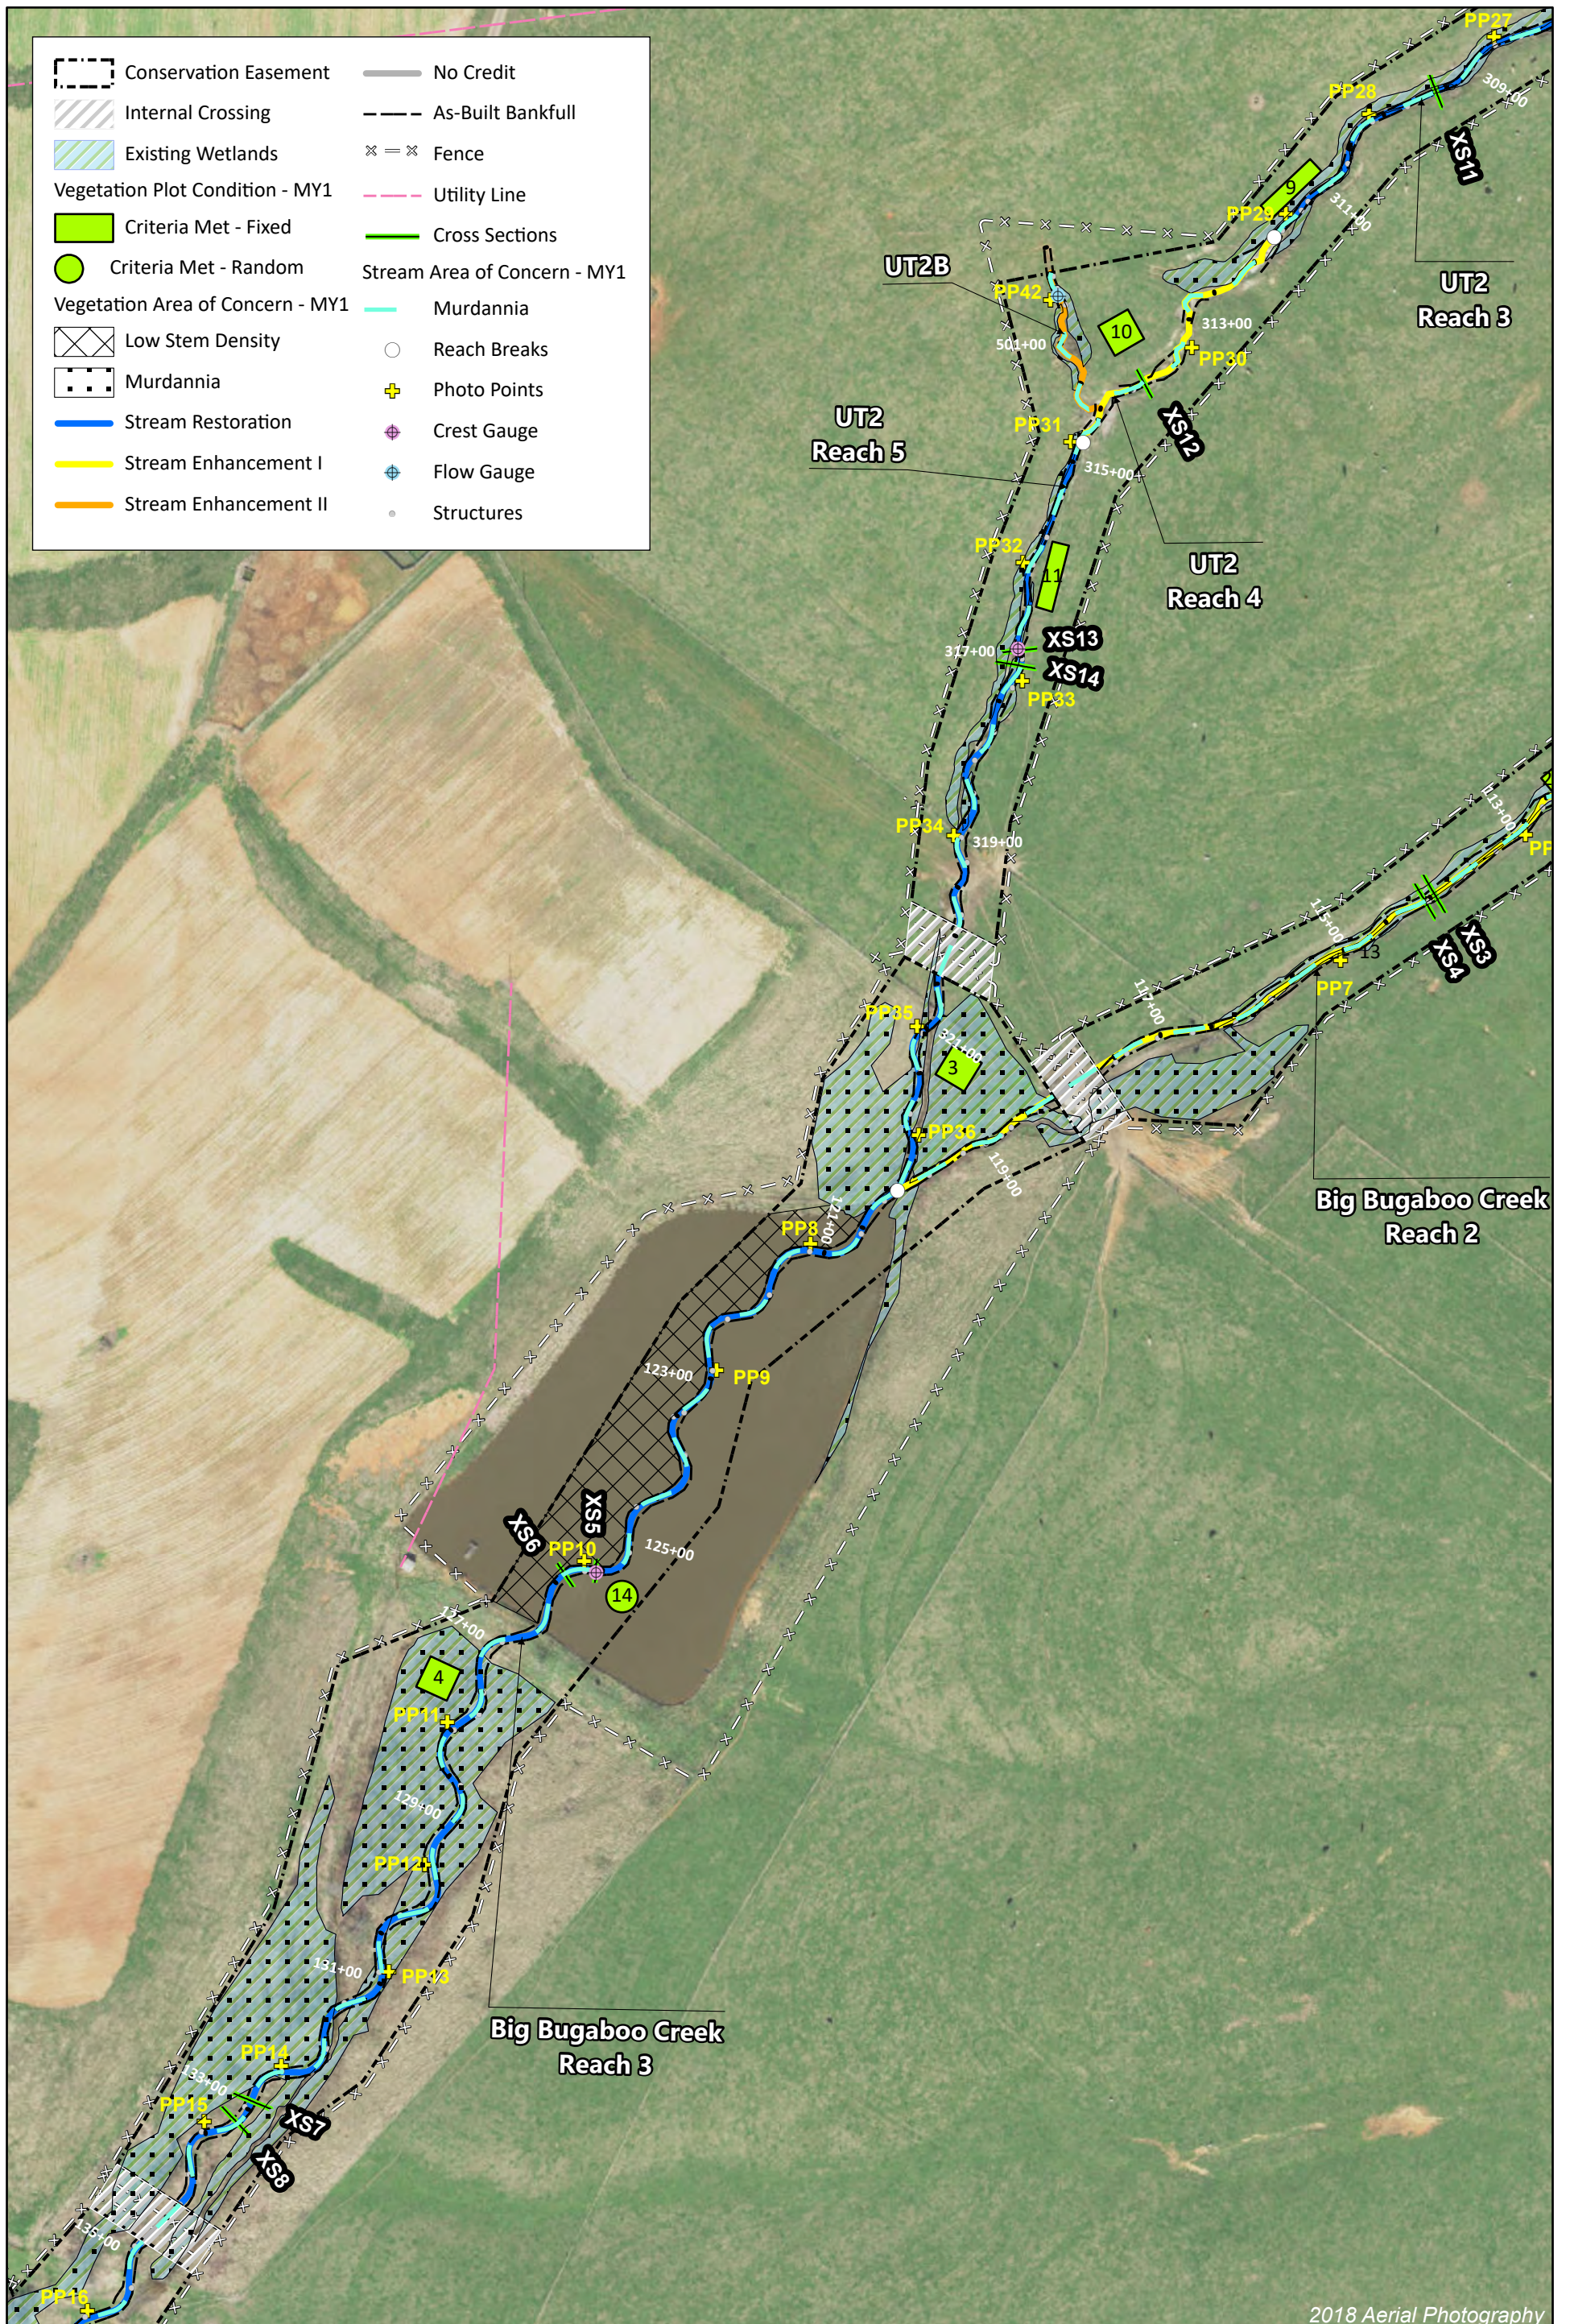
Figure 1b. Current Condition Plan View
 Bug Headwaters Mitigation Site
 DMS Project No. 100084
 Monitoring Year 1 - 2021

The MY1 assessment indicated only a small number of planted trees survived in the old pond bottoms along the right side of Big Bugaboo Creek Reach 3 and both sides of UT3 (Figure 1b-c). The visual assessment of the right side of Big Bugaboo Creek Reach 3 indicated some planted trees survived, but

not at the appropriate densities to meet the MY7 final requirement of 210 stems per acre. The visual assessment of UT3 indicated only black willows (*Salix nigra*) are becoming established. The major cause for the tree mortality in these areas is likely highly saturated soils. These areas in the old pond bottom are naturally low spots in the floodplain and have standing water on them for a portion of the year. These areas will be evaluated and planted in the winter of 2022 with woody stems more suited for saturated conditions. The low stem density areas are only nine percent (1.75 acres) of the entire planted acreage (19.00 acres). Even though many of the planted trees did not survive the saturated soil conditions, herbaceous vegetation, including pollinator species, is thriving. Refer to Section 2.7 for more information on the management plan for the low stem density areas.

Murdannia has grown throughout the existing wetlands (6.61 acres) on the Site (Figure 1a-c). The invasive vegetation was treated in July 2021 using a chemical treatment but follow up treatments will occur in MY2. Refer to Section 2.7 for more information on the management plan for *Murdannia*.

Murdannia has spread from the wetlands into the stream channels on the Site (Figure 1a-c). The in-stream vegetation was also treated in July 2021 at the same time as the wetland treatments. Due to the amount of in-stream vegetation throughout the channels, some sediment deposition has occurred. Once the invasive vegetation is removed, it is expected the sediment will flush through the system. Refer to Section 2.7 for more information on the management plan for *Murdannia*.

Supplemental planting will occur in the former pond bottoms along the right side of Big Bugaboo Creek Reach 3 and both sides of UT3. Due to saturated soil conditions, a mixture of bare roots and live stakes will be planted in the winter of 2022. While species selection will be dependent on nursery availability, the current plan includes black willow (*Salix nigra*), silky willow (*Salix sericea*), elderberry (*Sambucus spp.*), and button bush (*Cephalanthus occidentalis*) as live stakes and sycamore (*Platanus occidentalis*),
