**MONITORING YEAR 1
ANNUAL REPORT**
Final

BUG HEADWATERS MITIGATION SITE

Wilkes County, NC
Yadkin River Basin
HUC 03040101

DMS Project No. 100084
DMS RFP No. 16-007406
NCDEQ Contract No. 7617
USACE Action ID No. 2018-01788
DWR Project No. 2018-1273

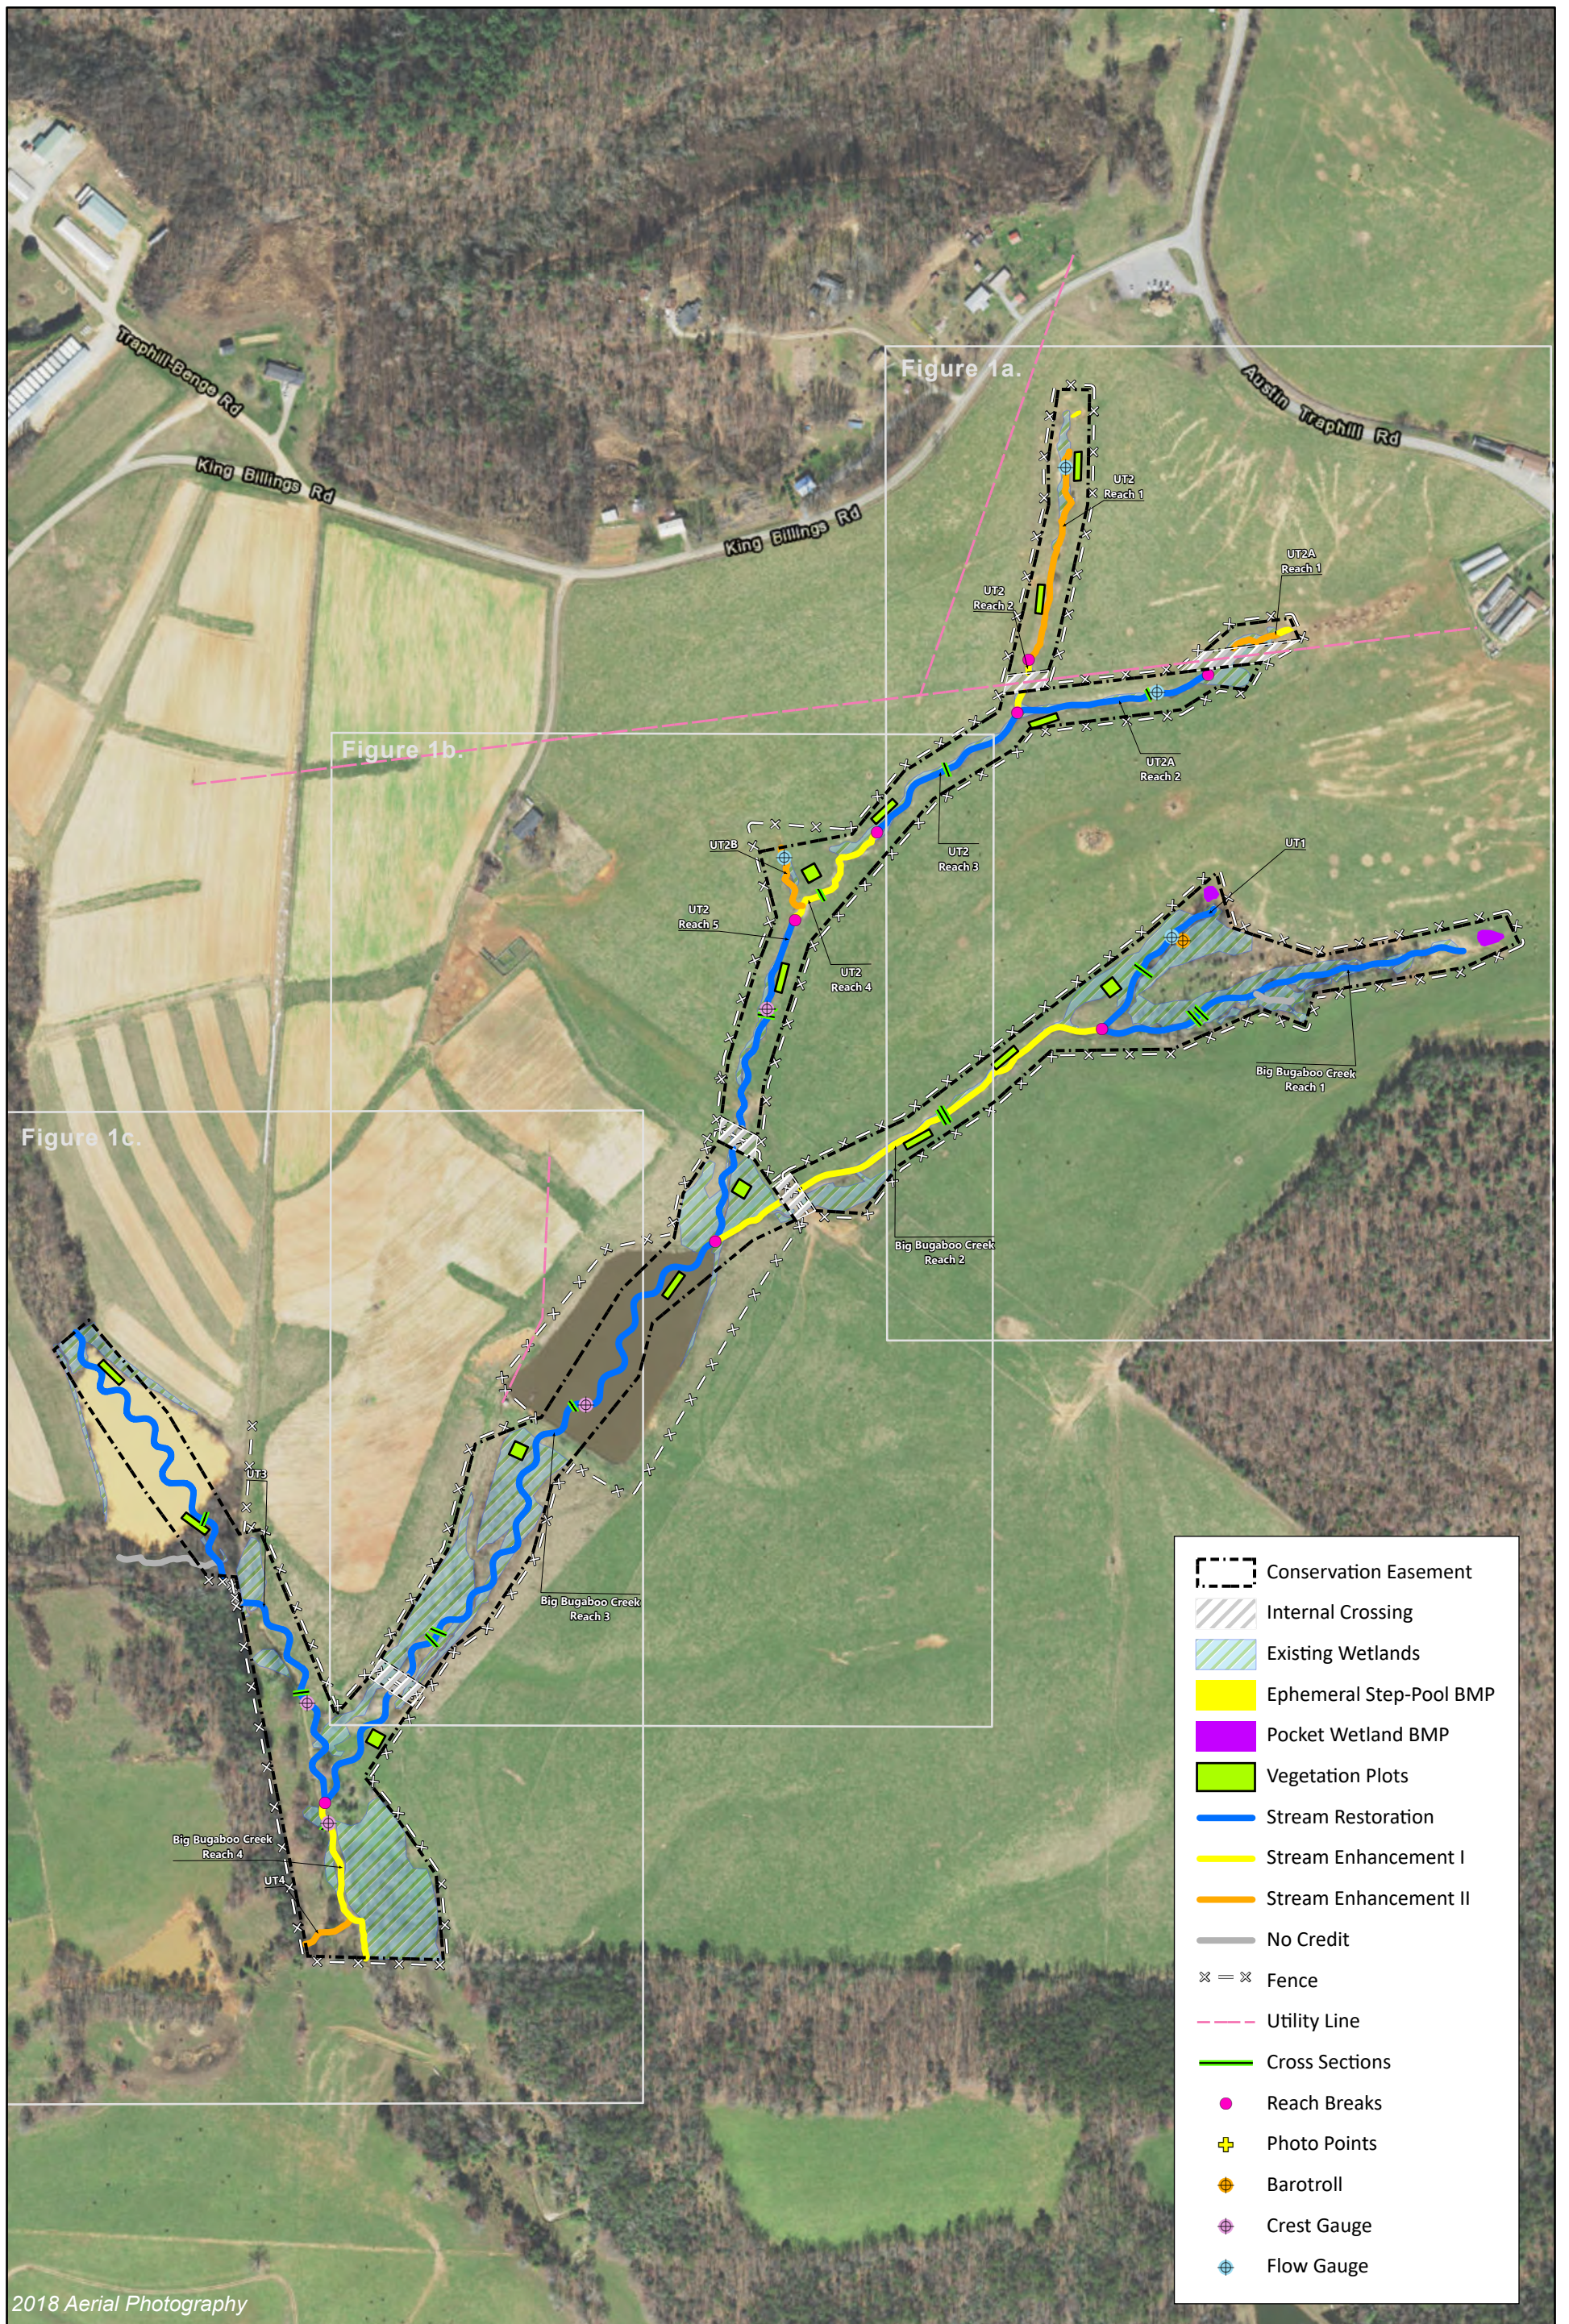
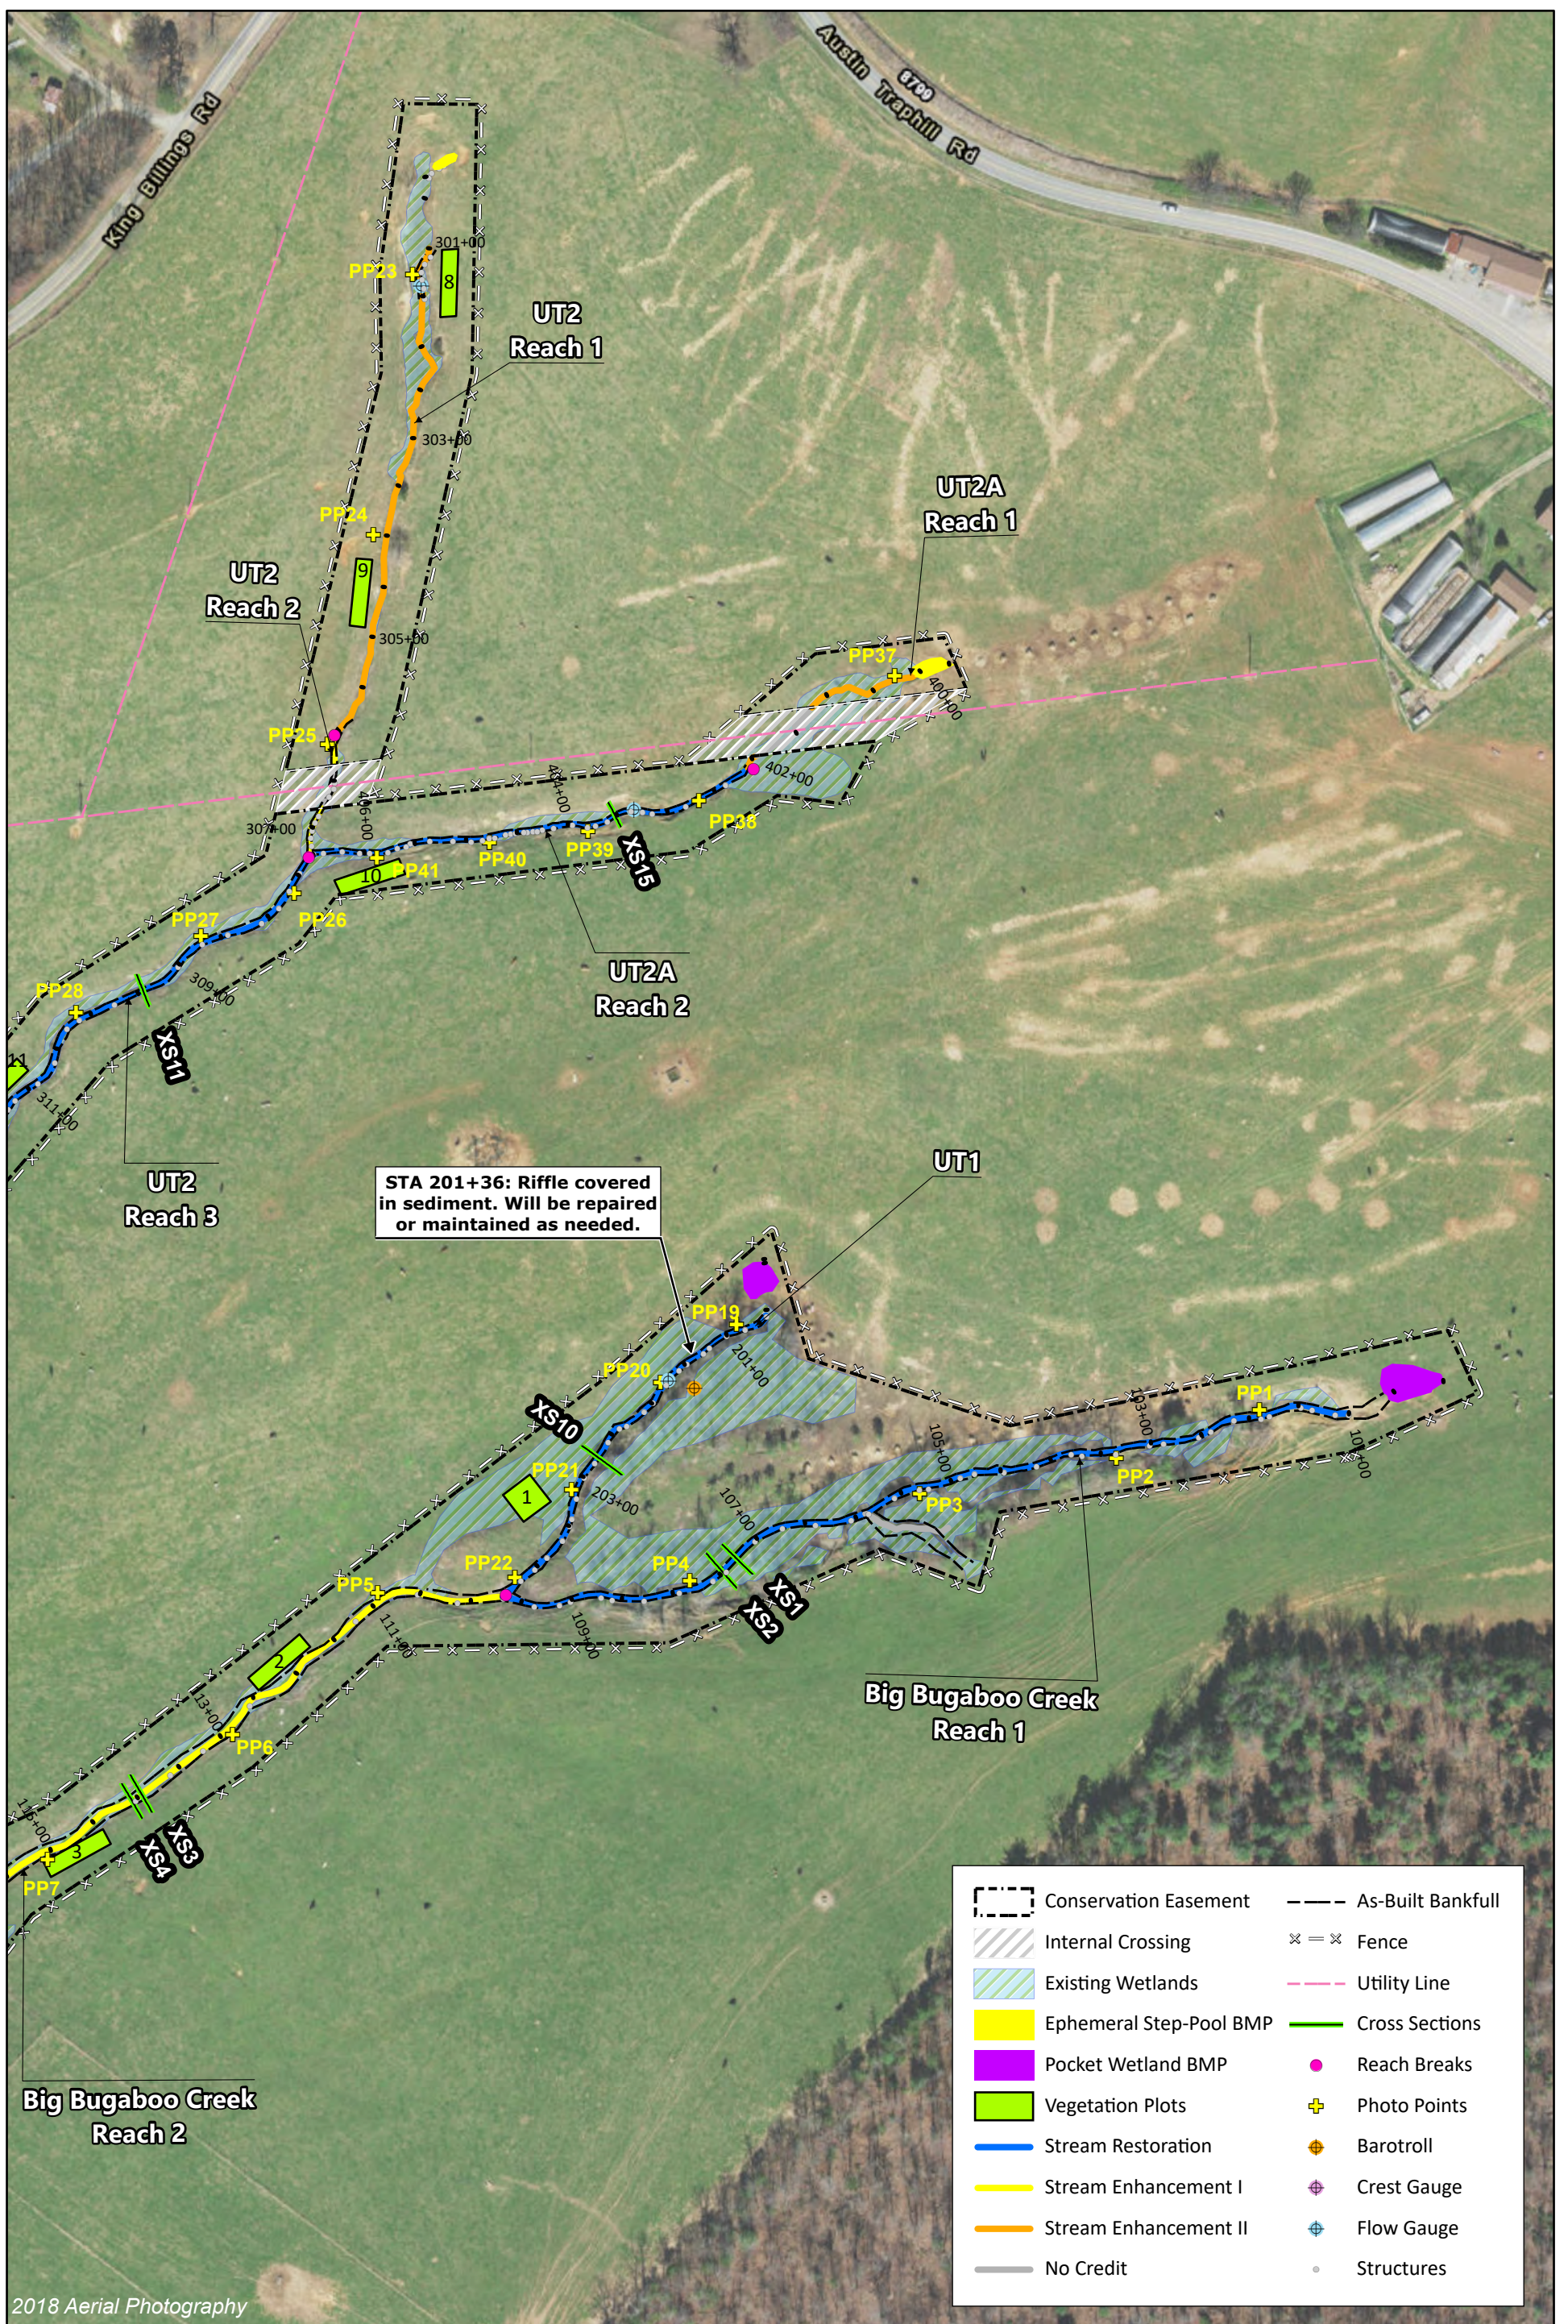
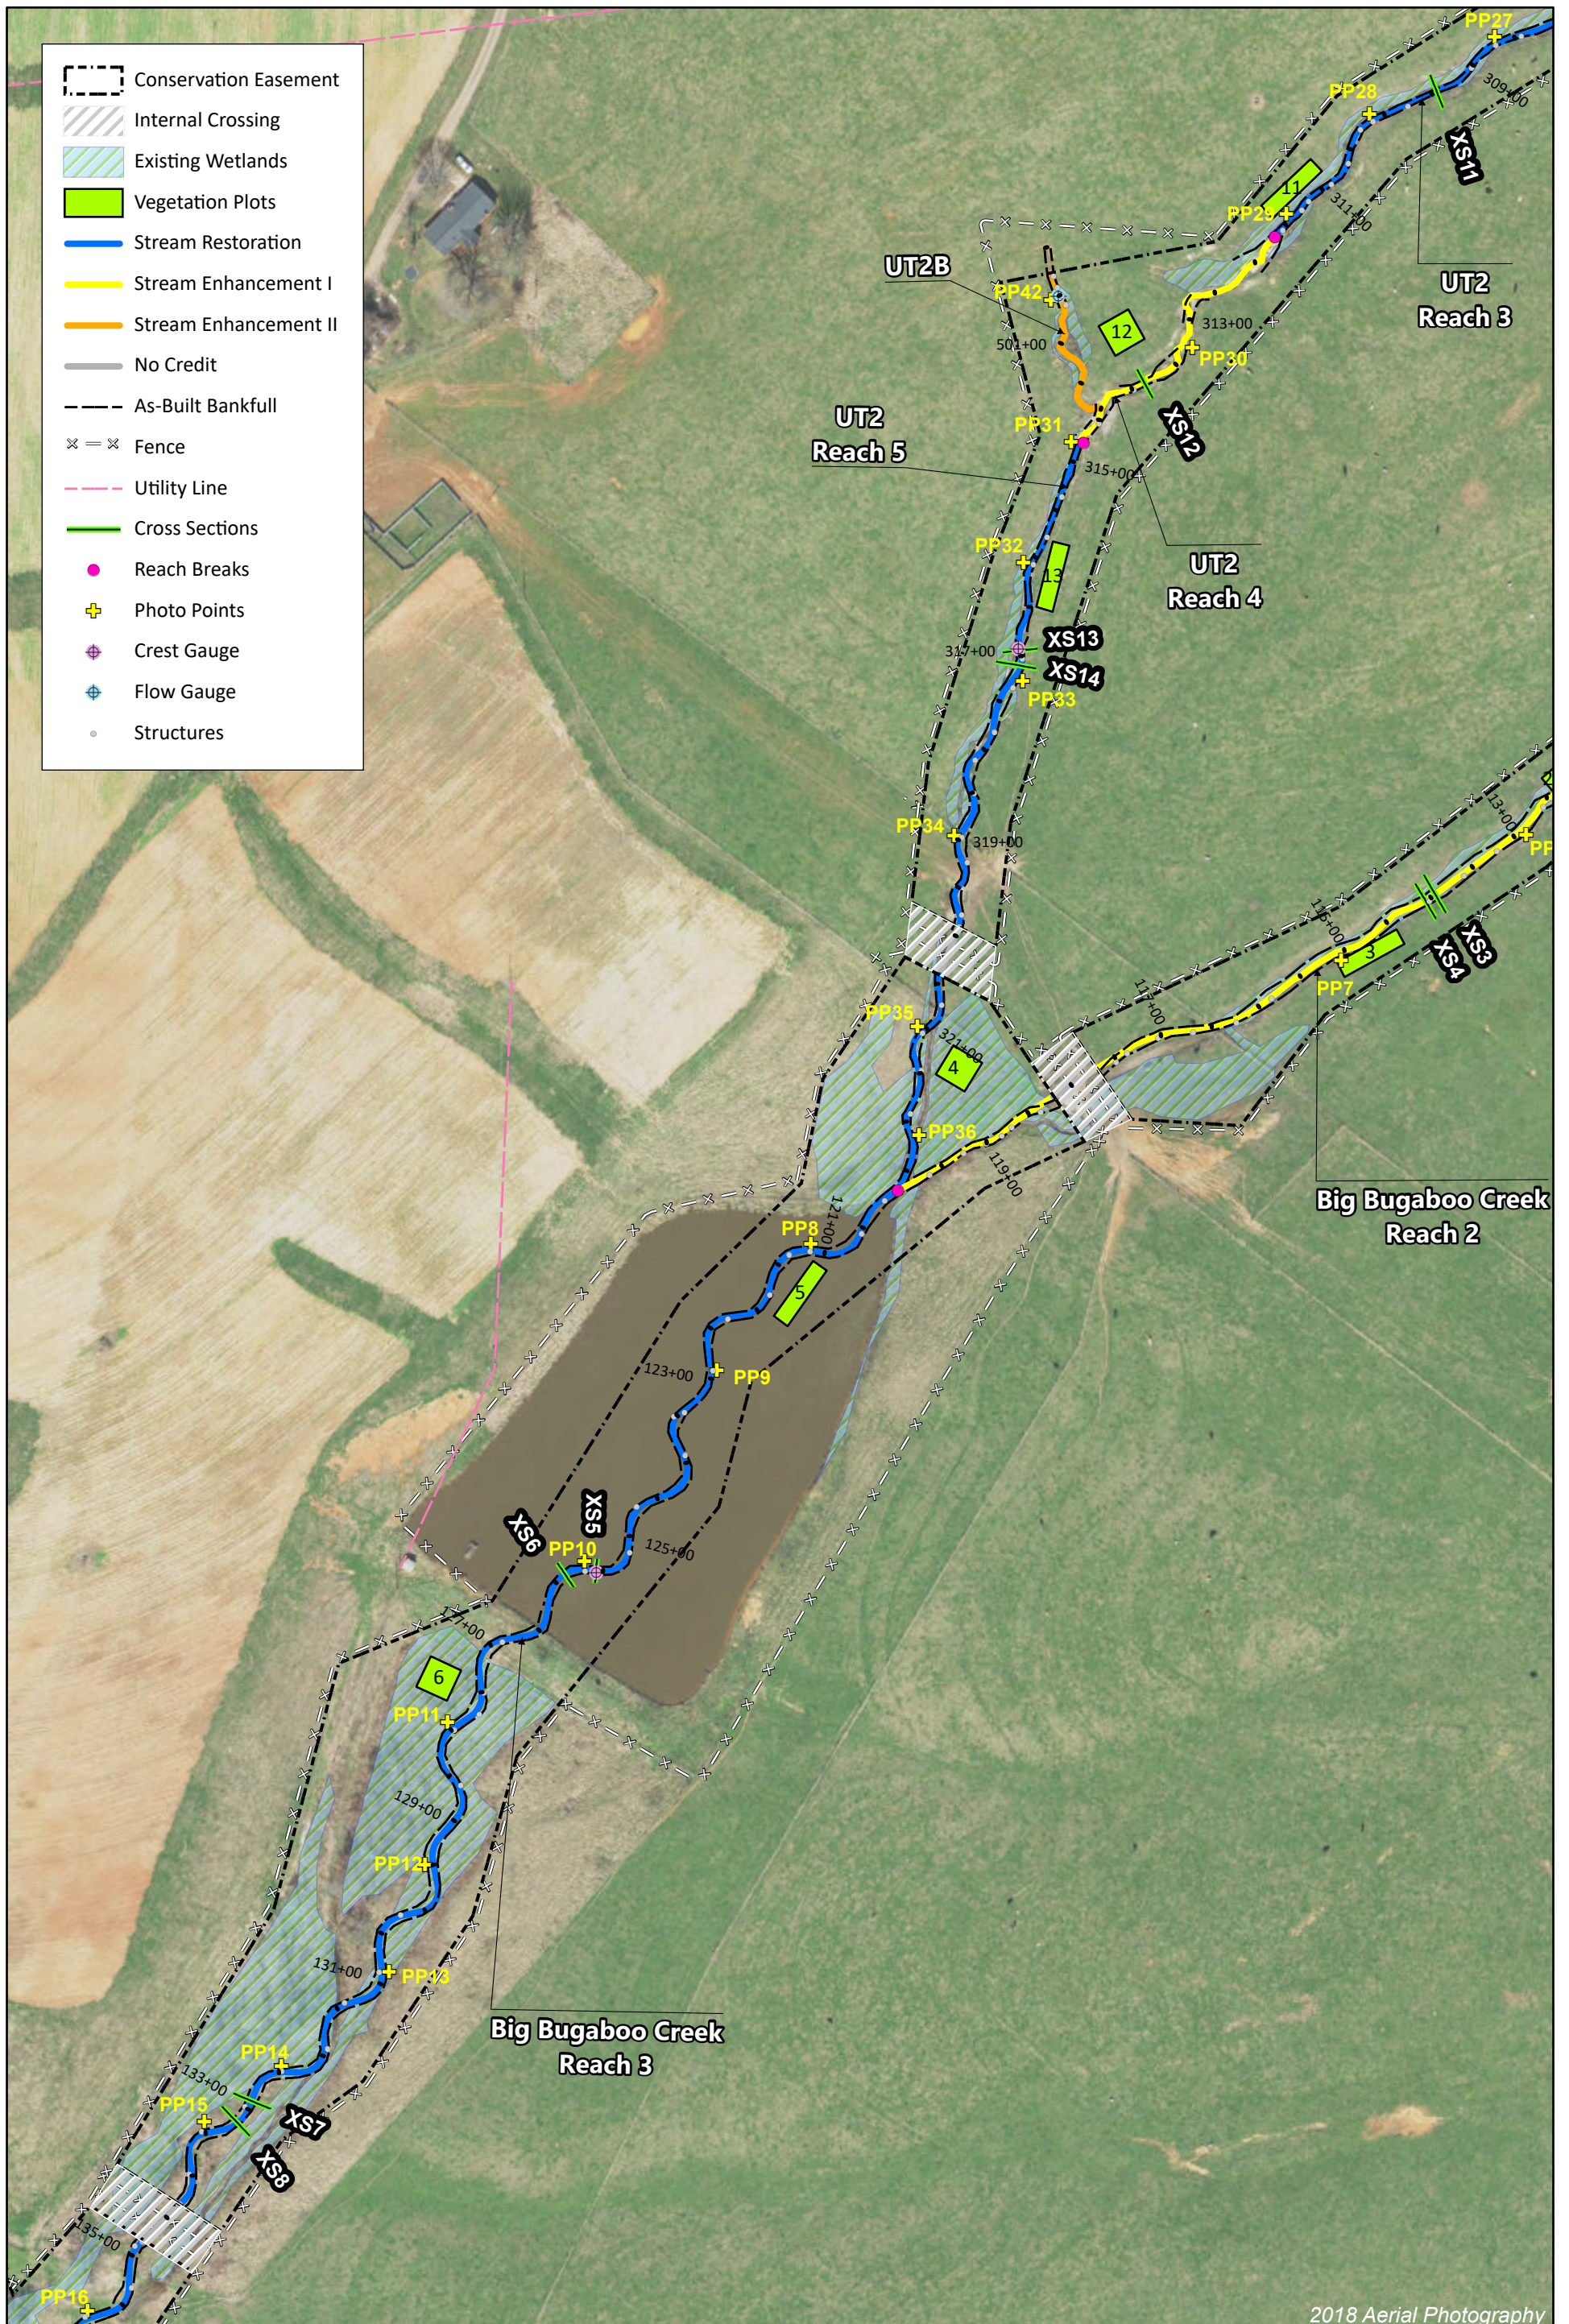
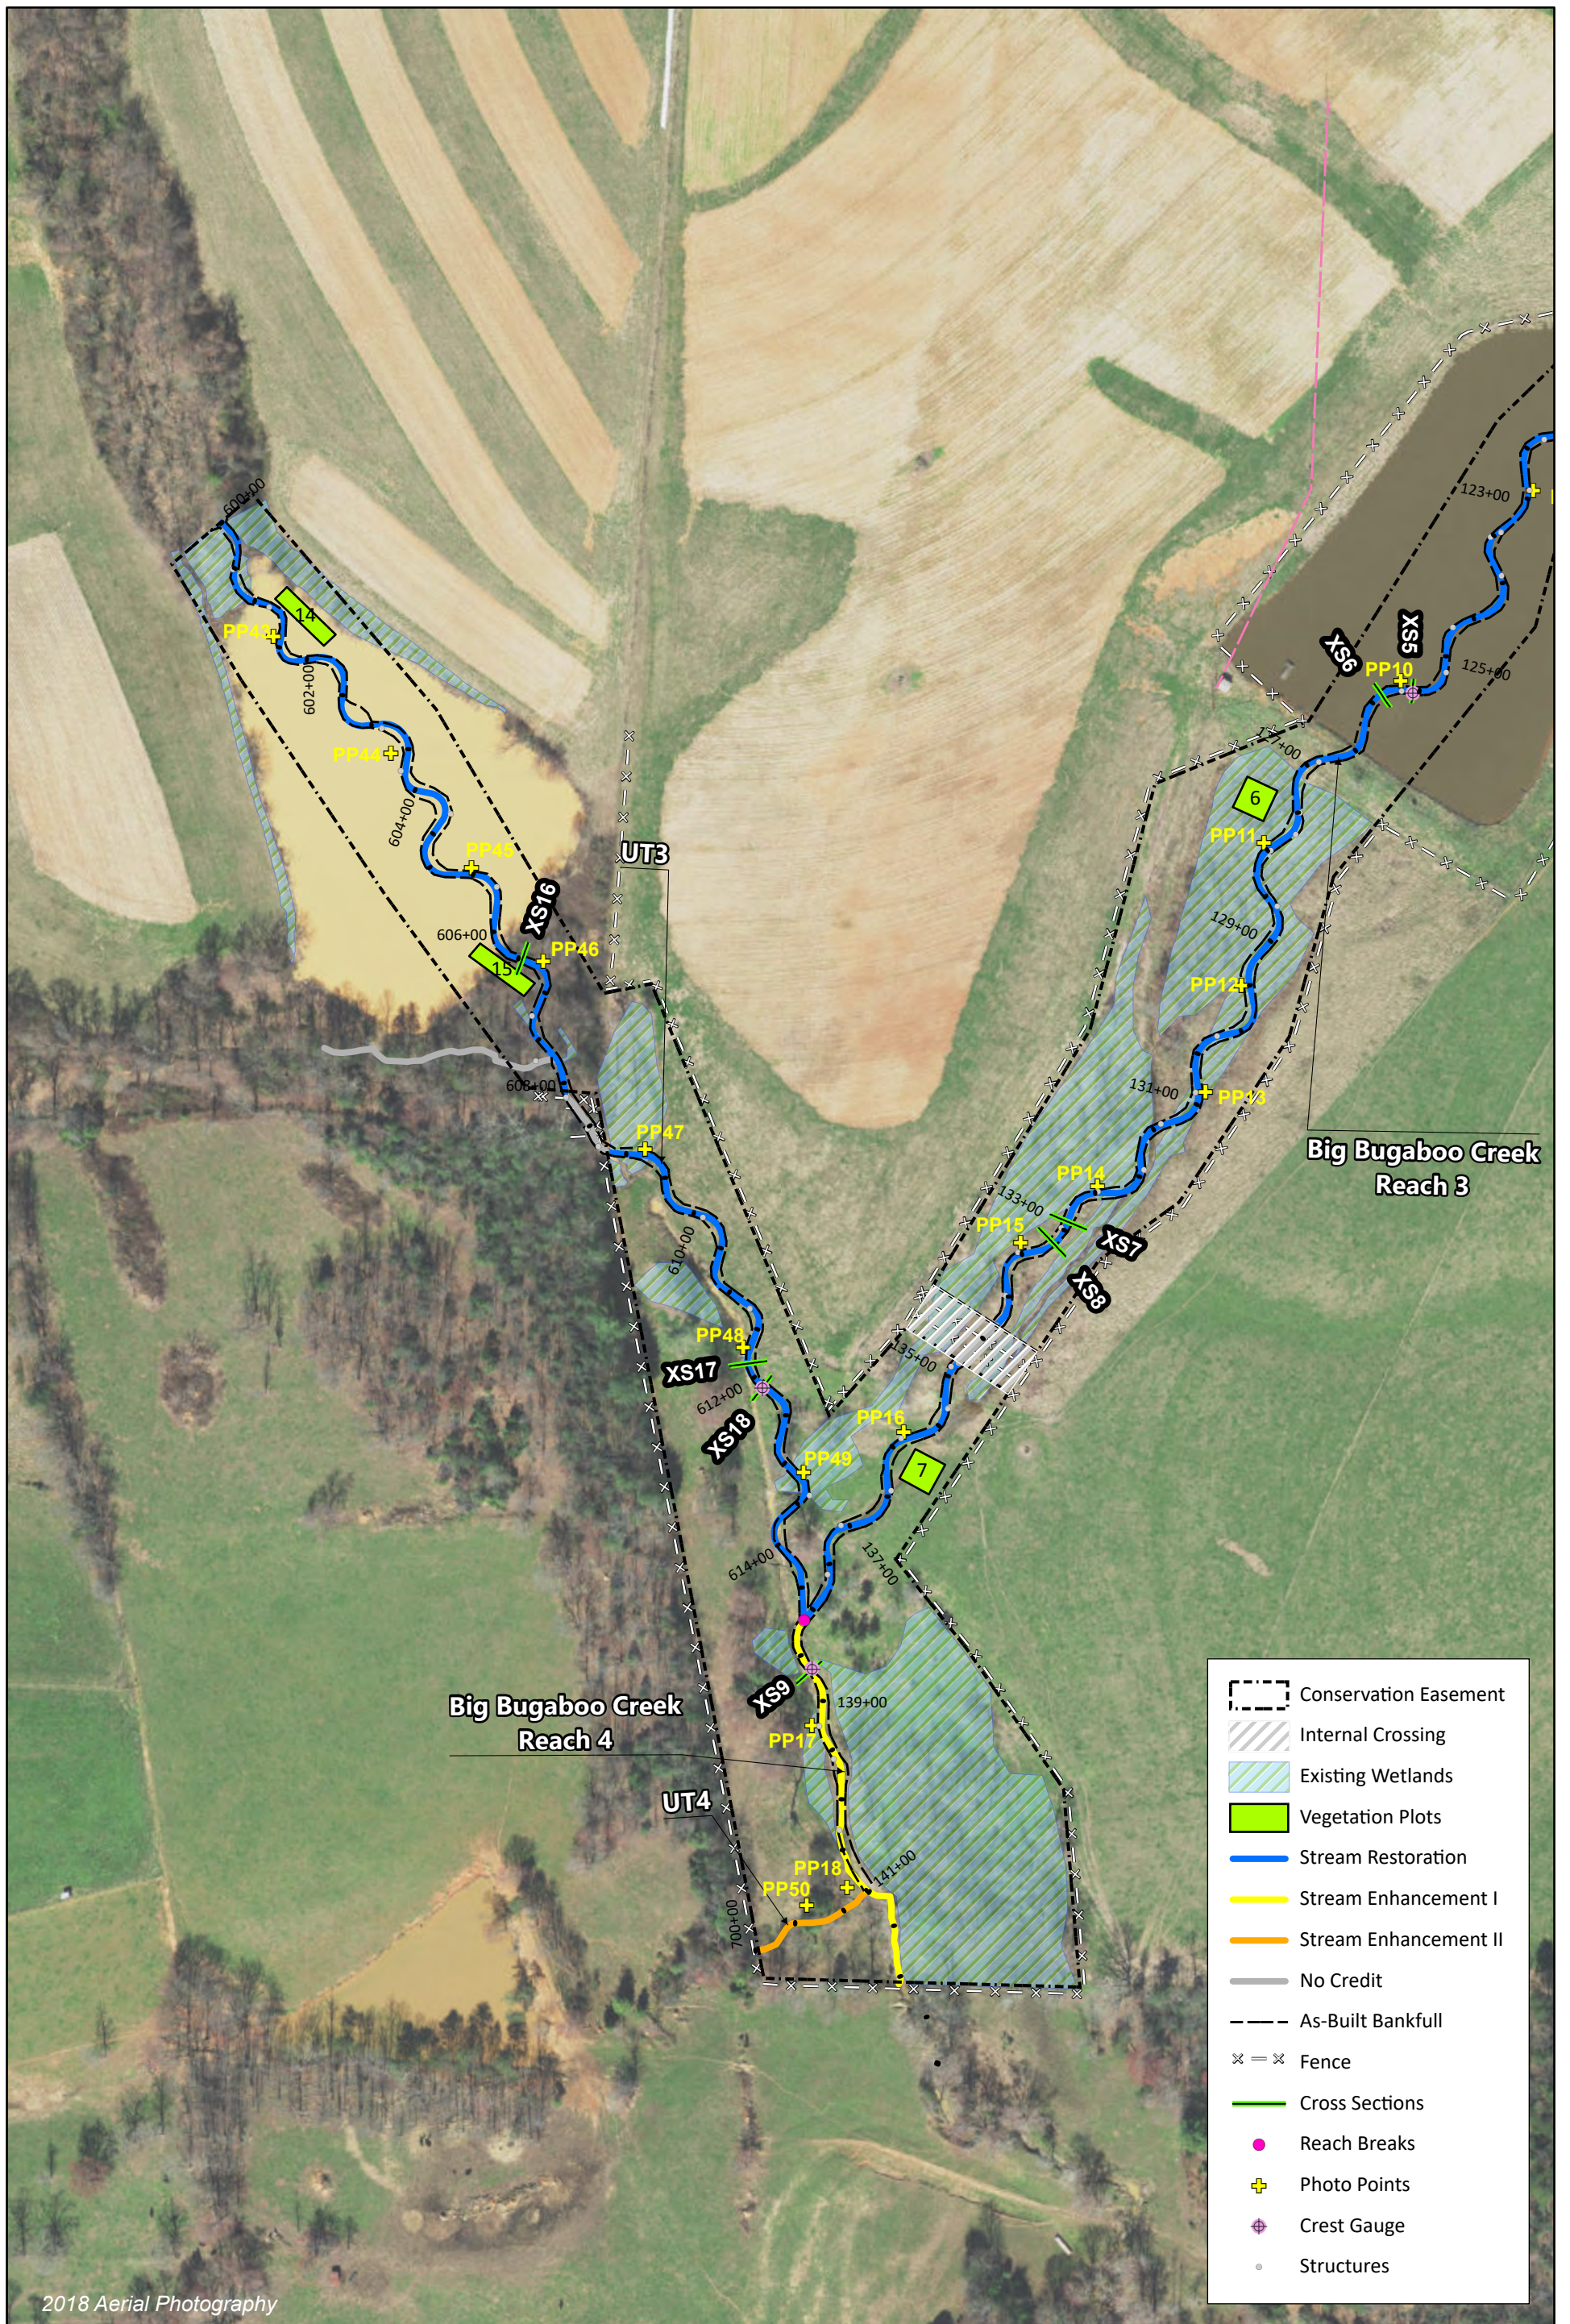
Figure 1. Current Condition Plan View Key
 Bug Headwaters Mitigation Site
 Yadkin Basin 03040101
 Monitoring Year 0 - 2021
 Wilkes County, NC

The MY1 assessment indicated only a small number of planted trees survived in the old pond bottoms along the right side of Big Bugaboo Creek Reach 3 and both sides of UT3 (Figure 1b-c). The visual assessment of the right side of Big Bugaboo Creek Reach 3 indicated some planted trees survived, but

Murdannia has grown throughout the existing wetlands (6.61 acres) on the Site (Figure 1a-c). The invasive vegetation was treated in July 2021 using a chemical treatment but follow up treatments will occur in MY2. Refer to Section 2.7 for more information on the management plan for *Murdannia*.

Murdannia has spread from the wetlands into the stream channels on the Site (Figure 1a-c). The in-stream vegetation was also treated in July 2021 at the same time as the wetland treatments. Due to the amount of in-stream vegetation throughout the channels, some sediment deposition has occurred. Once the invasive vegetation is removed, it is expected the sediment will flush through the system. Refer to Section 2.7 for more information on the management plan for *Murdannia*.
