Year 2 Monitoring Report

CATBIRD SITE

NCDMS Project #100022 (Contract #7186)
USACE Action ID: SAW-2017-01506
DWR Project #20171039

RE: Catbird Site: Year 2 Monitoring Report (NCDMS ID 100022)

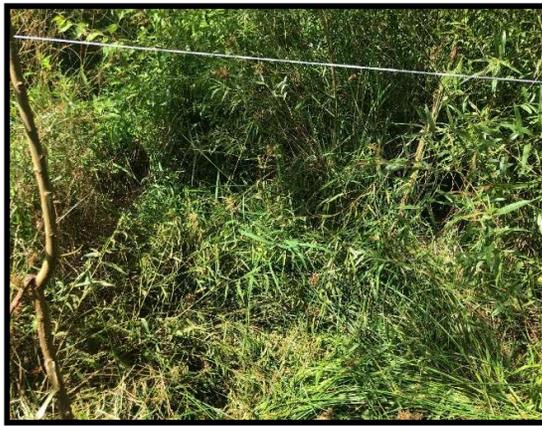
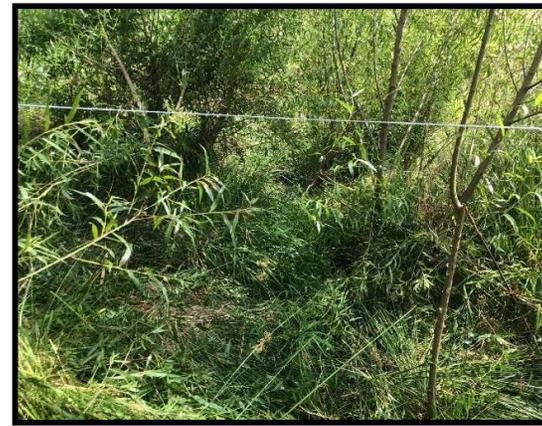
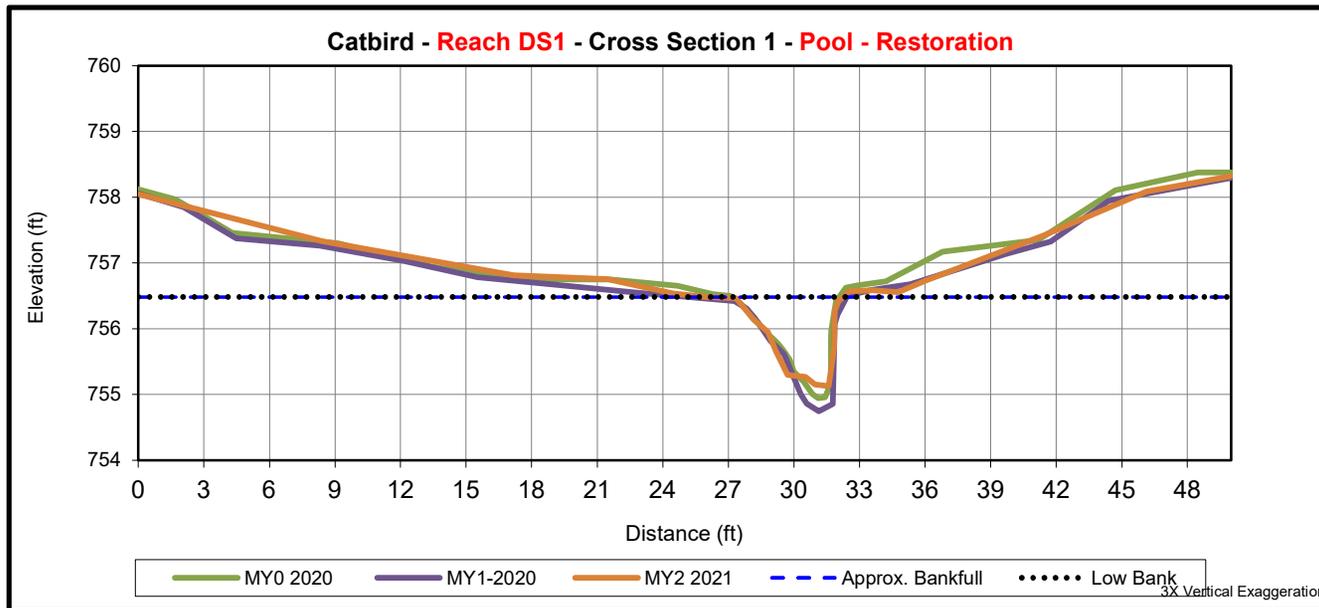
Cross Section 1 (Pool)						
	MY0	MY1	MY2	MY3	MY5	MY7	MY+
Bankfull Elevation (ft) - Based on AB-XSA¹	756.50	756.4	756.5				
Bankfull Width (ft) ¹	5.0	4.7	6.1				
Floodprone Width (ft) ¹	-	-	-				
Bankfull Max Depth (ft) ²	1.6	1.7	1.4				
Low Bank Elevation (ft)	756.50	756.4	756.5				
Bankfull Cross Sectional Area (ft ²) ²	3.9	4.2	3.9				
Bankfull Entrenchment Ratio ¹	-	-	-				
Bankfull Bank Height Ratio ¹	-	-	-

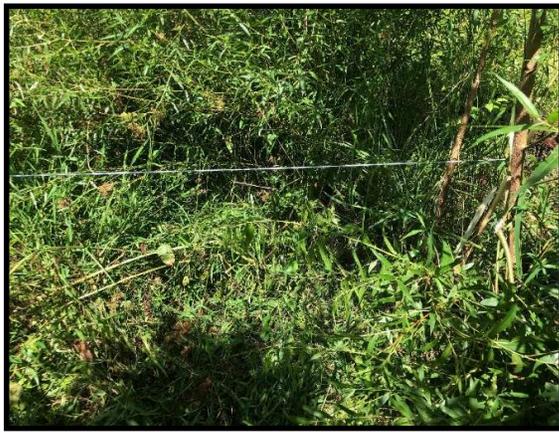
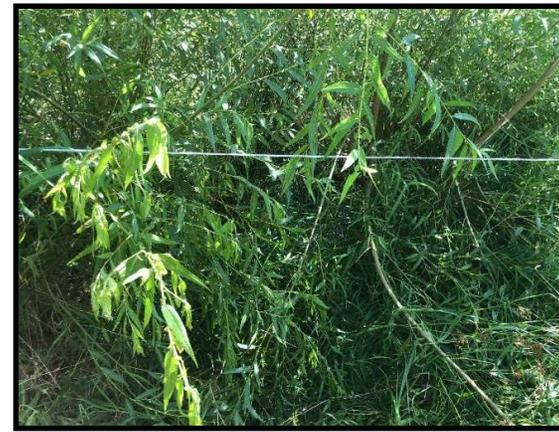
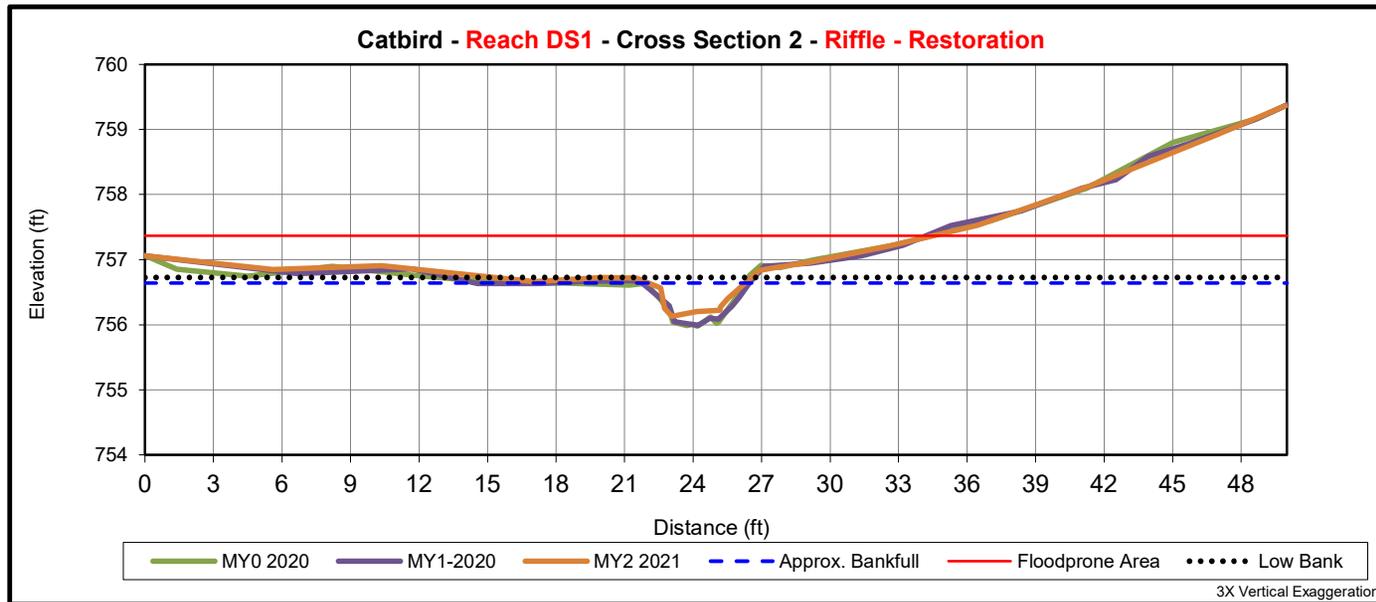
Cross Section 2 (Riffle)						
	MY0	MY1	MY2	MY3	MY5	MY7	MY+
Bankfull Elevation (ft) - Based on AB-XSA¹	756.64	756.6	756.8				
Bankfull Width (ft) ¹	7.3	4.7	6.5				
Floodprone Width (ft) ¹	>33.6	>33.7	>34.5				
Bankfull Max Depth (ft) ²	0.7	0.7	0.6				
Low Bank Elevation (ft)	756.64	756.7	765.7				
Bankfull Cross Sectional Area (ft ²) ²	1.9	2.1	1.8				
Bankfull Entrenchment Ratio ¹	>6.9	>7.2	>5.3				
Bankfull Bank Height Ratio ¹	1.0	1.1	1.0

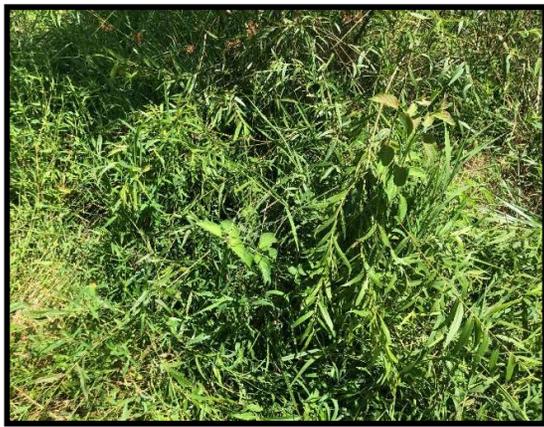
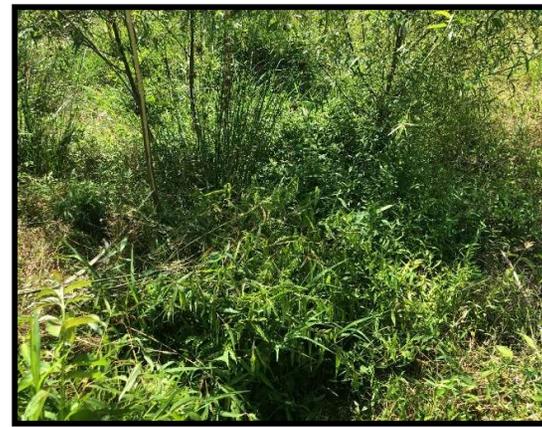
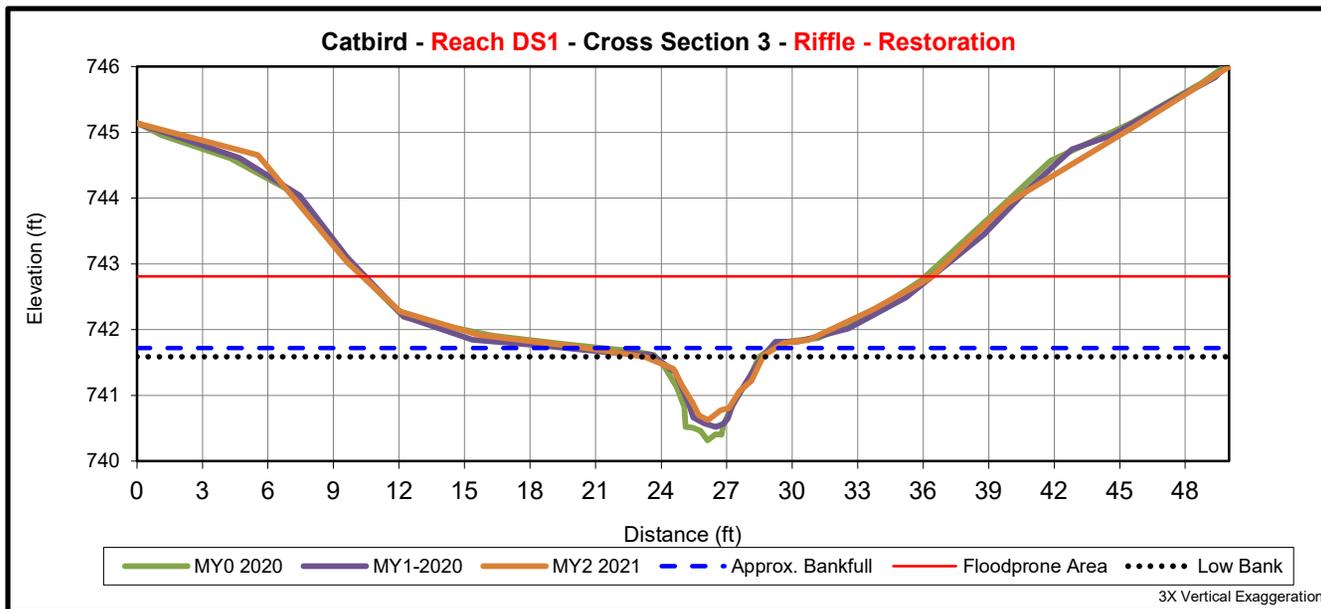
Cross Section 3 (Riffle)						
	MY0	MY1	MY2	MY3	MY5	MY7	MY+
Bankfull Elevation (ft) - Based on AB-XSA¹	741.62	741.7	741.7				
Bankfull Width (ft) ¹	5.1	5.4	8.6				
Floodprone Width (ft) ¹	26	26.6	26.1				
Bankfull Max Depth (ft) ²	1.3	1.1	1.0				
Low Bank Elevation (ft)	741.62	741.6	741.6				
Bankfull Cross Sectional Area (ft ²) ²	3.5	3.0	2.6				
Bankfull Entrenchment Ratio ¹	9.9	4.9	3.0				
Bankfull Bank Height Ratio ¹	1.0	0.9	0.9

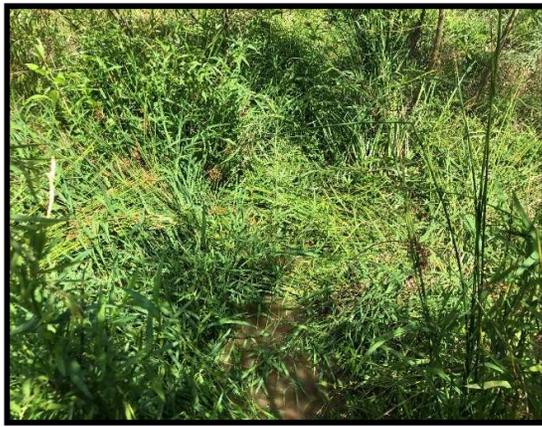
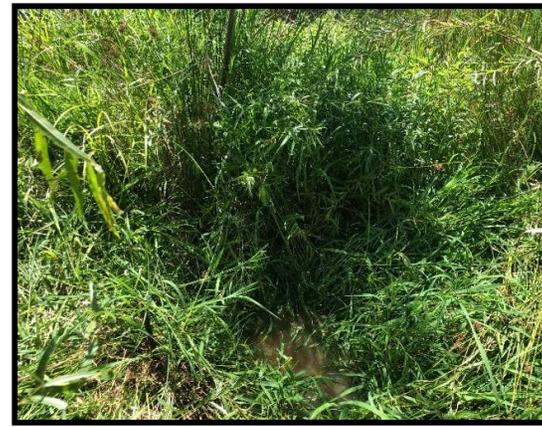
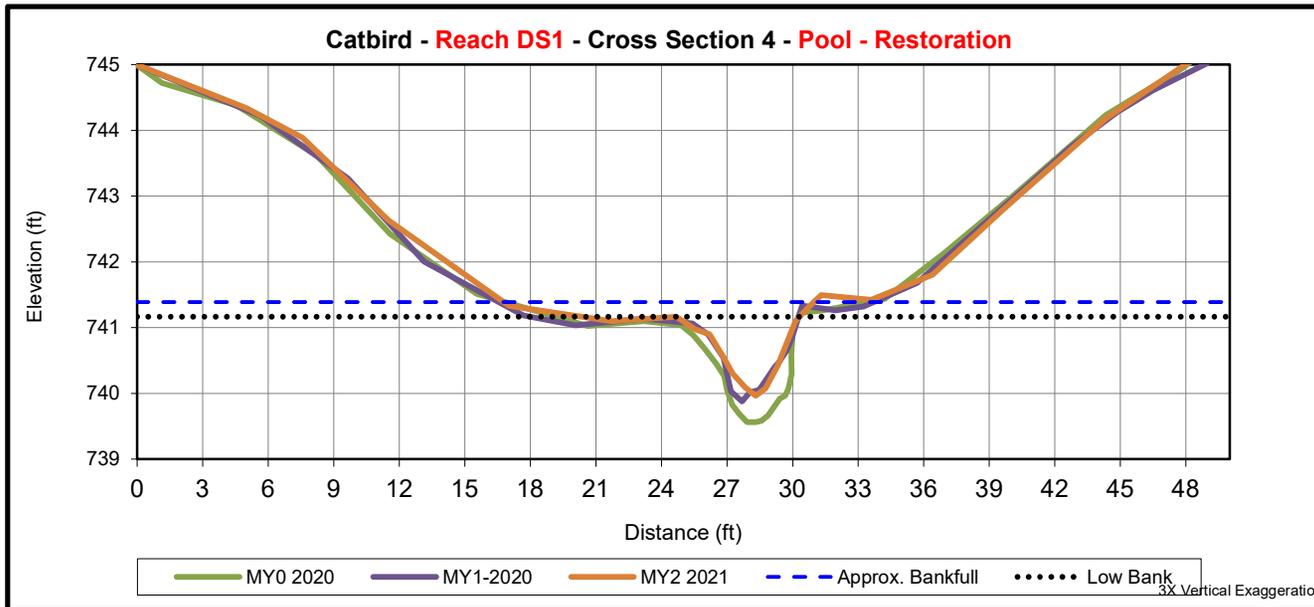
Cross Section 4 (Pool)						
	MY0	MY1	MY2	MY3	MY5	MY7	MY+
Bankfull Elevation (ft) - Based on AB-XSA¹	741.04	741.4	741.4				
Bankfull Width (ft) ¹	5.6	5.0	6.3				
Floodprone Width (ft) ¹	-	-	-				
Bankfull Max Depth (ft) ²	1.5	1.2	1.2				
Low Bank Elevation (ft)	741.04	741.1	741.2				
Bankfull Cross Sectional Area (ft ²) ²	4.6	3.0	3.3				
Bankfull Entrenchment Ratio ¹	-	-	-				
Bankfull Bank Height Ratio ¹	-	-	-

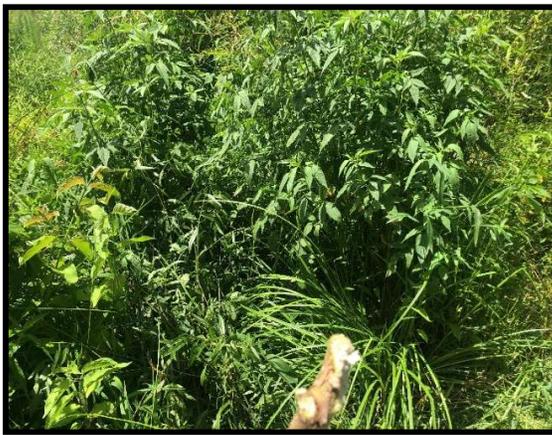
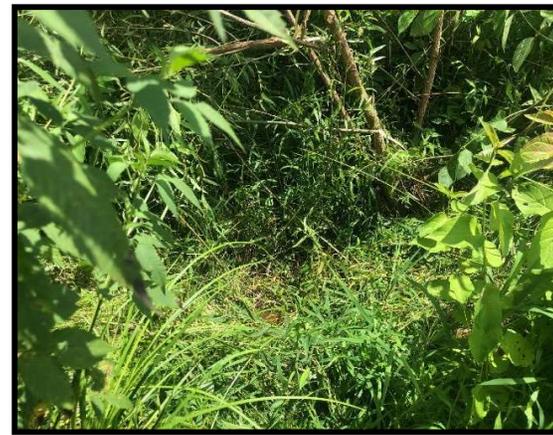
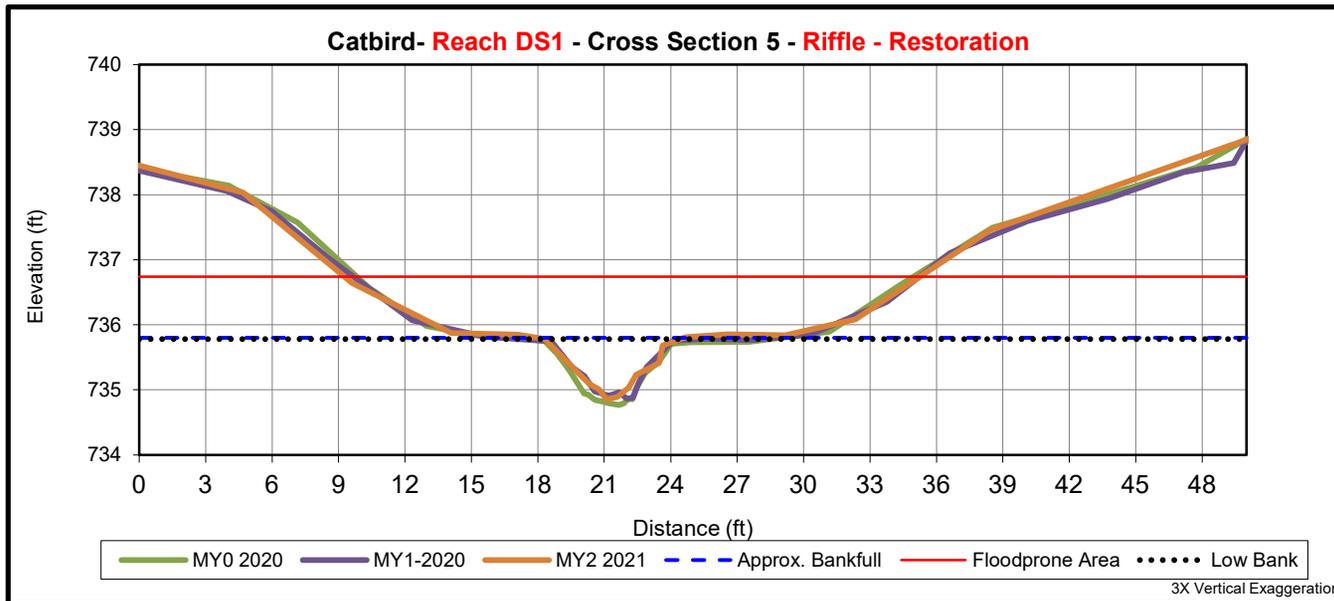
Cross Section 5 (Riffle)						
	MY0	MY1	MY2	MY3	MY5	MY7	MY+
Bankfull Elevation (ft) - Based on AB-XSA¹	735.70	735.8	735.8				
Bankfull Width (ft) ¹	5.6	5.5	6.7				
Floodprone Width (ft) ¹	24	25.5	26.0				
Bankfull Max Depth (ft) ²	0.9	0.9	0.9				
Low Bank Elevation (ft)	735.70	735.7	735.8				
Bankfull Cross Sectional Area (ft ²) ²	3.1	2.8	2.9				
Bankfull Entrenchment Ratio ¹	9.0	4.6	3.9				
Bankfull Bank Height Ratio ¹	1.0	0.9	1.0

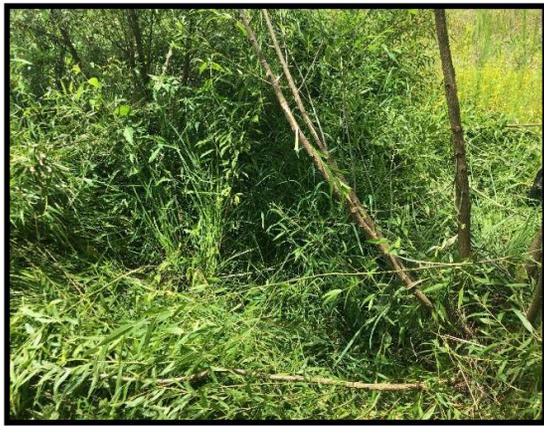
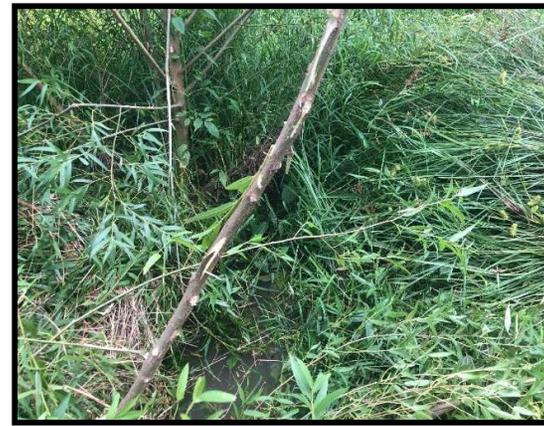
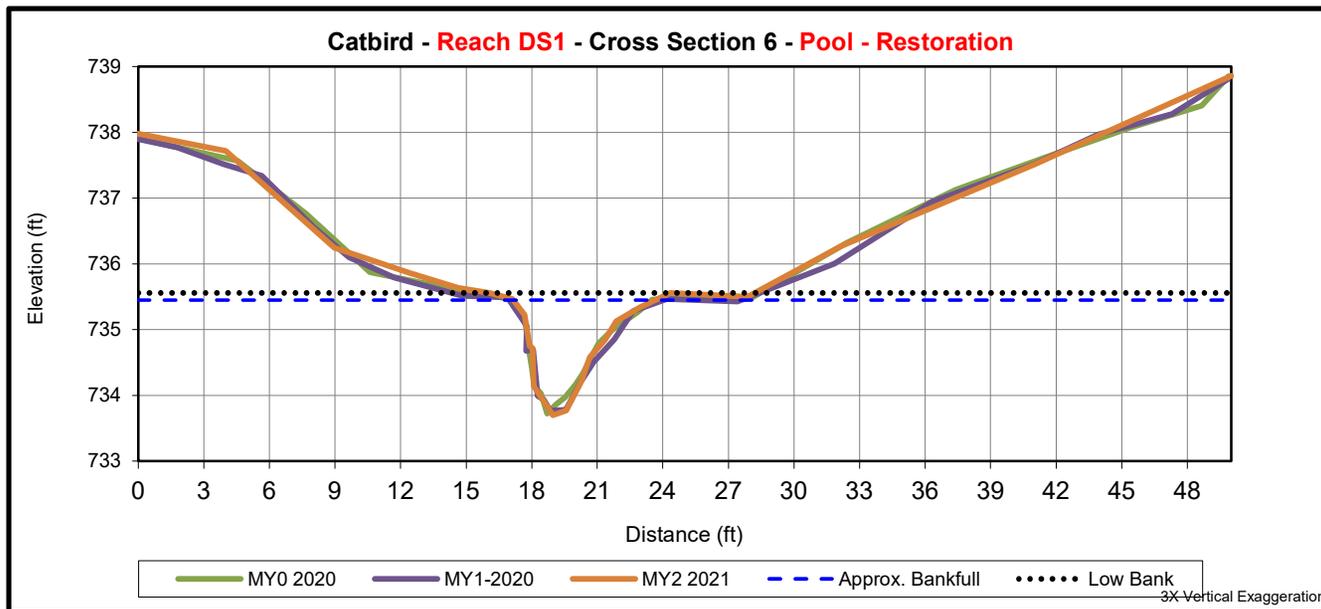
Cross Section 6 (Pool)						
	MY0	MY1	MY2	MY3	MY5	MY7	MY+
Bankfull Elevation (ft) - Based on AB-XSA ¹	735.46	735.4	735.5				
Bankfull Width (ft) ¹	6.5	6.4	6.5				
Floodprone Width (ft) ¹	-	-	-				
Bankfull Max Depth (ft) ²	1.7	1.7	1.9				
Low Bank Elevation (ft)	735.46	735.5	735.6				
Bankfull Cross Sectional Area (ft ²) ²	5.1	5.6	6.0				
Bankfull Entrenchment Ratio ¹	-	-	-				
Bankfull Bank Height Ratio ¹	-	-	-

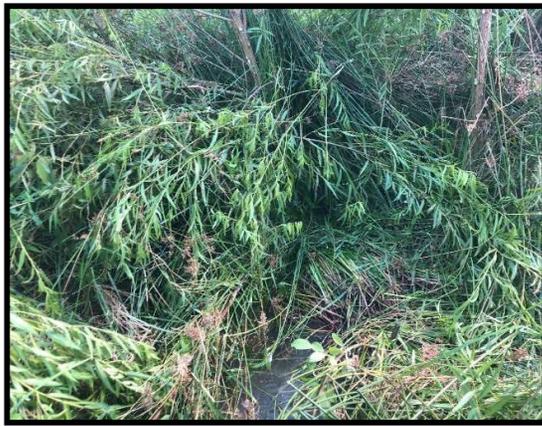
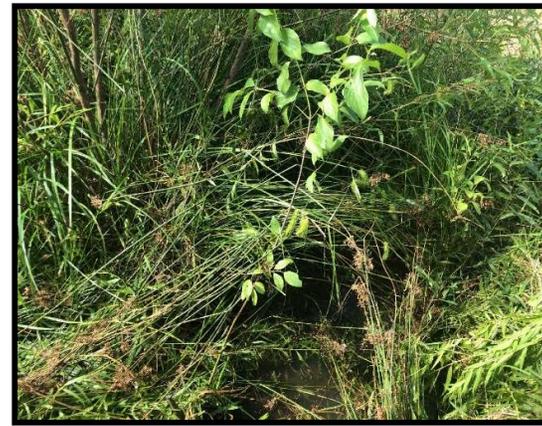
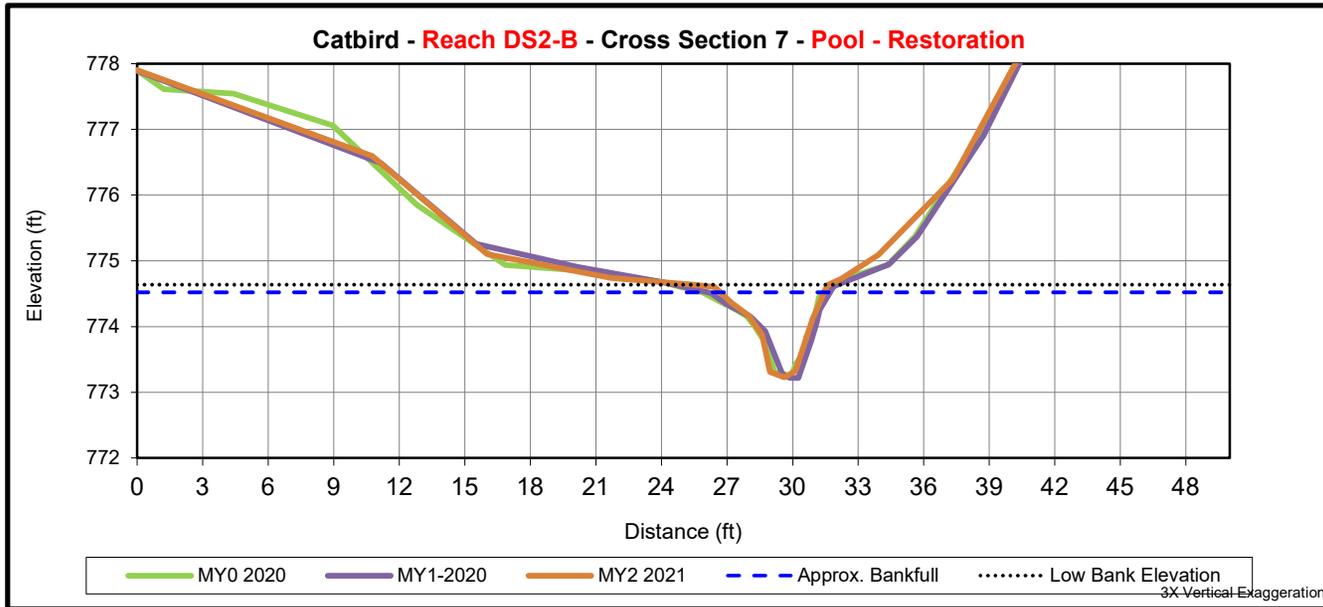
Cross Section 7 (Pool)						
	MY0	MY1	MY2	MY3	MY5	MY7	MY+
Bankfull Elevation (ft) - Based on AB-XSA¹	774.52	774.5	774.5				
Bankfull Width (ft) ¹	5.5	5.4	4.7				
Floodprone Width (ft) ¹	-	-	-				
Bankfull Max Depth (ft) ²	1.3	1.3	1.4				
Low Bank Elevation (ft)	774.52	774.5	774.6				
Bankfull Cross Sectional Area (ft ²) ²	3.1	3.2	3.7				
Bankfull Entrenchment Ratio ¹	-	-	-				
Bankfull Bank Height Ratio ¹	-	-	-

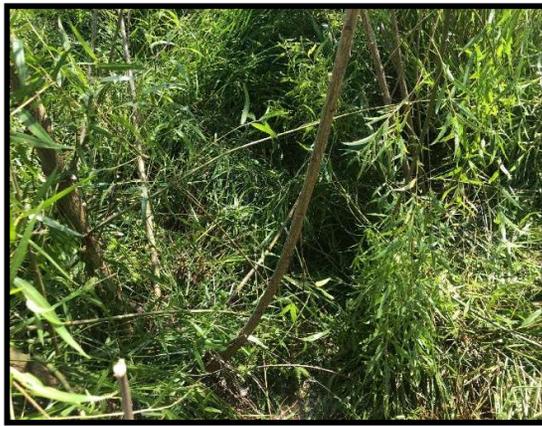
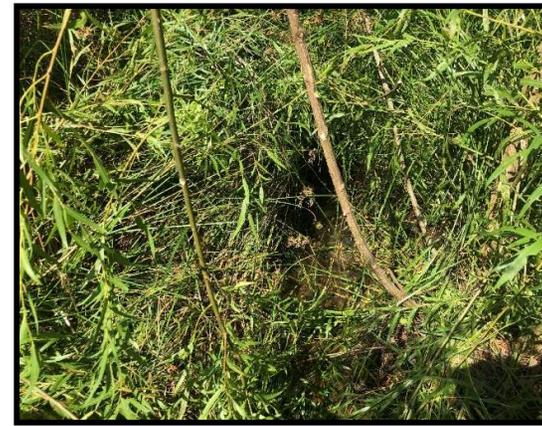
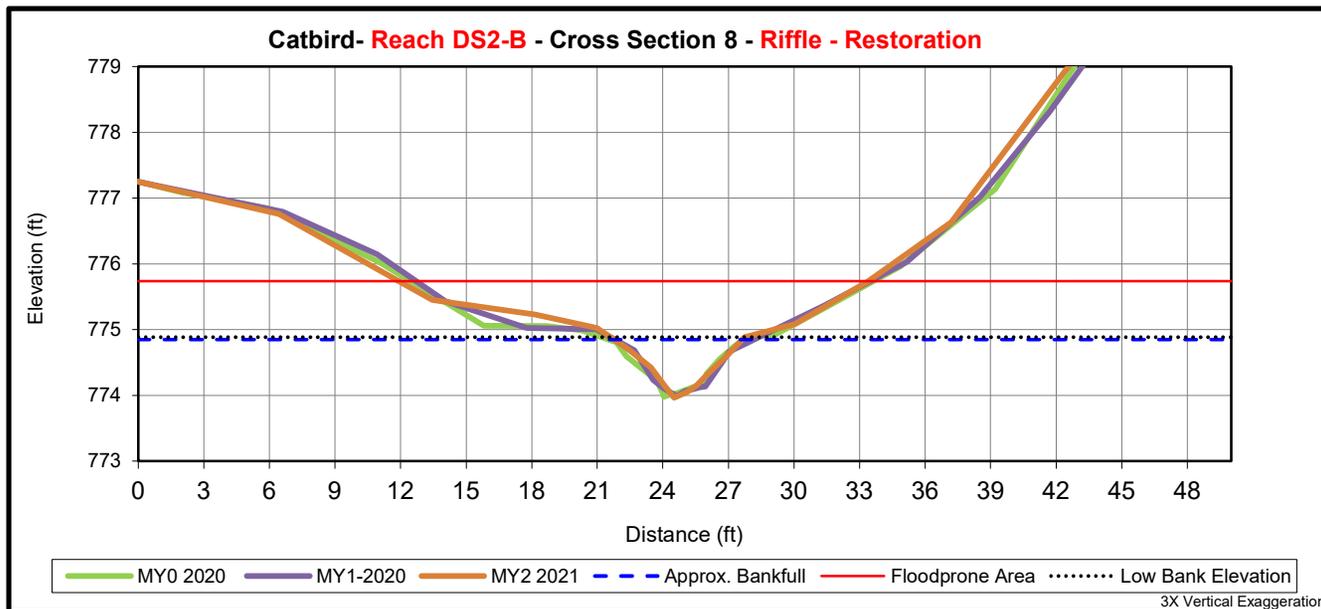
Cross Section 8 (Riffle)						
	MY0	MY1	MY2	MY3	MY5	MY7	MY+
Bankfull Elevation (ft) - Based on AB-XSA ¹	774.81	774.8	774.9				
Bankfull Width (ft) ¹	5.6	5.1	5.9				
Floodprone Width (ft) ¹	20	19.8	21.5				
Bankfull Max Depth (ft) ²	0.8	0.7	0.9				
Low Bank Elevation (ft)	774.81	774.7	774.9				
Bankfull Cross Sectional Area (ft ²) ²	2.6	1.8	2.6				
Bankfull Entrenchment Ratio ¹	8.8	3.9	3.7				
Bankfull Bank Height Ratio ¹	1.0	0.8	1.0

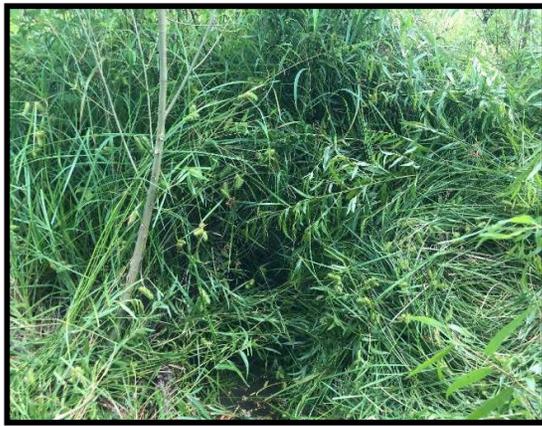
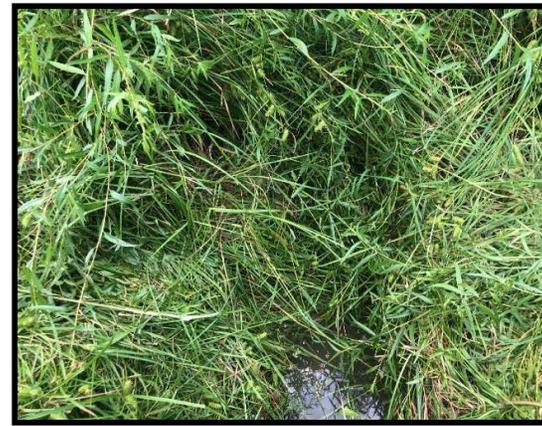
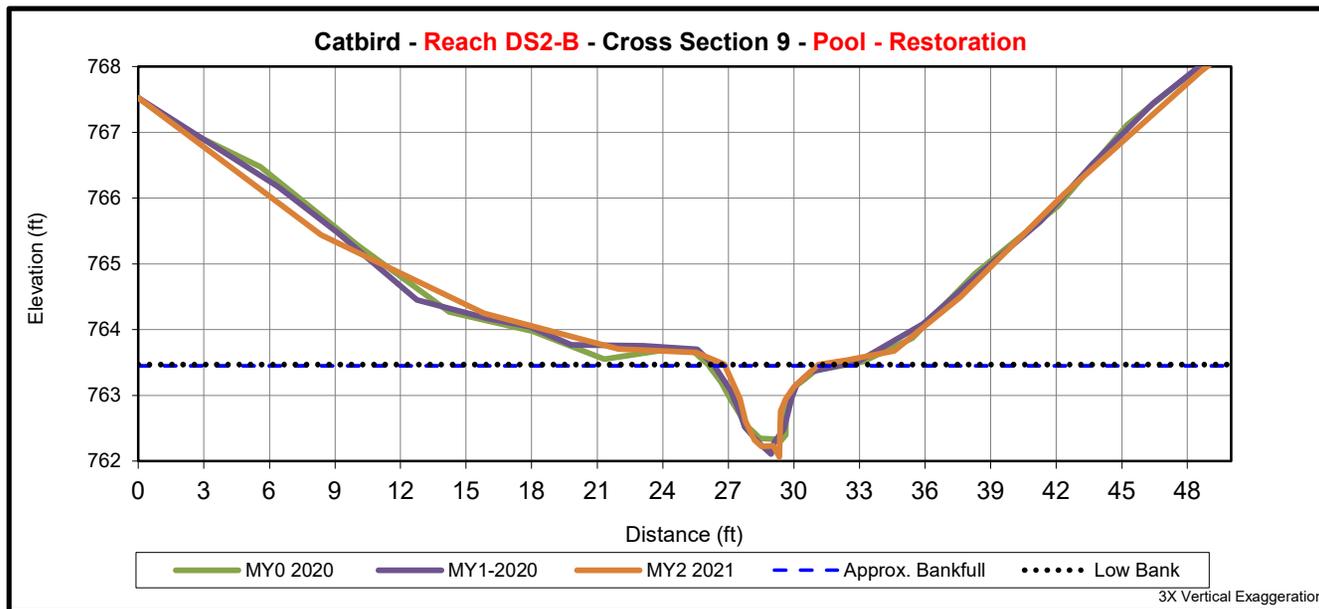
Cross Section 9 (Pool)						
	MY0	MY1	MY2	MY3	MY5	MY7	MY+
Bankfull Elevation (ft) - Based on AB-XSA¹	763.39	763.4	763.5				
Bankfull Width (ft) ¹	4.8	4.5	4.2				
Floodprone Width (ft) ¹	-	-	-				
Bankfull Max Depth (ft) ²	1.1	1.3	1.4				
Low Bank Elevation (ft)	763.39	763.4	763.5				
Bankfull Cross Sectional Area (ft ²) ²	2.7	2.7	2.7				
Bankfull Entrenchment Ratio ¹	-	-	-				
Bankfull Bank Height Ratio ¹	-	-	-

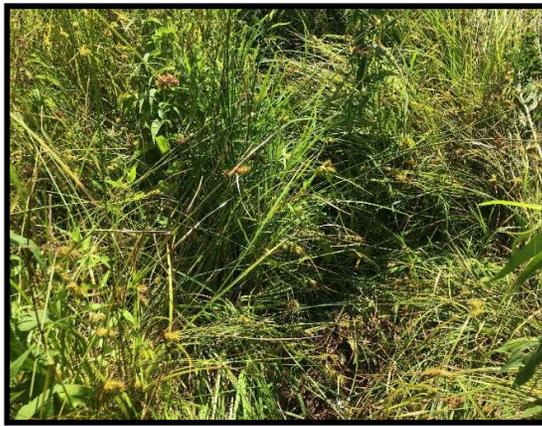
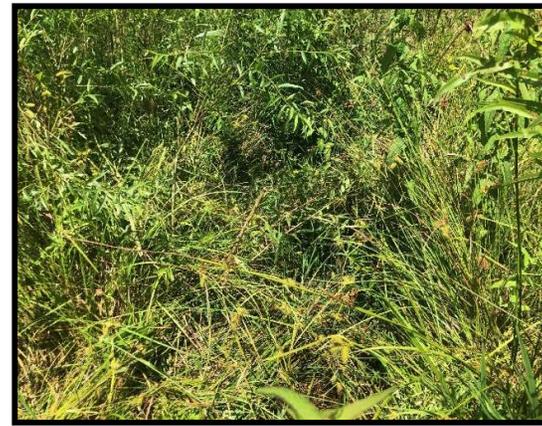
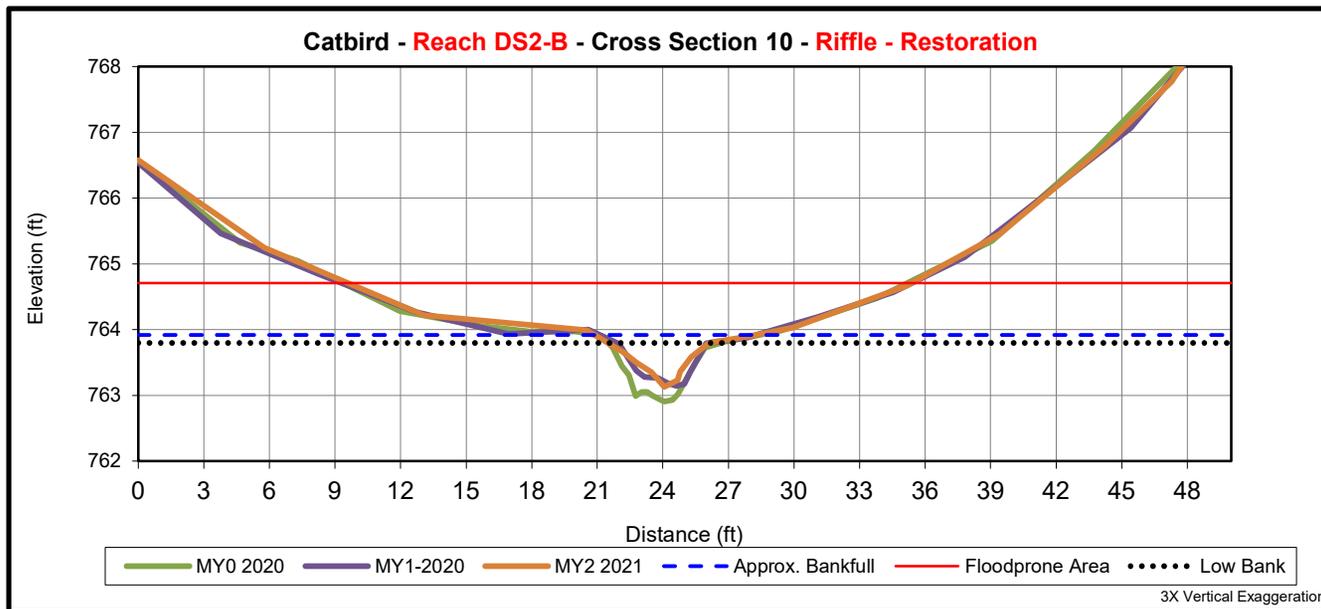
Cross Section 10 (Riffle)						
	MY0	MY1	MY2	MY3	MY5	MY7	MY+
Bankfull Elevation (ft) - Based on AB-XSA¹	763.73	763.9	763.9				
Bankfull Width (ft) ¹	4.2	4.7	3.5				
Floodprone Width (ft) ¹	24	25.3	25.8				
Bankfull Max Depth (ft) ²	0.8	0.6	0.7				
Low Bank Elevation (ft)	763.73	763.8	763.8				
Bankfull Cross Sectional Area (ft ²) ²	2.2	1.7	1.5				
Bankfull Entrenchment Ratio ¹	11.8	5.4	3.5				
Bankfull Bank Height Ratio ¹	1.0	0.9	0.8

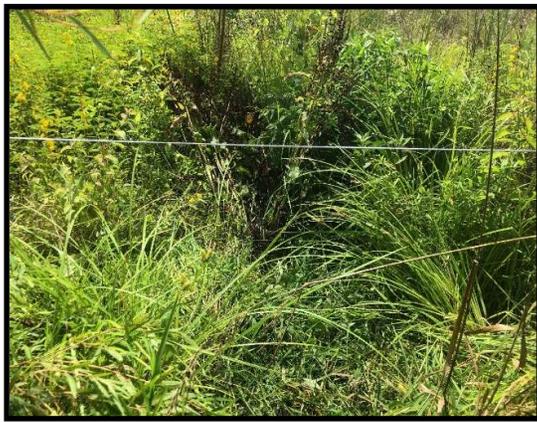
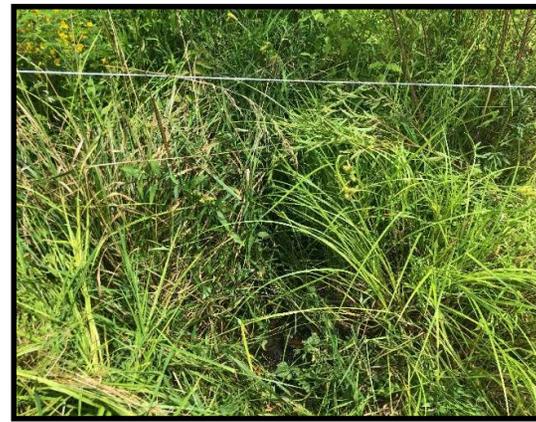
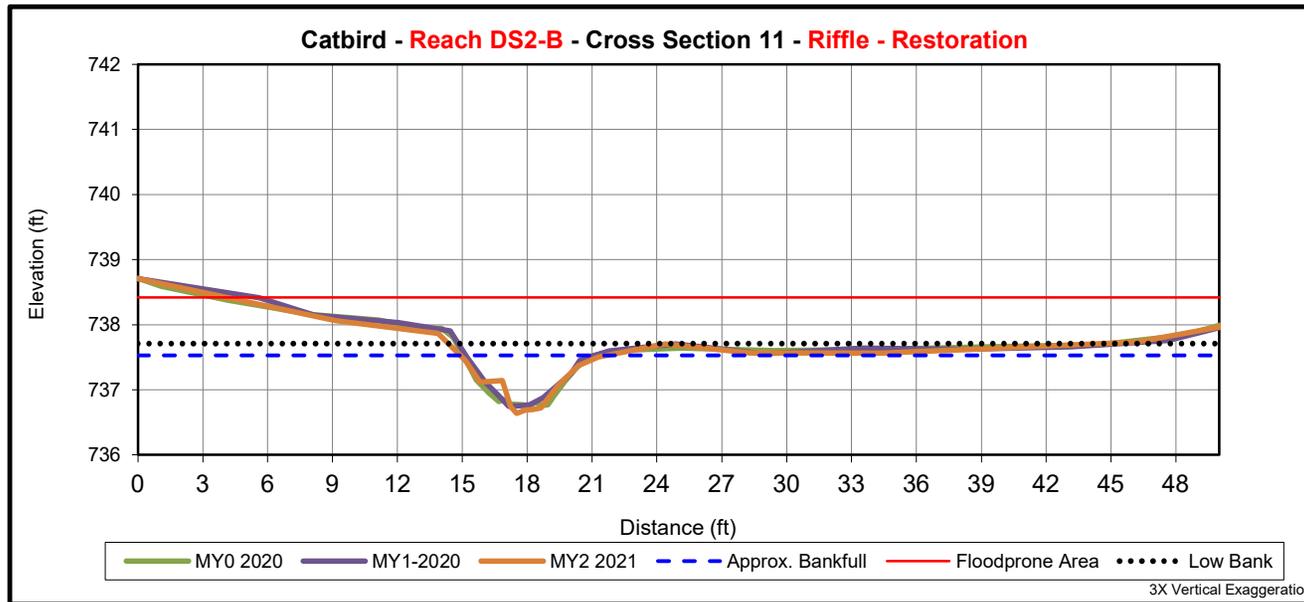
Cross Section 11 (Riffle)						
	MY0	MY1	MY2	MY3	MY5	MY7	MY+
Bankfull Elevation (ft) - Based on AB-XSA¹	737.51	737.6	737.5				
Bankfull Width (ft) ¹	5.7	5.3	6.8				
Floodprone Width (ft) ¹	>43.9	>44.2	>46.1				
Bankfull Max Depth (ft) ²	0.8	0.7	1.1				
Low Bank Elevation (ft)	737.51	737.5	737.7				
Bankfull Cross Sectional Area (ft) ²	2.9	2.3	4.4				
Bankfull Entrenchment Ratio ¹	>8.7	>8.7	>6.8				
Bankfull Bank Height Ratio ¹	1.0	0.9	1.2

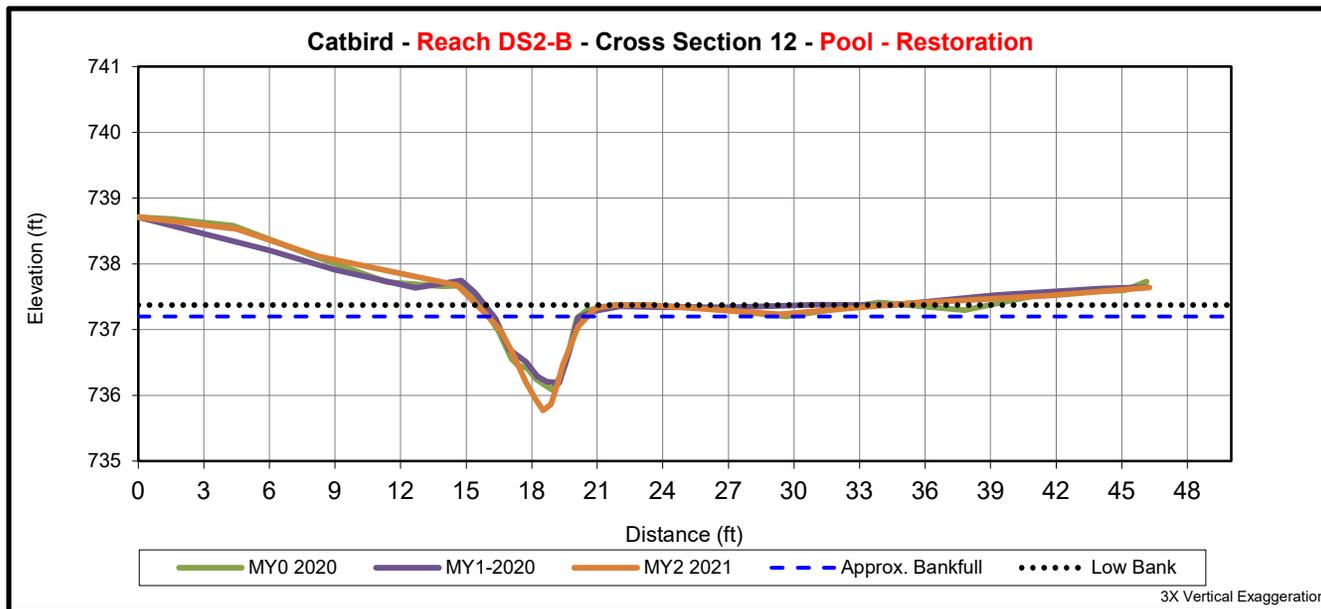
Cross Section 12 (Pool)						
	MY0	MY1	MY2	MY3	MY5	MY7	MY+
Bankfull Elevation (ft) - Based on AB-XSA¹	737.29	737.3	737.2				
Bankfull Width (ft) ¹	4.6	5.0	4.5				
Floodprone Width (ft) ¹	-	-	-				
Bankfull Max Depth (ft) ²	1.2	0.7	1.6				
Low Bank Elevation (ft)	737.29	737.3	737.4				
Bankfull Cross Sectional Area (ft ²) ²	3.1	2.3	4.4				
Bankfull Entrenchment Ratio ¹	-	-	-				
Bankfull Bank Height Ratio ¹	-	-	-

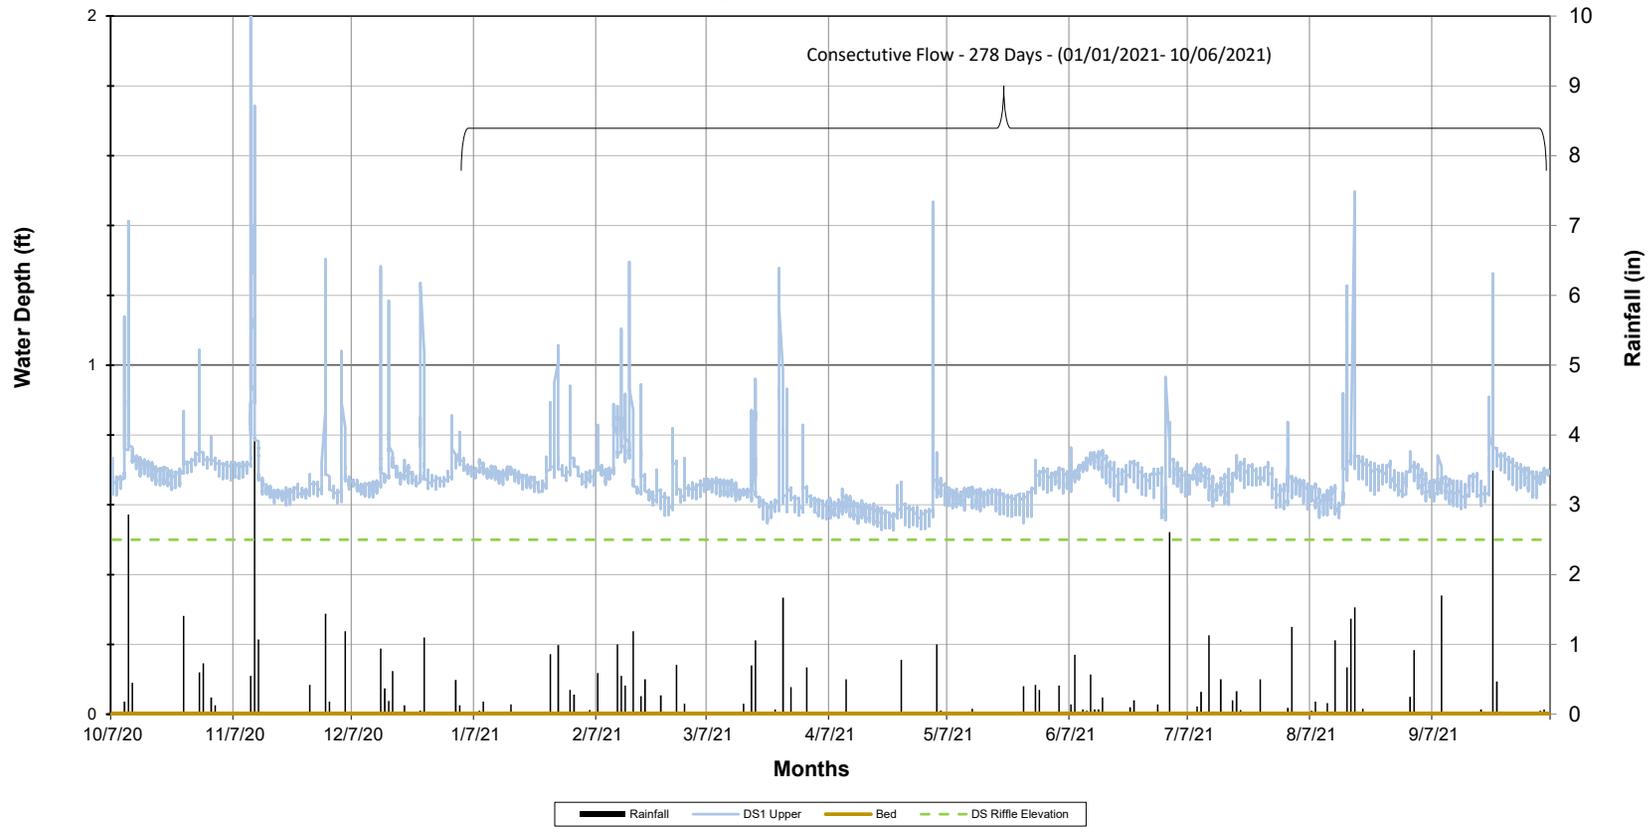
MY2 Catbird Flow Gauge DS1 Upper Stream Flow Hydrograph

Year	Number of Bankfull Events	Maximum Bankfull Height (ft)	Date of Maximum Bankfull Event
Stage Recorder DS1 (Lower)			
MY1 2020	8	0.92	8/15/2020
MY2 2021	16	0.61	5/3/2021
Stage Recorder DS2-B (Lower)			
MY1 2020	8	0.62	8/15/2020
MY2 2021	1	0.08	5/3/2021
Year	Number of Flow Events	Maximum Consecutive Flow Days	Maximum Cumulative Flow Days
Flow Gauge DS1 (Upper)			
MY1 2020	1	215	215
MY2 2021	1	278	278
