**CEDAR CREEK STREAM AND WETLAND RESTORATION  
PROJECT  
MONITORING REPORT  
MONITORING YEAR 7  
FINAL**

SAMPSON COUNTY, NORTH CAROLINA  
CONTRACT No. 005011 - PROJECT No. 95718  
USACE ACTION ID No. 2012-00389 – NCDWR PROJECT No. 2013-0186

January 2022

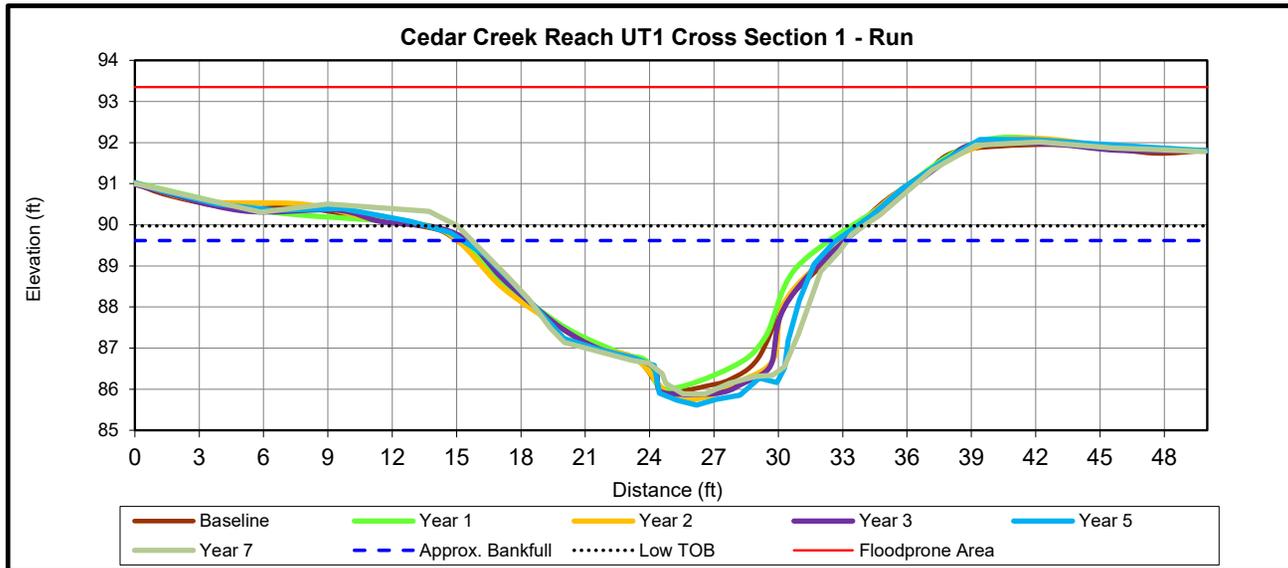
Dimension	Cross Section 1 (Run)						
	Base	MY1	MY2	MY3	MY5	MY7	MY+
Bankfull Elevation (ft) - Based on AB-XSA <sup>1</sup>	89.8	89.8	89.8	89.8	89.6	89.6	
Bankfull Width (ft) <sup>1</sup>	19.0	18.5	19.0	18.9	17.4	17.5	
Floodprone Width (ft) <sup>1</sup>	50.0	50.0	50.0	50.0	50.0	50.0	
Bankfull Mean Depth (ft)	2.2	2.1	2.3	2.3	-	-	
Bankfull Max Depth (ft) <sup>2</sup>	3.8	3.8	4.0	3.9	4.2	4.1	
Low Bank Elevation (ft)	-	-	-	-	89.8	90.0	
Bankfull Cross Sectional Area (ft <sup>2</sup> ) <sup>2</sup>	41.6	38.9	43.6	42.8	45.0	48.1	
Bankfull Width/Depth Ratio	8.6	8.8	8.2	8.3	-	-	
Bankfull Entrenchment Ratio <sup>1</sup>	>2.2	>2.2	>2.2	>2.2	>2.2	>2.9	
Bankfull Bank Height Ratio <sup>1</sup>	1.0	1.0	1.0	1.0	1.0	1.1

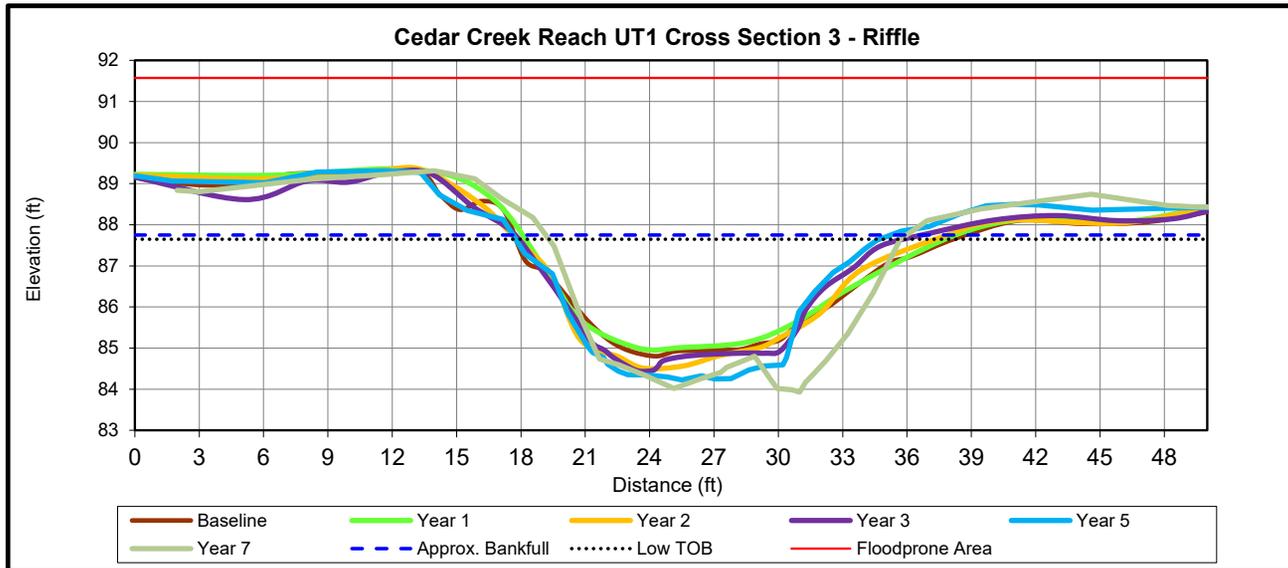
Dimension	Cross Section 3 (Riffle)						
	Base	MY1	MY2	MY3	MY5	MY7	MY+
<b>Bankfull Elevation (ft) - Based on AB-XSA<sup>1</sup></b>	88.1	88.1	88.1	88.1	88.1	87.8	
Bankfull Width (ft) <sup>1</sup>	23.8	26.1	23.5	23.1	20.2	16.5	
Floodprone Width (ft) <sup>1</sup>	50.0	50.0	50.0	50.0	50.2	50.0	
Bankfull Mean Depth (ft)	1.9	1.7	2.0	1.9	-	-	
Bankfull Max Depth (ft) <sup>2</sup>	3.3	3.1	3.6	3.7	3.4	3.7	
Low Bank Elevation (ft)	-	-	-	-	87.6	87.6	
Bankfull Cross Sectional Area (ft <sup>2</sup> ) <sup>2</sup>	45.5	43.7	46.8	44.6	37.6	43.8	
Bankfull Width/Depth Ratio	12.4	15.6	11.8	12.0	-	-	
Bankfull Entrenchment Ratio <sup>1</sup>	2.1	1.9	2.1	2.2	>2.2	>2.9	
Bankfull Bank Height Ratio <sup>1</sup>	1.0	1.0	1.0	1.1	<1	1.0

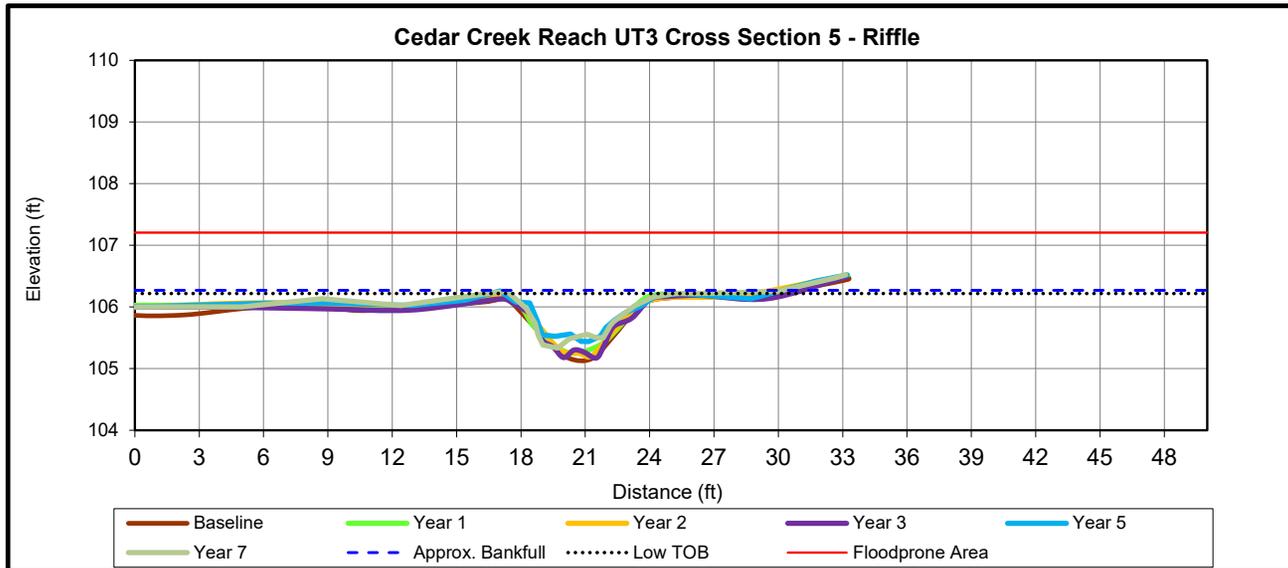
Dimension	Cross Section 5 (Riffle)						
	Base	MY1	MY2	MY3	MY5	MY7	MY+
<b>Bankfull Elevation (ft) - Based on AB-XSA<sup>1</sup></b>	106.1	106.1	106.1	106.1	106.3	106.3	
Bankfull Width (ft) <sup>1</sup>	6.9	6.3	6.9	6.6	7.2	7.8	
Floodprone Width (ft) <sup>1</sup>	50.0	50.0	50.0	50.0	33.2	50.0	
Bankfull Mean Depth (ft)	0.5	0.5	0.5	0.5	-	-	
Bankfull Max Depth (ft) <sup>2</sup>	1.0	0.8	0.9	0.9	0.7	0.9	
Low Bank Elevation (ft)	-	-	-	-	106.2	106.2	
Bankfull Cross Sectional Area (ft <sup>2</sup> ) <sup>2</sup>	3.7	3.2	3.2	3.3	2.8	3.4	
Bankfull Width/Depth Ratio	12.8	12.2	14.5	13.1	-	-	
Bankfull Entrenchment Ratio <sup>1</sup>	>2.2	>2.2	>2.2	>2.2	>2.2	>4.2	
Bankfull Bank Height Ratio <sup>1</sup>	1.0	1.0	1.0	1.0	<1	0.9

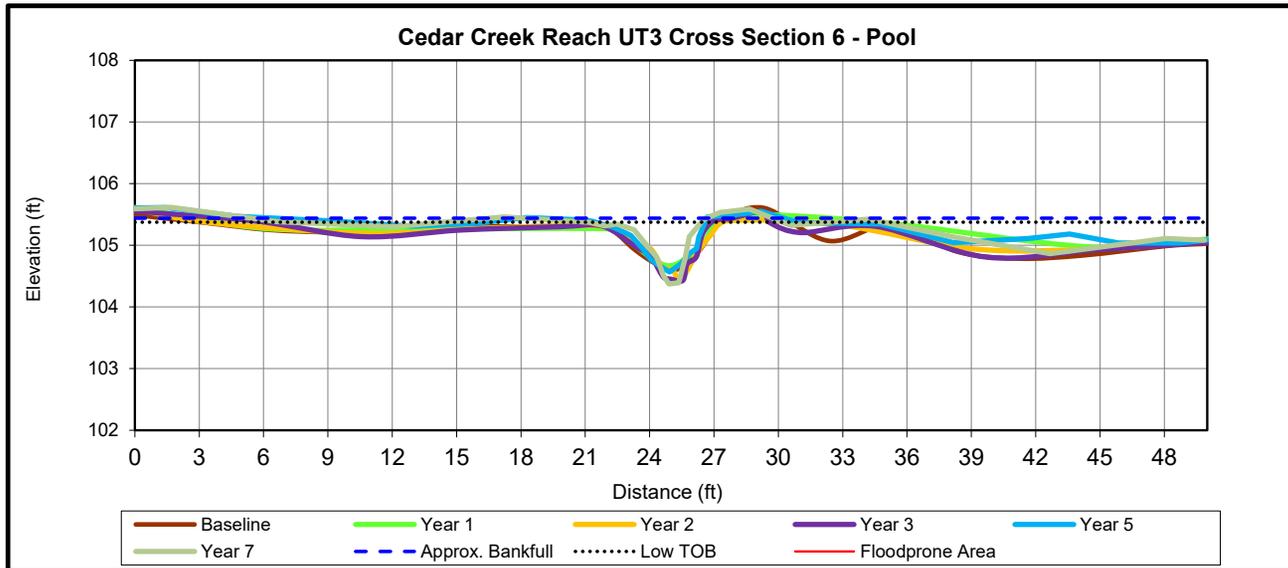
Dimension	Cross Section 6 (Pool)						
	Base	MY1	MY2	MY3	MY5	MY7	MY+
<b>Bank full Elevation (ft) - Based on AB-XSA<sup>1</sup></b>	105.3	105.3	105.3	105.3	105.4	105.4	
Bankfull Width (ft) <sup>1</sup>	5.9	4.6	5.3	4.9	5.3	5.5	
Floodprone Width (ft) <sup>1</sup>	50.0	50.0	50.0	50.0	50.0	50.0	
Bankfull Mean Depth (ft)	0.4	0.4	0.4	0.4	-	-	
Bankfull Max Depth (ft) <sup>2</sup>	0.7	0.6	0.9	0.9	0.8	1.0	
Low Bank Elevation (ft)	-	-	-	-	105.4	105.4	
Bankfull Cross Sectional Area (ft <sup>2</sup> ) <sup>2</sup>	2.1	1.6	2.0	2.1	2.1	1.8	
Bankfull Width/Depth Ratio	16.0	12.8	13.7	11.2	-	-	
Bankfull Entrenchment Ratio <sup>1</sup>	>2.2	>2.2	>2.2	N/A	N/A	N/A	
Bankfull Bank Height Ratio <sup>1</sup>	1.0	1.0	1.0	N/A	N/A	N/A
