MONITORING YEAR 1 ANNUAL REPORT FINAL

MCLENNY ACRES MITIGATION SITE

Wayne County, NC
Neuse River Basin
HUC 03020201

DMS Project No. 100038
NCDEQ Contract No. 7423
DWR Project No. 2018-0197
USACE Action ID No. 2018-02042

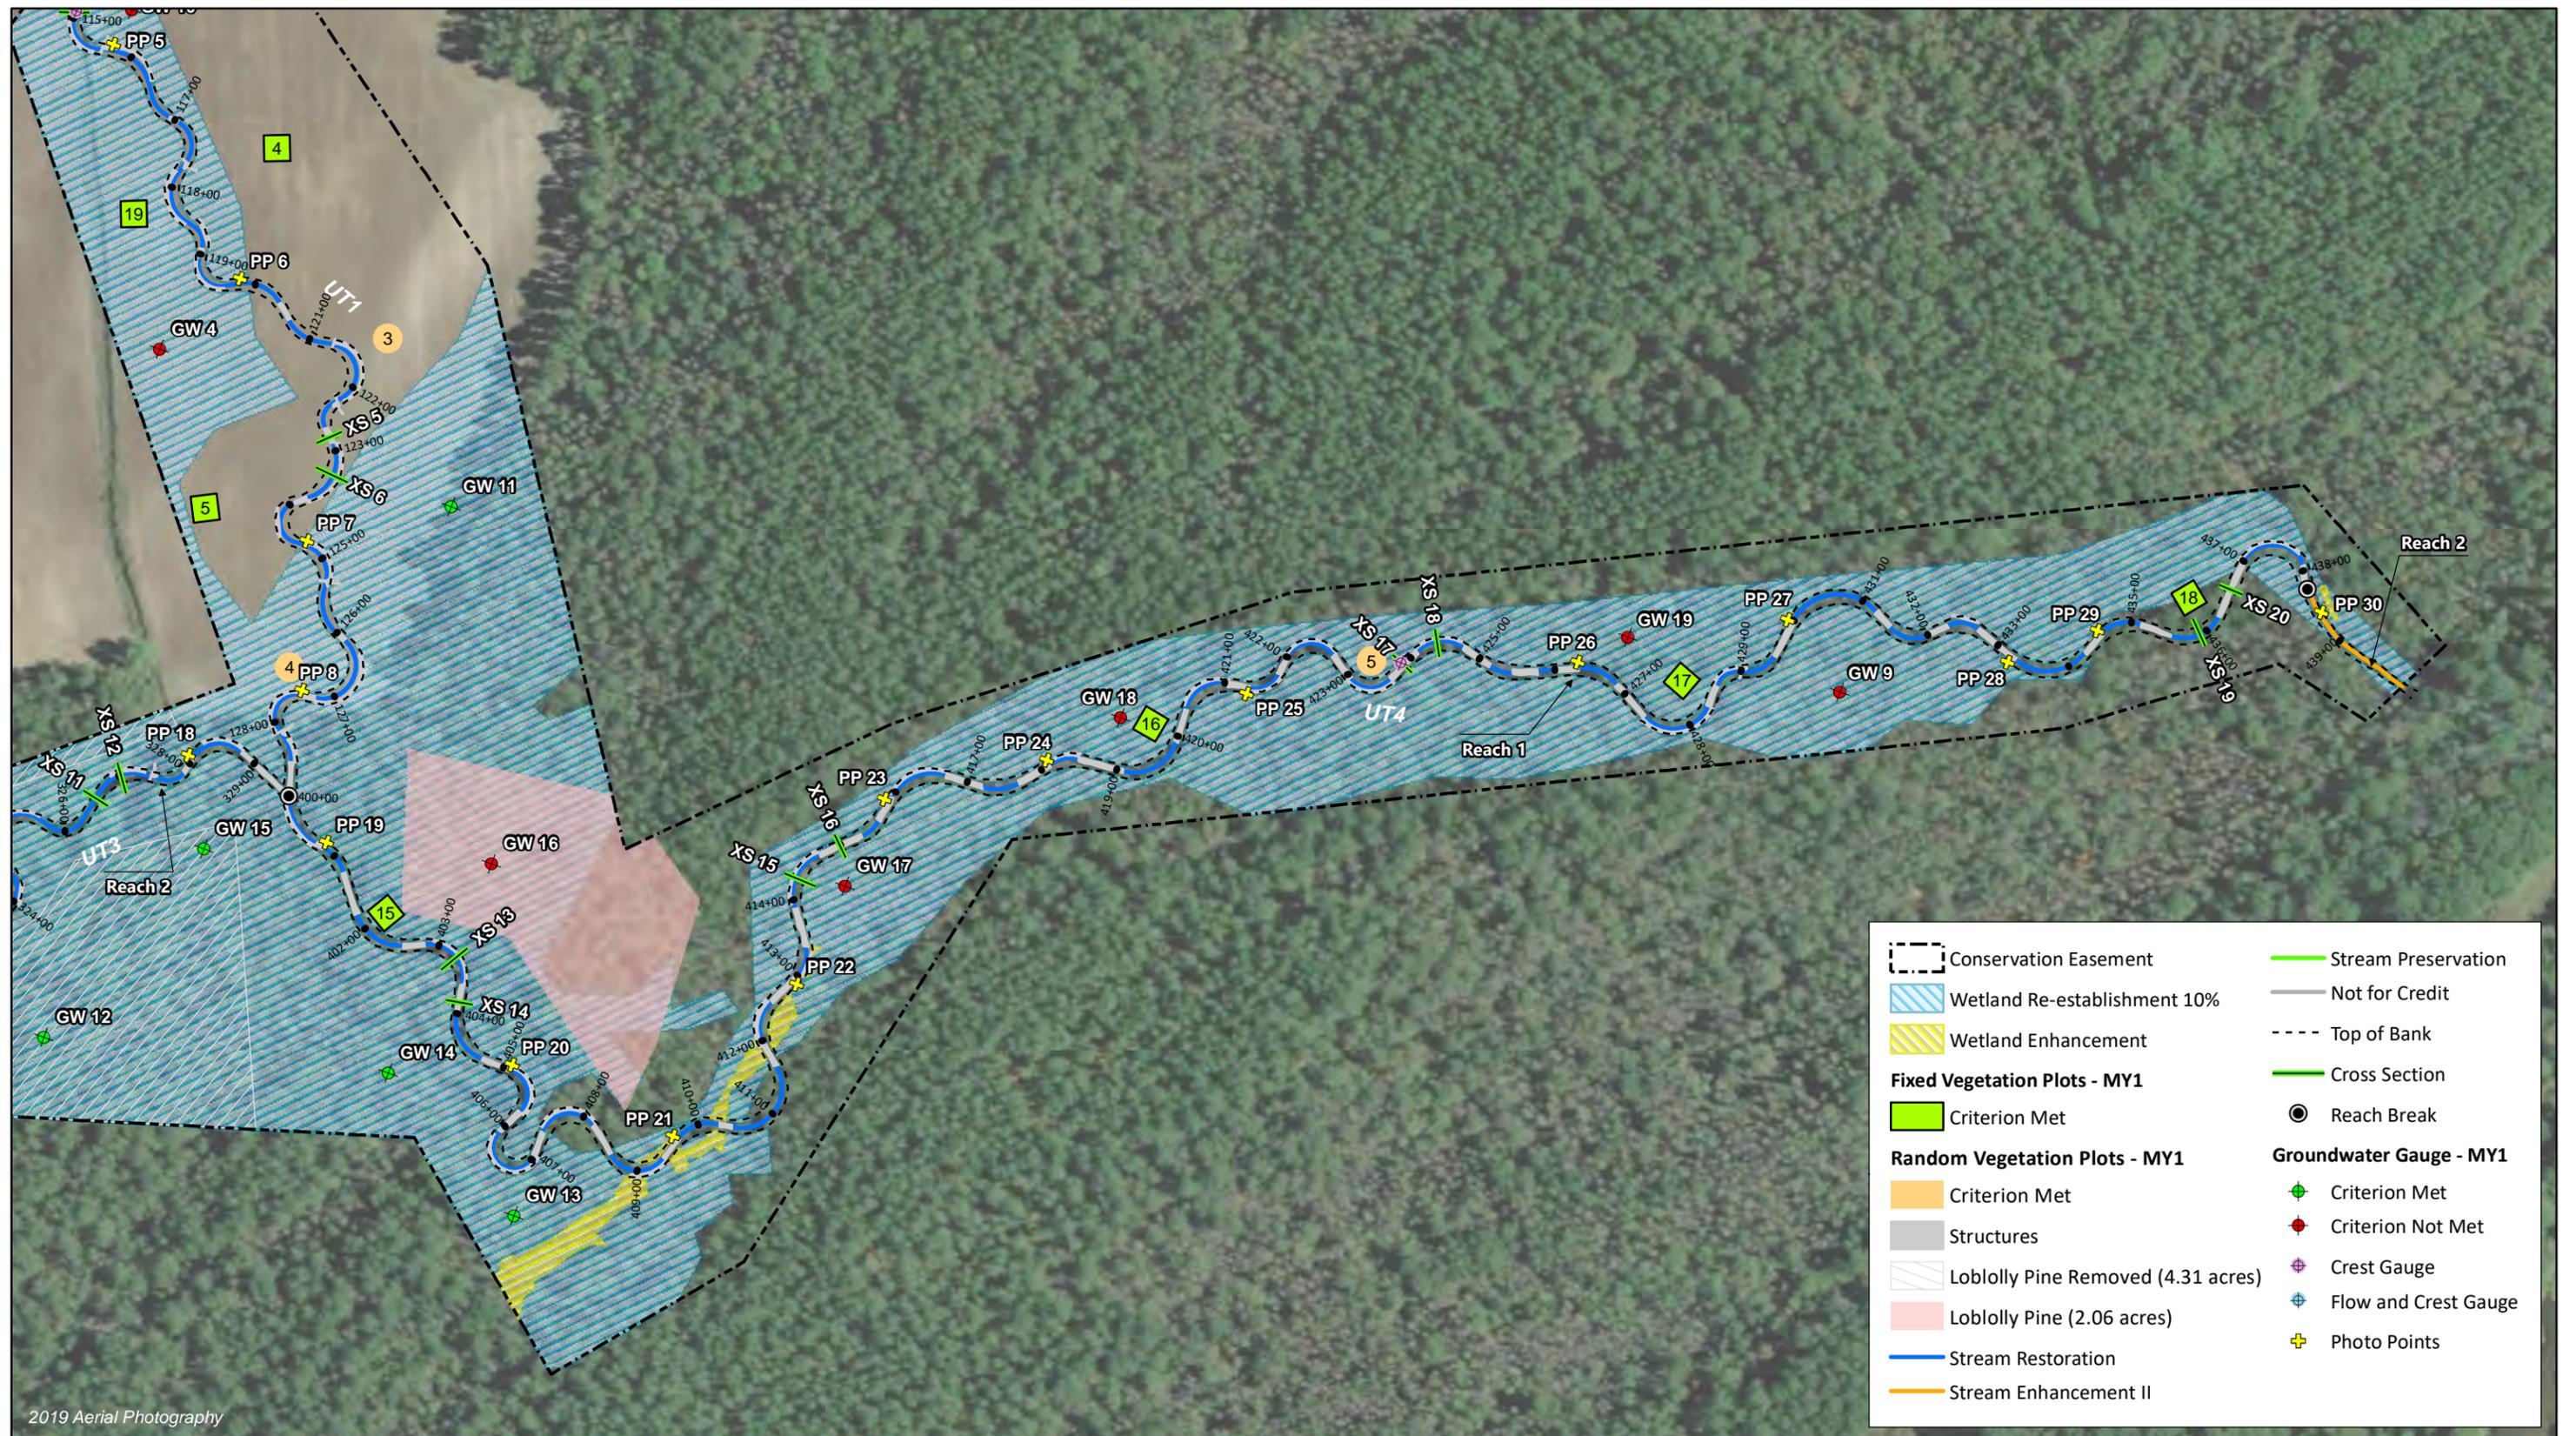
Figure 1a - Current Condition Plan View
 McClenny Acres Mitigation Site
 DMS Project No. 100038
 Monitoring Year 1 - 2021

Mature pine (*Pinus taeda*) trees were harvested and removed from a 4.31 acre area within the conservation easement surrounding UT3 during December of 2021. Additional mature pines remain within a 2.06 acre area along the east side of upper UT4. Girdling this area of pine trees will be considered to reduce the seed source within the conservation easement, although it is Wildlands' understanding that pine removal is not required as a condition of the mitigation plan or subsequent correspondence in this area (Figure 1a, 1b). No other vegetation areas of concern were identified during MY1.
