**Year 1 Monitoring Report**

**MOCKINGBIRD SITE**

NCDMS Project # 100021 (Contract # 7185)

Davie County, North Carolina

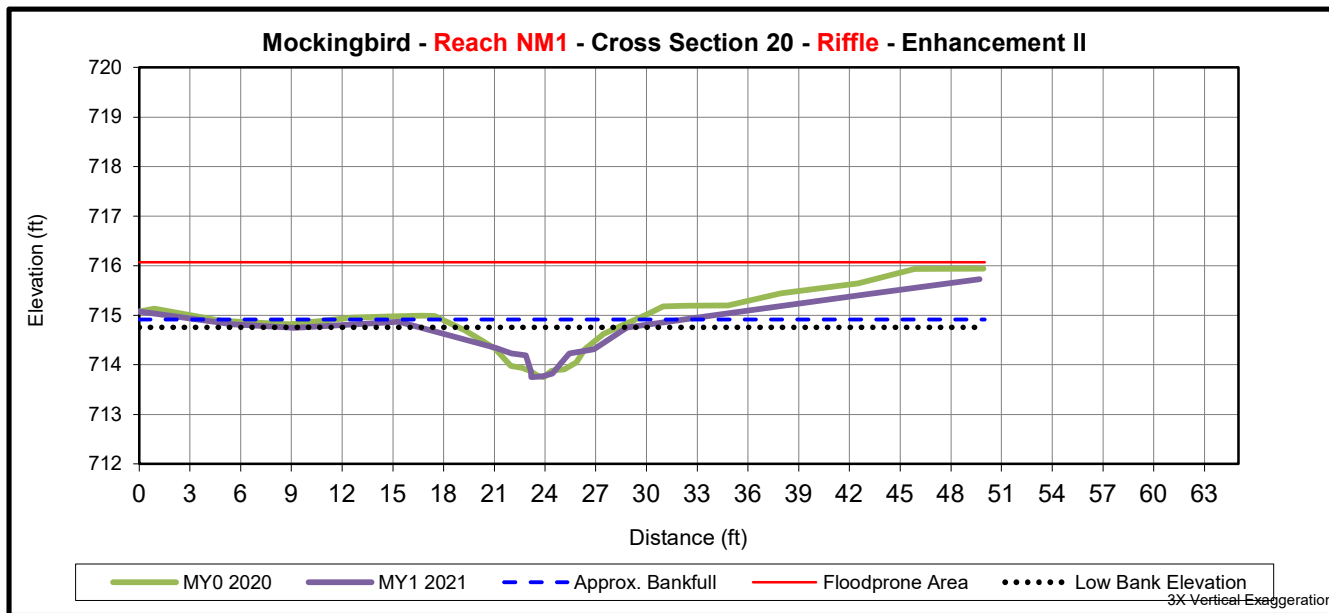
<b>Cross Section 20 (Riffle)</b>						
	MY0	MY1	MY2	MY3	MY5	MY7	MY+
<b>Bankfull Elevation (ft) - Based on AB-XSA<sup>1</sup></b>	714.99	714.9					
Bankfull Width (ft) <sup>1</sup>	12.4	16.9					
Floodprone Width (ft) <sup>1</sup>	>49.9	>49.7					
Bankfull Max Depth (ft) <sup>2</sup>	1.2	1.0					
Low Bank Elevation (ft)	714.99	714.8					
Bankfull Cross Sectional Area (ft <sup>2</sup> ) <sup>2</sup>	7.5	5.1					
Bankfull Entrenchment Ratio <sup>1</sup>	>4.0	>2.9					
Bankfull Bank Height Ratio <sup>1</sup>	1.0	0.9

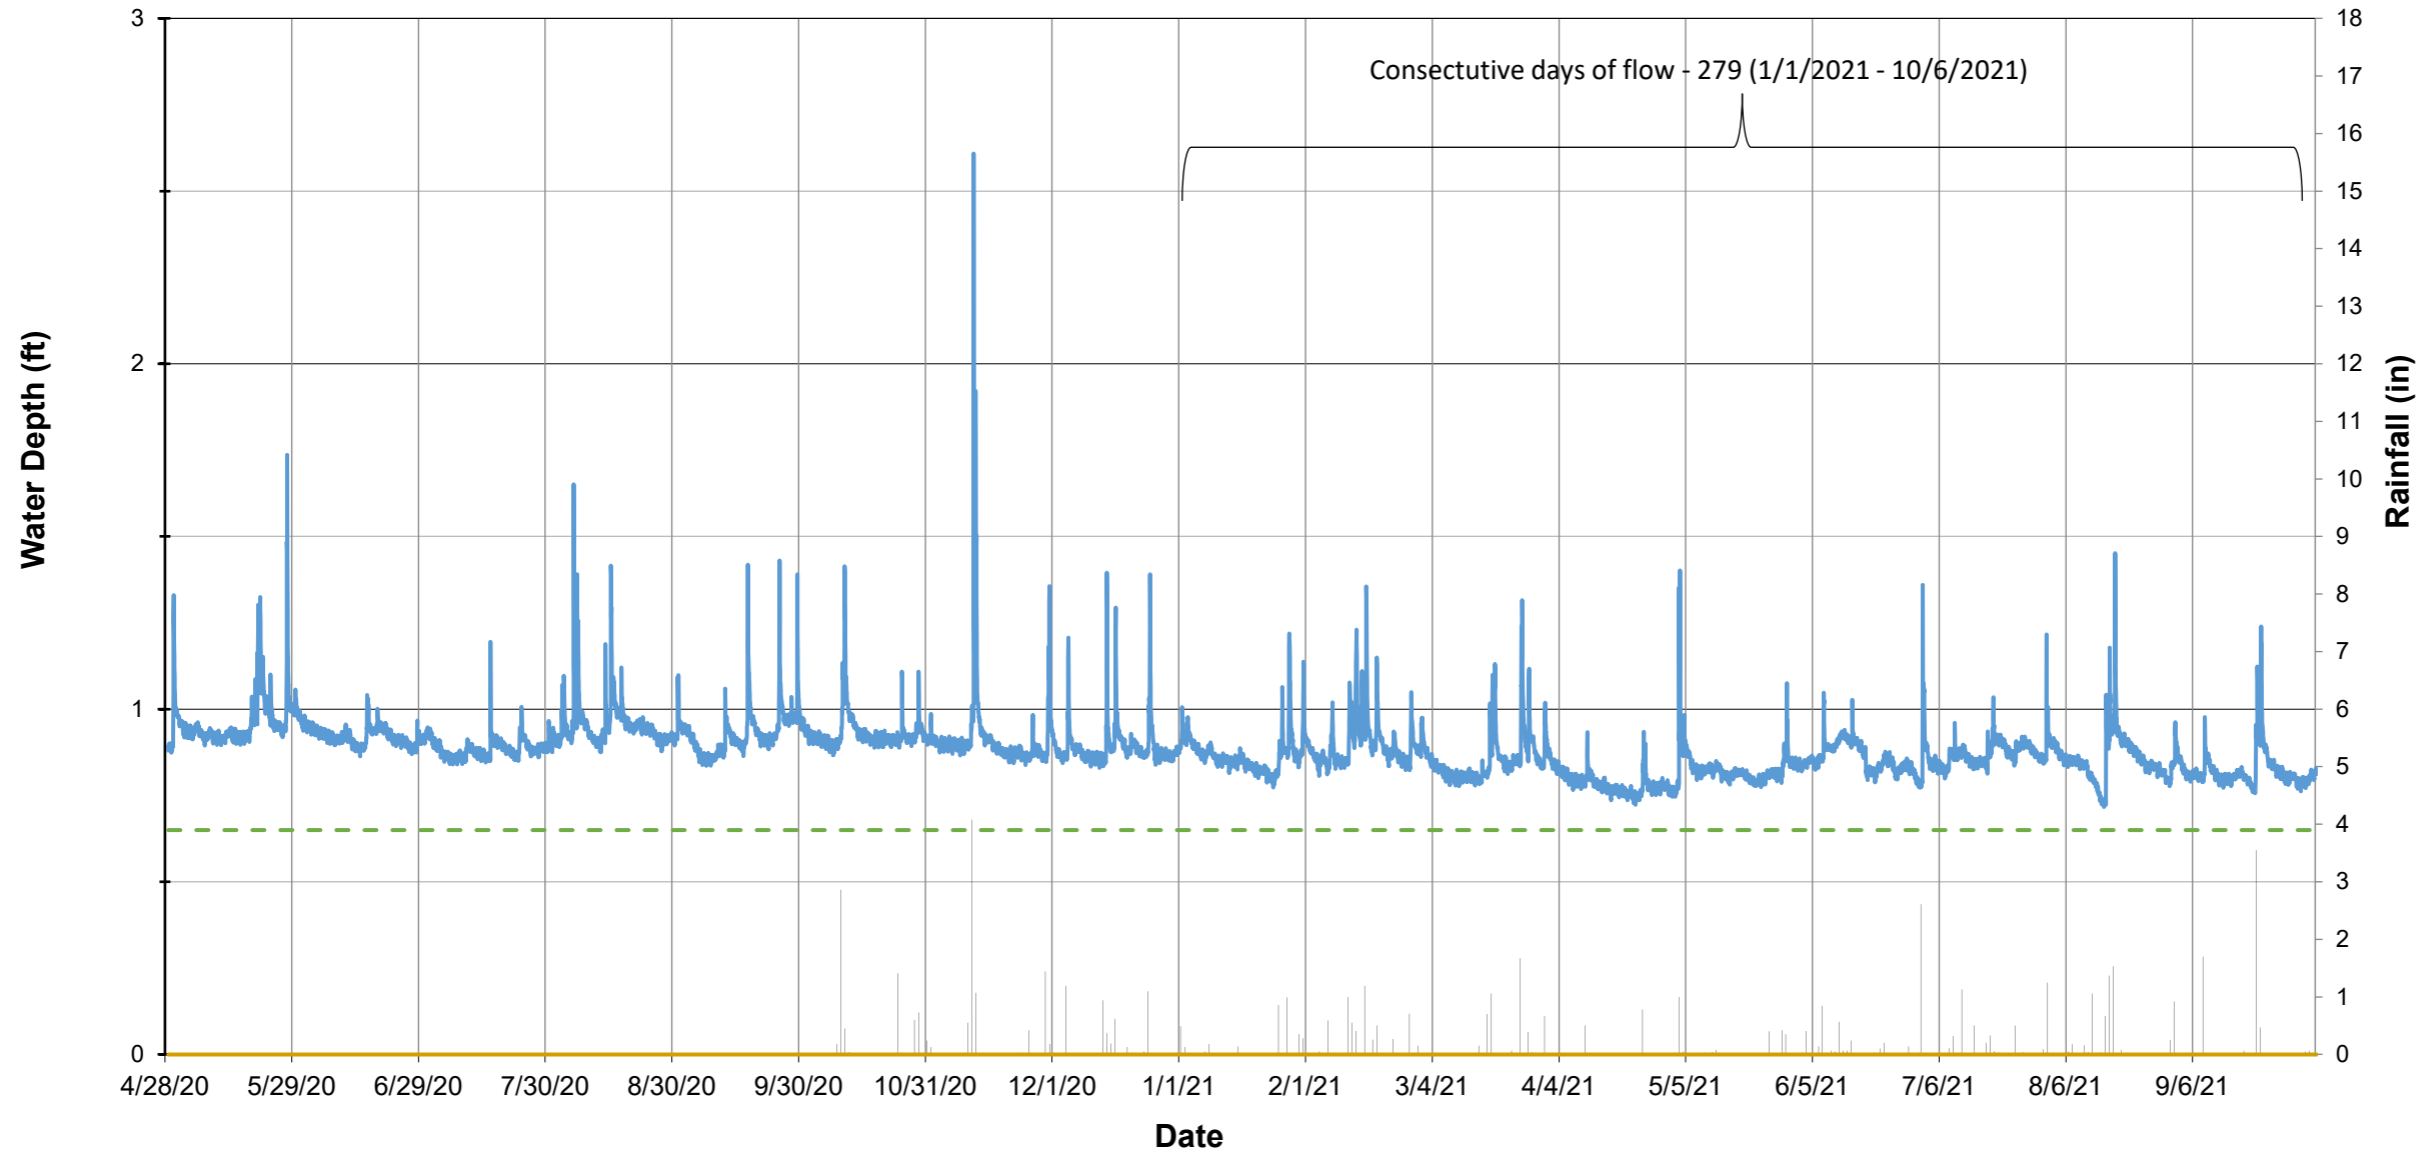
# MY1 2021 Mockingbird TP3 Flow Gauge

<b>Year</b>	<b>Number of Bankfull Events</b>	<b>Maximum Bankfull Height (ft)</b>	<b>Date of Maximum Bankfull Event</b>	
<b>Stage Recorder HC1</b>				
MY0/1 2020	10	3.447	11/11/2020	
MY1 2021	4	1.257	5/3/2021	
<b>Stage Recorder NM2</b>				
MY0/1 2020	4	1.04	11/11/2020	
MY1 2021	1	0.13	8/18/2021	
<b>Year</b>	<b>Number of Flow Events</b>	<b>Maximum Consecutive Flow Days</b>	<b>Maximum Cumulative Flow Days</b>	<b>Maximum Consecutive Flow Date Range</b>
<b>Flow Gauge NM1</b>				
MY0/1 2020	2	51	54	11/11/2020 - 12/31/2021
MY1 2021	5	97	132	7/1/2021 - 10/6/2021
<b>Flow Gauge NM4</b>				
MY0/1 2020	2	165	169	6/19/2020 - 12/1/2020
MY1 2021	2	156	159	5/3/2021 - 10/6/2021
<b>Flow Gauge TP2</b>				
MY0/1 2020	2	168	246	7/16/2020 - 12/31/2020
MY1 2021	5	210	260	1/1/2021 - 7/29/2021
<b>Flow Gauge TP3</b>				
MY0/1 2020	1	247	247	4/28/2020 - 12/31/2020
MY1 2021	1	279	279	1/1/2021 - 10/6/2021

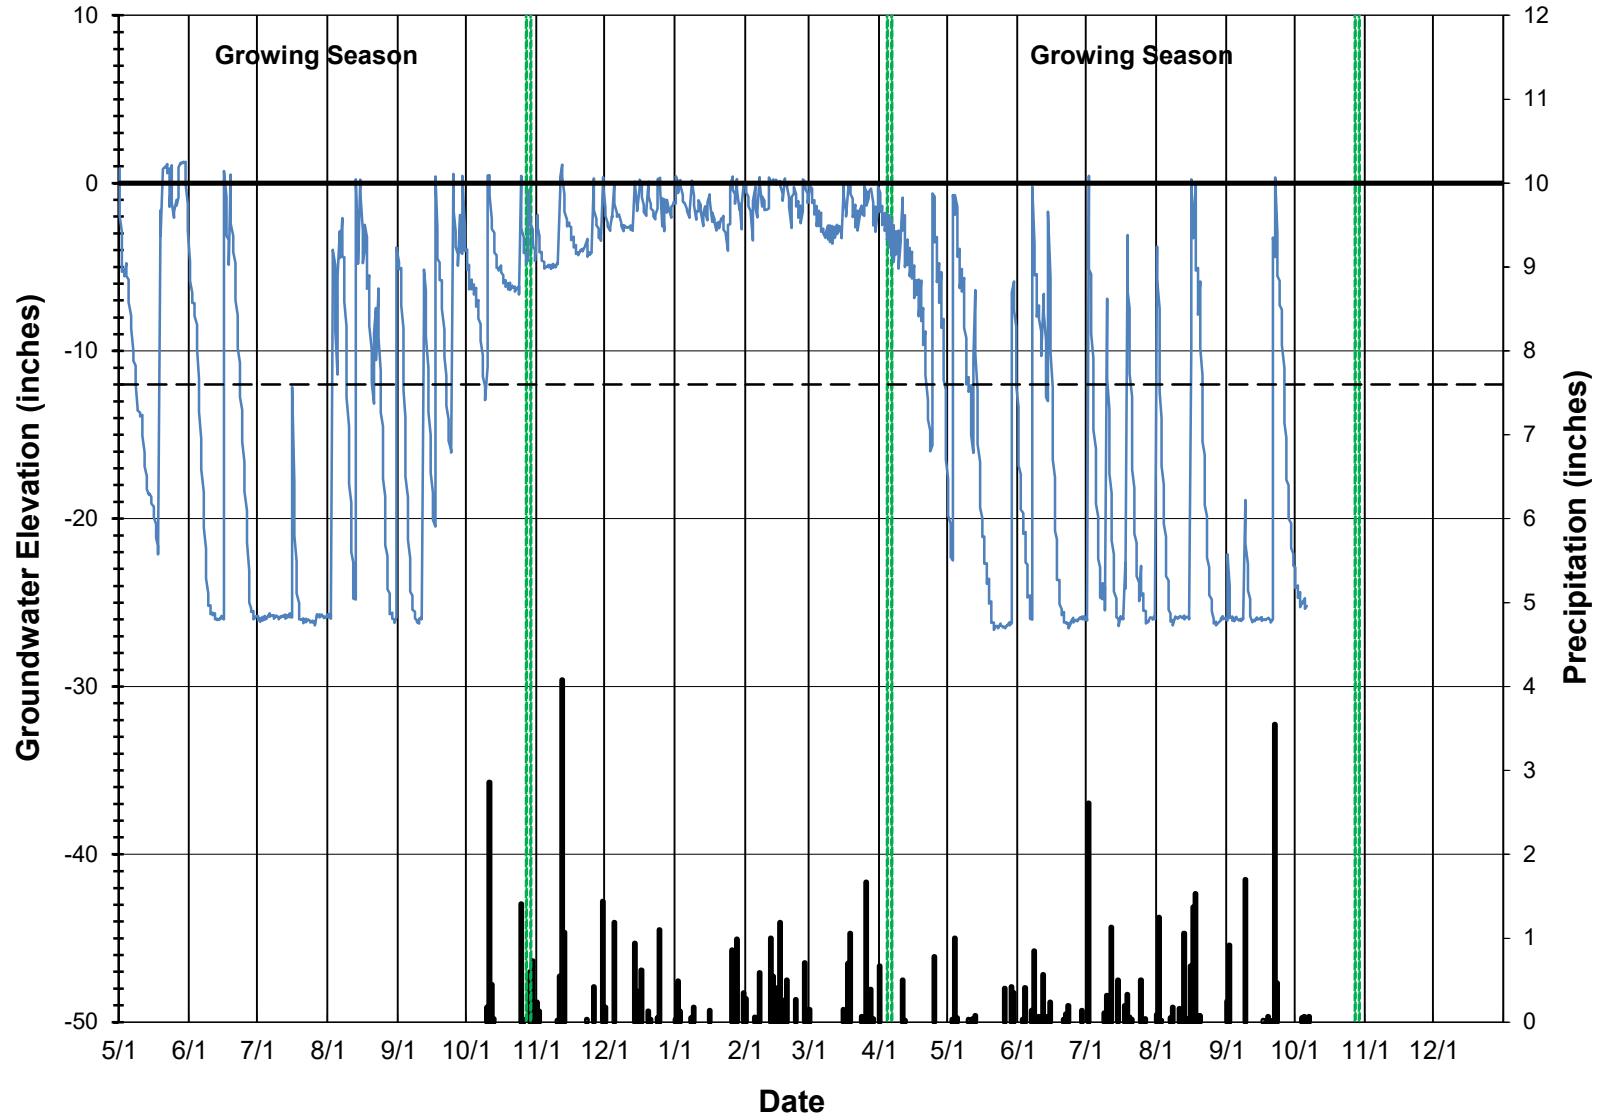
# MY1 2021 Mockingbird GW1

<b>Summary of Groundwater Monitoring Results Mockingbird</b>								
<b>Well ID</b>	<b>Hydroperiod (%)</b>							
	<b>Year 0/1 (2020)</b>	<b>Year 1 (2021)</b>	<b>Year 2 (2022)</b>	<b>Year 3 (2023)</b>	<b>Year 4 (2024)</b>	<b>Year 5 (2025)</b>	<b>Year 6 (2026)</b>	<b>Year 7 (2027)</b>
<b>GW1</b>	9	8
