FINAL
MONITORING REPORT
YEAR 4 (2021)
MUD LICK CREEK MITIGATION SITE

Chatham County, North Carolina

NCDMS Project No. 93482

Submission: January 2022

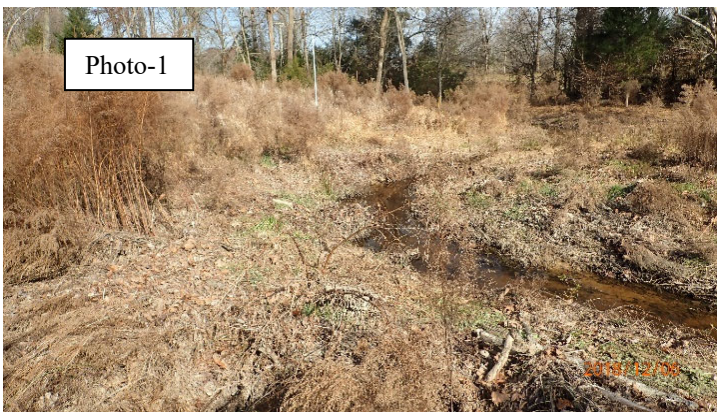
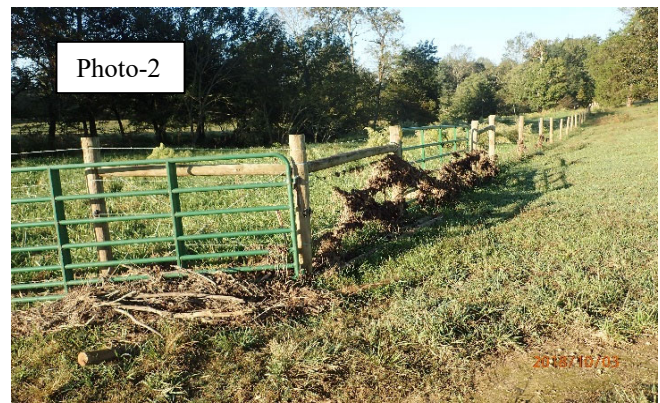
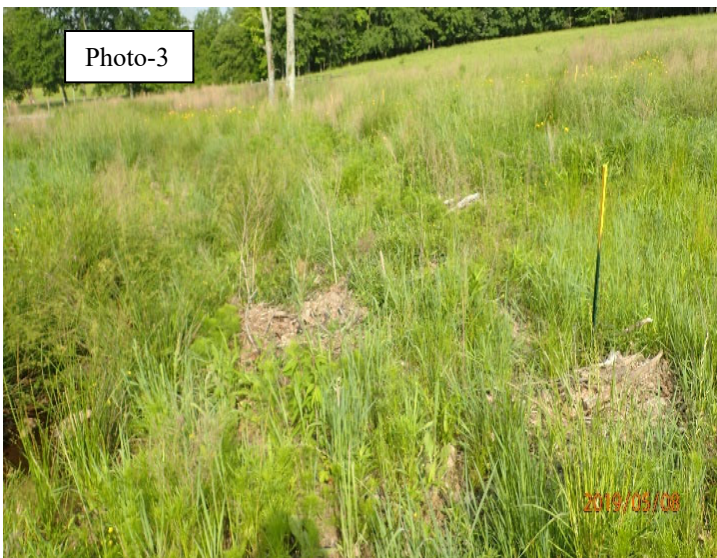
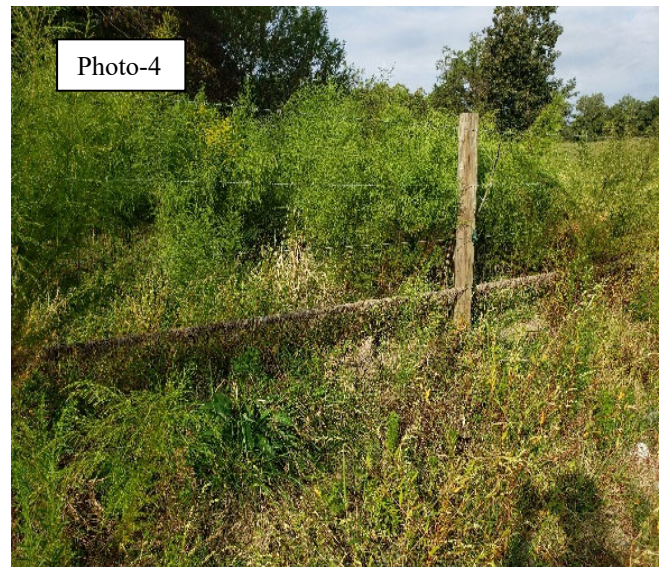
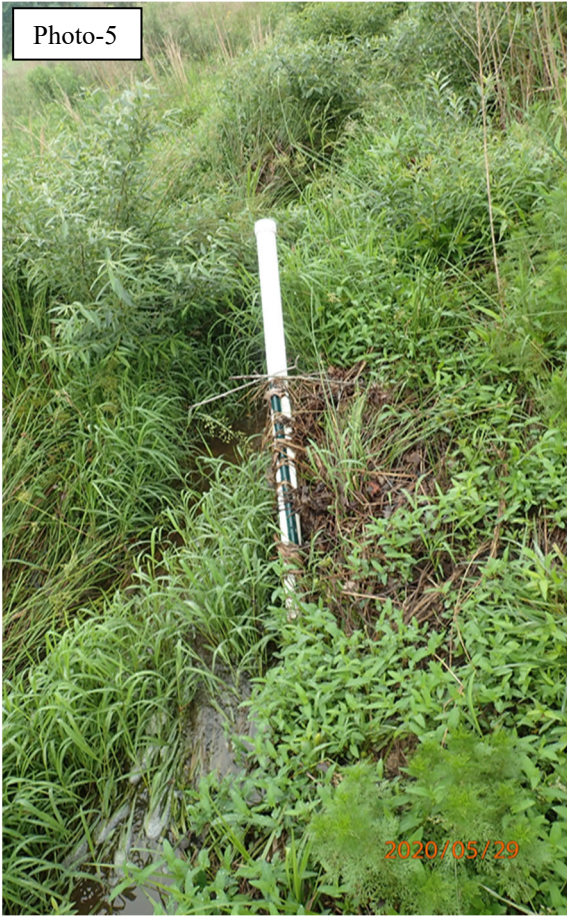
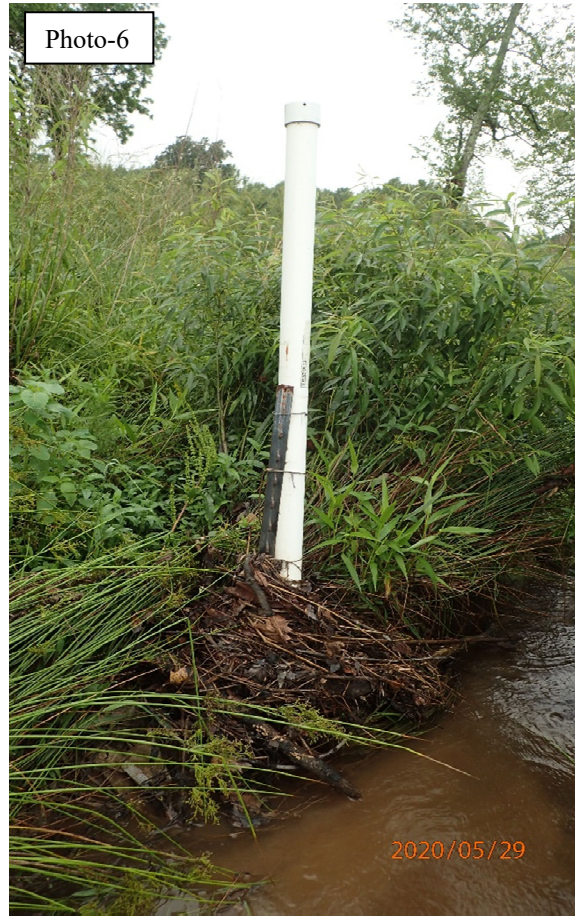
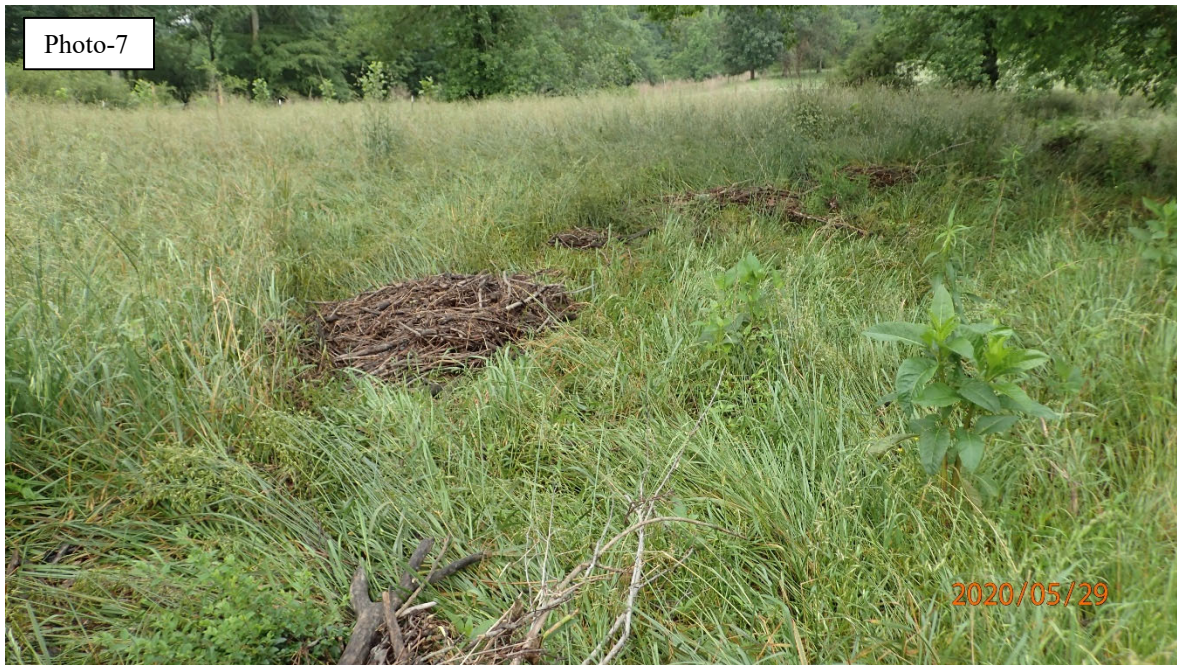
Date of Data Collection	Date of Occurrence	Method	Photo (if available)
December 6, 2018	October 16-17, 2018	Observations throughout floodplain and crest gauge indicate a bankfull event after 4.61 inches of rain fell over 48 hours.	1, 2
May 8, 2019	February 24, 2019	Observation of wrack in floodplain along North Branch R2 and crest gauge data from all site crest gauges indicate a bankfull event after 2.27 inches of rain fell over 48 hours.	3
September 18, 2019	July 24, 2019	Observation of wrack on Mud Lick Creek R2 floodplain fences and crest gauge data from all site crest gauges indicate a bankfull event after 3.02 inches of rain fell over 48 hours.	4
May 29, 2020	February 7, 2020	Observations of wrack throughout site along all stream reaches, and crest gauge data from all site crest gauges indicate a bankfull event after approximately 3.59 inches of rain fell over 24-hour period.	5, 6, 7
November 16, 2020	November 12, 2020	Observations of wrack throughout site along all stream reaches, and crest gauge data from all site crest gauges indicate a bankfull event after approximately 4.60 inches of rain fell over 48-hour period.	8, 9

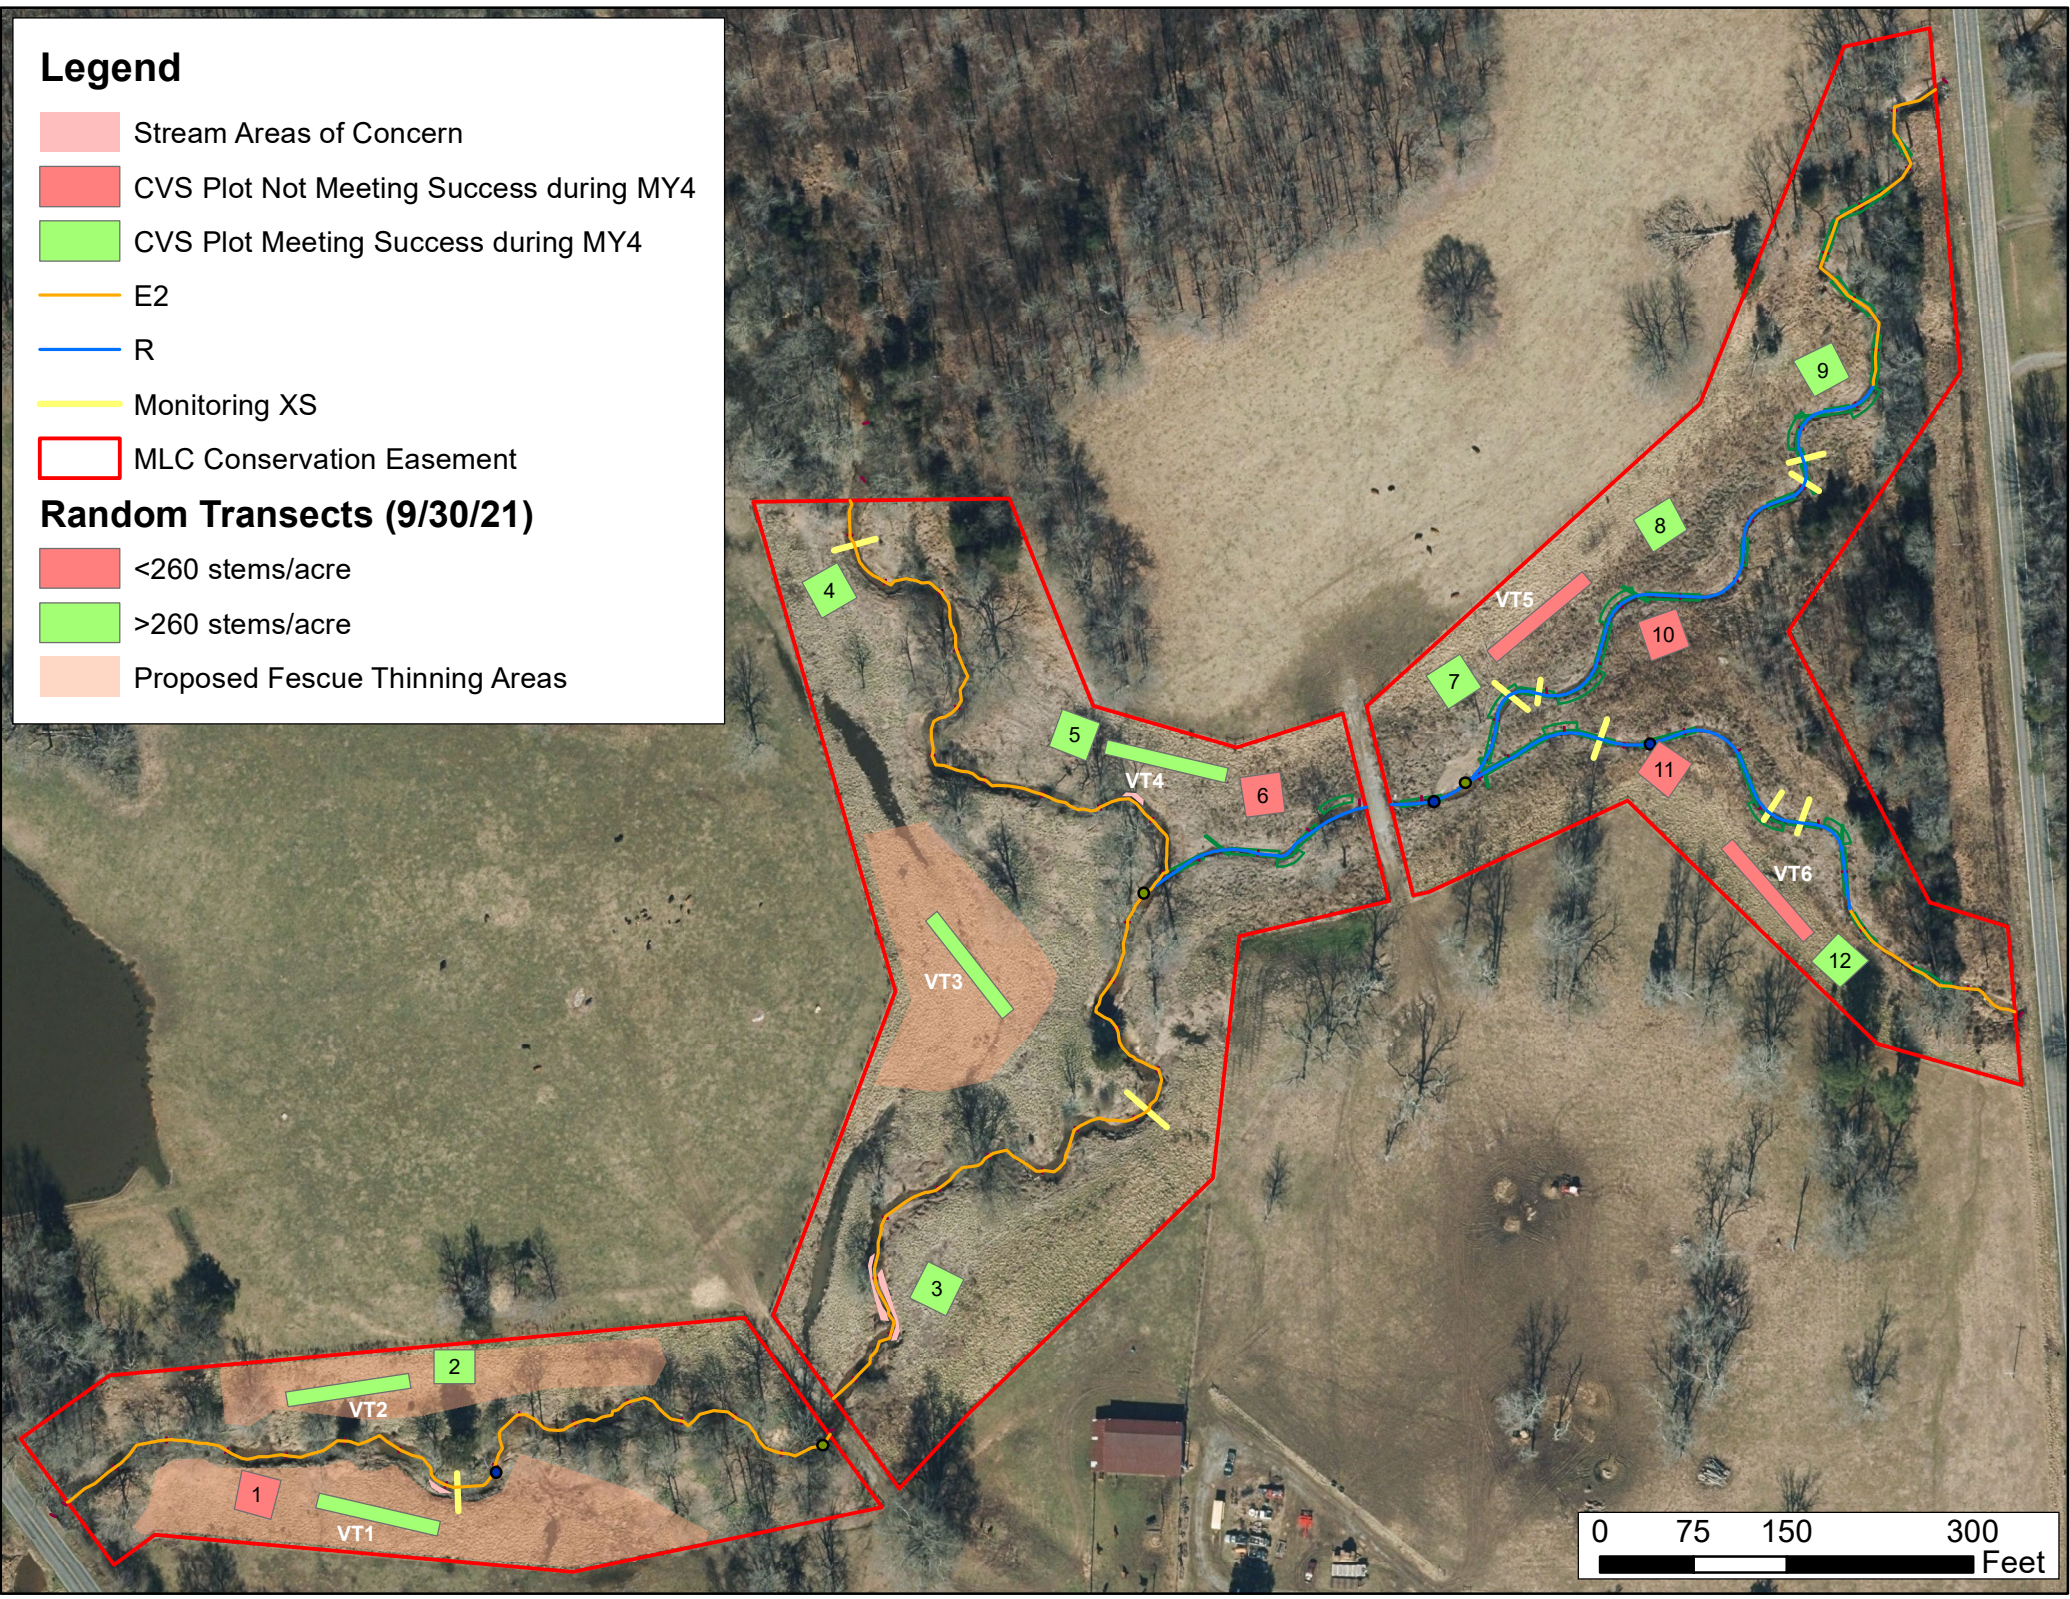
Random Transects (9/30/21)

- <260 stems/acre
- >260 stems/acre
- Proposed Fescue Thinning Areas
