Year 7 Monitoring Report

UT Millers Creek
Duplin County, NC

DMS Project ID No. 95719 Contract No. 5000

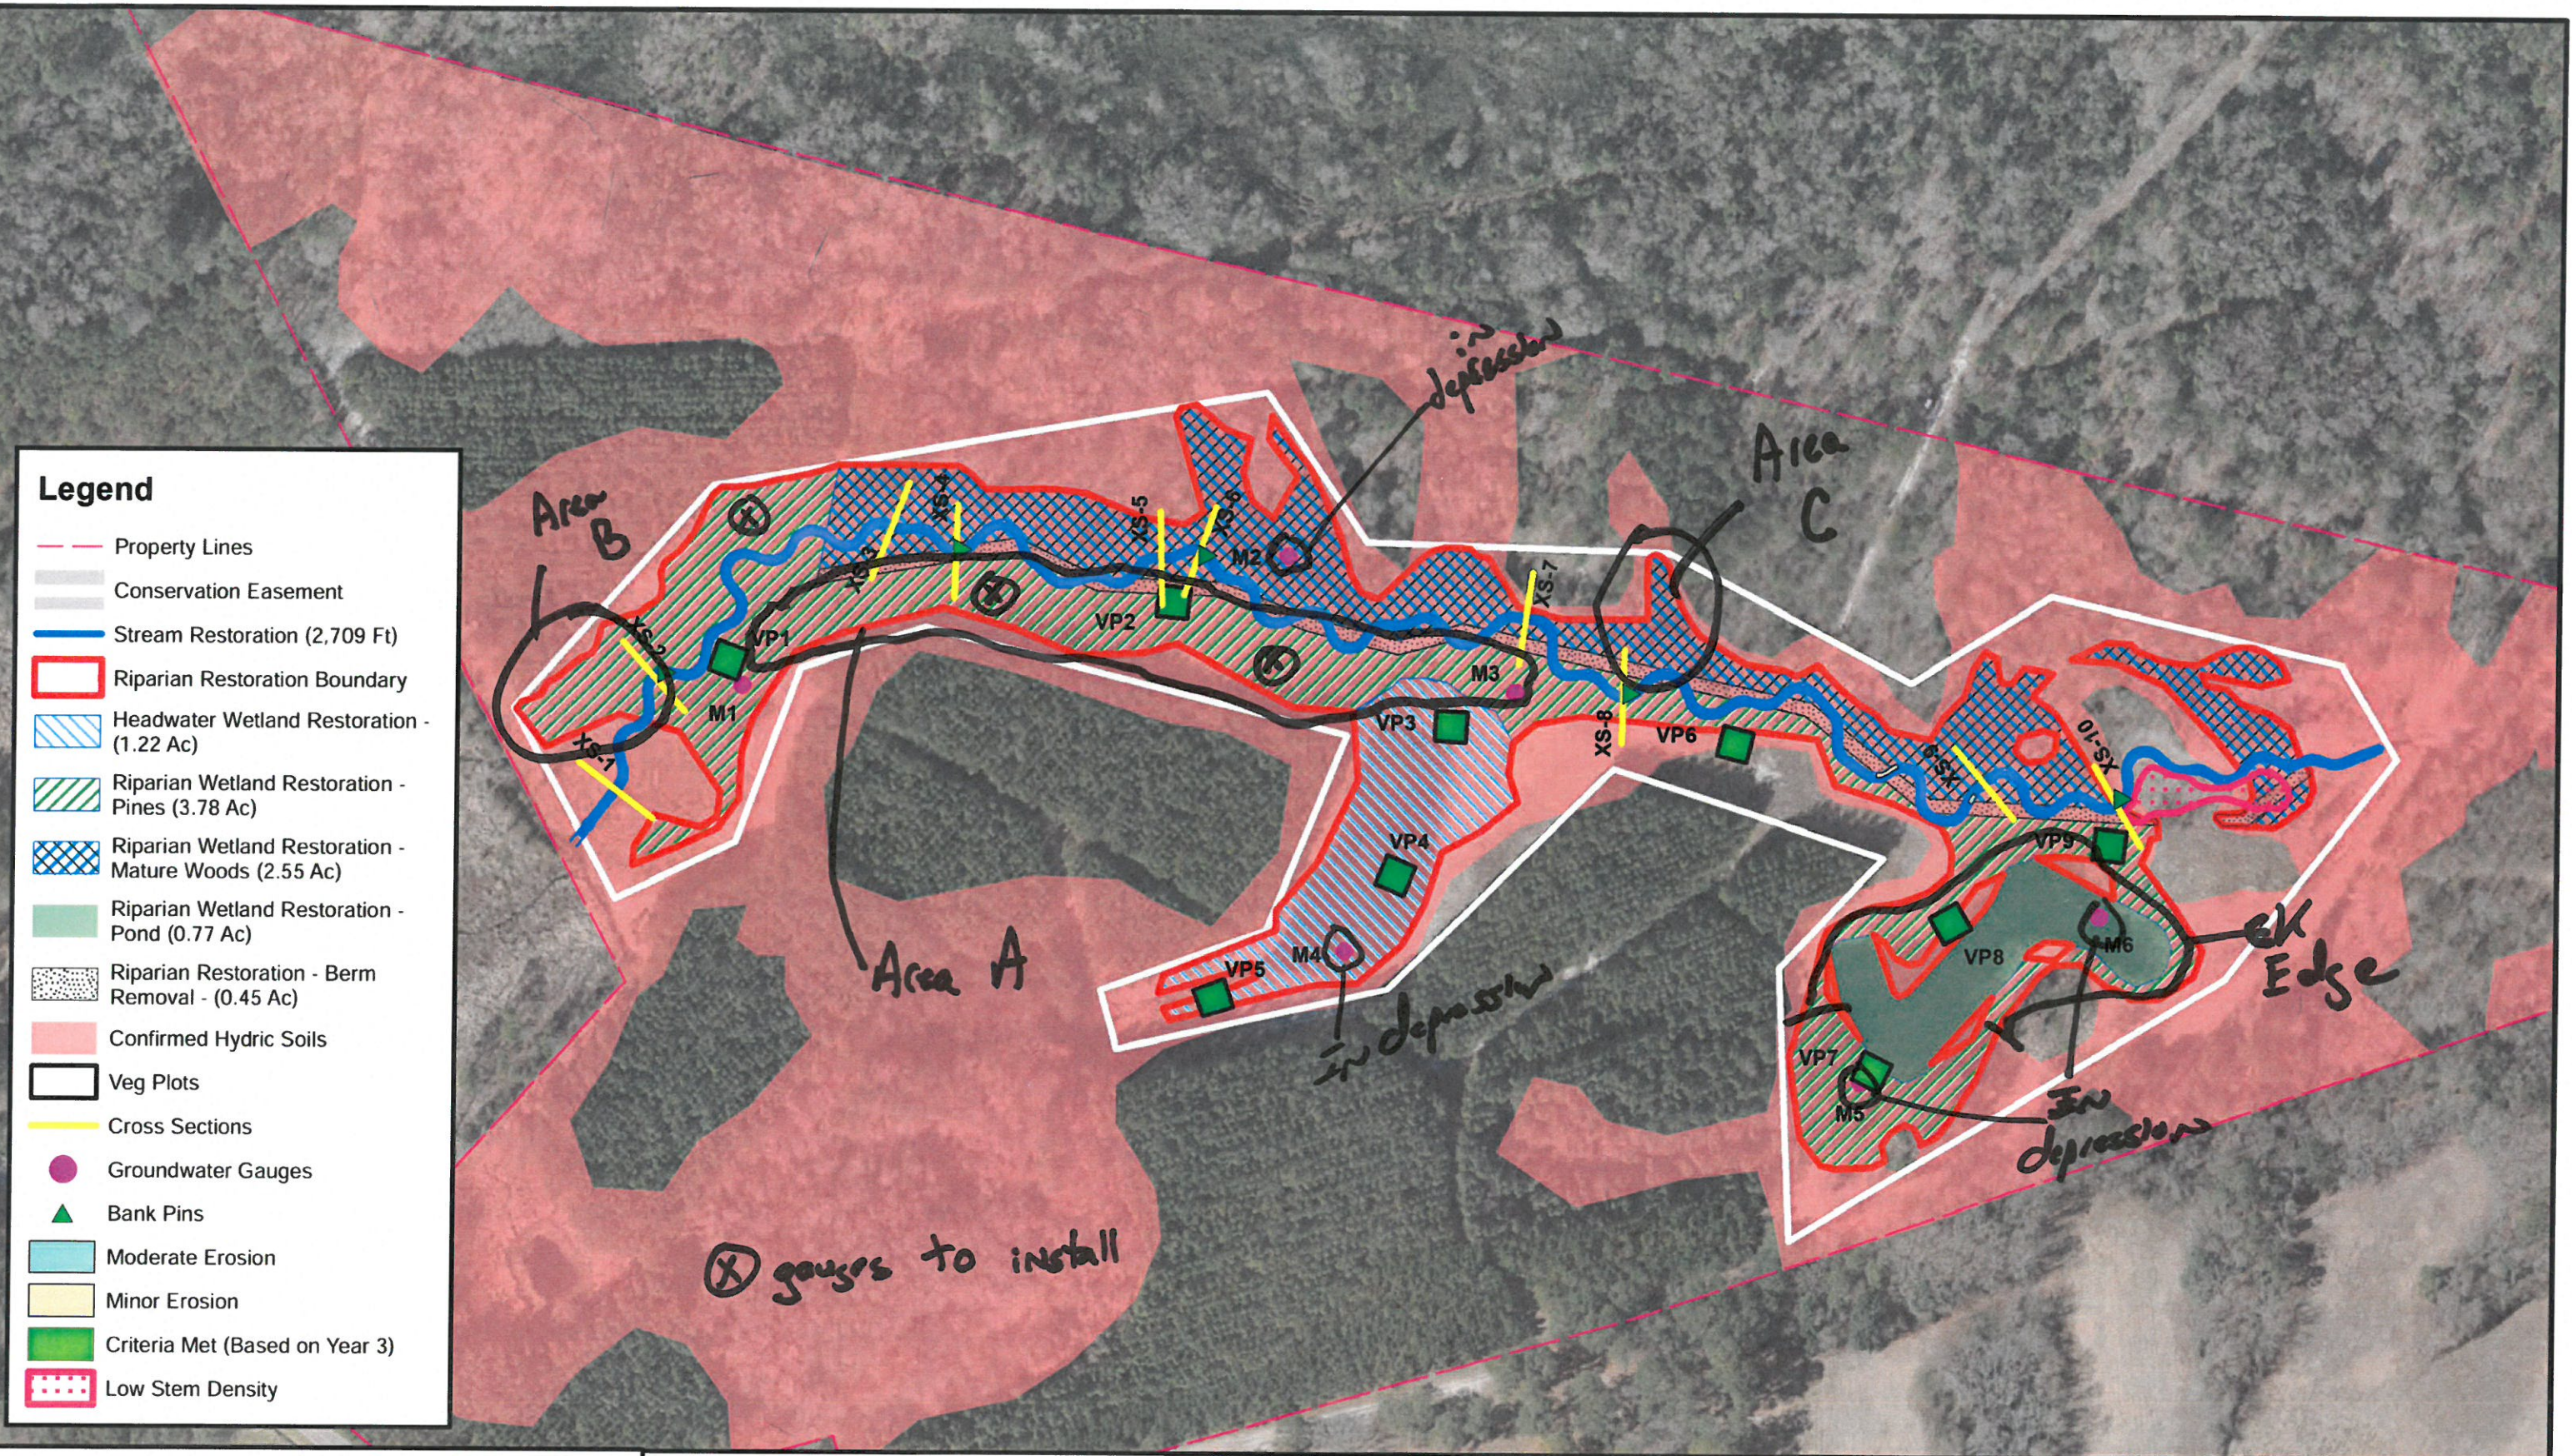
Current Condition Plan View - Year 5
 UT Millers Creek, Duplin County, North Carolina

The group then walked the west side of the stream down to gauge M2. Gauge M2 was also in a depressional landscape position. Another area noted as Area C needs to be checked regarding extent of wetlands proposed. Finally, we visited the bottom of the project where the pond was initially. The amount of ponded water has decreased but tree growth is limited. The two gauges in this area M5 and M6 are both located in depressional areas. Moreover, the proposed wetland area around the edge of the pond needs to be checked for wetland status as indicated on Figure 2.1

In summary, DWR recommends to the IRT that for any wetland credit to be released, there should be at least 3 groundwater monitoring gauges installed (now) and a wetland delineation performed to check the areas mentioned which DWR believes to be at risk. DWR is ok with releasing stream credit.
