Year 1 Monitoring Report

APPLE VALLEY PROJECT

NCDMS Project #100063 (Contract #7531)

Henderson County, North Carolina

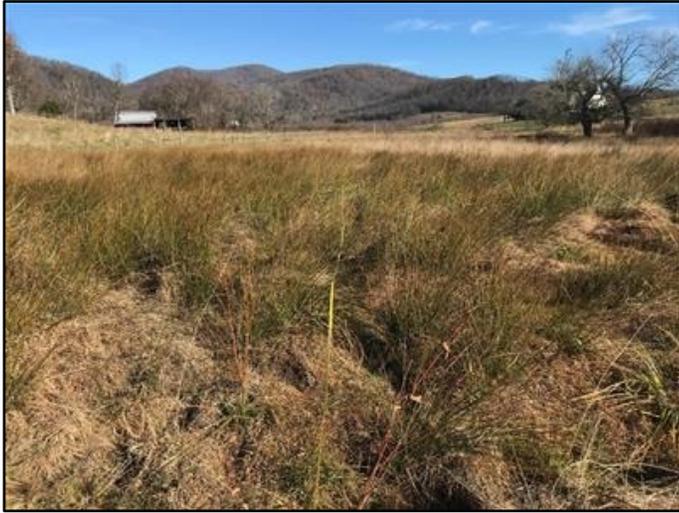
Random Vegetation Plot 1 (12/7/2021)

overall lower stems number. RES observed similar tree density across the site and believes there is similar in the random areas as there are in the fixed plots. No volunteer stems were noted in the plots during Year 1 monitoring. A total of eight species were documented within the plots. The average stem height in the plots was 1.9 feet.

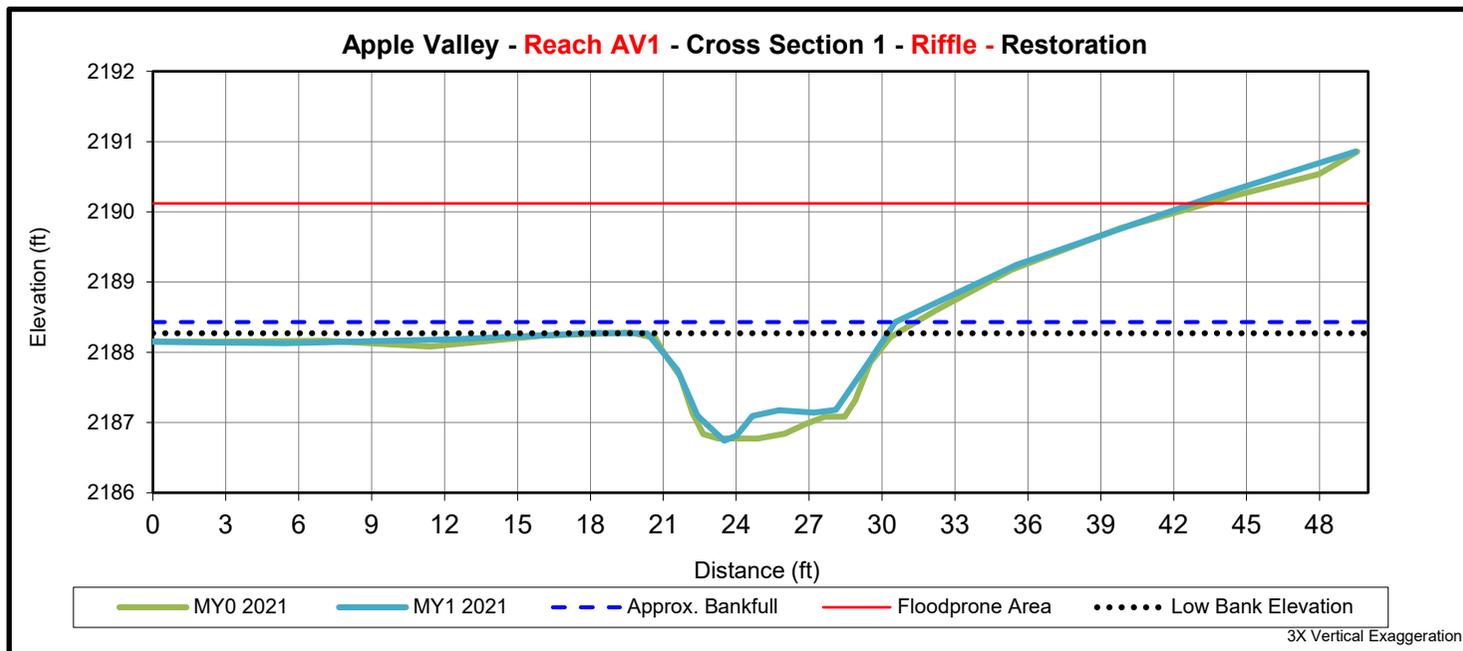
Cross Section 1 (Riffle)						
	MY0	MY1	MY2	MY3	MY5	MY7	MY+
Bankfull Elevation (ft) - Based on AB-XSA¹	2188.28	2188.4					
Bankfull Width (ft) ¹	11.0	10.2					
Floodprone Width (ft) ¹	40.0	>42.8					
Bankfull Max Depth (ft) ²	1.5	1.5					
Low Bank Elevation (ft)	2188.28	2188.3					
Bankfull Cross Sectional Area (ft ²) ²	10.7	9.1					
Bankfull Entrenchment Ratio ¹	>3.6	>4.2					
Bankfull Bank Height Ratio ¹	1.0	0.9

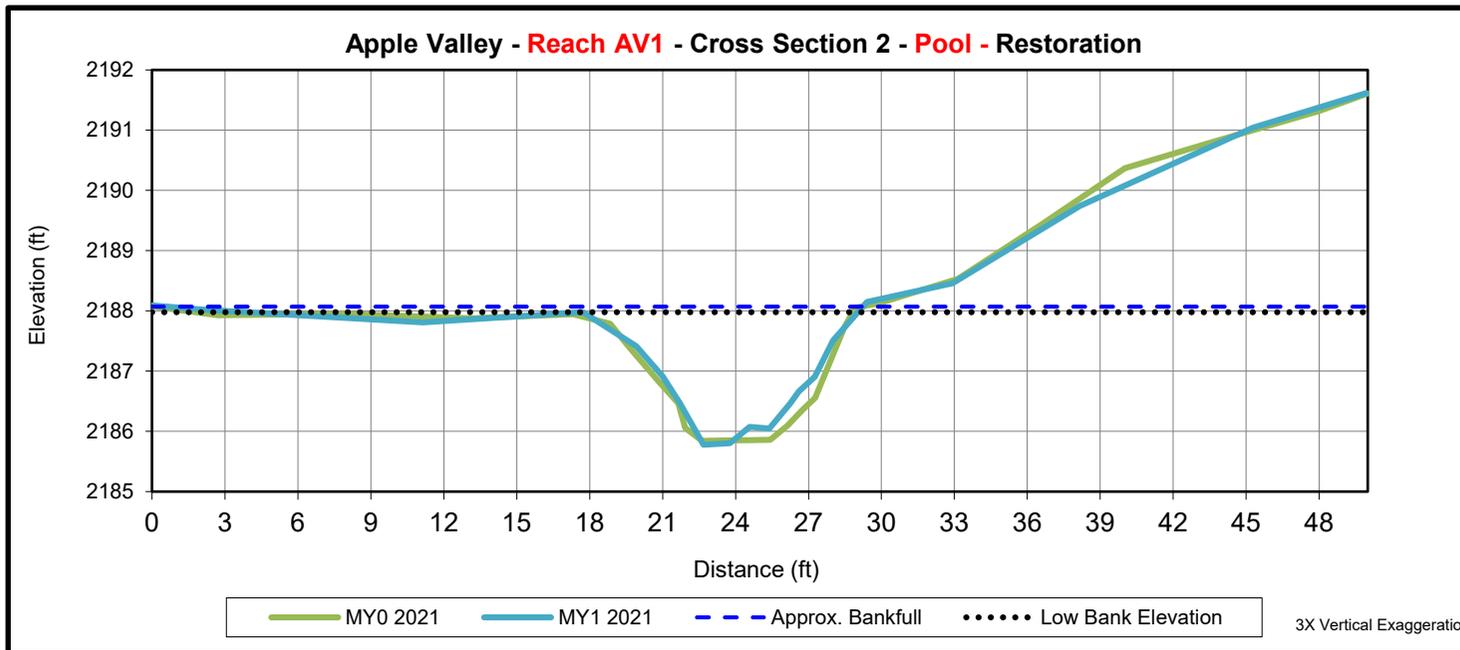
Cross Section 2 (Pool)						
	MY0	MY1	MY2	MY3	MY5	MY7	MY+
Bankfull Elevation (ft) - Based on AB-XSA¹	2187.95	2188.1					
Bankfull Width (ft) ¹	NA	N/A					
Floodprone Width (ft) ¹	NA	N/A					
Bankfull Max Depth (ft) ²	2.1	1.2					
Low Bank Elevation (ft)	2187.95	2188.0					
Bankfull Cross Sectional Area (ft ²) ²	14.4	13.4					
Bankfull Entrenchment Ratio ¹	NA	N/A					
Bankfull Bank Height Ratio ¹	NA	N/A

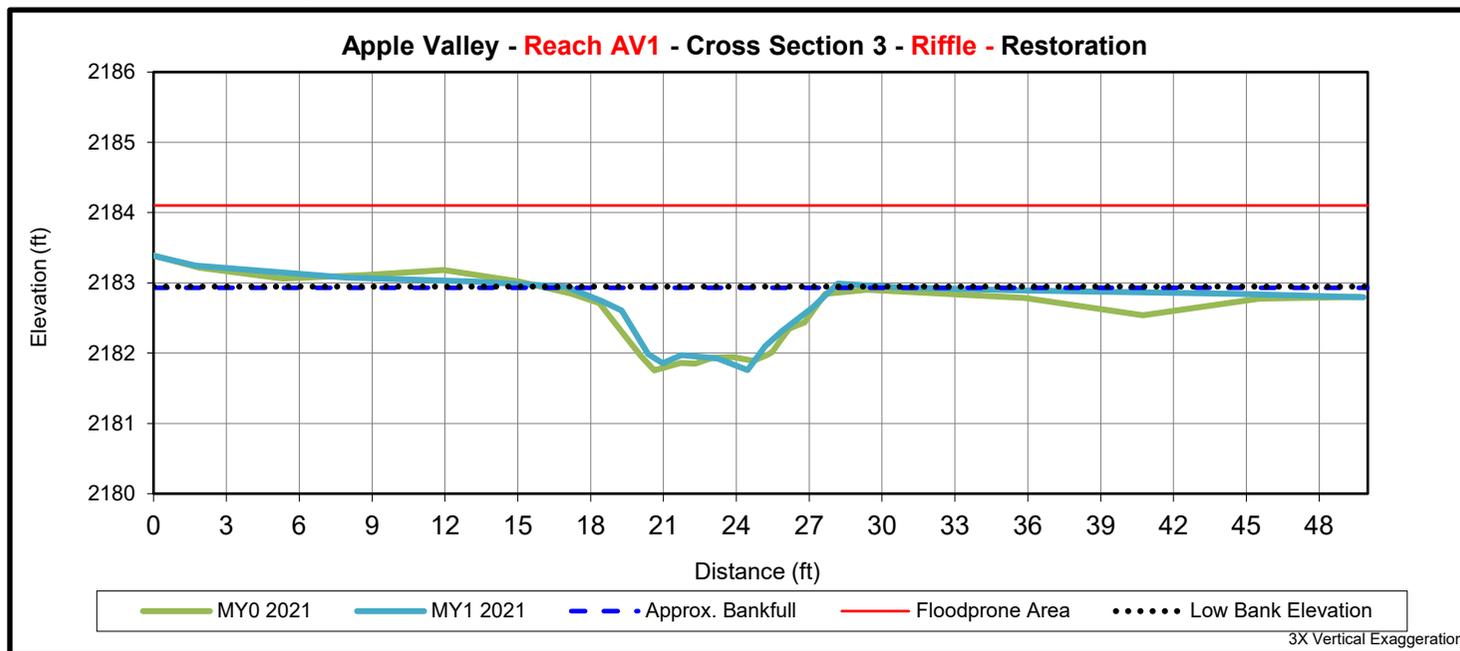
Cross Section 3 (Riffle)						
	MY0	MY1	MY2	MY3	MY5	MY7	MY+
Bankfull Elevation (ft) - Based on AB-XSA¹	2182.85	2182.9					
Bankfull Width (ft) ¹	10.7	10.9					
Floodprone Width (ft) ¹	>49.7	>49.8					
Bankfull Max Depth (ft) ²	1.1	1.2					
Low Bank Elevation (ft)	2182.85	2182.9					
Bankfull Cross Sectional Area (ft ²) ²	7.1	7.3					
Bankfull Entrenchment Ratio ¹	>4.6	>4.6					
Bankfull Bank Height Ratio ¹	1.0	1.0

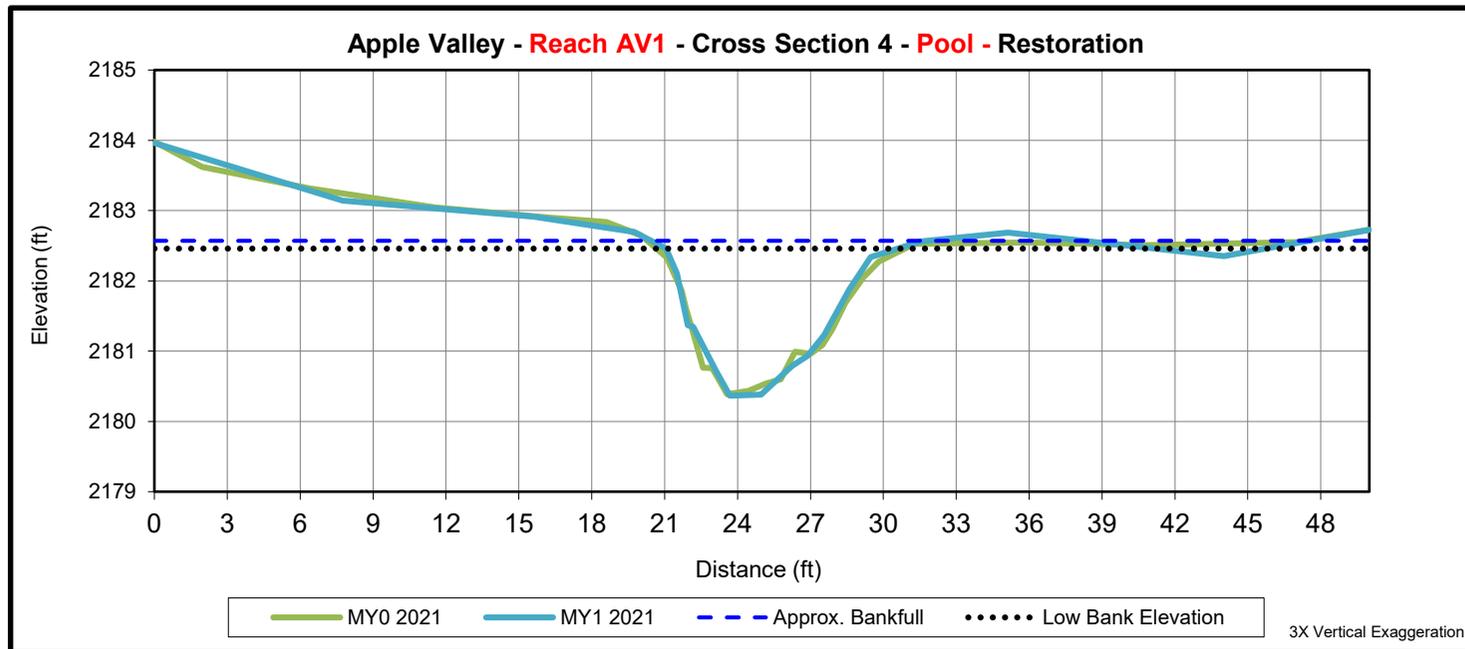
Cross Section 4 (Pool)						
	MY0	MY1	MY2	MY3	MY5	MY7	MY+
Bankfull Elevation (ft) - Based on AB-XSA¹	2182.53	2182.6					
Bankfull Width (ft) ¹	NA	N/A					
Floodprone Width (ft) ¹	NA	N/A					
Bankfull Max Depth (ft) ²	2.1	2.1					
Low Bank Elevation (ft)	2182.53	2182.5					
Bankfull Cross Sectional Area (ft ²) ²	12.5	11.4					
Bankfull Entrenchment Ratio ¹	NA	N/A					
Bankfull Bank Height Ratio ¹	NA	N/A

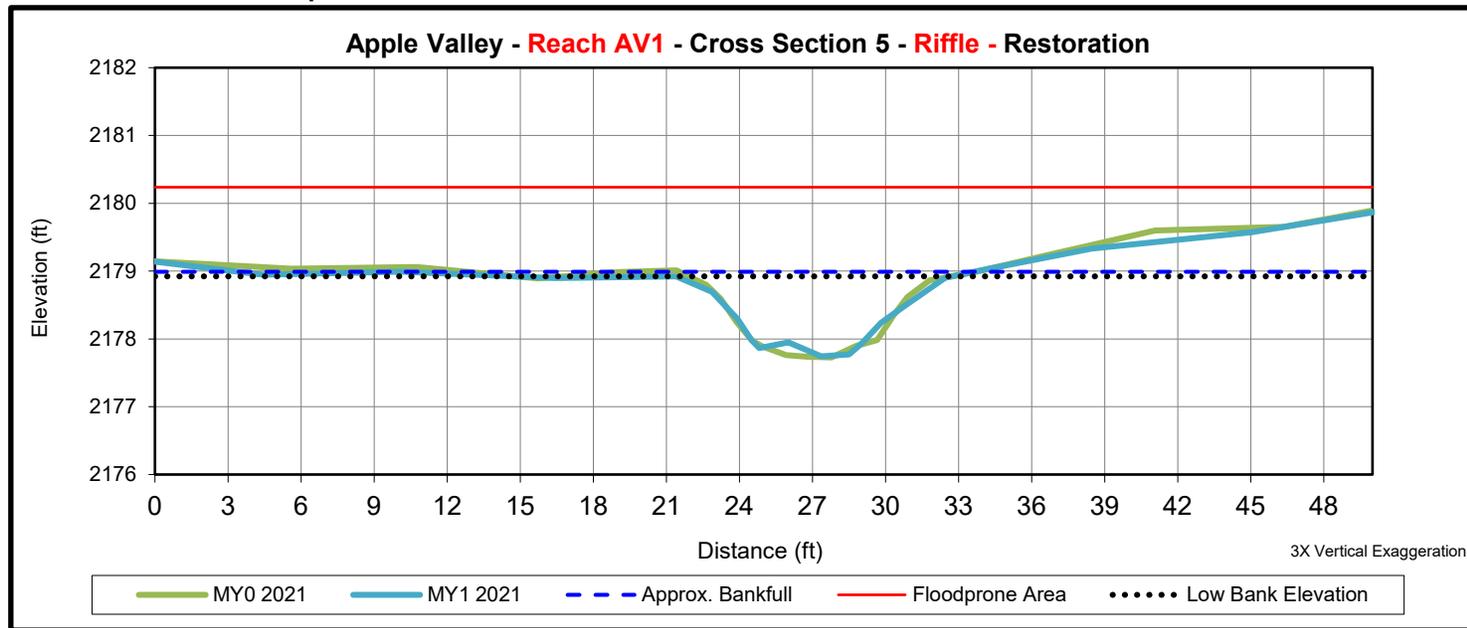
Cross Section 5 (Riffle)						
	MY0	MY1	MY2	MY3	MY5	MY7	MY+
Bankfull Elevation (ft) - Based on AB-XSA¹	2178.98	2179.0					
Bankfull Width (ft) ¹	8.3	11.1					
Floodprone Width (ft) ¹	>49.9	>50.1					
Bankfull Max Depth (ft) ²	1.3	1.2					
Low Bank Elevation (ft)	2178.98	2178.9					
Bankfull Cross Sectional Area (ft ²) ²	8.3	7.3					
Bankfull Entrenchment Ratio ¹	>4.2	>4.5					
Bankfull Bank Height Ratio ¹	1.0	0.9

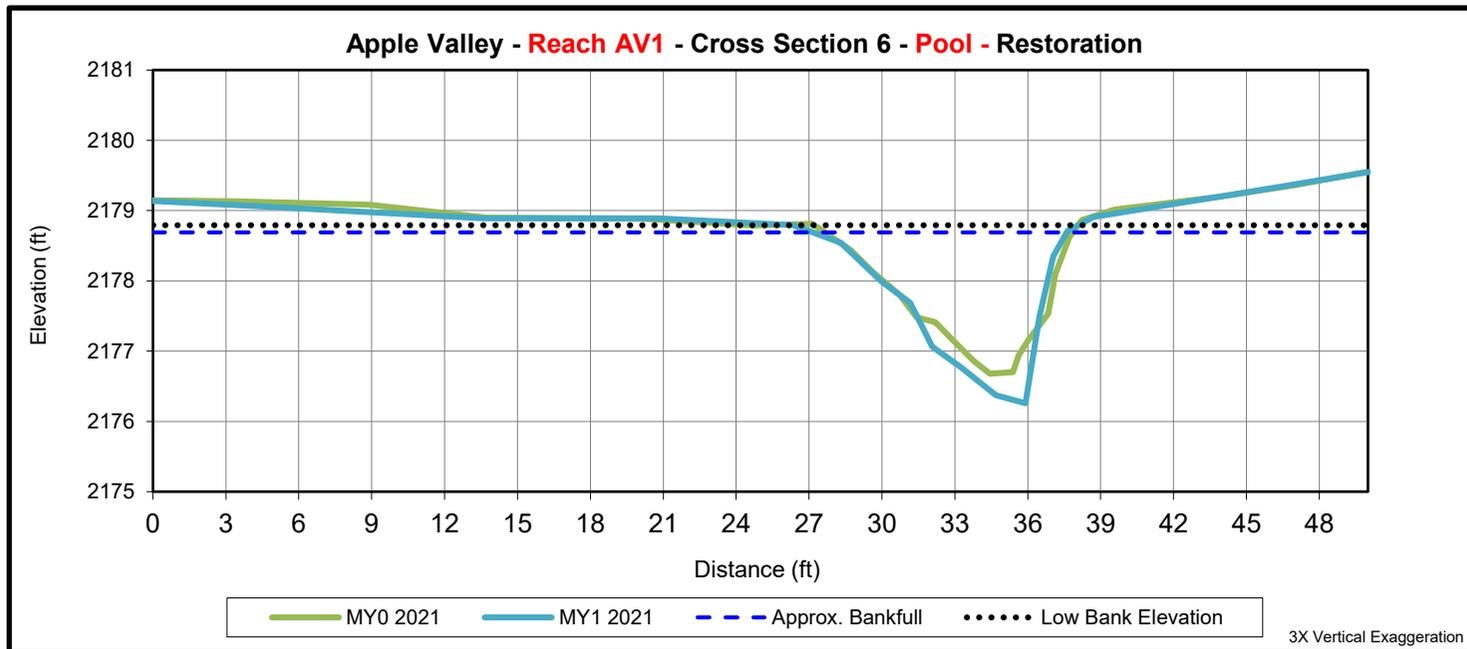
Cross Section 6 (Pool)						
	MY0	MY1	MY2	MY3	MY5	MY7	MY+
Bankfull Elevation (ft) - Based on AB-XSA¹	2178.81	2178.7					
Bankfull Width (ft) ¹	NA	N/A					
Floodprone Width (ft) ¹	NA	N/A					
Bankfull Max Depth (ft) ²	2.1	2.5					
Low Bank Elevation (ft)	2178.81	2178.8					
Bankfull Cross Sectional Area (ft ²) ²	12.6	13.7					
Bankfull Entrenchment Ratio ¹	NA	N/A					
Bankfull Bank Height Ratio ¹	NA	N/A

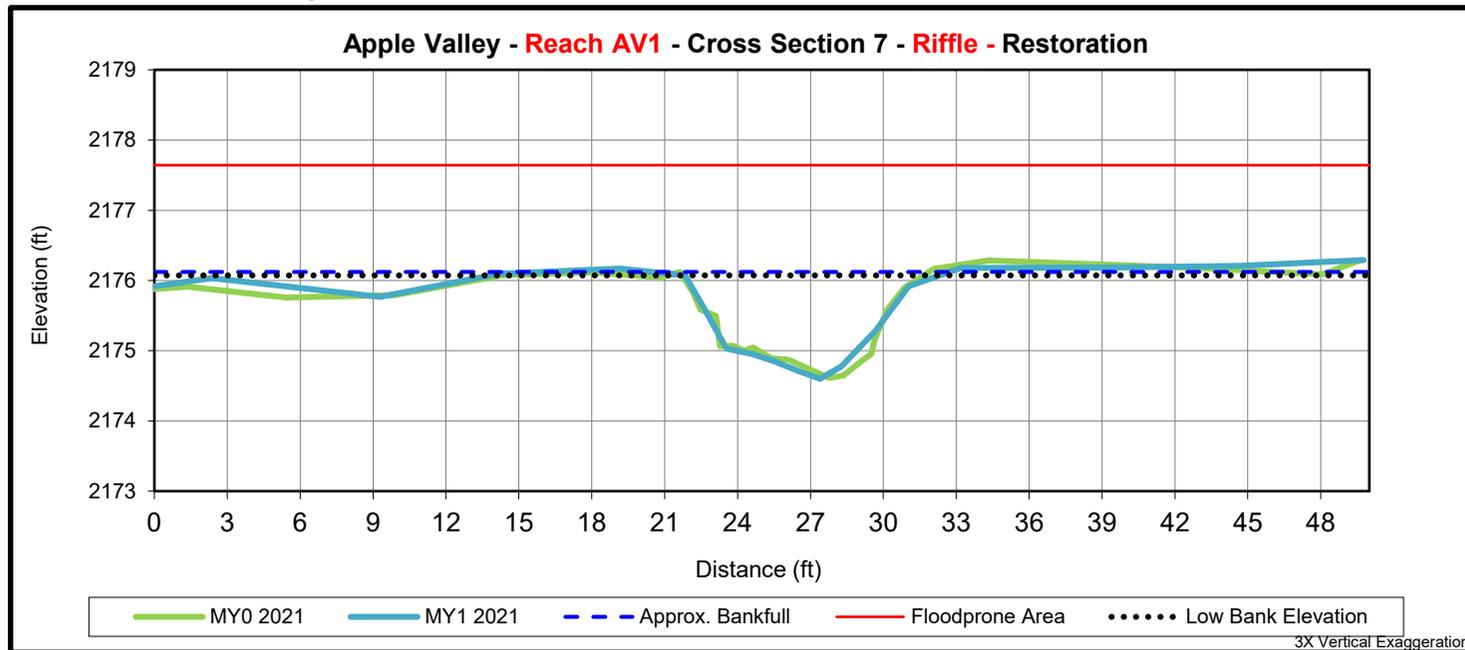
Cross Section 7 (Riffle)						
	MY0	MY1	MY2	MY3	MY5	MY7	MY+
Bankfull Elevation (ft) - Based on AB-XSA¹	2176.12	2176.1					
Bankfull Width (ft) ¹	12.4	10.9					
Floodprone Width (ft) ¹	>49.6	>49.8					
Bankfull Max Depth (ft) ²	1.5	1.5					
Low Bank Elevation (ft)	2176.12	2176.1					
Bankfull Cross Sectional Area (ft ²) ²	9.6	9.1					
Bankfull Entrenchment Ratio ¹	>4.0	>4.6					
Bankfull Bank Height Ratio ¹	1.0	1.0

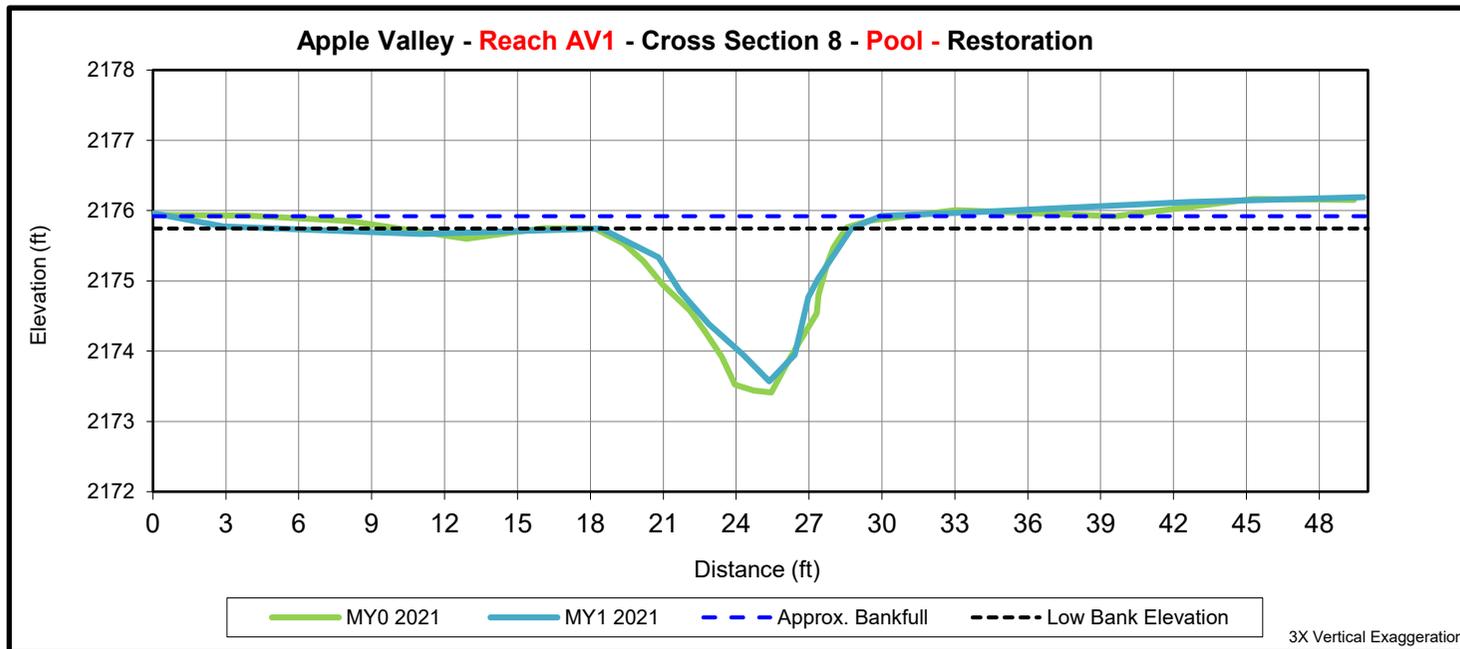
Cross Section 8 (Pool)						
	MY0	MY1	MY2	MY3	MY5	MY7	MY+
Bankfull Elevation (ft) - Based on AB-XSA¹	2175.74	2175.9					
Bankfull Width (ft) ¹	NA	-					
Floodprone Width (ft) ¹	NA	-					
Bankfull Max Depth (ft) ²	2.3	2.2					
Low Bank Elevation (ft)	2175.74	2175.7					
Bankfull Cross Sectional Area (ft ²) ²	12.3	10.4					
Bankfull Entrenchment Ratio ¹	NA	-					
Bankfull Bank Height Ratio ¹	NA	-

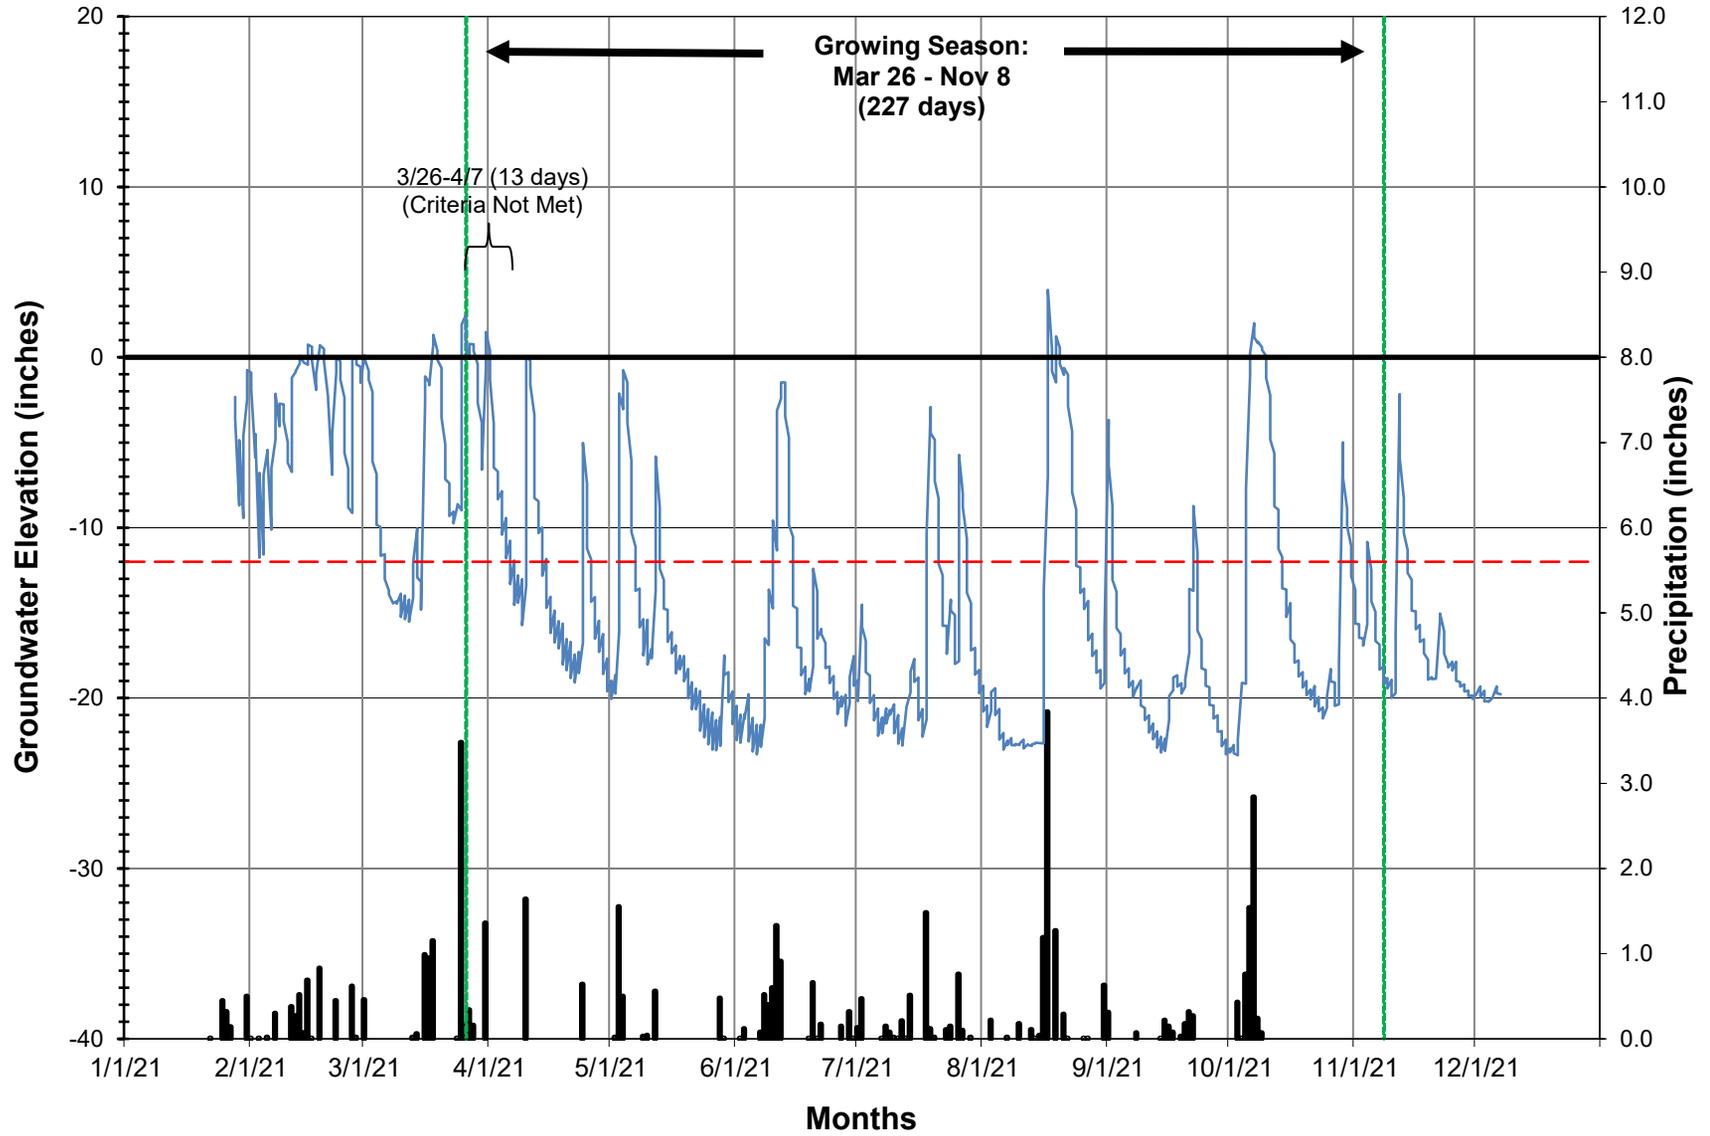
2021 Apple Valley GW8

the well was not dug deep enough. However, photo documentation of GW4 does not suggest that the well was installed improperly; in fact, the photo of GW4 shows the well surrounded with wetland vegetation (*Juncus* sp.) (**Appendix B**). GW8 at the bottom of the Project, also fell short of the success criteria. This failure could be attributed to its proximity to a ditch, south of the easement, running parallel to the road, possibly diverting water from the wetland. However, photo documentation of this well also shows it surrounded by wetland vegetation (*Juncus* sp. and *Ludwigia alternifolia*) (**Appendix B**). RES expects the hydroperiods to increase in subsequent years as the wetlands continue to establish and the surrounding vegetation matures. Groundwater well locations can be found on **Figure 2** and the data is in **Appendix E**.
