# **Monitoring Report MY04**

**Cedar Branch Restoration Site  
Monitoring Year 04  
DMS Contract 6598  
DMS Project Number 97009**

**DWR #: 20150904  
USACE Action ID: 2003-21395  
Randolph County, North Carolina**

**Monitoring Data Collected: 2021  
Date Submitted: January 2022**

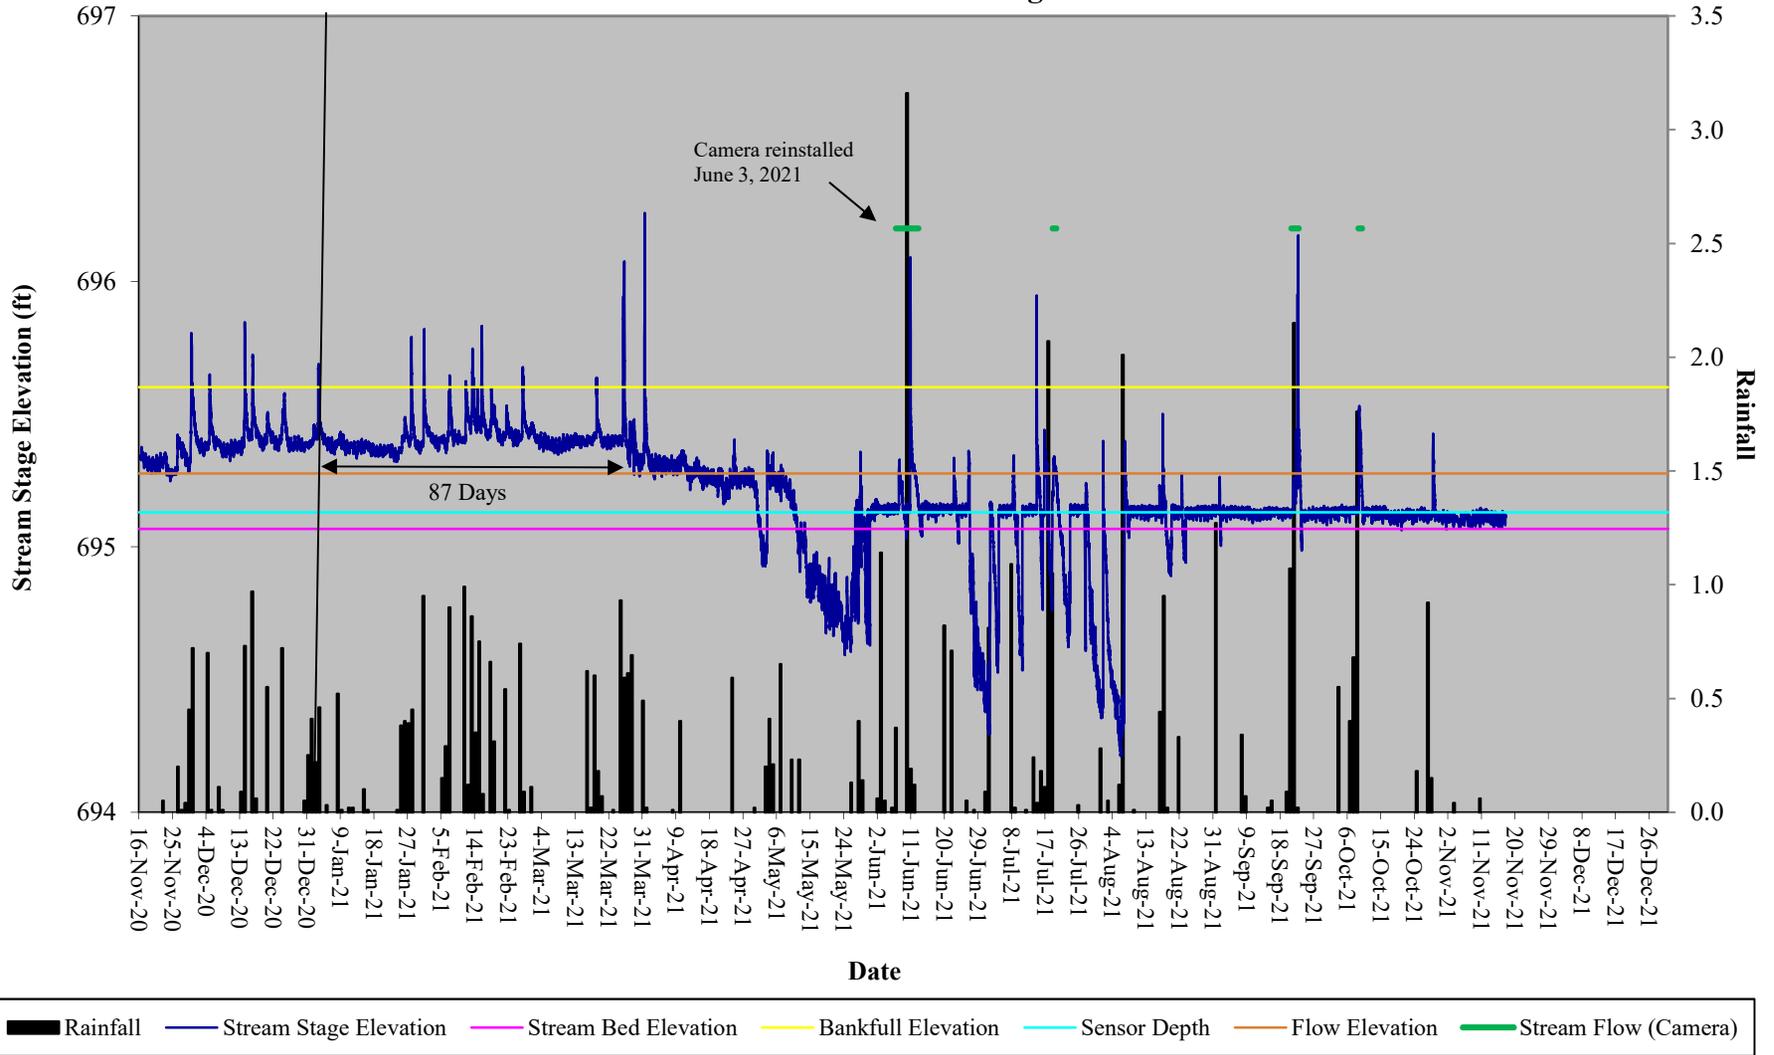
### Cedar Branch Restoration Site Hydrograph T1-1 Stream Flow Gauge

Camera on T1-1 malfunctioned and only recorded 7 days according to report. Has all equipment been repaired/replaced and functioning correctly moving into MY5? Please add a short statement regarding the status of the monitoring equipment to this section.

➤ *The camera on T1-1 malfunctioned from January 1 to June 3 of 2021. The camera was replaced on June 3, 2021 and had a maximum of seven consecutive flow days and a total of 15 days of flow. The camera malfunctioned during the wetter part of the growing season and since the gauge on T1-1 was flowing for 87 consecutive days one can assume that the camera would have recorded flow days during that time if it had been working properly. All cameras and gauges will be working properly before the growing season for Monitoring Year 5.*
