MONITORING YEAR 2 ANNUAL REPORT

KEY MILL MITIGATION SITE

Surry County, NC
NCDEQ Contract No. 7180
DMS Project No. 100025
USACE Action ID No. SAW-2017-01504
NCDEQ DWR Certification No. 17-1045
RFP #: 16-006993

Data Collection Period: January 2021 – November 2021
Final Submission Date: February 1, 2022

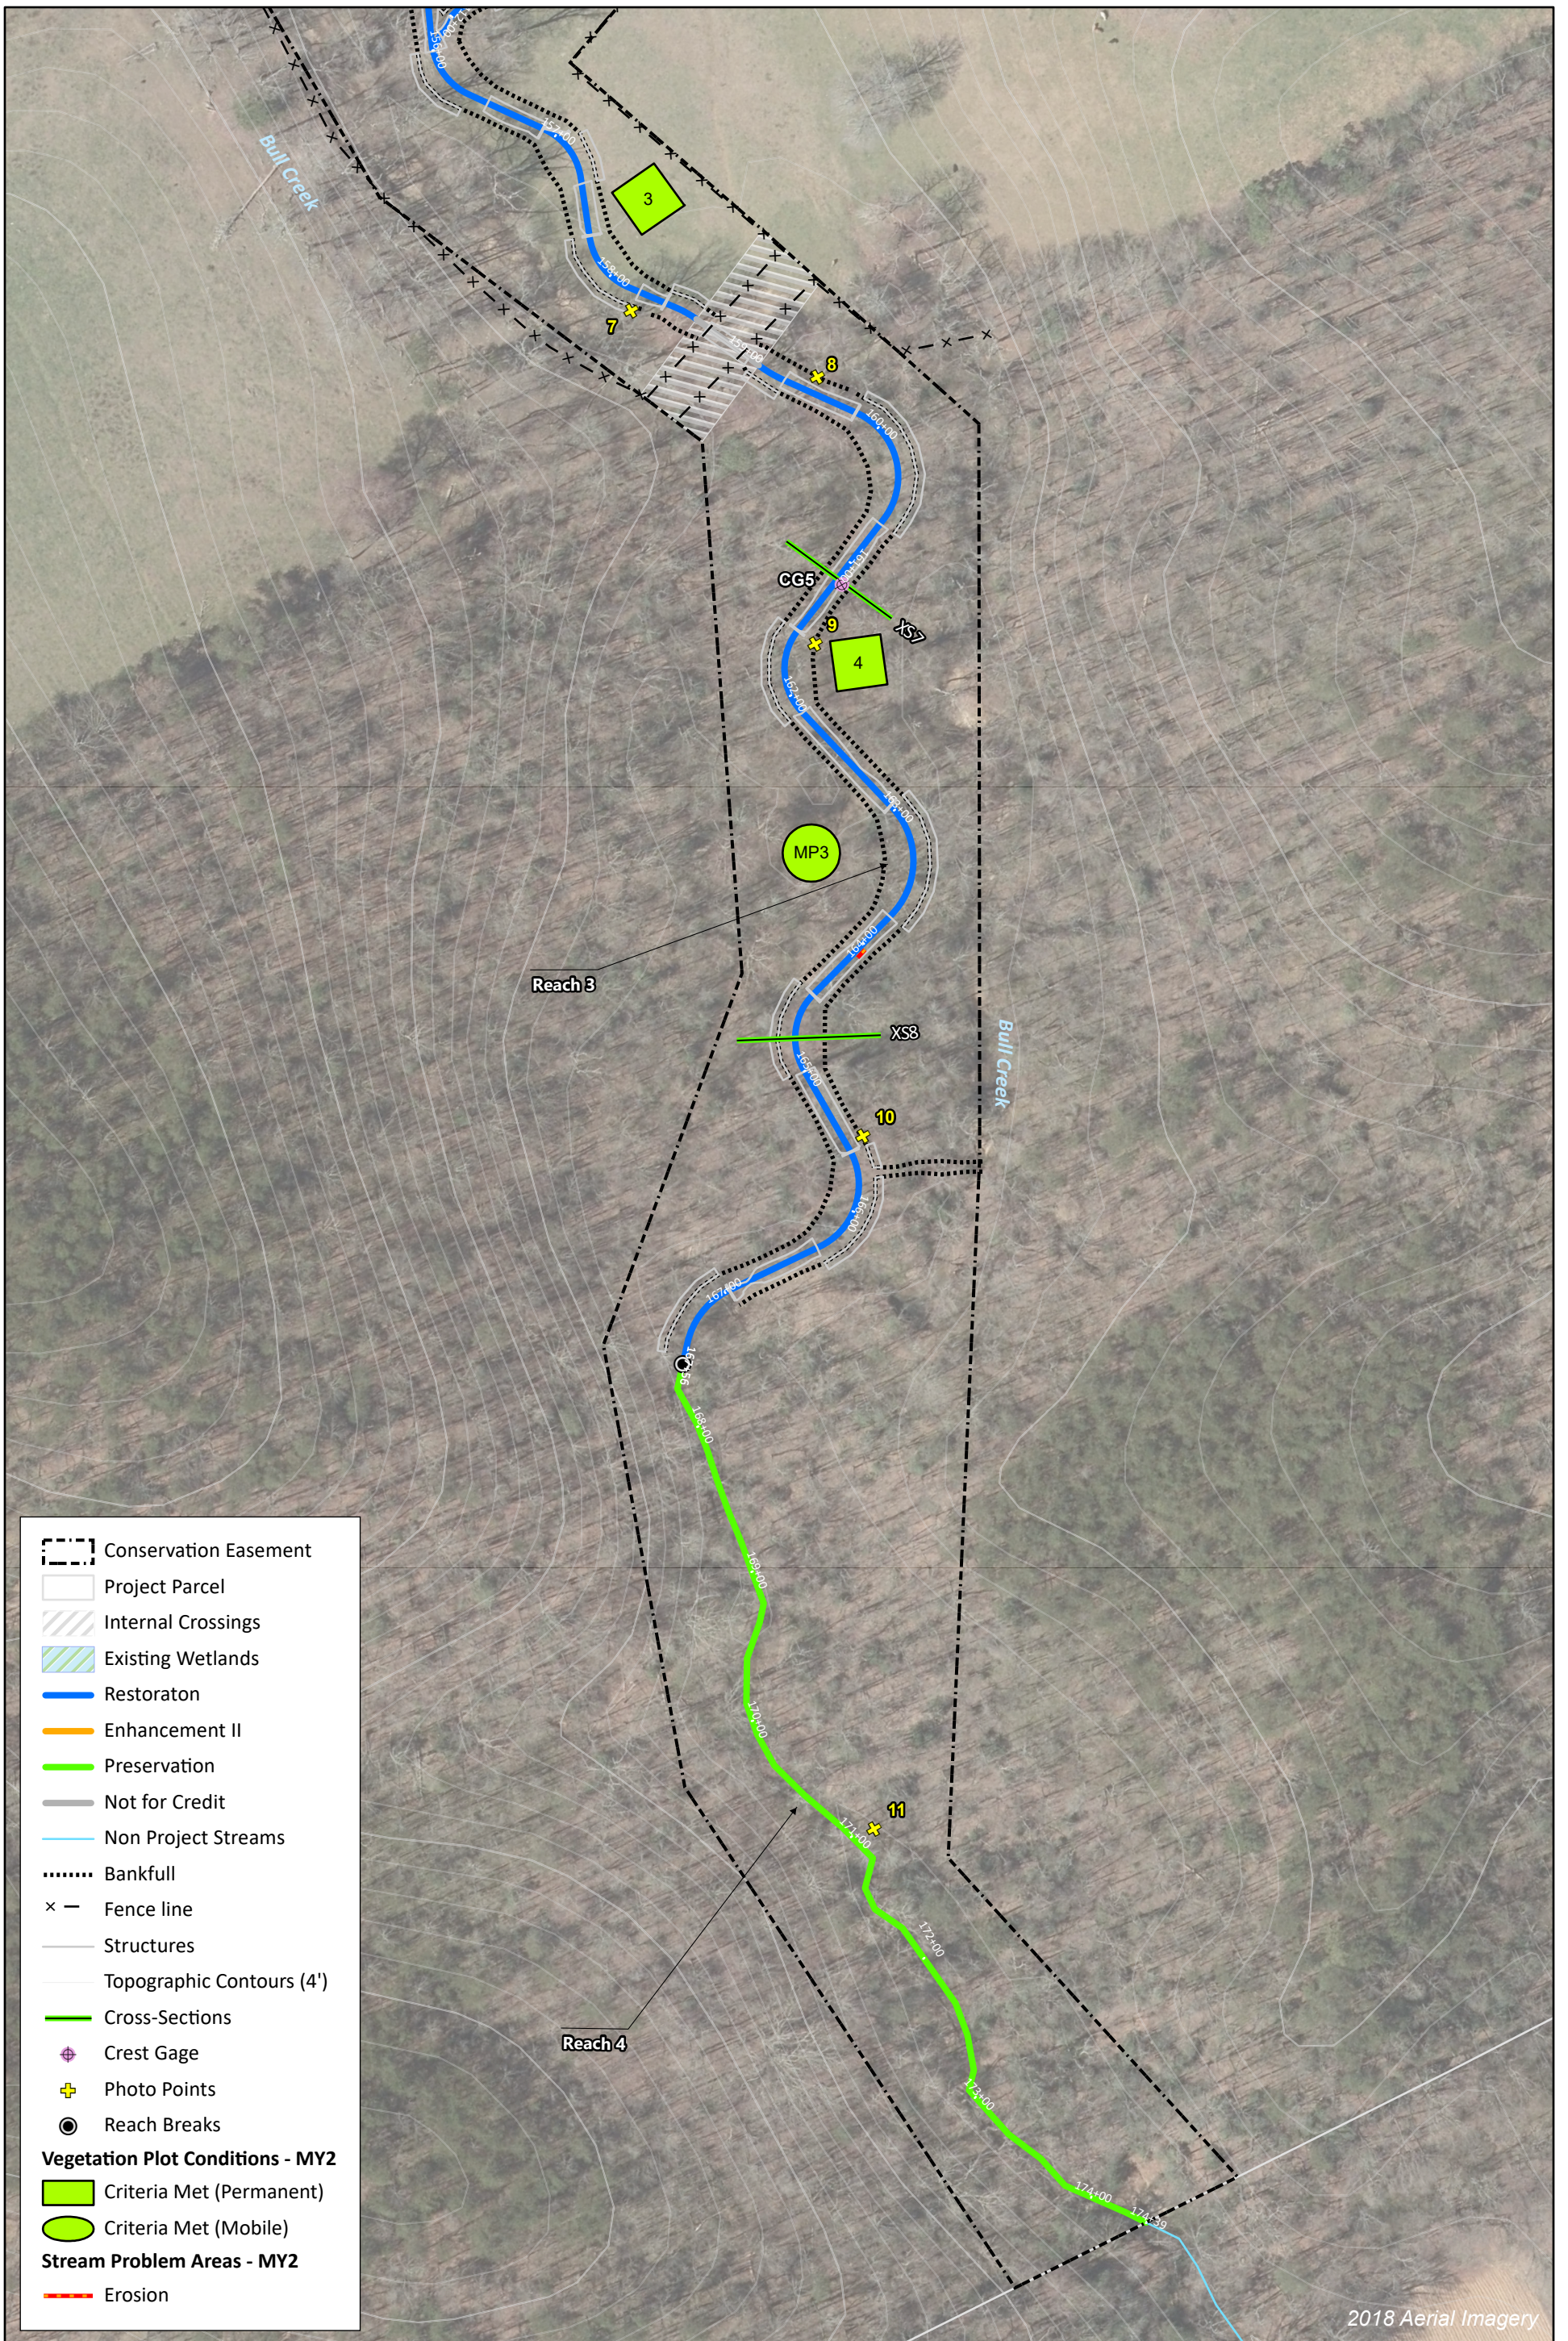
Figure 3.3 Current Conditions Plan View Map
 Key Mill Mitigation Site
 DMS Project No. 100025
 Monitoring Year 2 - 2021
 Surry County, NC

DMS comment: Table 6d: Table shows 1 section or degradation, but it does not occur on the CCPV. Also, the piping structure identified on the site is located on this reach and is shown on the CCPV, but

Wildlands' response: The degradation and the piping structure are referring to the same thing and were inadvertently depicted as two different issues. Therefore, the structure shown on the CCPV map was changed to a line in the CCPV map to correctly reflect a length of degradation.

DMS comment: Please include a feature representing the 7 feet of degradation along Bull Creek Reach 3.

Wildlands' response: Wildlands has included the line feature representing the 7 feet of degradation along Bull Creek Reach 3.

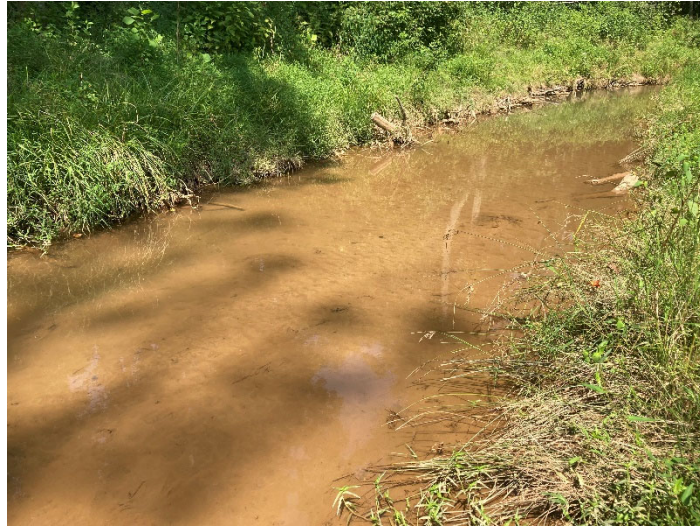
Bull Creek Reach 1A: Aggradation at Station 104+00 – looking upstream (08/26/2021)

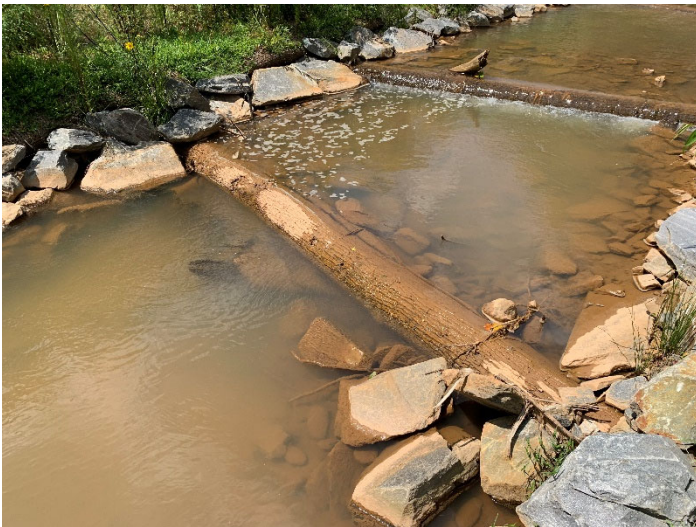
Bull Creek Reach 3: Piping at Station 164+00– looking upstream (08/26/2021)

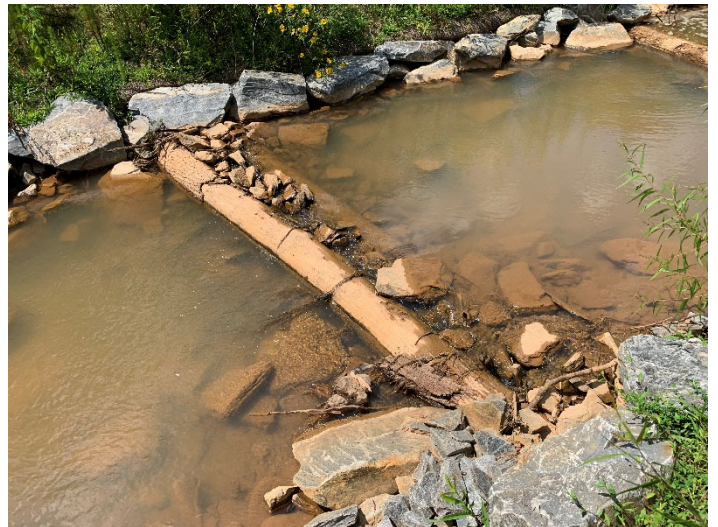
Bull Creek Reach 3: Header Dislocated from Footer at Station 164+07 – looking upstream (08/26/2021)

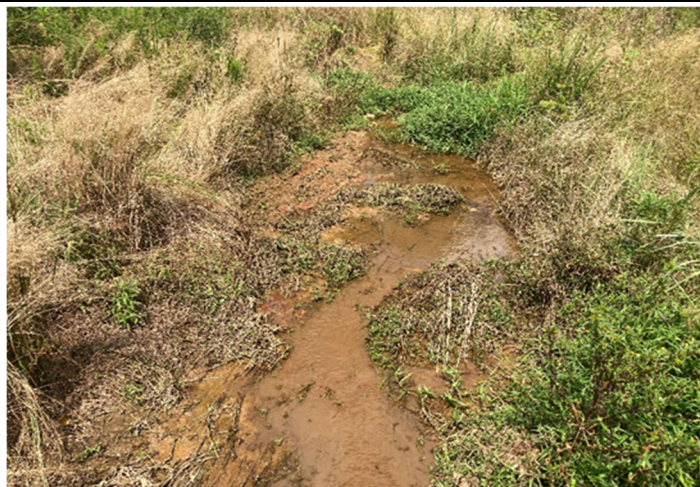
UTC3: Aggradation at Station 408+52 – looking upstream (08/26/2021)

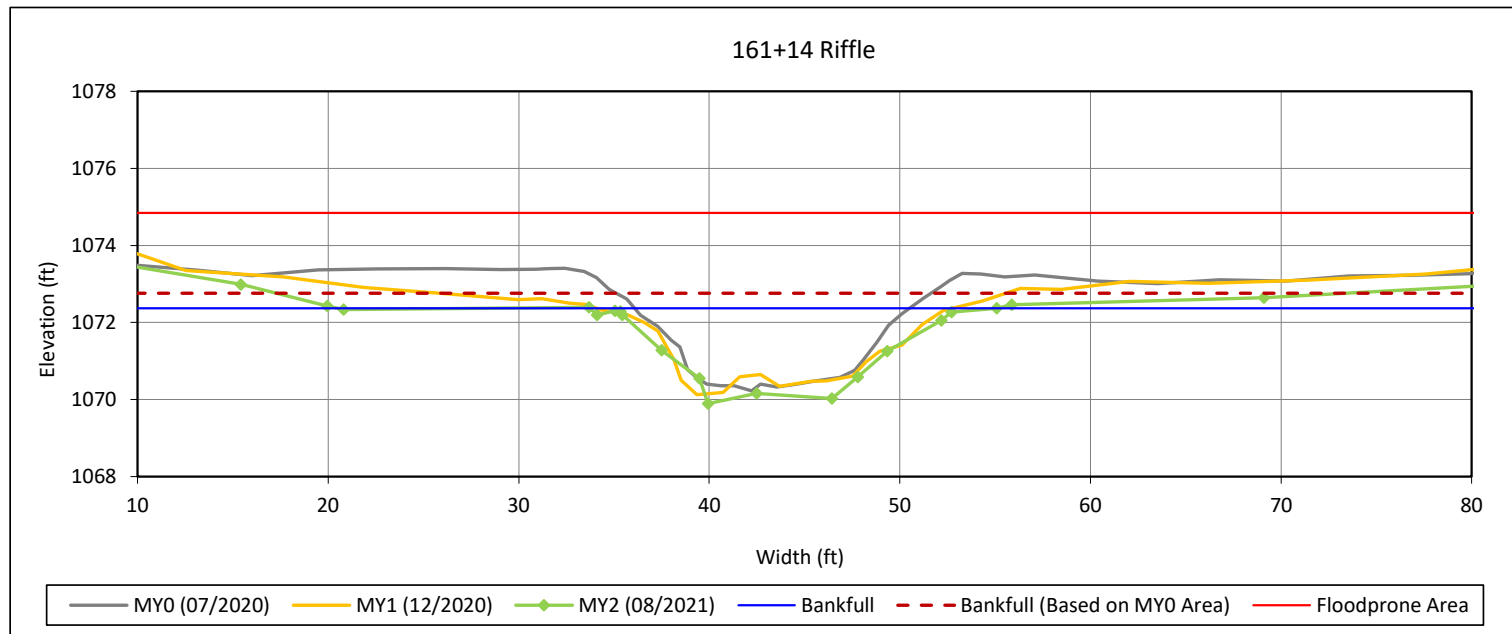
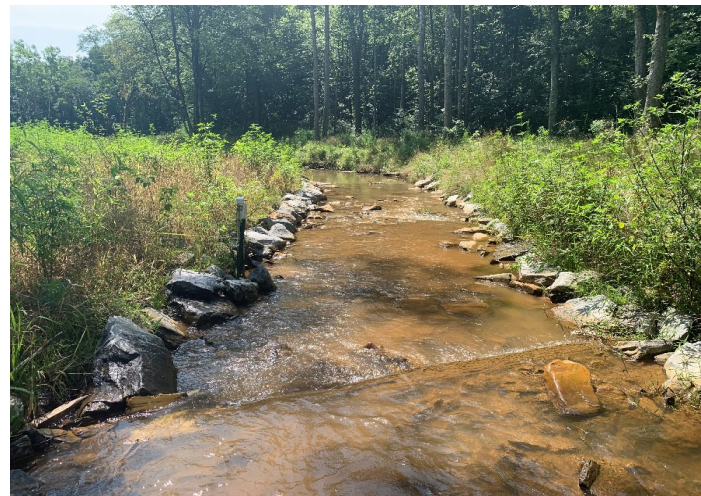
Cross-Section 7-Bull Creek Reach 3

*Cross Section affected by repairs conducted during July 2021.

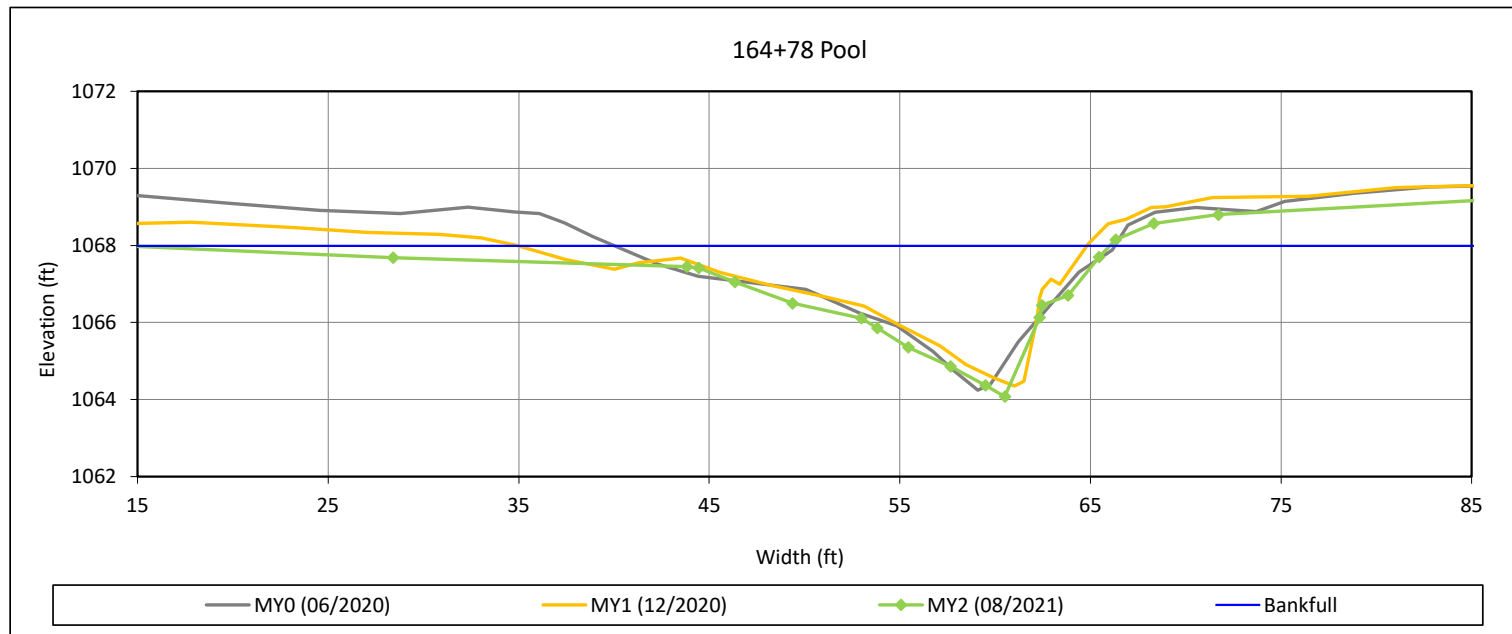
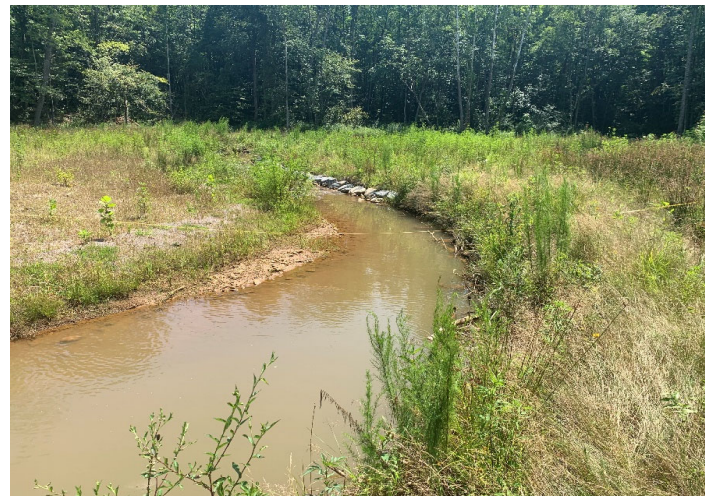
Cross-Section 8-Bull Creek Reach 3

*Cross Section affected by repairs conducted during July 2021.

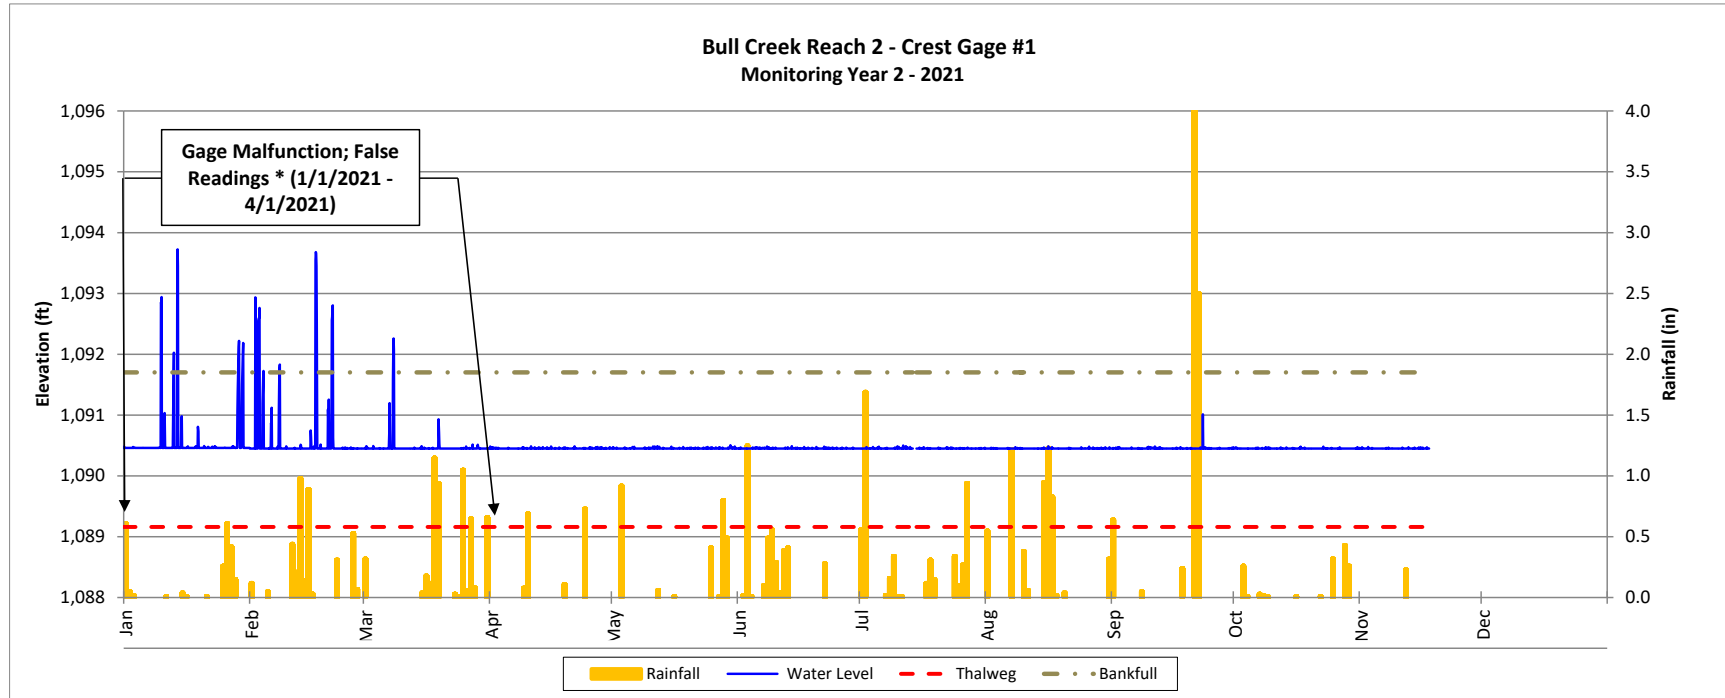
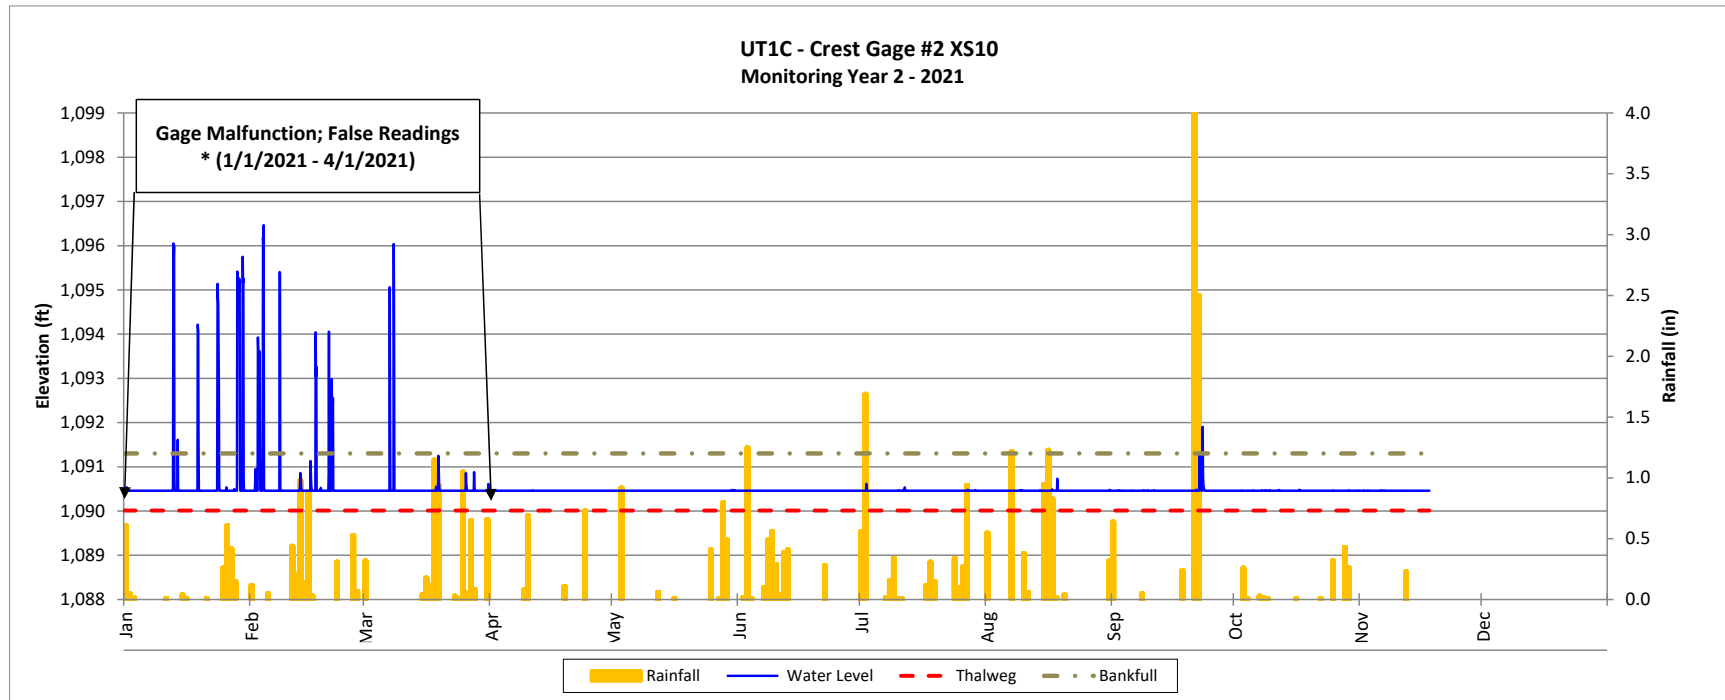
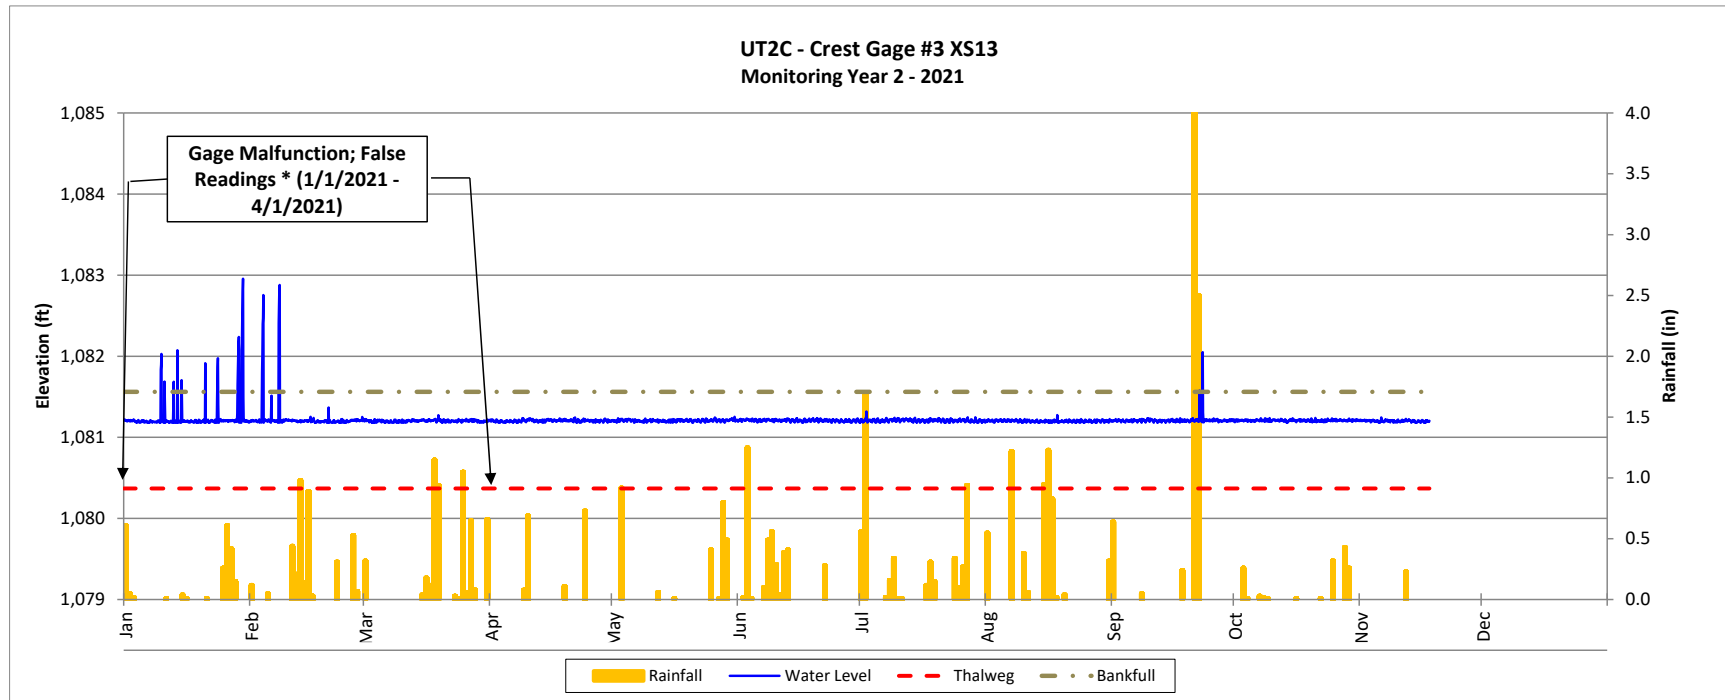
*Due to the large spikes that do not seem to correlate with rainfall amounts, but occurred only during the winter months, Wildlands pulled air temperature data for the surrounding area and noticed a correlation between the spikes and when the air temperatures dropped below freezing. Therefore, Wildlands contacted In-situ on 11.18.21 to gain some technical insight on these findings. A Technical Support Specialist, Kaylie Haynes, at In-situ confirmed that these spikes are likely false readings due to freezing water around the pressure diaphragm in the gage. She referred us to specification sheet for the pressure transducers, Rugged TROLL[®] 100 Data Loggers, that Wildlands commonly uses in the field (2021). Therefore, Wildlands ignored the bankfull event spikes recorded from 01.01.21 - 04.01.21, when air temperature is more likely to fall below freezing, and only include bankfull events recorded between 04.01.21 - 10.31.21 when air temperature is more likely to remain above freezing and that positively correlated with rainfall amounts from the nearest rainfall gage. Moving forward, Wildlands will check the calibration on the gages using a known depths of water. If the gage is recording correctly, it will be reinstalled for use in 2022. If the gage is not recording correctly, Wildlands will refrain from using the gage unless it can be refurbished by In-situ, upon which Wildlands will check the calibration before reinstalling it for use during 2022.

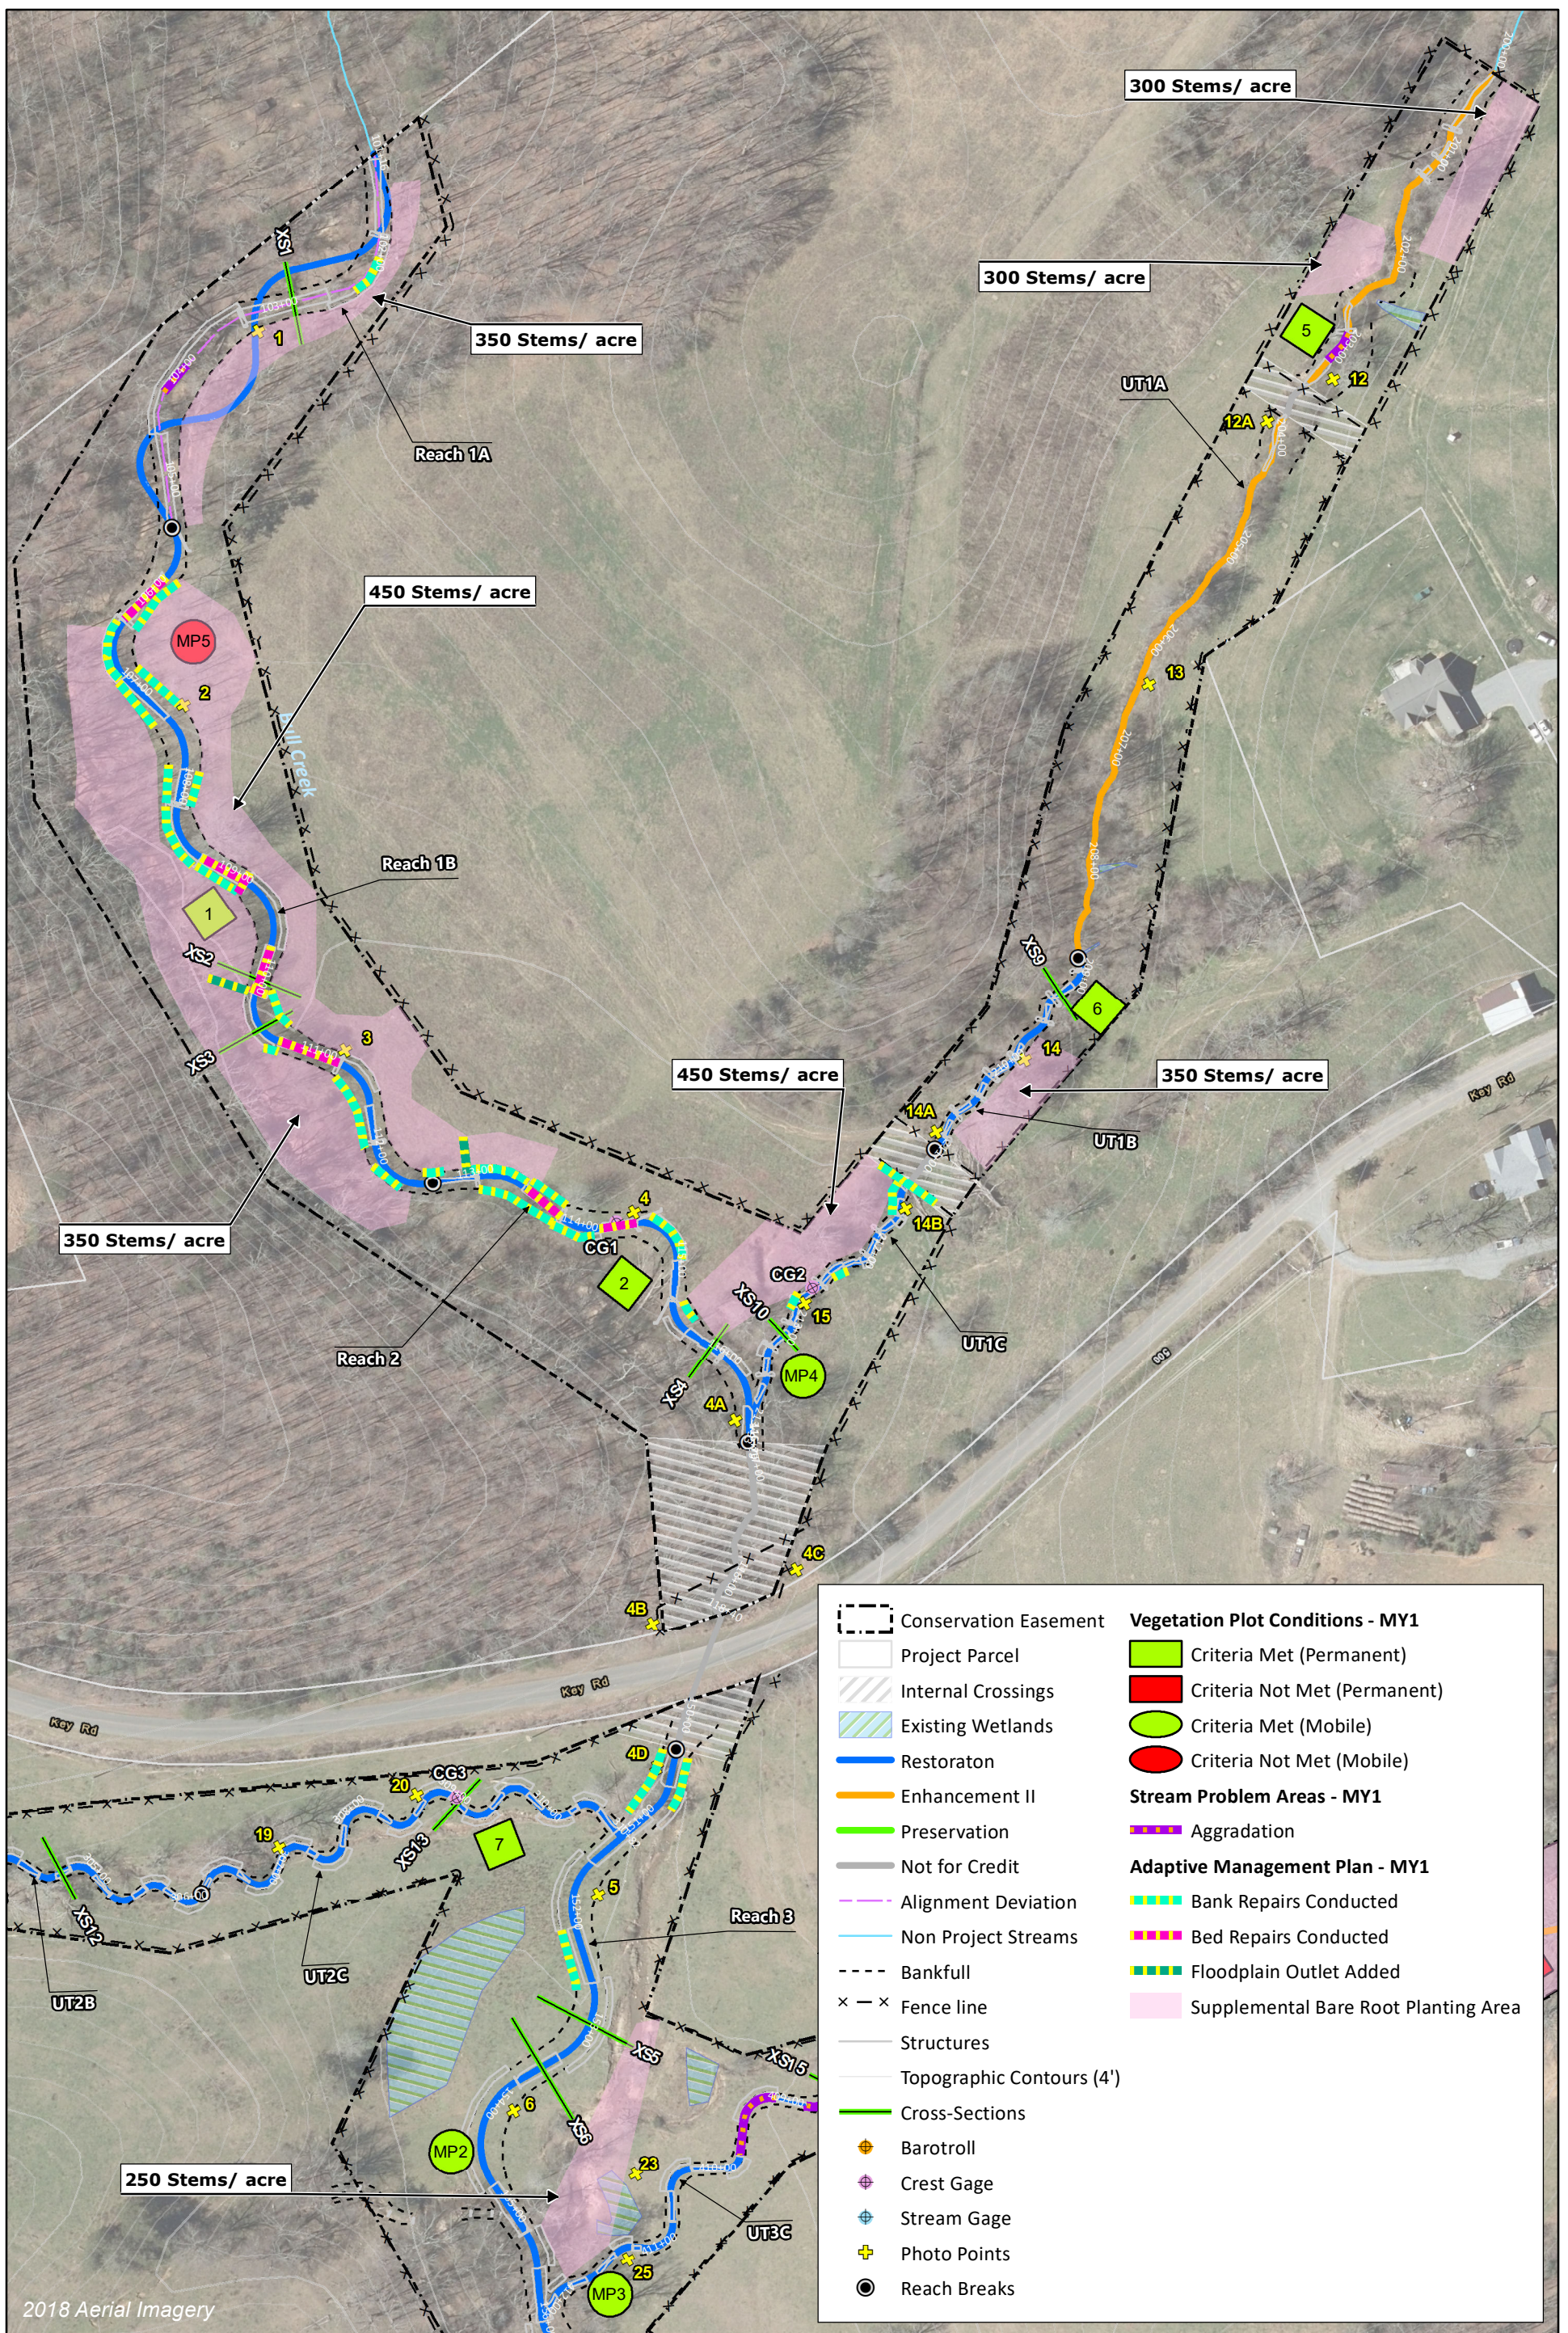
Figure 1.1 Stream Repairs & Supplemental Planting Map
 Key Mill Mitigation Site DMS Project No. 100025
 Adaptive Management Plan - As-built Record Drawings

Annual monitoring for MY1 was conducted between October and December 2020 to assess the condition of the project. The stream and vegetative performance criteria for the Site follows the approved success criteria presented in the Key Mill Mitigation Plan (Wildlands, 2019). Stream and vegetative monitoring features and locations are shown in Figures 1.1 – 1.3 in Appendix 1.

See Appendix 1 for the location of areas of poor vegetative performance (Figures 1.1 – 1.3) and Appendix 2 (Tables 1 and 2a-c) for the MY1 vegetation plot monitoring results.

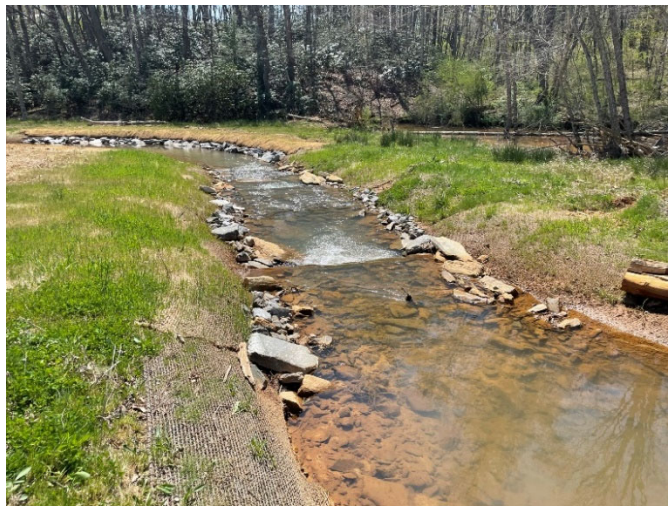
Pre-Repair – STA 105+85 Downstream; Erosion Along Left Bank at Structure Tie-ins and Loss of Riffle Material (11/02/2020)

Post-Repair – STA 105+85 Downstream; Rebuilt Riffle and Regraded and Matted Left Bank (04/07/2021)

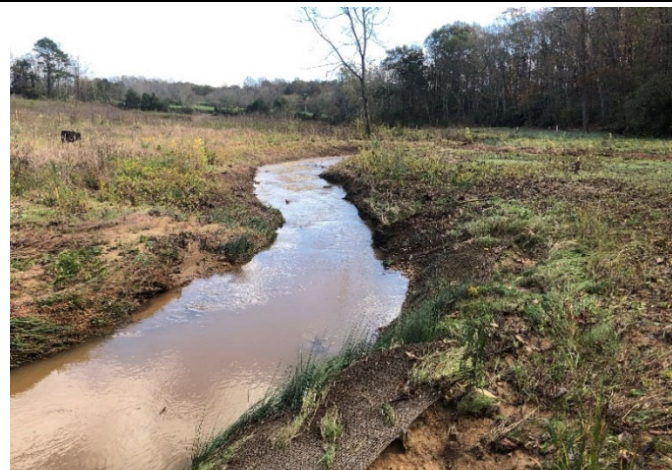
Pre-Repair – STA 107+00 Downstream; Erosion Along Right and Left Banks (11/02/2020)

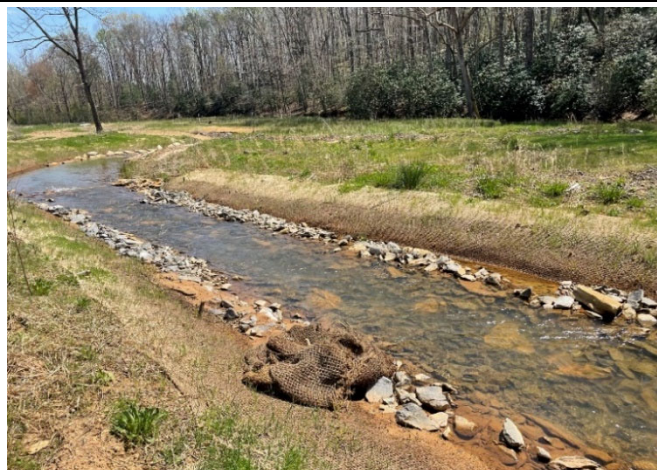
Post-Repair – STA 107+00 Downstream; Right and Left Banks Regraded and Matted (04/07/2021)

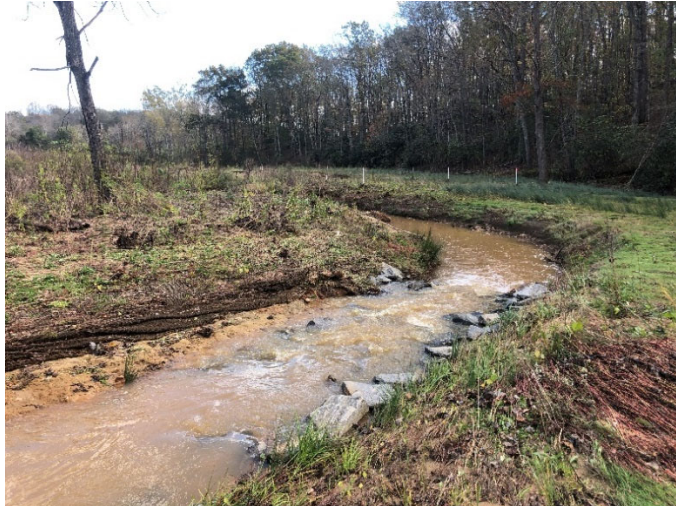
Pre-Repair – STA 107+90 Downstream; Erosion Along Right and Left Banks
 STA 108+20 Downstream; Erosion Along Right Bank and Brush Toe (11/02/2020)

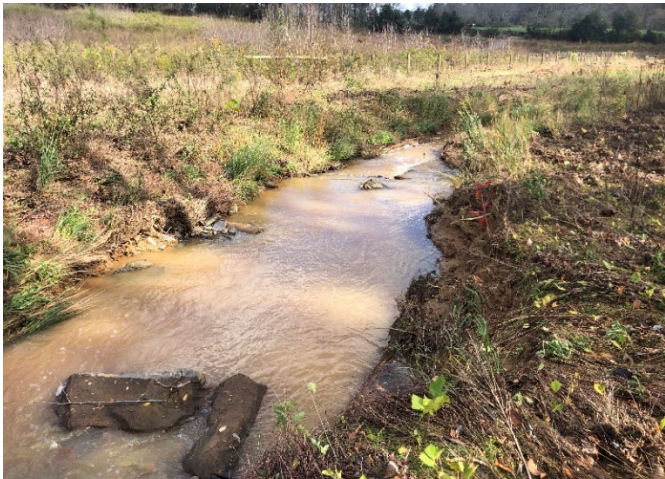
Pre-Repair – STA 108+70 Downstream; Loss of Riffle Material and
 Dislodged Log Sill (11/02/2020)

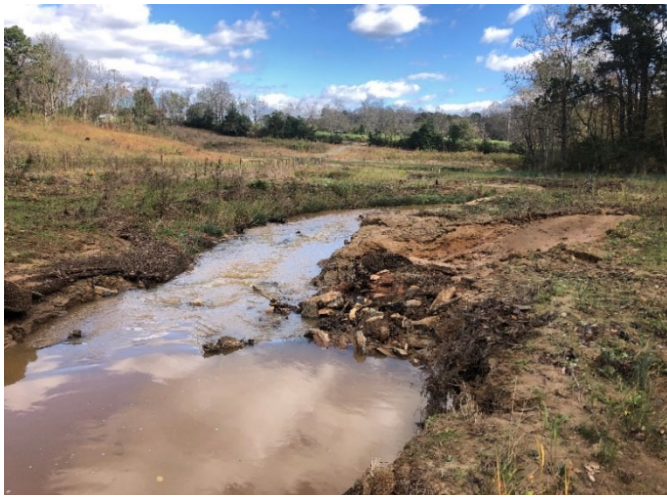
Pre-Repair – STA 110+65 Downstream; Scour Pocket Along Right Bank and Displacement of Riffle Material (11/02/2020)

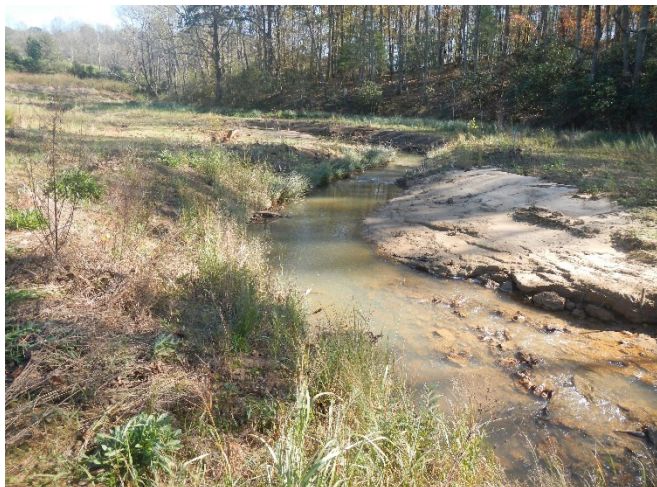
Pre-Repair – STA 111+25 Downstream; Scour on Right Bank from Point Bar into Riffle (11/03/2020)

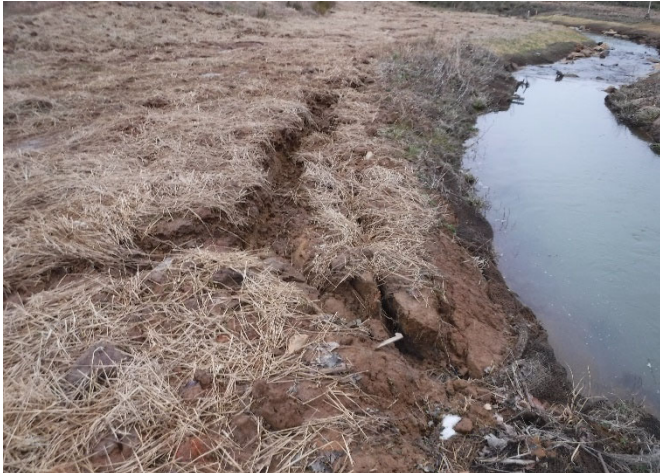
Pre-Repair – STA 113+00 Downstream; After the November Repair a Floodplain Seep Created Erosion Behind Brush Toe and Outlet (12/30/2020)

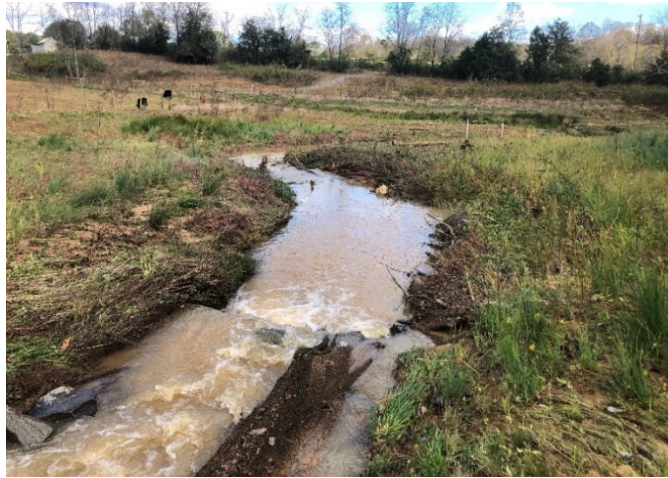
Pre-Repair – STA 113+40 – 113+80 Downstream; Riffle Scour and Erosion Along Left Bank at Riffle and Along Right Bank from Riffle Through the Brush Toe (11/02/2020)

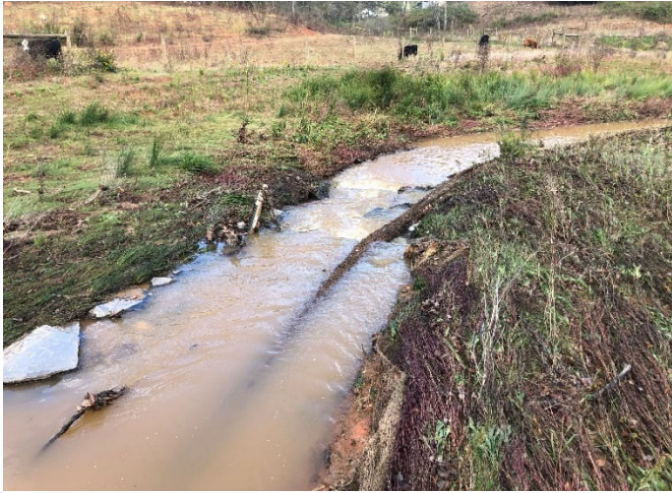
Pre-Repair – STA 114+20 Downstream; Riffle Scour (11/02/2020)

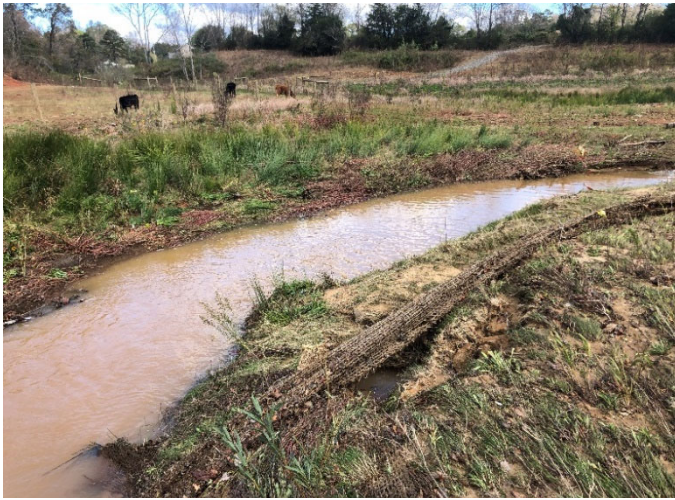
Pre-Repair – STA 114+65 Downstream; Erosion Along Left Bank and Brush Toe (11/02/2020)

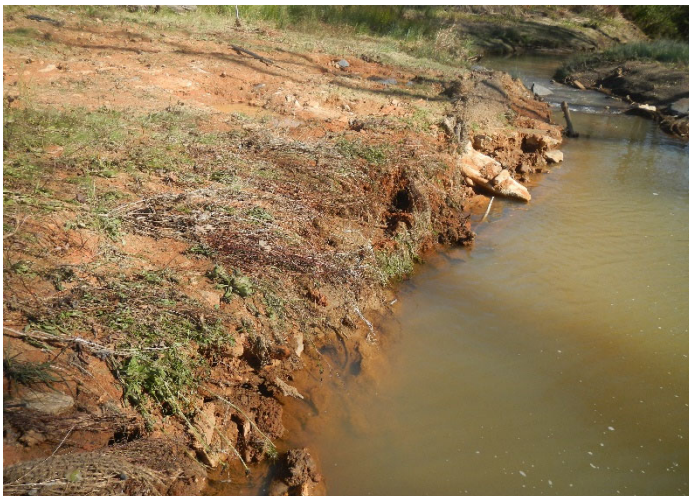
Pre-Repair – STA 115+35 Downstream; Erosion Along Right Bank (11/02/2020)

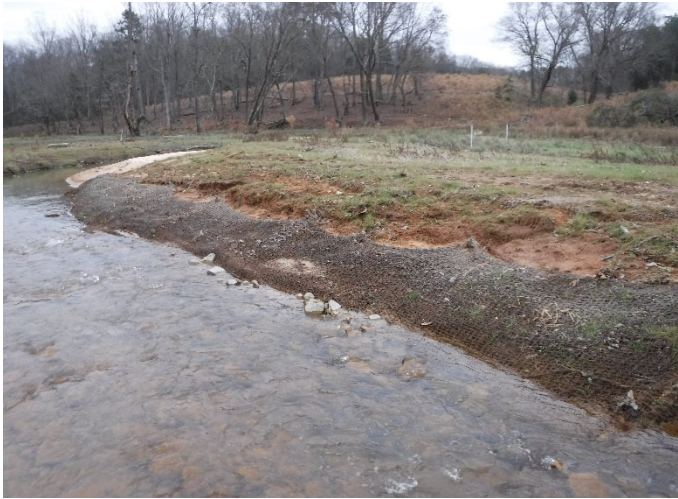
Pre-Repair – STA 152+10 Downstream; Erosion along Right Bank (12/30/2020)

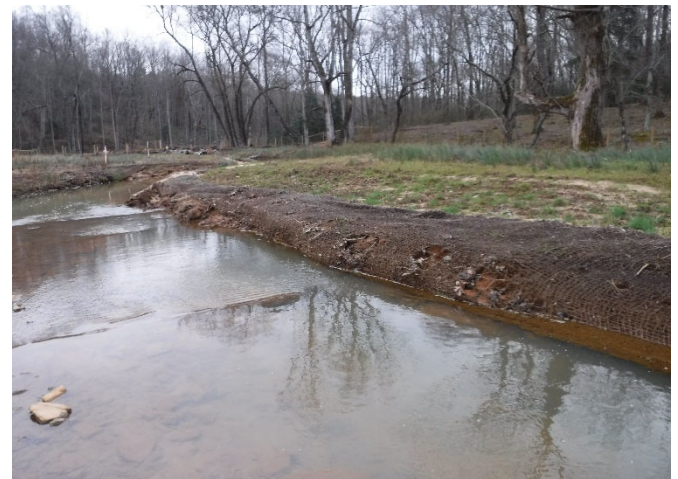
Pre-Repair – STA 156+35 Downstream; Erosion Along Right Bank (10/30/2020)

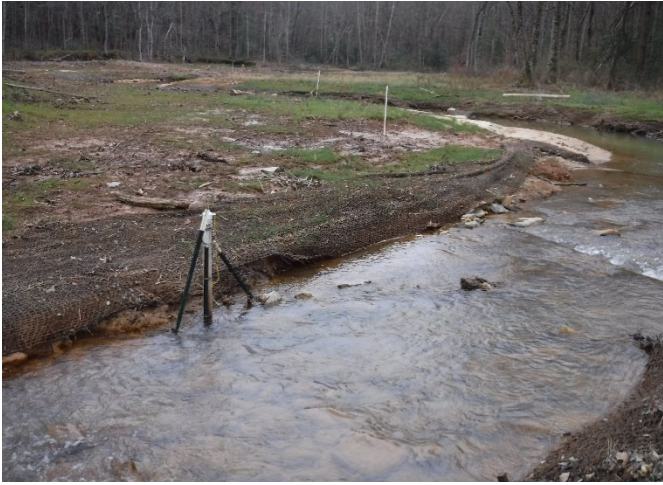
Pre-Repair – STA 160+65 Downstream; Erosion Along Left Bank (12.30.20)

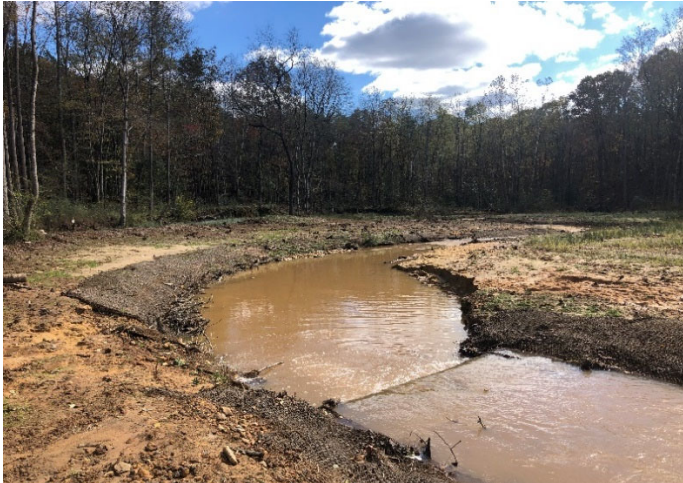
Pre-Repair – STA 163+00 Downstream; Left Bank Erosion from Floodplain Discharge and Erosion Along Right Bank (11/02/2020)

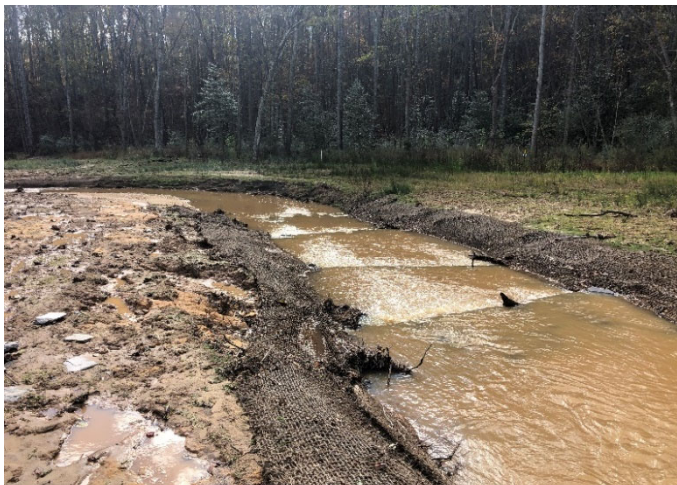
Pre-Repair – STA 163+70 Downstream; Erosion Along Right and Left Banks (11/02/2020)

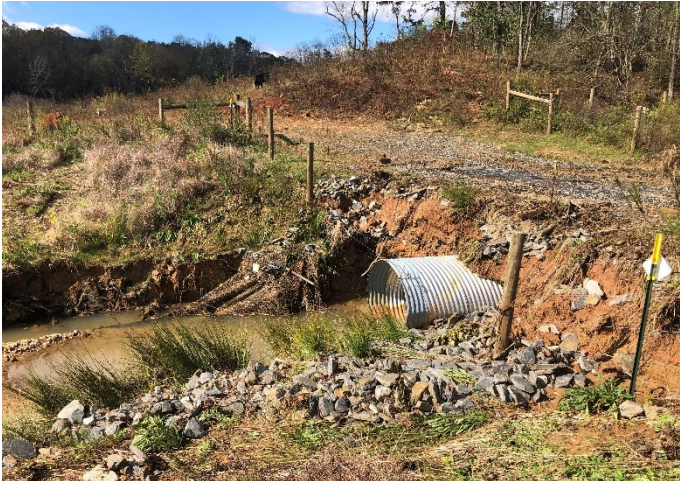
Pre-Repair – STA 211+50 From Left Bank; Erosion along Downstream Side of Crossing and Around Culvert (11/02/2020)

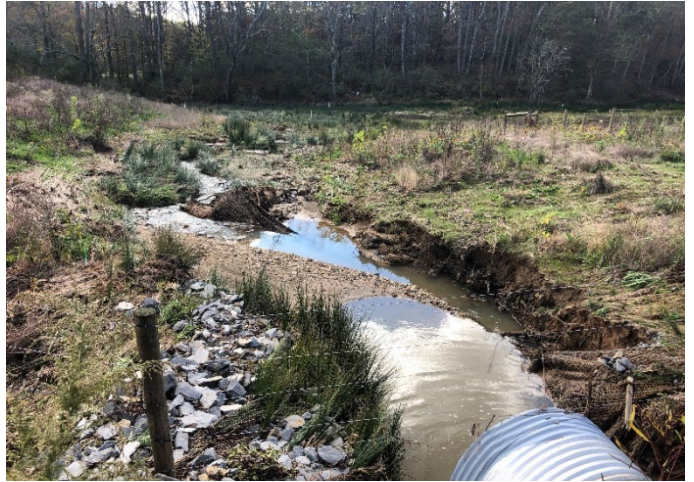
Pre-Repair – STA 211+50 Downstream; Erosion Along Right Bank (11/02/2020)
