MONITORING YEAR 2 ANNUAL REPORT

KEY MILL MITIGATION SITE

Surry County, NC
NCDEQ Contract No. 7180
DMS Project No. 100025
USACE Action ID No. SAW-2017-01504
NCDEQ DWR Certification No. 17-1045
RFP #: 16-006993

Data Collection Period: January 2021 – November 2021
Final Submission Date: February 1, 2022

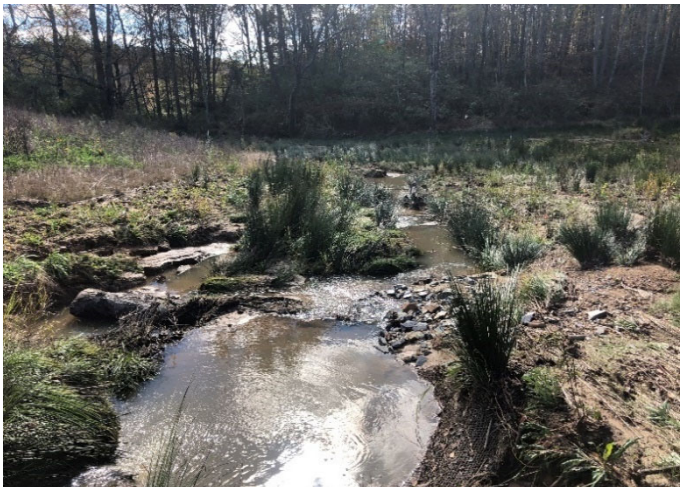
Pre-Repair – STA 212+30 Downstream; Erosion Along Left Bank Causing Channel Migration (11/02/2020)

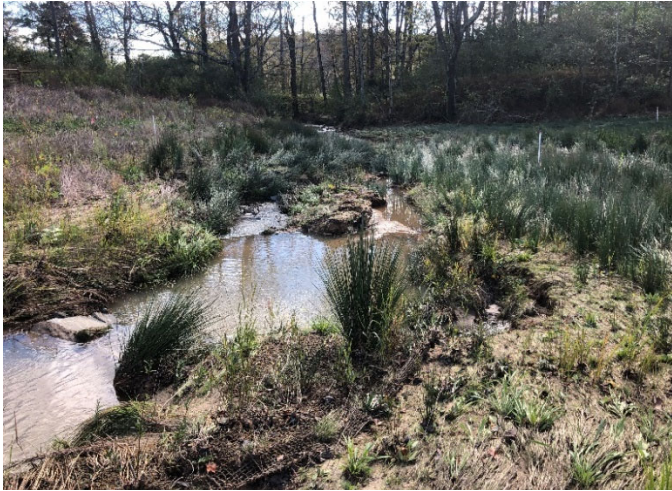
Pre-Repair – STA 212+80 Downstream; Erosion Along Right Bank (11/02/2020)

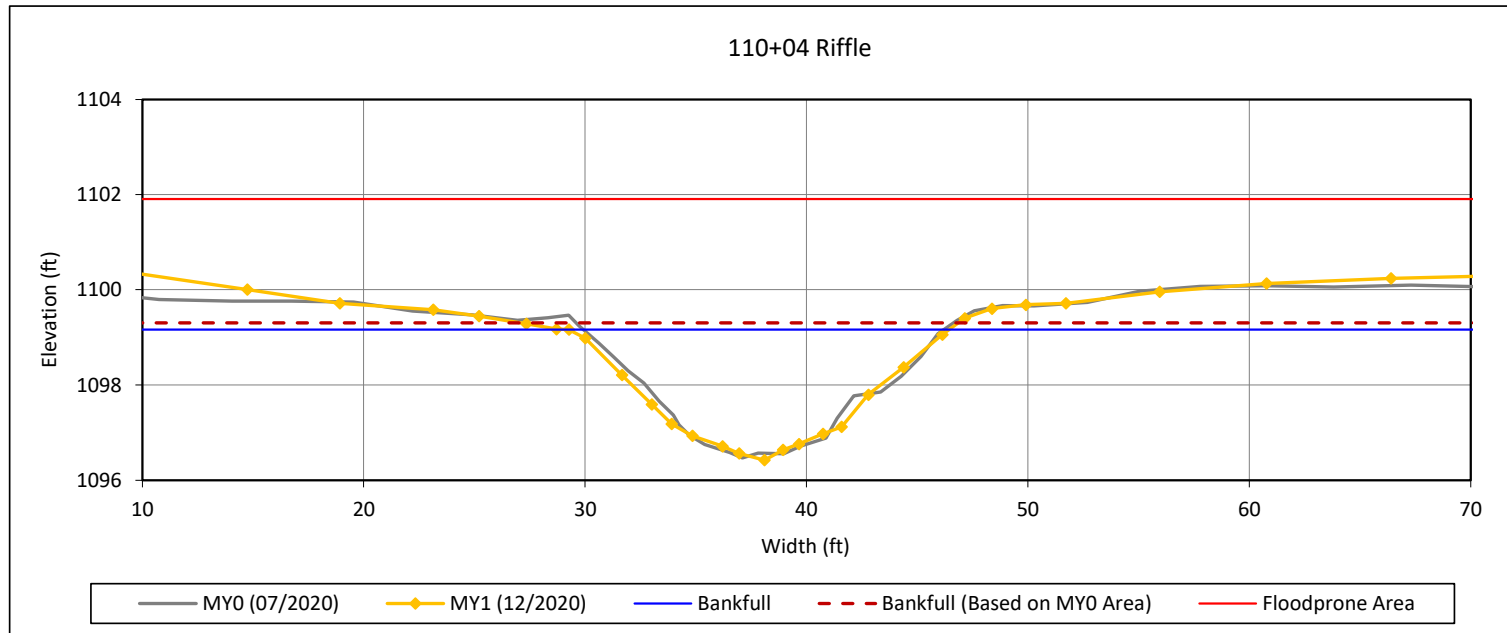
Cross-Section 2-Bull Creek Reach 1B

regrading on the left bank. These repairs resulted in a slight lateral shift in the channel alignment at XS2 and an enlargement of the cross-sectional area, bankfull width, and mean depth of XS3.

*Repairs conducted during MY1 resulted in a slight shift in the cross-section alignment between the MY0 and MY1 cross-section pin locations; therefore the plot was adjusted so that the cross-sections lined up for easier comparison.

As briefly mentioned in Section 2.2.2, cross-sections 2 and 3 are located in an area of repair work conducted on Bull Creek R1B. Work conducted in this area was completed prior to the MY1 survey and consisted of rebuilding the riffle, resetting the log sill, moving a flood plain outlet upstream, and

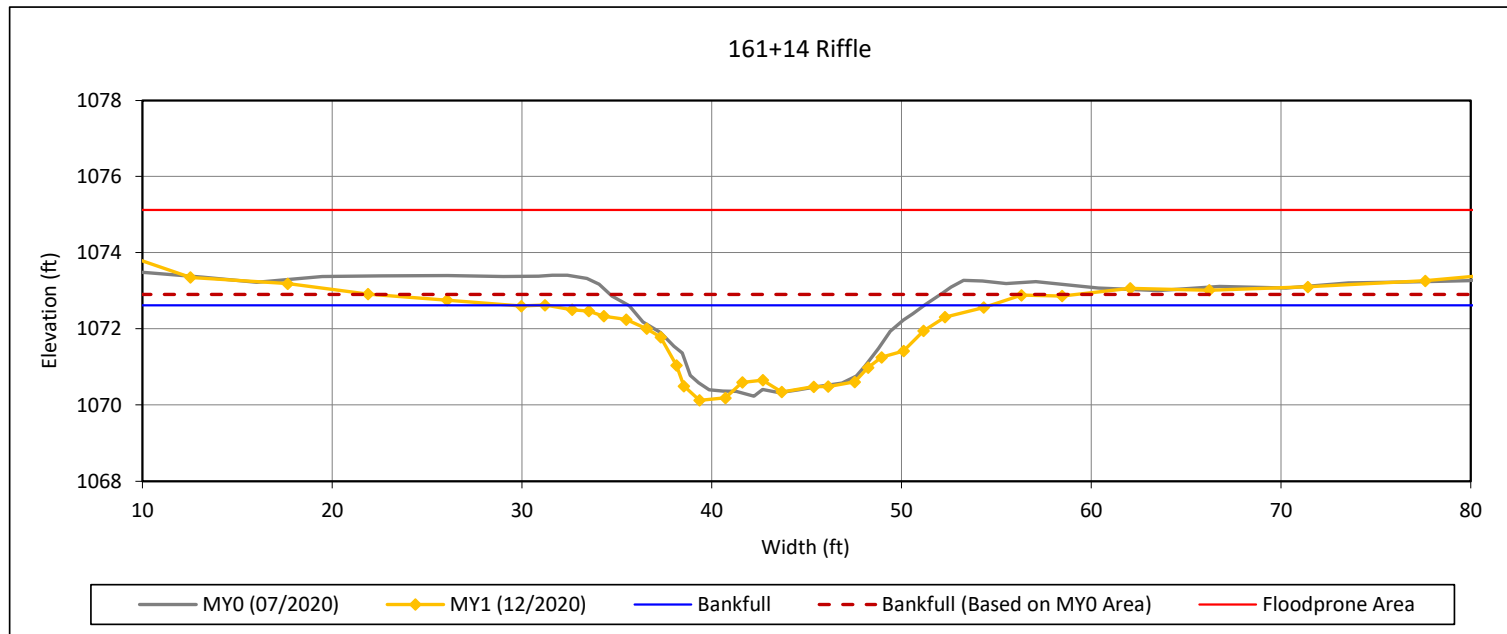
Cross-Section 7-Bull Creek Reach 3

Cross-sections 7 and 14 are also located in areas where repairs were needed. However, repairs in these areas were conducted after the completion of the MY1 survey, so repair work did not affect variations in cross-sectional dimensions reported in MY1. Instead, these variations were likely due to storm damage in the form of bank erosion along the riffle and the displacement of bed material within the riffle and resulted in an increase in bankfull width and width to depth ratio on XS7 and an increase in the BHR for XS10 and XS14.

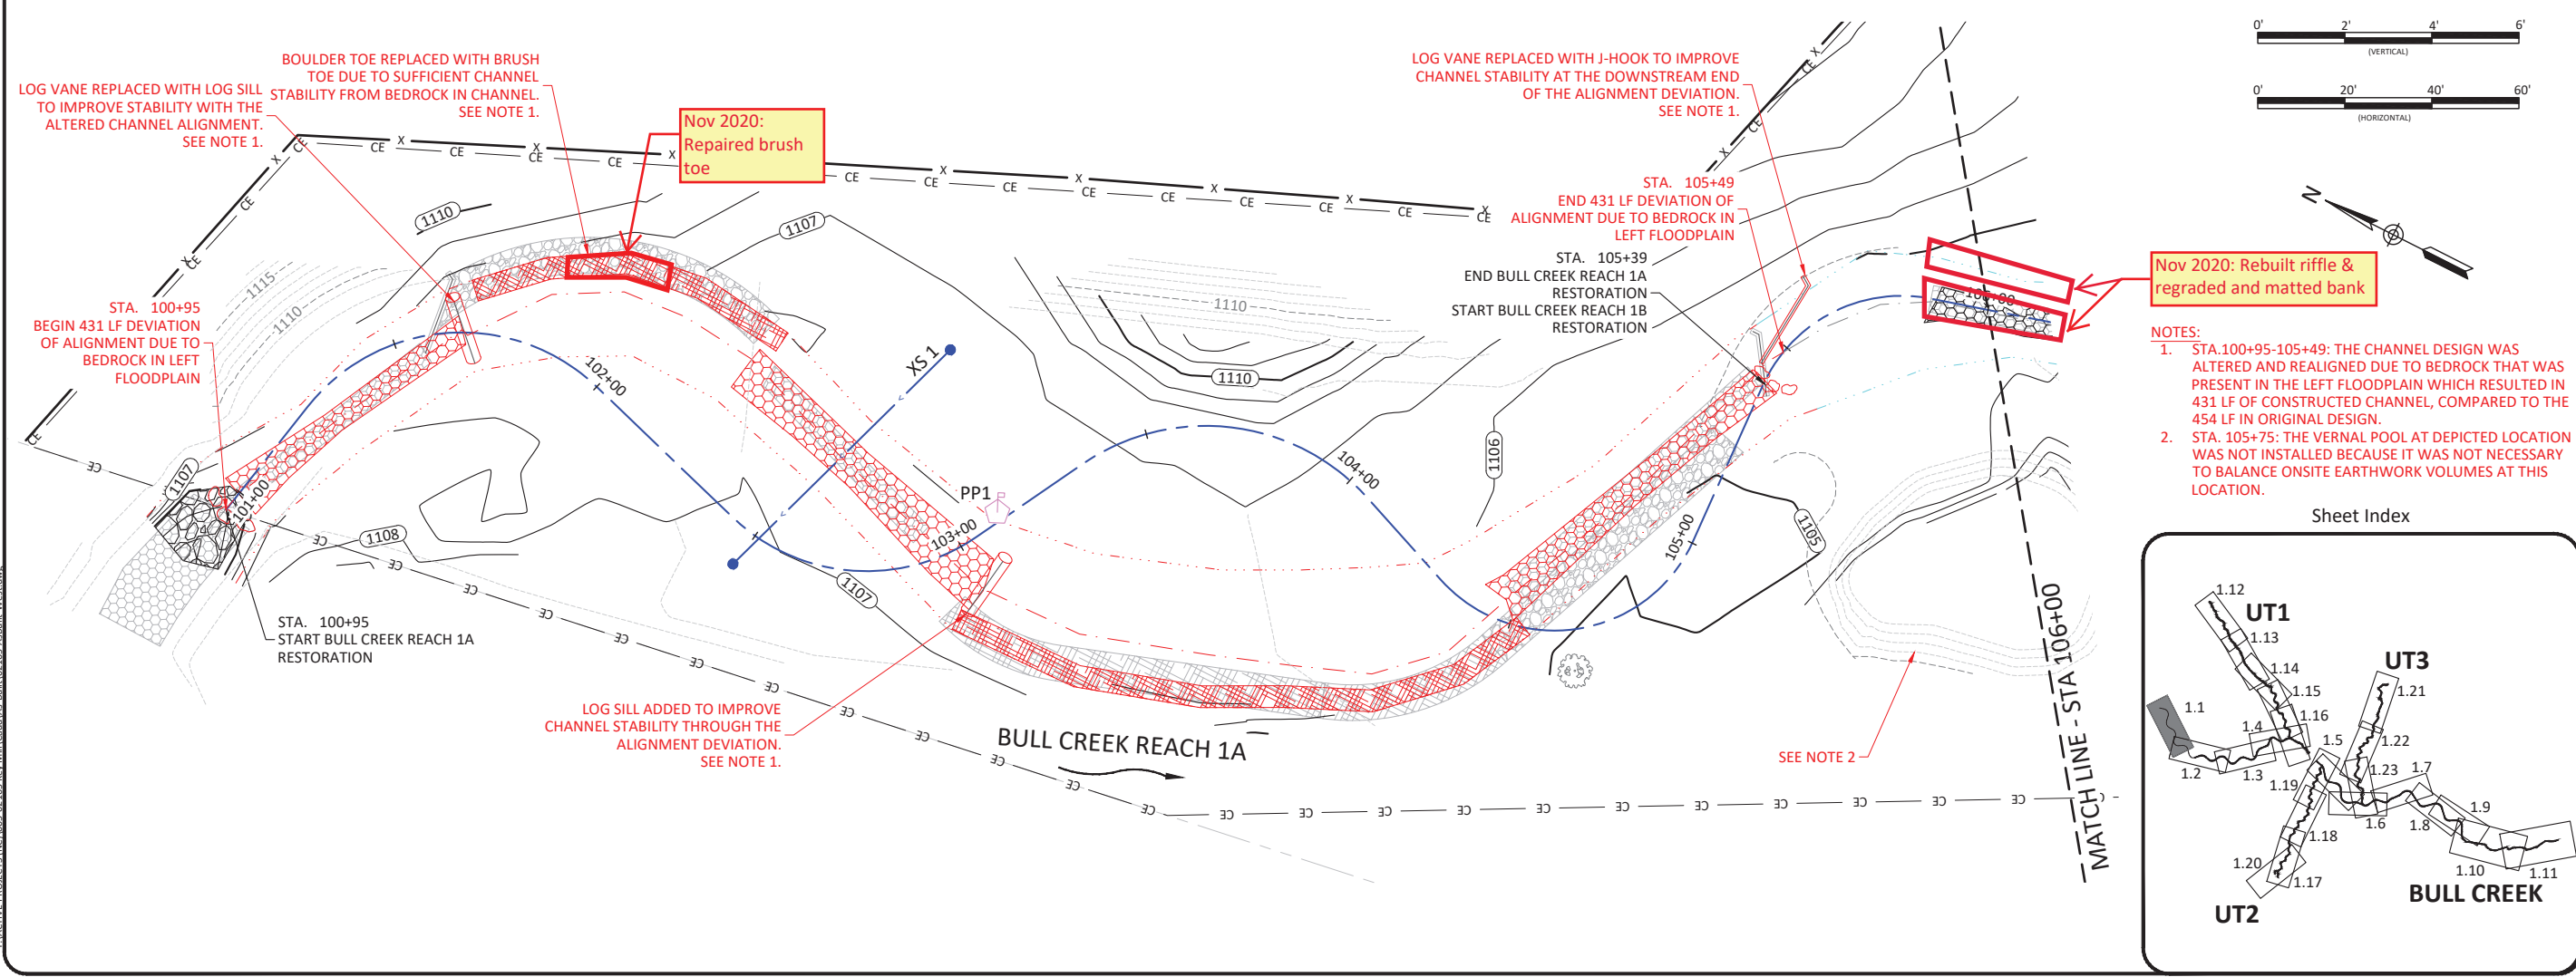
- NOTES:**
1. STA.100+95-105+49: THE CHANNEL DESIGN WAS ALTERED AND REALIGNED DUE TO BEDROCK THAT WAS PRESENT IN THE LEFT FLOODPLAIN WHICH RESULTED IN 431 LF OF CONSTRUCTED CHANNEL, COMPARED TO THE 454 LF IN ORIGINAL DESIGN.
 2. STA. 105+75: THE VERNAL POOL AT DEPICTED LOCATION WAS NOT INSTALLED BECAUSE IT WAS NOT NECESSARY TO BALANCE ONSITE EARTHWORK VOLUMES AT THIS LOCATION.

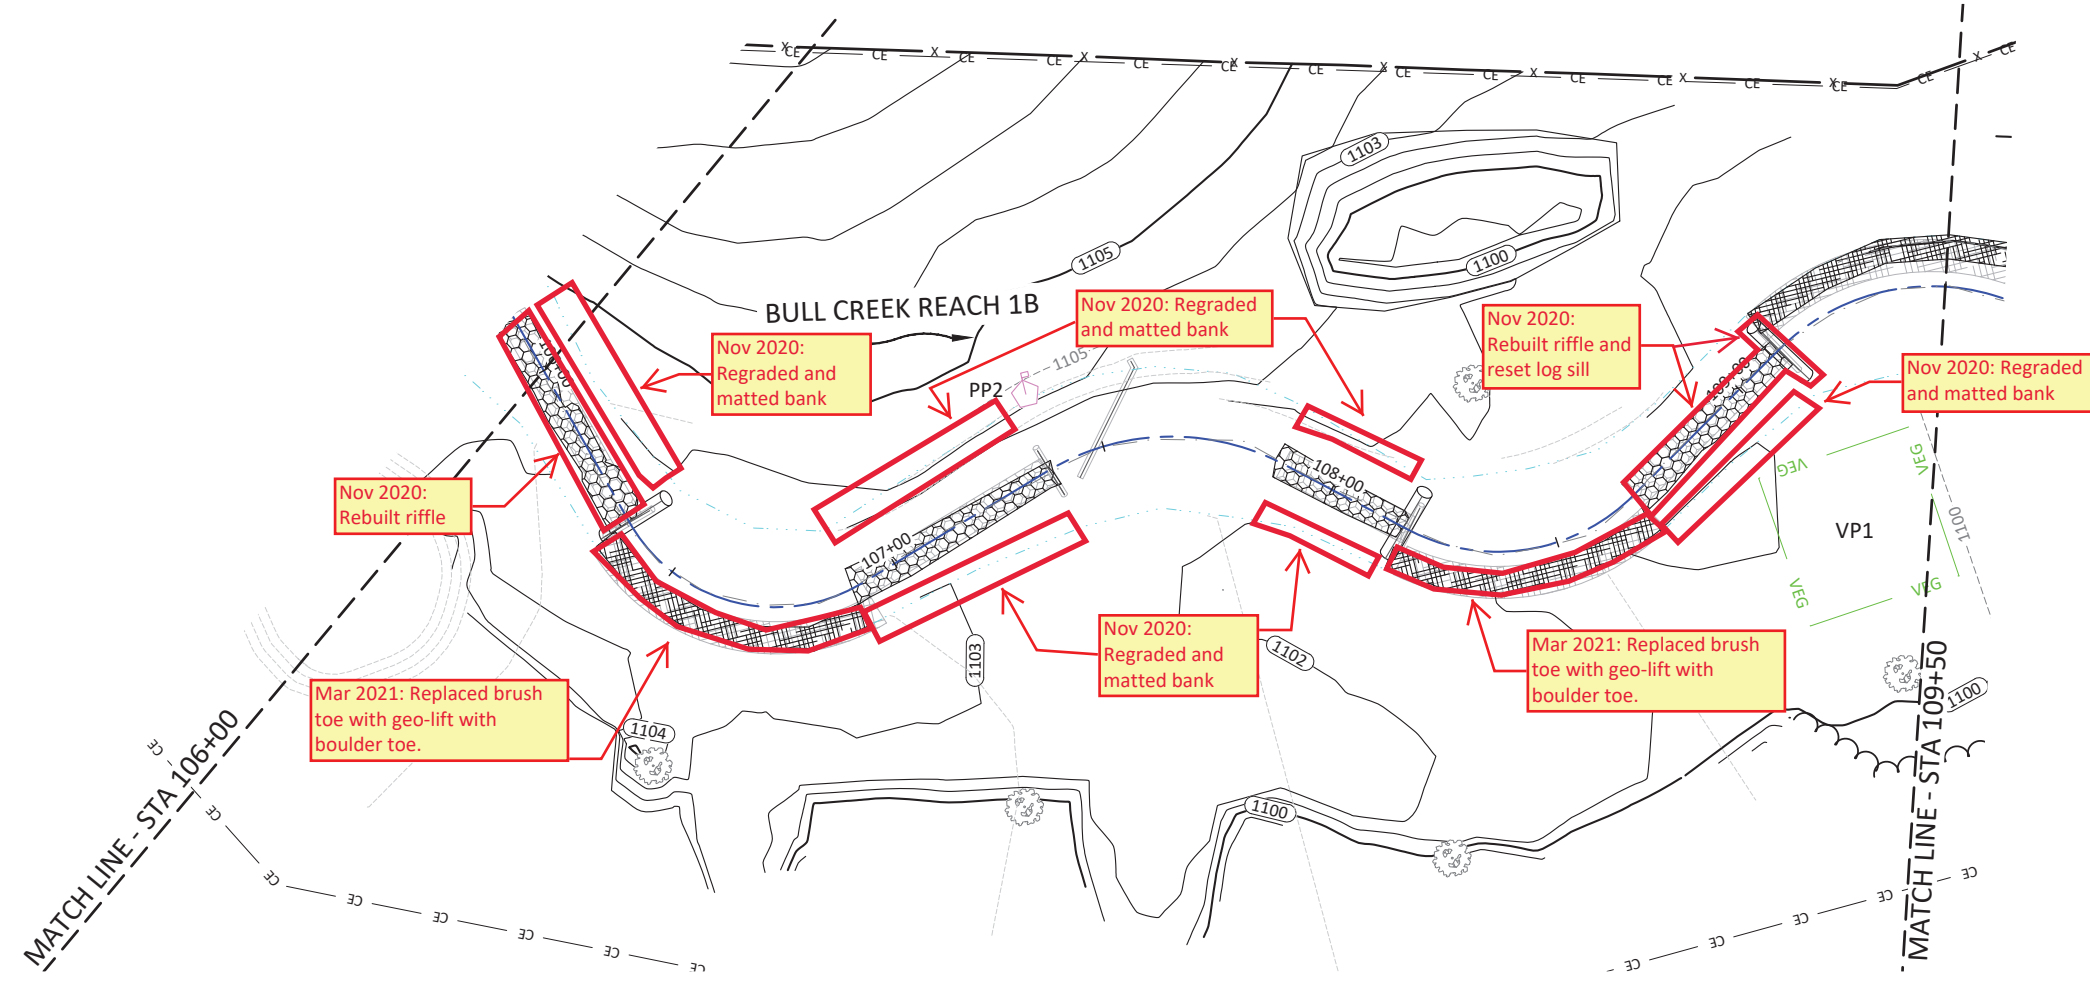
Key Mill Mitigation Site - Record Drawings
 Surry County, North Carolina
 Bull Creek Reach 1B
 Stream Plan and Profile

NOTE:
 1. STA. 107+40: THE LOG SILL AND LOG VANE WERE OMITTED DUE TO PRESENCE OF BEDROCK.

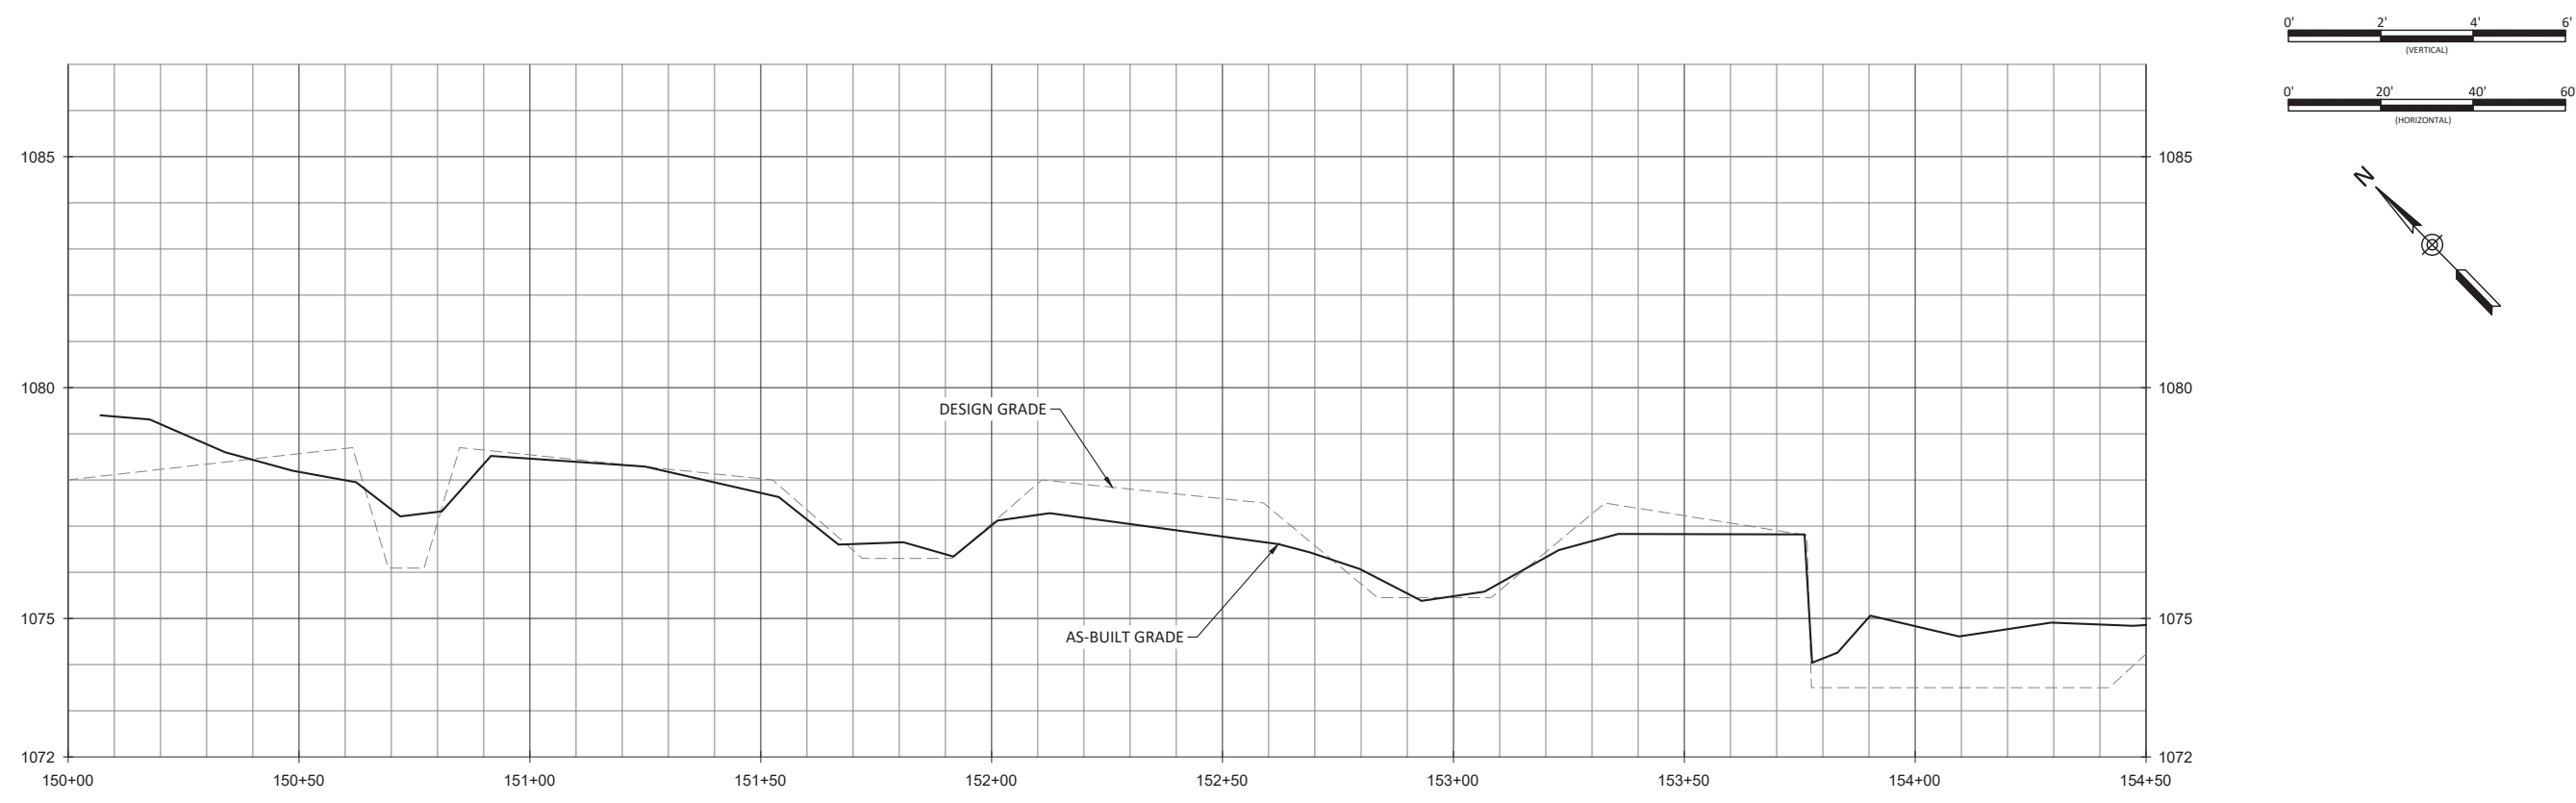
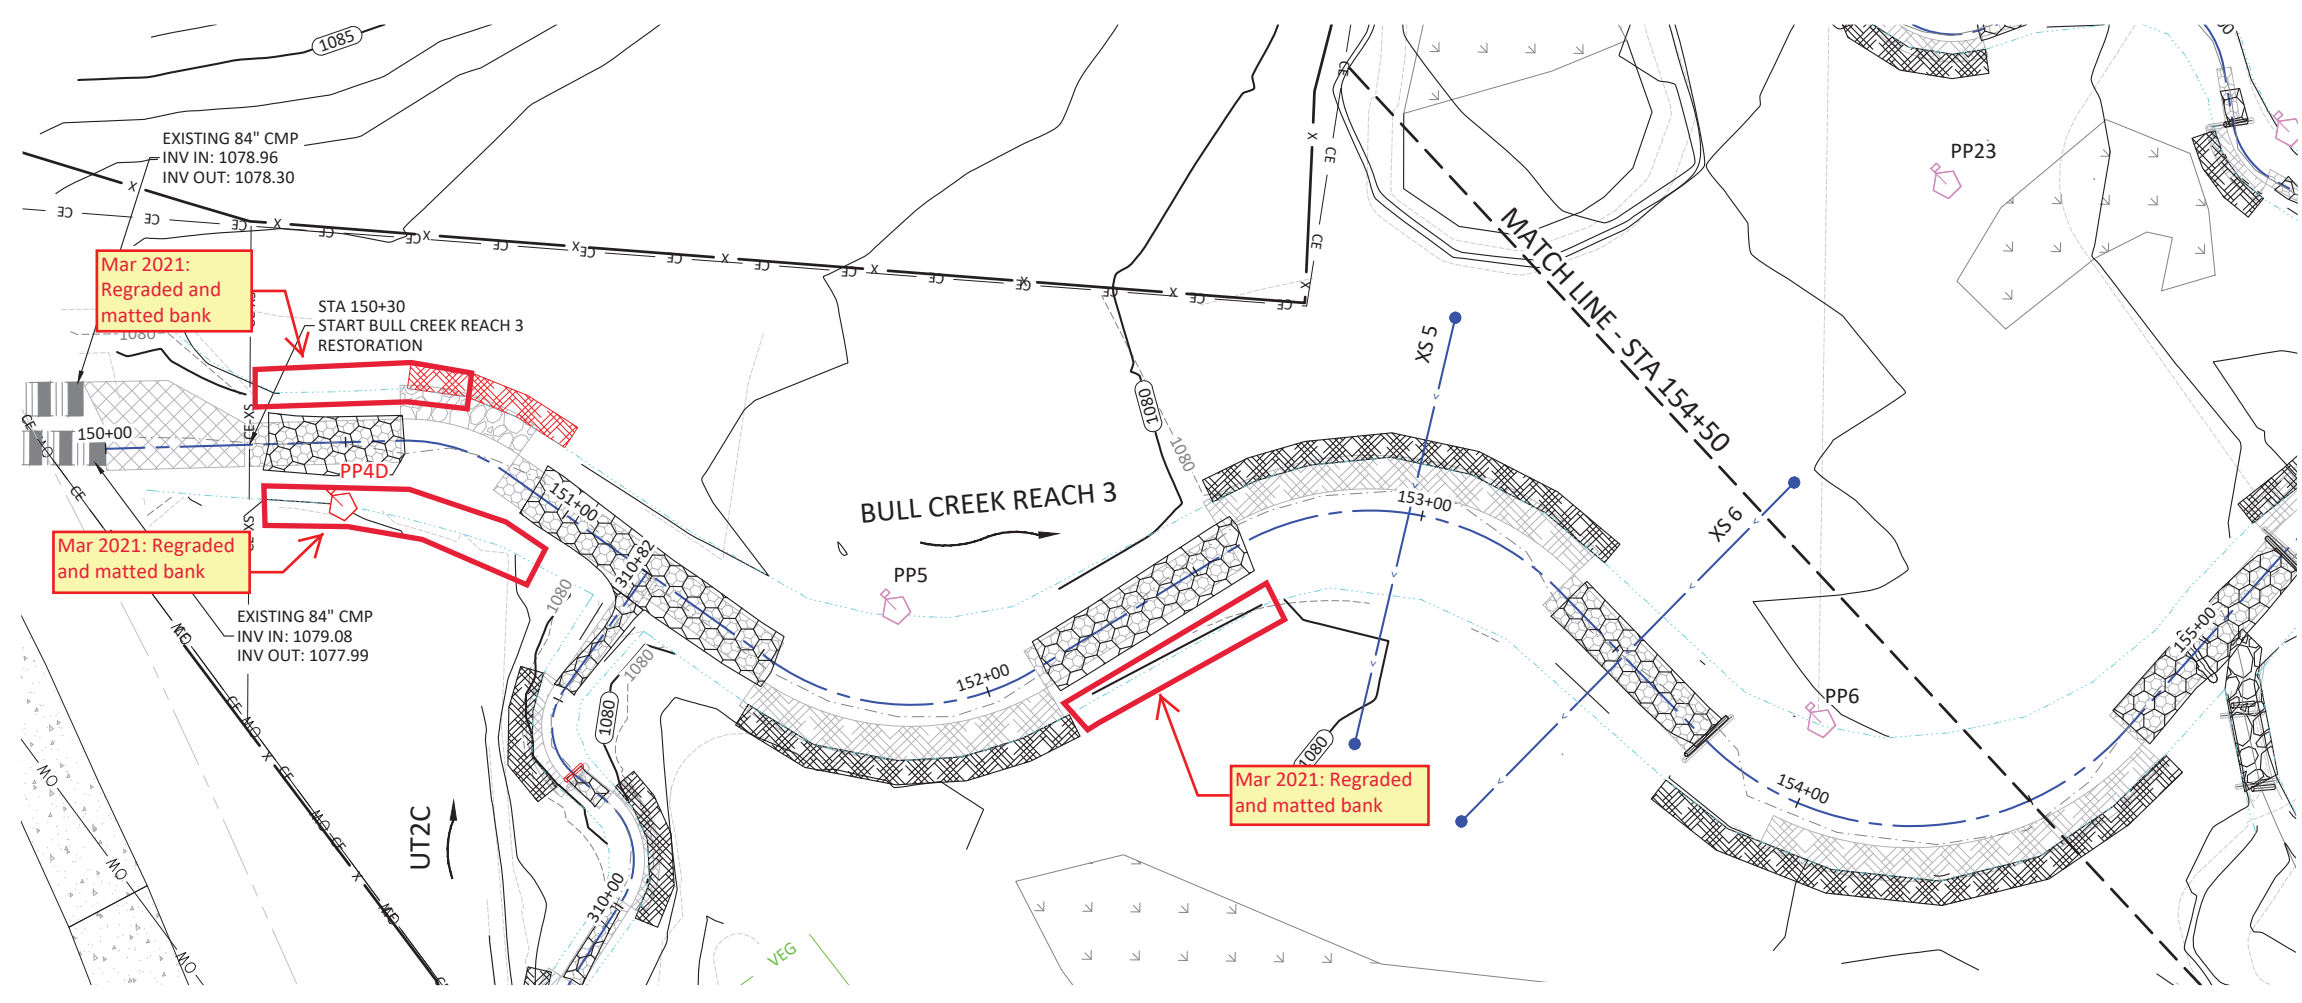
- NOTE:**
1. STA. 150+50: PHOTO POINT 4D WAS ADDED AFTER THE SURVEY WAS COMPLETED AT THE REQUEST OF DMS TO CAPTURE THE CONSERVATION EASEMENT BREAK.
 2. STA. 150+62: BOULDER TOE REPLACED WITH BRUSH TOE DUE TO LOCAL MATERIAL AVAILABILITY AND TO IMPROVE IN-STREAM HABITAT.

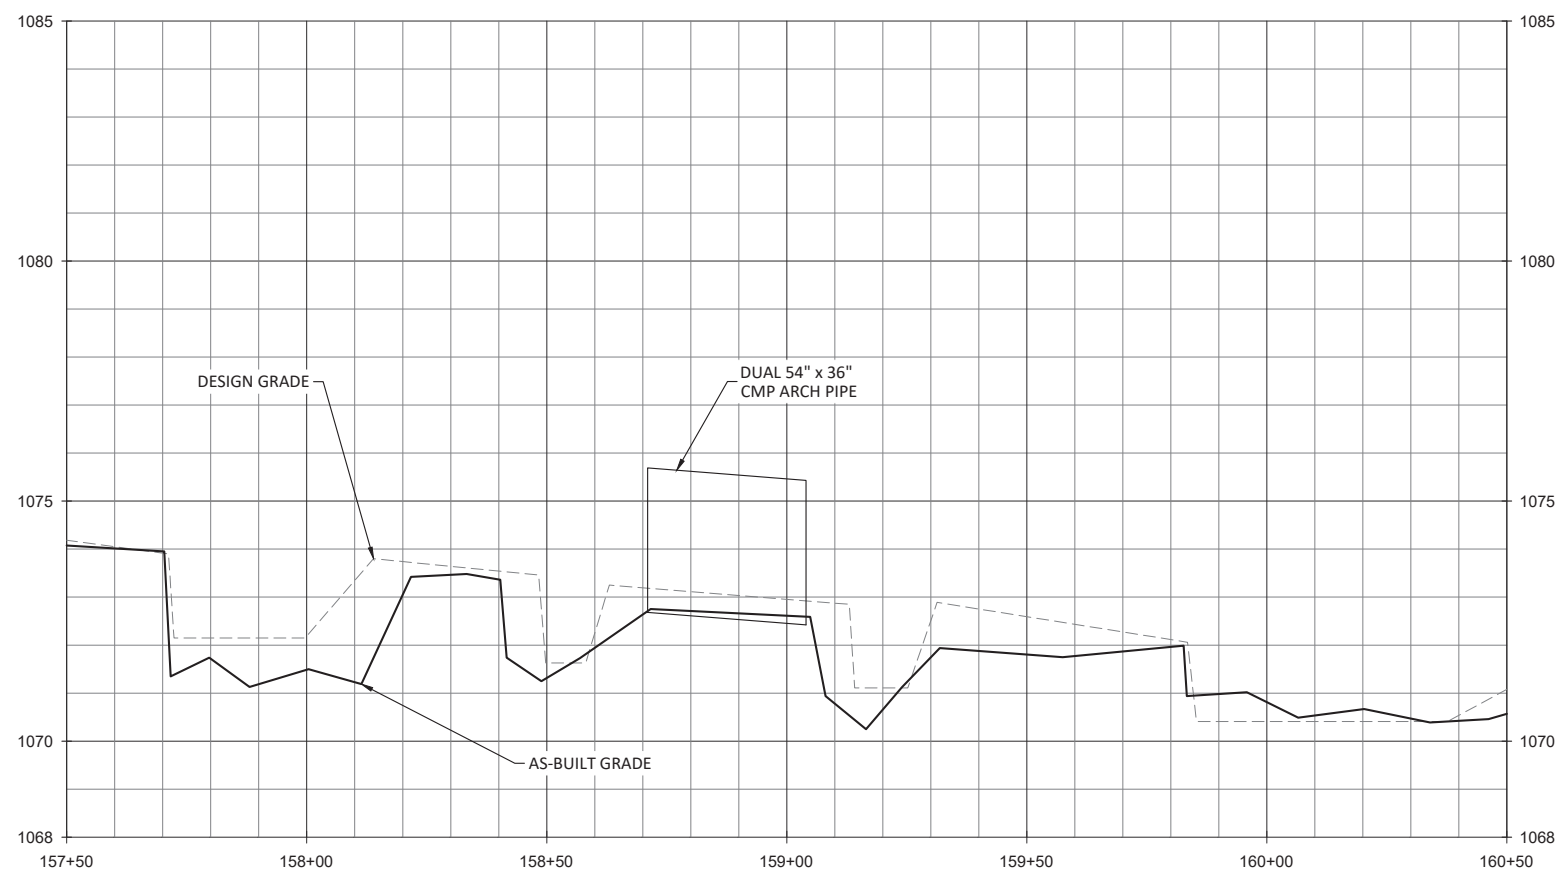
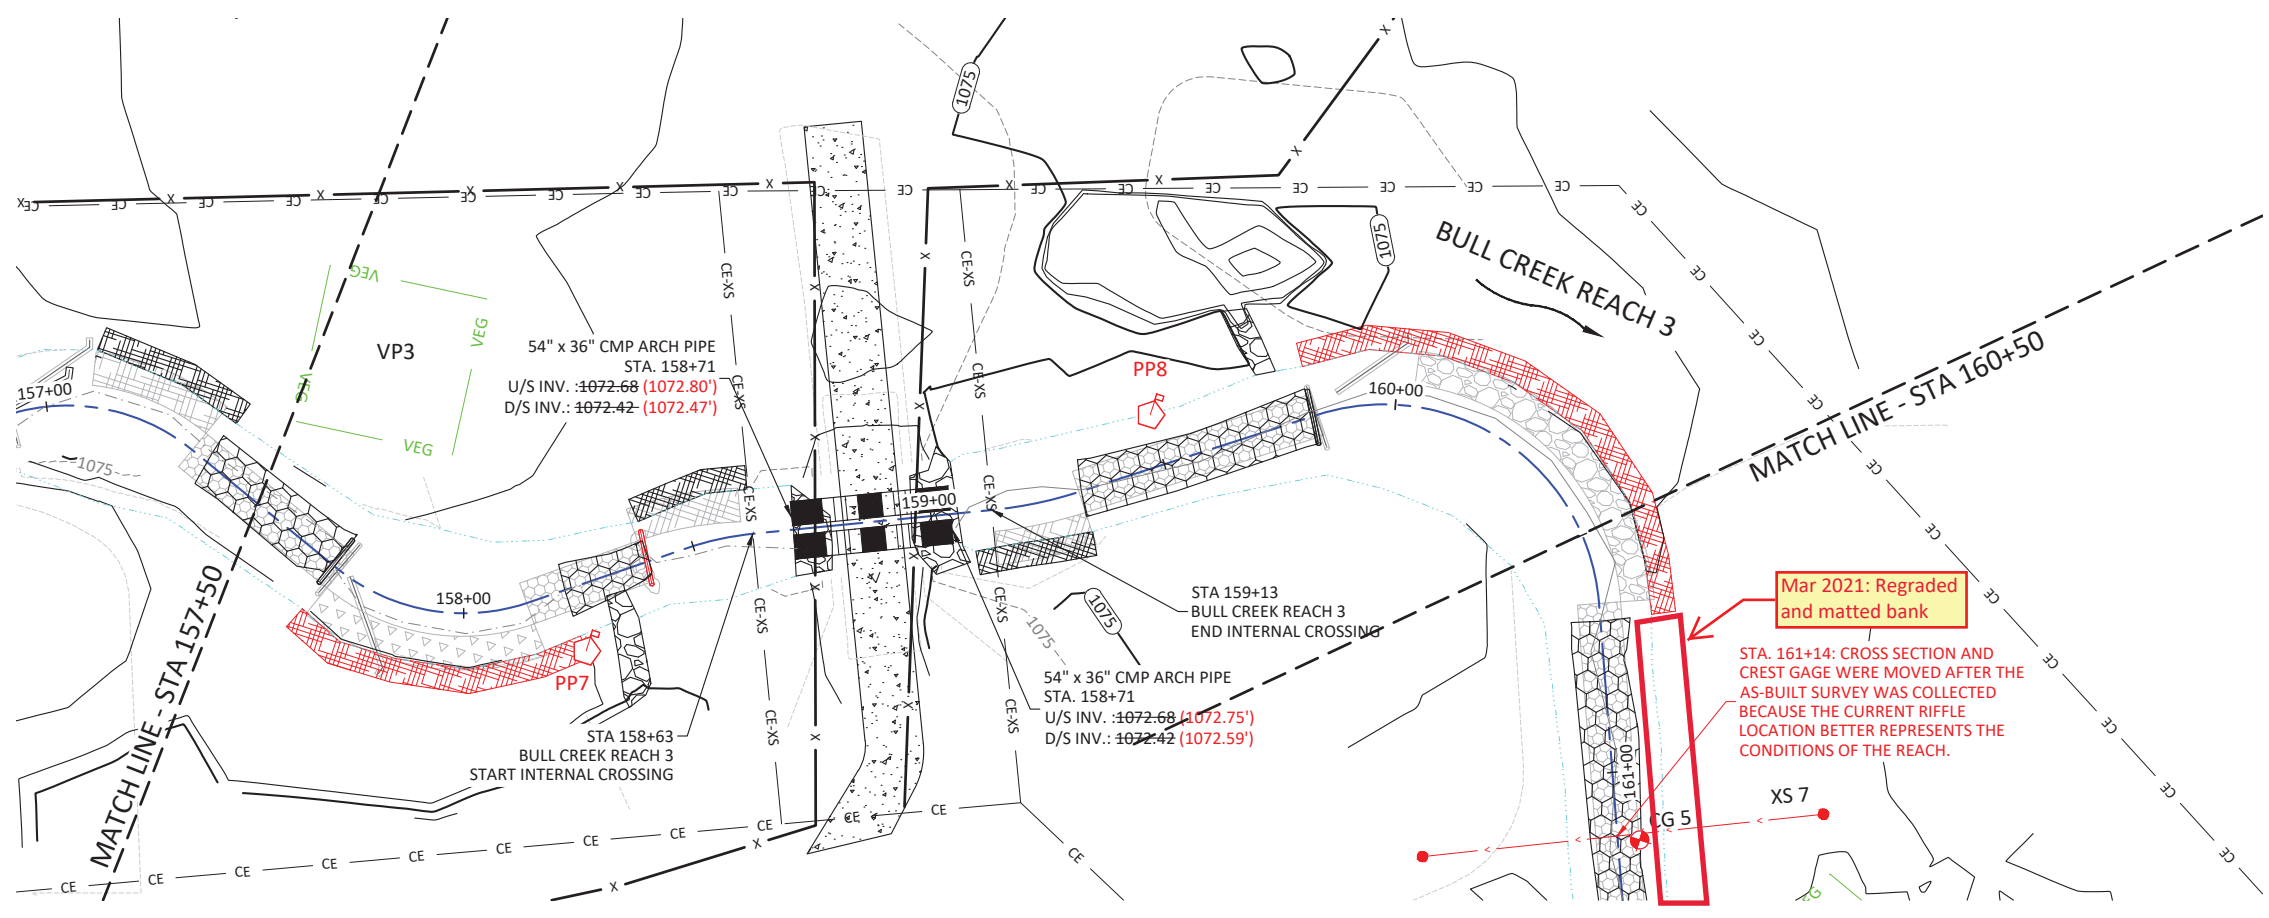
- NOTE:**
1. STA. 157+72: BRUSH MATTRESS REPLACED WITH BRUSH TOE DUE TO TIME OF YEAR OF INSTALLATION. LOG VANE REMOVED DUE TO BANK STABILITY AND HABITAT ENHANCEMENT PROVIDED BY BRUSH TOE.
 2. STA. 158+22: PHOTO POINT 7 WAS MOVED AFTER THE SURVEY WAS COMPLETED AT THE REQUEST OF DMS TO CAPTURE A DOWNSTREAM VIEW OF THE CULVERT CROSSING.
 3. STA. 158+40: ROCK SILL REPLACED WITH LOG SILL DUE TO LOCAL MATERIAL AVAILABILITY AND SIMILAR FUNCTIONALITY.
 4. STA. 159+50: PHOTO POINT 8 WAS MOVED AFTER THE SURVEY WAS COMPLETED AT THE REQUEST OF DMS TO CAPTURE AN UPSTREAM VIEW OF THE CULVERT CROSSING.
 5. STA. 159+84: BRUSH TOE WAS SUBSTITUTED FOR BOULDER TOE AND LOG VANE REMOVED DUE TO LOCAL MATERIAL AVAILABILITY AND THE BANK STABILITY AND HABITAT ENHANCEMENT PROVIDED BY BRUSH TOE.

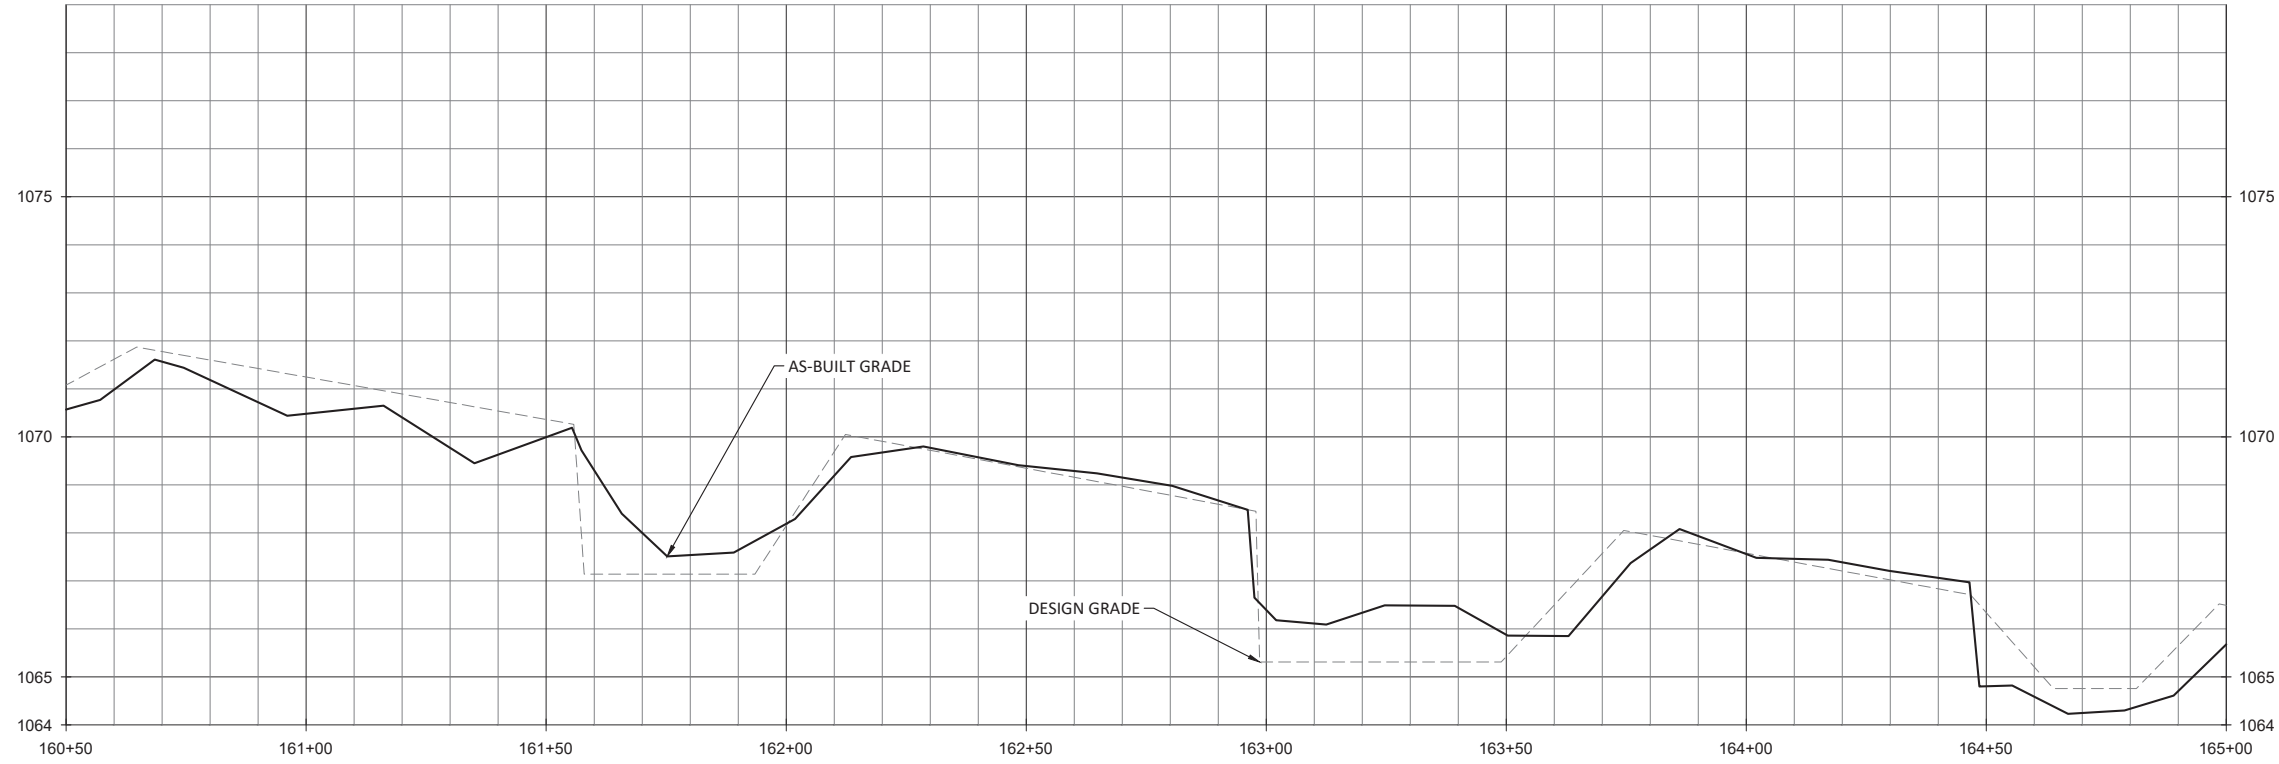
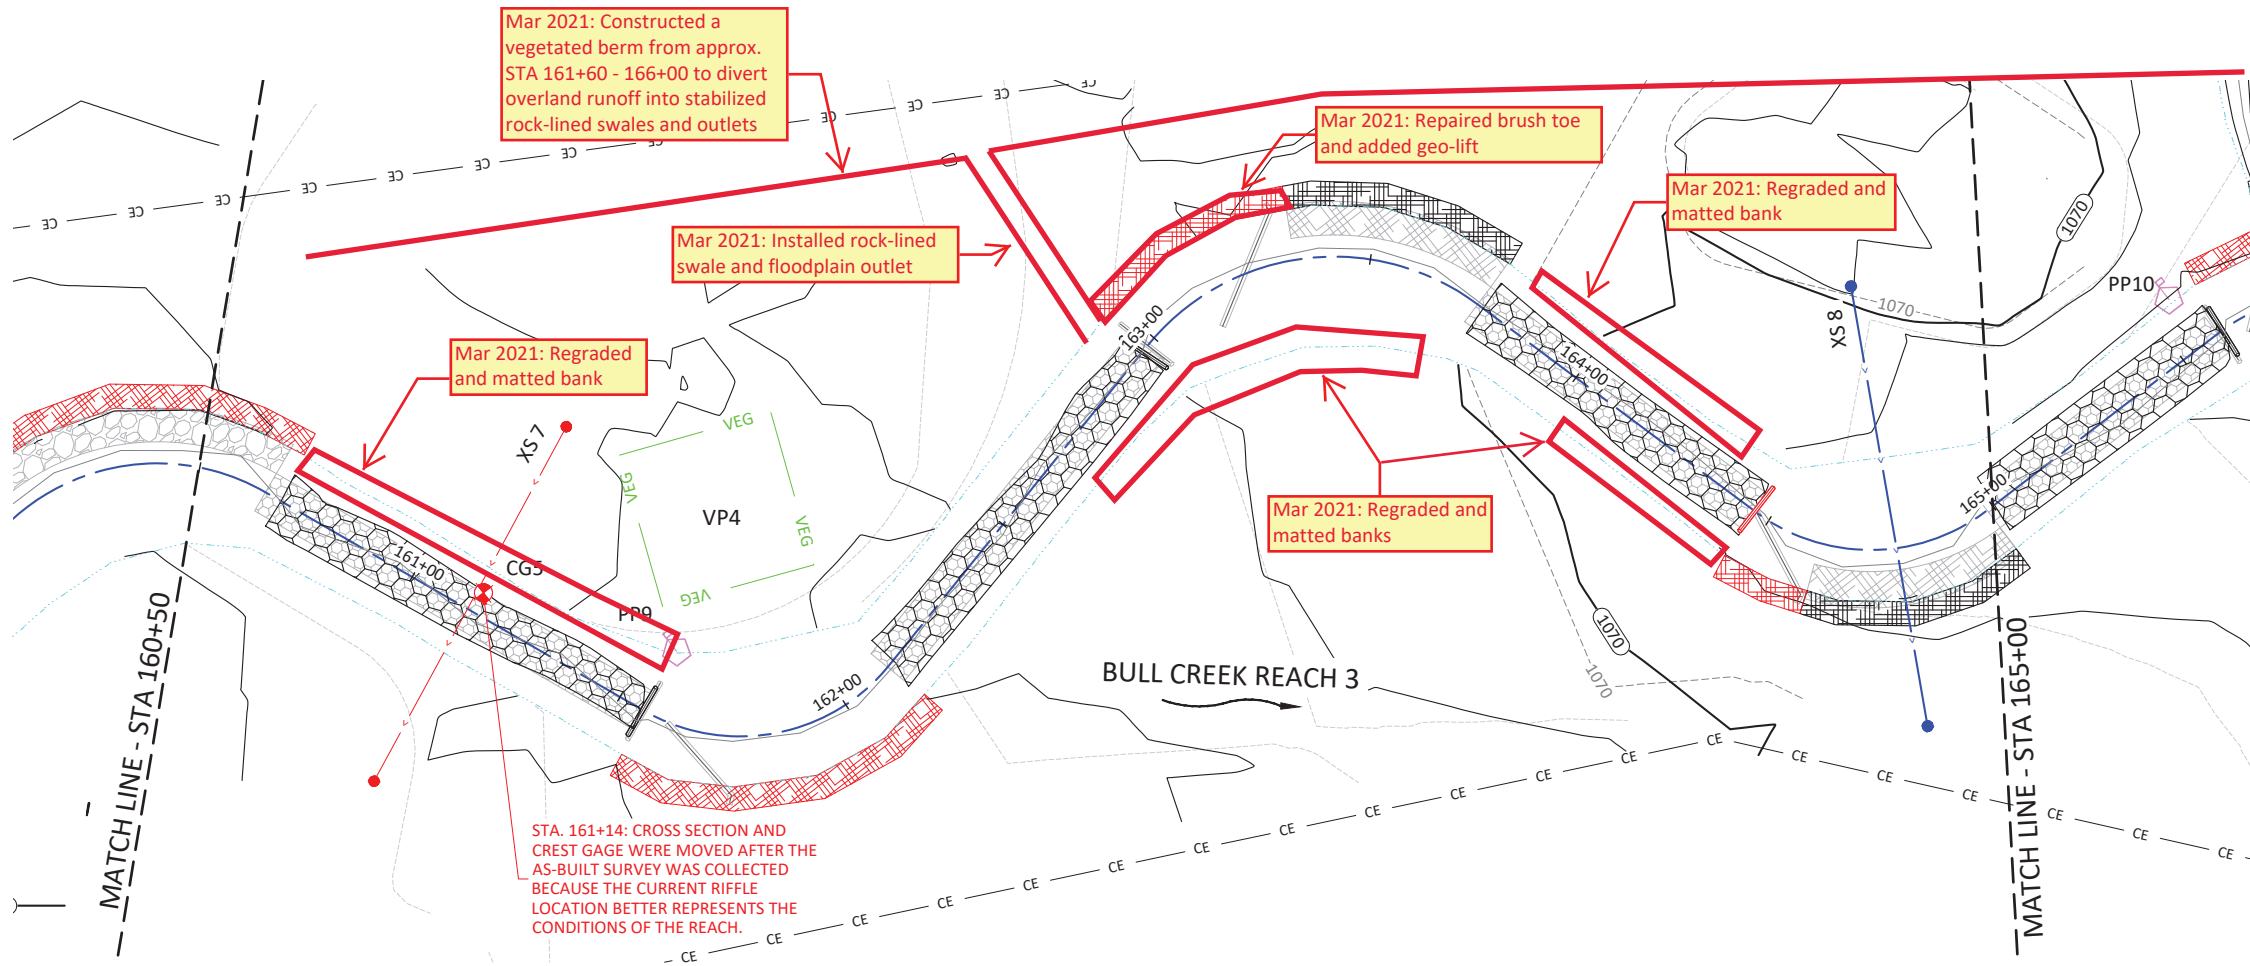
Sheet

- NOTE:**
1. STA. 161+56: LOG VANE REMOVED AND BRUSH TOE ADDED TO OUTSIDE BANK TO IMPROVE STABILITY FOR THE ENTIRE OUTSIDE BANK.
 2. STA. 163+30: LOG VANE REMOVED AND BRUSH TOE EXTENDED DUE TO AVAILABILITY OF MATERIALS AND TO IMPROVE STREAM BANK STABILITY AND HABITAT.
 3. STA. 164+47: LOG VANE REMOVED, LOG SILL ADDED AND BRUSH TOE EXTENDED DUE TO LOCAL AVAILABILITY OF MATERIALS AND TO IMPROVE CHANNEL STABILITY AND HABITAT.

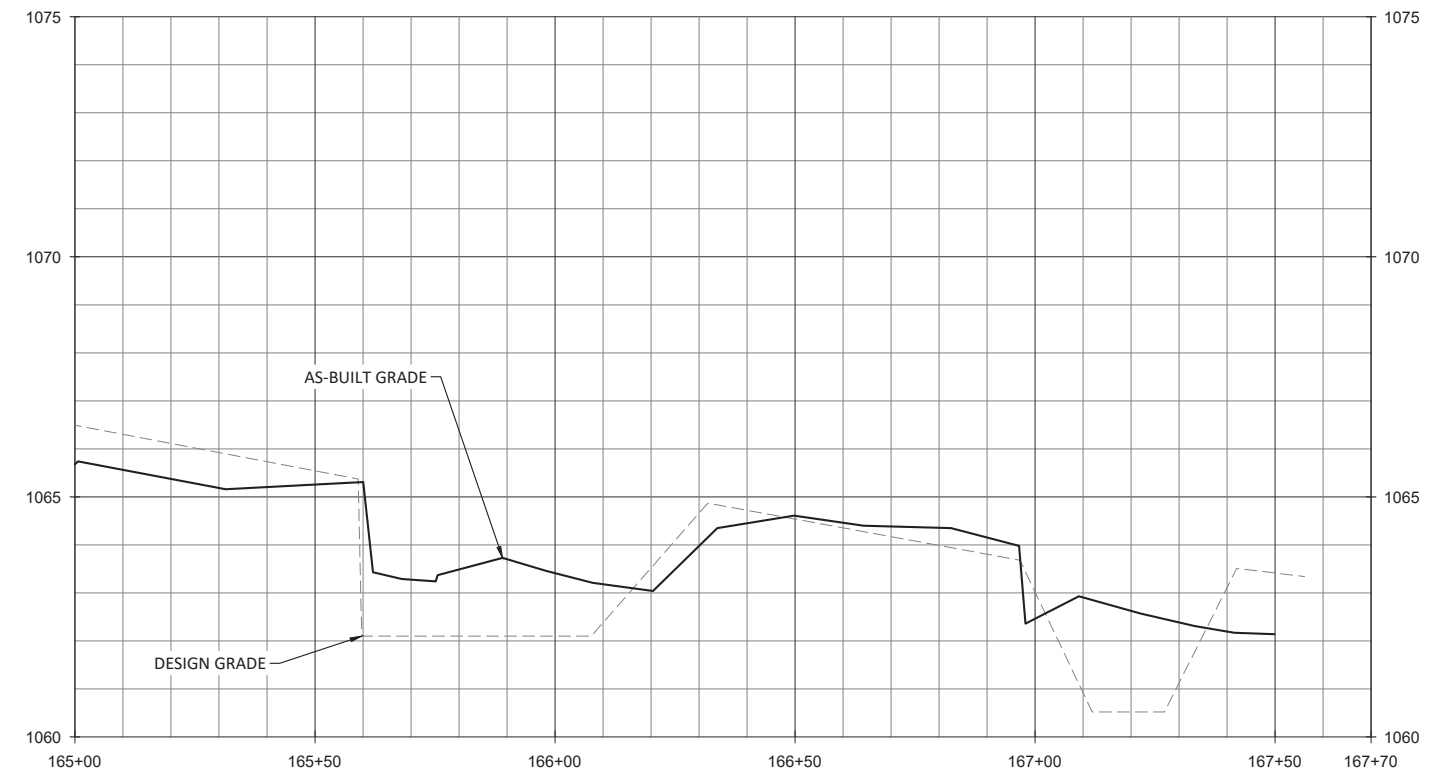
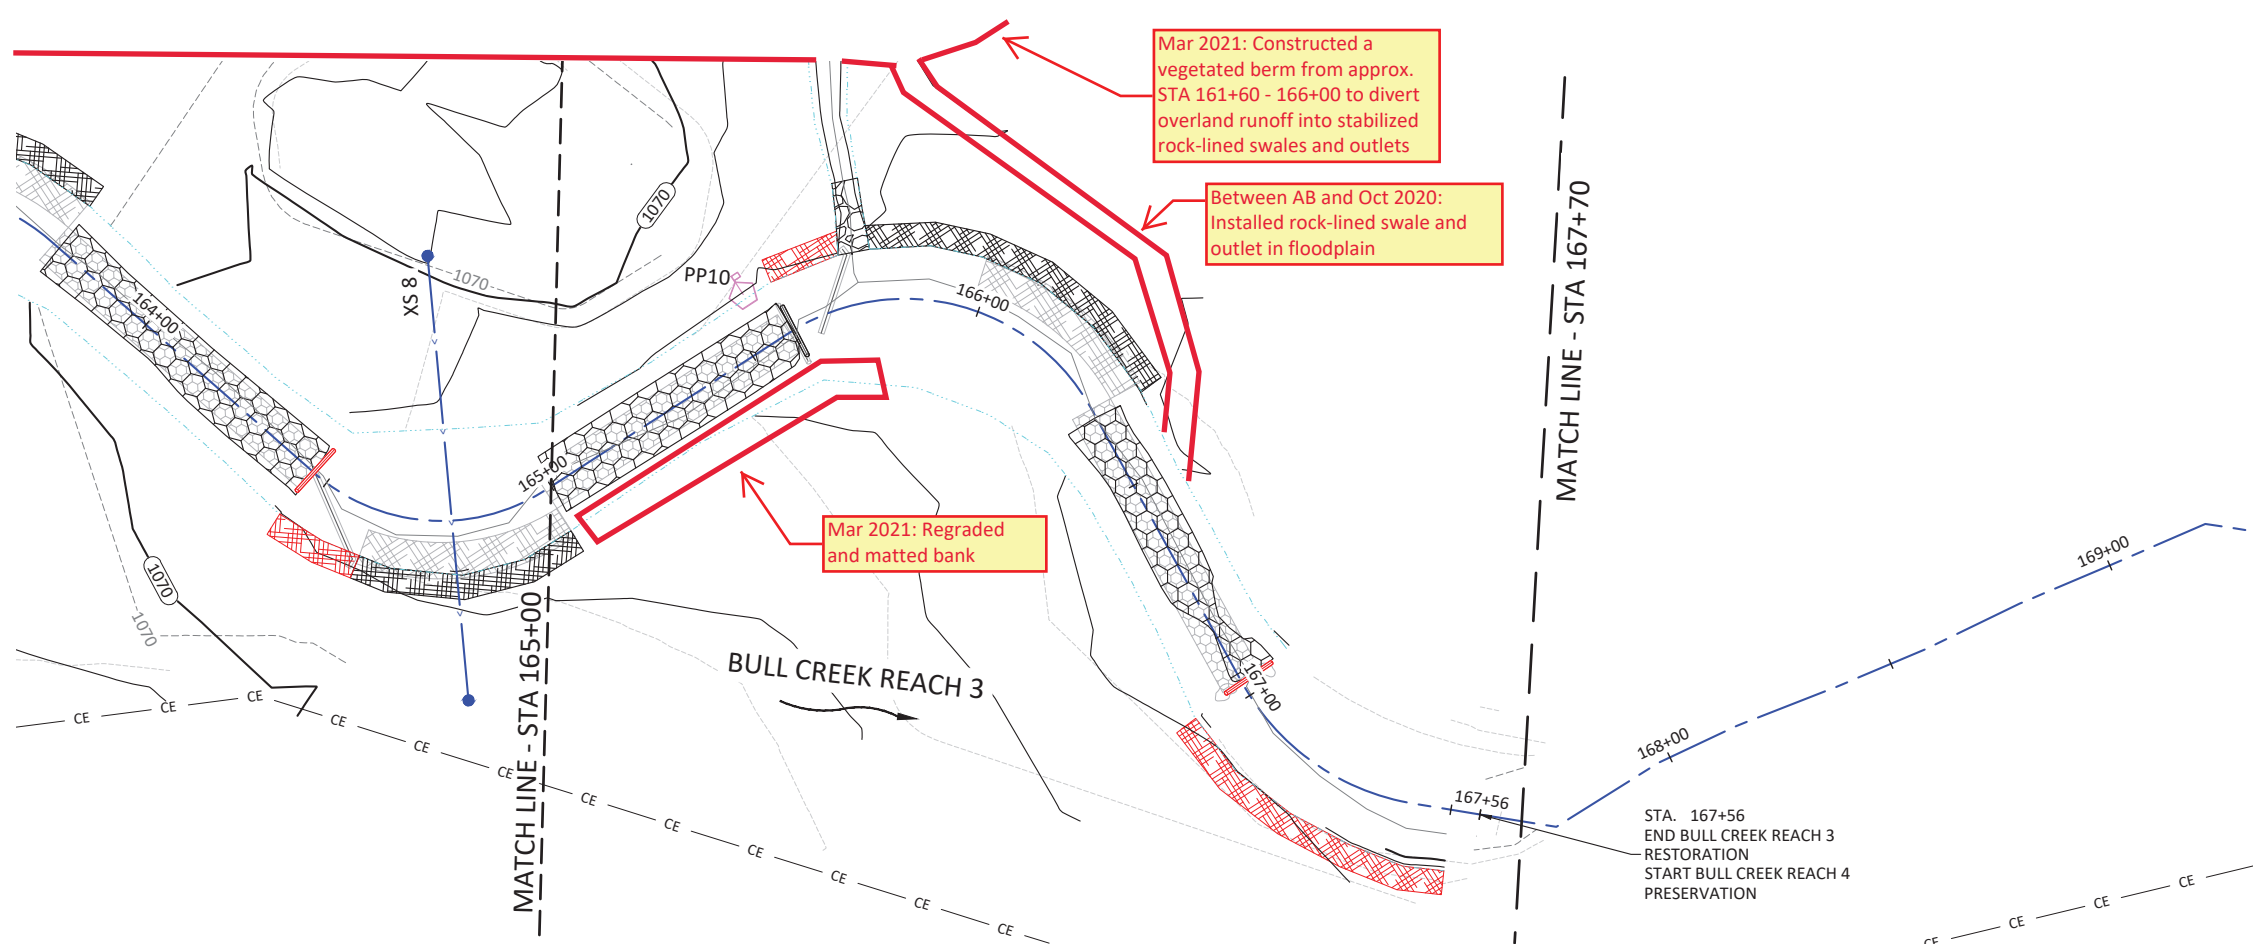
Bull Creek Reach 3
 Stream Plan and Profile

- NOTE:**
1. STA. 165+75: LOG VANE REMOVED AND BRUSH TOE EXTENDED DUE TO AVAILABILITY OF MATERIALS AND THE IMPROVED HABITAT PROVIDED BY BRUSH TOE.
 2. STA. 166+97: LOG SILL WAS SUBSTITUTED FOR ROCK SILL DUE TO LOCAL MATERIAL AVAILABILITY AND SITE CONDITIONS.
 3. STA. 167+00: BRUSH TOE WAS ADDED TO IMPROVE BANK STABILITY.
