MONITORING YEAR 2 ANNUAL REPORT

KEY MILL MITIGATION SITE

Surry County, NC
NCDEQ Contract No. 7180
DMS Project No. 100025
USACE Action ID No. SAW-2017-01504
NCDEQ DWR Certification No. 17-1045
RFP #: 16-006993

Data Collection Period: January 2021 – November 2021
Final Submission Date: February 1, 2022

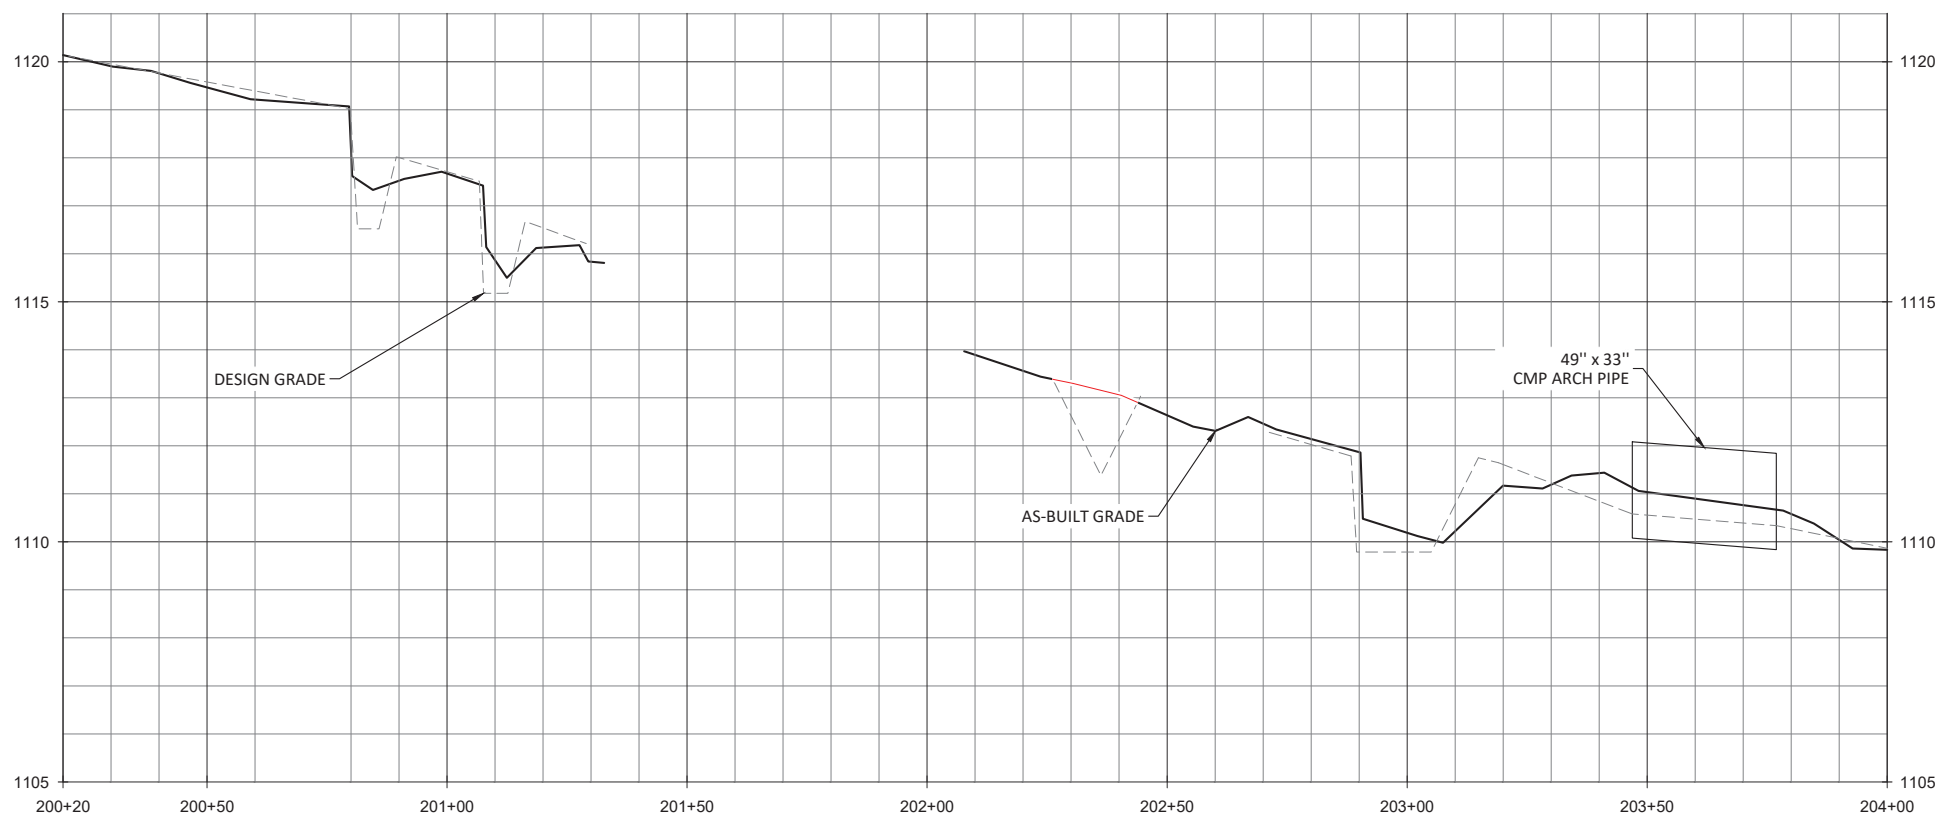
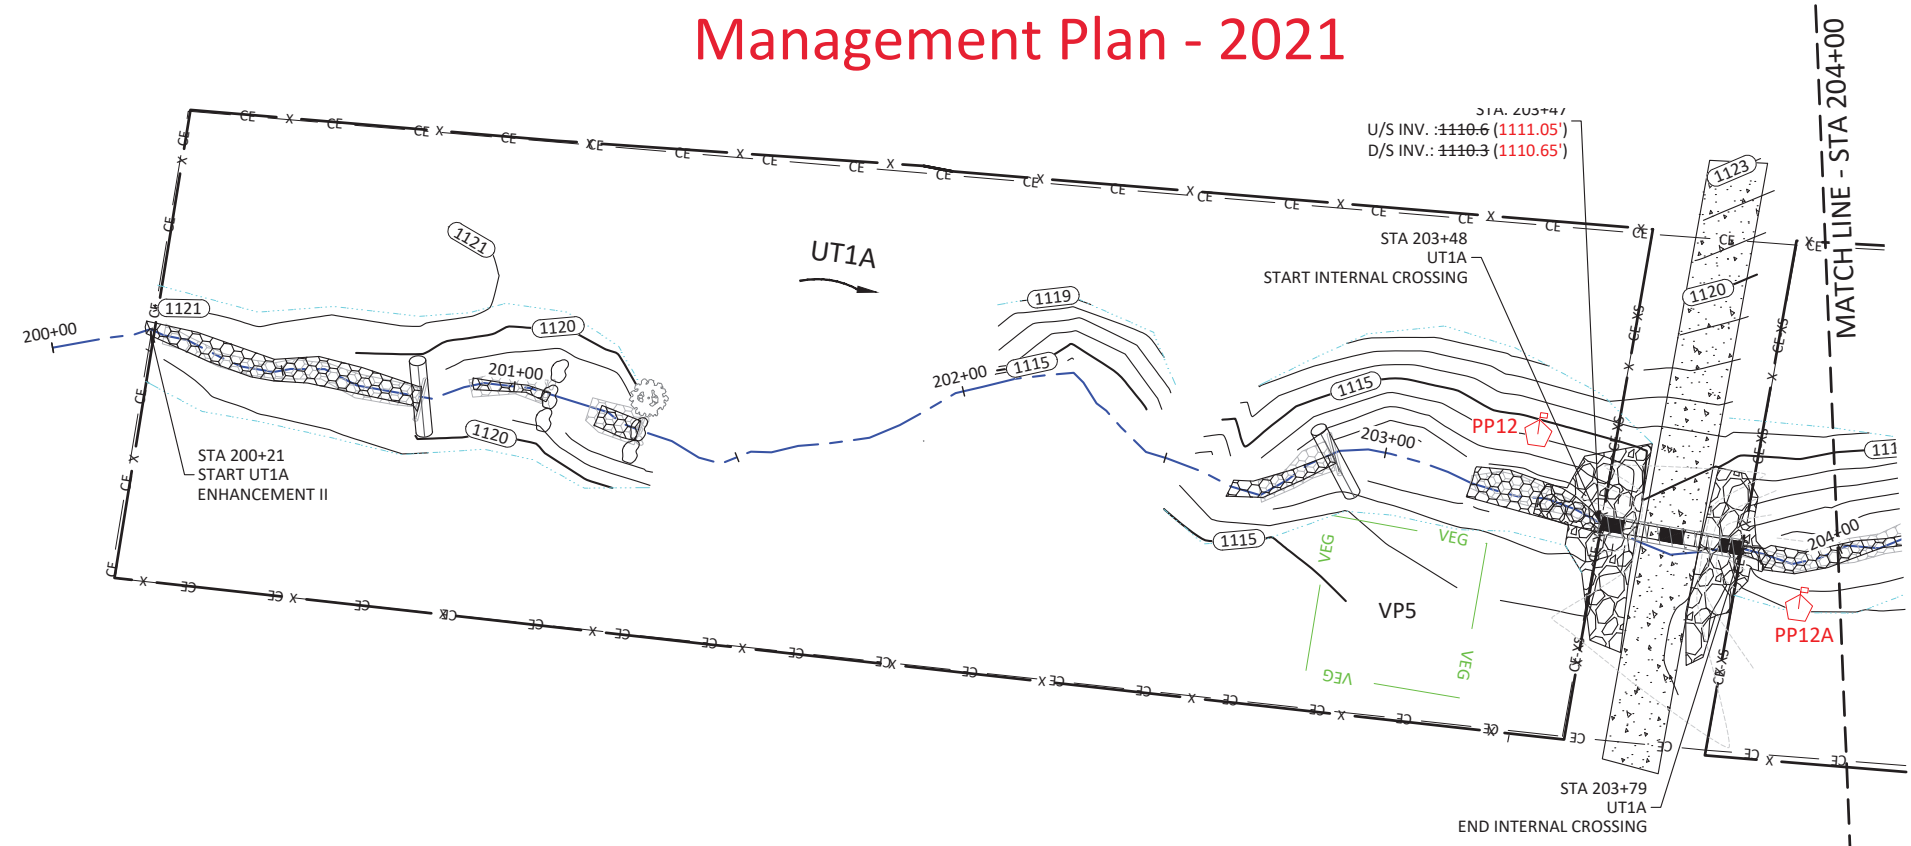
UT1A
 Stream Plan and Profile

- NOTES:**
1. STA. 202+26: POOL WAS NOT EXCAVATED DUE TO EXISTING PROFILE STABILITY.
 2. STA. 203+32: PHOTO POINT 12 WAS MOVED AFTER THE SURVEY WAS COMPLETED AT THE REQUEST OF DMS TO CAPTURE A DOWNSTREAM VIEW OF THE CULVERT CROSSING.
 3. STA. 203+90: PHOTO POINT 12A WAS ADDED AFTER THE SURVEY WAS COMPLETED AT THE REQUEST OF DMS TO CAPTURE AN UPSTREAM VIEW OF THE CULVERT CROSSING.

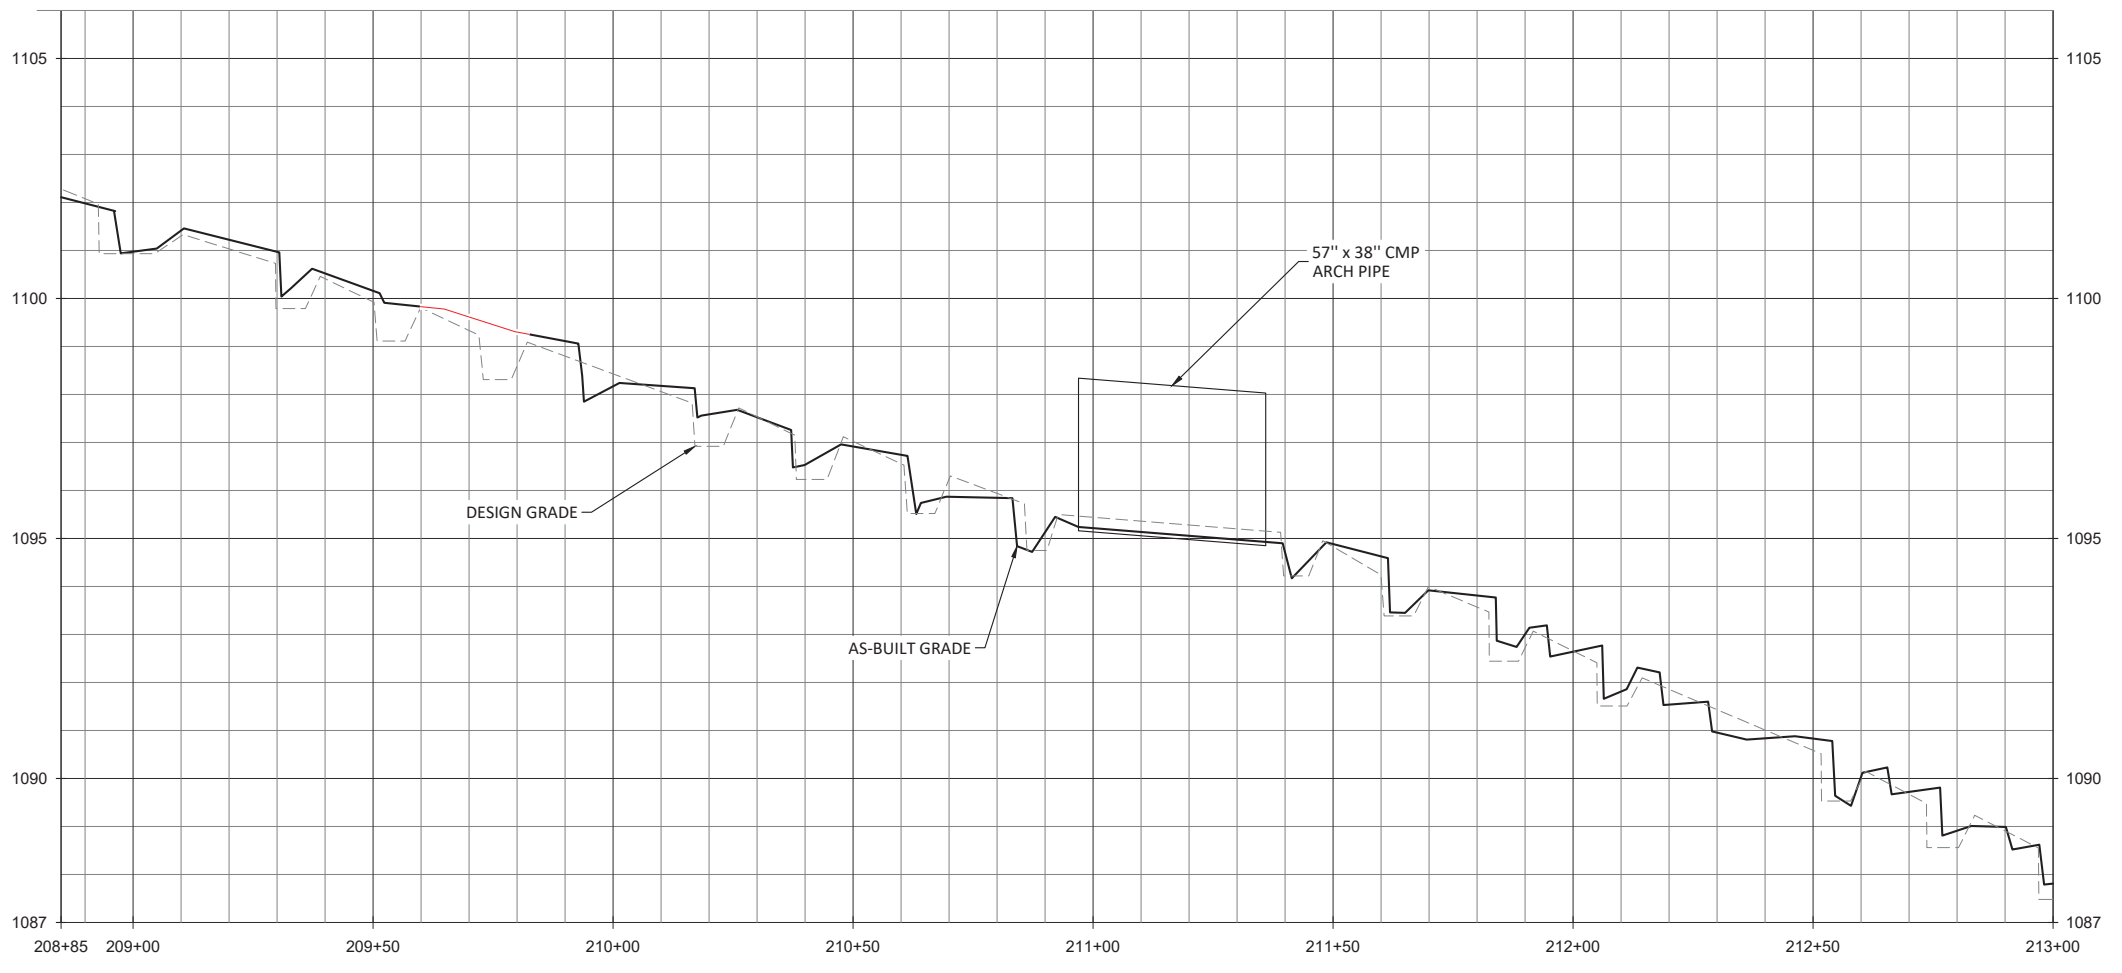
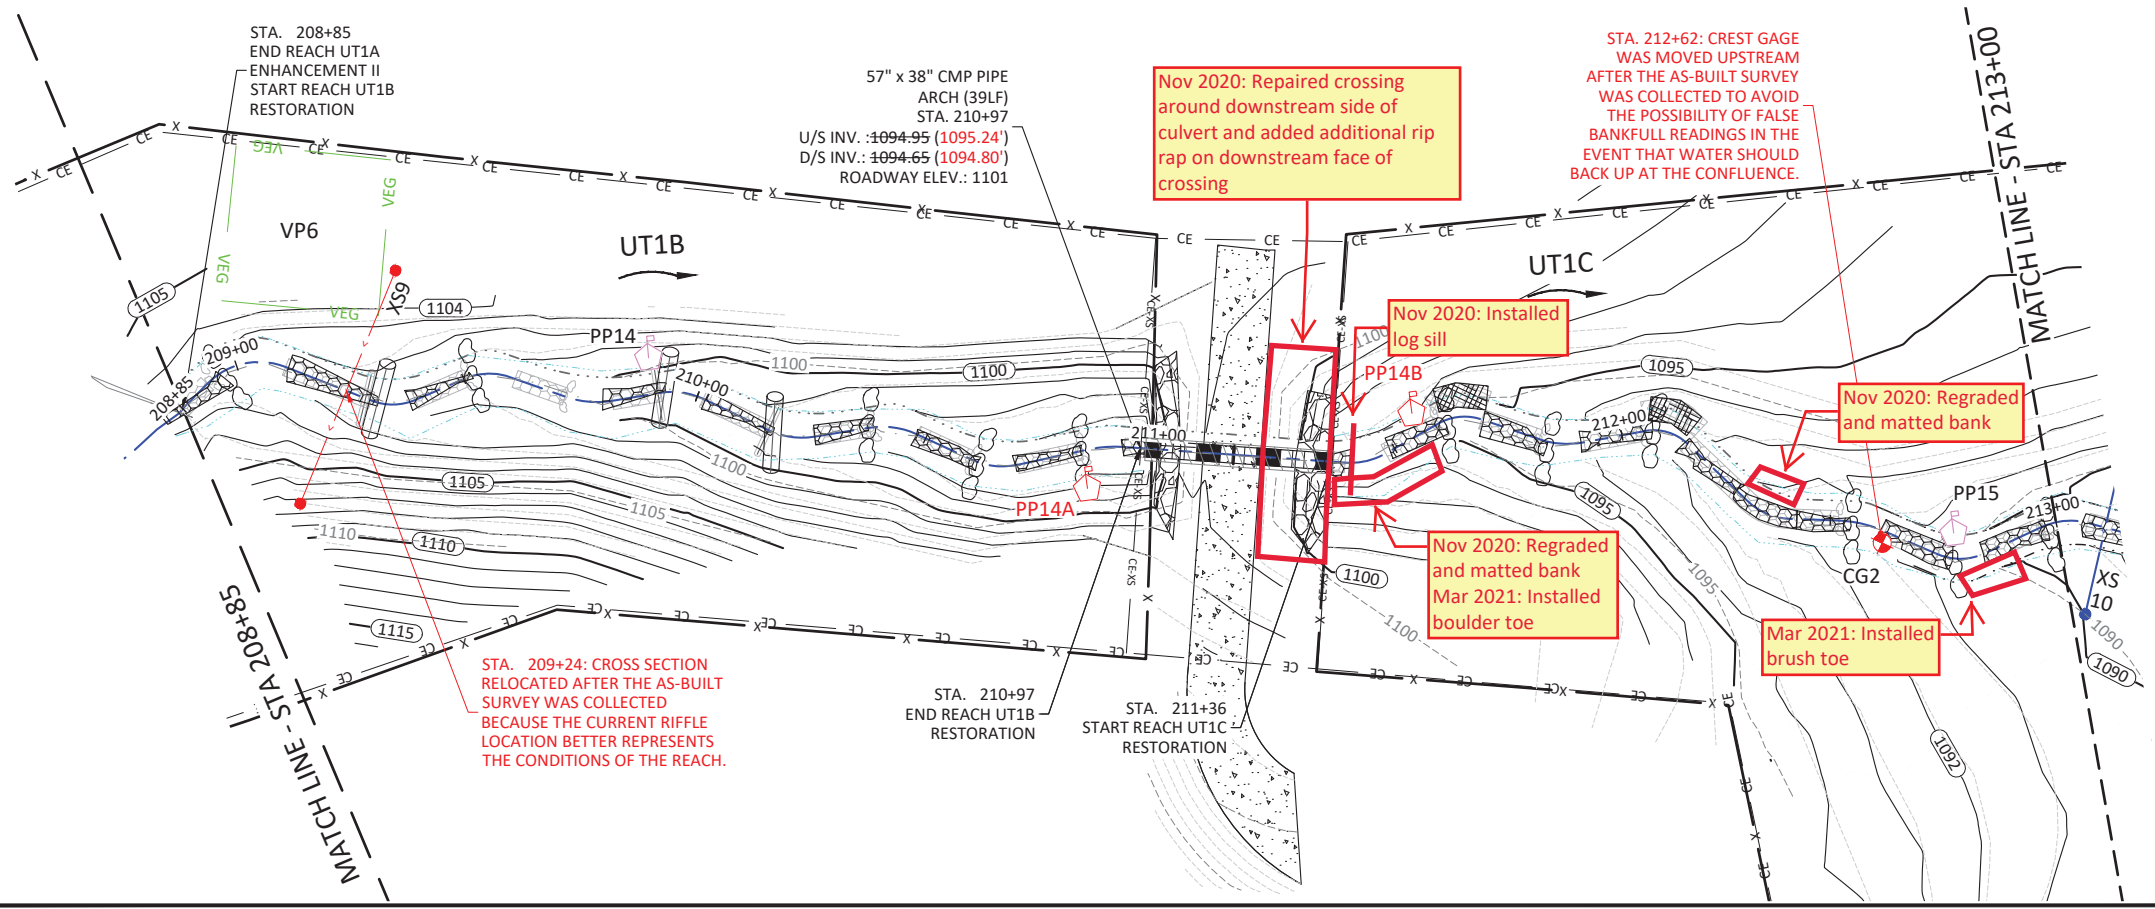
UT1B
 Stream Plan and Profile

- NOTE:**
1. STA. 209+65: RIFFLE, ROCK SILL AND POOL WERE OMITTED DUE TO SUFFICIENT STABILITY AND SLOPE ON THE REACH.
 2. STA. 210+83: PHOTO POINT 14A WAS ADDED AFTER THE SURVEY WAS COMPLETED AT THE REQUEST OF DMS TO CAPTURE A DOWNSTREAM VIEW OF THE CULVERT CROSSING.
 3. STA. 211+57: PHOTO POINT 14B WAS ADDED AFTER THE SURVEY WAS COMPLETED AT THE REQUEST OF DMS TO CAPTURE AN UPSTREAM VIEW OF THE CULVERT CROSSING.
 4. STA. 212+35: UPSTREAM ROCK AND ROLL RIFFLE BOULDER SILL WAS OMITTED AND RIFFLE WAS EXTENDED TO CONNECT TO DOWNSTREAM ROCK AND ROLL RIFFLE.

5. It was noted that baseflow was piping under the log sill downstream of the culvert crossing on UT1 (STA 211+40). The log appeared to be installed at the right elevation to back water into the culvert.

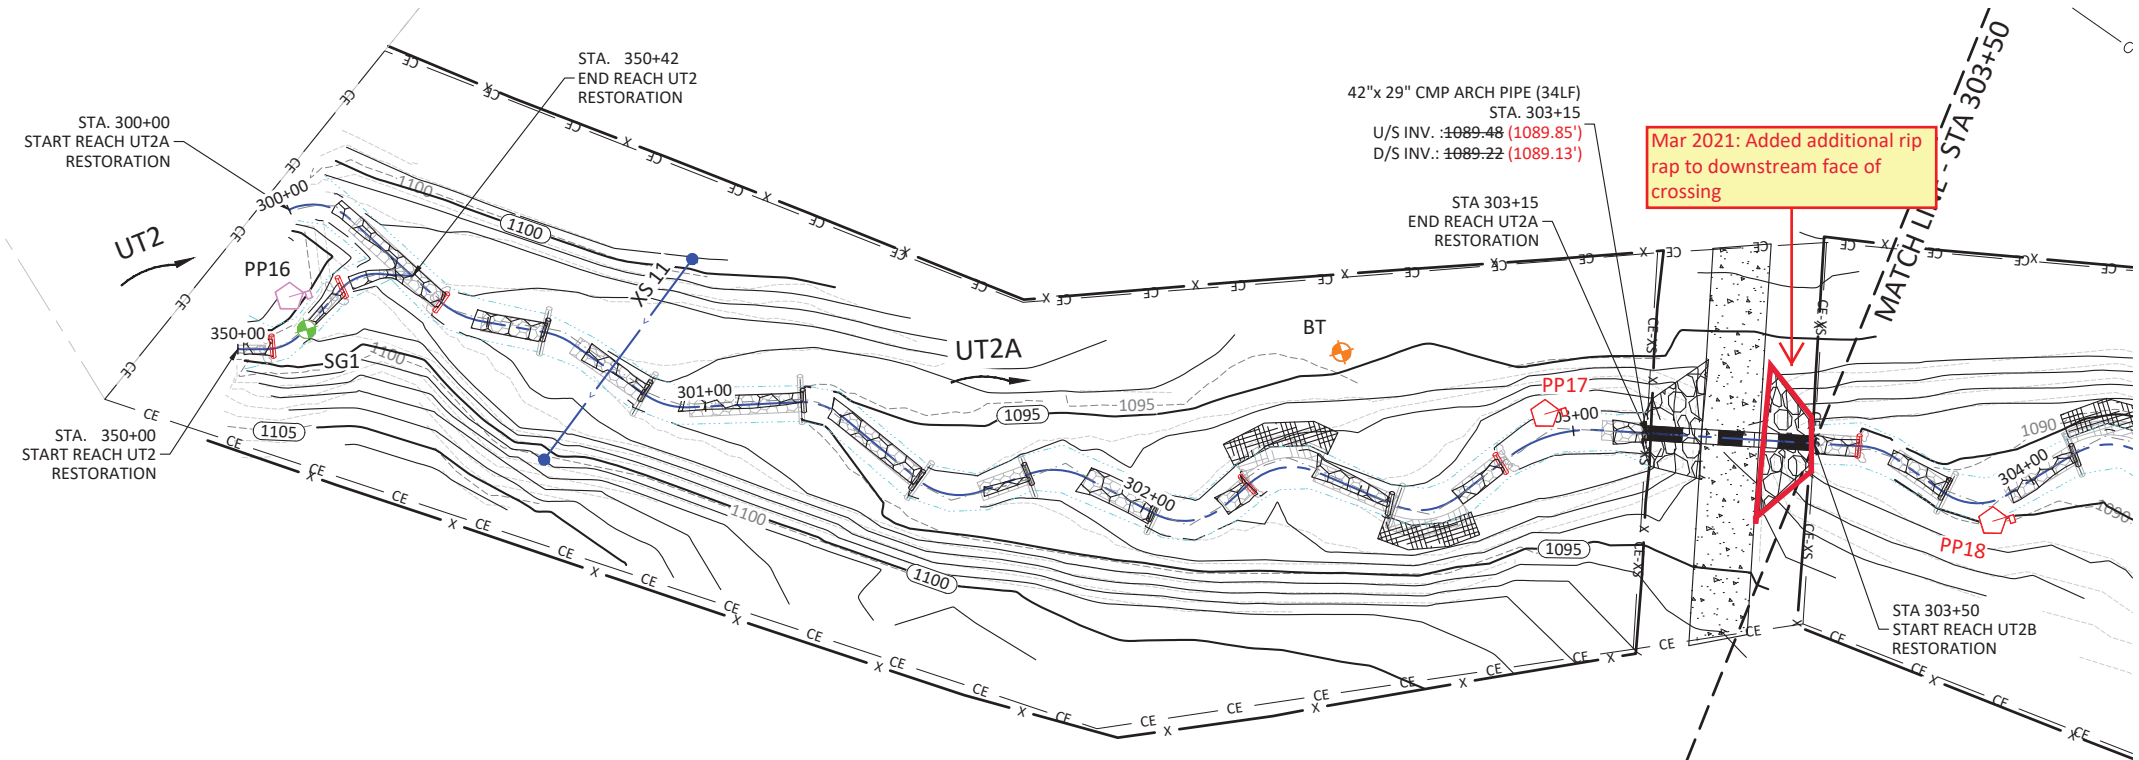
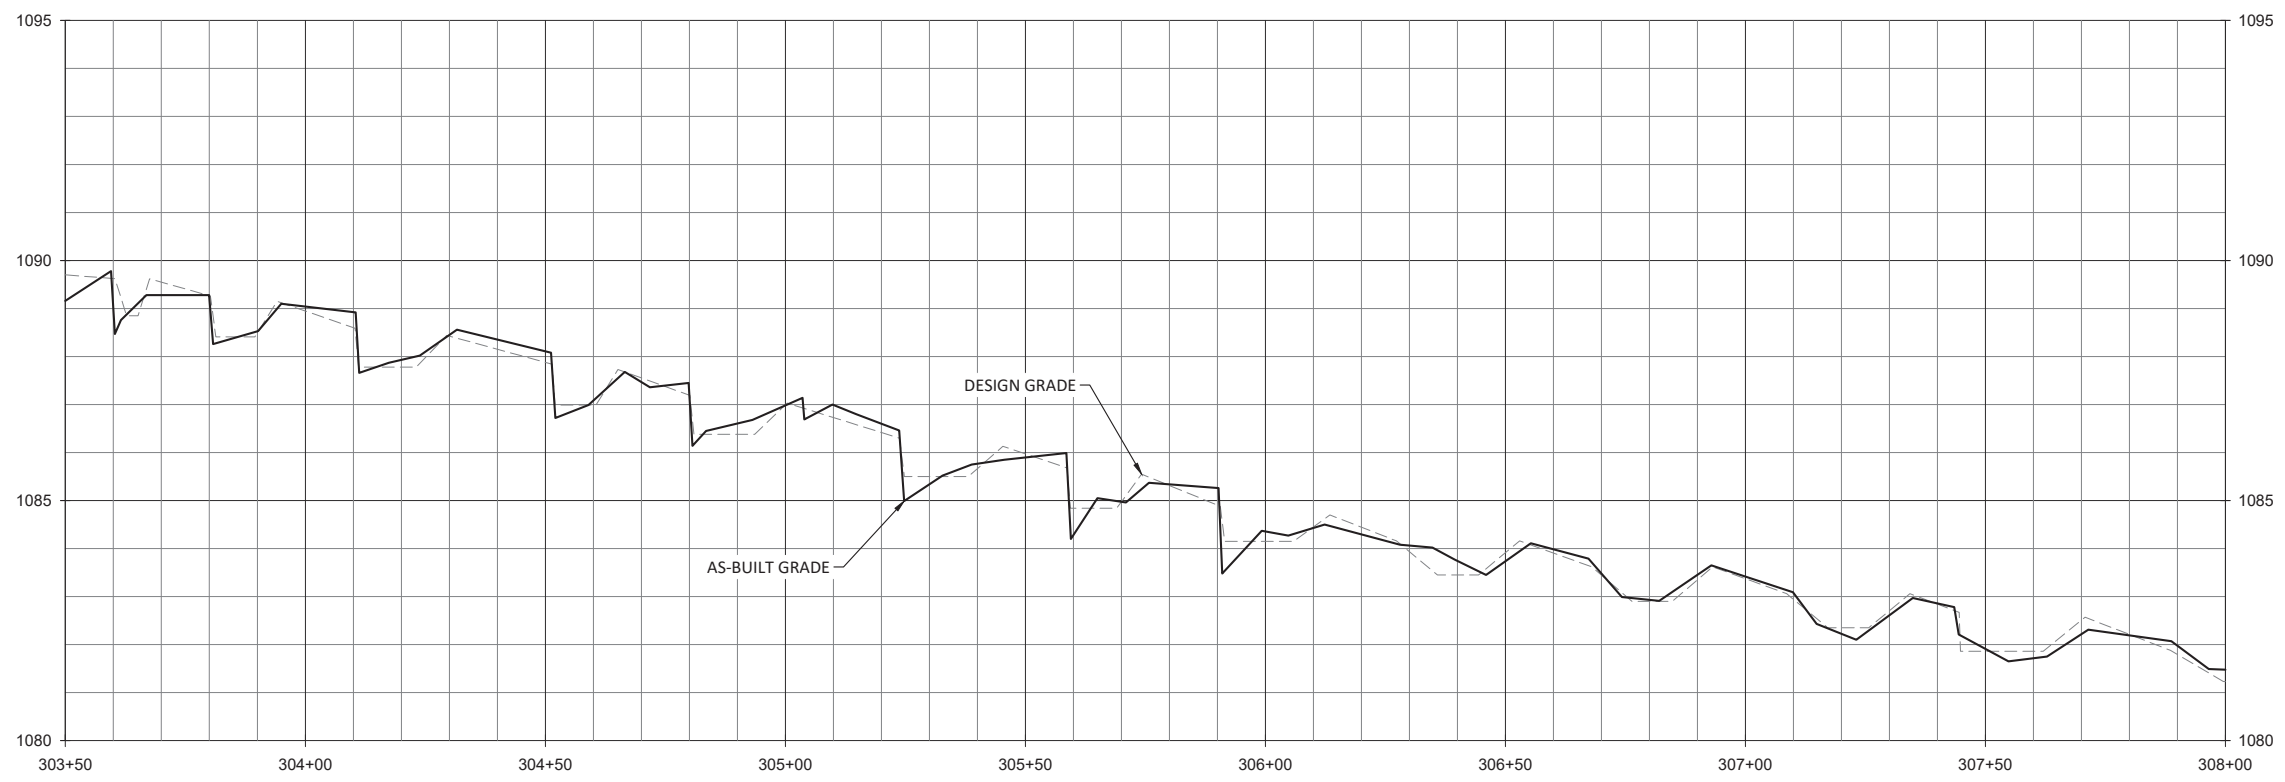
UT2A
Stream Plan and Profile

- NOTE:**
1. STA. 300+40, 302+25, & 302+83: ROCK SILLS REPLACED WITH LOG SILLS DUE TO LOCAL MATERIAL AVAILABILITY AND SIMILAR FUNCTIONALITY.
 2. STA. 302+95: PHOTO POINT 17 WAS MOVED AFTER THE SURVEY WAS COMPLETED AT THE REQUEST OF DMS TO CAPTURE A DOWNSTREAM VIEW OF THE CULVERT CROSSING.

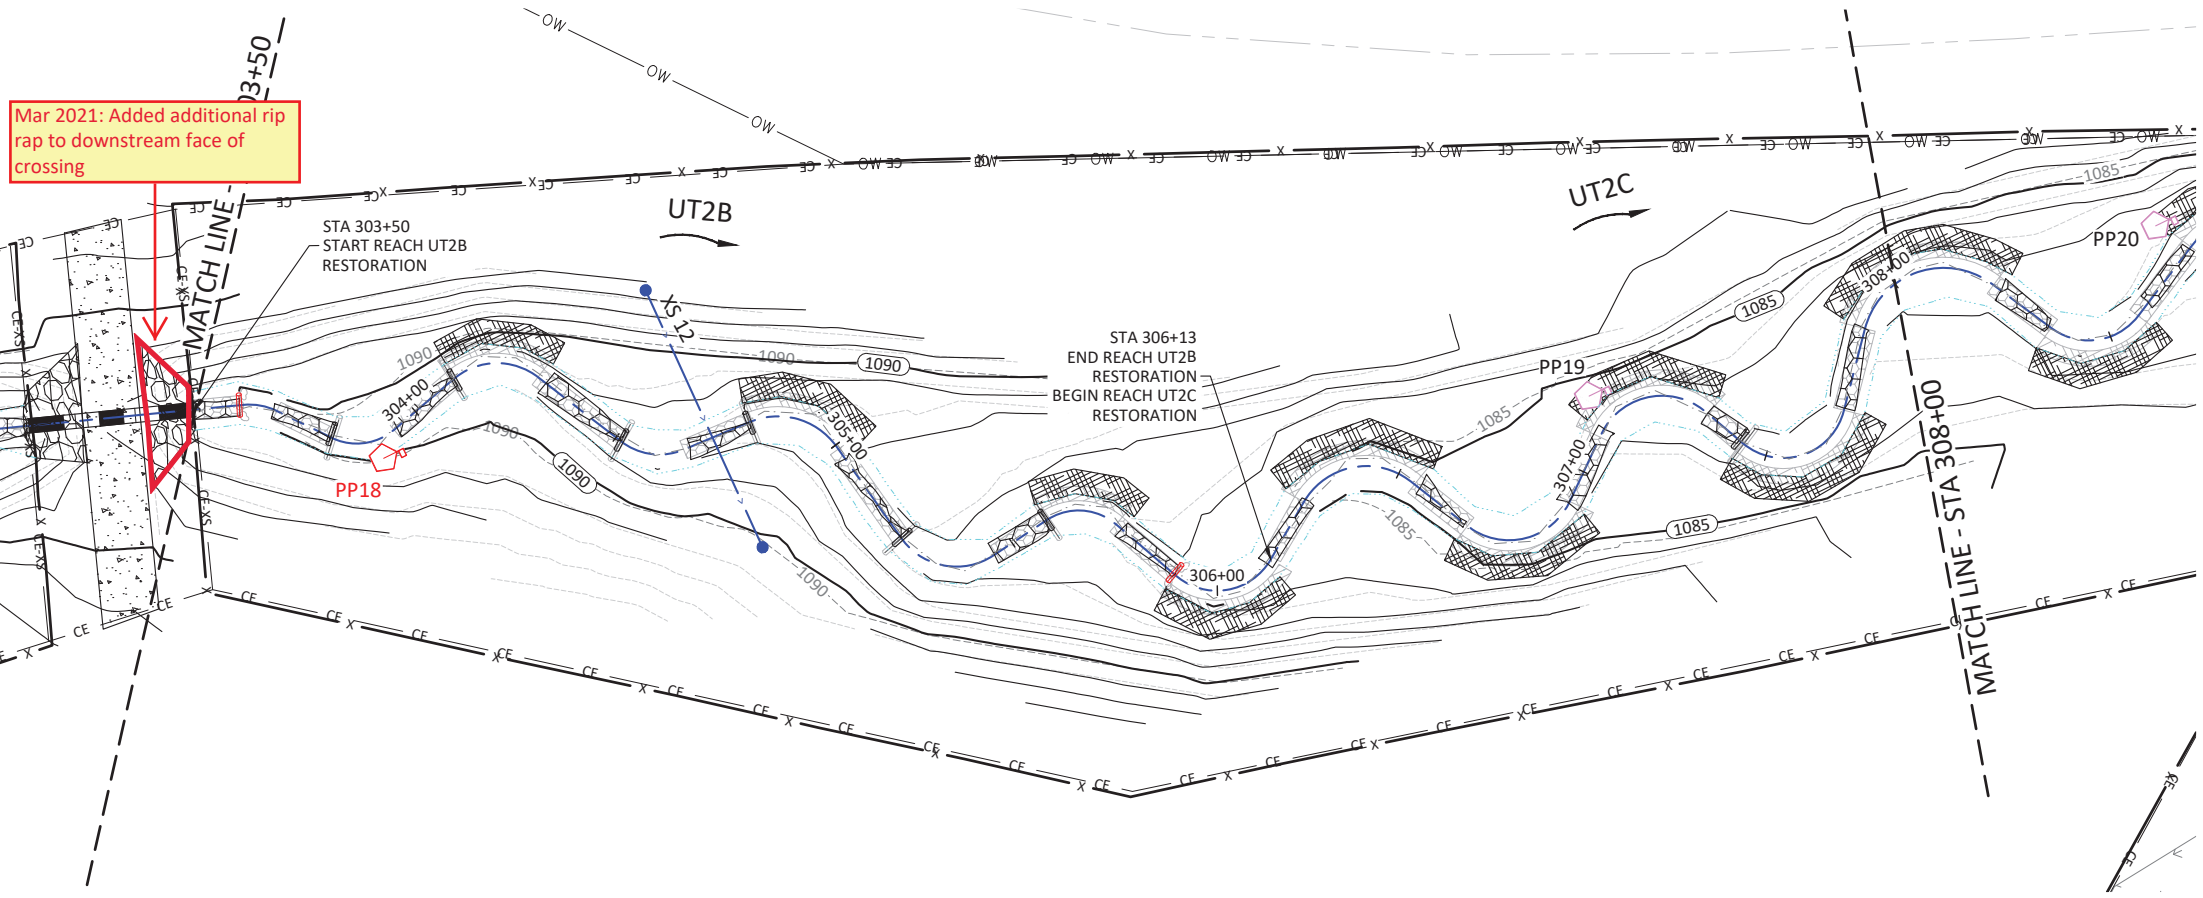
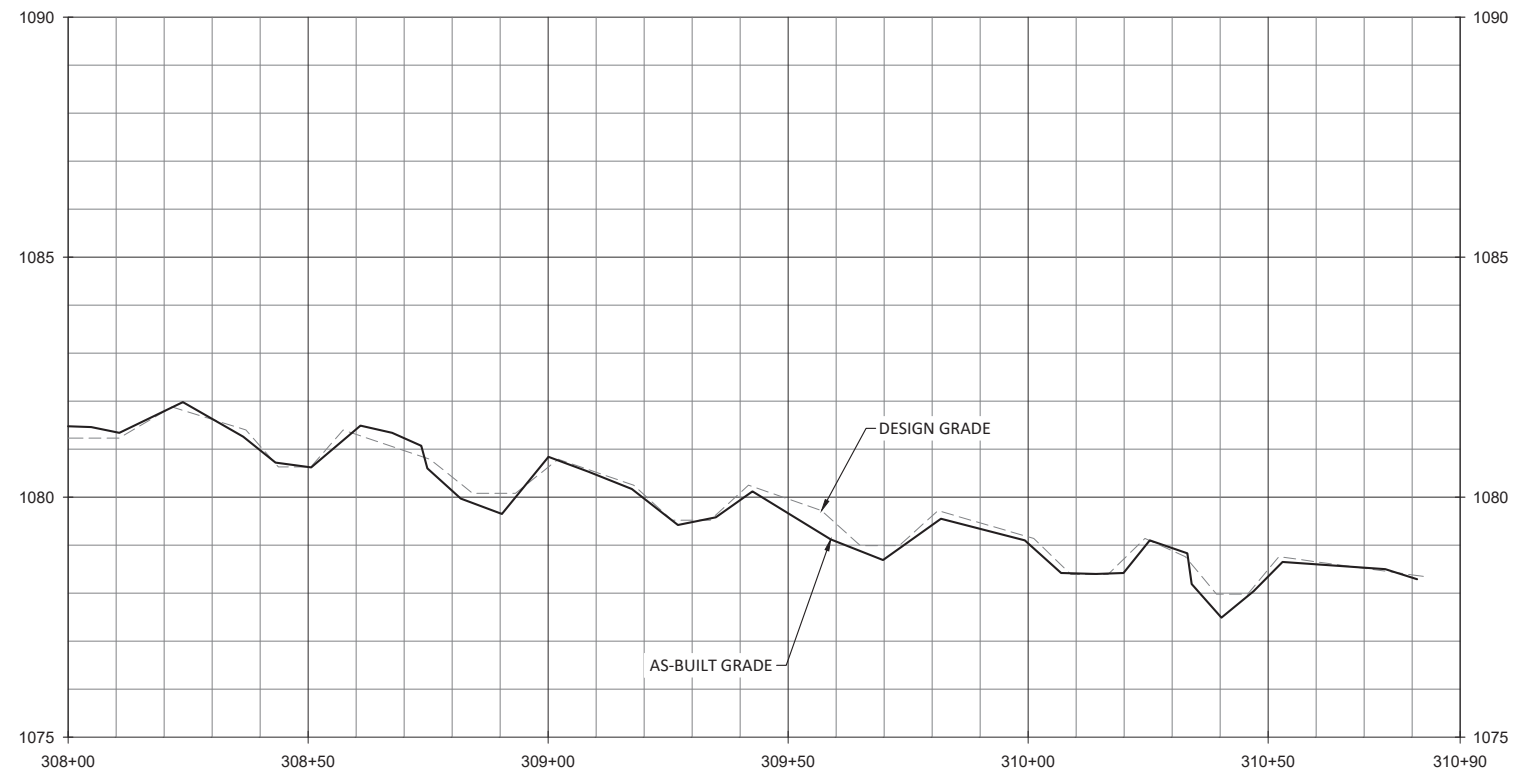
UT2B
 Stream Plan and Profile

- NOTE:**
1. STA. 303+59 & 305+90: ROCK SILLS REPLACED WITH LOG SILLS DUE TO LOCAL MATERIAL AVAILABILITY AND SIMILAR FUNCTIONALITY.
 2. STA. 303+90: PHOTO POINT 18 WAS MOVED AFTER THE SURVEY WAS COMPLETED AT THE REQUEST OF DMS TO CAPTURE AN UPSTREAM VIEW OF THE CULVERT CROSSING.

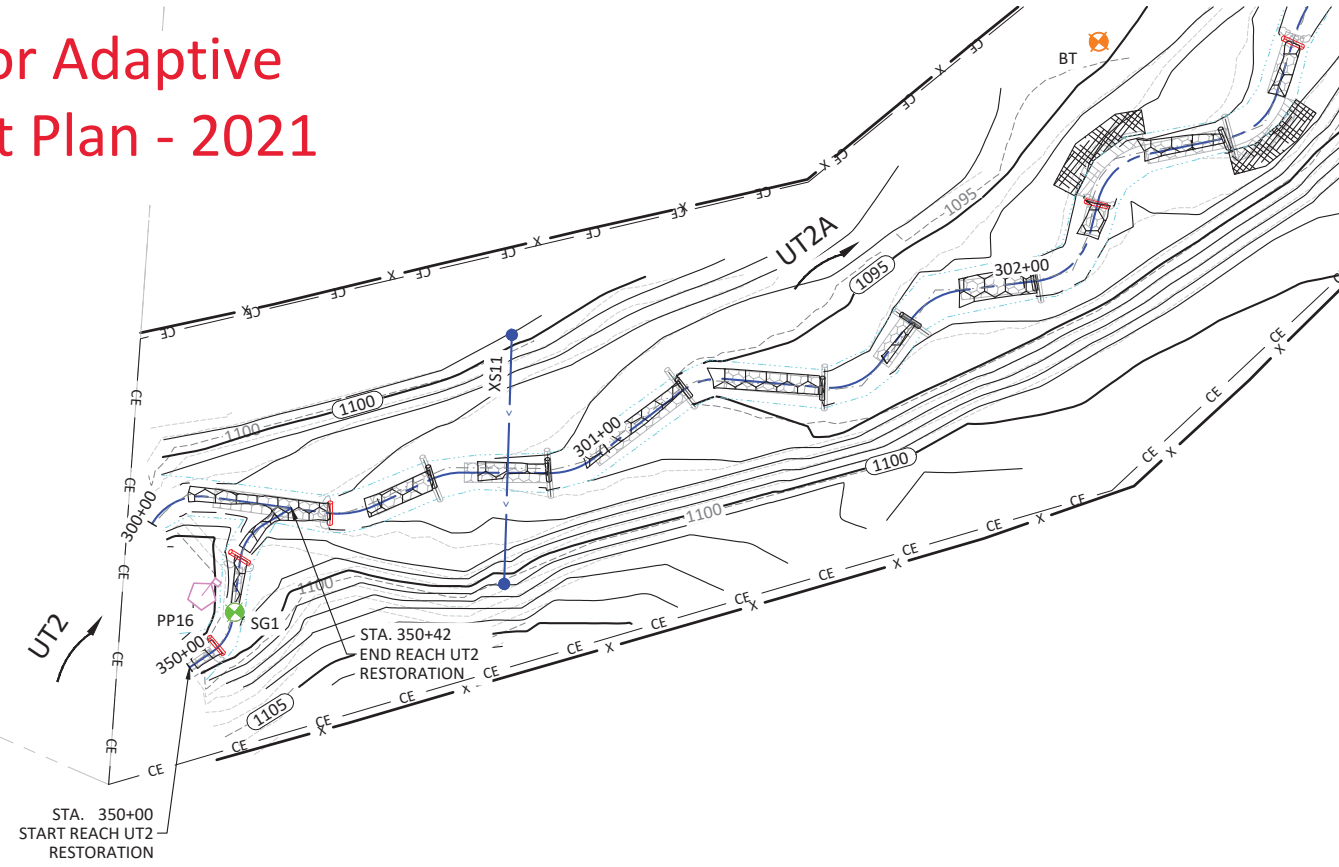
NOTE:
1. STA. 350+08 & 350+27: ROCK SILLS REPLACED WITH LOG SILLS DUE TO LOCAL MATERIAL AVAILABILITY AND SIMILAR FUNCTIONALITY.

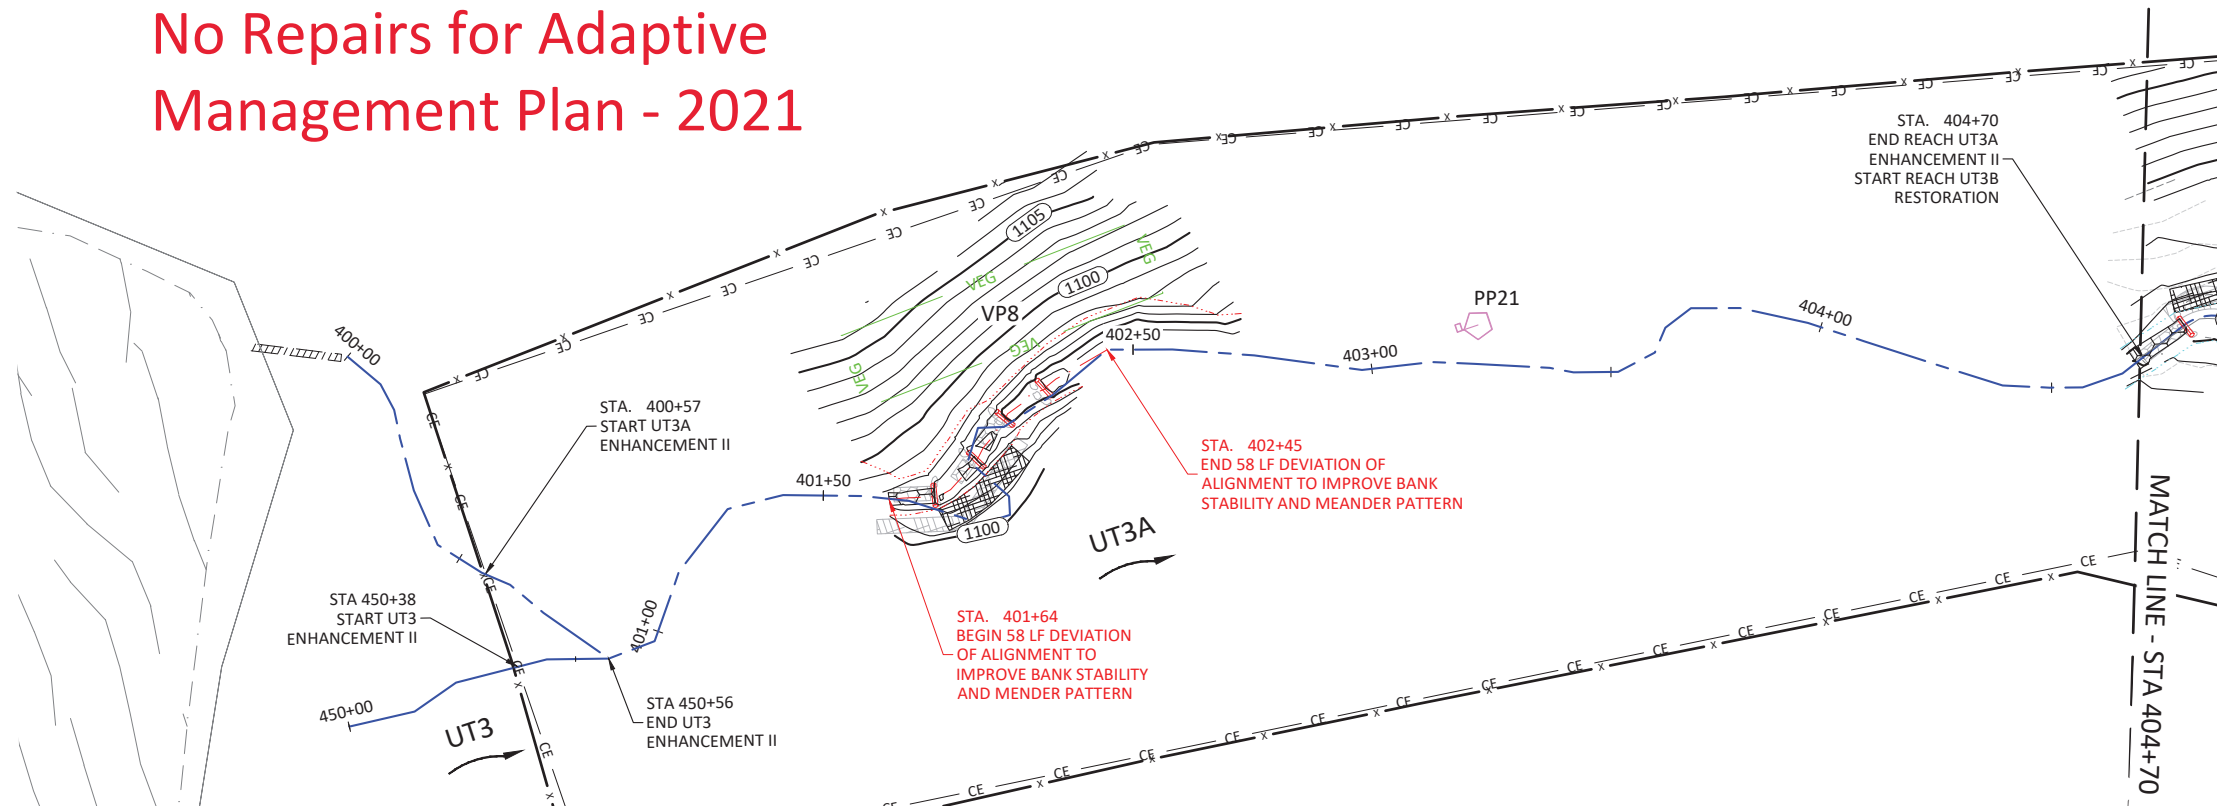
- NOTE:**
1. STA. 401+64 - 402+45: THE CHANNEL DESIGN WAS ALTERED AND REALIGNED TO IMPROVE BANK STABILITY AND MEANDER PATTERN WHICH RESULTED IN 58 LF OF CONSTRUCTED CHANNEL, COMPARED TO 81 LF IN THE ORIGINAL DESIGN.
 2. STA. 401+71 - 402+29: ROCK SILLS REPLACED WITH LOG SILLS DUE TO LOCAL MATERIAL AVAILABILITY AND SIMILAR FUNCTIONALITY.

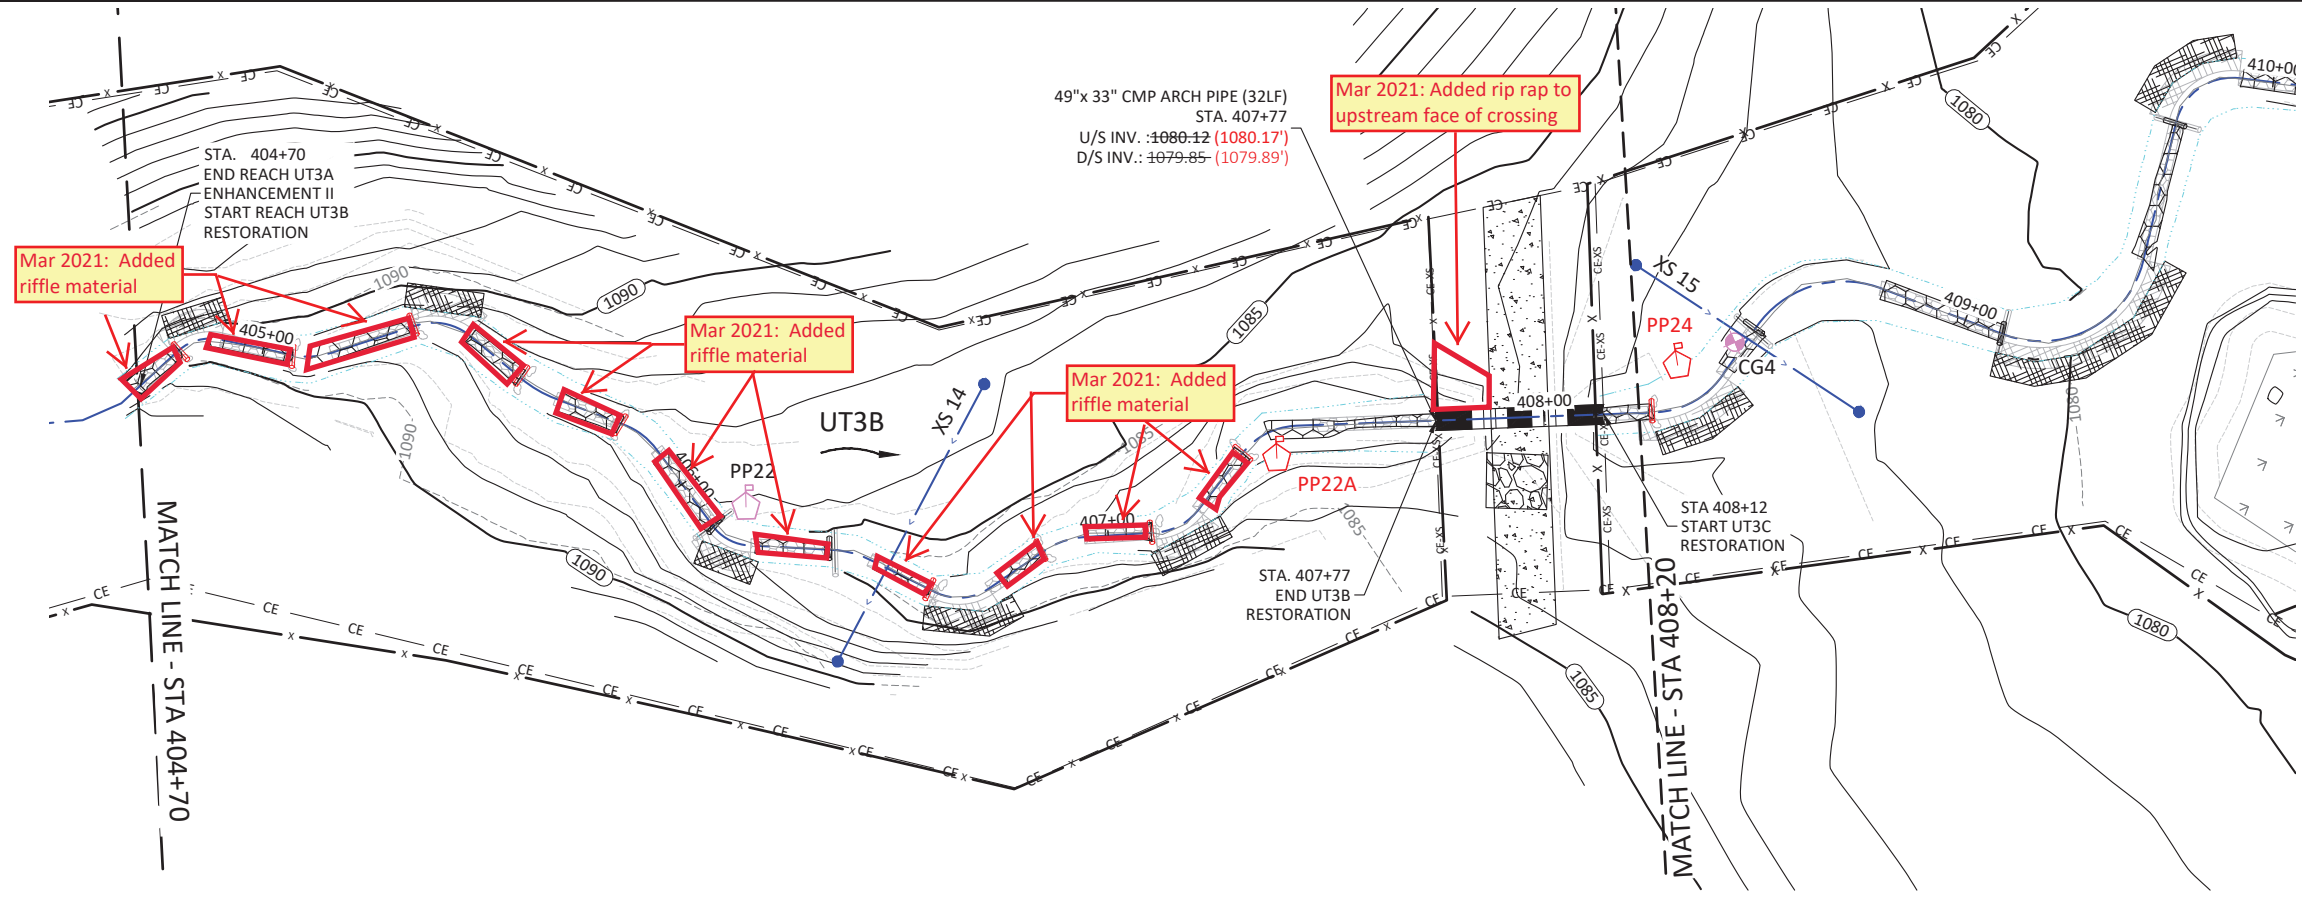
Key Mill Mitigation Site - Record Drawings
Surry County, North Carolina
 UT3B and UT3C
 Stream Plan and Profile

- NOTE:**
1. STA. 404+82, 405+06, 405+32, 405+58, 405+82, 406+59, 406+85, 407+09 AND 407+35: ROCK SILLS REPLACED WITH LOG SILLS DUE TO LOCAL MATERIAL AVAILABILITY AND SIMILAR FUNCTIONALITY.
 2. STA. 404+89 - 407+35: RIFFLE ELEVATIONS ADJUSTED DUE TO THE UPSTREAM TIE IN ELEVATION BEING CHANGED DUE TO FIELD CONDITIONS.
 3. STA. 407+41: PHOTO POINT 22A WAS ADDED AFTER THE SURVEY WAS COMPLETED AT THE REQUEST OF DMS TO CAPTURE A DOWNSTREAM VIEW OF THE CULVERT CROSSING.

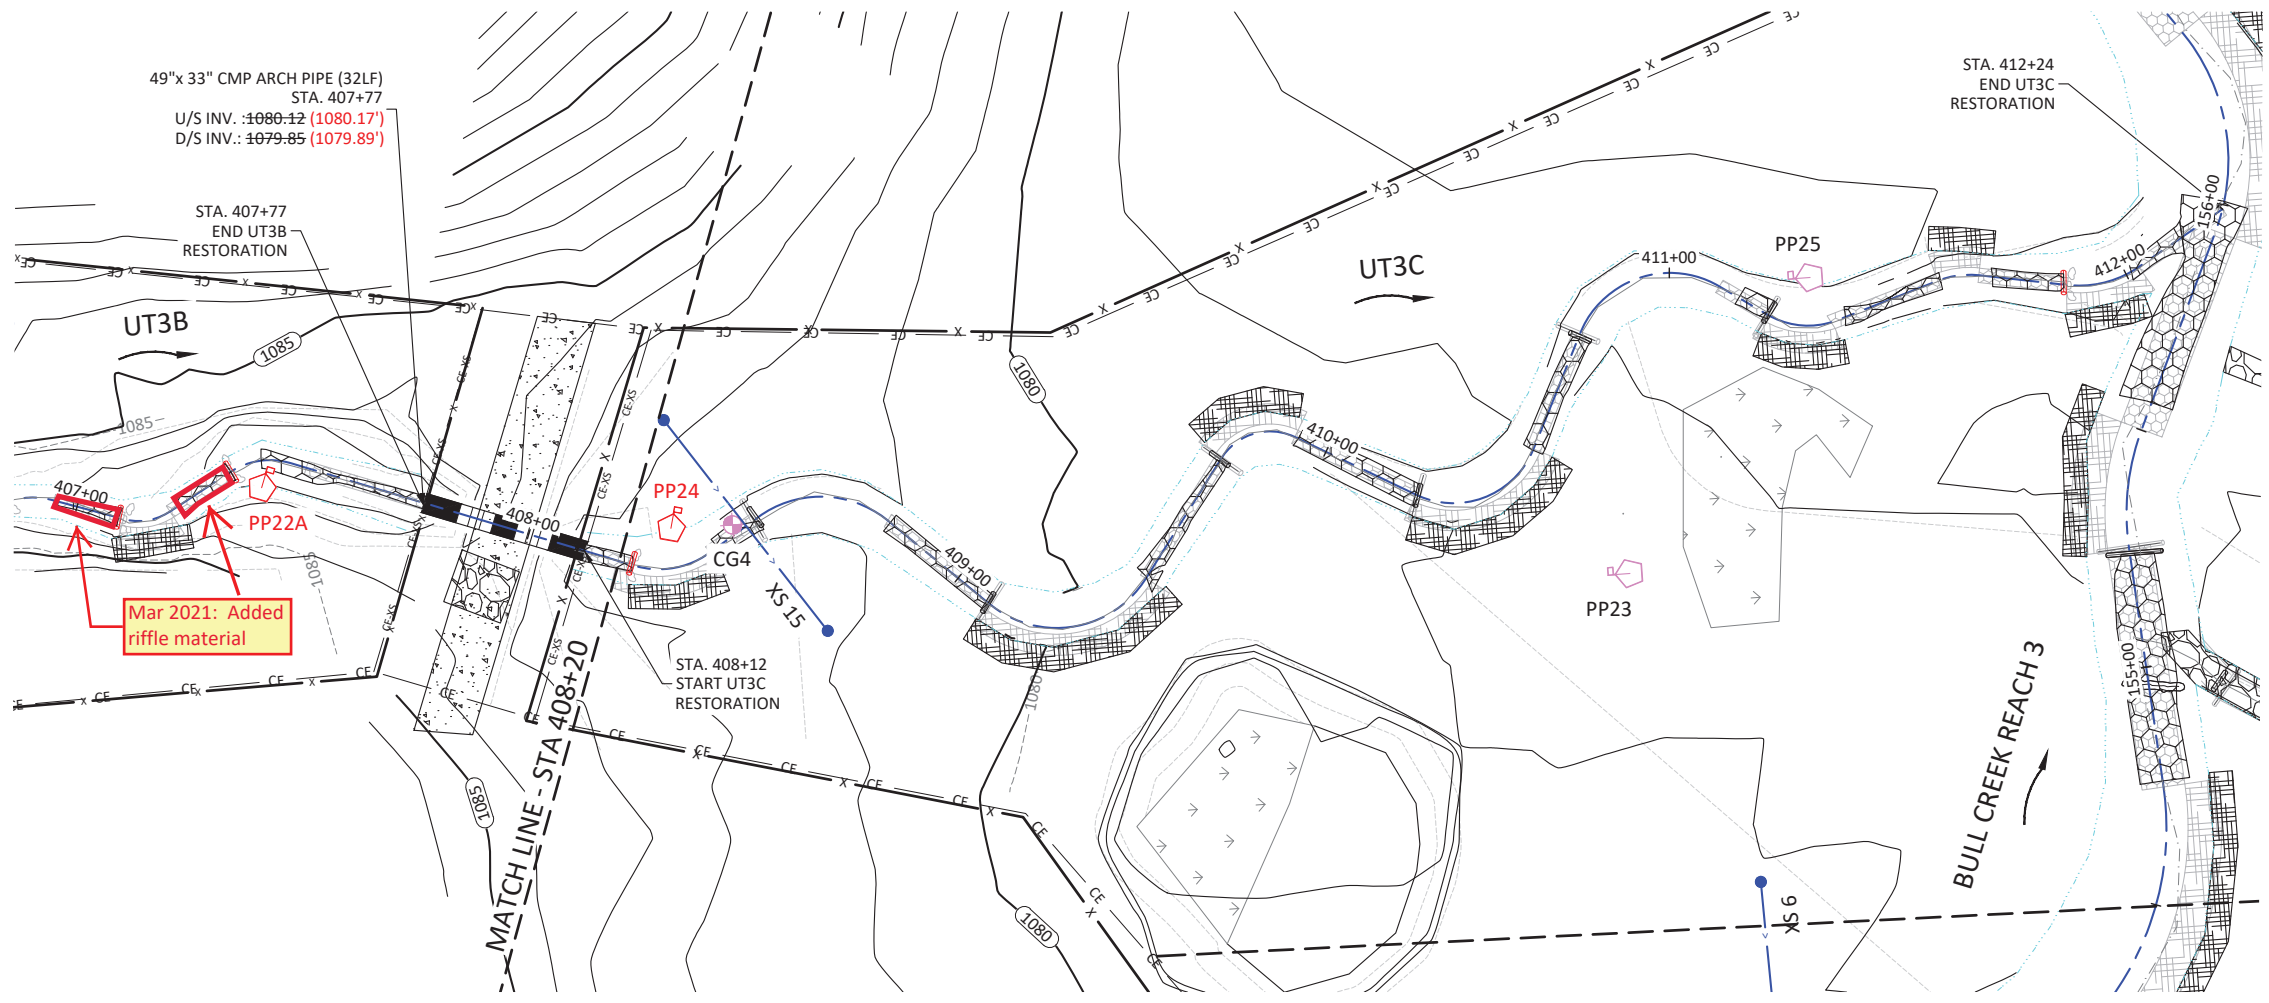
UT3C
 Stream Plan and Profile

- NOTE:**
1. STA. 408+22: ROCK SILLS REPLACED WITH LOG SILLS DUE TO LOCAL MATERIAL AVAILABILITY AND SIMILAR FUNCTIONALITY.
 2. STA. 408+33: PHOTO POINT 24 WAS MOVED AFTER THE SURVEY WAS COMPLETED AT THE REQUEST OF DMS TO CAPTURE AN UPSTREAM VIEW OF THE CULVERT CROSSING.
 3. STA. 411+86: ROCK SILL REPLACED WITH LOG SILL DUE TO LOCAL MATERIAL AVAILABILITY AND SIMILAR FUNCTIONALITY.
