MONITORING YEAR 2 ANNUAL REPORT

KEY MILL MITIGATION SITE

Surry County, NC
NCDEQ Contract No. 7180
DMS Project No. 100025
USACE Action ID No. SAW-2017-01504
NCDEQ DWR Certification No. 17-1045
RFP #: 16-006993

Data Collection Period: January 2021 – November 2021
Final Submission Date: February 1, 2022

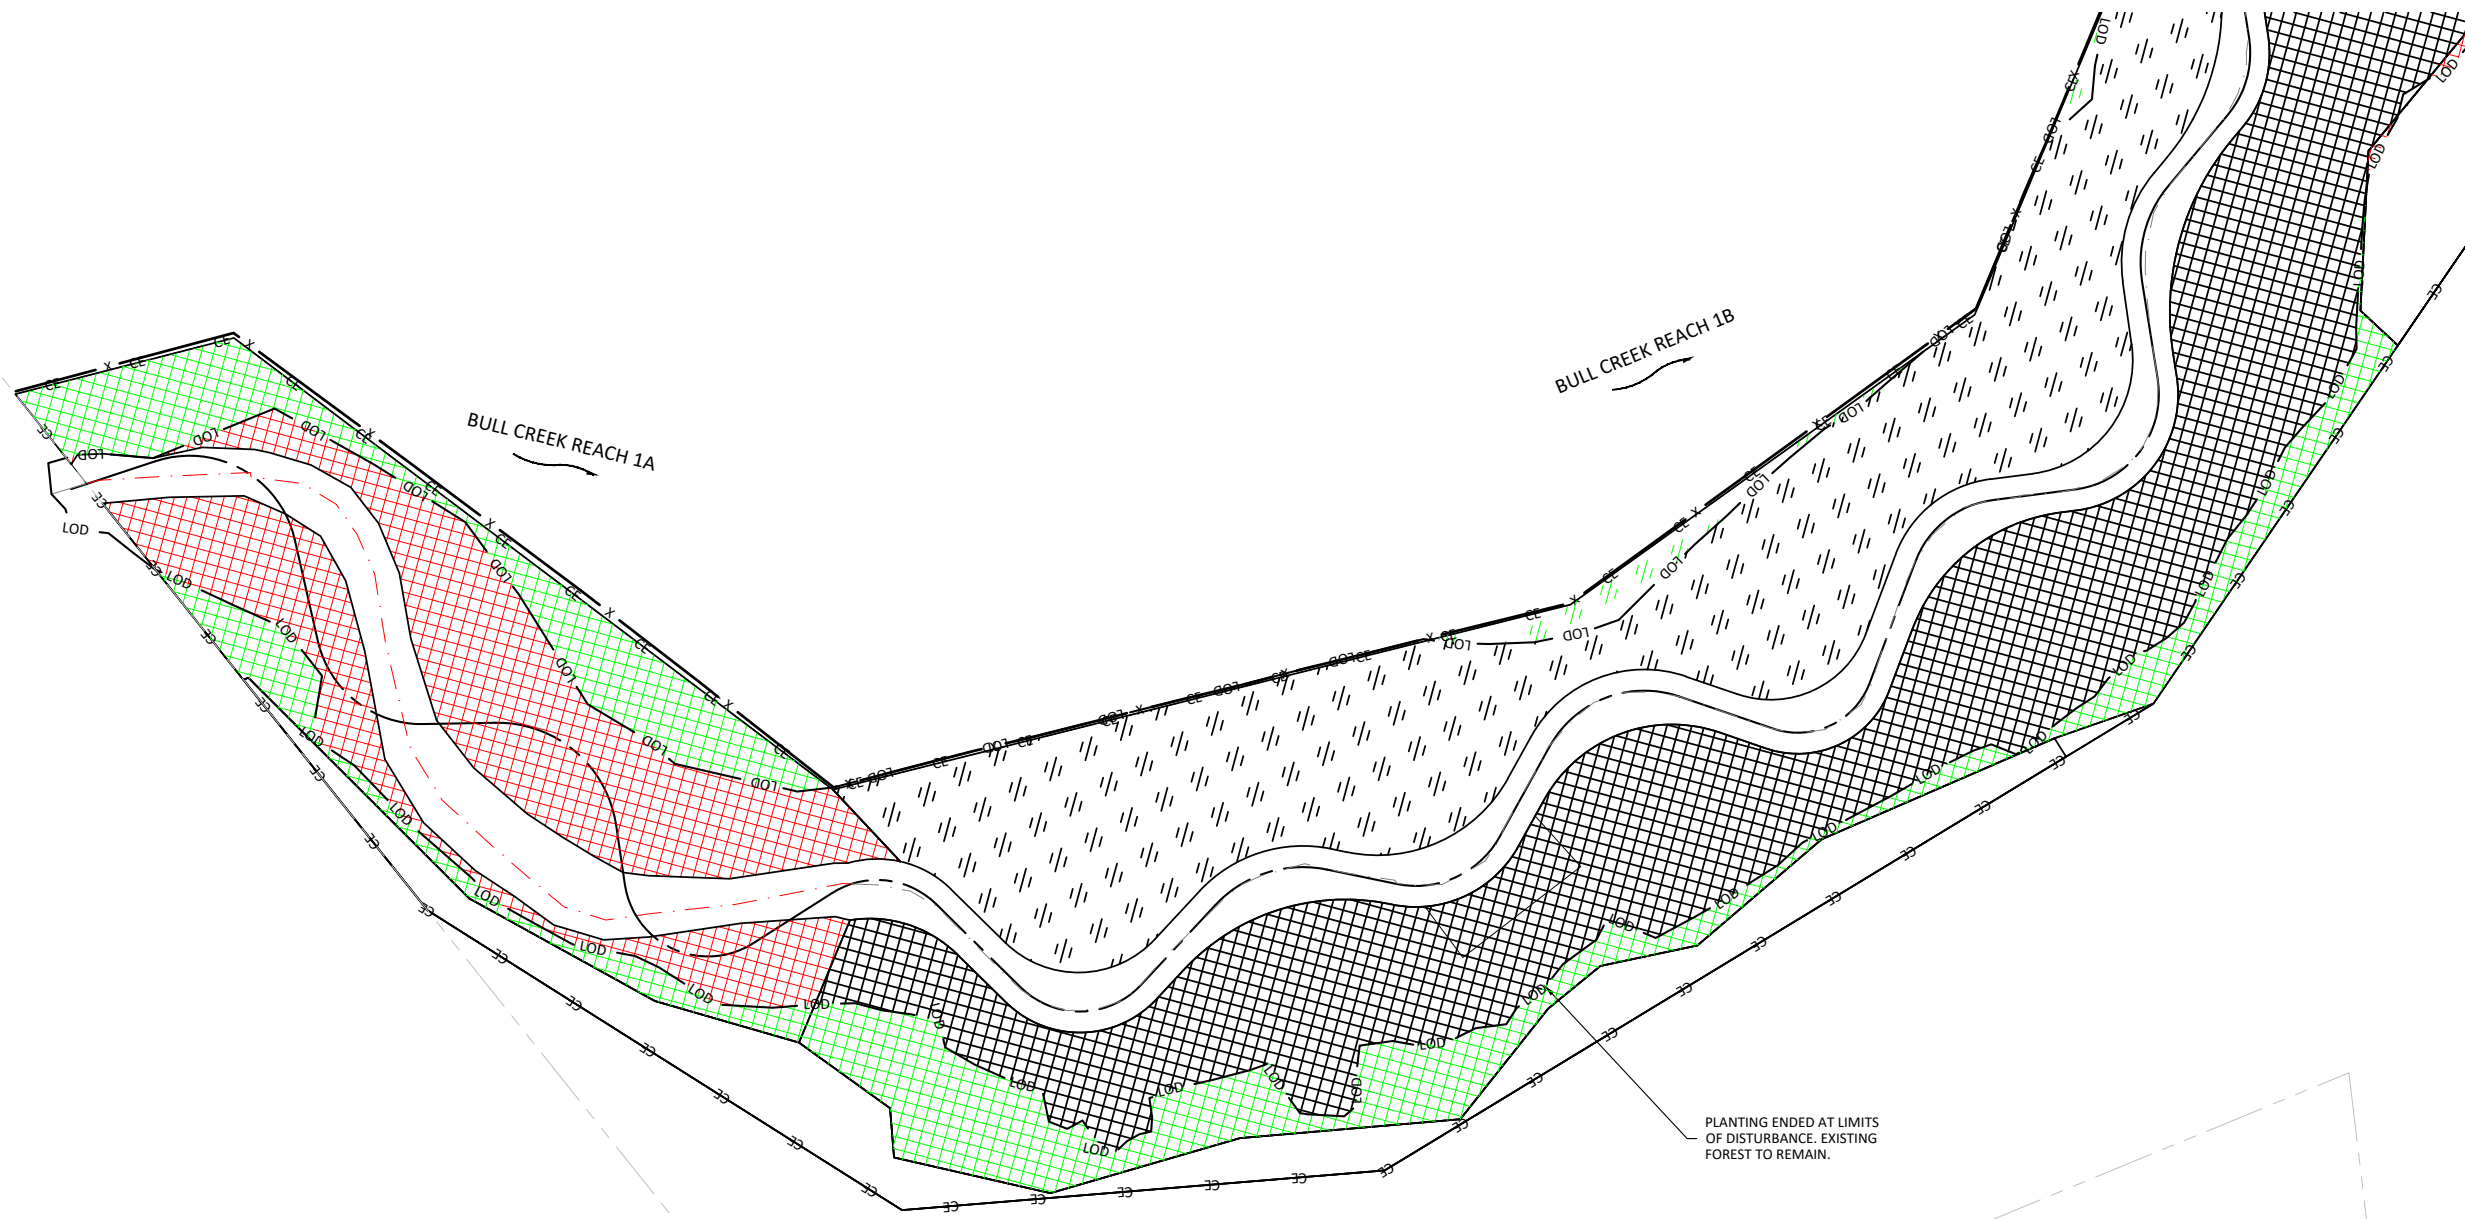
Bull Creek West
 Planting Plan

- NOTES:**
1. DEVIATIONS TO THE DESIGN PLANTING PLAN THAT WERE INSIDE OF THE AS-BUILT LIMIT OF DISTURBANCE AND WERE PLANTED ARE SHOWN IN **RED**.
 2. DEVIATIONS TO THE DESIGN PLANTING PLAN THAT WERE OUTSIDE THE AS-BUILT LIMIT OF DISTURBANCE AND WERE NOT PLANTED ARE SHOWN IN **GREEN**.
 3. **STA.100+95-105+39: PLANTING AREA ALTERED DUE TO BEDROCK THAT WAS PRESENT IN THE LEFT FLOODPLAIN.**

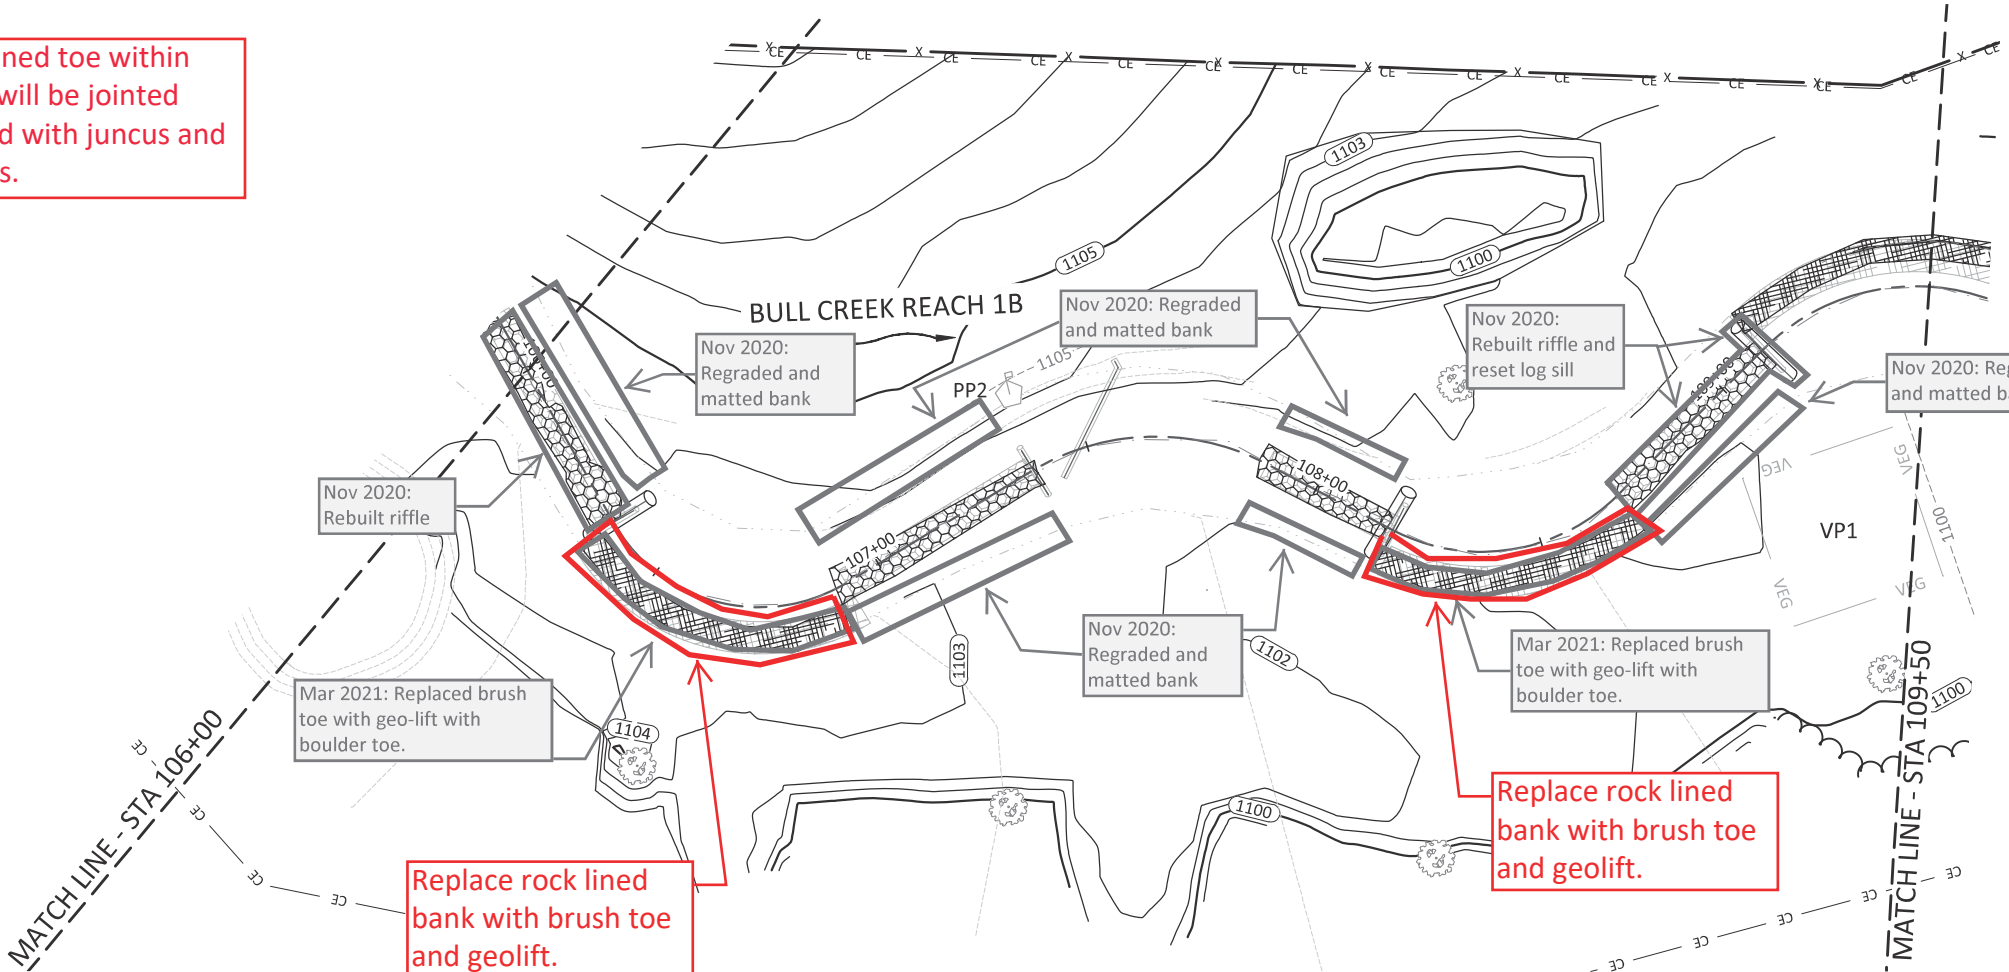
Key Mill Mitigation Site - Record Drawings
Surry County, North Carolina
 Bull Creek Reach 1B
 Stream Plan and Profile

NOTE:
 1. STA. 107+40: THE LOG SILL AND LOG VANE WERE OMITTED DUE TO PRESENCE OF BEDROCK.

Rock-lined toe within riffles will be jointed planted with juncus and willows.

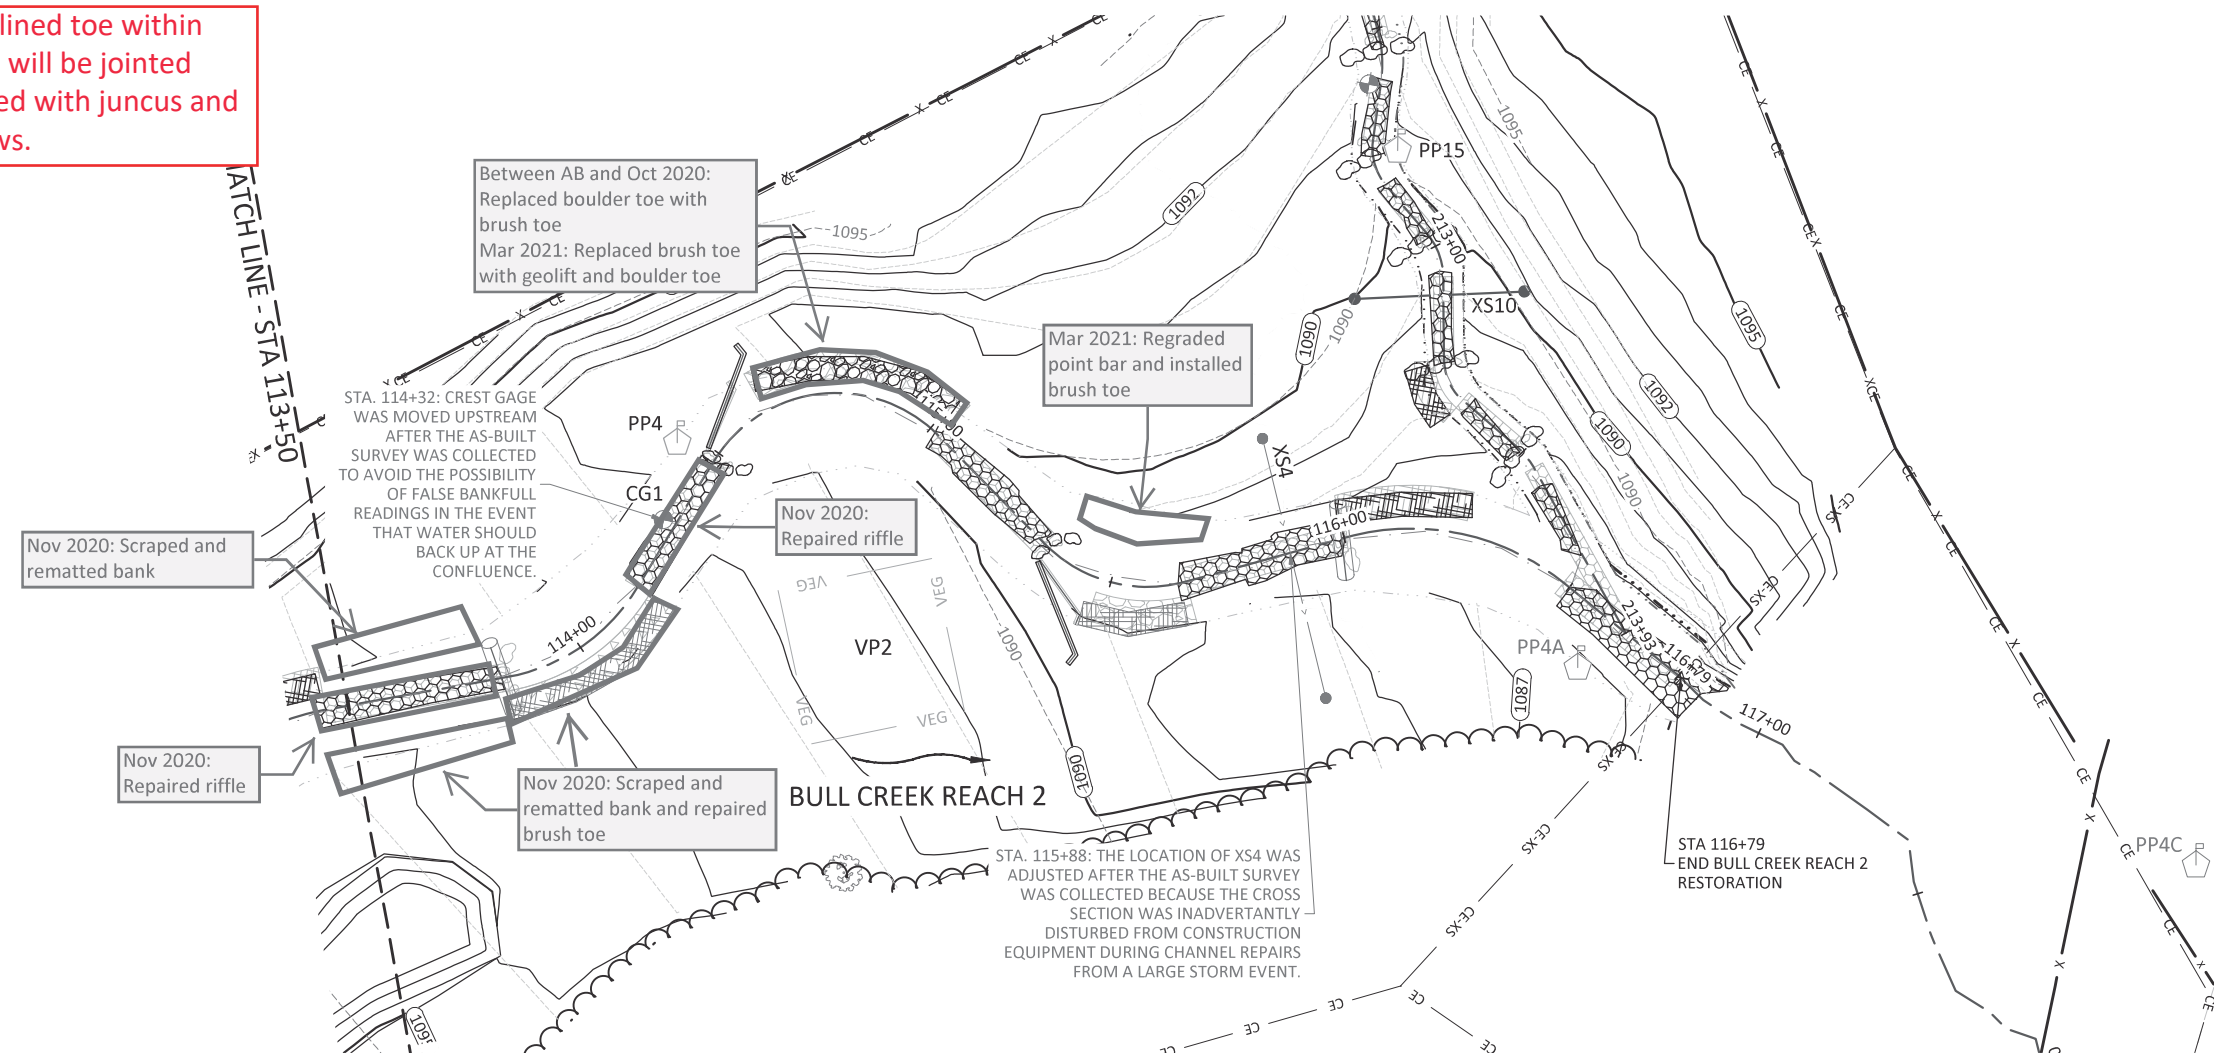
- NOTES:**
1. STA. 113+80: LOG SILL WAS SUBSTITUTED FOR ROCK SILL DUE TO LOCAL MATERIAL AVAILABILITY AND SITE CONDITIONS.
 2. STA. 113+85: BRUSH TOE WAS SUBSTITUTED FOR BRUSH MATTRESS DUE TO SUFFICIENT BANK STABILITY FOLLOWING CONSTRUCTION OF THE PROPOSED CHANNEL.
 3. STA. 115+45: BRUSH TOE WAS SUBSTITUTED FOR BOULDER TOE DUE TO SUFFICIENT BANK STABILITY FOLLOWING CONSTRUCTION OF THE PROPOSED CHANNEL.
 4. STA. 116+00: LOG SILL WAS SUBSTITUTED FOR ROCK SILL DUE TO LOCAL MATERIAL AVAILABILITY AND SIMILAR FUNCTIONALITY.
 5. STA. 116+62: PHOTO POINT 4A WAS ADDED AFTER THE SURVEY WAS COMPLETED AT THE REQUEST OF DMS TO CAPTURE THE CONSERVATION EASEMENT BREAK.

Rock-lined toe within riffles will be jointed planted with juncus and willows.

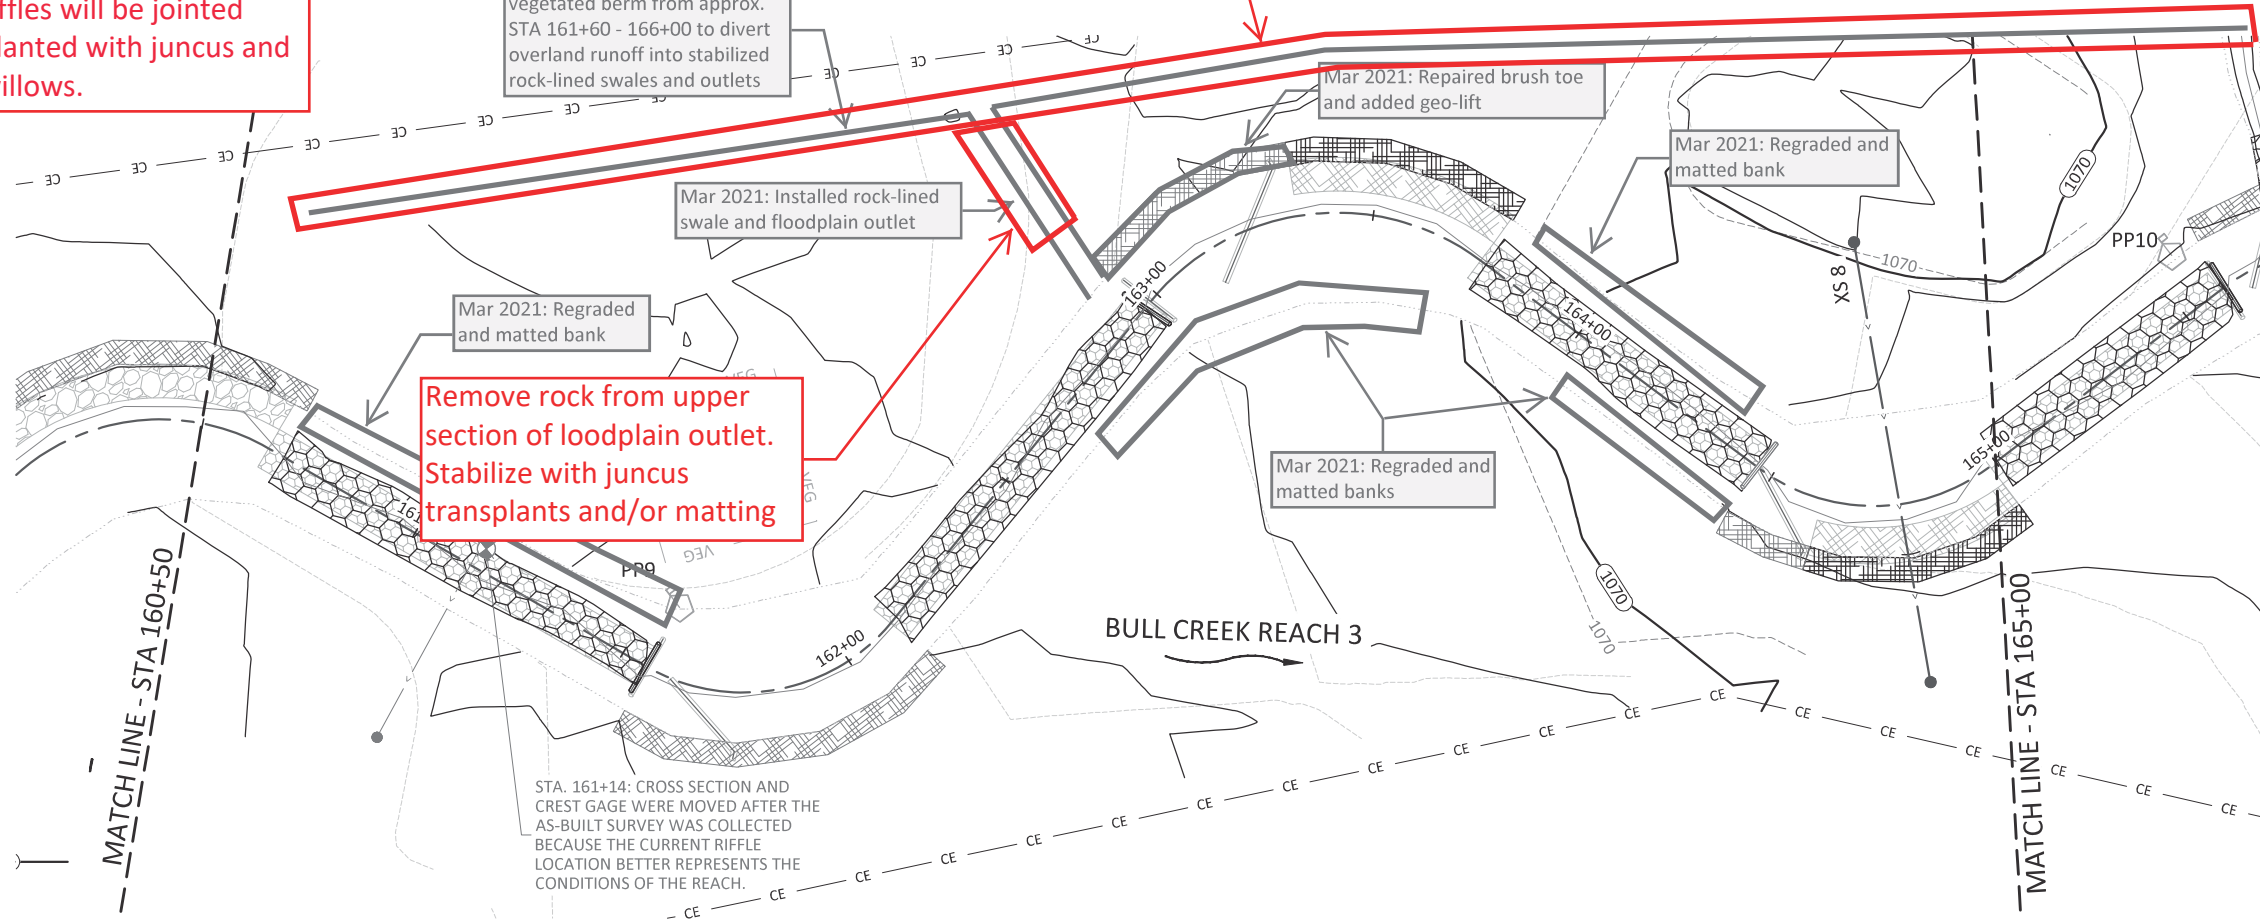
Key Mill Mitigation Site - Record Drawings
Surry County, North Carolina
Bull Creek Reach 2
Stream Plan and Profile

- NOTE:
1. STA. 161+56: LOG VANE REMOVED AND BRUSH TOE ADDED TO OUTSIDE BANK TO IMPROVE STABILITY FOR THE ENTIRE OUTSIDE BANK.
 2. STA. 163+30: LOG VANE REMOVED AND BRUSH TOE EXTENDED DUE TO AVAILABILITY OF MATERIALS AND TO IMPROVE STREAM BANK STABILITY AND HABITAT.
 3. STA. 164+47: LOG VANE REMOVED, LOG SILL ADDED AND BRUSH TOE EXTENDED DUE TO LOCAL AVAILABILITY OF MATERIALS AND TO IMPROVE CHANNEL STABILITY AND HABITAT.

STA. 161+14: CROSS SECTION AND CREST GAGE WERE MOVED AFTER THE AS-BUILT SURVEY WAS COLLECTED BECAUSE THE CURRENT RIFFLE LOCATION BETTER REPRESENTS THE CONDITIONS OF THE REACH.

Rock-lined toe within riffles will be jointed planted with juncus and willows.

Mar 2021: Constructed a vegetated berm from approx. STA 161+60 - 166+00 to divert overland runoff into stabilized rock-lined swales and outlets

Mar 2021: Repaired brush toe and added geo-lift

Mar 2021: Regraded and matted banks

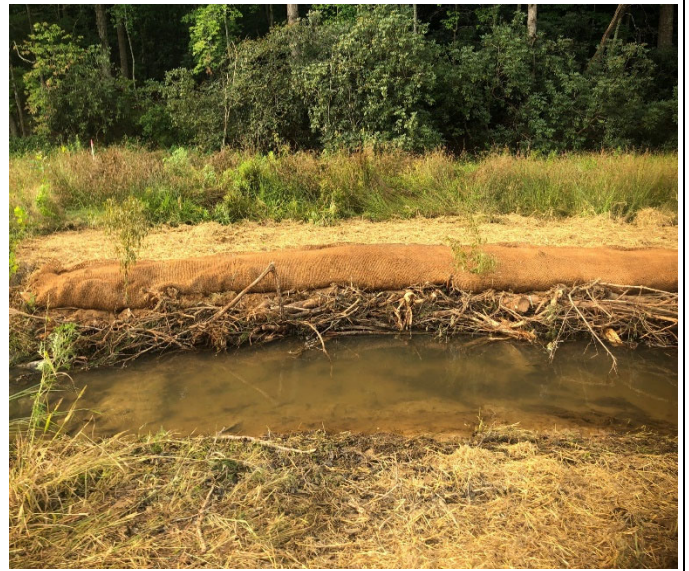
Post-Repair – A2 106+50 (08/16/2021)

| Item | Description | Action |
|---|---|---|
| A2 | Rock-lined outer meander bends on Bull Creek STA 106+35 – 115+10. | Remove rock placed on outer meander bends and replace with brush toe or proper rock toe with geolift. |

Replace rock lined bank with brush toe and geolift.

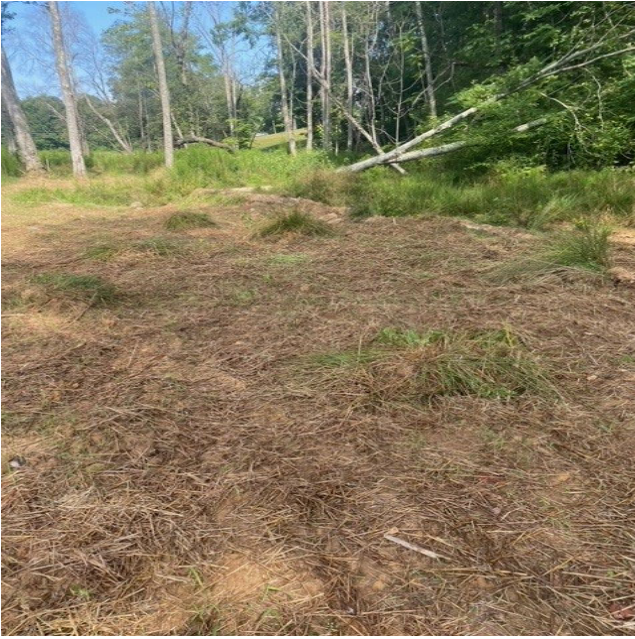
Post-Repair – A6 160+50 – 163+00 (08/16/2021)

11. Travis noted the cattails in the wetland pocket near Bull Creek STA 155+50 left floodplain.
12. On Bull Creek (STA 160+70 – 165+60), rock was added along the toe of multiple riffles. Similar to item 6, this was not in the mitigation plan and size and placement were concerning.
13. The berm and multiple rock-lined floodplain outlets installed in the left floodplain of Bull Creek (STA 160+60 – 166+00) is preventing diffuse flow across the vegetated buffer. The length of rock placement in the floodplain outlets was considered too extensive. Travis noted the size of the rock in the floodplain outlet at STA 163+00 was too large for turtles.
14. Erin noted the presence of privet along the Bull Creek woodline (STA 160+50 – 167+56).
