Monitoring Report MY05

**Sandy Bridge Restoration Site
DMS Contract 6400
DMS Project Number 96920**

**DWR #: 15-0414
USACE Action ID: 201500827
Rutherford County, North Carolina**

**Monitoring Data Collected: 2021
Date Submitted: December 2021**

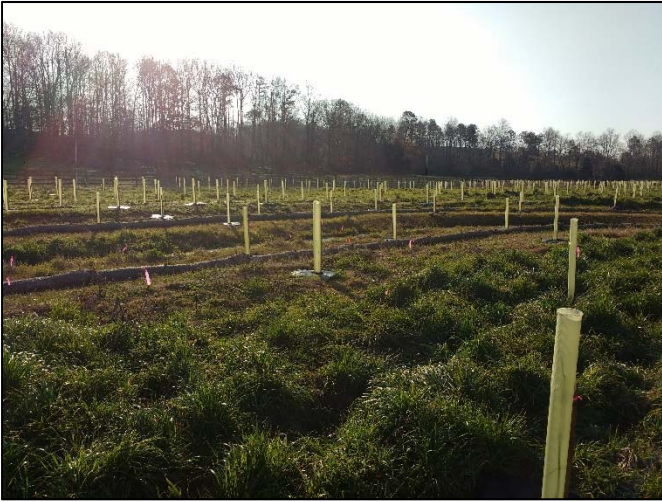
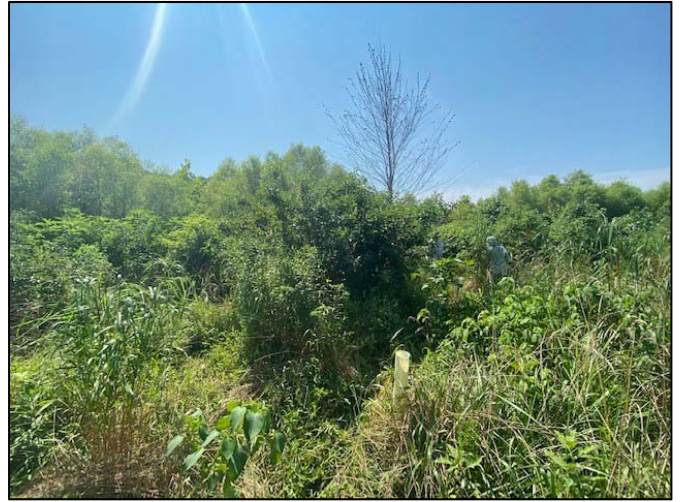
Vegetation Plot 1 – MY-00 – 3/21/17

- It is understood that beaver have caused most of the vegetation damage and the site vegetation is doing well overall, but is KCI planning any additional planting and/or MY6 vegetation monitoring based on the MY5 plot attainment data? Please address the plot non-attainments in VPs 1, 3, 5, and 6 in more detail.

KCI Response: No additional planting is planned for the Sandy Bridge site. Overall the site is well vegetated with many large and healthy trees present throughout the site. While VP 1 and 3 are below the Year 5 success criteria of 260 stems/acre, they are above the Year 7 success criteria of 210 stems/acre and so do not present a long term problem for the site's success. Additionally, all 4 of the low performing veg plots have at least 283 stems/acre when including volunteers. All of the volunteer species in these plots, except for one American elm, are species that were included in the planting plan. So although the beavers have significantly damaged the vegetation on site it is still performing as expected. It is believed that over the long term, the large, high quality seed source of woody vegetation that is present on the site will make up for any of the small areas of the site that are below the expected standards, as demonstrated by the presence of high quality volunteers that can be found in nearly all of the veg plots.

Vegetation Plot 1 – MY-05 – 7/6/21

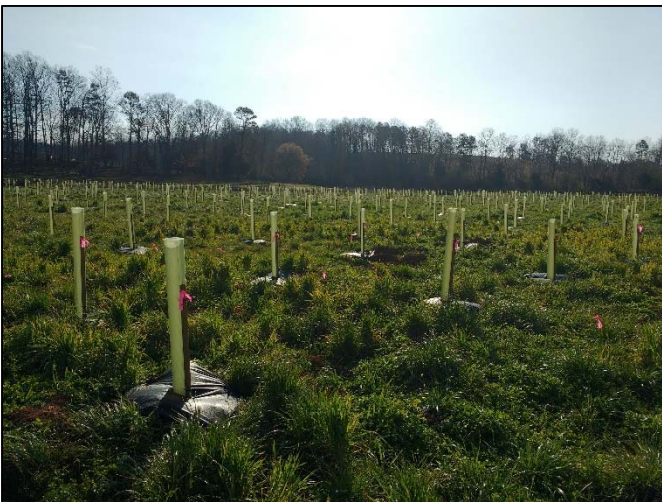
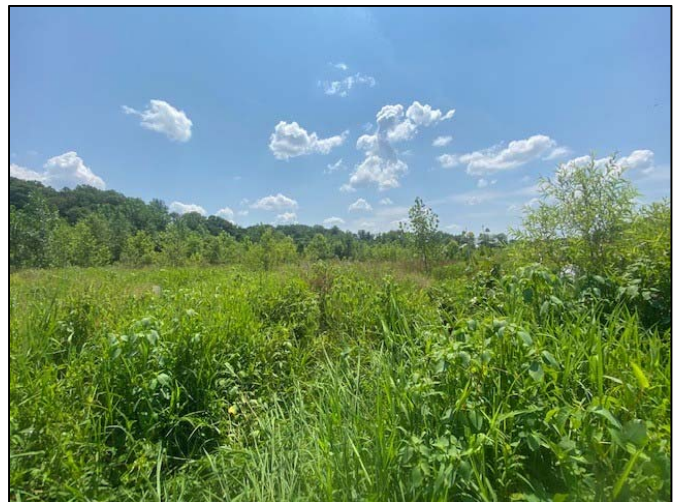
Vegetation Plot 3 – MY-00 – 3/21/17

Vegetation Plot 3 – MY-05 – 7/6/21

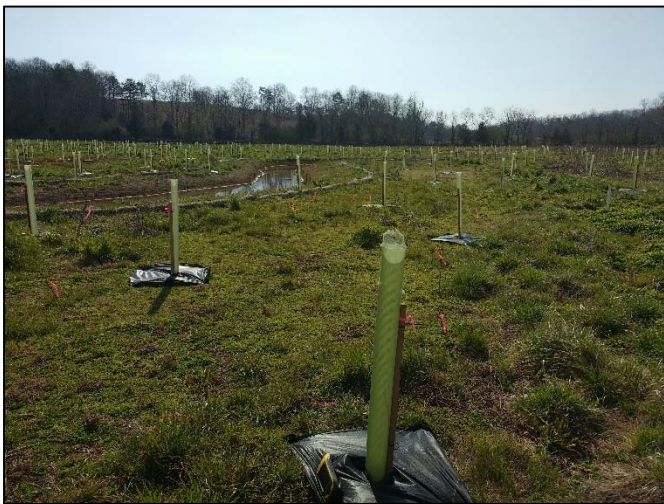
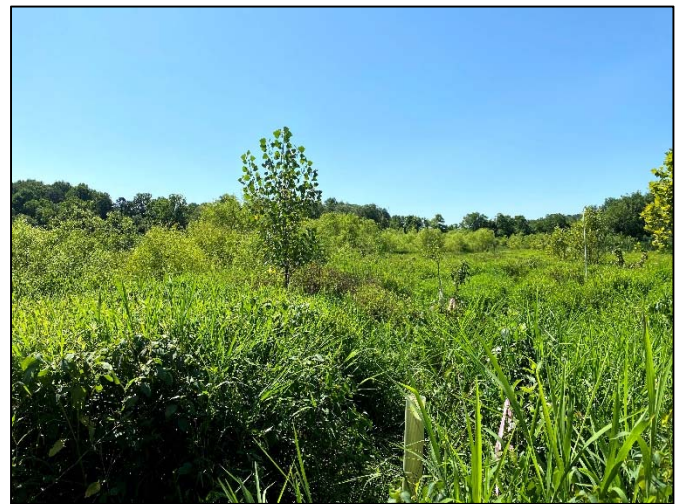
Vegetation Plot 5 – MY-00 – 3/21/17

Vegetation Plot 5 – MY-05 – 7/15/21

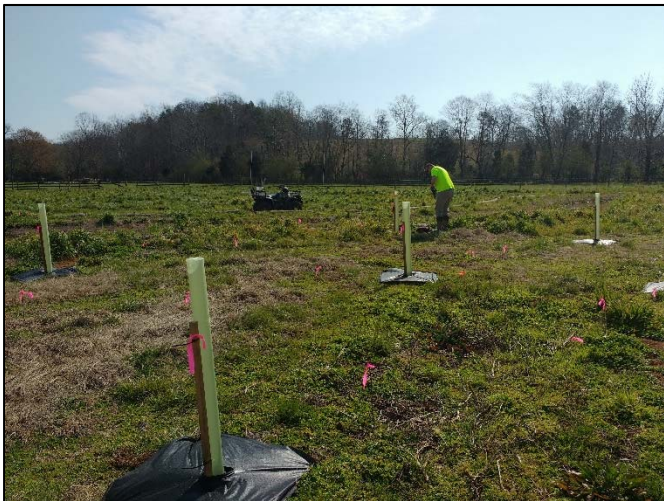
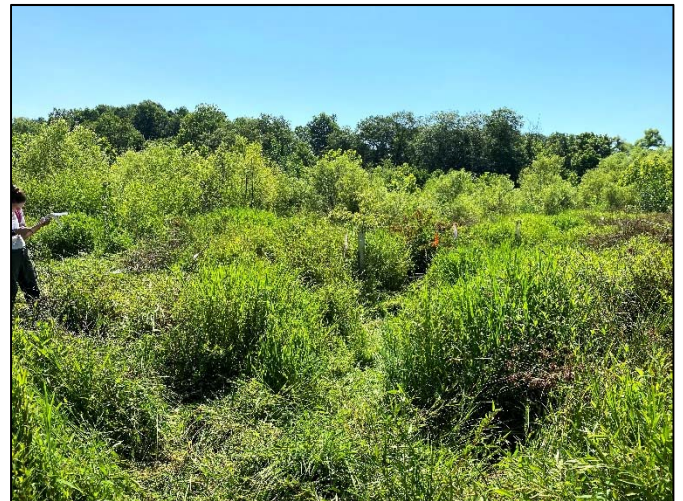
Vegetation Plot 6 – MY-00 – 3/21/17

Vegetation Plot 6 – MY-05 – 7/15/21

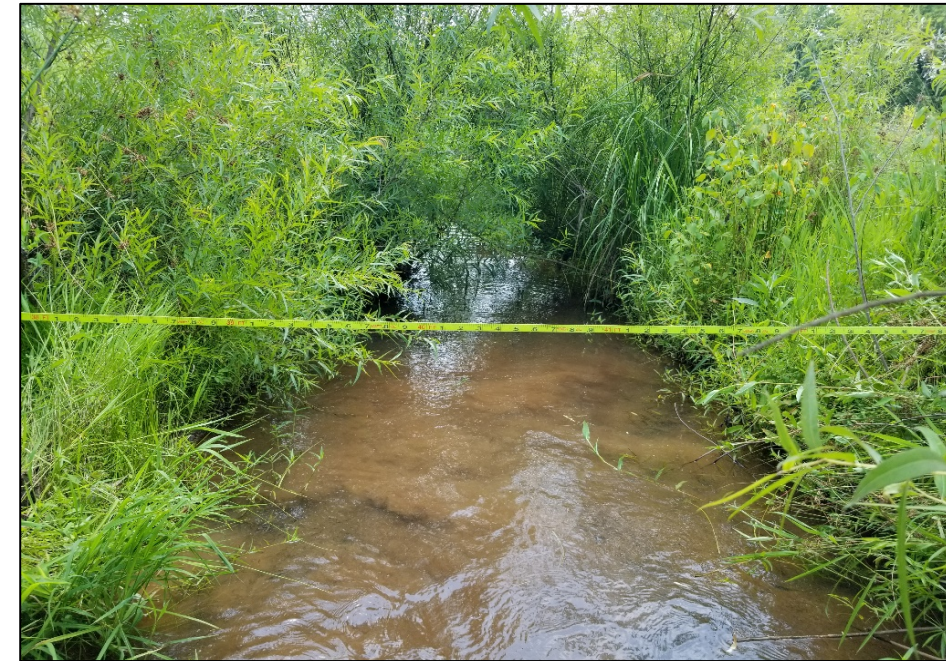
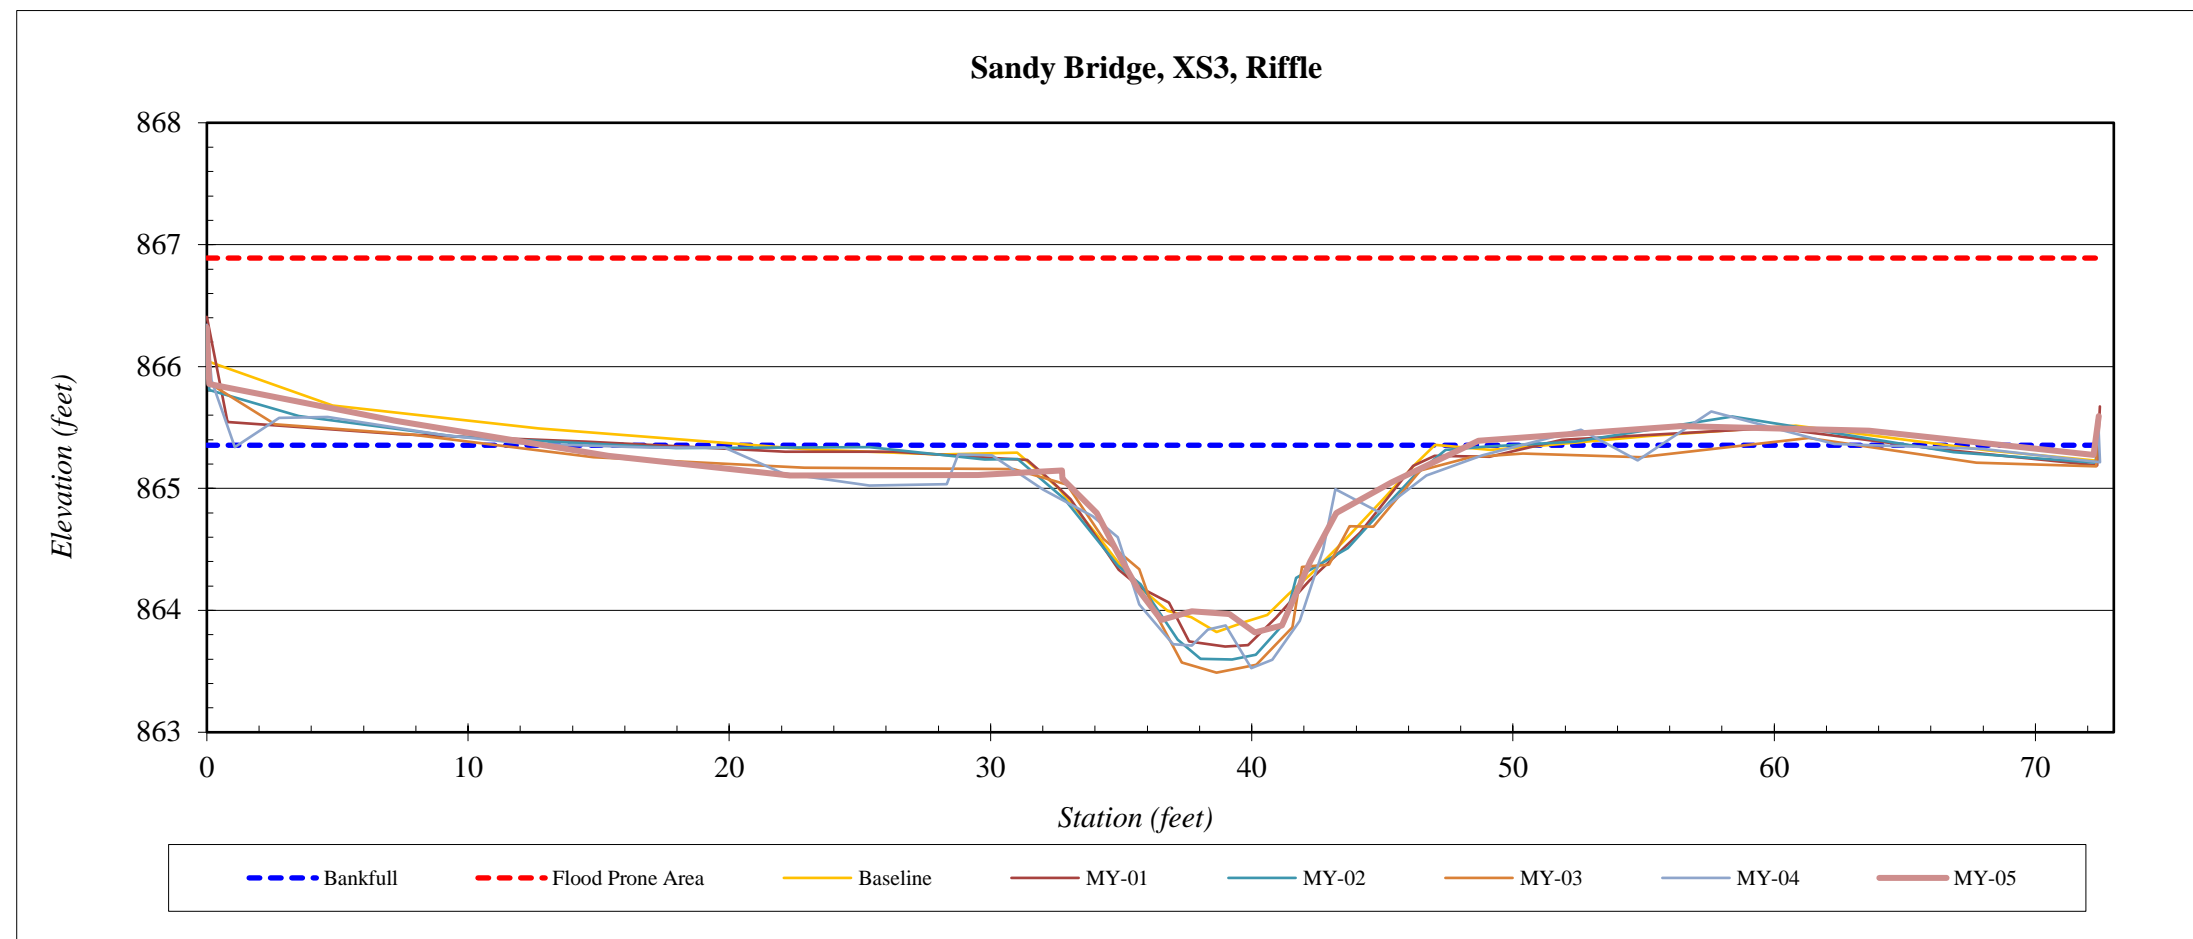
River Basin:	Broad
Site:	Sandy Bridge
XS ID	XS3
Drainage Area:	837 acres
Date:	7/6/2021
Field Crew:	T. Seelinger, C. Pristupa

SUMMARY DATA	
Current Bankfull Elevation:	865.35
Bankfull Cross-Sectional Area:	13.1
Total Cross-Sectional Area:	12.2
Bankfull Width:	15.6
Flood Prone Area Elevation:	866.9
Flood Prone Width:	72.4
Max Depth at Bankfull:	1.5
Mean Depth at Bankfull:	0.8
W / D Ratio:	18.5
Entrenchment Ratio:	4.7
Bank Height Ratio:	0.8

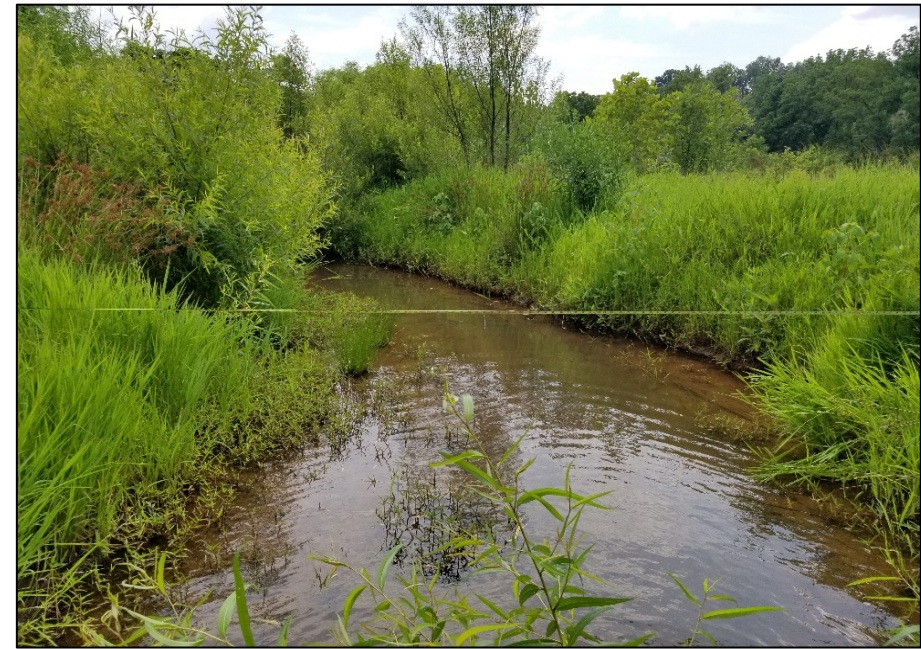
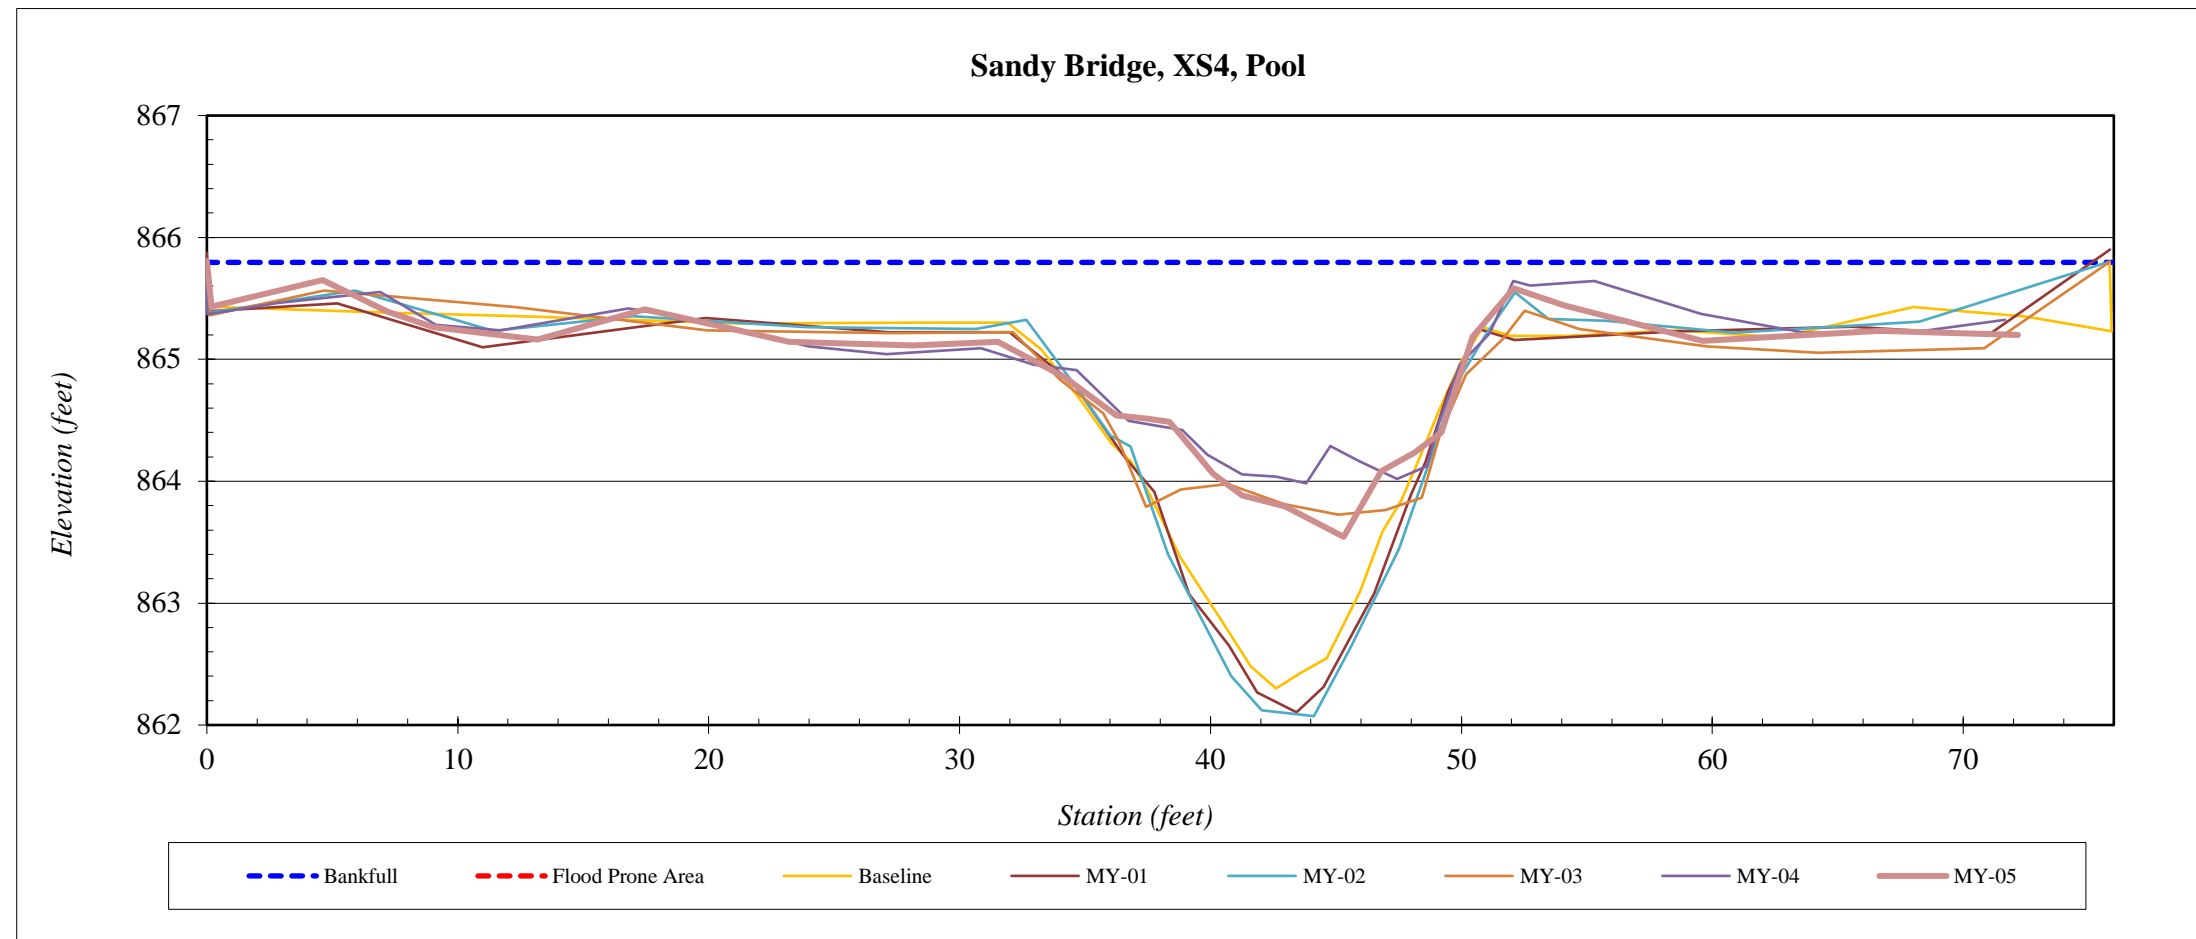
River Basin:	Broad
Site:	Sandy Bridge
XS ID	XS4
Drainage Area:	837 acres
Date:	7/6/2021
Field Crew:	T. Seelinger, C. Pristupa

SUMMARY DATA	
Current Bankfull Elevation:	865.80
Bankfull Cross-Sectional Area:	28.8
Total Cross-Sectional Area:	18.1
Bankfull Width:	20.5
Flood Prone Area Elevation:	---
Flood Prone Width:	---
Max Depth at Bankfull:	2.3
Mean Depth at Bankfull:	1.4
W / D Ratio:	---
Entrenchment Ratio:	---
Bank Height Ratio:	---
