**Bowl Basin Restoration Site  
Monitoring Report MY07  
DMS Project # 95721  
DMS Contract # 005012**

**Onslow County, NC  
CU# 03020106  
DWR# 2013-0864  
SAW# 2013-00393**

**Construction Completed: February 2015  
Data Collection: 2021  
Submitted: February 2022**

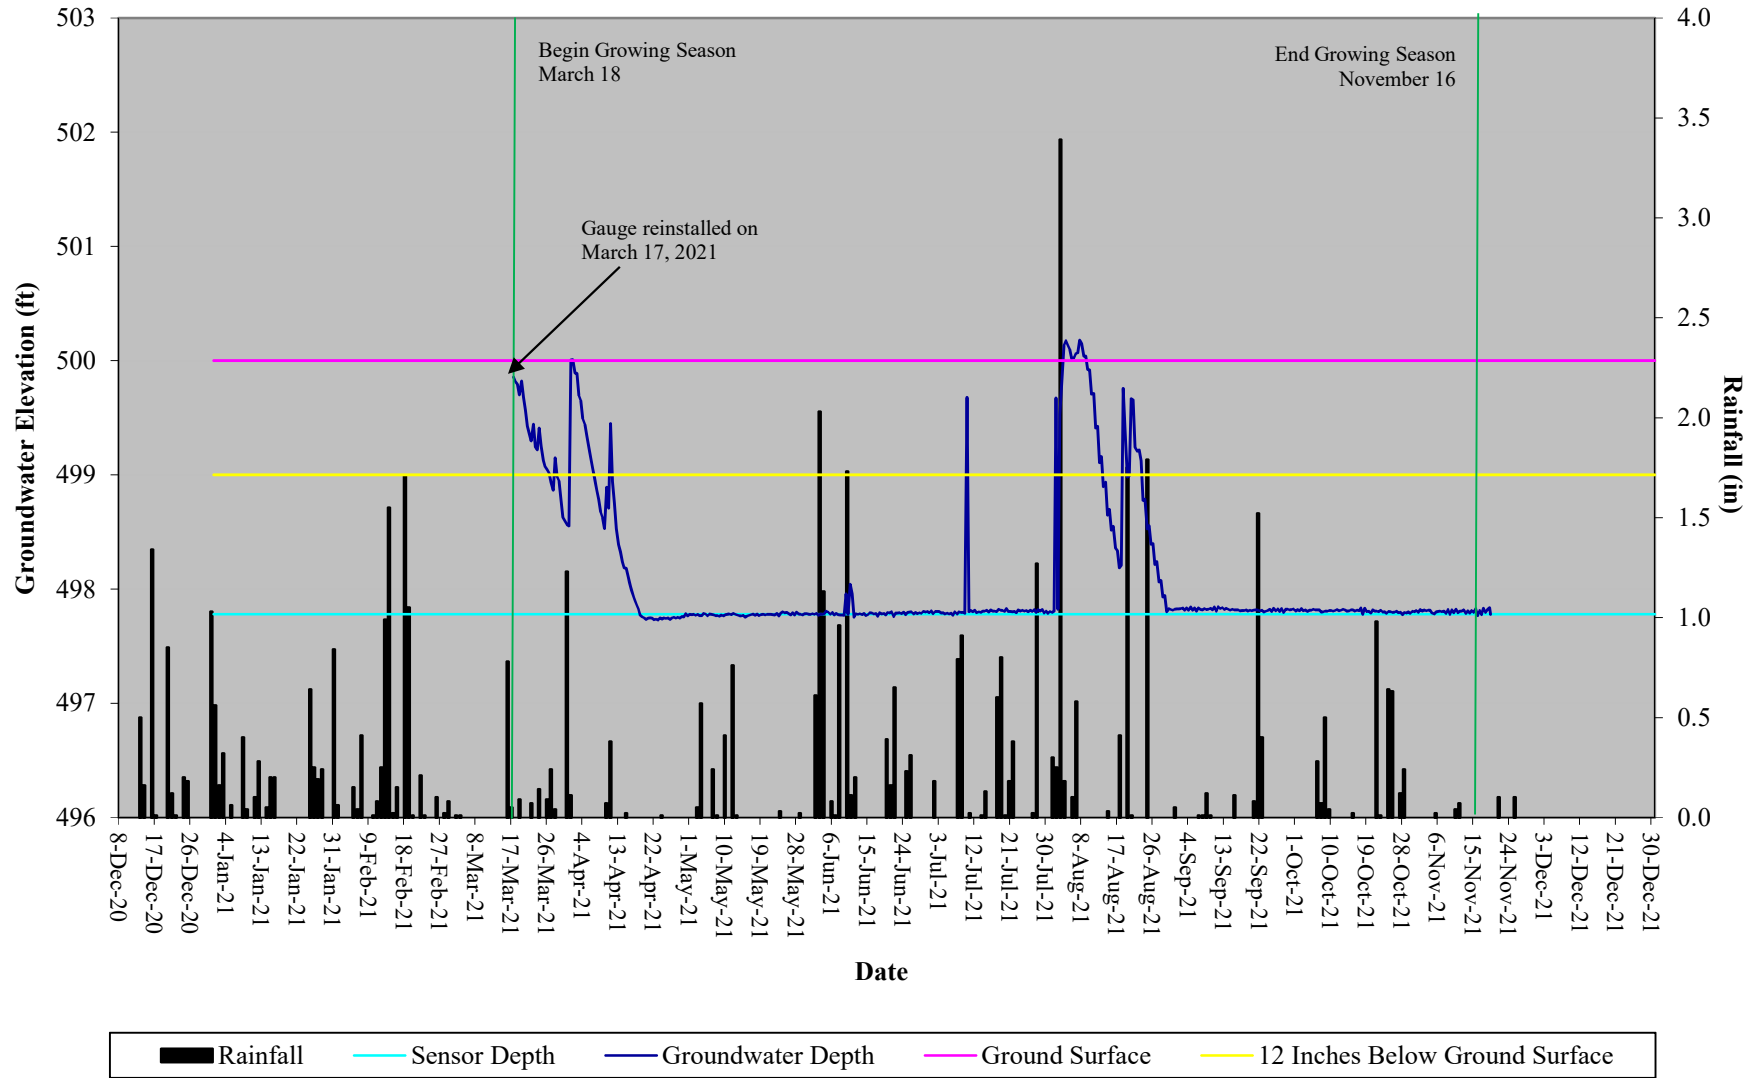
### Bowl Basin Restoration Site Hydrograph Wetland Gauge 4

<b>Table 7. Wetland Hydrology Criteria Attainment Table</b>							
<b>Project Number and Name: 95721 - Bowl Basin Restoration Site</b>							
	<b>Success Criteria Achieved/ Max Consecutive Days During Growing Season (Percentage)</b>						
<b>Non-Riparian Gauges Success Criteria (22 Days) (9%)</b>	<b>MY-01 2015</b>	<b>MY-02 2016</b>	<b>MY-03 2017</b>	<b>MY-04 2018</b>	<b>MY-05 2019</b>	<b>MY-06 2020</b>	<b>MY-07 2021</b>
Rainfall Conditions	Normal	Normal	Drier than Normal	Normal	Drier than Normal	Normal	Normal
Gauge 1	Yes/37 (15.2%)	Yes/29 (11.9%)	Yes/24 (9.8%)	Yes/35 (14.3%)	No/12 (4.9%)	No/18 (7.4%)	No/11 (4.5%)
Gauge 2	Yes/69 (28.3%)	Yes/49 (20.1%)	Yes/32 (13.1%)	Yes/37 (15.2%)	No/17 (7.0%)	Yes/22 (9.1%)	No/13 (5.3%)
Gauge 3	No/20 (8.2%)	Yes/27 (11.1%)	No/13 (5.3%)	Yes/27 (11.1%)	No/13 (5.3%)	No/14 (5.8%)	No/4 (1.6%)
Gauge 4	Yes/29 (11.9%)	Yes/41 (16.8%)	Yes/26 (10.7%)	Yes/32 (13.1%)	No/14 (5.7%)	No/18 (7.4%)	No/11 (4.5%)
