Fletcher Stream and Wetland Mitigation Site

Annual Monitoring Report

Monitoring Year 2 of 7

Henderson County, North Carolina

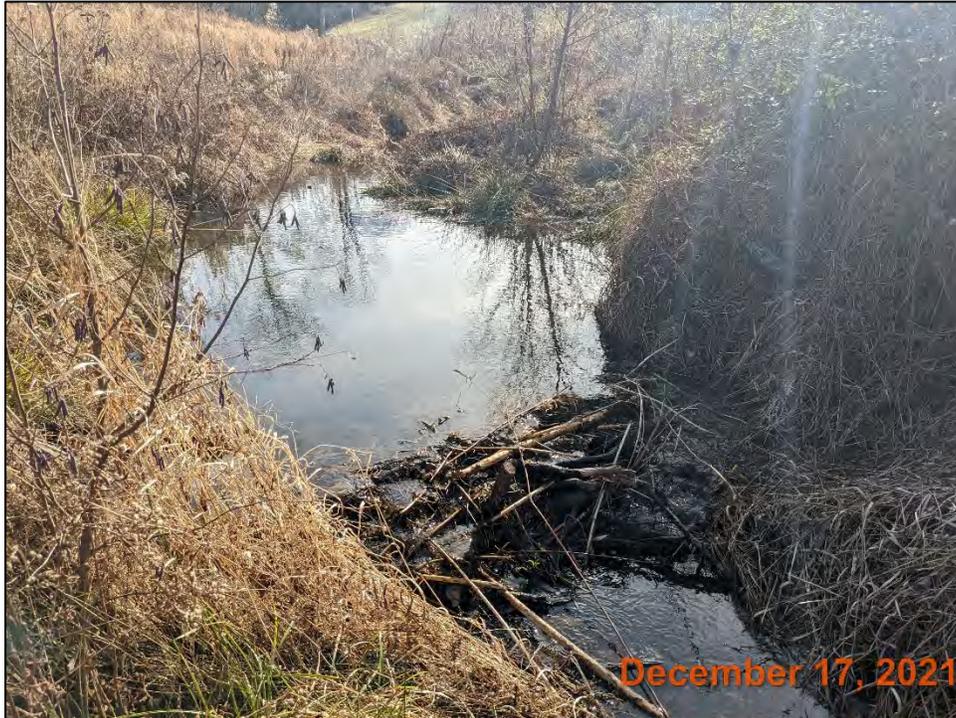
Beaver Dam Fletcher Reach 1C, Station 119+00

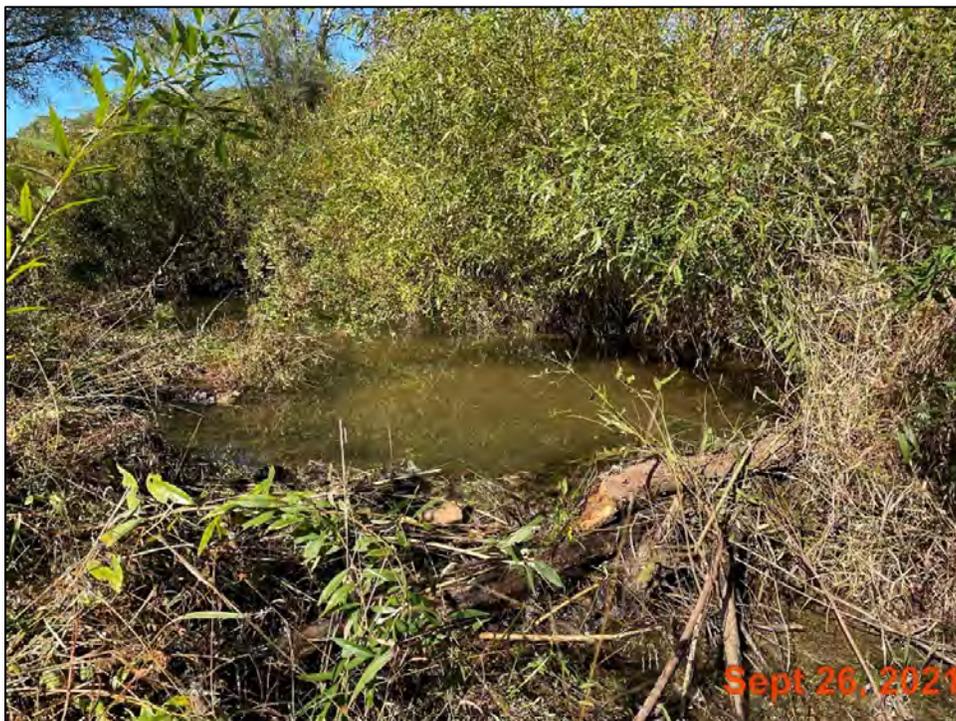
Beaver Dam Fletcher Reach 1C, Station 135+00

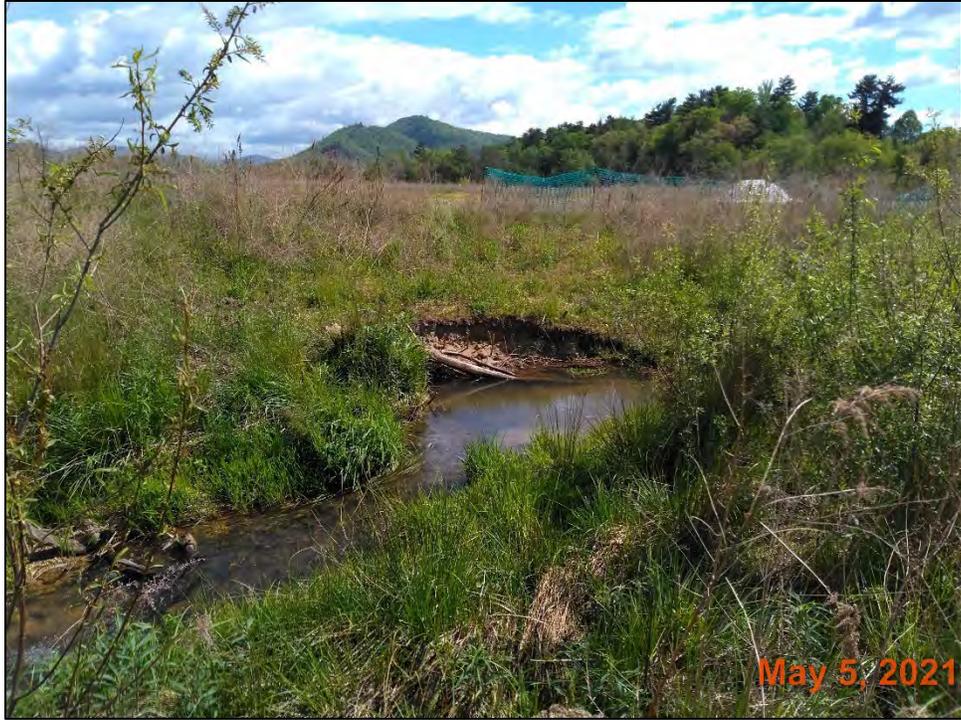
Bank Scour Fletcher Reach 2 Station 144+00

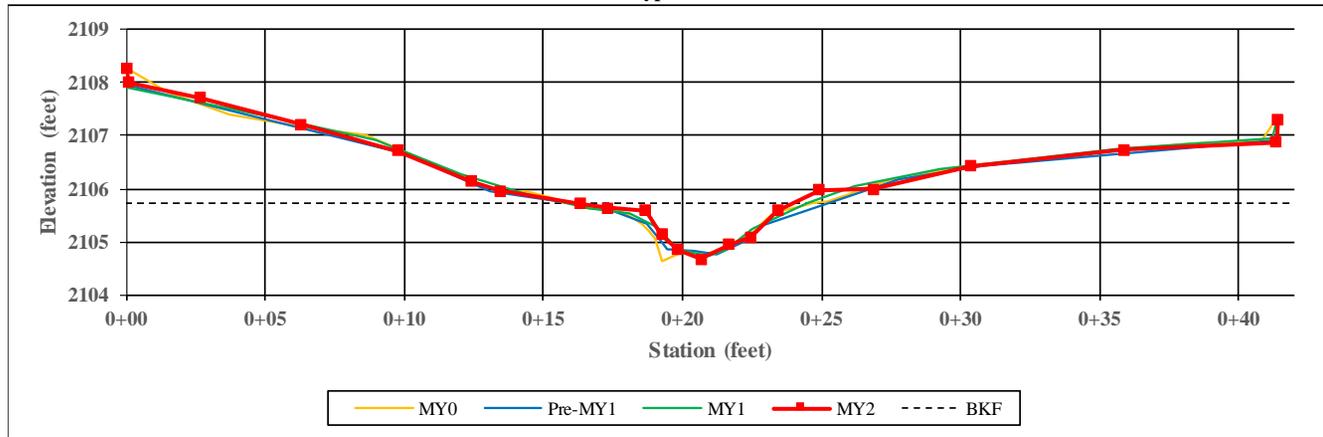
XS Number: 28

Station: 317+42

Reach Name: Coates Branch 1D

XS Type: Riffle

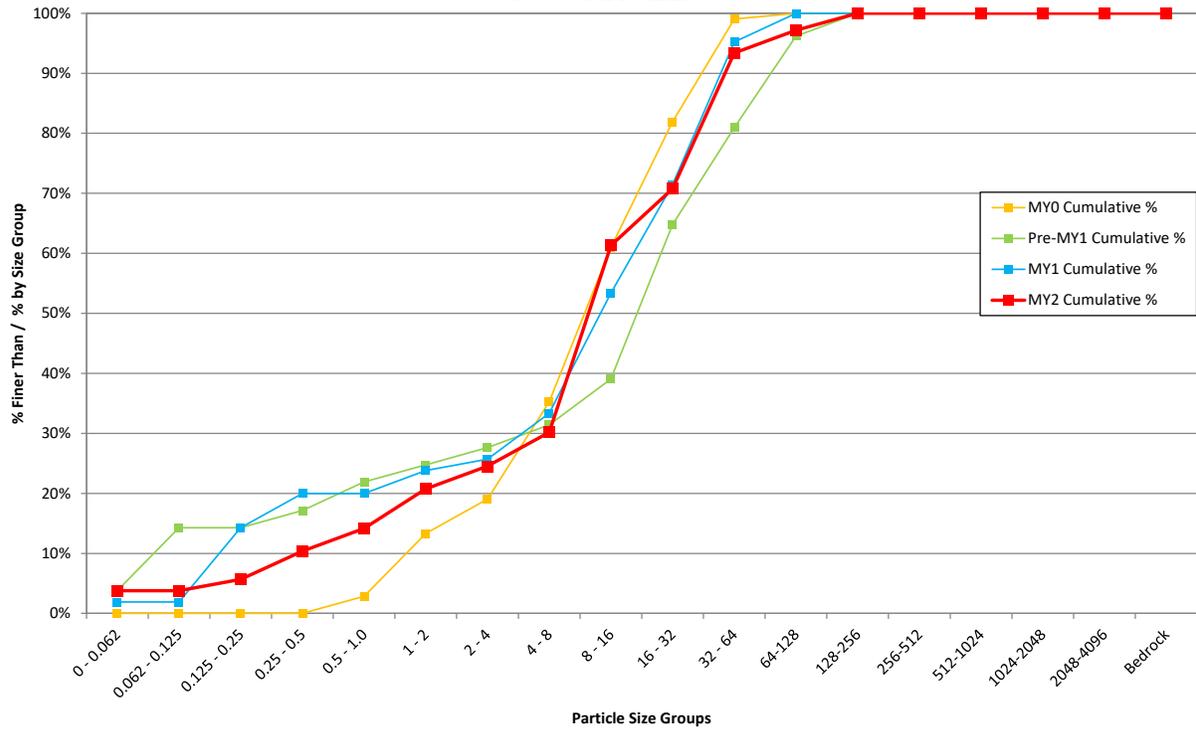
Fletcher Mitigation Site
Pebble Count - Percent Cumulative
Cross-Section 1 - Riffle

Fletcher Mitigation Site			
Cross Section 1 - Riffle			
Monitoring Year - 2021; MY2			
Bed Surface Material Particle Size Class (mm)	Number	% Individual	% Cumulative
0 - 0.062	4	3.8%	4%
0.062 - 0.125	0	0.0%	4%
0.125 - 0.25	2	1.9%	6%
0.25 - 0.5	5	4.7%	10%
0.5 - 1.0	4	3.8%	14%
1 - 2	7	6.6%	21%
2 - 4	4	3.8%	25%
4 - 8	6	5.7%	30%
8 - 16	33	31.1%	61%
16 - 32	10	9.4%	71%
32 - 64	24	22.6%	93%
64-128	4	3.8%	97%
128-256	3	2.8%	100%
256-512	0	0.0%	100%
512-1024	0	0.0%	100%
1024-2048	0	0.0%	100%
2048-4096	0	0.0%	100%
Bedrock	0	0.0%	100%
Total	106	100%	100%
		Summary Data	
		D50	13
		D84	48
		D95	78

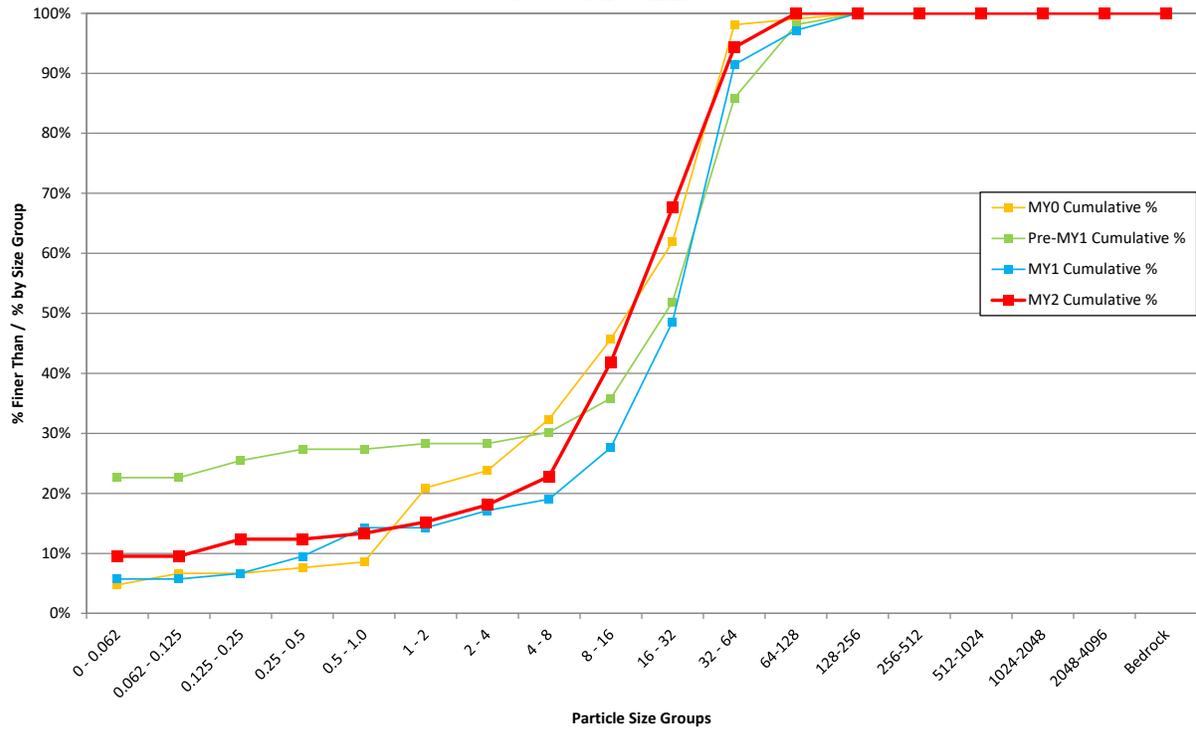
Fletcher Mitigation Site
Pebble Count - Percent Cumulative
Cross-Section 4 - Riffle

Fletcher Mitigation Site			
Cross Section 4 - Riffle			
Monitoring Year - 2021; MY2			
Bed Surface Material Particle Size Class (mm)	Number	% Individual	% Cumulative
0 - 0.062	10	9.5%	10%
0.062 - 0.125	0	0.0%	10%
0.125 - 0.25	3	2.9%	12%
0.25 - 0.5	0	0.0%	12%
0.5 - 1.0	1	1.0%	13%
1 - 2	2	1.9%	15%
2 - 4	3	2.9%	18%
4 - 8	5	4.8%	23%
8 - 16	20	19.0%	42%
16 - 32	27	25.7%	68%
32 - 64	28	26.7%	94%
64-128	6	5.7%	100%
128-256	0	0.0%	100%
256-512	0	0.0%	100%
512-1024	0	0.0%	100%
1024-2048	0	0.0%	100%
2048-4096	0	0.0%	100%
Bedrock	0	0.0%	100%
Total	105	100%	100%
		Summary Data	
		D50	18
		D84	42
		D95	68

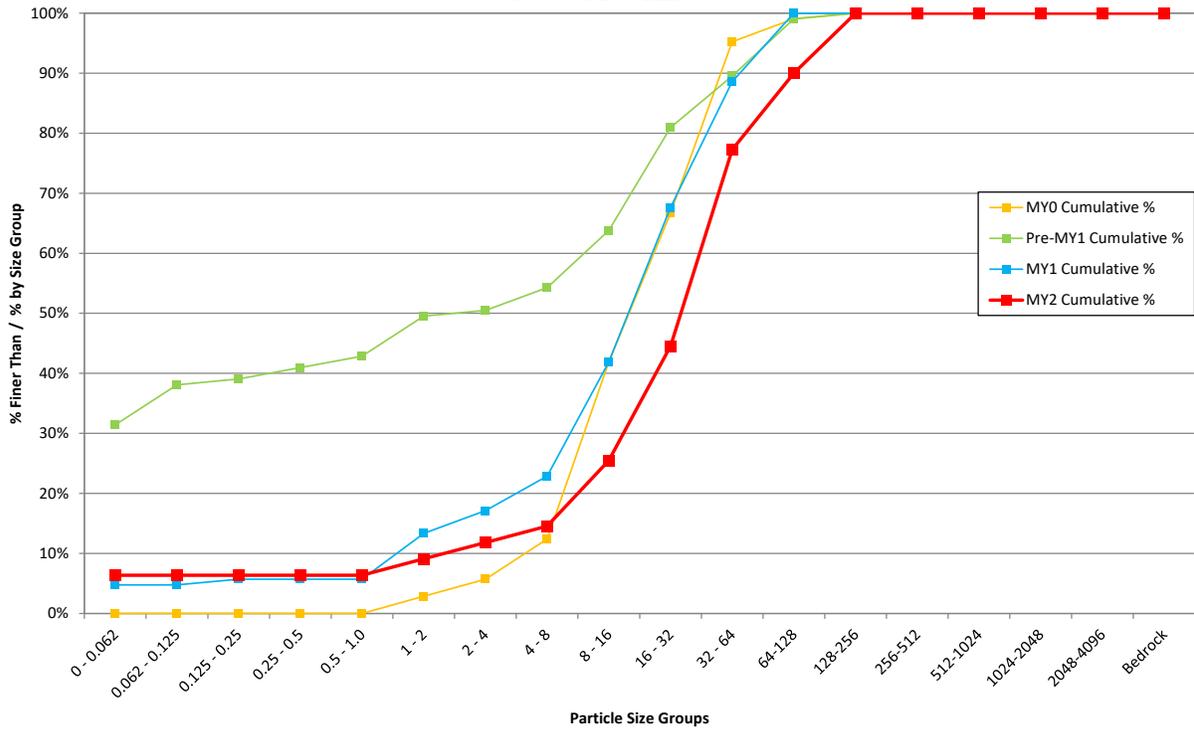
Fletcher Mitigation Site
Pebble Count - Percent Cumulative
Cross-Section 6 - Riffle

Fletcher Mitigation Site			
Cross Section 6 - Riffle			
Monitoring Year - 2021; MY2			
Bed Surface Material Particle Size Class (mm)	Number	% Individual	% Cumulative
0 - 0.062	7	6.4%	6%
0.062 - 0.125	0	0.0%	6%
0.125 - 0.25	0	0.0%	6%
0.25 - 0.5	0	0.0%	6%
0.5 - 1.0	0	0.0%	6%
1 - 2	3	2.7%	9%
2 - 4	3	2.7%	12%
4 - 8	3	2.7%	15%
8 - 16	12	10.9%	25%
16 - 32	21	19.1%	45%
32 - 64	36	32.7%	77%
64-128	14	12.7%	90%
128-256	11	10.0%	100%
256-512	0	0.0%	100%
512-1024	0	0.0%	100%
1024-2048	0	0.0%	100%
2048-4096	0	0.0%	100%
Bedrock	0	0.0%	100%
Total	110	100%	100%
		Summary Data	
		D50	36
		D84	85
		D95	150

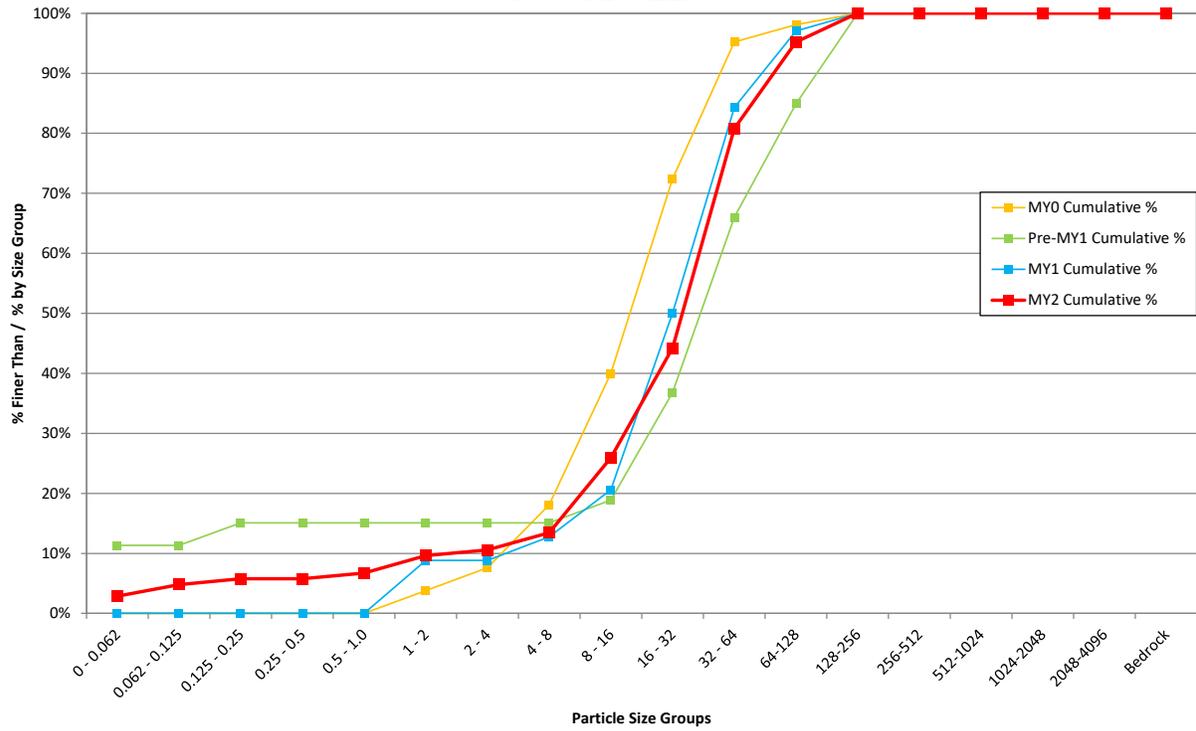
Fletcher Mitigation Site
Pebble Count - Percent Cumulative
Cross-Section 7 - Riffle

Fletcher Mitigation Site			
Cross Section 7 - Riffle			
Monitoring Year - 2021; MY2			
Bed Surface Material Particle Size Class (mm)	Number	% Individual	% Cumulative
0 - 0.062	3	2.9%	3%
0.062 - 0.125	2	1.9%	5%
0.125 - 0.25	1	1.0%	6%
0.25 - 0.5	0	0.0%	6%
0.5 - 1.0	1	1.0%	7%
1 - 2	3	2.9%	10%
2 - 4	1	1.0%	11%
4 - 8	3	2.9%	13%
8 - 16	13	12.5%	26%
16 - 32	19	18.3%	44%
32 - 64	38	36.5%	81%
64-128	15	14.4%	95%
128-256	5	4.8%	100%
256-512	0	0.0%	100%
512-1024	0	0.0%	100%
1024-2048	0	0.0%	100%
2048-4096	0	0.0%	100%
Bedrock	0	0.0%	100%
Total	104	100%	100%
		Summary Data	
		D50	35
		D84	80
		D95	130

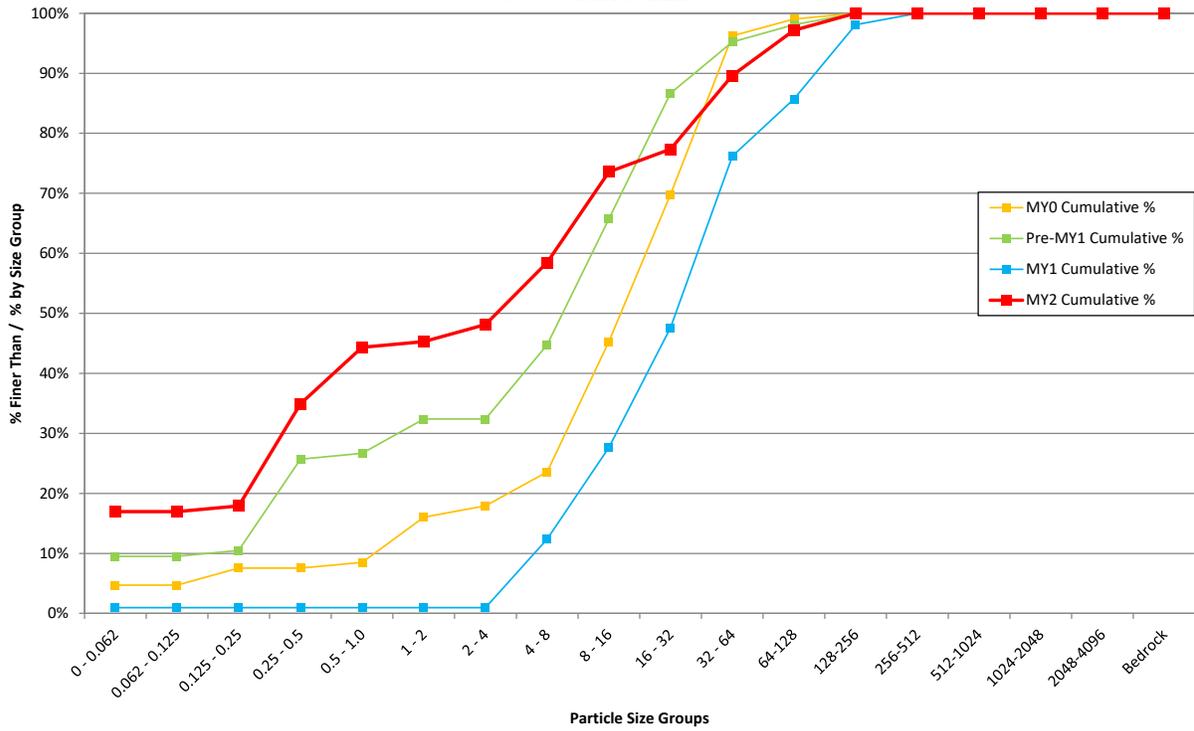
Fletcher Mitigation Site
Pebble Count - Percent Cumulative
Cross-Section 14 - Riffle

Fletcher Mitigation Site			
Cross Section 14 - Riffle			
Monitoring Year - 2021; MY2			
Bed Surface Material Particle Size Class (mm)	Number	% Individual	% Cumulative
0 - 0.062	18	17.0%	17%
0.062 - 0.125	0	0.0%	17%
0.125 - 0.25	1	0.9%	18%
0.25 - 0.5	18	17.0%	35%
0.5 - 1.0	10	9.4%	44%
1 - 2	1	0.9%	45%
2 - 4	3	2.8%	48%
4 - 8	11	10.4%	58%
8 - 16	16	15.1%	74%
16 - 32	4	3.8%	77%
32 - 64	13	12.3%	90%
64-128	8	7.5%	97%
128-256	3	2.8%	100%
256-512	0	0.0%	100%
512-1024	0	0.0%	100%
1024-2048	0	0.0%	100%
2048-4096	0	0.0%	100%
Bedrock	0	0.0%	100%
Total	106	100%	100%
		Summary Data	
		D50	5.2
		D84	52
		D95	98

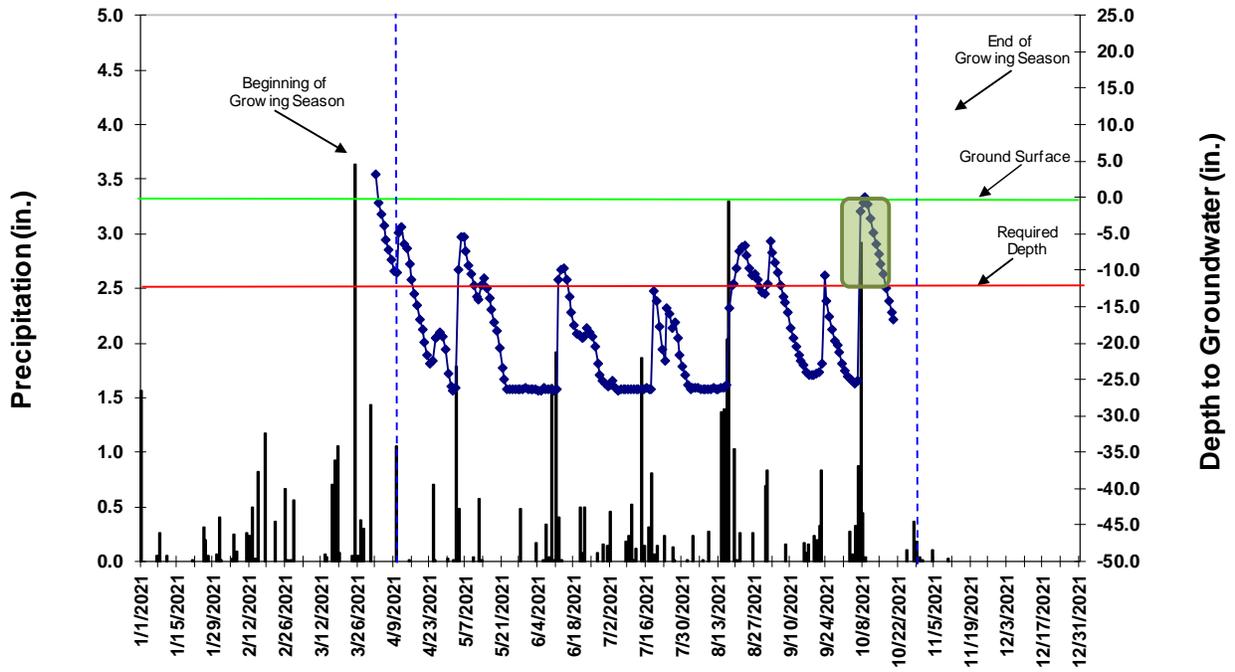
Gauge ID: **MW4**
 Total Number of Consecutive Days Water Table within 12 inches of Soil Surface: **10**
 Percentage of Growing Season Water Table within 12 inches of Soil Surface: **5%**

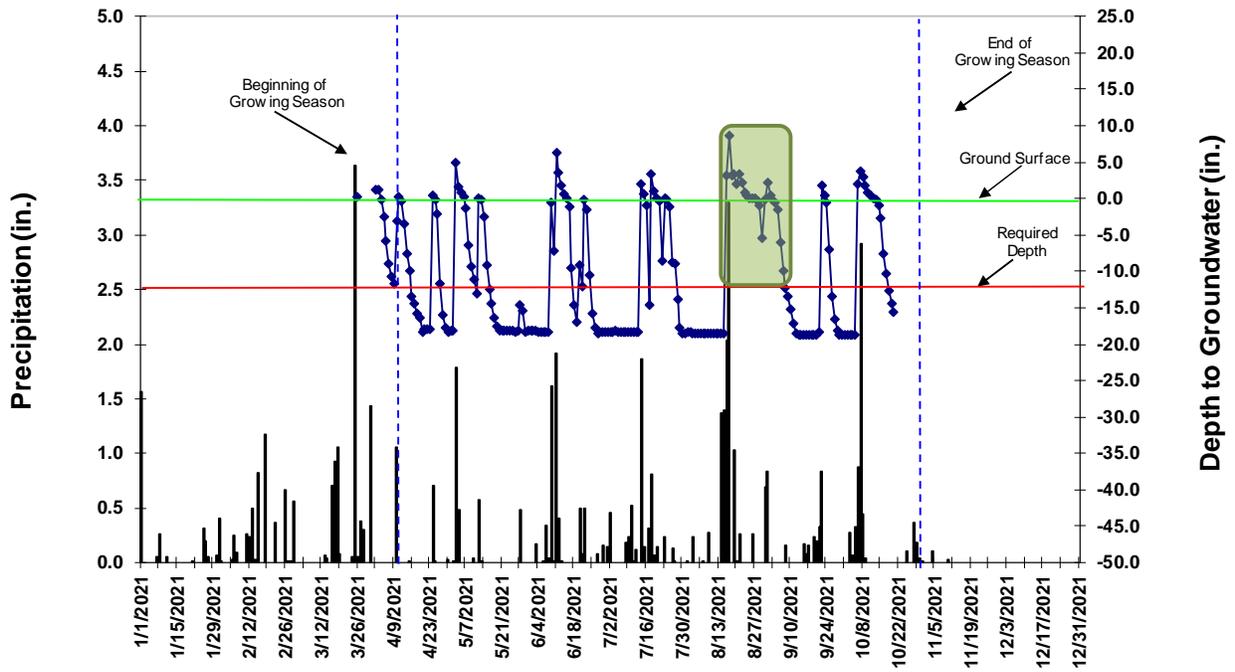
Gauge ID: **MW5**
 Total Number of Consecutive Days Water Table within 12 inches of Soil Surface: **23**
 Percentage of Growing Season Water Table within 12 inches of Soil Surface: **11%**

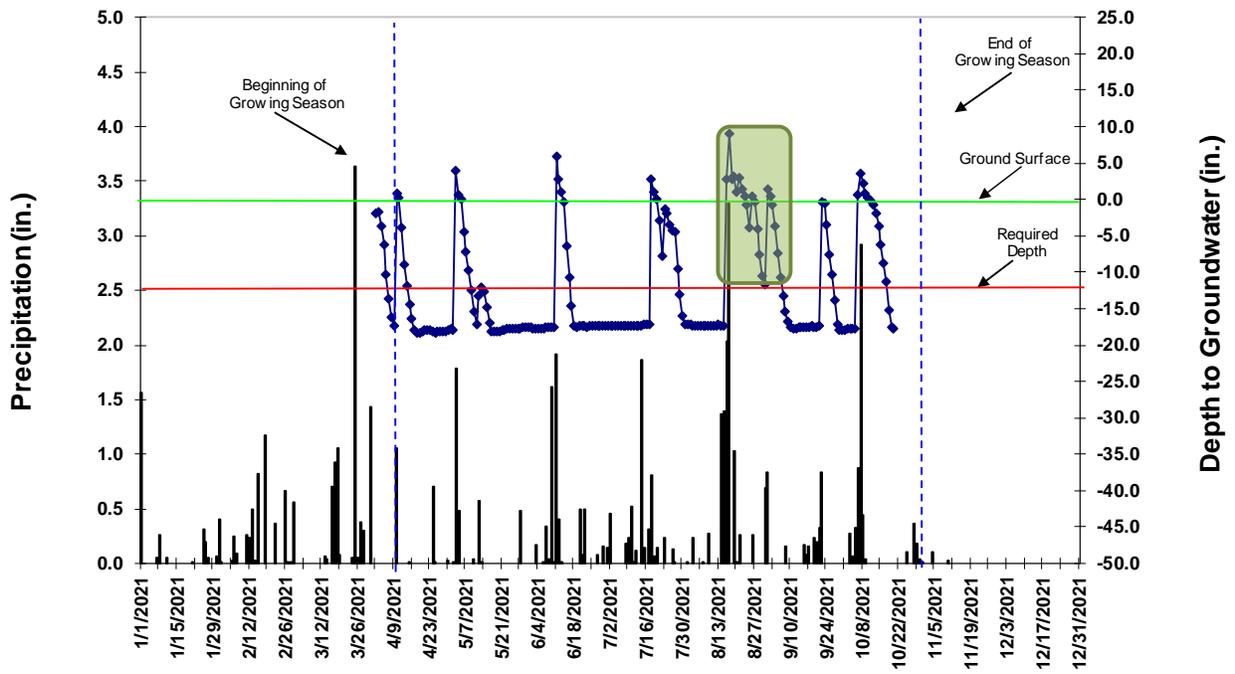
Gauge ID: **MW6**
 Total Number of Consecutive Days Water Table within 12 inches of Soil Surface: **22**
 Percentage of Growing Season Water Table within 12 inches of Soil Surface: **11%**

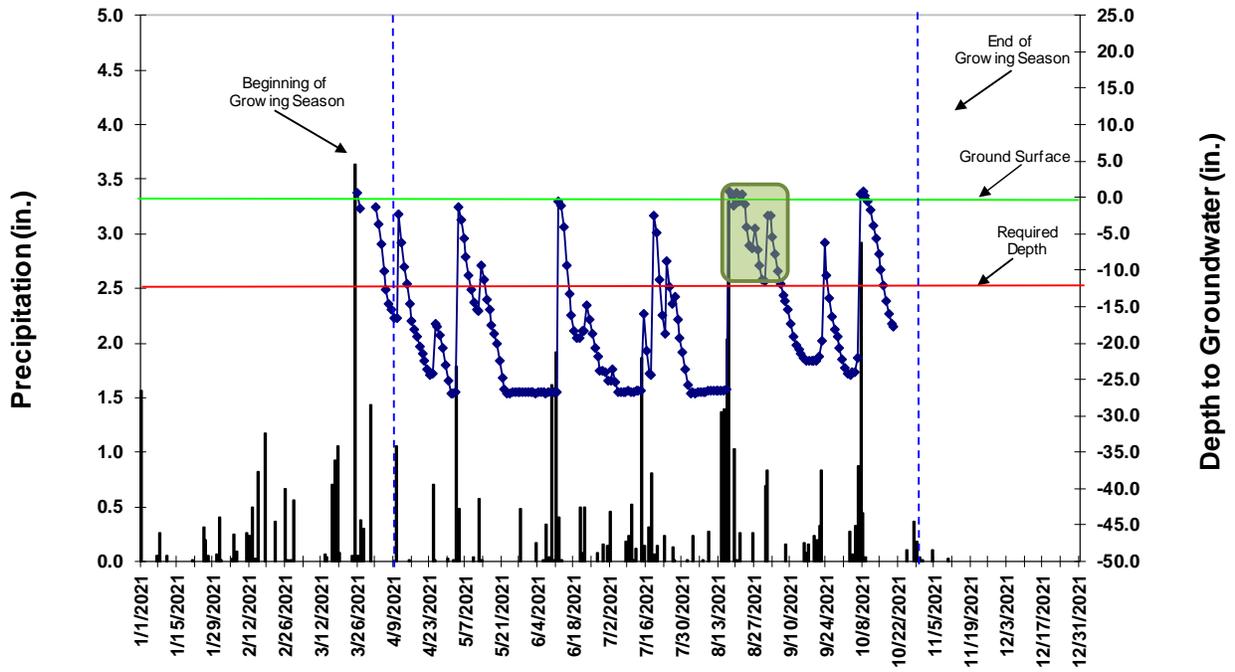
Gauge ID: **MW8**
 Total Number of Consecutive Days Water Table within 12 inches of Soil Surface: **21**
 Percentage of Growing Season Water Table within 12 inches of Soil Surface: **10%**

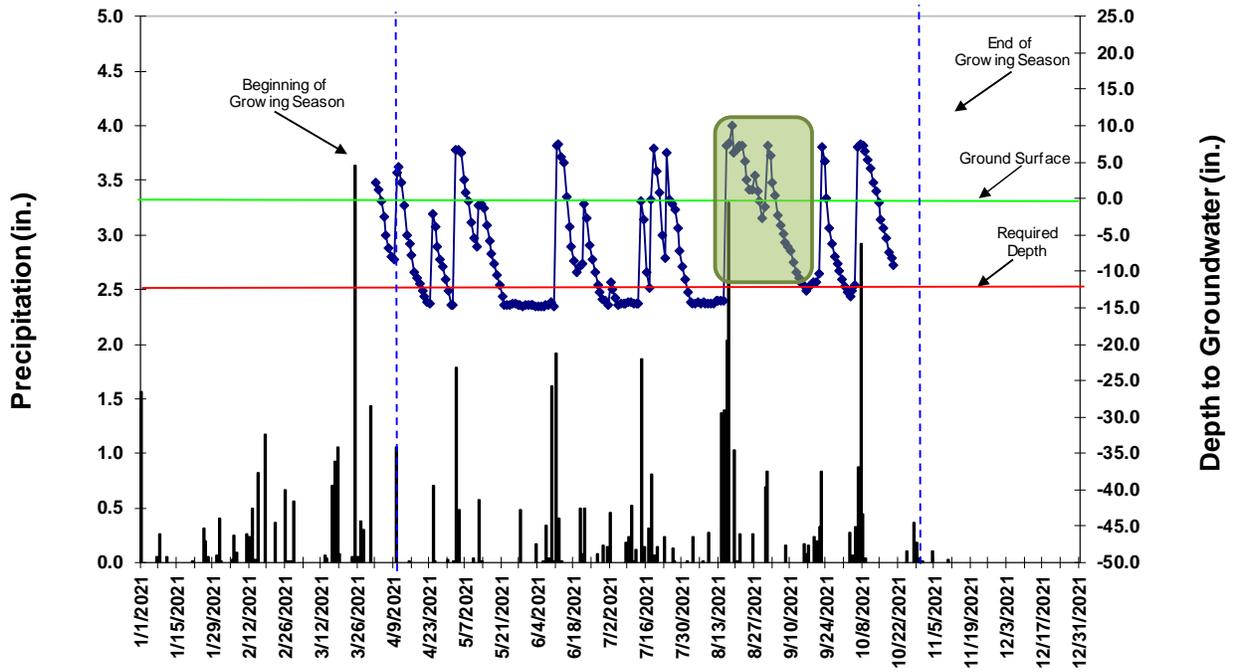
Gauge ID: **MW9**
 Total Number of Consecutive Days Water Table within 12 inches of Soil Surface: **31**
 Percentage of Growing Season Water Table within 12 inches of Soil Surface: **15%**

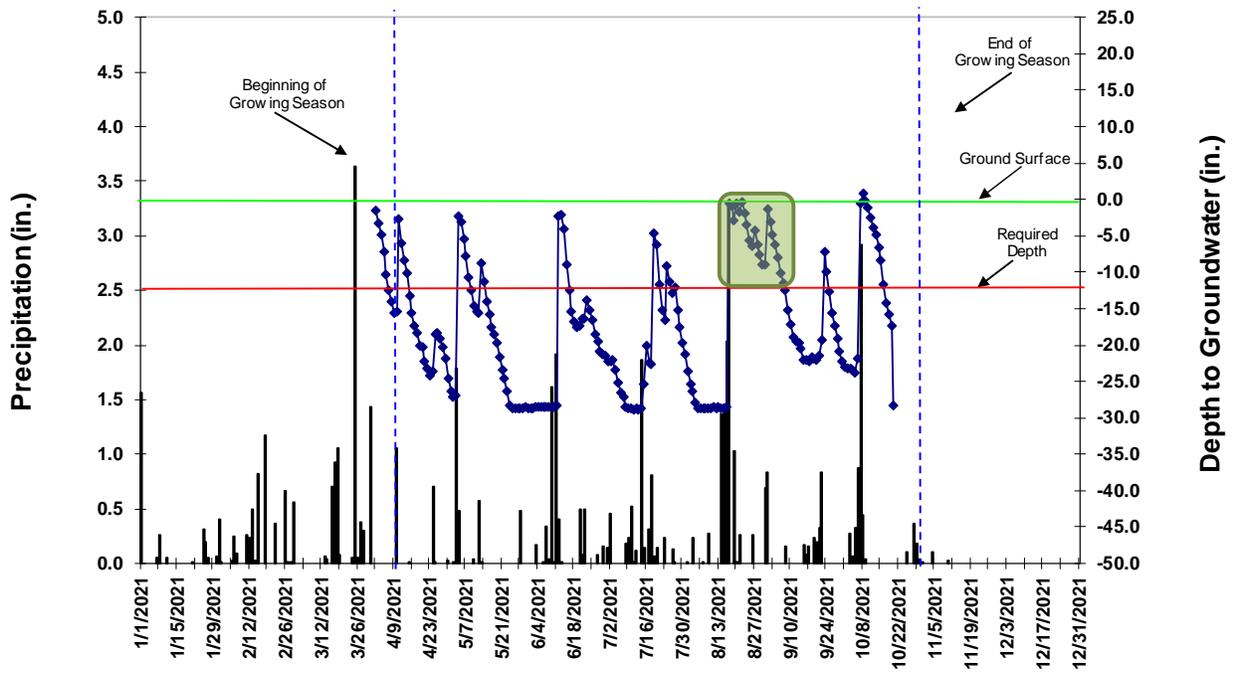
Gauge ID: **MW10**
 Total Number of Consecutive Days Water Table within 12 inches of Soil Surface: **22**
 Percentage of Growing Season Water Table within 12 inches of Soil Surface: **11%**
