Monitoring Report

Harrell Stream and Wetland Mitigation Site

Monitoring Year 2 (2021)

NCDMS Project No. 100005

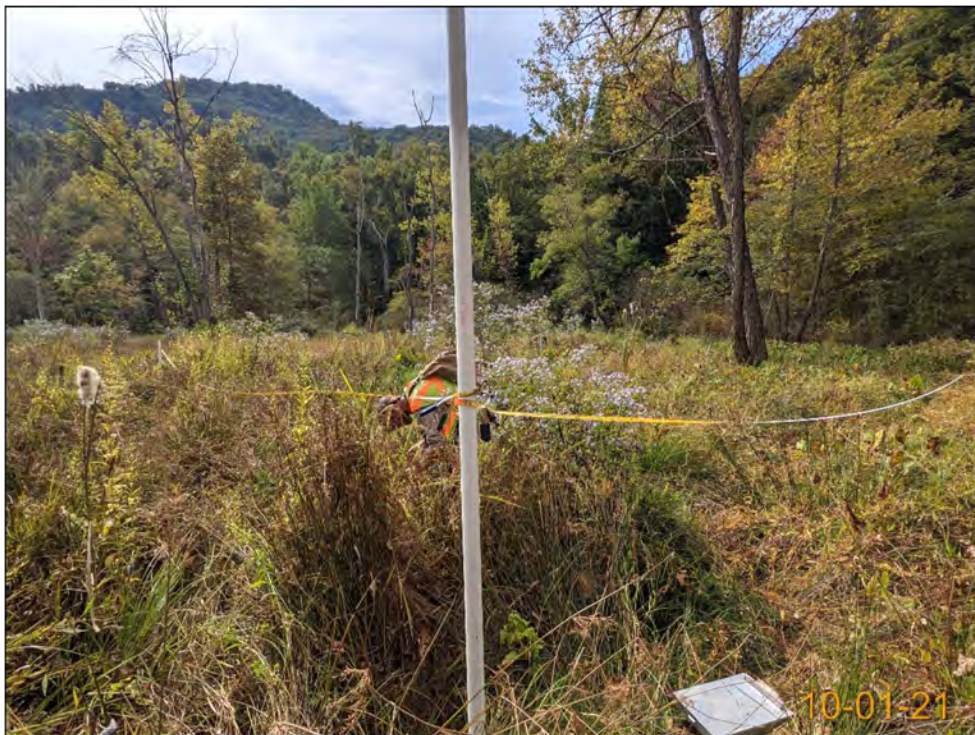
Vegetation Monitoring Plot 4

stems per acre. Supplemental planting of more wet-tolerant species within the vicinity of Vegetation Plots 4 and 5 was conducted on February 4, 2021, and consisted of 1–2-year-old bare root plants, planted on 6-foot centers, with silky dogwood (*Cornus amomum*), tag alder (*Alnus serrulata*), and black willow (*Salix nigra*). A map and summary of the supplemental plantings can be found in Appendix F.

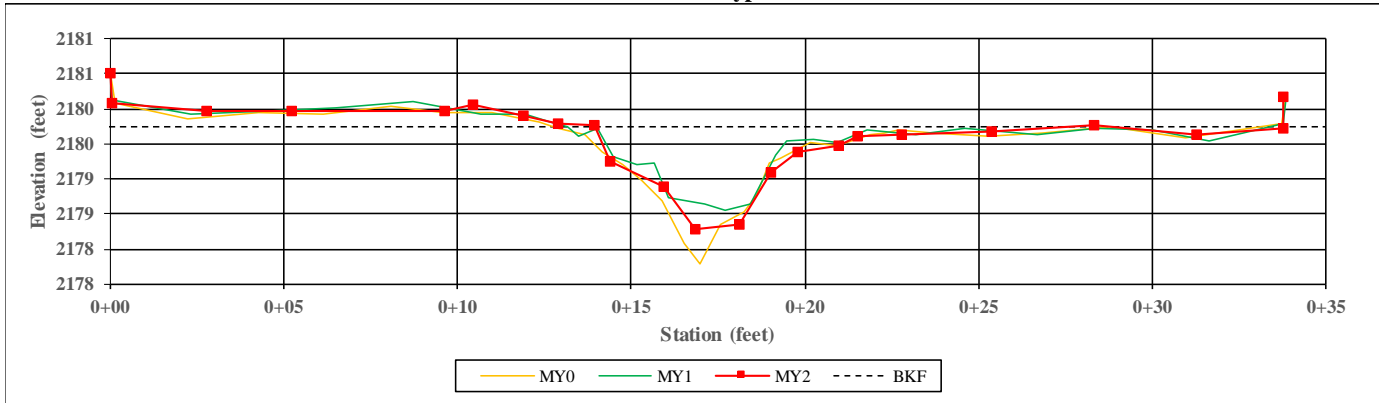
XS Number: 1
XS Type: Pool

CHANNEL DIMENSIONS SUMMARY	MY0	MY1	MY2	MY3	MY4	MY5	MY6	MY7
Bankful Width (ft)	9.6	20.4	11.0	-	-	-	-	-
Floodprone Width (ft)	50.0	50.0	50.0	-	-	-	-	-
Bankfull Mean Depth (ft)	0.6	0.3	0.6	-	-	-	-	-
Bankfull Max Depth (ft)	1.9	1.2	1.5	-	-	-	-	-
Bankfull Cross-Sectional Area (ft ²)	6.0	6.0	6.0	-	-	-	-	-
Width/Depth Ratio	15.2	69.1	19.9	-	-	-	-	-
Entrenchment Ratio	5.2	2.5	4.6	-	-	-	-	-
Bank Height Ratio	1.0	0.9	0.9	-	-	-	-	-

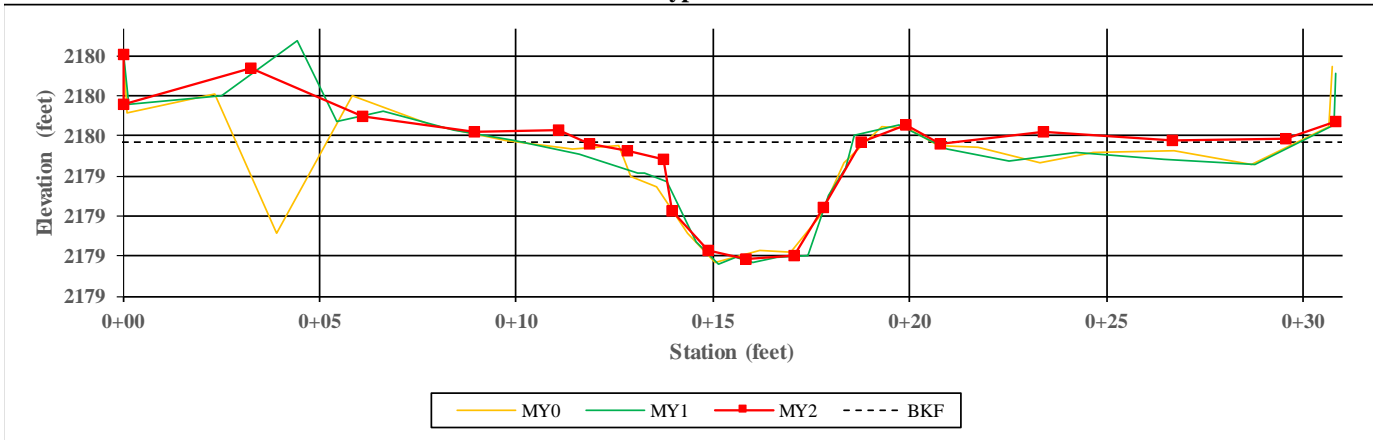
XS Number: 2
XS Type: Riffle

noted in Cross-section 2 during MY2 suggests a reduction in fine sediment inputs from upstream. The channel substrate will continue to be monitored in future years for shifts in particle size distribution.

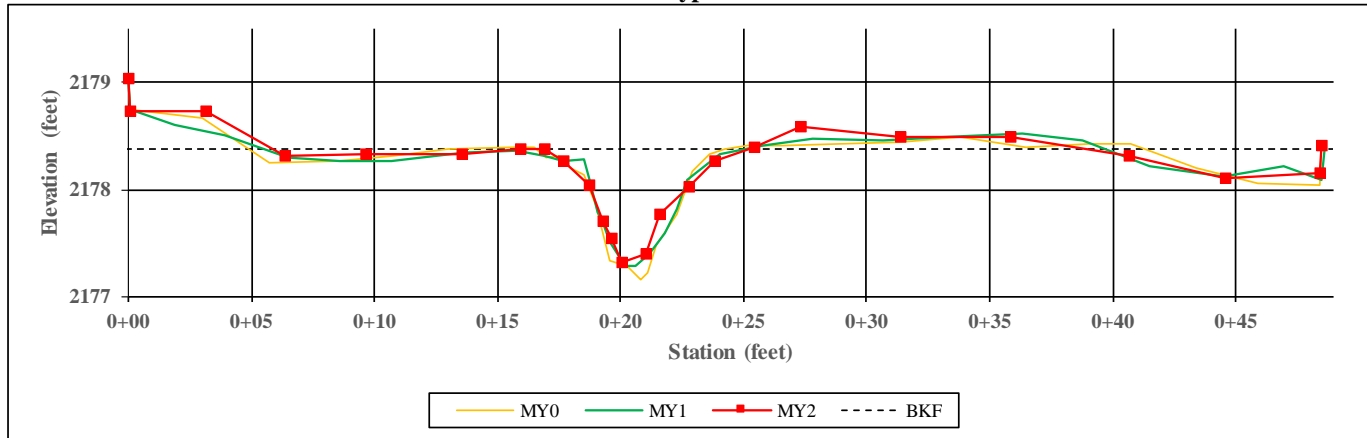
XS Number: 4
XS Type: Riffle

Since project completion in early 2020, 16 bankfull events have been documented at the Harrell Mitigation Site. The continuous stage recorder at Cross-Section #4 failed on May 6, 2021, and was restarted in September of 2021. A crest gauge will be installed in MY3 as a redundancy measure to mitigate for potential transducer failures moving forward. The suspected dates and associated precipitation records can be found in Table 10, Appendix E.

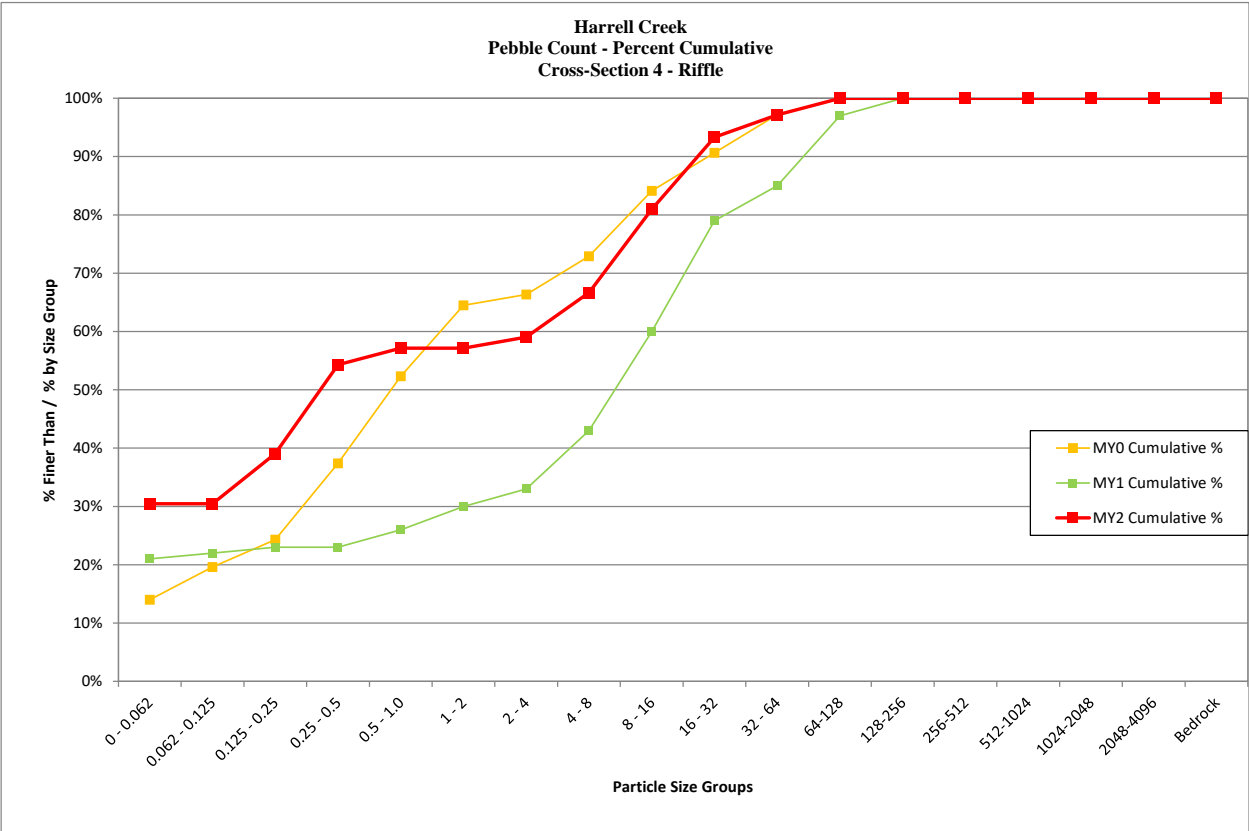
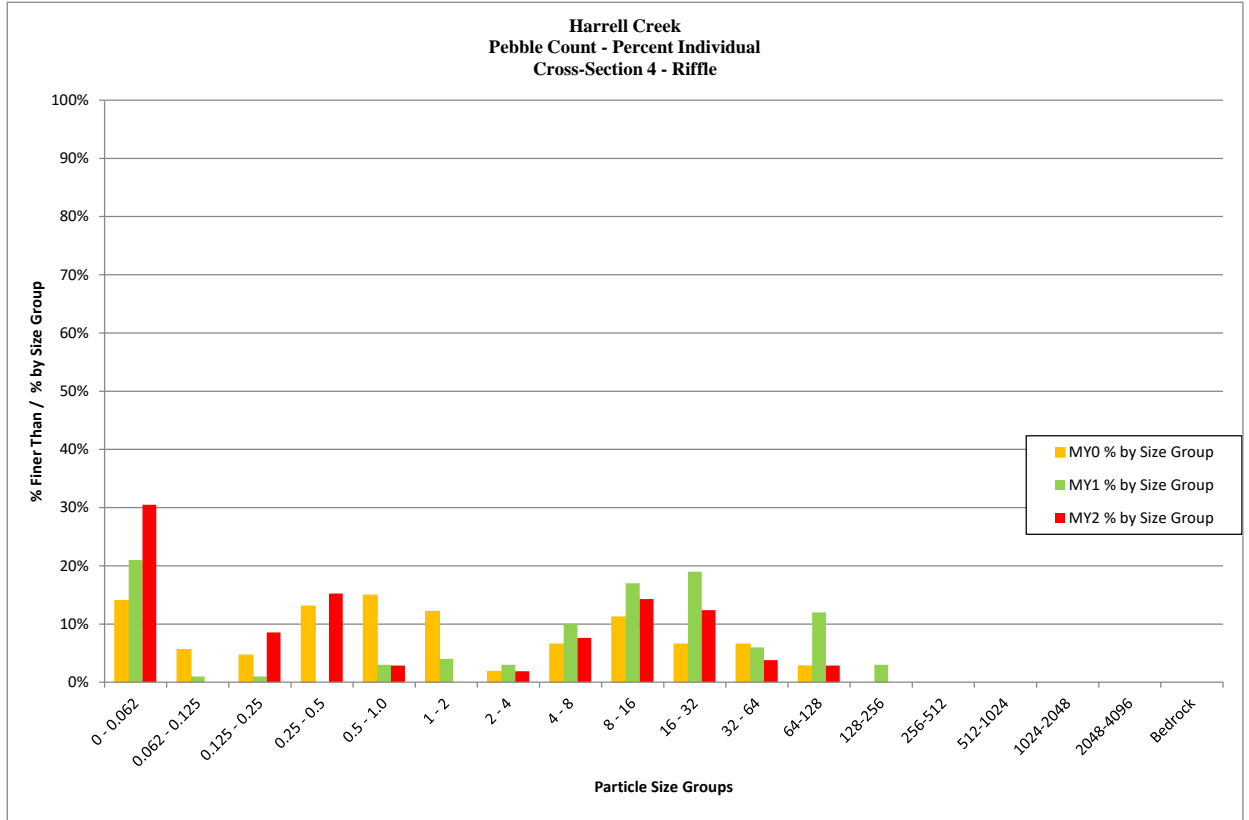
Pebble count D_{50} fell into the medium gravel category for Harrell Creek Reach 1 D, cross-section 5, very coarse to medium sand range for Harrell Creek Reach 1C, cross-sections 2 and 4, respectively. An increase in the relative percentages of silt was noted in both cross-sections 4 and 5 (Appendix D, Pebble Count Graphics and Tables). A similar observation was made in cross-section 2 in the previous monitoring year indicating a movement of fines through the system. Conversely, the increased coarseness

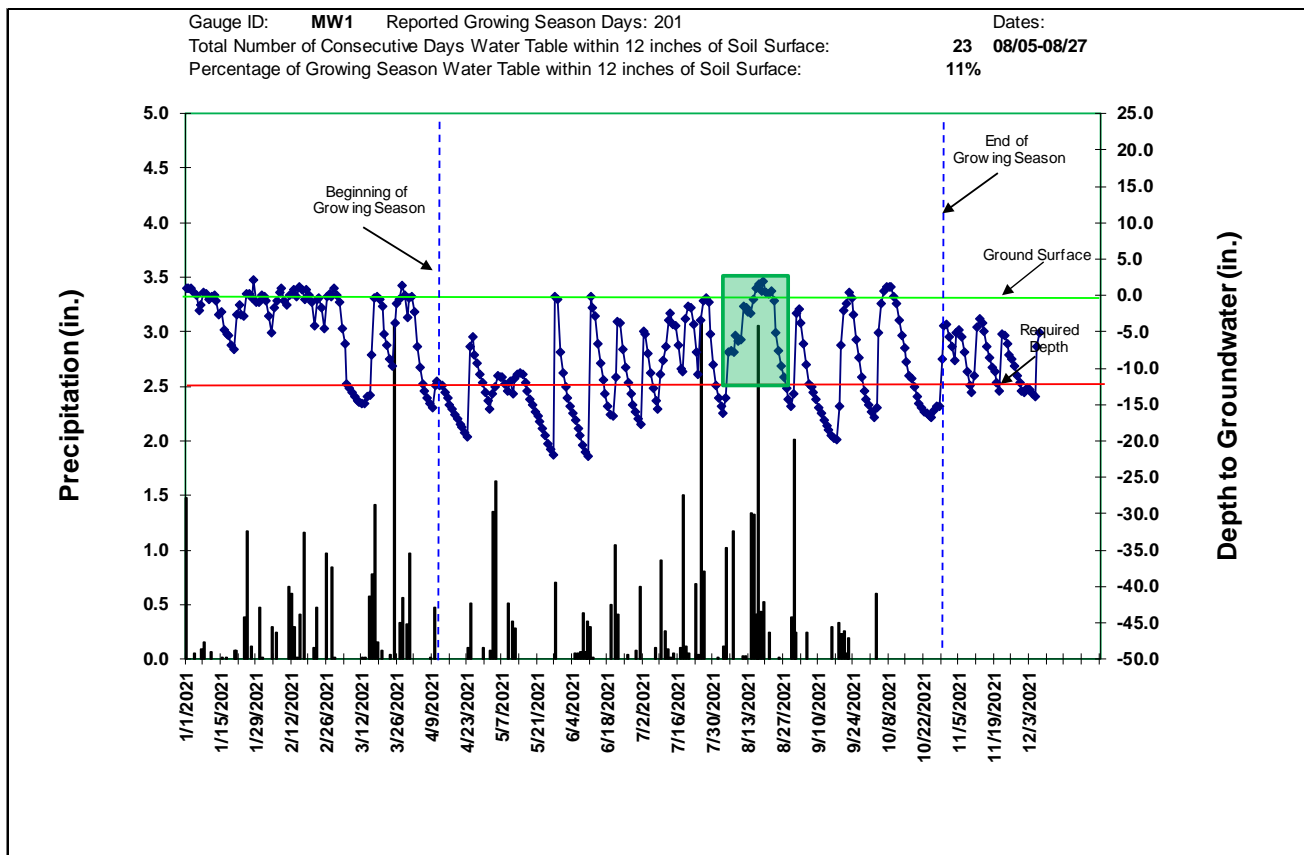
*Gauge failed to reset after deployment, occurring over a period of 208 days between March 5, 2021 and September 29, 2021. MY2 results are reflective of the period after reset.

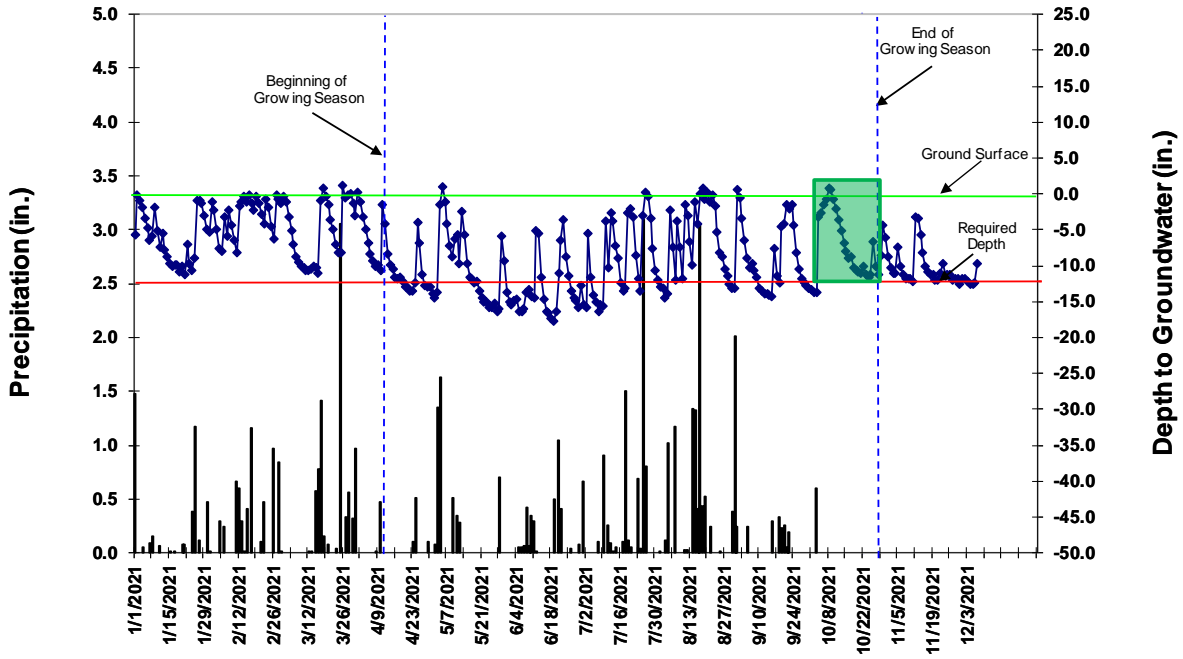
Gauge ID: **MW2** Reported Growing Season Days: 201
 Total Number of Consecutive Days Water Table within 12 inches of Soil Surface: **25** 10/04-10/29
 Percentage of Growing Season Water Table within 12 inches of Soil Surface: **12%**

Three groundwater wells, #1, 5 and 7, failed to meet the success criteria during MY2. Monitoring well #1 fell just short of the performance criteria at 11%. Monitoring well #2 was meeting at a marginal level, 13%. At the suggestion of the IRT, supplemental soil profiles will be conducted in MY3, MY5, and MY7 to capture any changes in wetland soil indicators. Groundwater gage graphics and supporting tables can be found in Appendix E.
