**Year 1 Monitoring Report**

**LITTLE SEBASTIAN SITE**

NCDMS Project # 100027 (Contract # 7187) | RFP 16-006993 (Issued 9/16/2016)  
USACE Action ID: SAW-2017-01507 | DWR Project # 2017-1041

**February 2022**

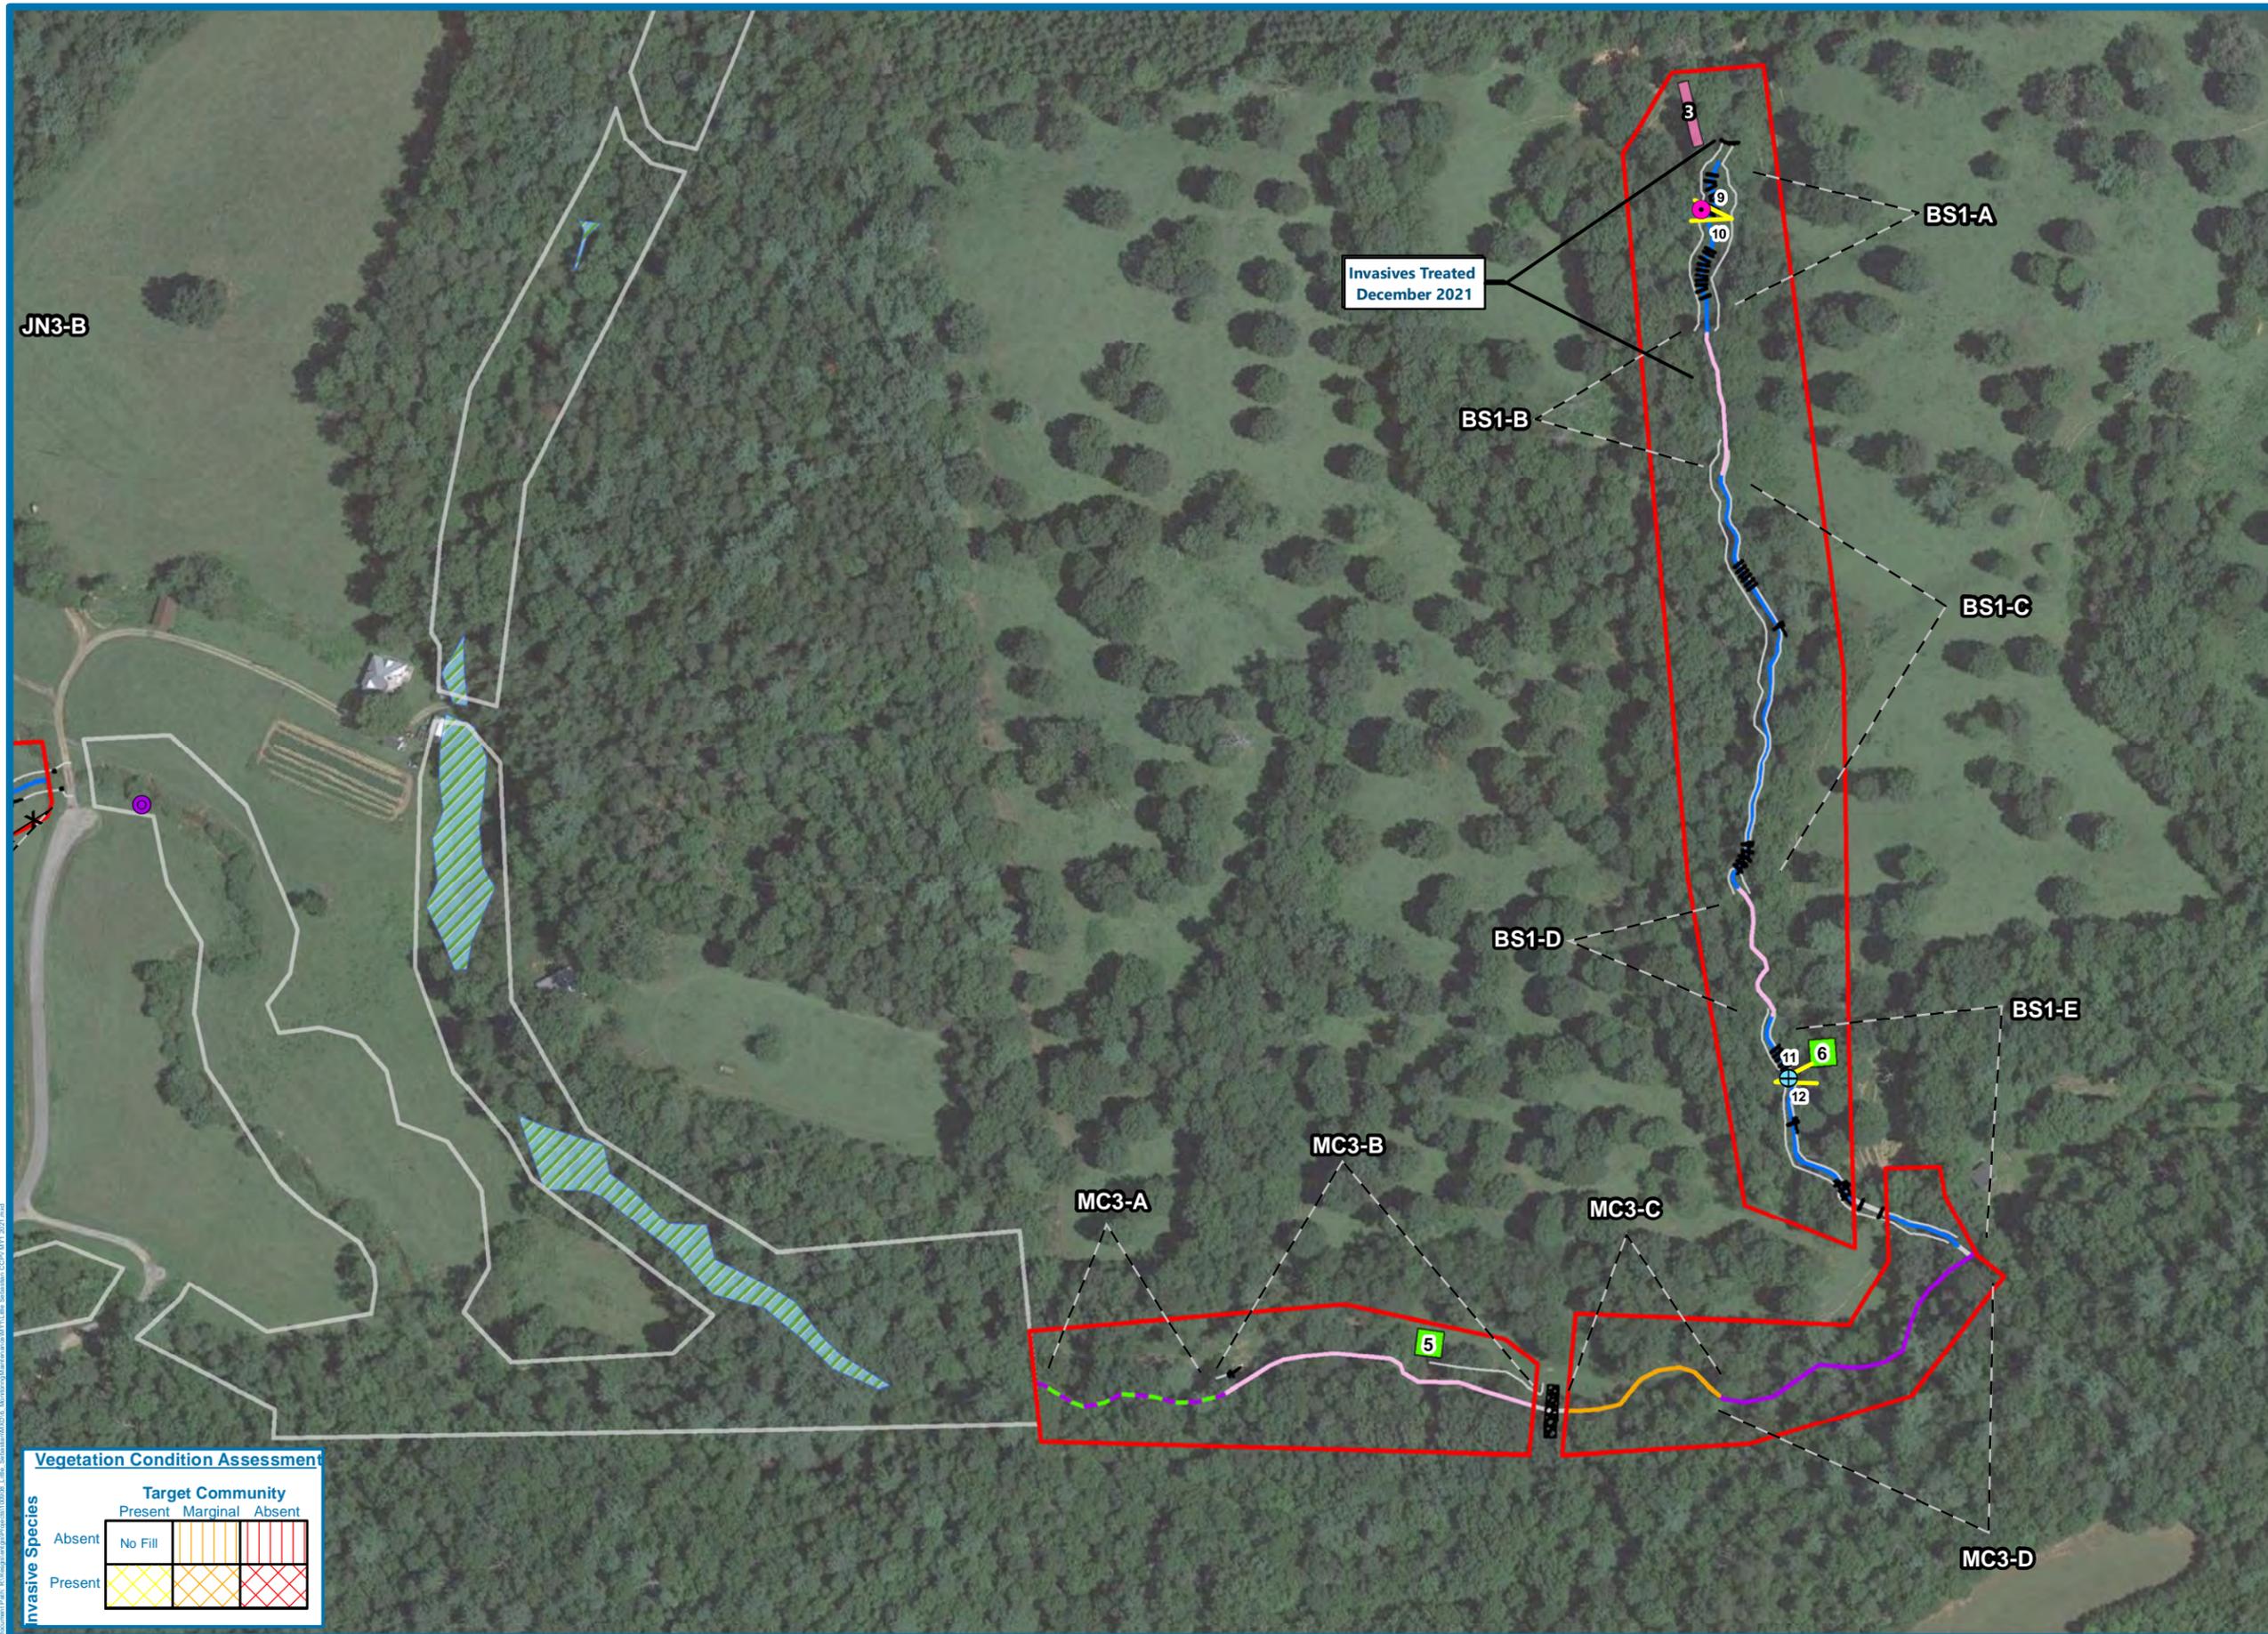
Current Conditions  
Plan View

Two areas of pre-existing fencing, adjacent to reach MC1, will be removed from the conservation easement in early 2022. Approximate fence locations can be found in **Figure 2, Appendix B**.

[These areas of fencing will be relocated in early 2022. Photo documentation and a call-out on the CCPV will be provided with the 2022 MY2 report. A note has been added to Section 1.7: Monitoring Performance in the MY1 report, regarding plans to remove the fencing from within the conservation easement.](#)

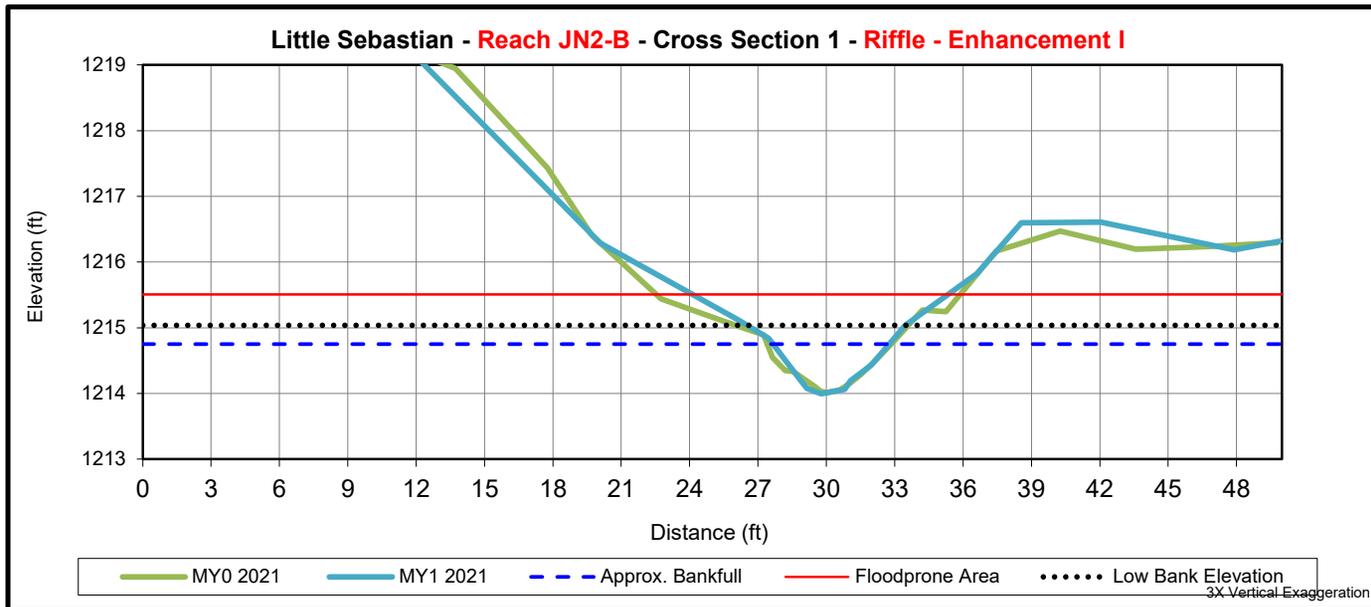
Cross Section 1 (Riffle)						
	Base	MY1	MY2	MY3	MY5	MY7	MY+
<b>Bankfull Elevation (ft) - Based on AB-XSA<sup>1</sup></b>	1214.7	1214.8					
Bankfull Width (ft) <sup>1</sup>	5.4	5.1					
Floodprone Width (ft) <sup>1</sup>	13.1	11.2					
Bankfull Max Depth (ft) <sup>2</sup>	0.7	1.0					
Low Bank Elevation (ft)	1214.74	1215.0					
Bankfull Cross Sectional Area (ft <sup>2</sup> ) <sup>2</sup>	2.4	4.1					
Bankfull Entrenchment Ratio <sup>1</sup>	2.4	2.2					
Bankfull Bank Height Ratio <sup>1</sup>	1.0	1.4

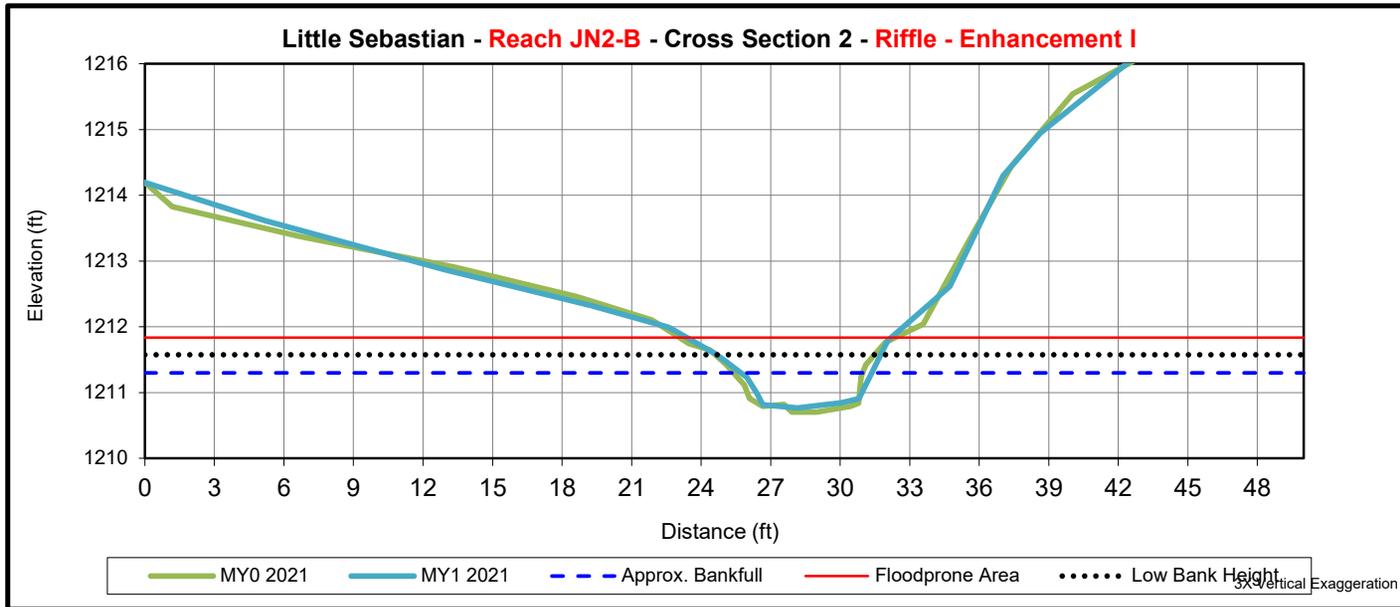
Cross Section 2 (Riffle)						
	Base	MY1	MY2	MY3	MY5	MY7	MY+
<b>Bankfull Elevation (ft) - Based on AB-XSA<sup>1</sup></b>	1211.2	1211.3					
Bankfull Width (ft) <sup>1</sup>	5.4	5.6					
Floodprone Width (ft) <sup>1</sup>	8.7	8.8					
Bankfull Max Depth (ft) <sup>2</sup>	0.5	0.8					
Low Bank Elevation (ft)	1211.2	1211.6					
Bankfull Cross Sectional Area (ft <sup>2</sup> ) <sup>2</sup>	2.3	4.1					
Bankfull Entrenchment Ratio <sup>1</sup>	1.6	1.6					
Bankfull Bank Height Ratio <sup>1</sup>	1.0	1.5

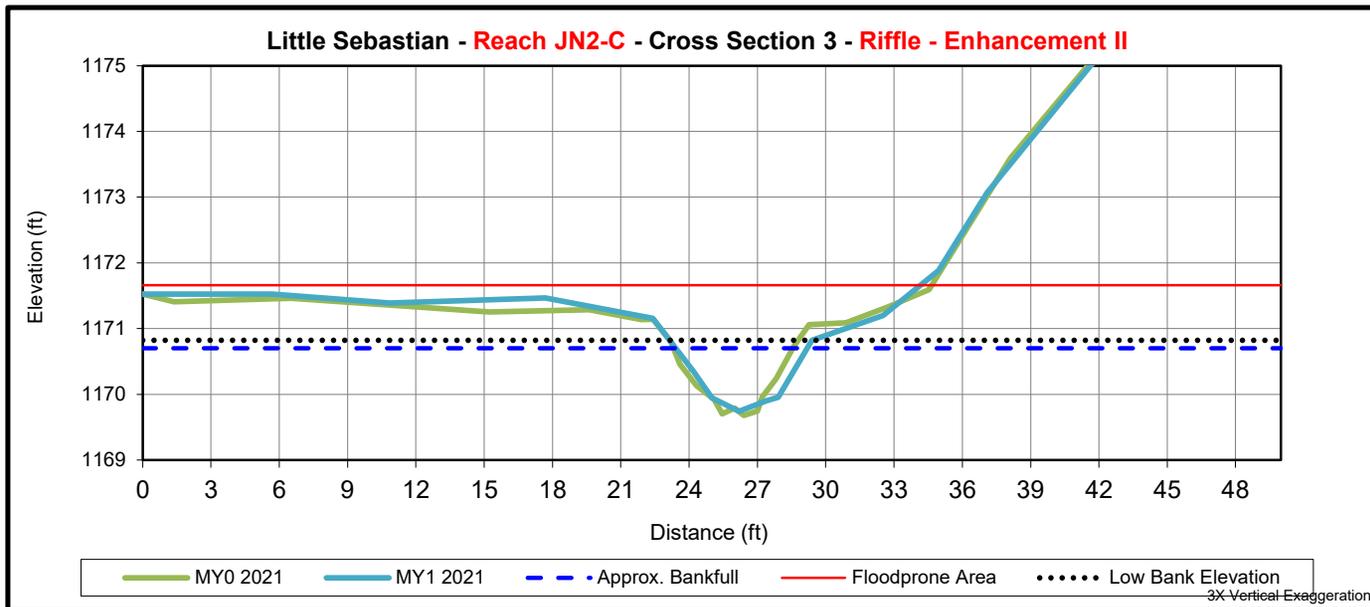
Cross Section 3 (Riffle)						
	Base	MY1	MY2	MY3	MY5	MY7	MY+
<b>Bankfull Elevation (ft) - Based on AB-XSA<sup>1</sup></b>	1170.7	1170.7					
Bankfull Width (ft) <sup>1</sup>	5.3	5.8					
Floodprone Width (ft) <sup>1</sup>	>34.8	>34.1					
Bankfull Max Depth (ft) <sup>2</sup>	1.0	1.1					
Low Bank Elevation (ft)	1170.7	1170.8					
Bankfull Cross Sectional Area (ft <sup>2</sup> ) <sup>2</sup>	3.5	4.3					
Bankfull Entrenchment Ratio <sup>1</sup>	>6.6	>5.9					
Bankfull Bank Height Ratio <sup>1</sup>	1.0	1.1

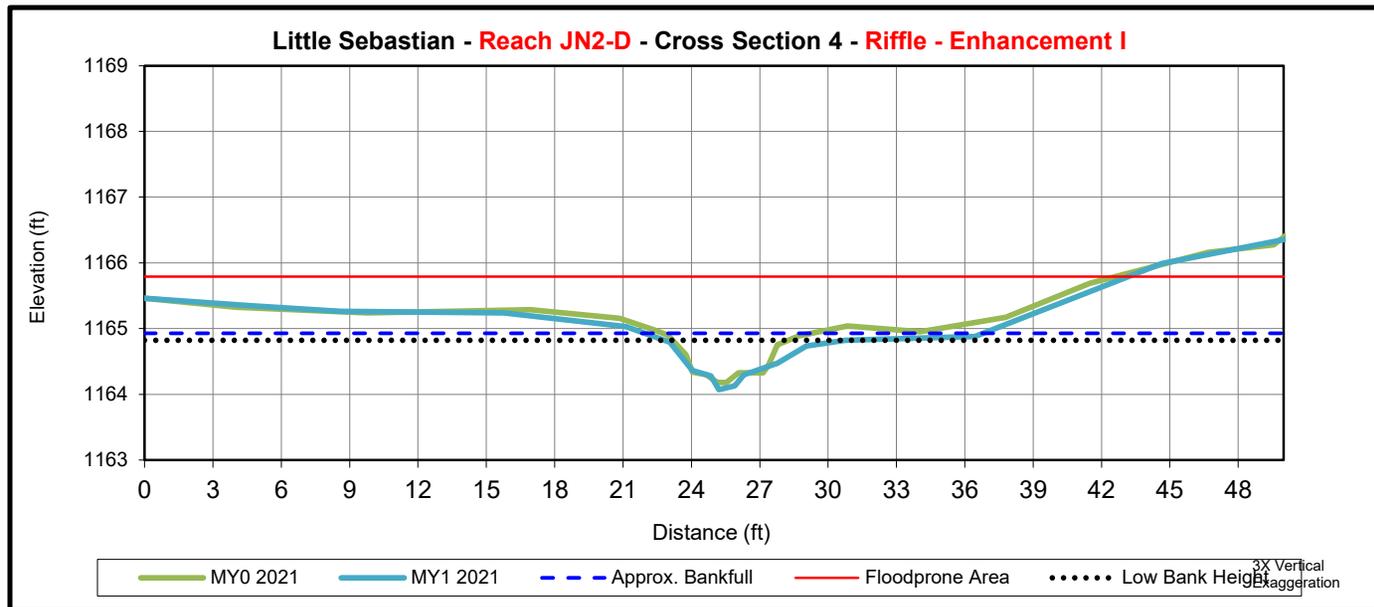
<b>Cross Section 4 (Riffle)</b>						
	Base	MY1	MY2	MY3	MY5	MY7	MY+
<b>Bankfull Elevation (ft) - Based on AB-XSA<sup>1</sup></b>	1165.0	1164.9					
Bankfull Width (ft) <sup>1</sup>	9.0	8.8					
Floodprone Width (ft) <sup>1</sup>	>43.9	>43.2					
Bankfull Max Depth (ft) <sup>2</sup>	0.9	0.8					
Low Bank Elevation (ft)	1165.0	1164.8					
Bankfull Cross Sectional Area (ft <sup>2</sup> ) <sup>2</sup>	3.5	2.6					
Bankfull Entrenchment Ratio <sup>1</sup>	>4.9	>4.9					
Bankfull Bank Height Ratio <sup>1</sup>	1.0	0.9

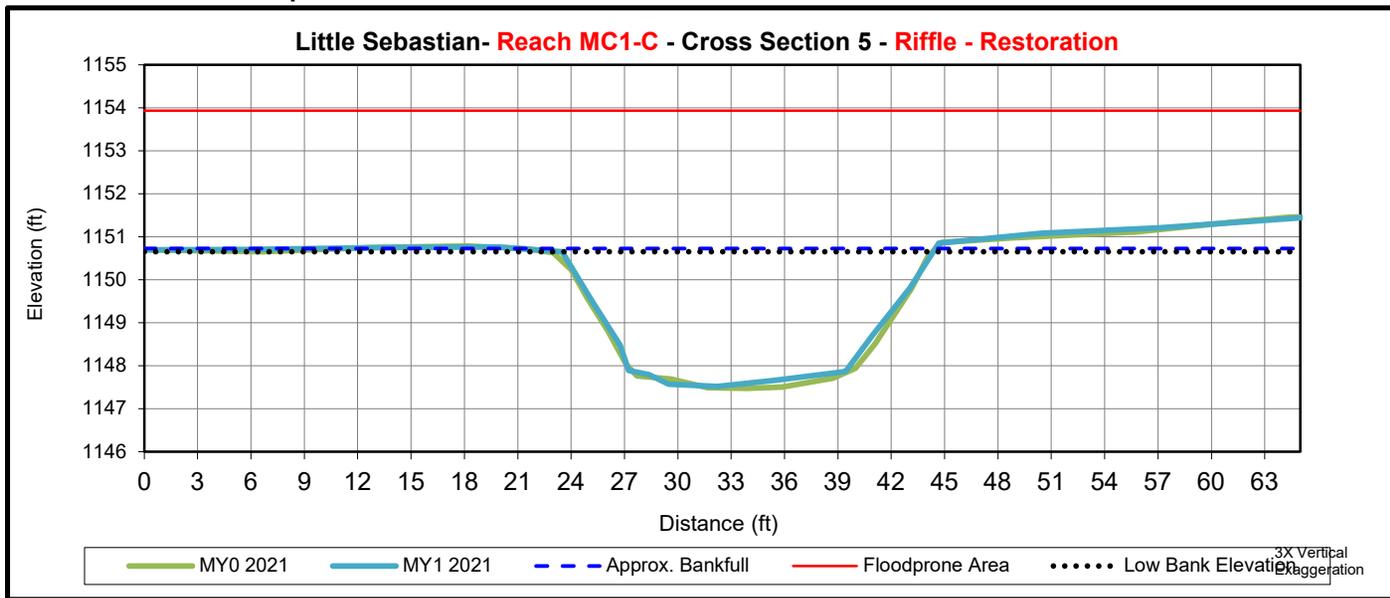
<b>Cross Section 5 (Riffle)</b>						
	Base	MY1	MY2	MY3	MY5	MY7	MY+
<b>Bankfull Elevation (ft) - Based on AB-XSA<sup>1</sup></b>	1150.6	1150.7					
Bankfull Width (ft) <sup>1</sup>	21.3	21.0					
Floodprone Width (ft) <sup>1</sup>	>64.9	>65.1					
Bankfull Max Depth (ft) <sup>2</sup>	3.2	3.1					
Low Bank Elevation (ft)	1150.6	1150.6					
Bankfull Cross Sectional Area (ft <sup>2</sup> ) <sup>2</sup>	49.8	48.2					
Bankfull Entrenchment Ratio <sup>1</sup>	>3.0	>3.1					
Bankfull Bank Height Ratio <sup>1</sup>	1.0	1.0

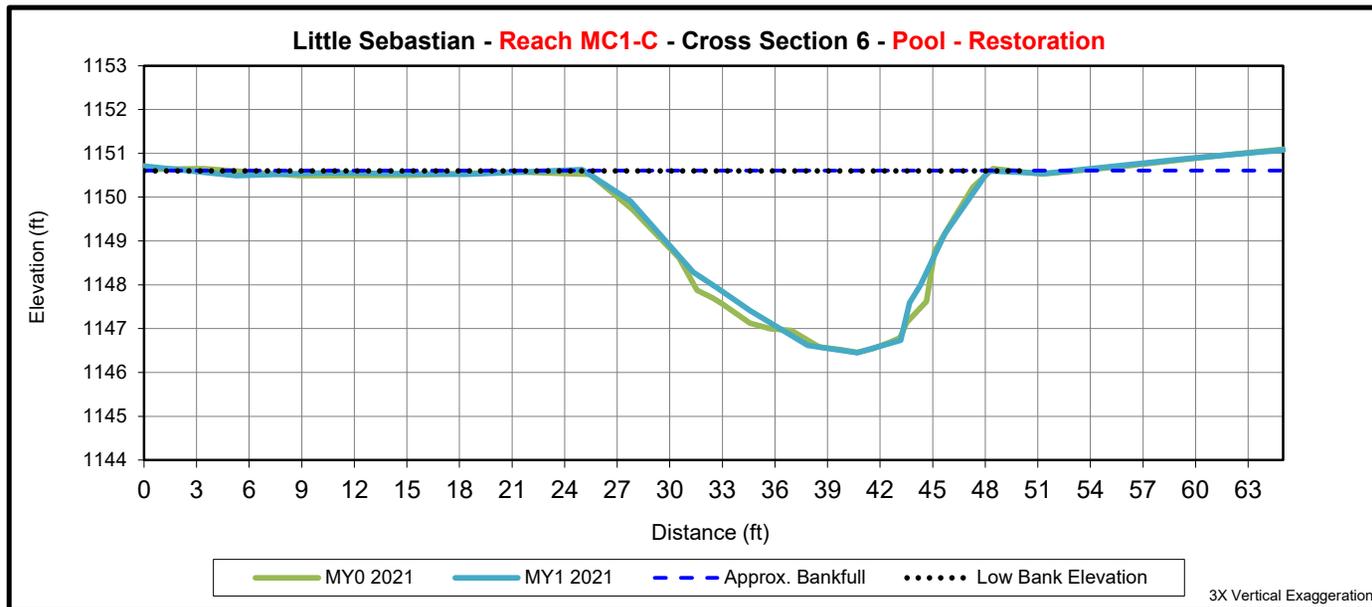
<b>Cross Section 6 (Pool)</b>						
	Base	MY1	MY2	MY3	MY5	MY7	MY+
<b>Bankfull Elevation (ft) - Based on AB-XSA<sup>1</sup></b>	1150.5	1150.6					
Bankfull Width (ft) <sup>1</sup>	-	-					
Floodprone Width (ft) <sup>1</sup>	-	-					
Bankfull Max Depth (ft) <sup>2</sup>	4.1	4.1					
Low Bank Elevation (ft)	-	-					
Bankfull Cross Sectional Area (ft <sup>2</sup> ) <sup>2</sup>	56.7	56.4					
Bankfull Entrenchment Ratio <sup>1</sup>	-	-					
Bankfull Bank Height Ratio <sup>1</sup>	-	-

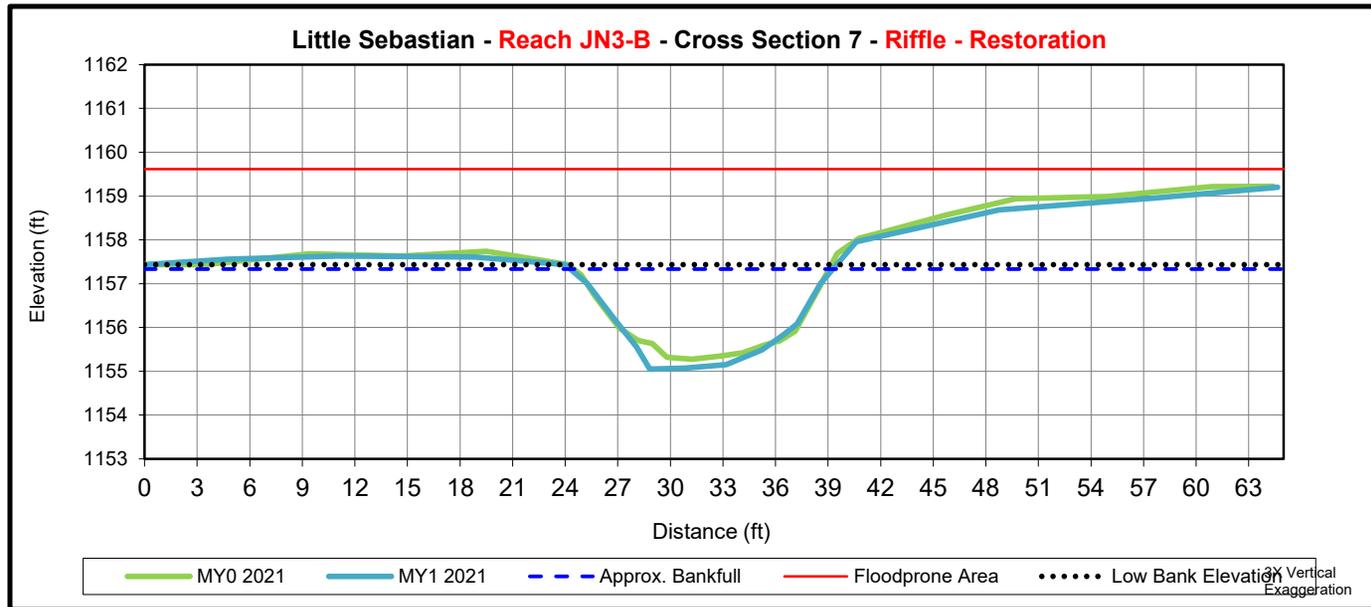
<b>Cross Section 7 (Riffle)</b>						
	Base	MY1	MY2	MY3	MY5	MY7	MY+
<b>Bankfull Elevation (ft) - Based on AB-XSA<sup>1</sup></b>	1157.4	1157.3					
Bankfull Width (ft) <sup>1</sup>	15.0	15.0					
Floodprone Width (ft) <sup>1</sup>	>64.4	>64.7					
Bankfull Max Depth (ft) <sup>2</sup>	2.2	2.4					
Low Bank Elevation (ft)	1157.4	1157.4					
Bankfull Cross Sectional Area (ft <sup>2</sup> ) <sup>2</sup>	22.8	24.4					
Bankfull Entrenchment Ratio <sup>1</sup>	>4.3	>4.3					
Bankfull Bank Height Ratio <sup>1</sup>	1.0	1.0
