Monitoring Report MY03

**Stony Fork Restoration Site
Upper Neuse River Basin - 03020201
Monitoring Year 03
DMS Contract 6830**

**DMS Project Number 97085
DWR #: 2016-0372
USACE Action ID: 2016-00875
Johnston County, North Carolina**

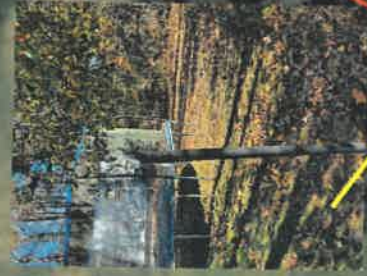
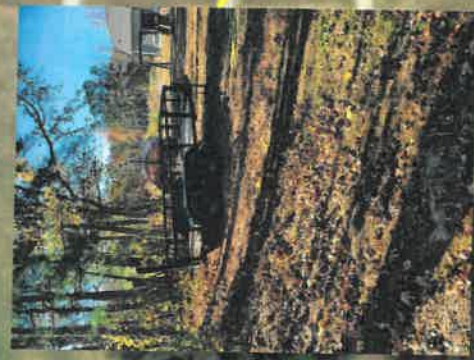
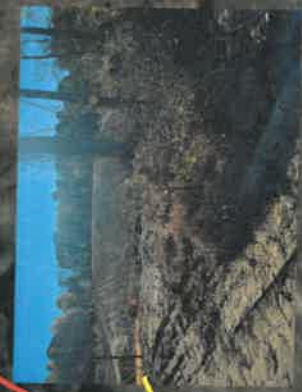
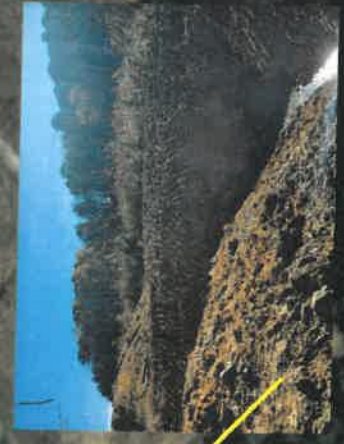
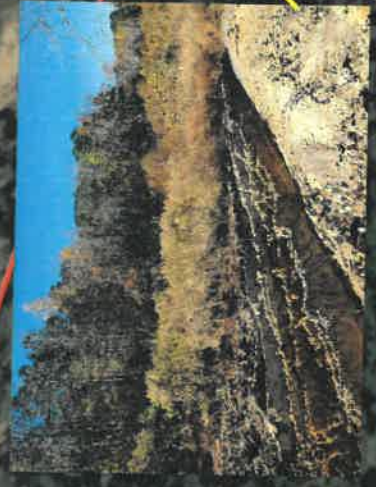
Stony Fork Easement Violations Sherill Farms LLC (Georeferenced)

On November 18th, 2021 NCDEQ was notified by stream monitoring contractors that the development adjacent to this easement had cut an outlet through the easement from a large offsite sediment basin to drain directly to the stream inside the easement. Staff inspected this violation on November 19th and confirmed that this is related to an offsite BMP outfall that was constructed for Phase II of the Sherrill Farms development. There is fill material 6-8' high at the basin near the easement edge. There are approximately 1,250 square feet of impacted area within the 50' riparian buffer and there is some evidence sediment in the stream.

During the November 19th inspection by the State of North Carolina, it was also observed that the easement trespass/encroachment on the north side of the conservation easement area (Sherrill Farms Phase 1) is also still ongoing. Property owners on lot 20S (Fede) and 21 (Stewart) are parking vehicles, trailers, and a trampoline inside the easement. Sherrill Farms LLC has been notified via email, phone and in person in 2018 and 2019 about these violations and is continuing to allow them.

As the landowner of the property subject to this conservation easement, it is your responsibility to ensure all easement requirements and restrictions are adhered to. The remedy for these damages shall be the following:
