**Year 1 Monitoring Report**

**UT WEST BRANCH ROCKY RIVER  
RESTORATION SITE**

NCDMS Project #92684 (Contract # WBRR010521)  
USACE Action ID: SAW-2017-00342 | NCDWR Project #18-1696

Mecklenburg County, North Carolina  
Yadkin River Basin | HUC 03040105

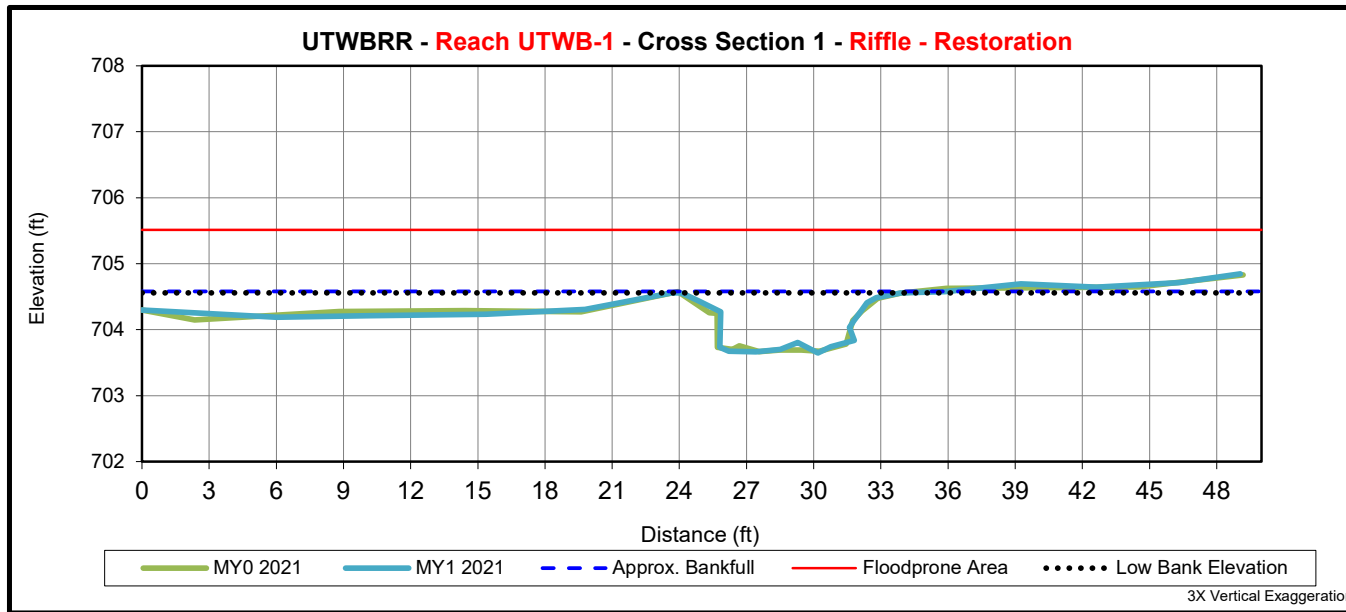
<b>Cross Section 1 (Riffle)</b>						
	MY0	MY1	MY2	MY3	MY5	MY7	MY+
<b>Bankfull Elevation (ft) - Based on AB-XSA<sup>1</sup></b>	704.56	704.6					
Bankfull Width (ft) <sup>1</sup>	9.8	9.9					
Floodprone Width (ft) <sup>1</sup>	>49.2	>49.1					
Bankfull Max Depth (ft) <sup>2</sup>	0.9	0.9					
Low Bank Elevation (ft)	704.56	704.6					
Bankfull Cross Sectional Area (ft <sup>2</sup> ) <sup>2</sup>	5.7	5.5					
Bankfull Entrenchment Ratio <sup>1</sup>	>5	>5					
Bankfull Bank Height Ratio <sup>1</sup>	1.0	1.0

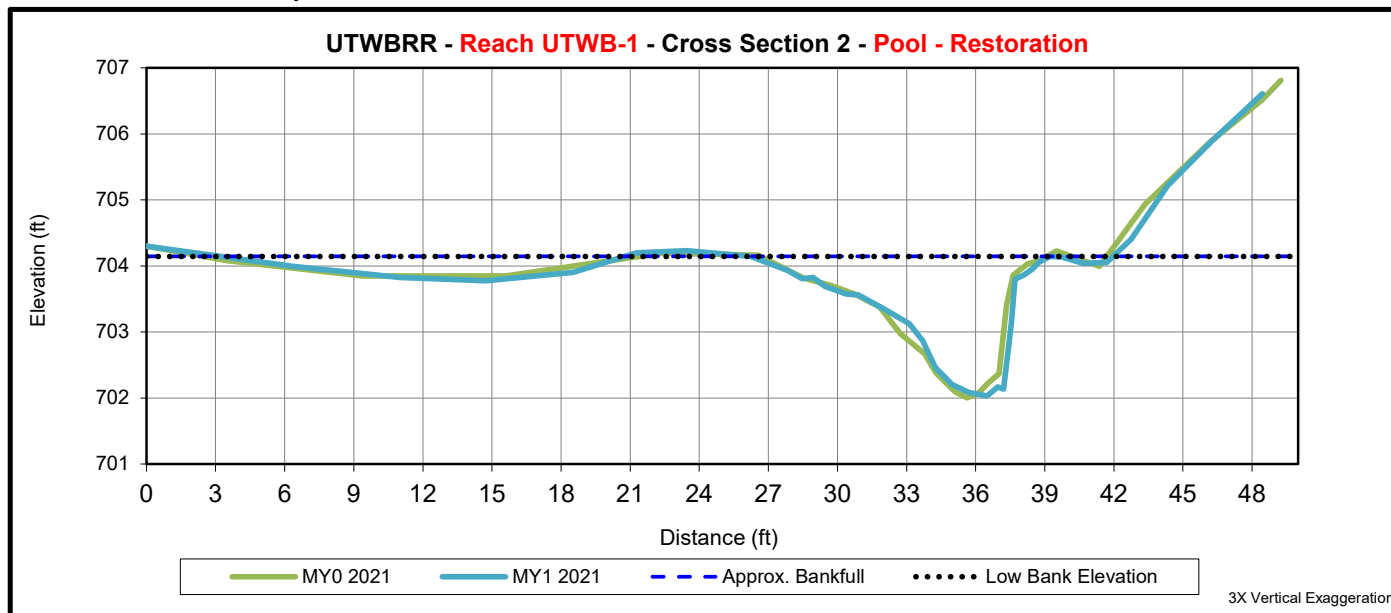
<b>Cross Section 2 (Pool)</b>						
	MY0	MY1	MY2	MY3	MY5	MY7	MY+
<b>Bankfull Elevation (ft) - Based on AB-XSA<sup>1</sup></b>	704.16	704.1					
Bankfull Width (ft) <sup>1</sup>	NA	NA					
Floodprone Width (ft) <sup>1</sup>	NA	NA					
Bankfull Max Depth (ft) <sup>2</sup>	2.2	2.1					
Low Bank Elevation (ft)	704.16	704.1					
Bankfull Cross Sectional Area (ft <sup>2</sup> ) <sup>2</sup>	11.5	11.5					
Bankfull Entrenchment Ratio <sup>1</sup>	NA	NA					
Bankfull Bank Height Ratio <sup>1</sup>	NA	NA
