**BASELINE MONITORING
DOCUMENT AND AS-BUILT
BASELINE REPORT
FINAL**

BUCKWATER MITIGATION SITE

Orange County, NC

DMS Project Number 97084

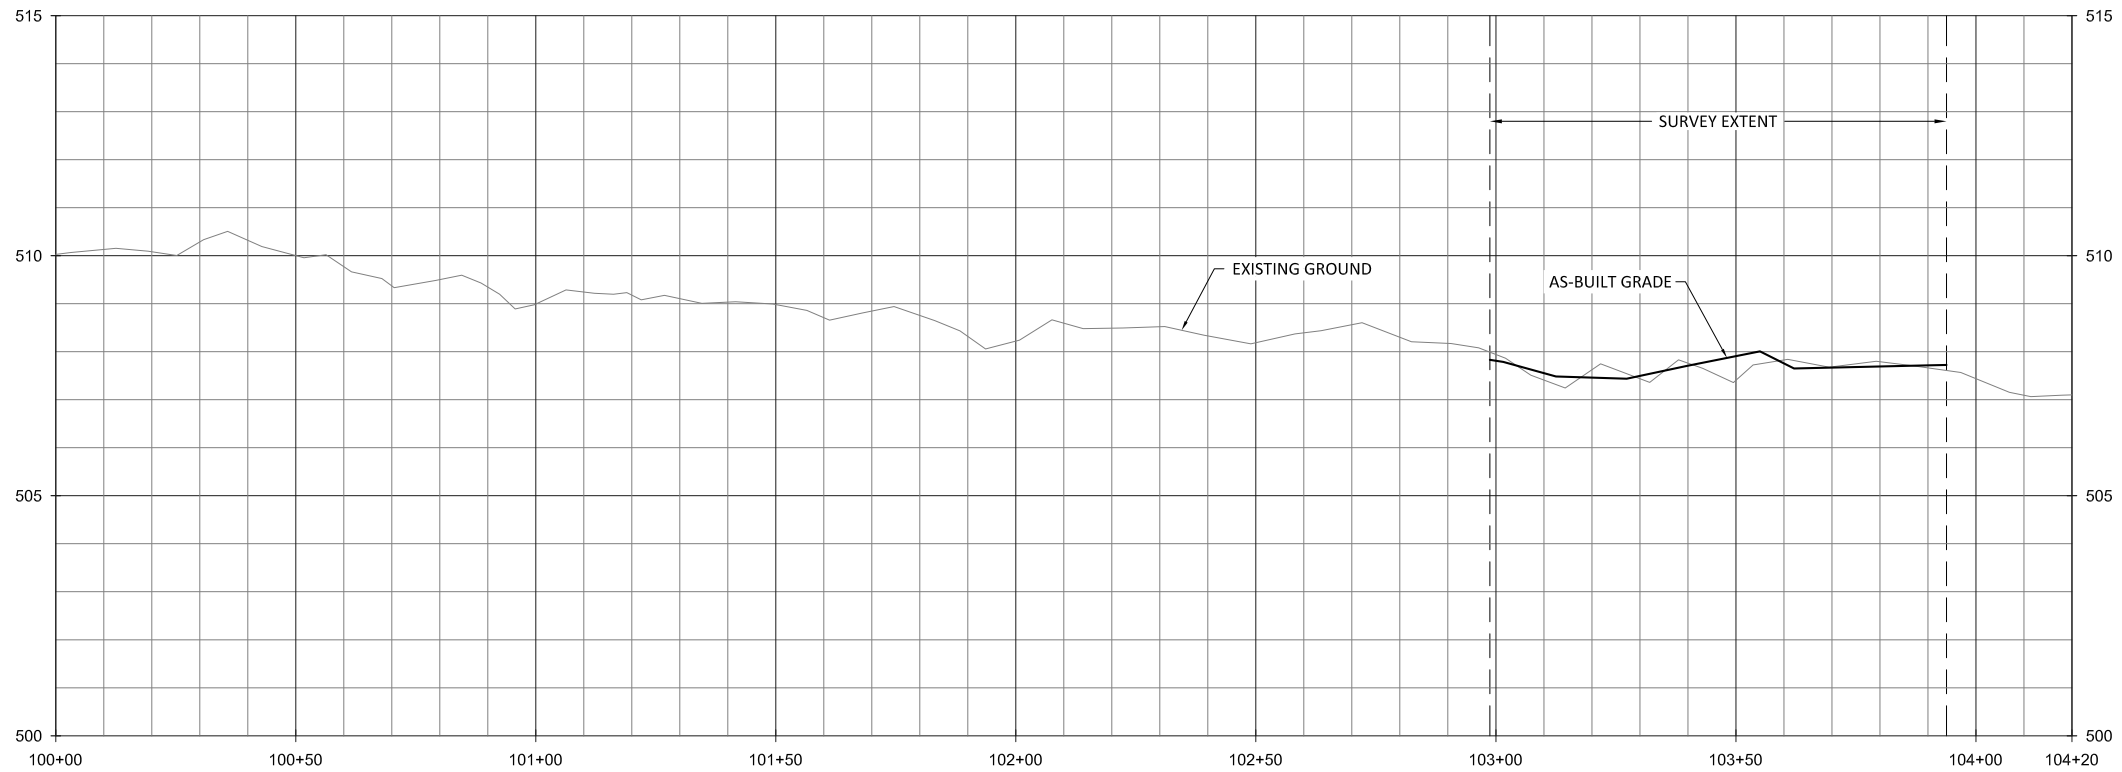
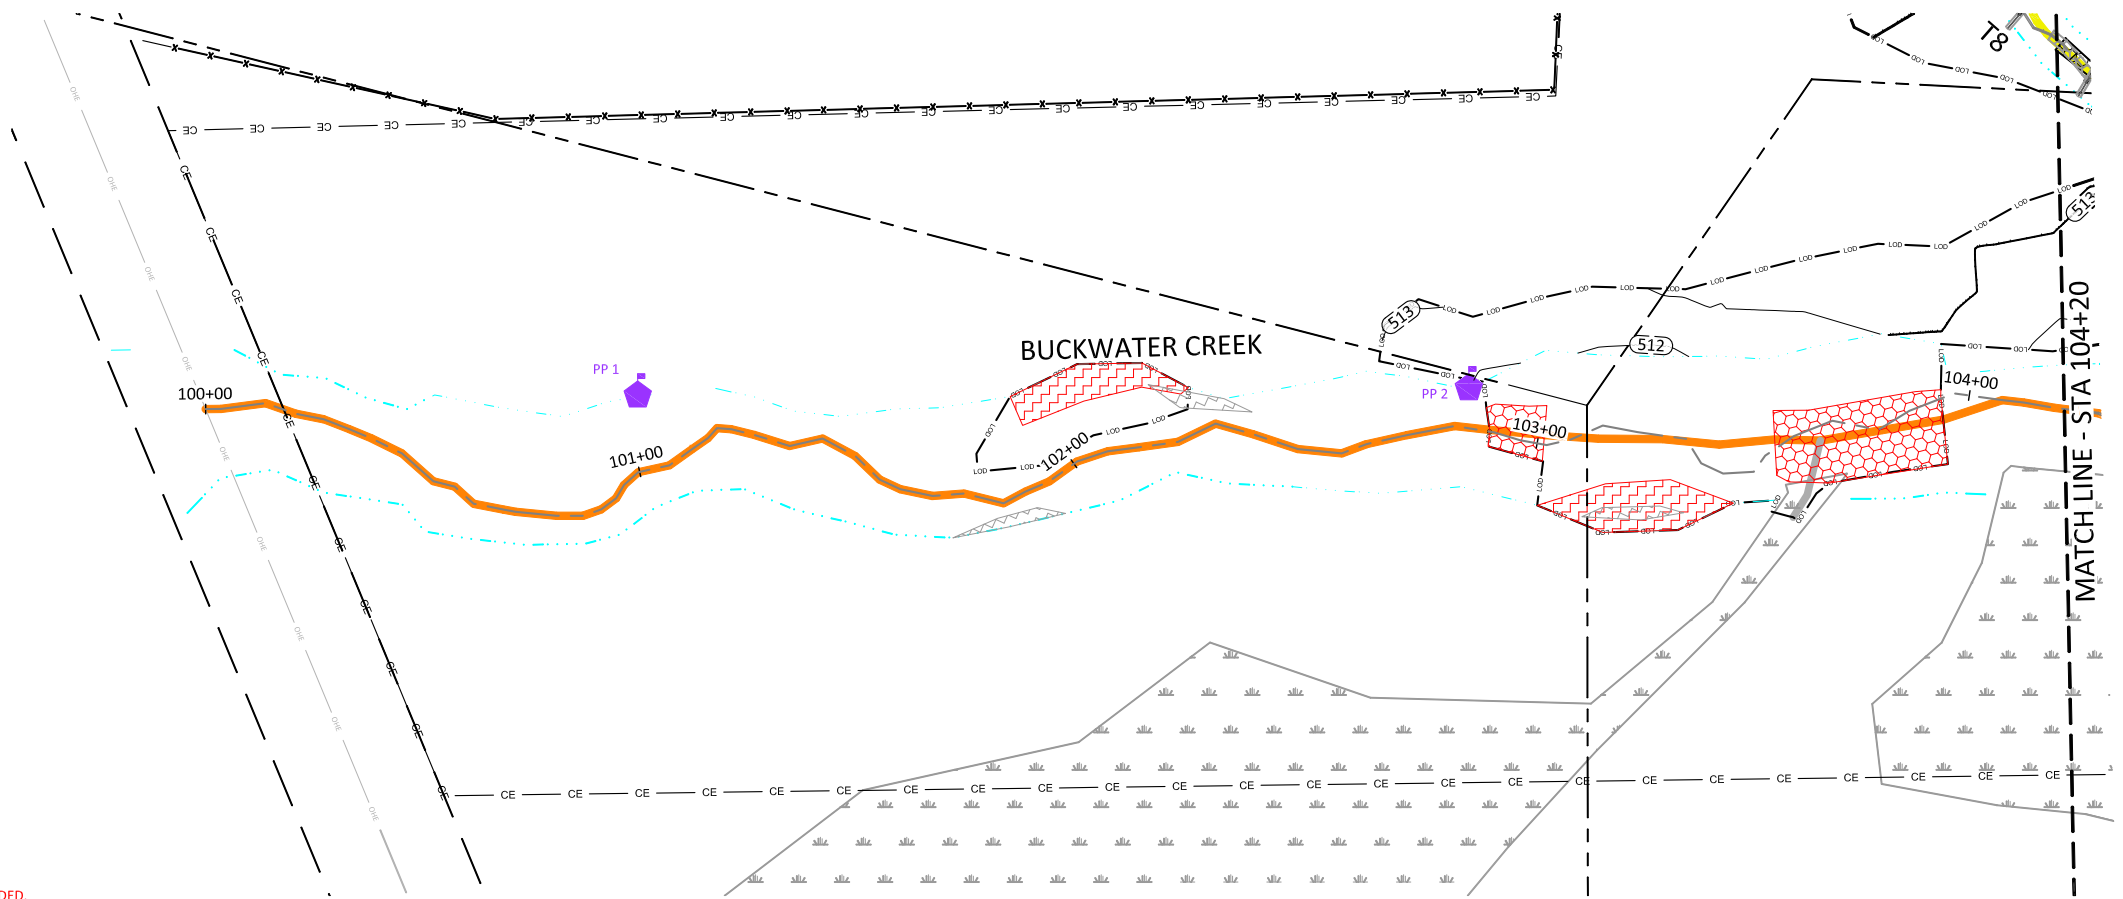
NOTE:
 1. STA 102+96 RIFFLE WAS ADDED.
 2. STA 103+67 RIFFLE WAS ADDED
 (SEE NOTE 1 SHEET 1.2).

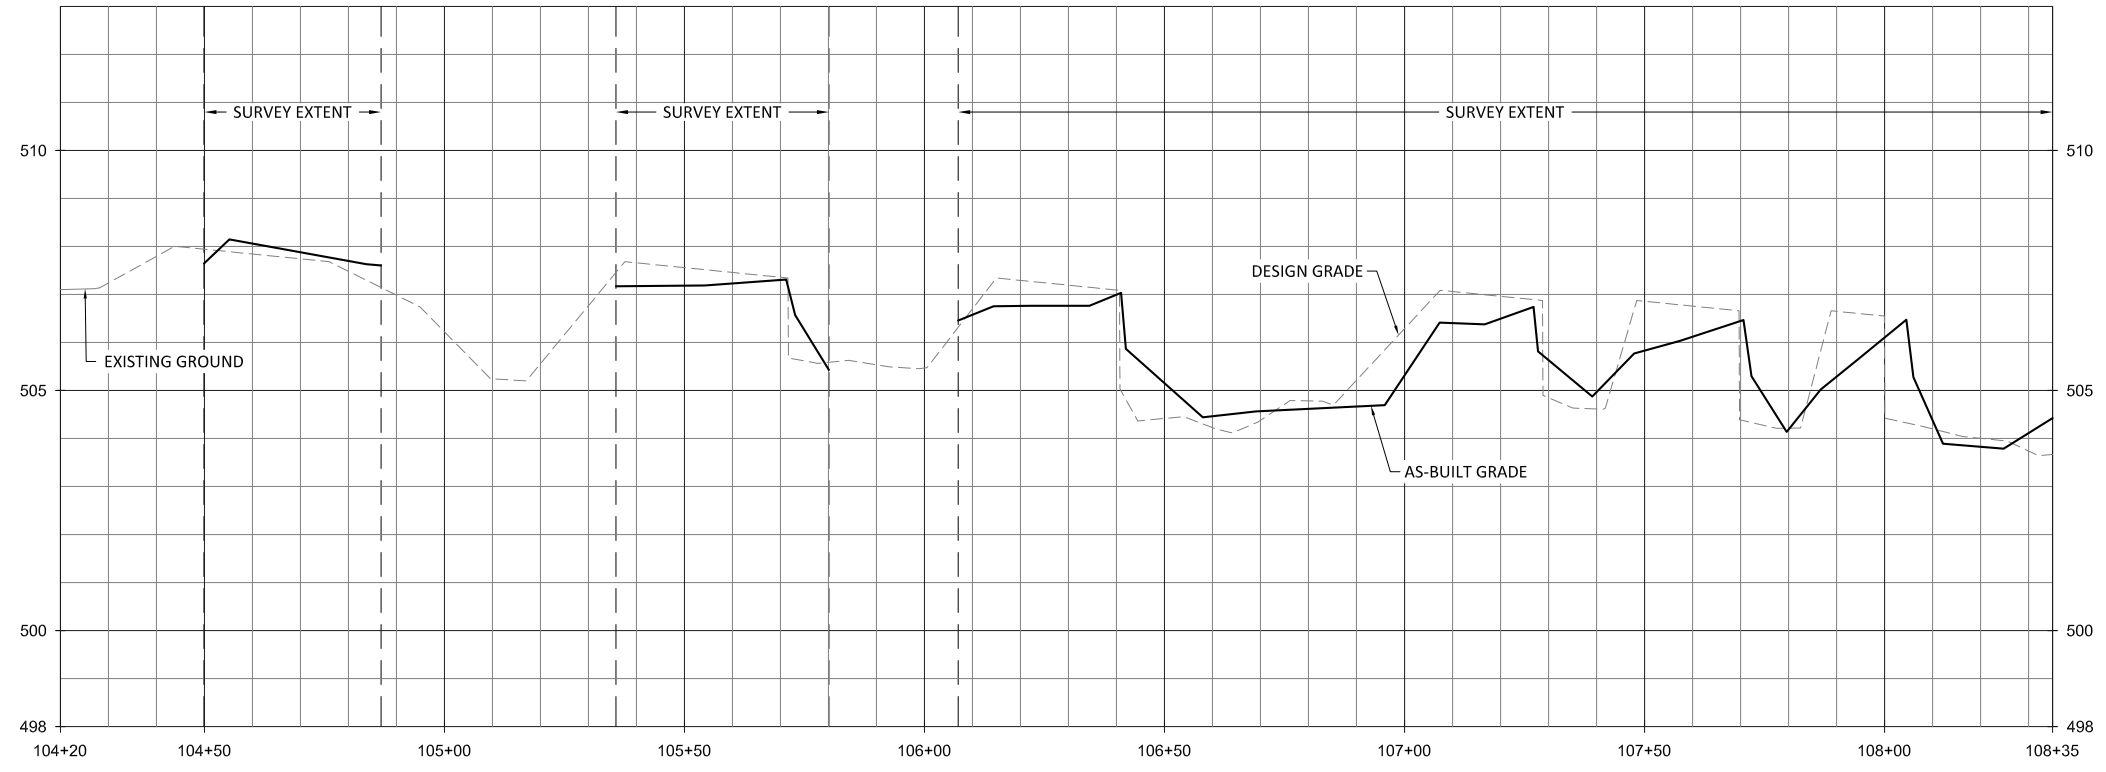
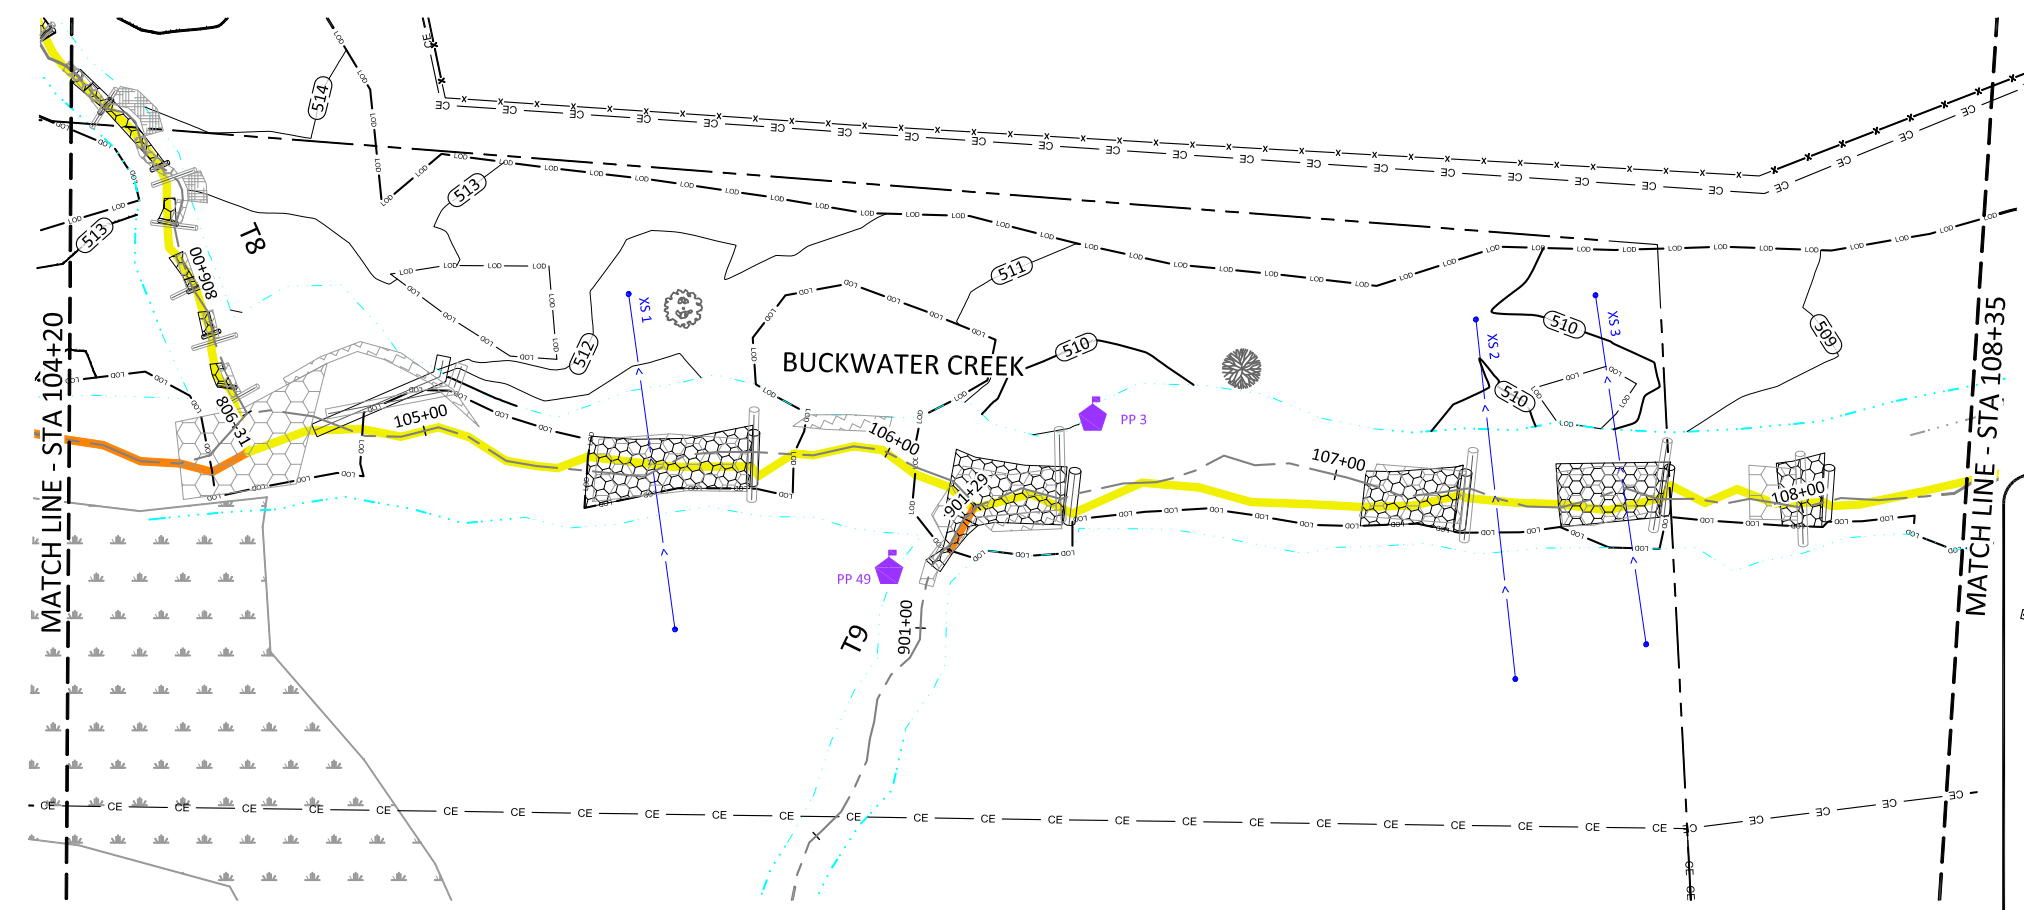
NOTE:
 1. STA 104+58: RIFFLE WAS INSTALLED UPSTREAM (SEE NOTE 2 SHEET 1.1).

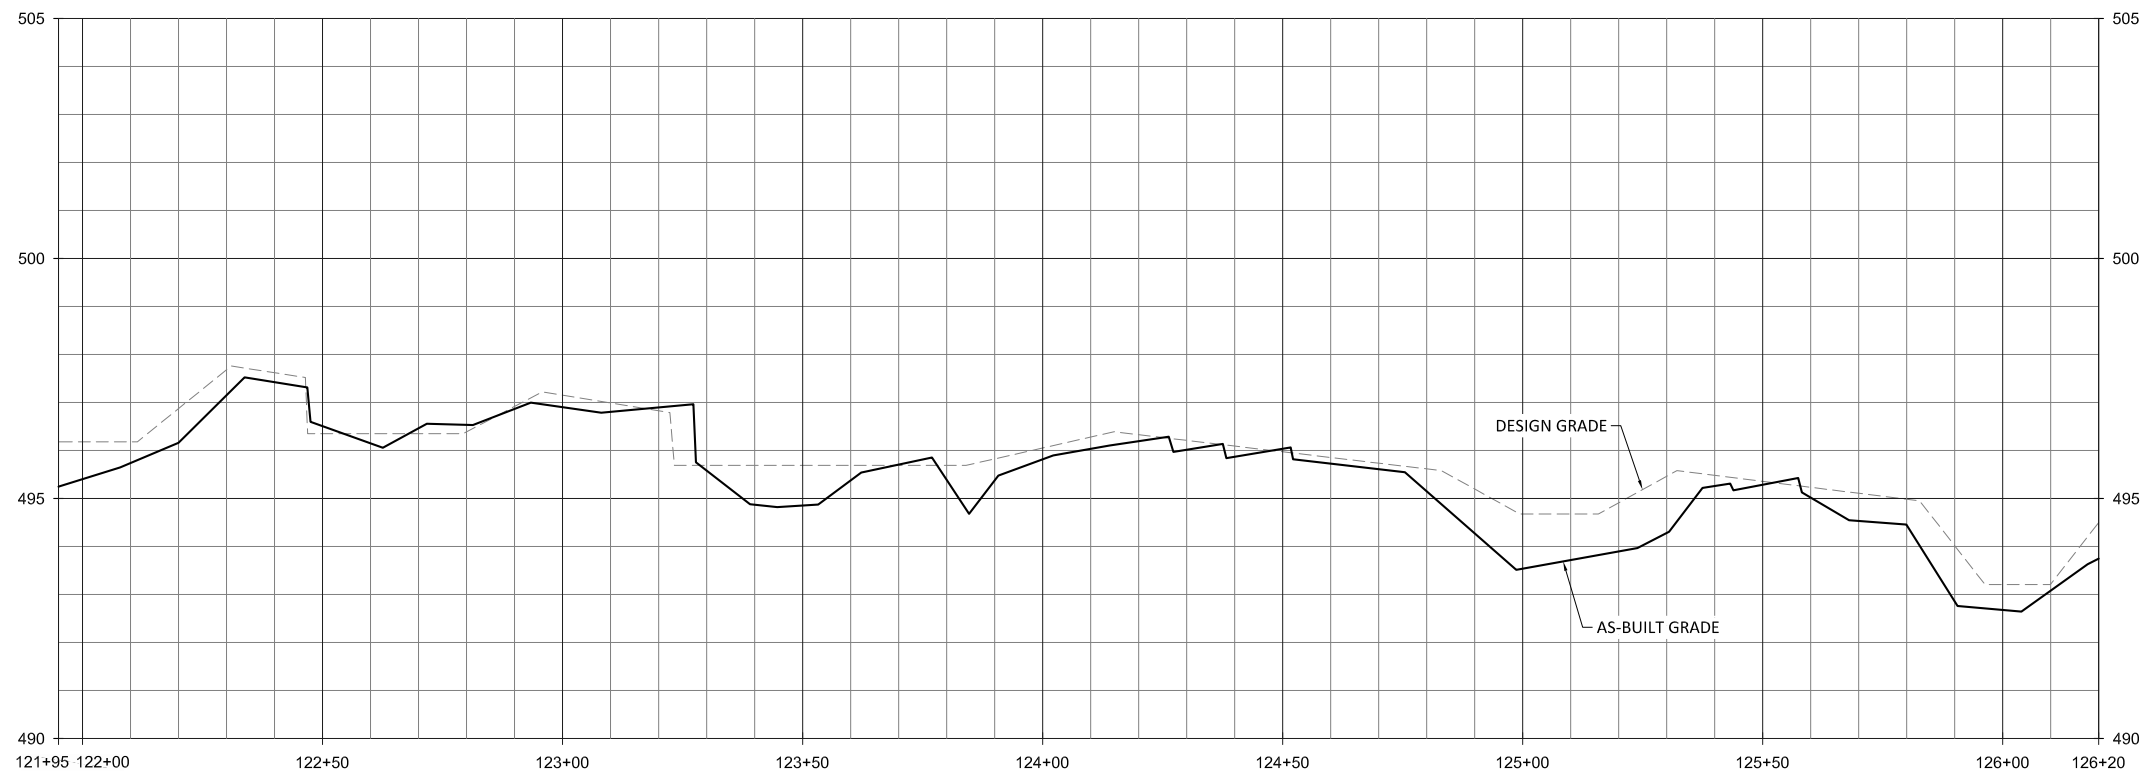
NOTE:
 1. STA 125+14: BRUSH TOE WAS INSTALLED.

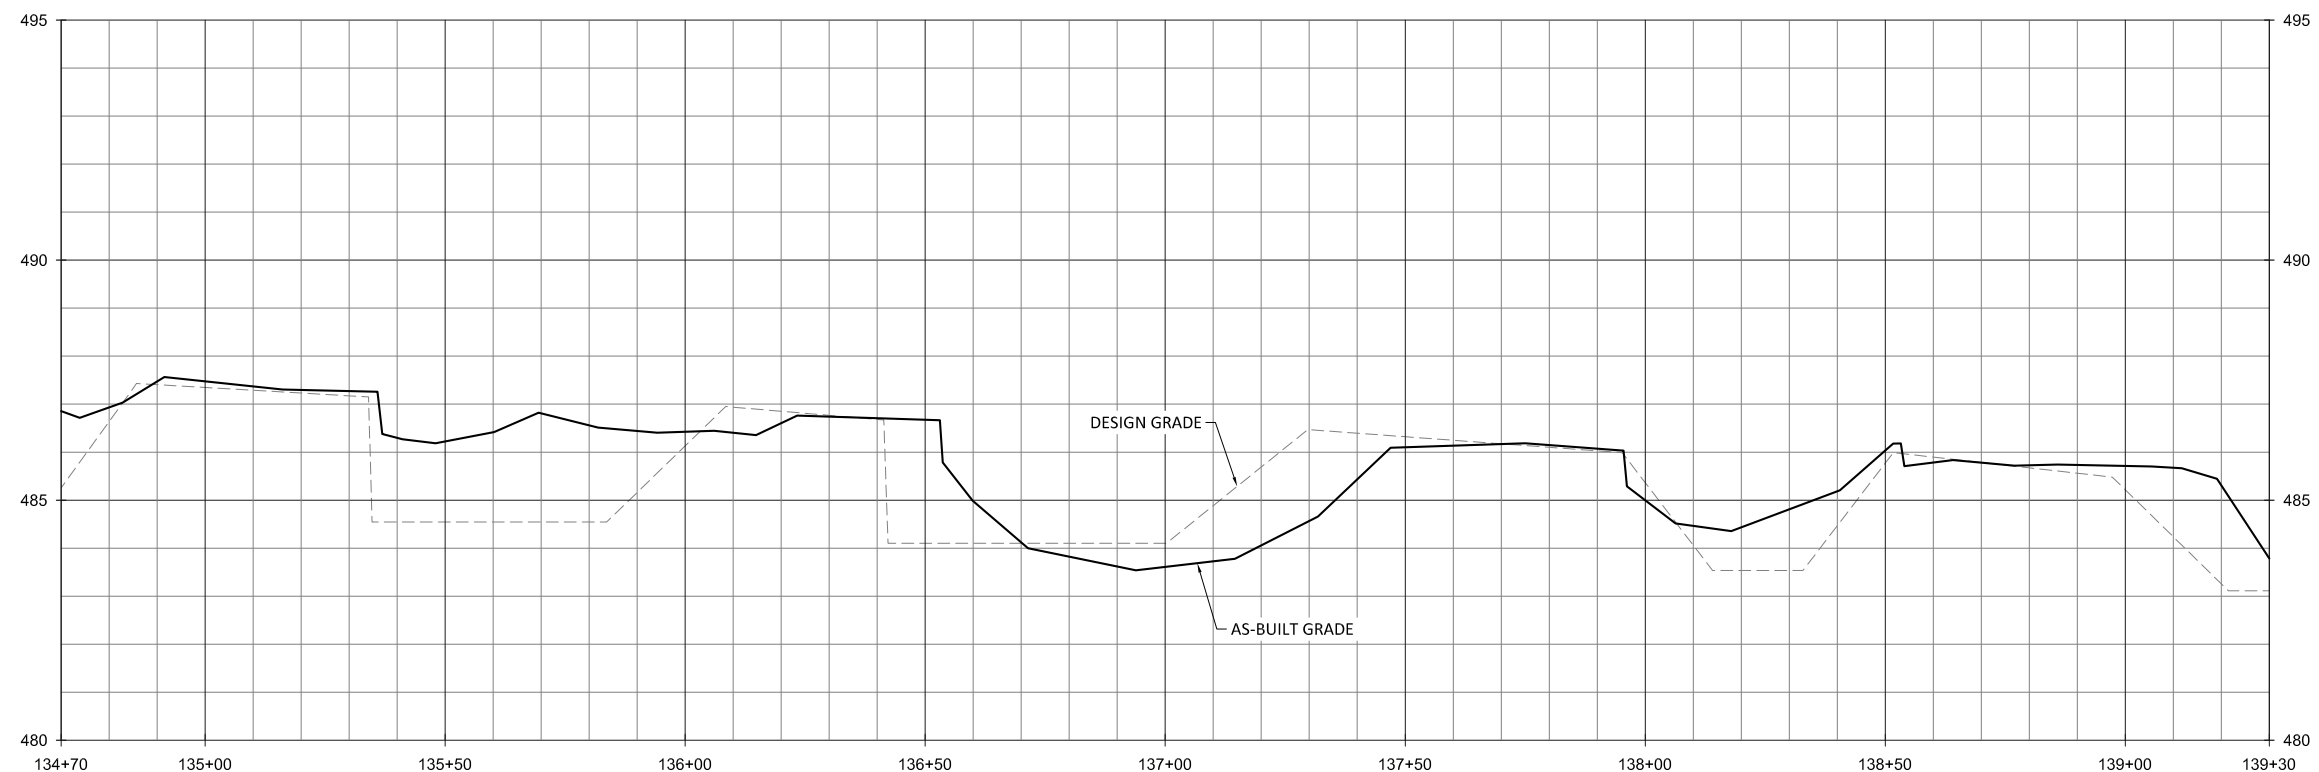
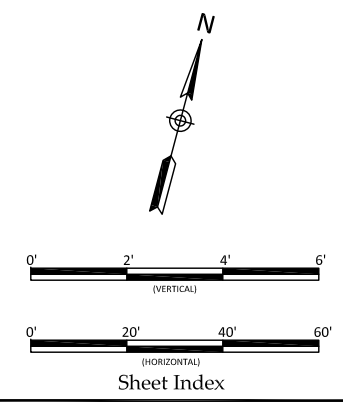
- NOTE:**
1. STA 135+15: A RIPRAP OUTLET WAS INSTALLED.
 2. STA 135+39: A LOG VANE WAS INSTALLED INSTEAD OF A LOG J HOOK.
 3. STA 137+88: A LOG SILL WAS INSTALLED.

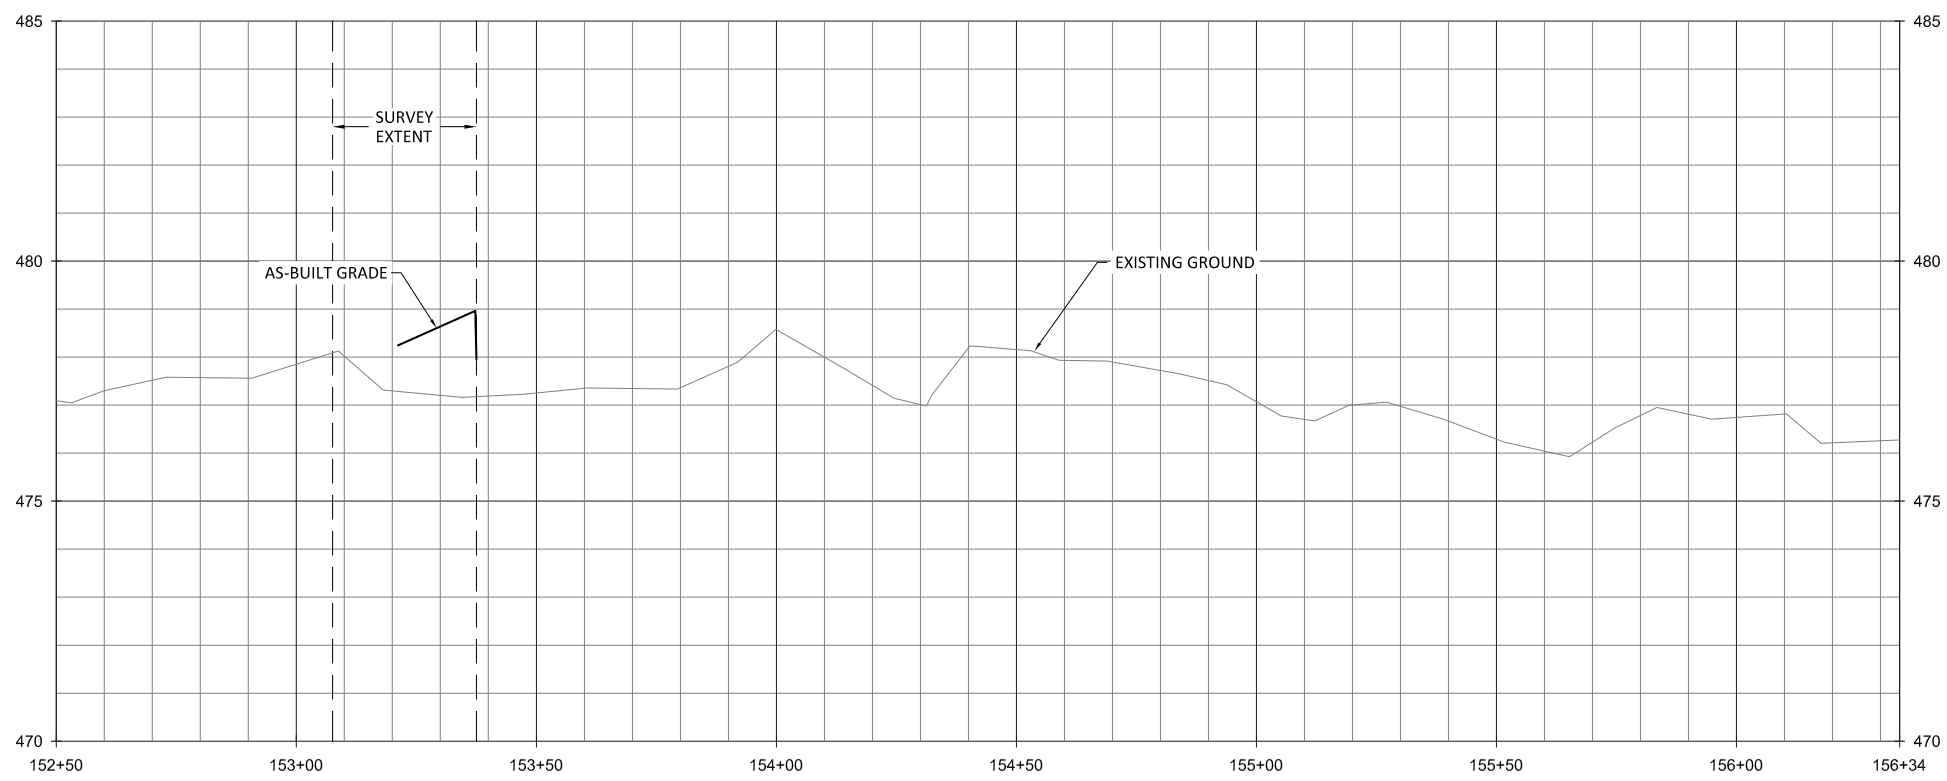
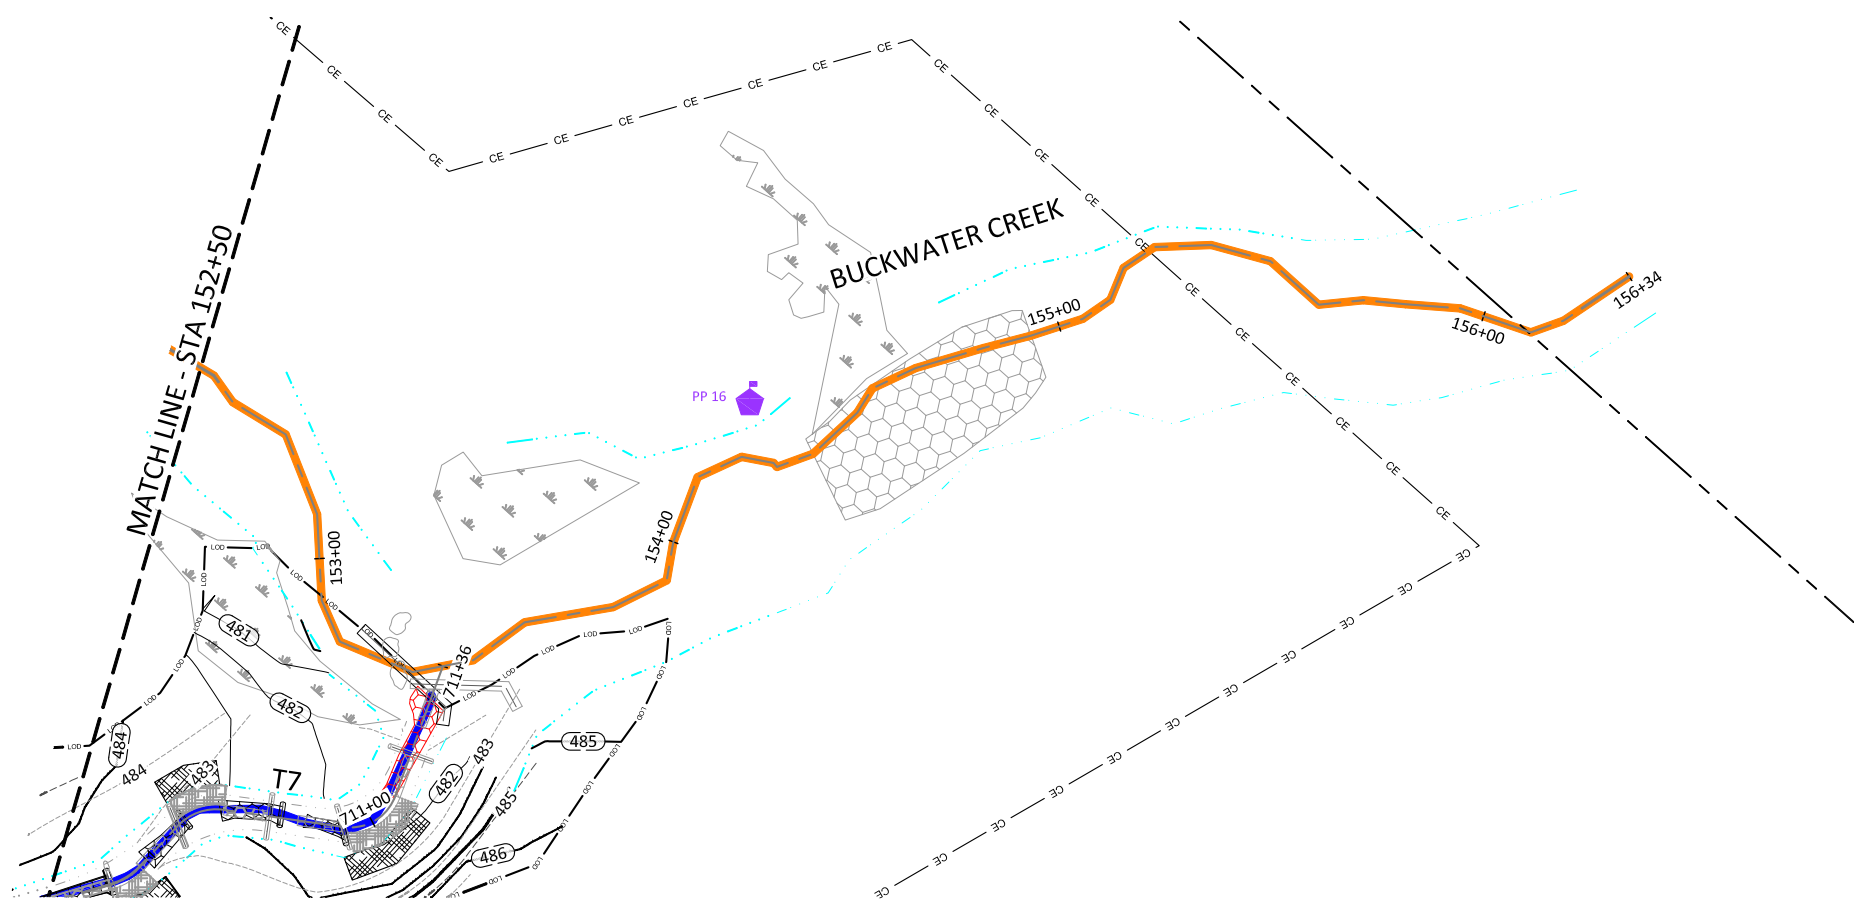
NOTE:
 1. STA 154+67: RIFFLE NATURALLY FORMS AND SHIFTS IN THIS AREA. NO RIFFLE WAS CONSTRUCTED.

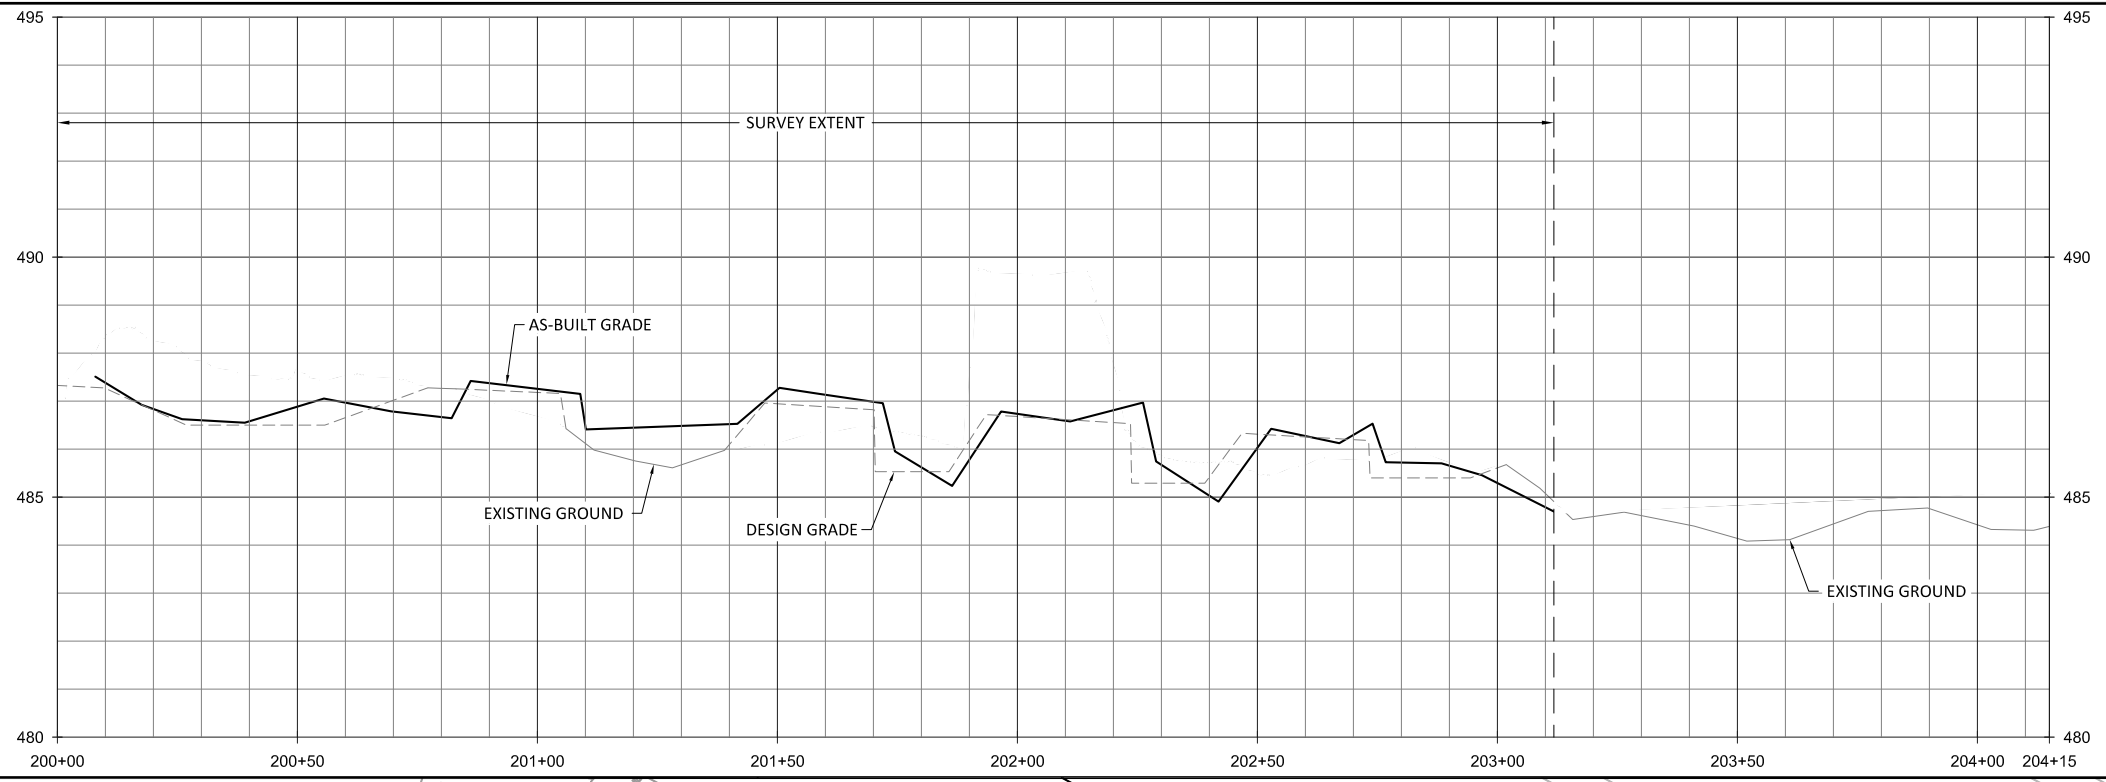
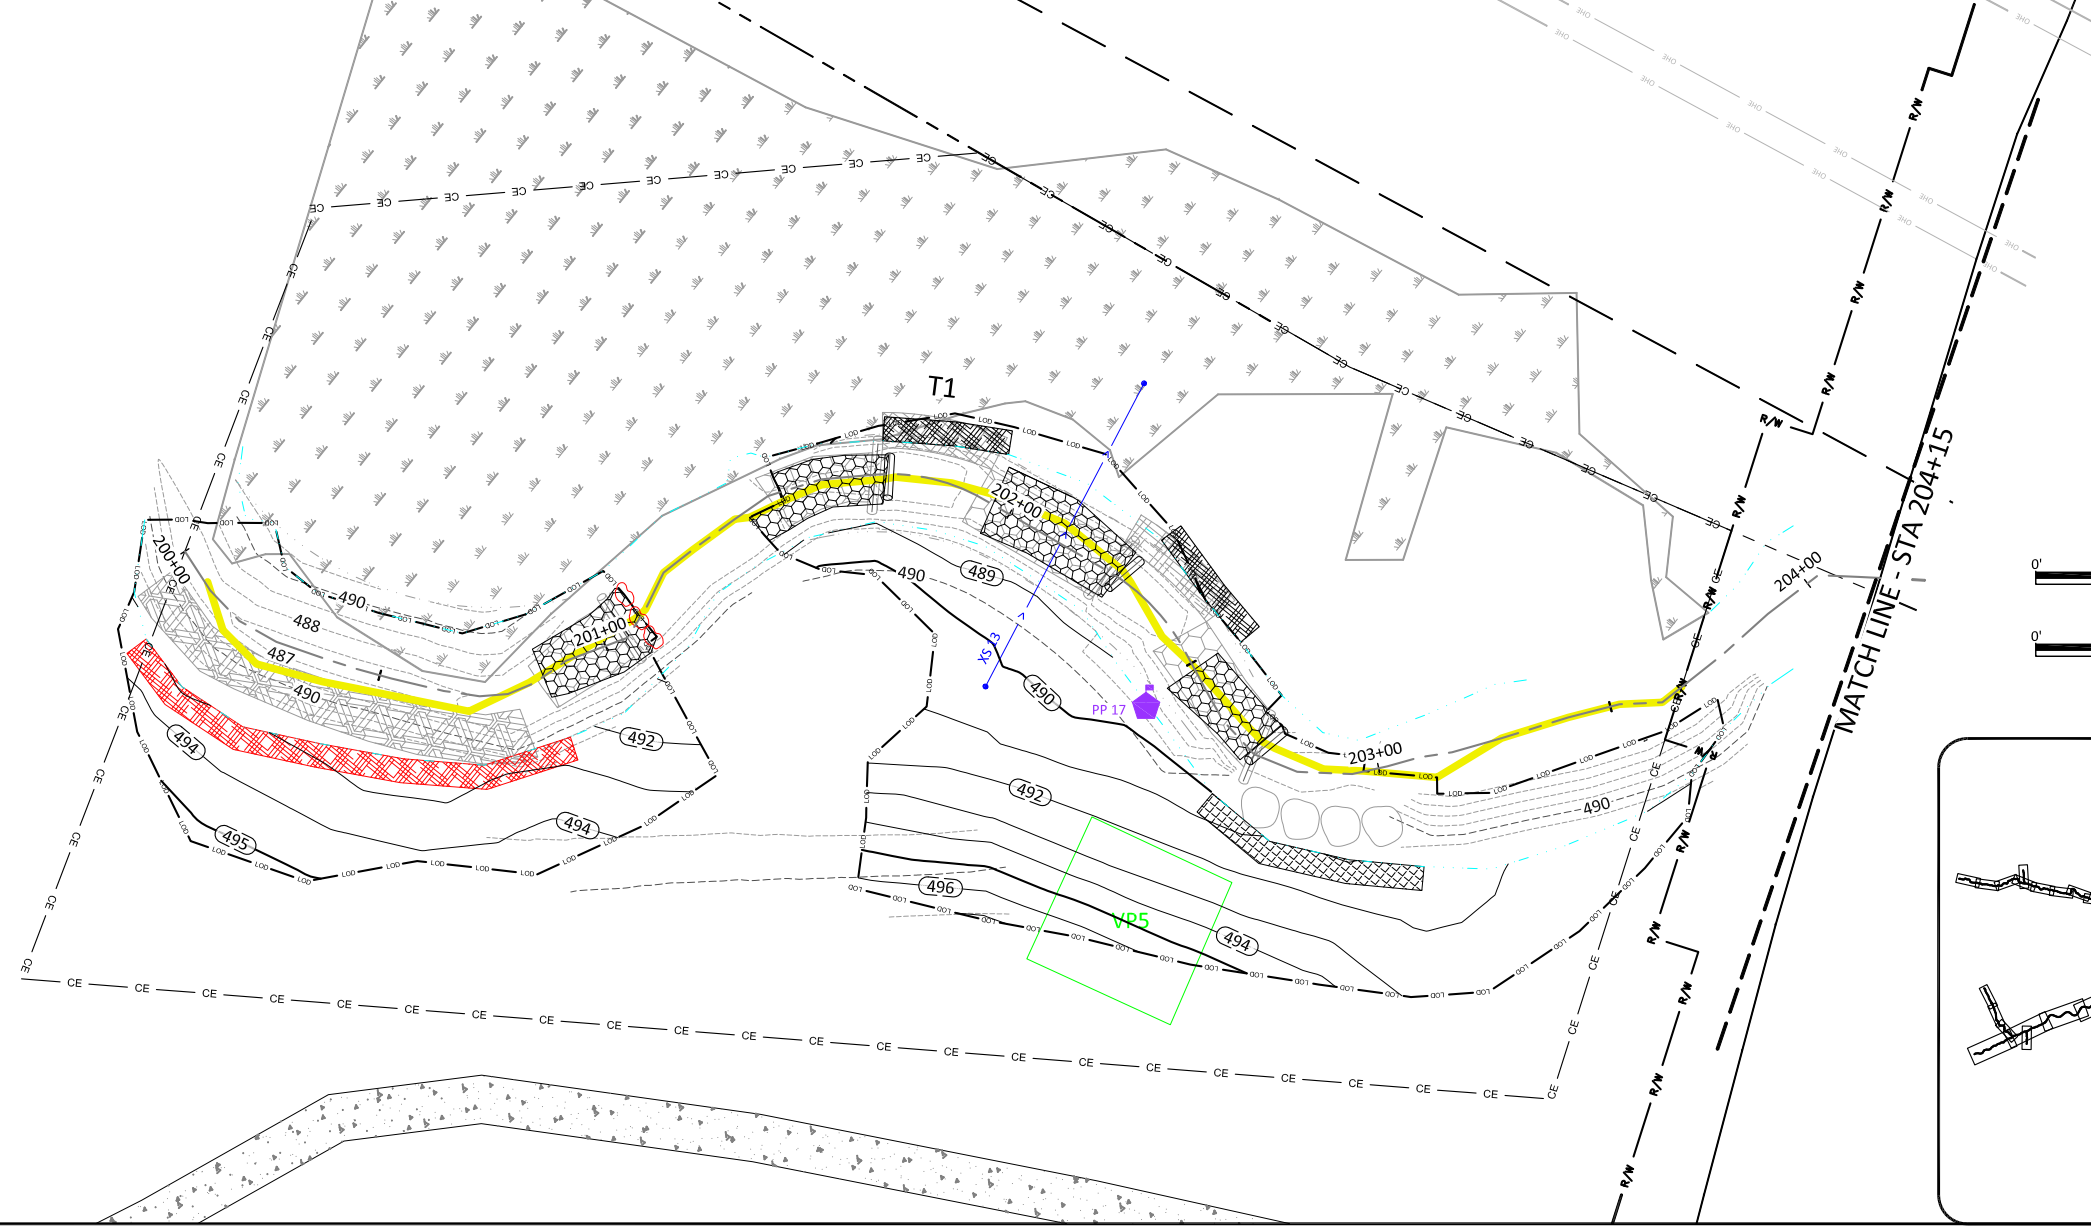
- NOTE:**
1. STA 200+54: BRUSH TOE WAS INSTALLED INSTEAD OF VEGETATED SOIL LIFT.
 2. STA 201+19: BOULDER SILL WAS INSTALLED INSTEAD OF A LOG SILL.

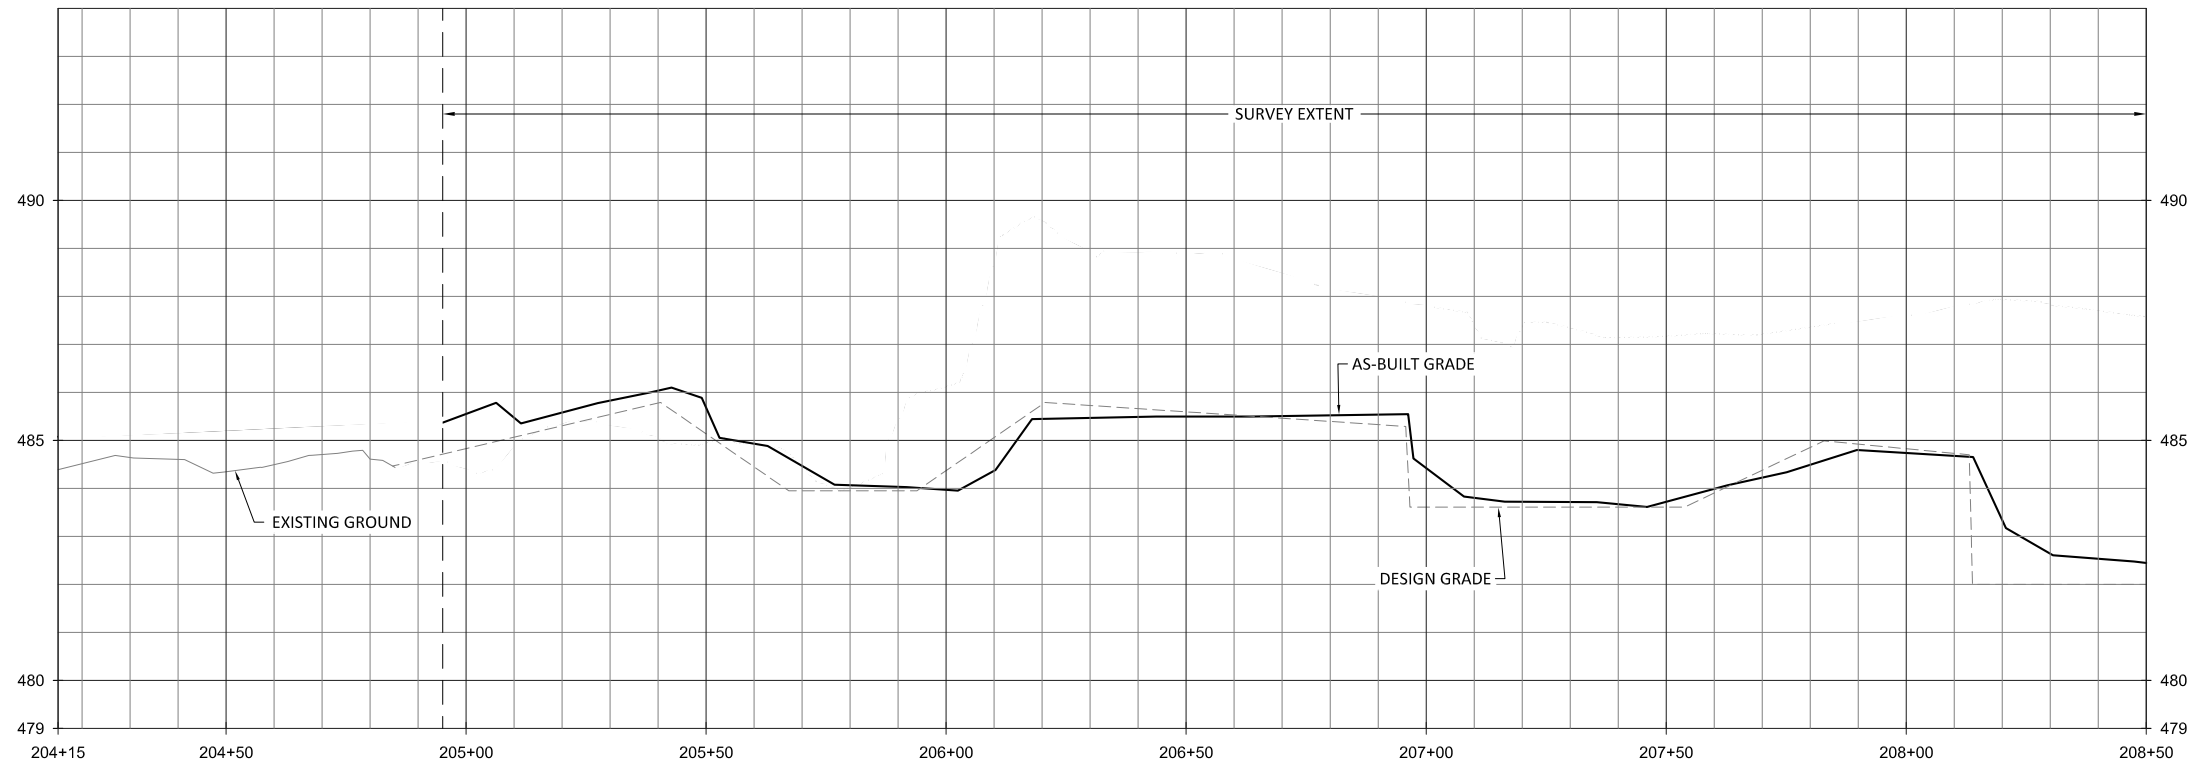
NOTE:
 1. STA 207+54: BOULDER TOE WAS INSTALLED INSTEAD OF SOD MATS.

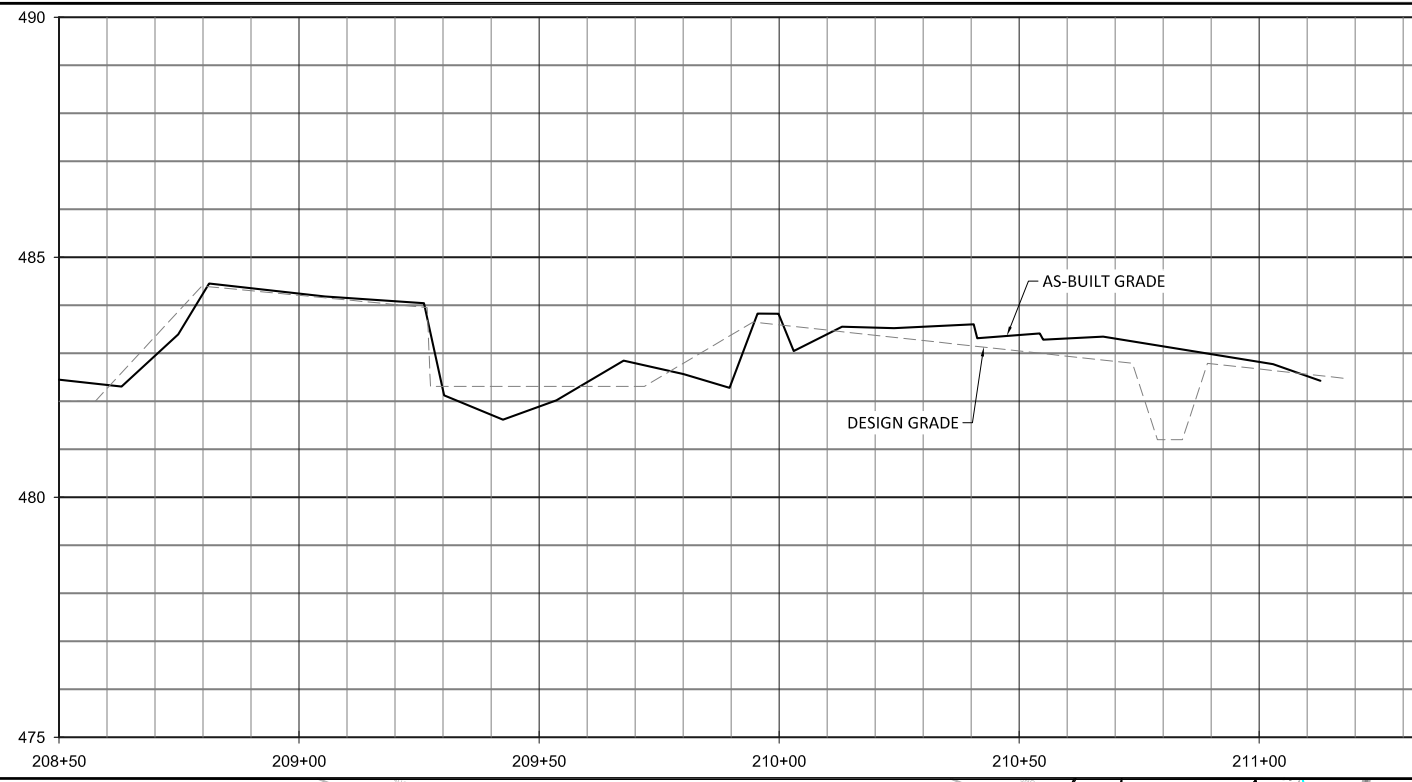
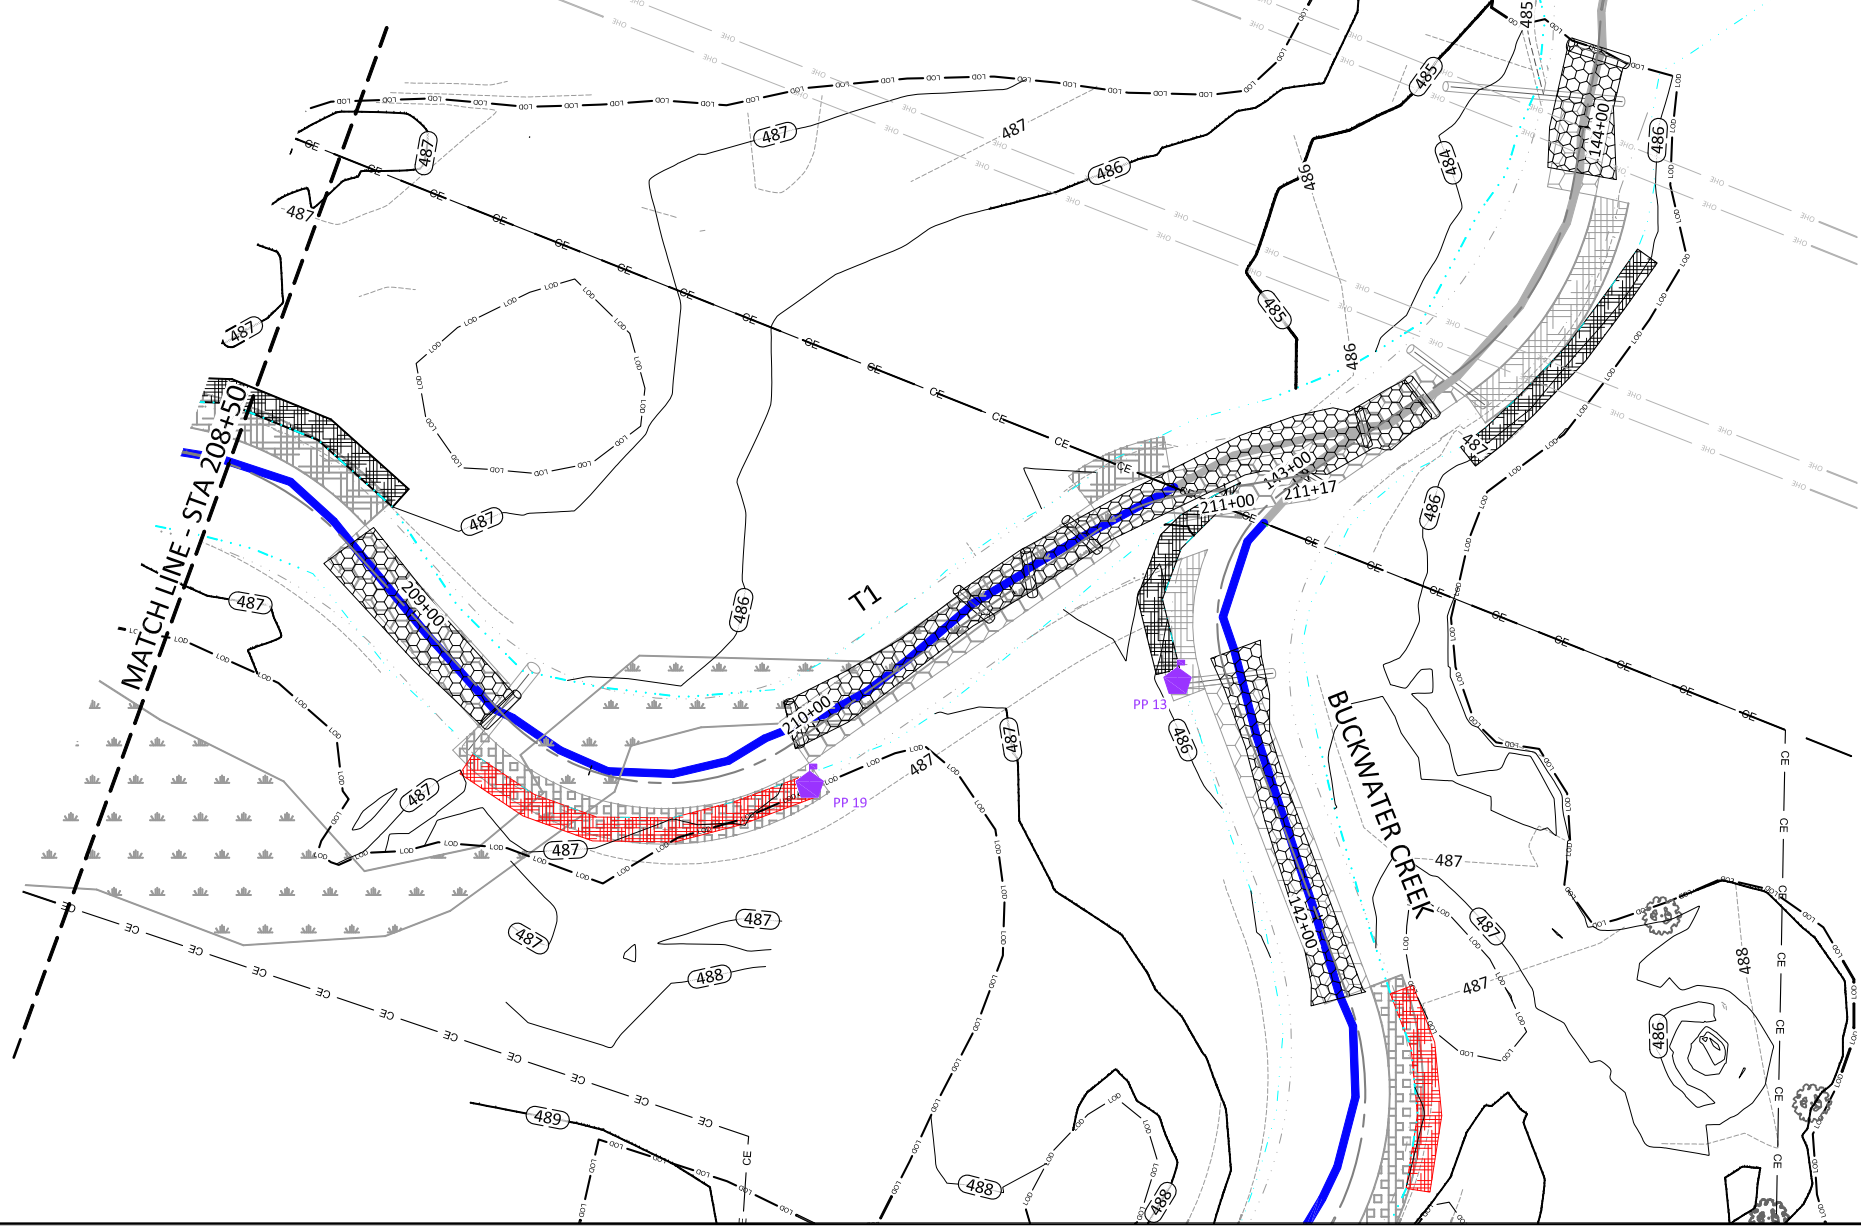
1.15

NOTE:
 1. STA 209+67: BRUSH TOE WAS INSTALLED INSTEAD OF SOD MATS.
