**BASELINE MONITORING
DOCUMENT AND AS-BUILT
BASELINE REPORT
FINAL**

BUCKWATER MITIGATION SITE

Orange County, NC

DMS Project Number 97084

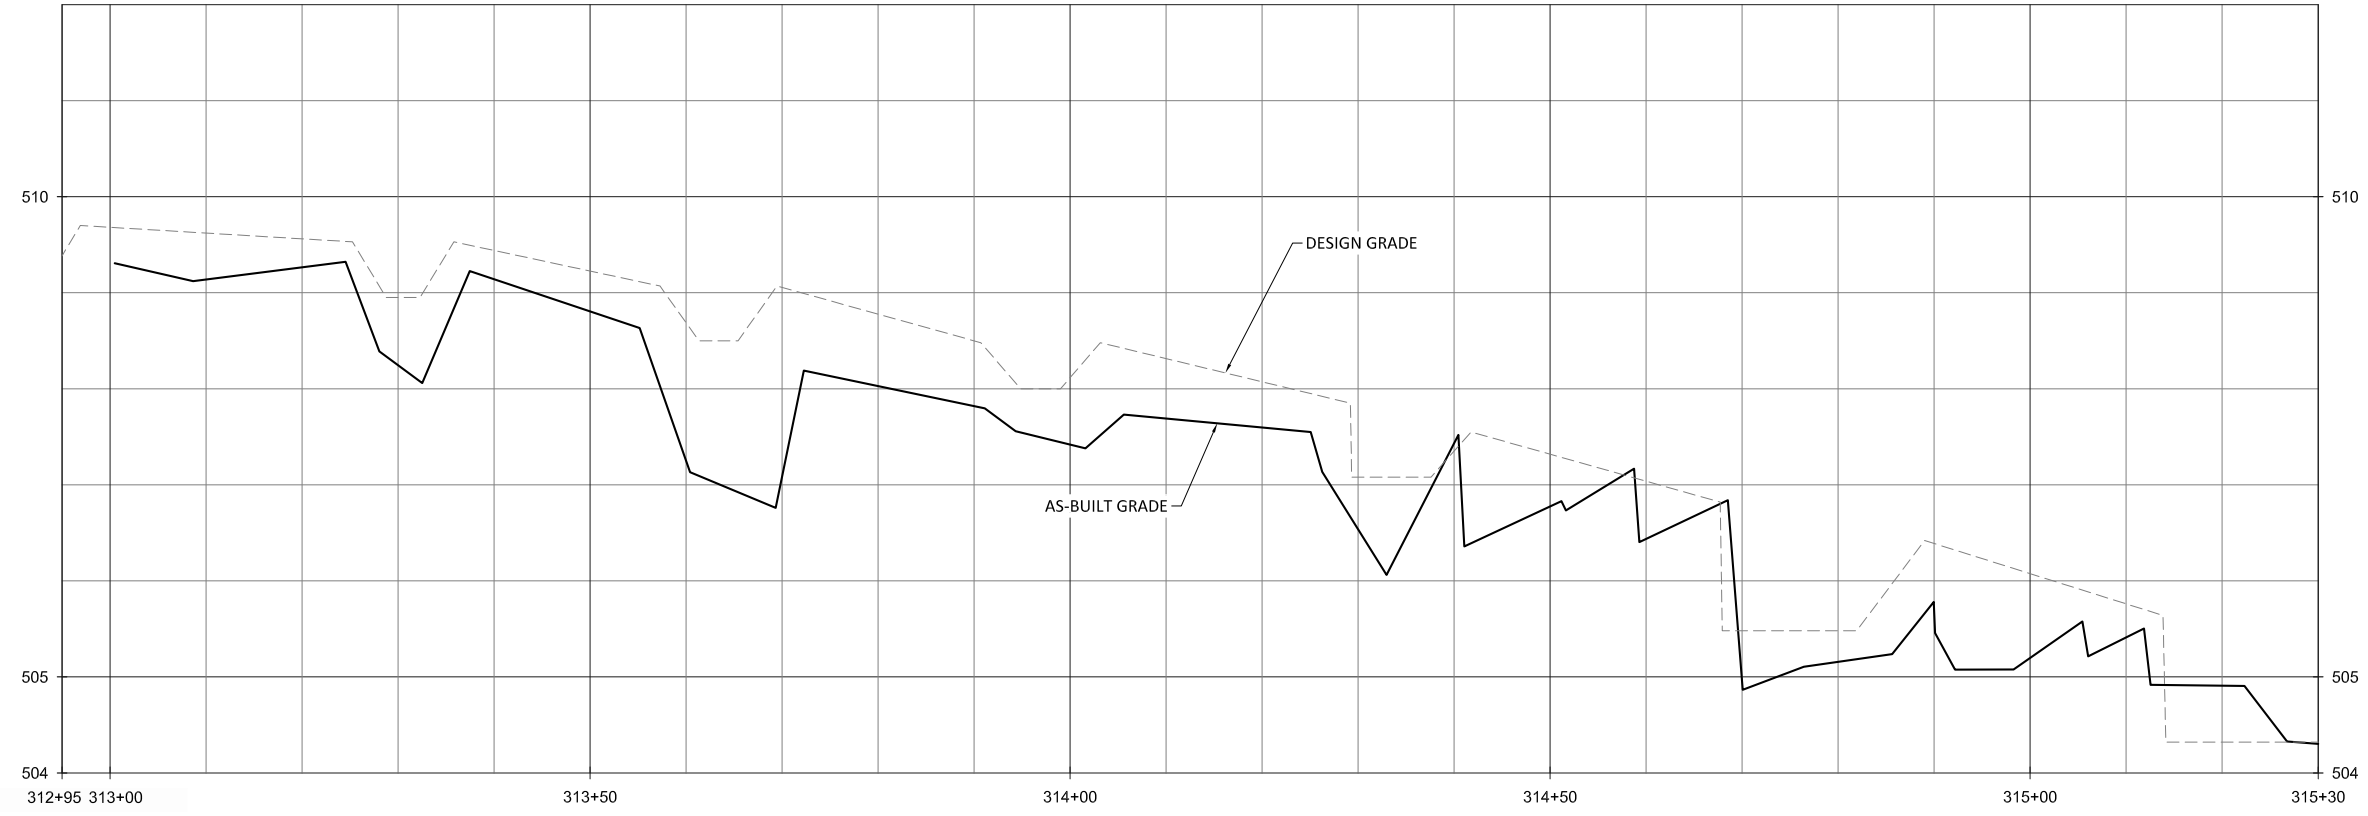
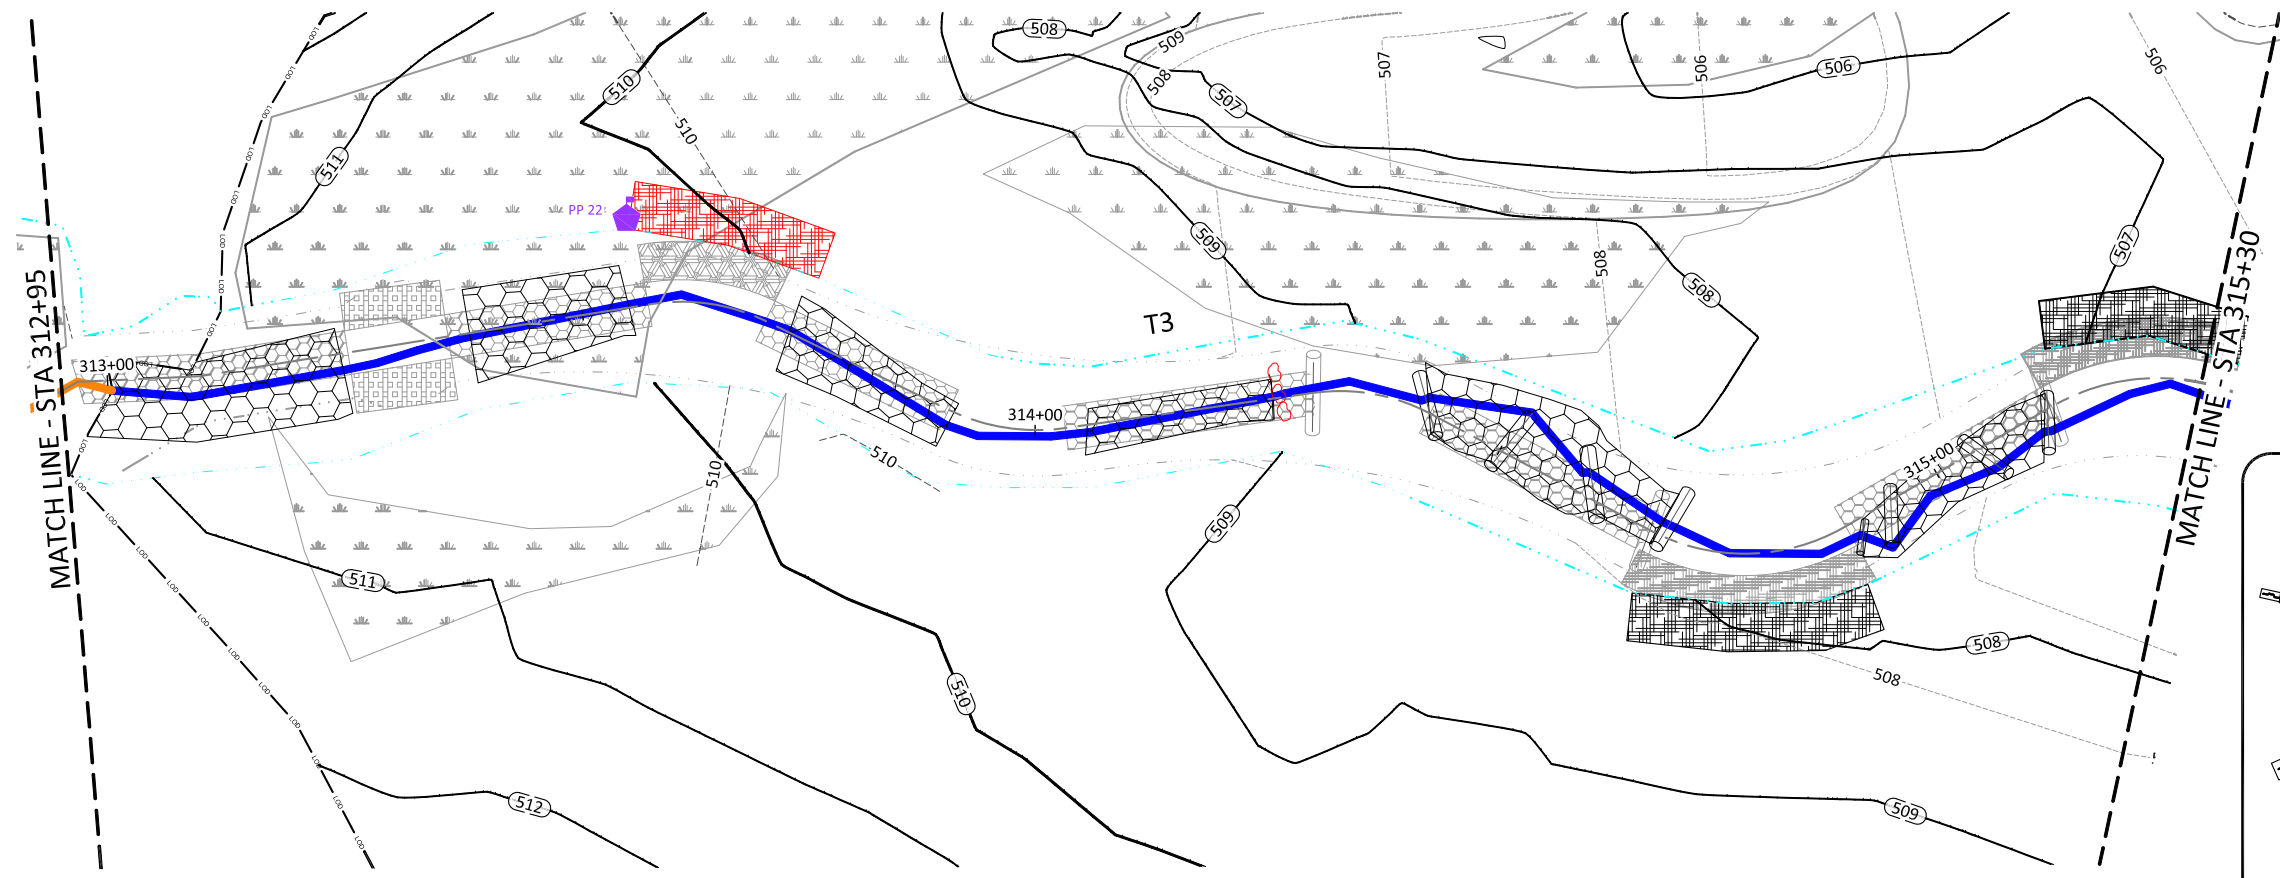
Buckwater Mitigation Site
 Orange County, North Carolina

- NOTE:**
1. STA 313+68: BRUSH TOE WAS INSTALLED INSTEAD OF VEGETATED SOIL LIFT.
 2. STA 314+32: BOULDER SILL INSTALLED INSTEAD OF LOG SILL.

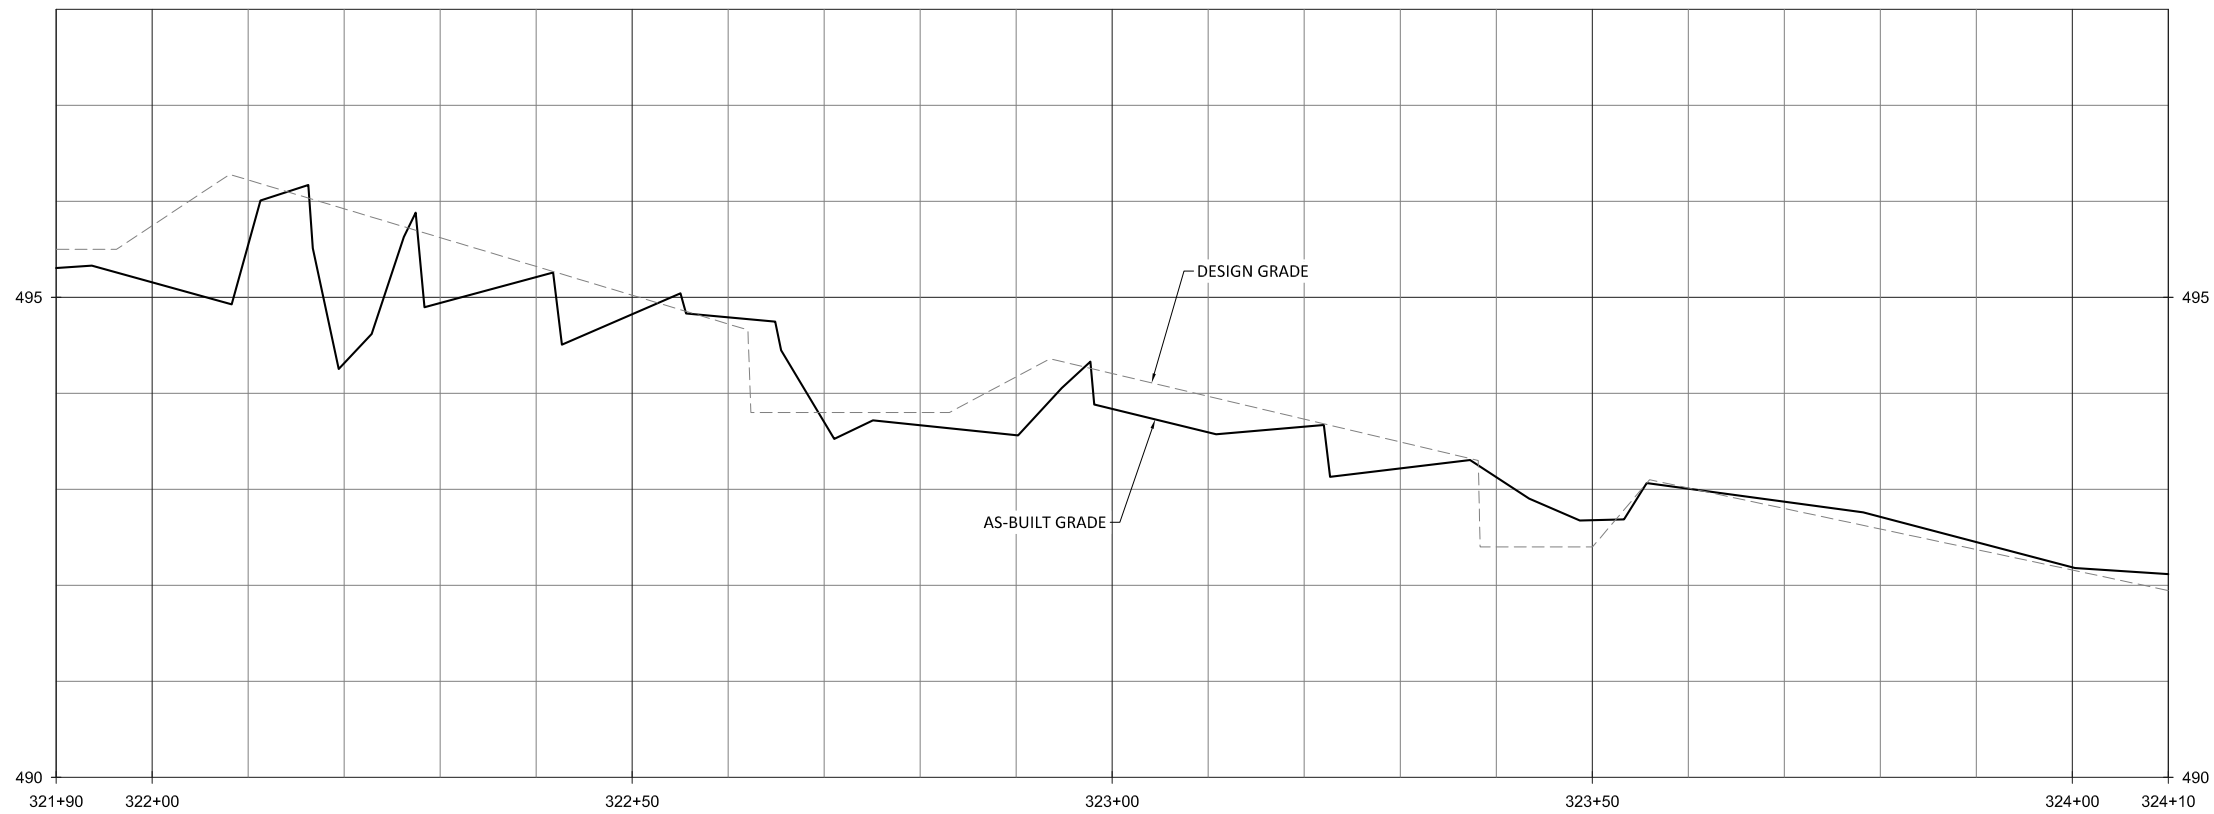
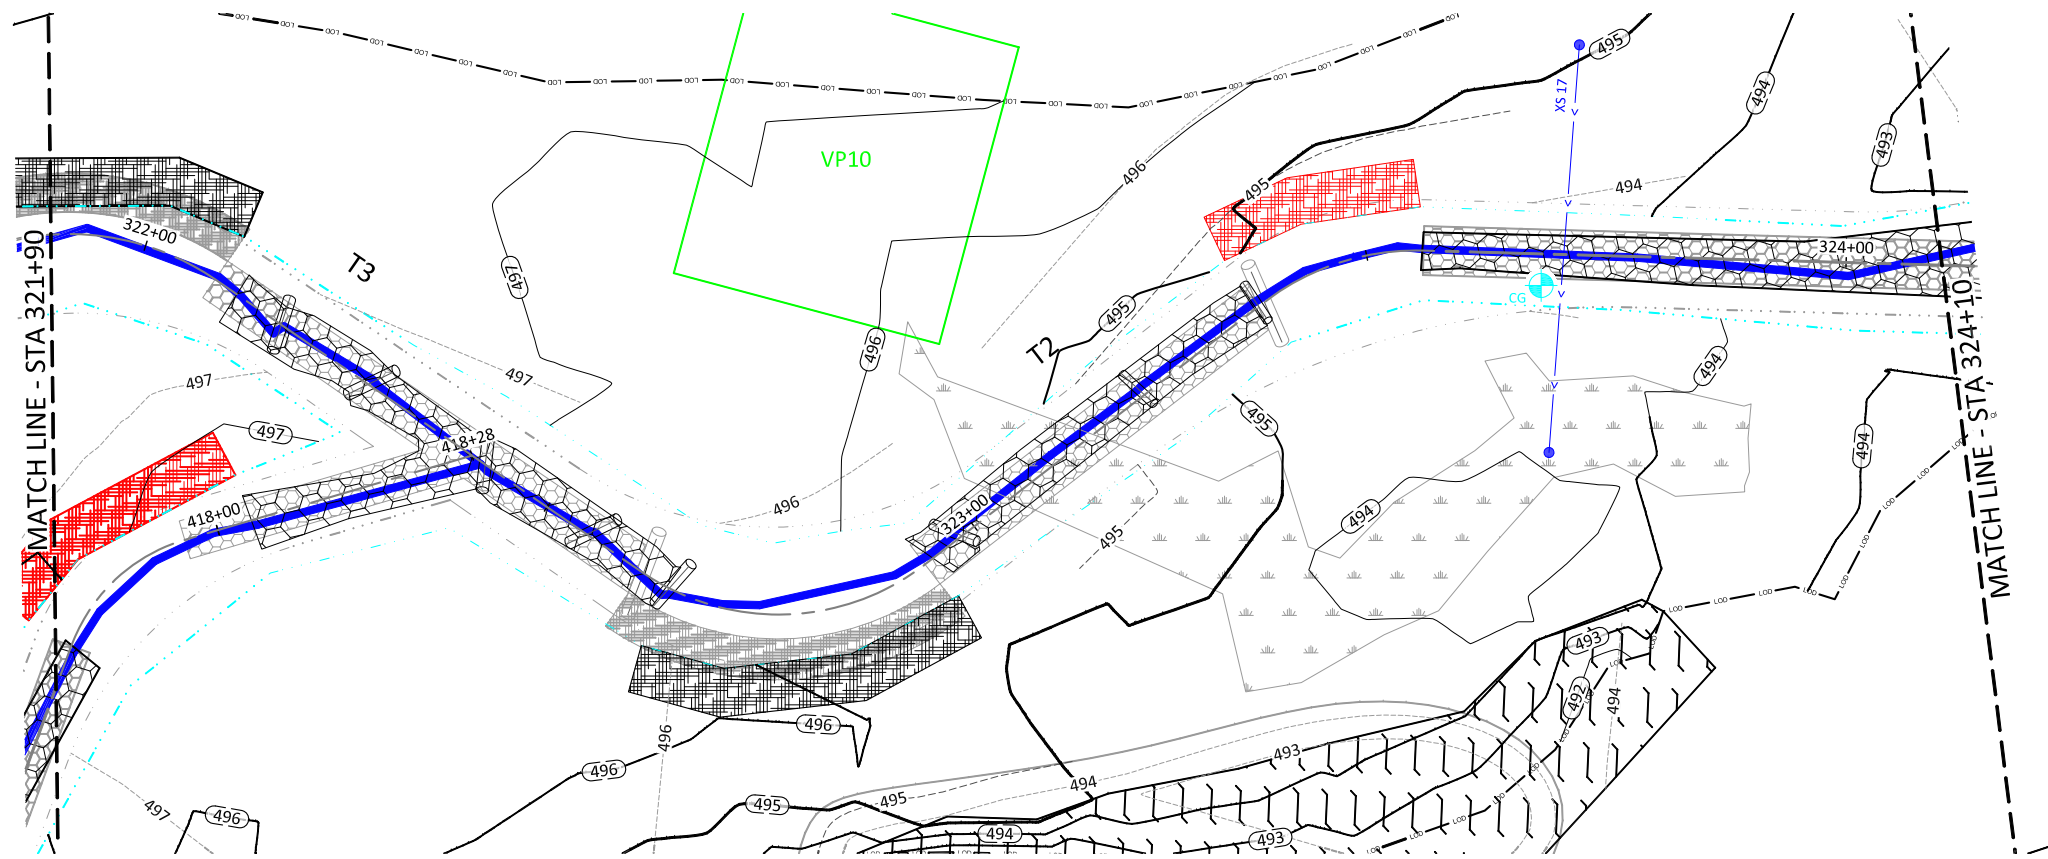
Buckwater Mitigation Site
 Orange County, North Carolina
 T3 Reach 2 & T2
 Stream Plan and Profile

NOTE:
 1. STA 323+61: BRUSH TOE WAS INSTALLED.

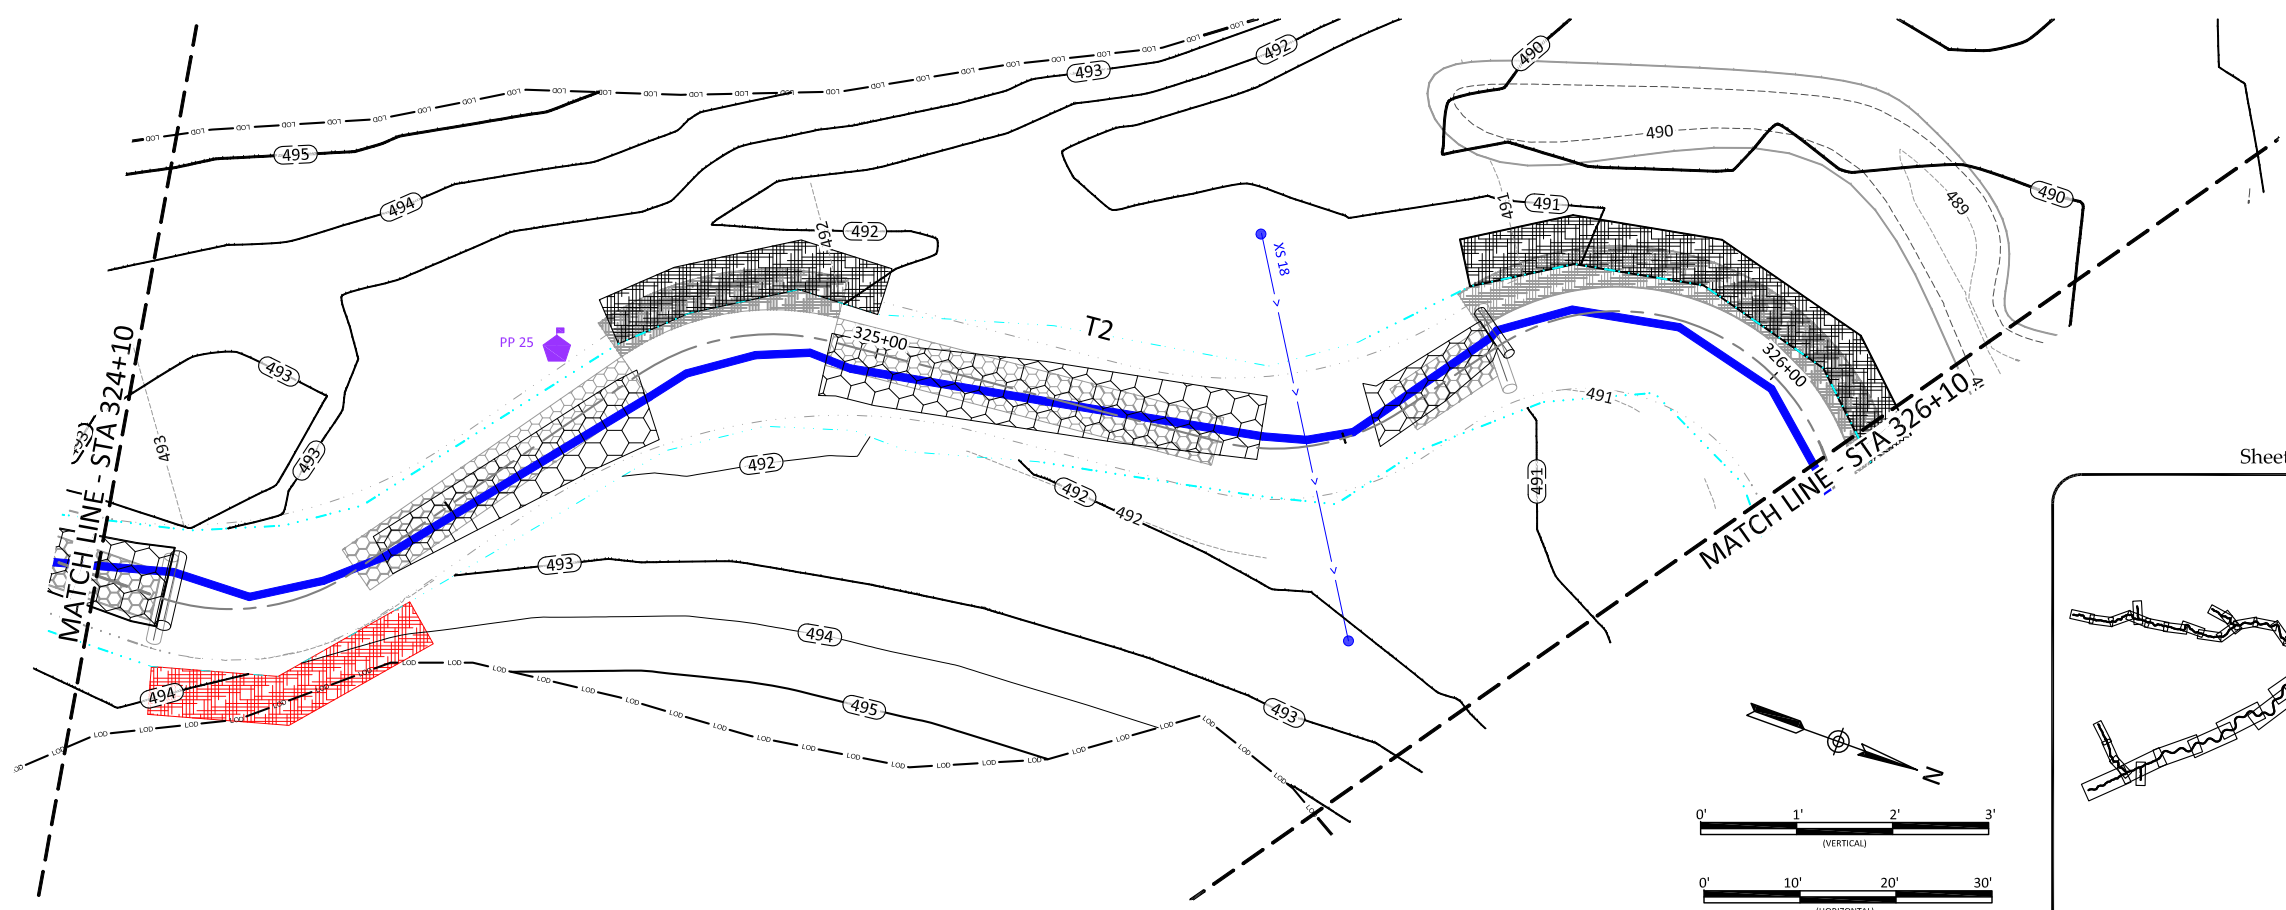
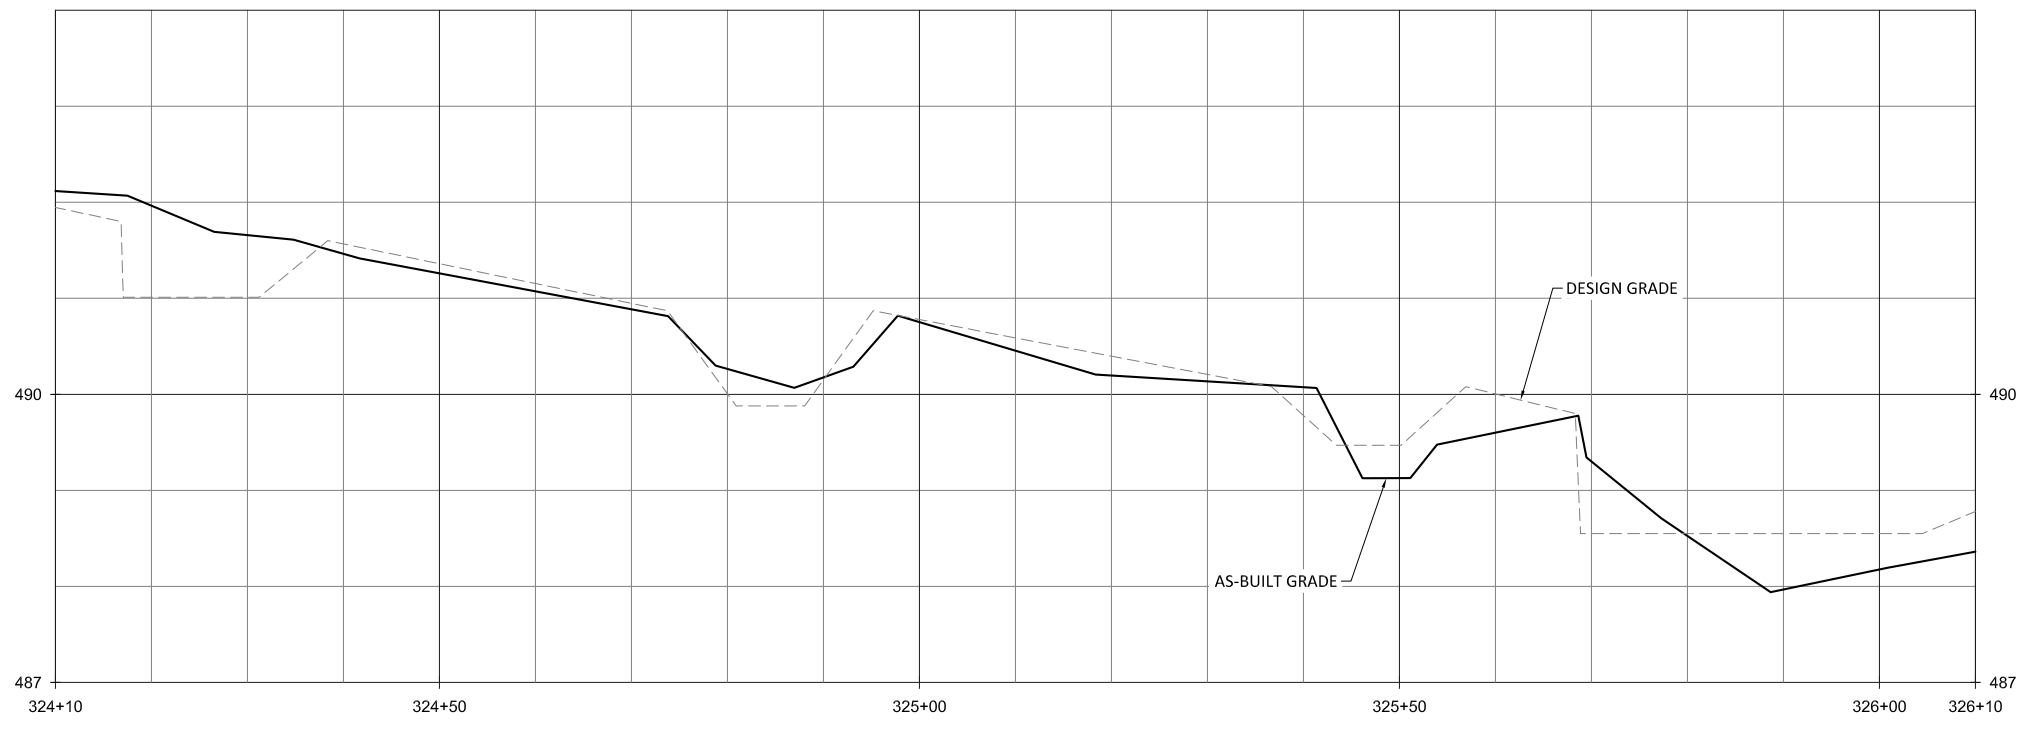
Buckwater Mitigation Site
Orange County, North Carolina
 T2
 Stream Plan and Profile

NOTE:
 1. STA 324+44: BRUSH TOE WAS INSTALLED.

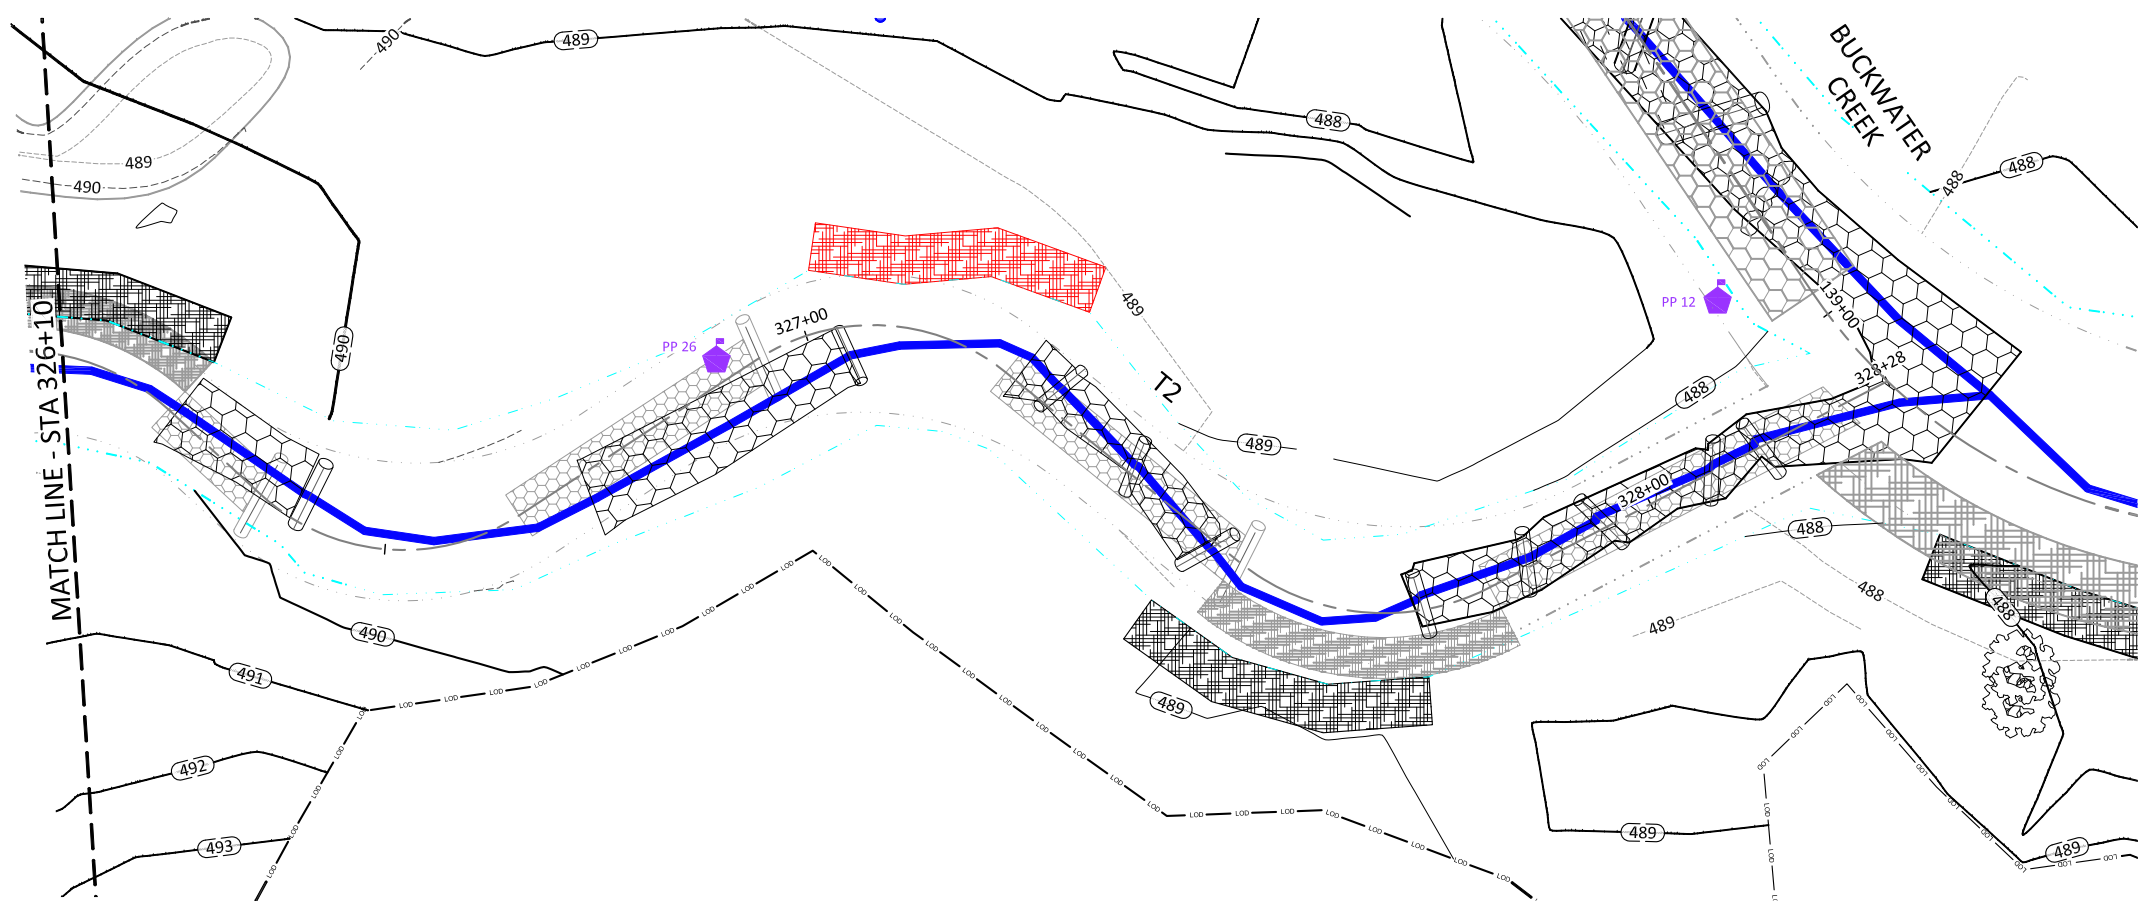
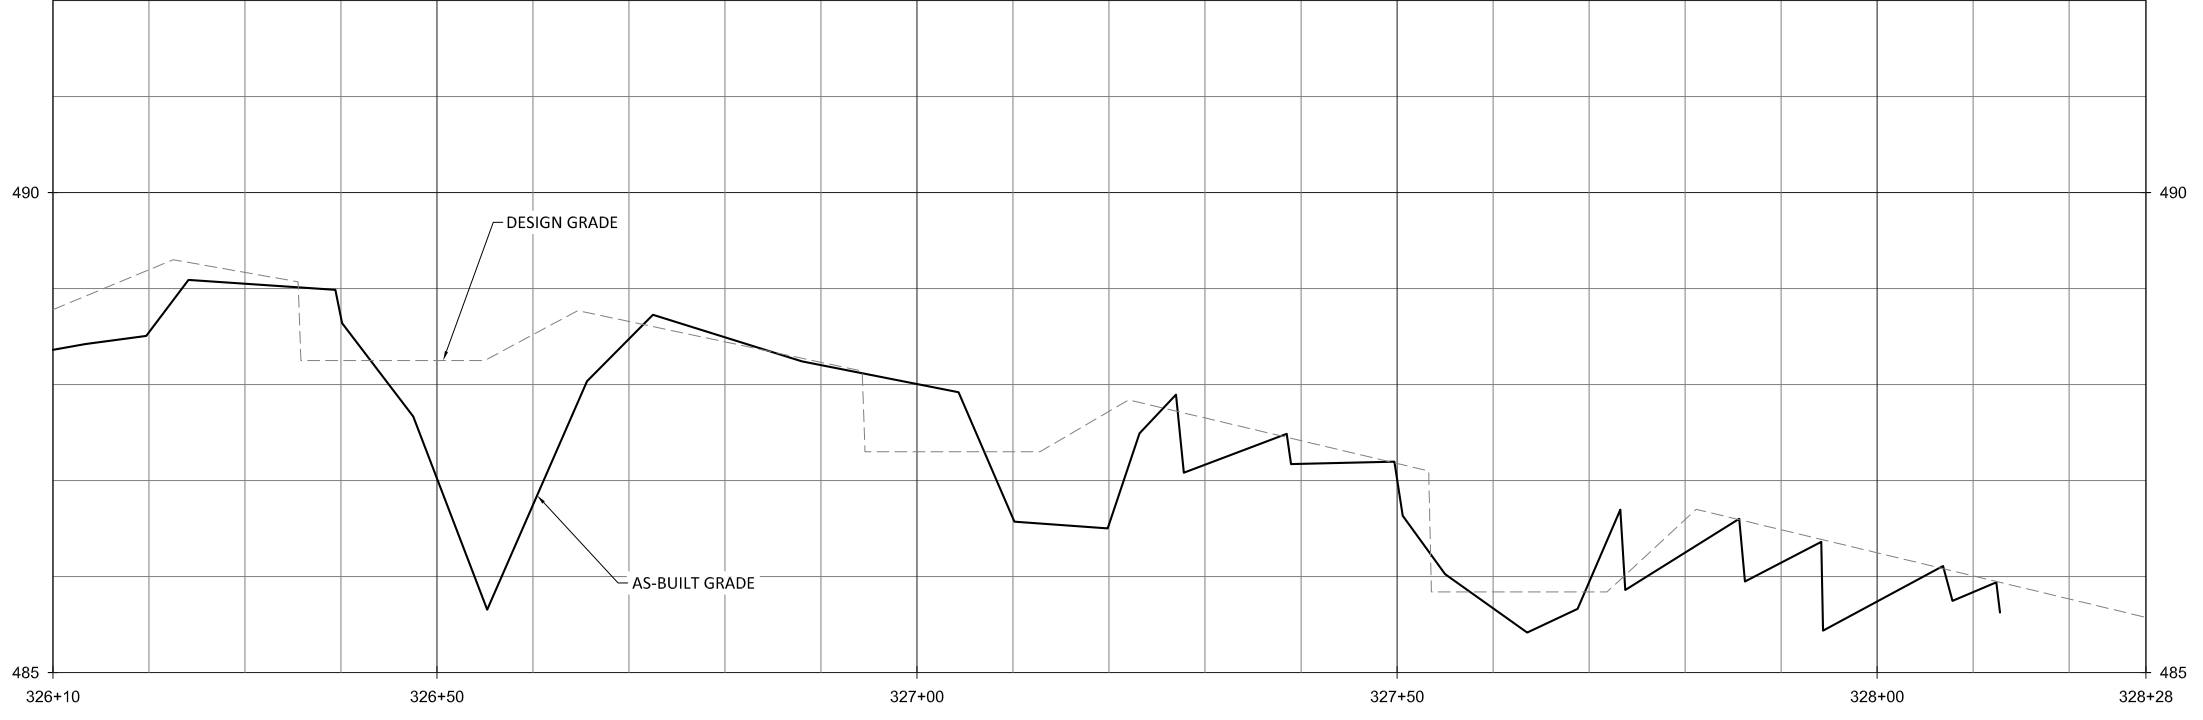
NOTE:
 1. STA 327+25: BRUSH TOE WAS INSTALLED.

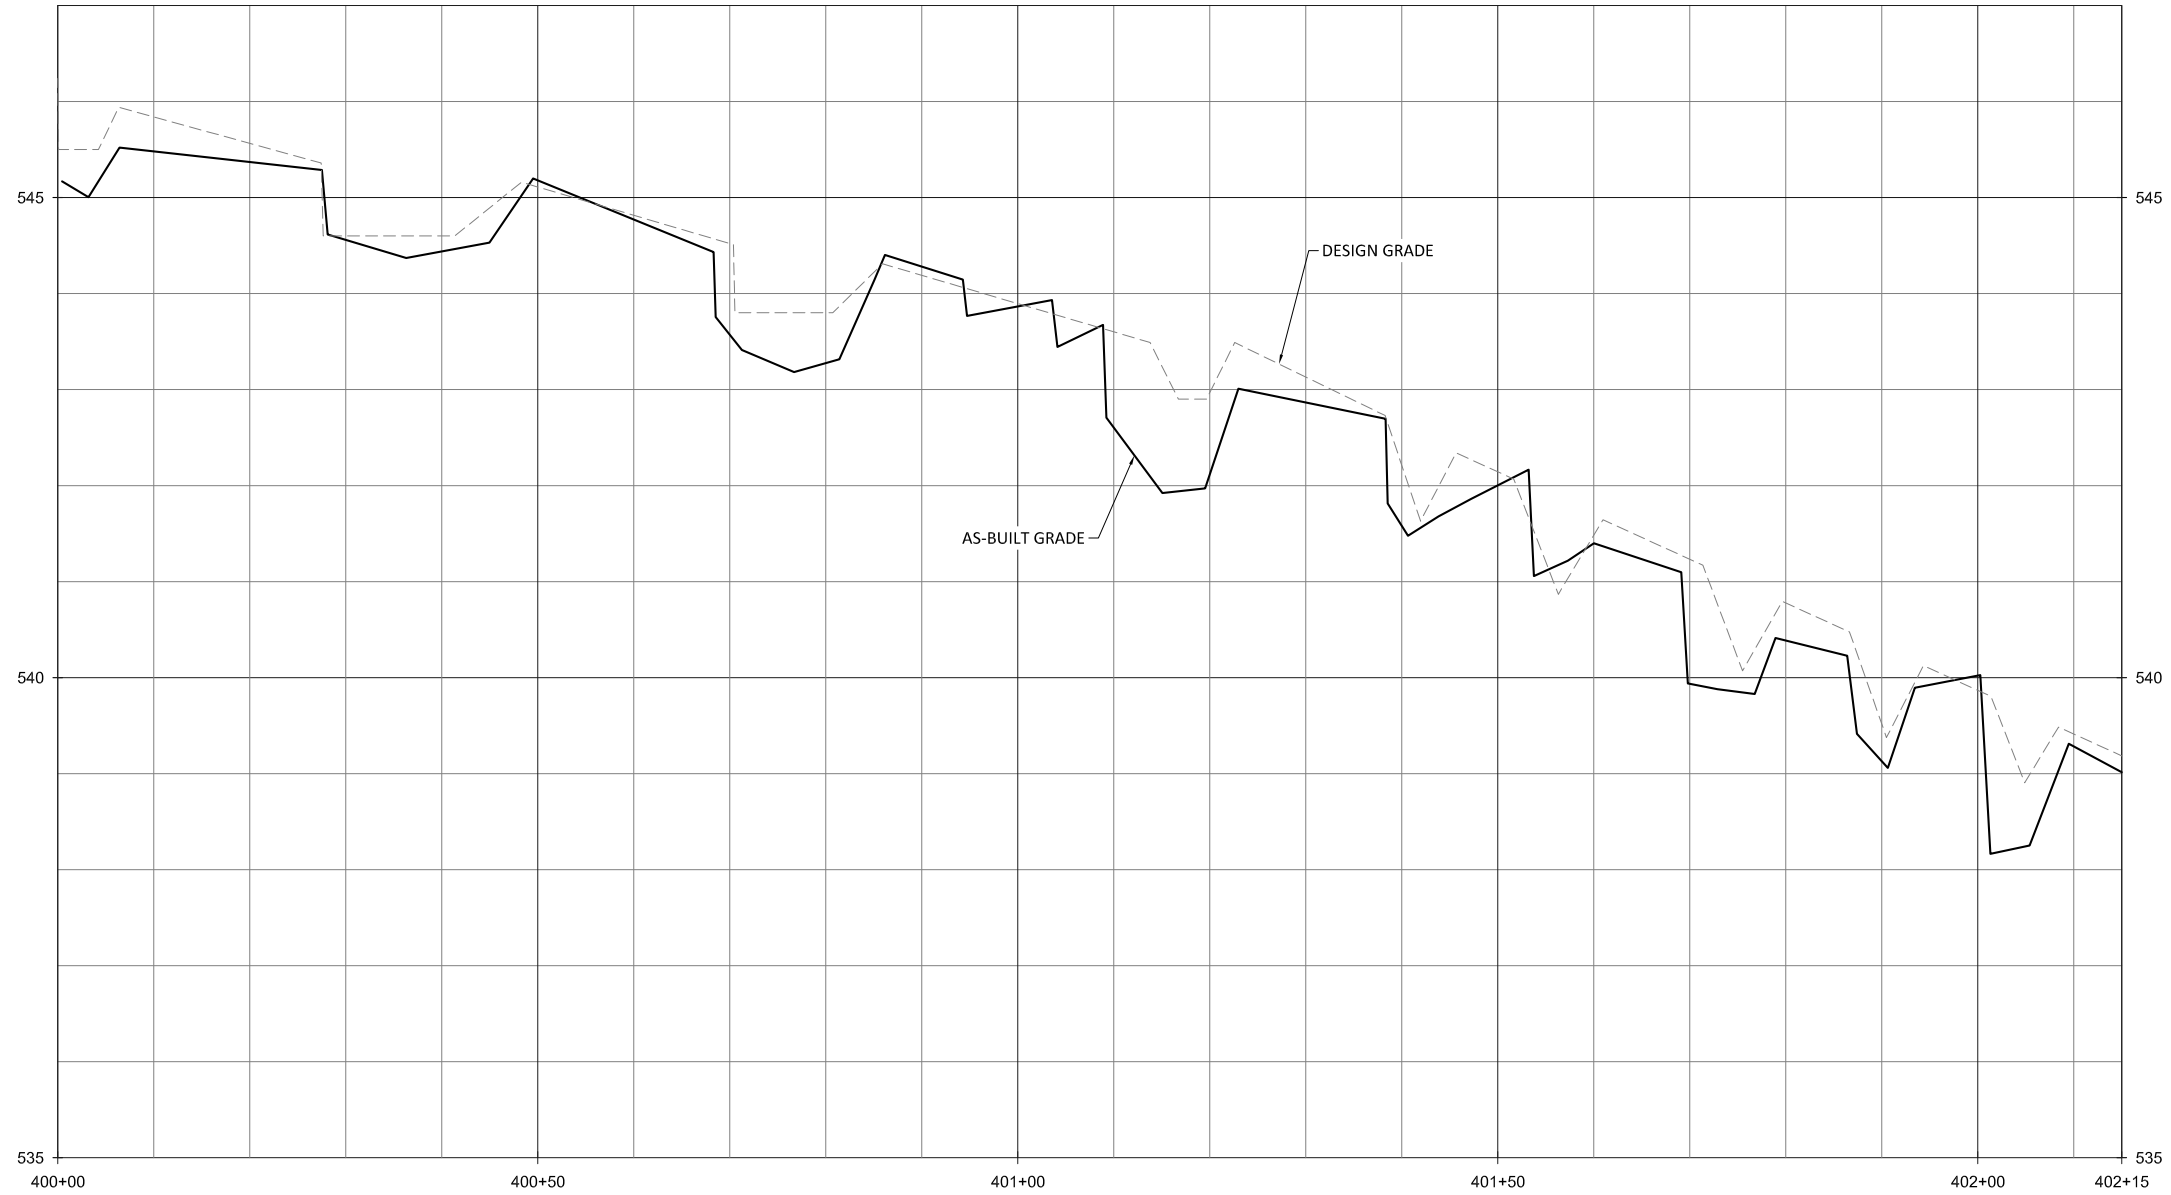
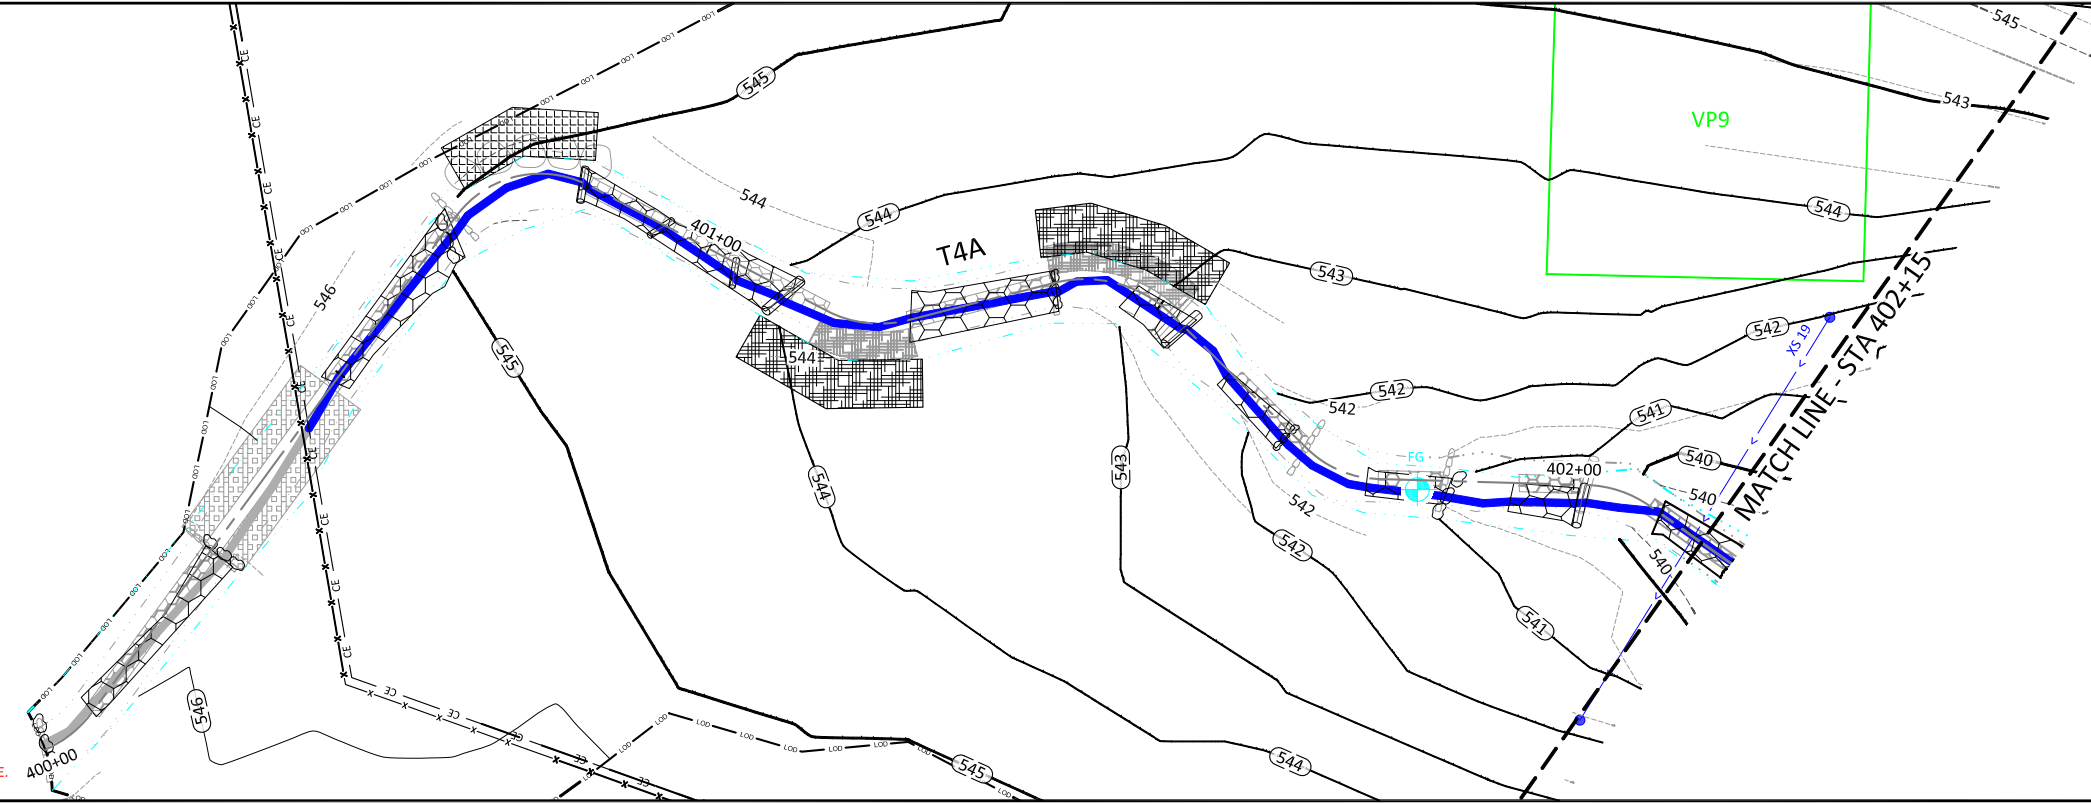
NOTE:
 1. STA 400+38': SOD MATS NOT INSTALLED. NO SOD AVAILABLE.

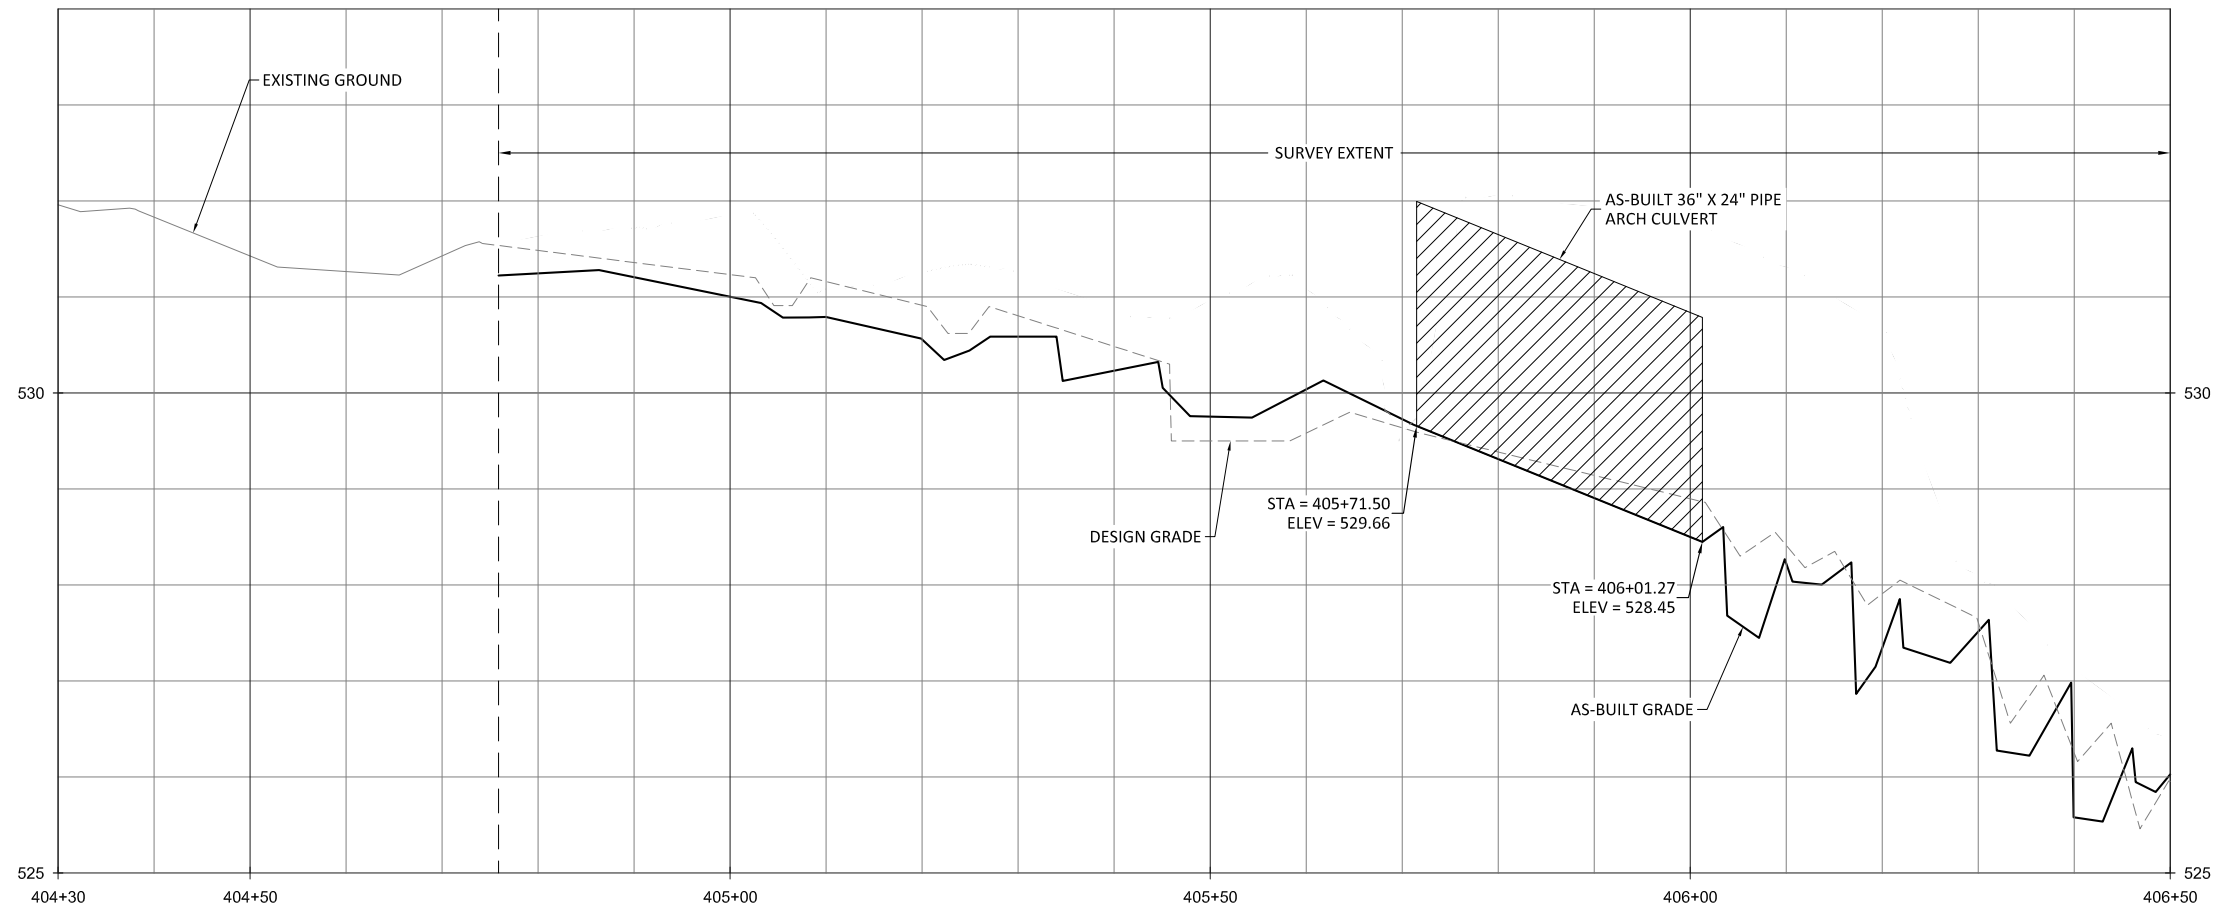
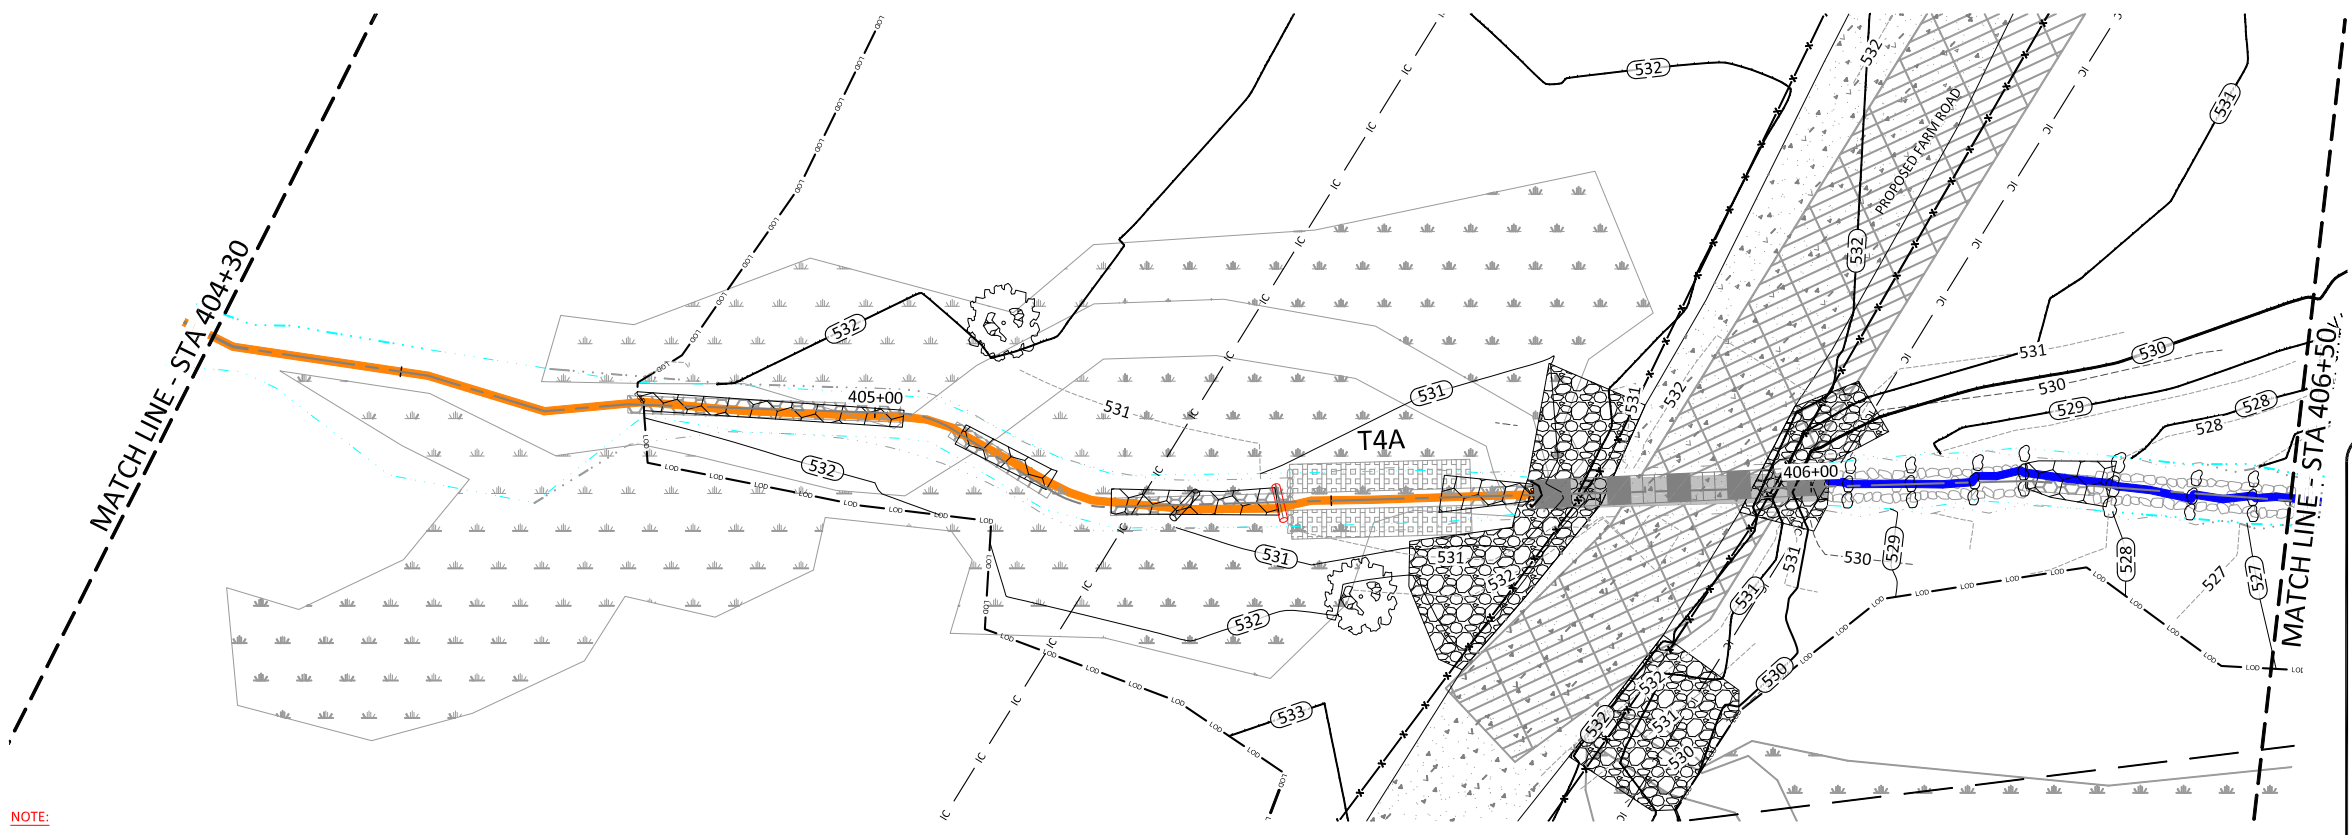
- NOTE:**
1. STA 405+45: LOG SILL WAS INSTALLED INSTEAD OF A BOULDER SILL.
 2. STA 405+56: SOD MATS NOT INSTALLED. NO SOD AVAILABLE.
