**BASELINE MONITORING
DOCUMENT AND AS-BUILT
BASELINE REPORT
FINAL**

BUCKWATER MITIGATION SITE

Orange County, NC

DMS Project Number 97084

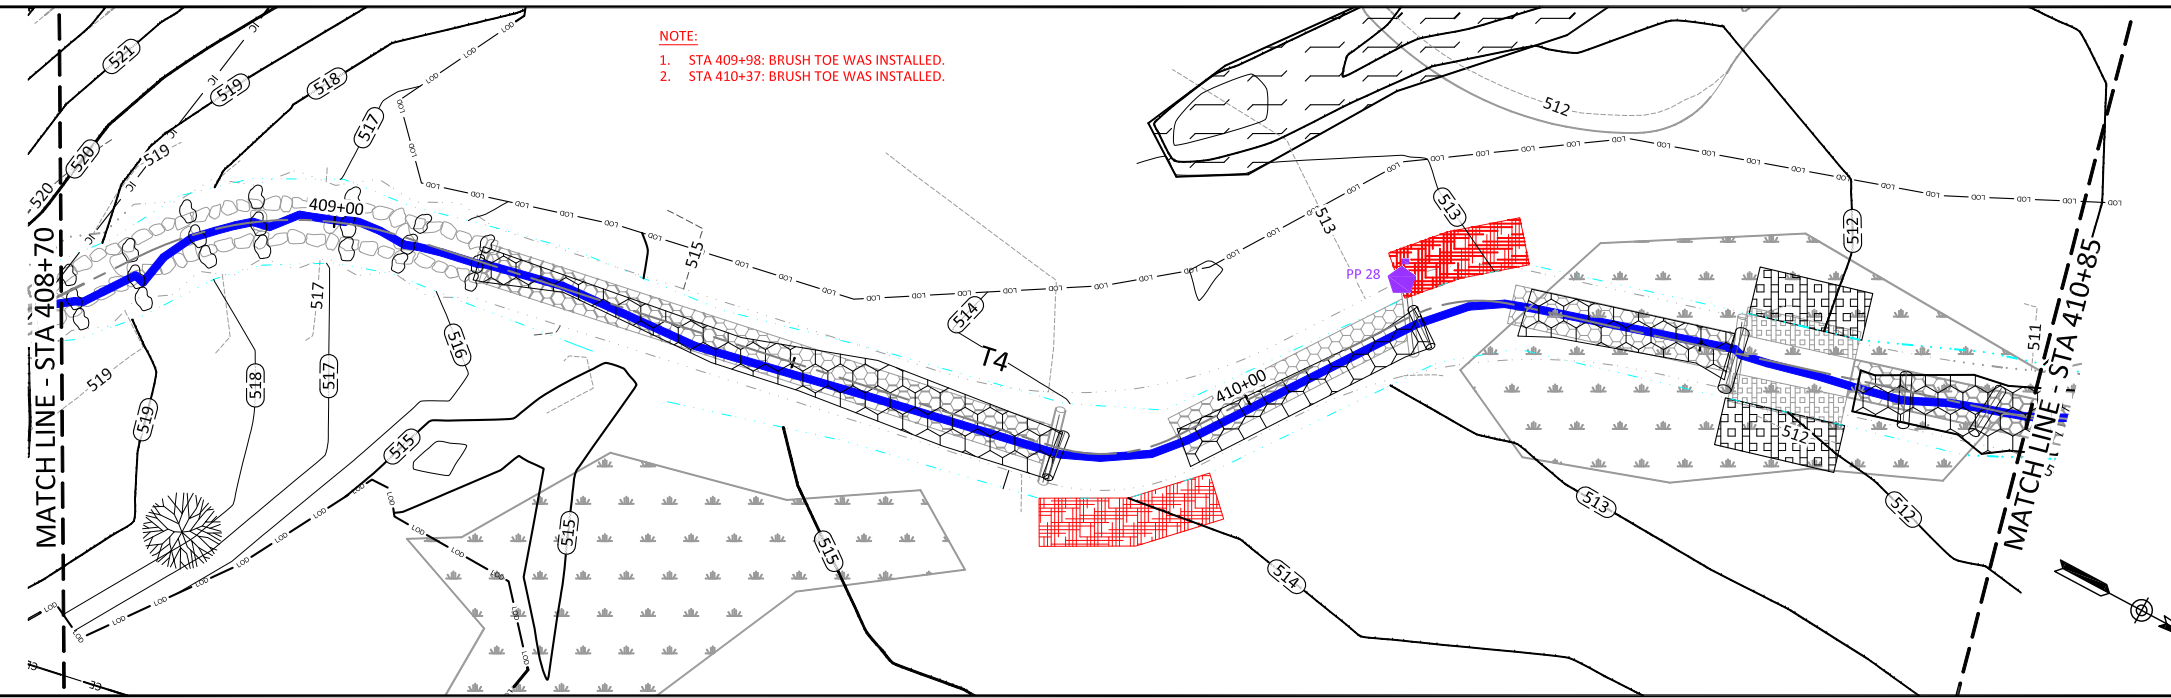
NOTE:
 1. STA 409+98: BRUSH TOE WAS INSTALLED.
 2. STA 410+37: BRUSH TOE WAS INSTALLED.

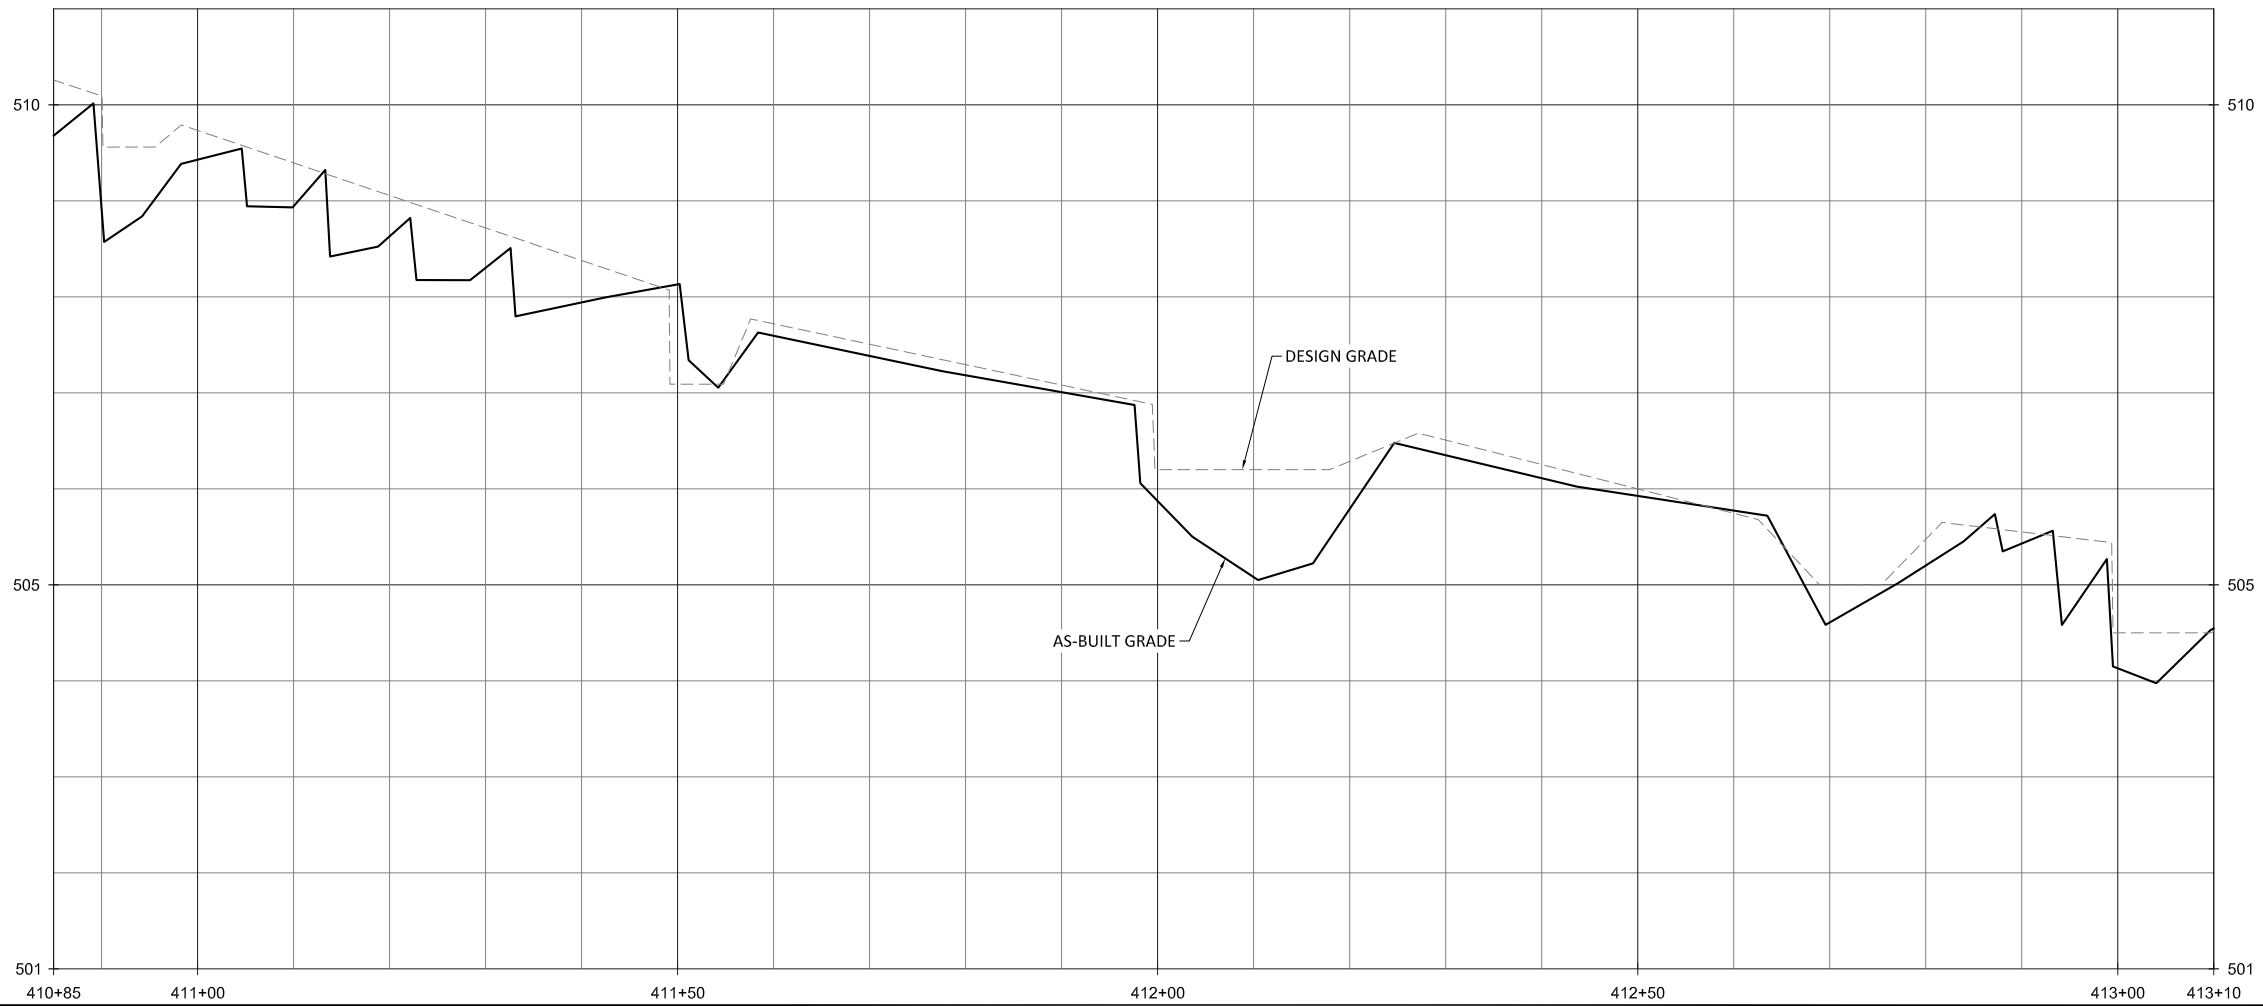
- NOTE:
1. STA 411+06: BRUSH TOE WAS INSTALLED.
 2. STA 411+98: LOG SILL WAS INSTALLED INSTEAD OF BOULDER SILL.
 3. STA 412+25: BRUSH TOE WAS INSTALLED.
 4. STA 413+19: BRUSH TOE WAS INSTALLED.

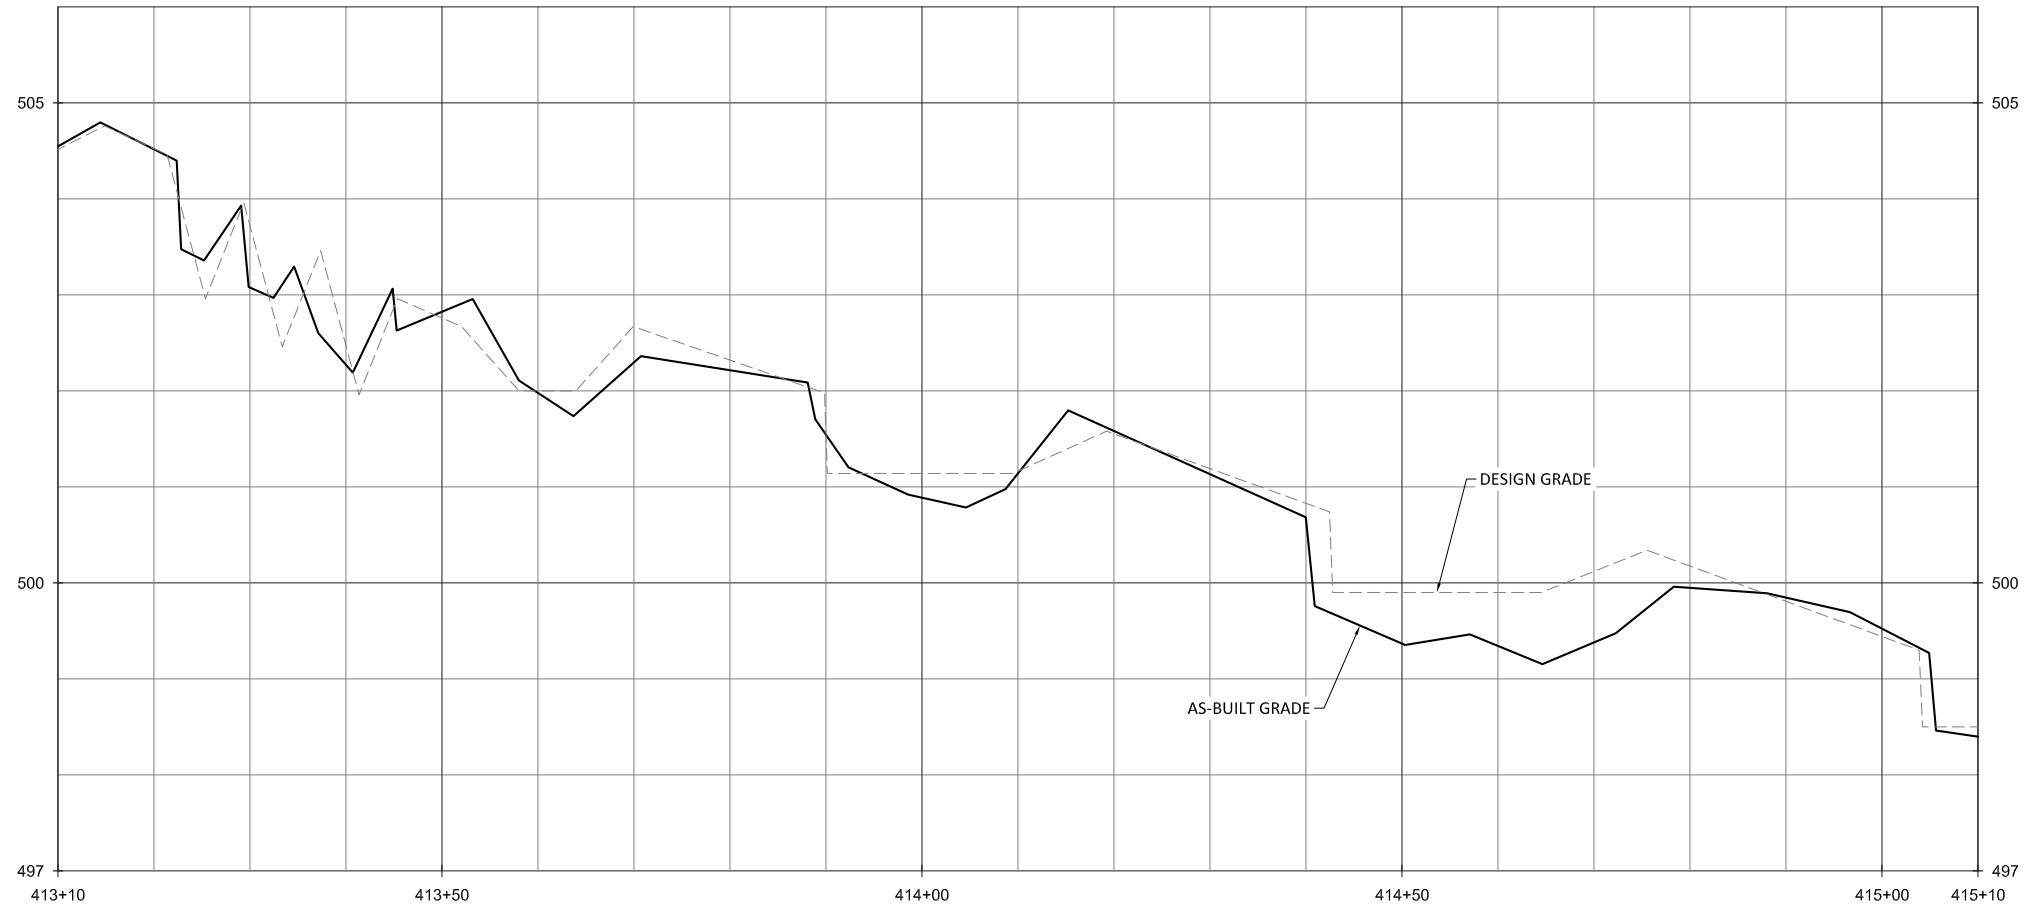
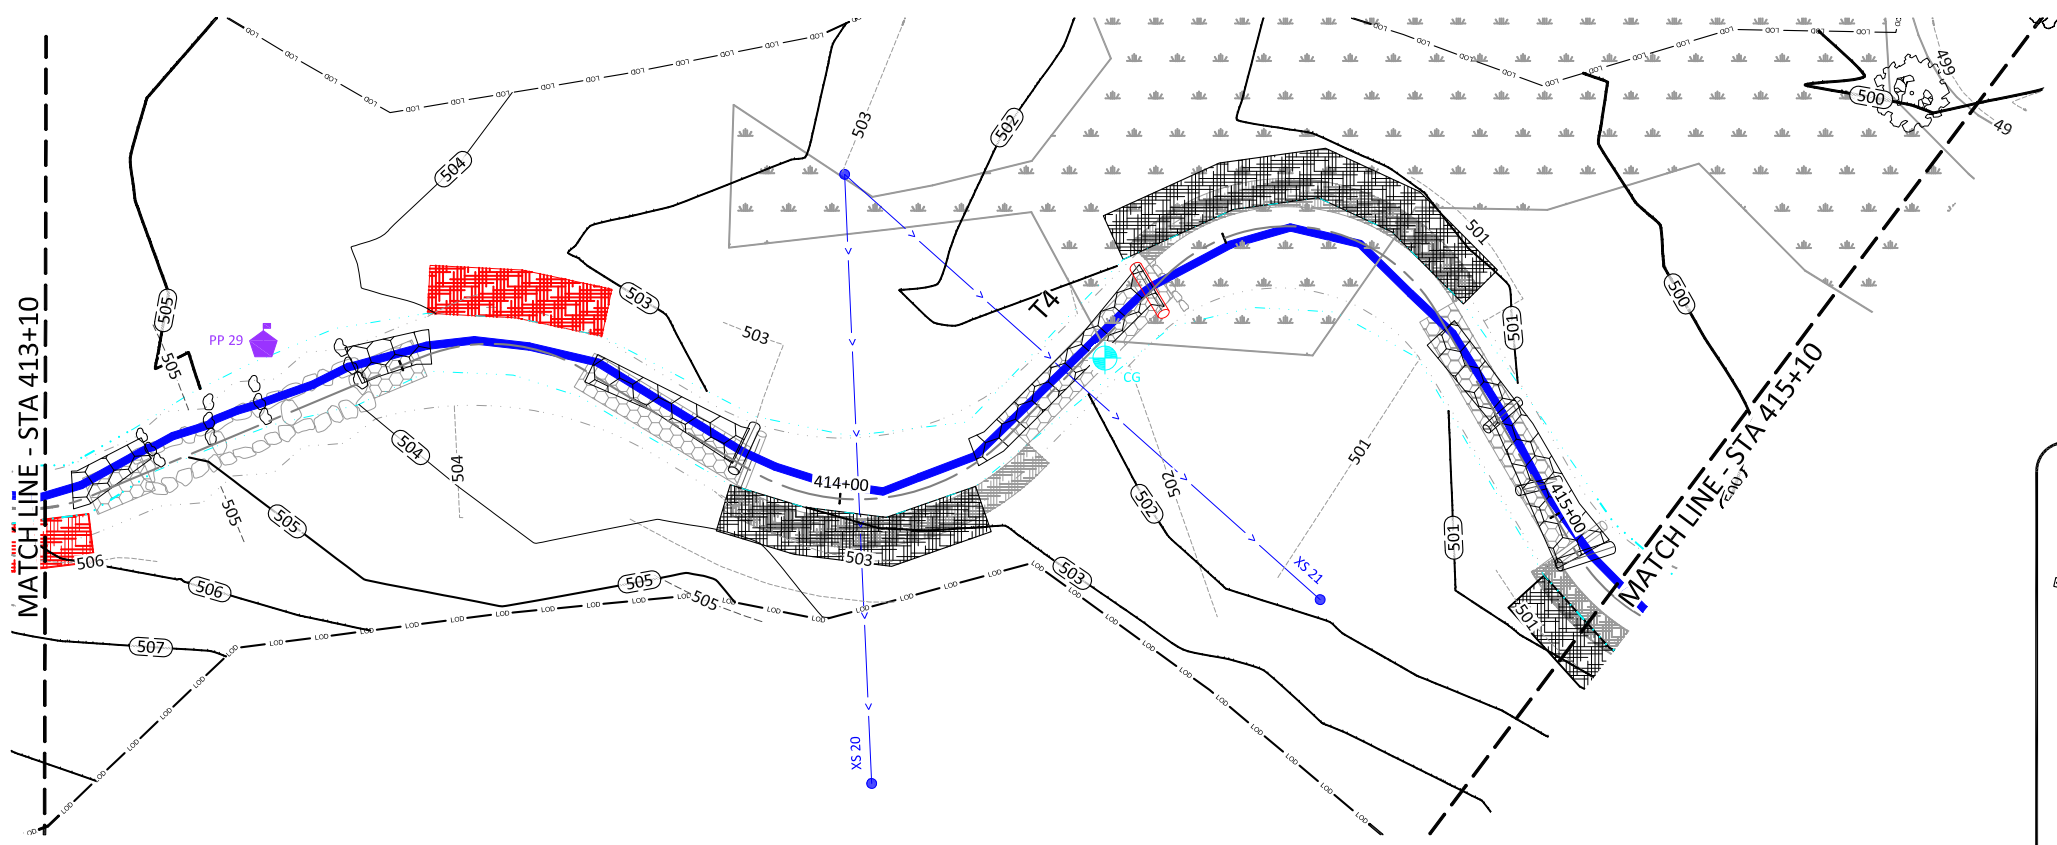
- NOTE:**
1. STA 413+75: BRUSH TOE WAS INSTALLED.
 2. STA 414+53: LOG SILL INSTALLED INSTEAD OF A BOULDER SILL.

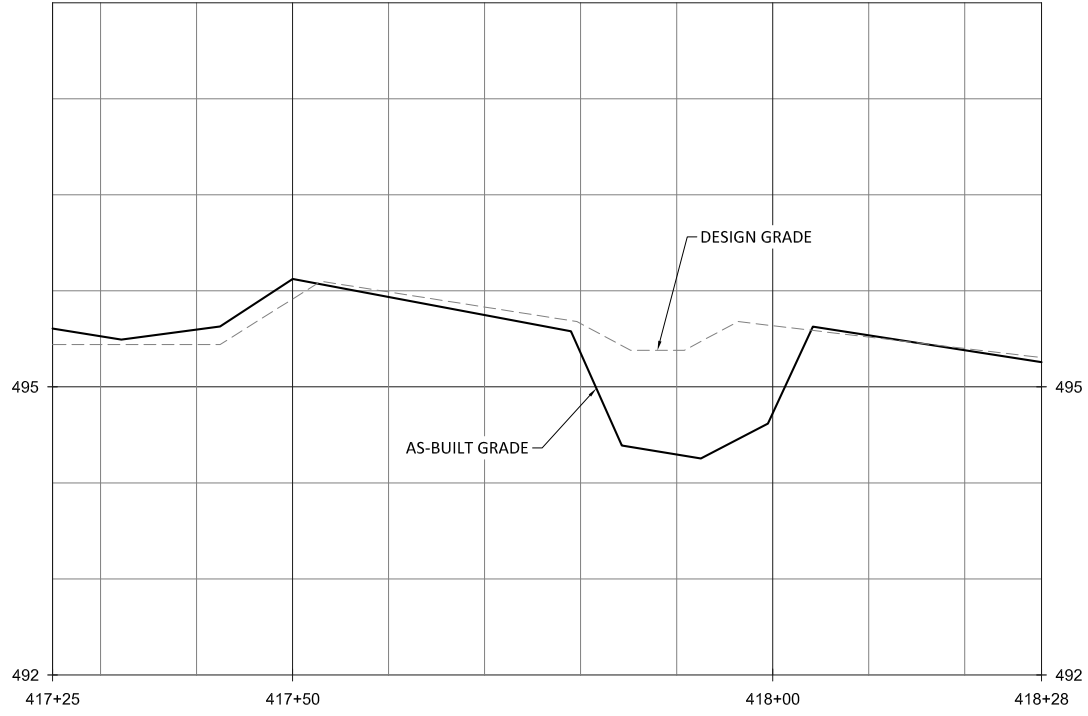
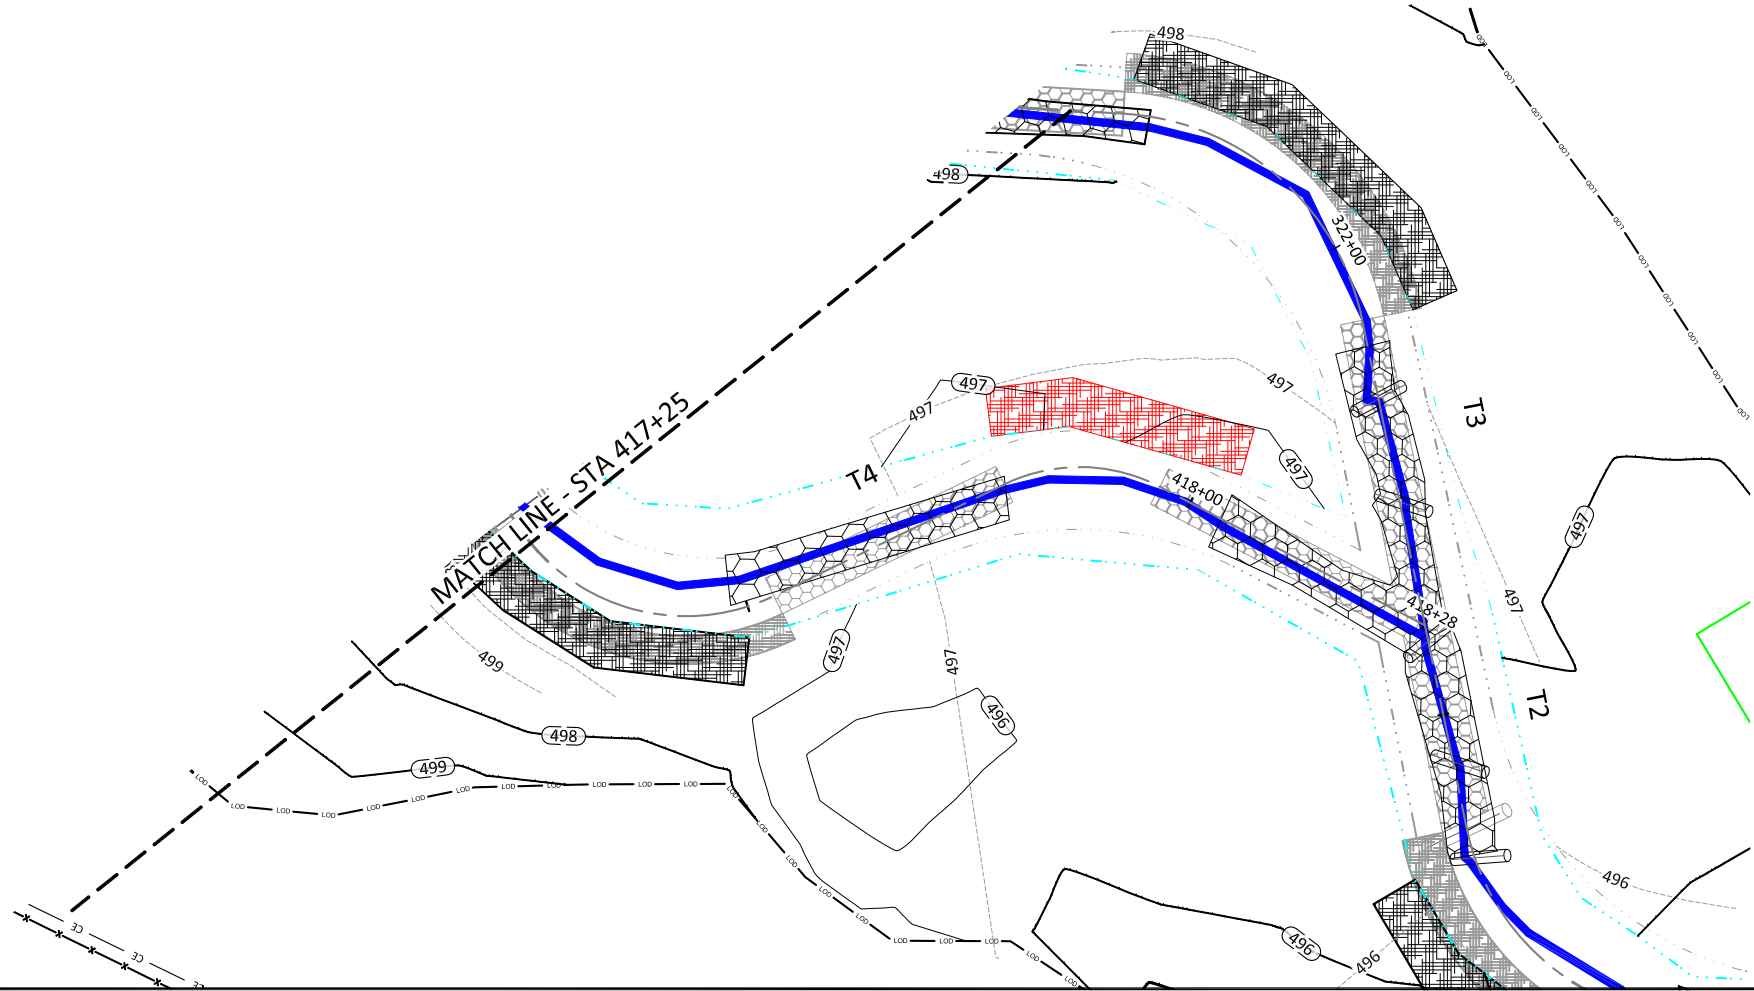
NOTE:
 1. STA 417+97: BRUSH TOE WAS INSTALLED.

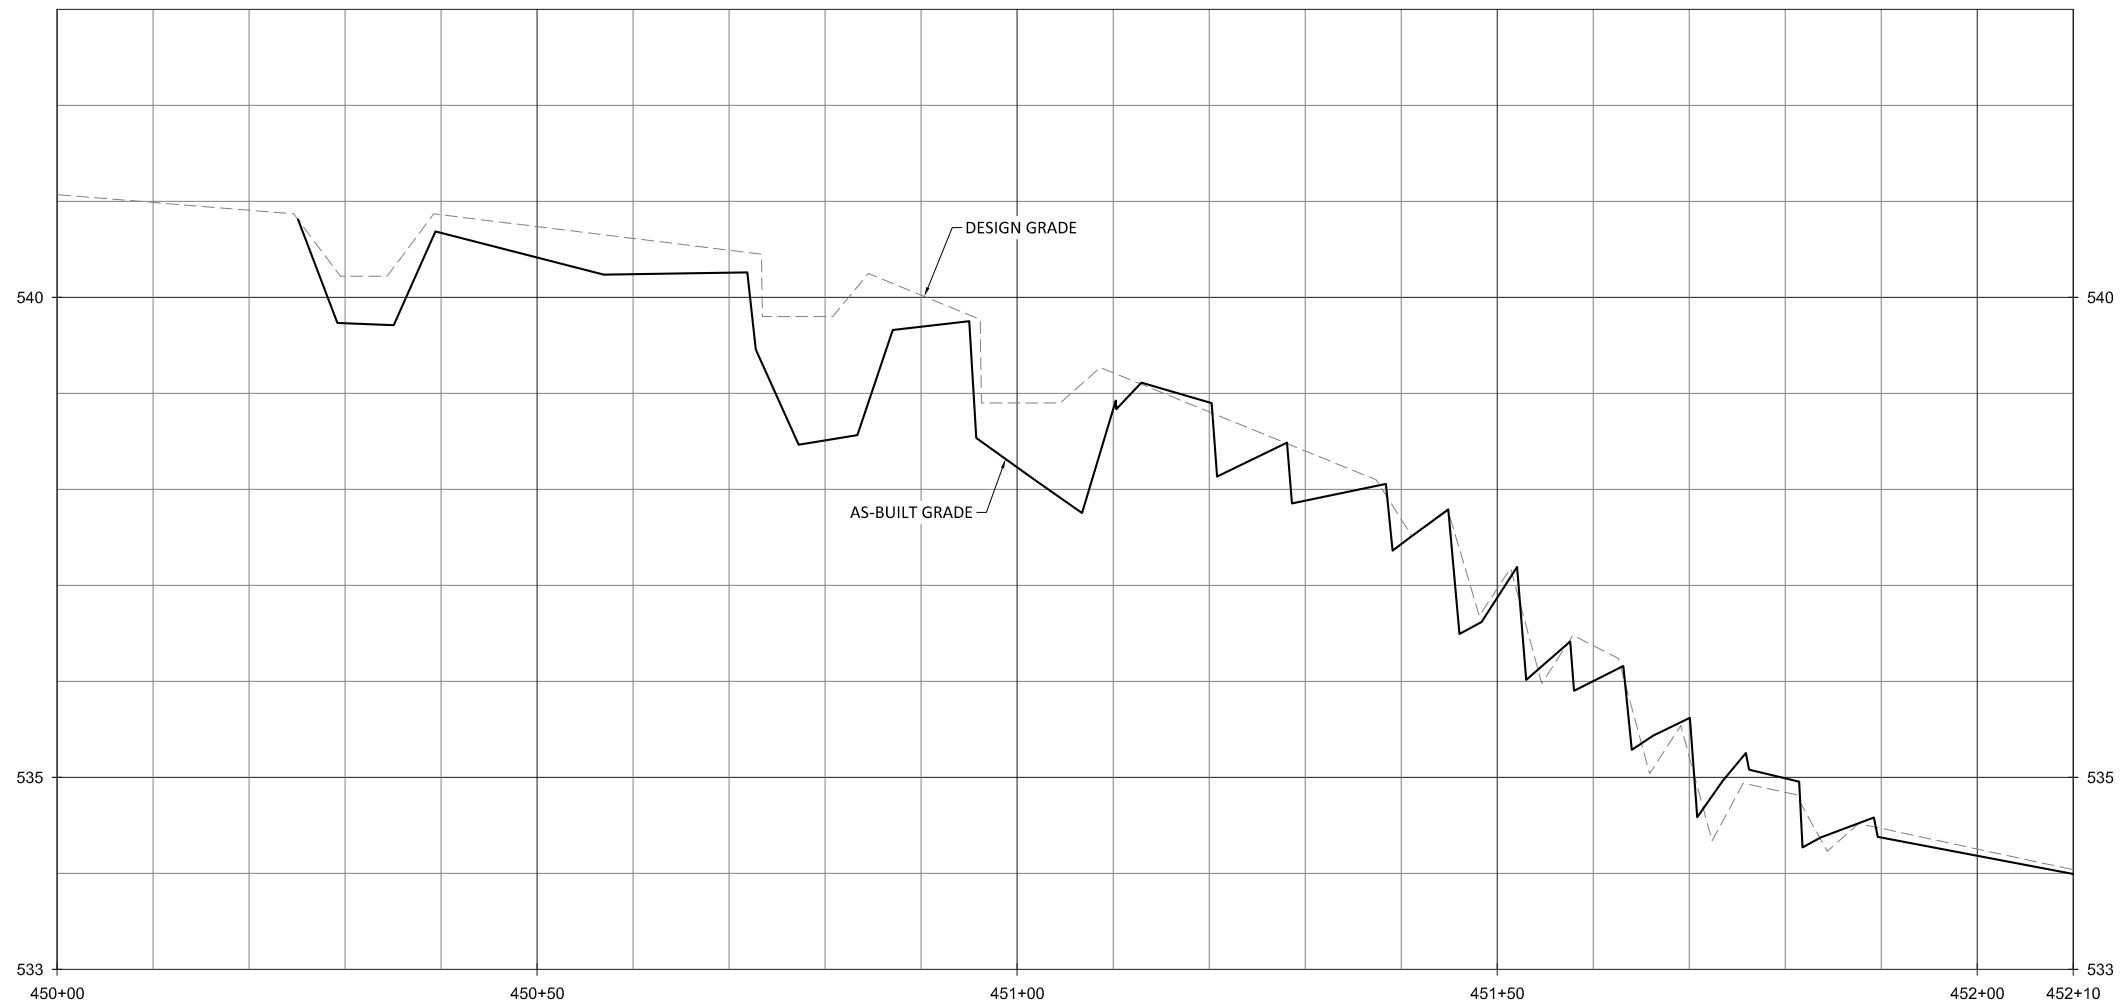
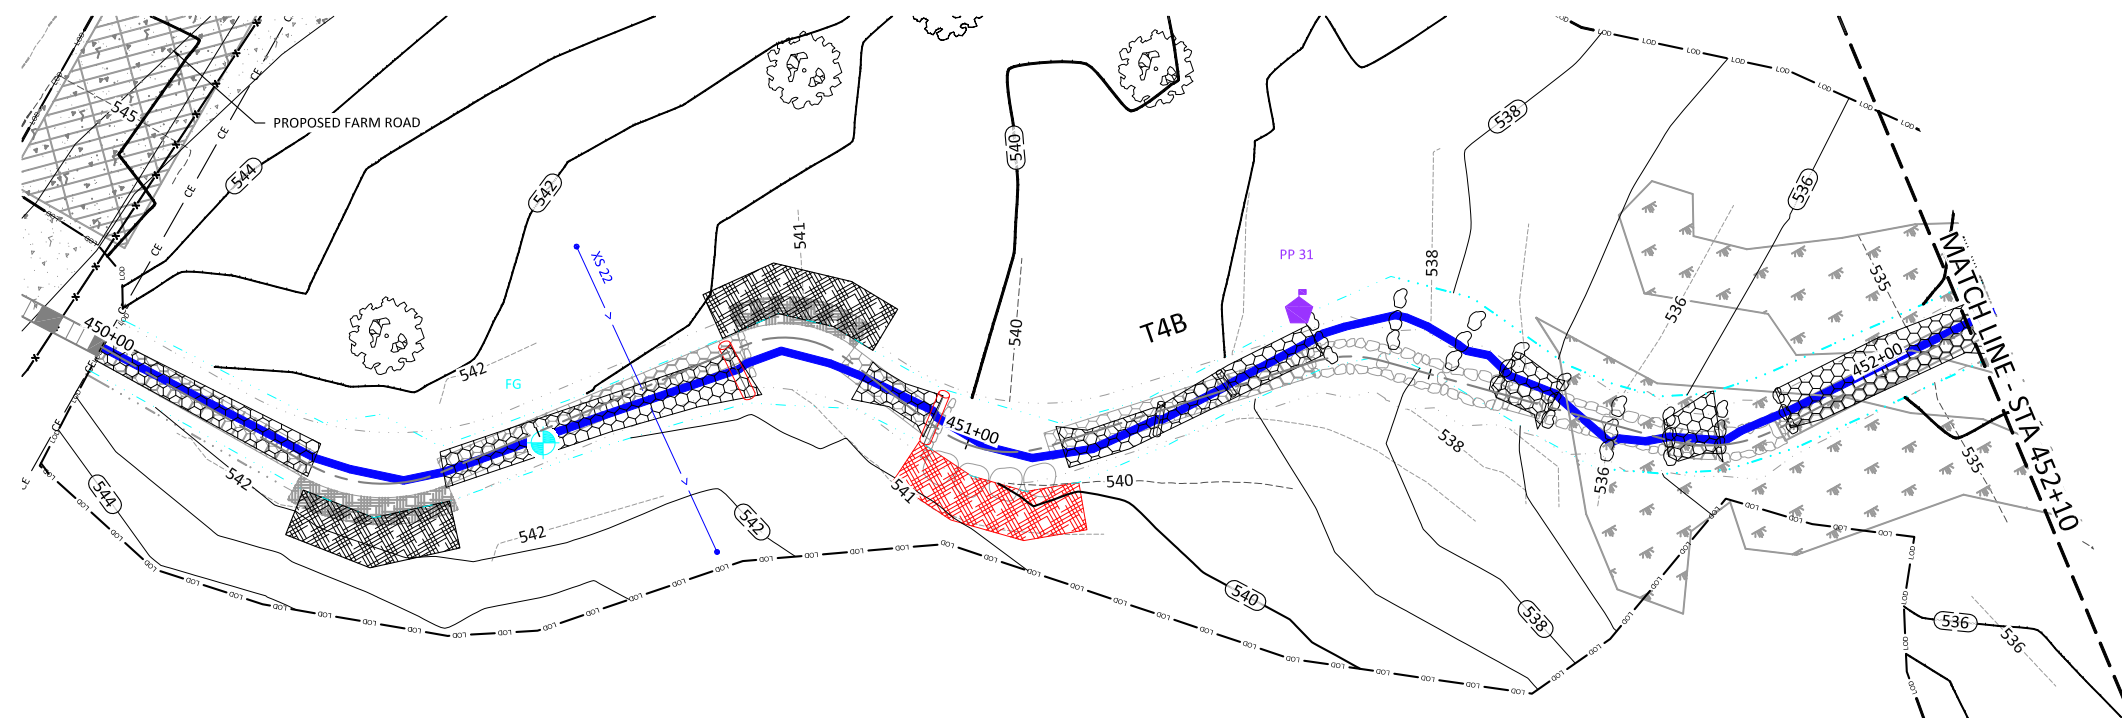
- NOTE:**
1. STA 450+71: LOG SILL WAS INSTALLED INSTEAD OF BOULDER SILL.
 2. STA 450+94: LOG SILL WAS INSTALLED INSTEAD OF BOULDER SILL.
 3. STA 451+02: BRUSH TOE WAS INSTALLED INSTEAD OF BOULDER TOE.

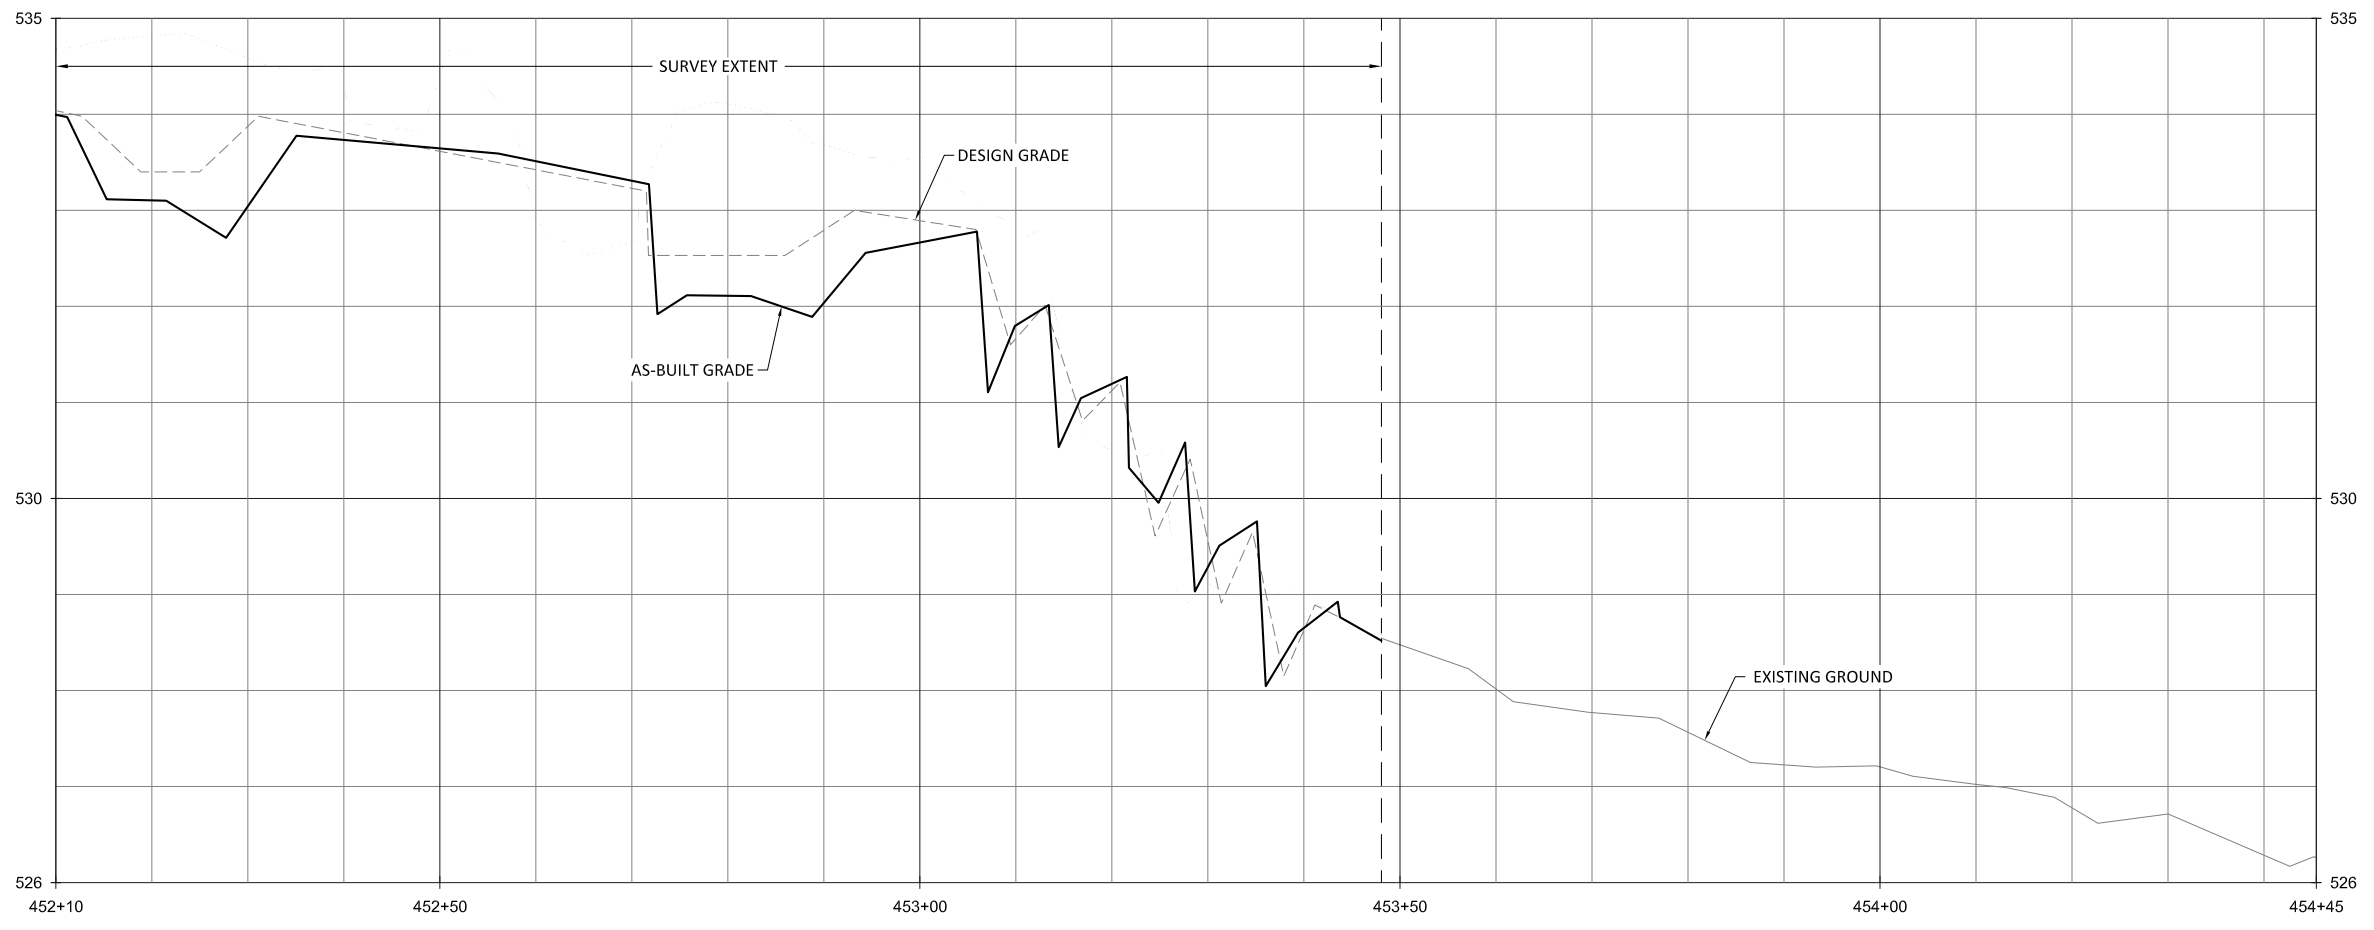
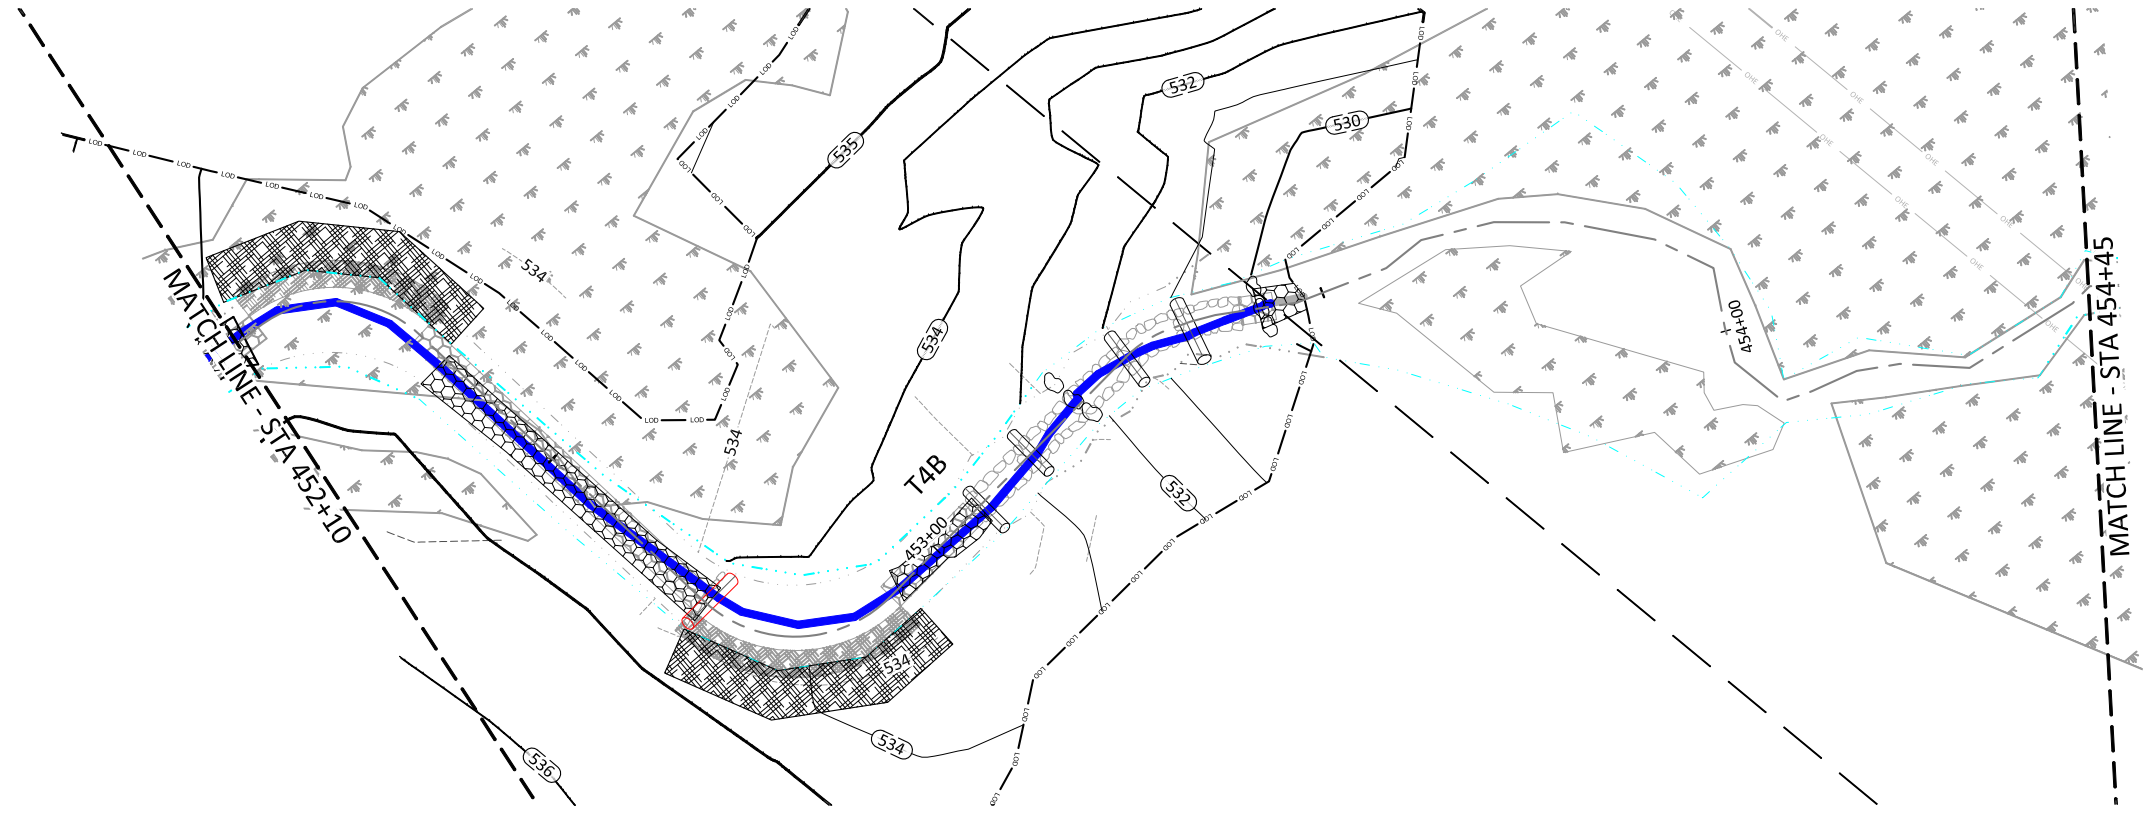
NOTE:
 1. STA 452+75: LOG SILL WAS INSTALLED INSTEAD OF BOULDER SILL.

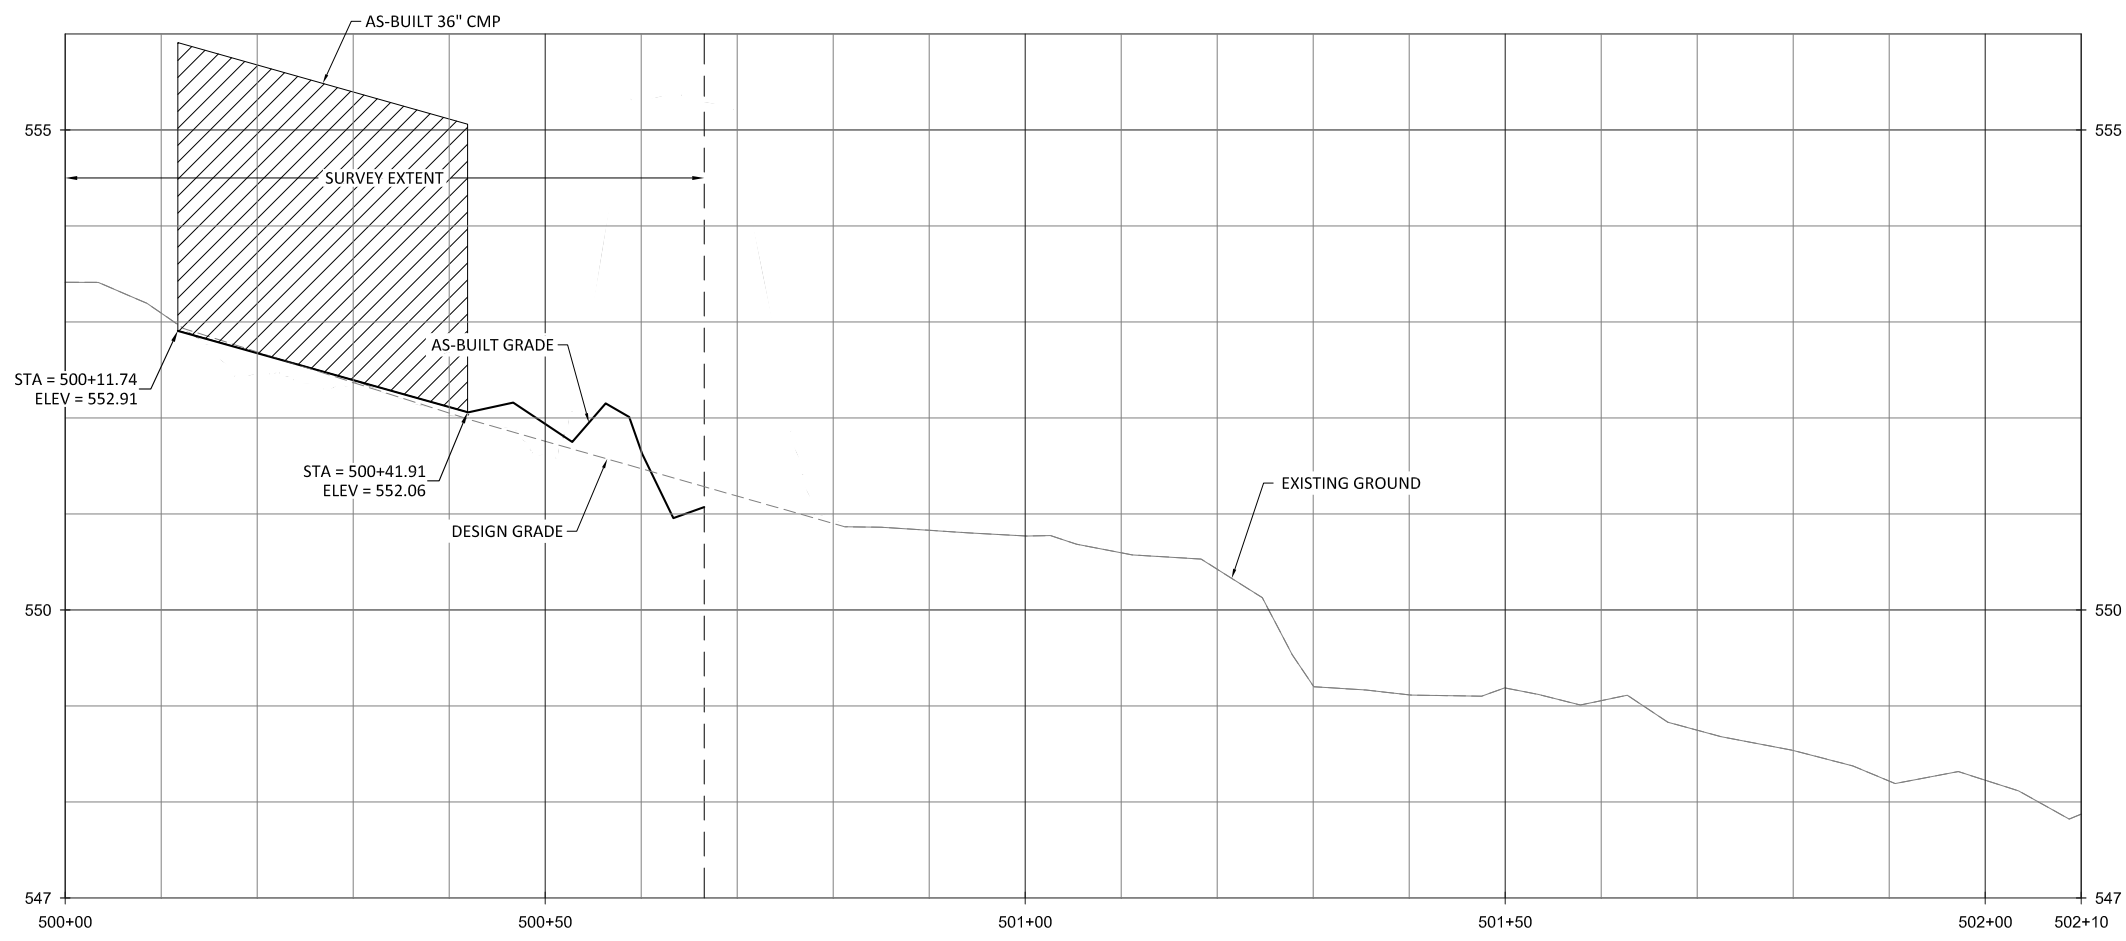
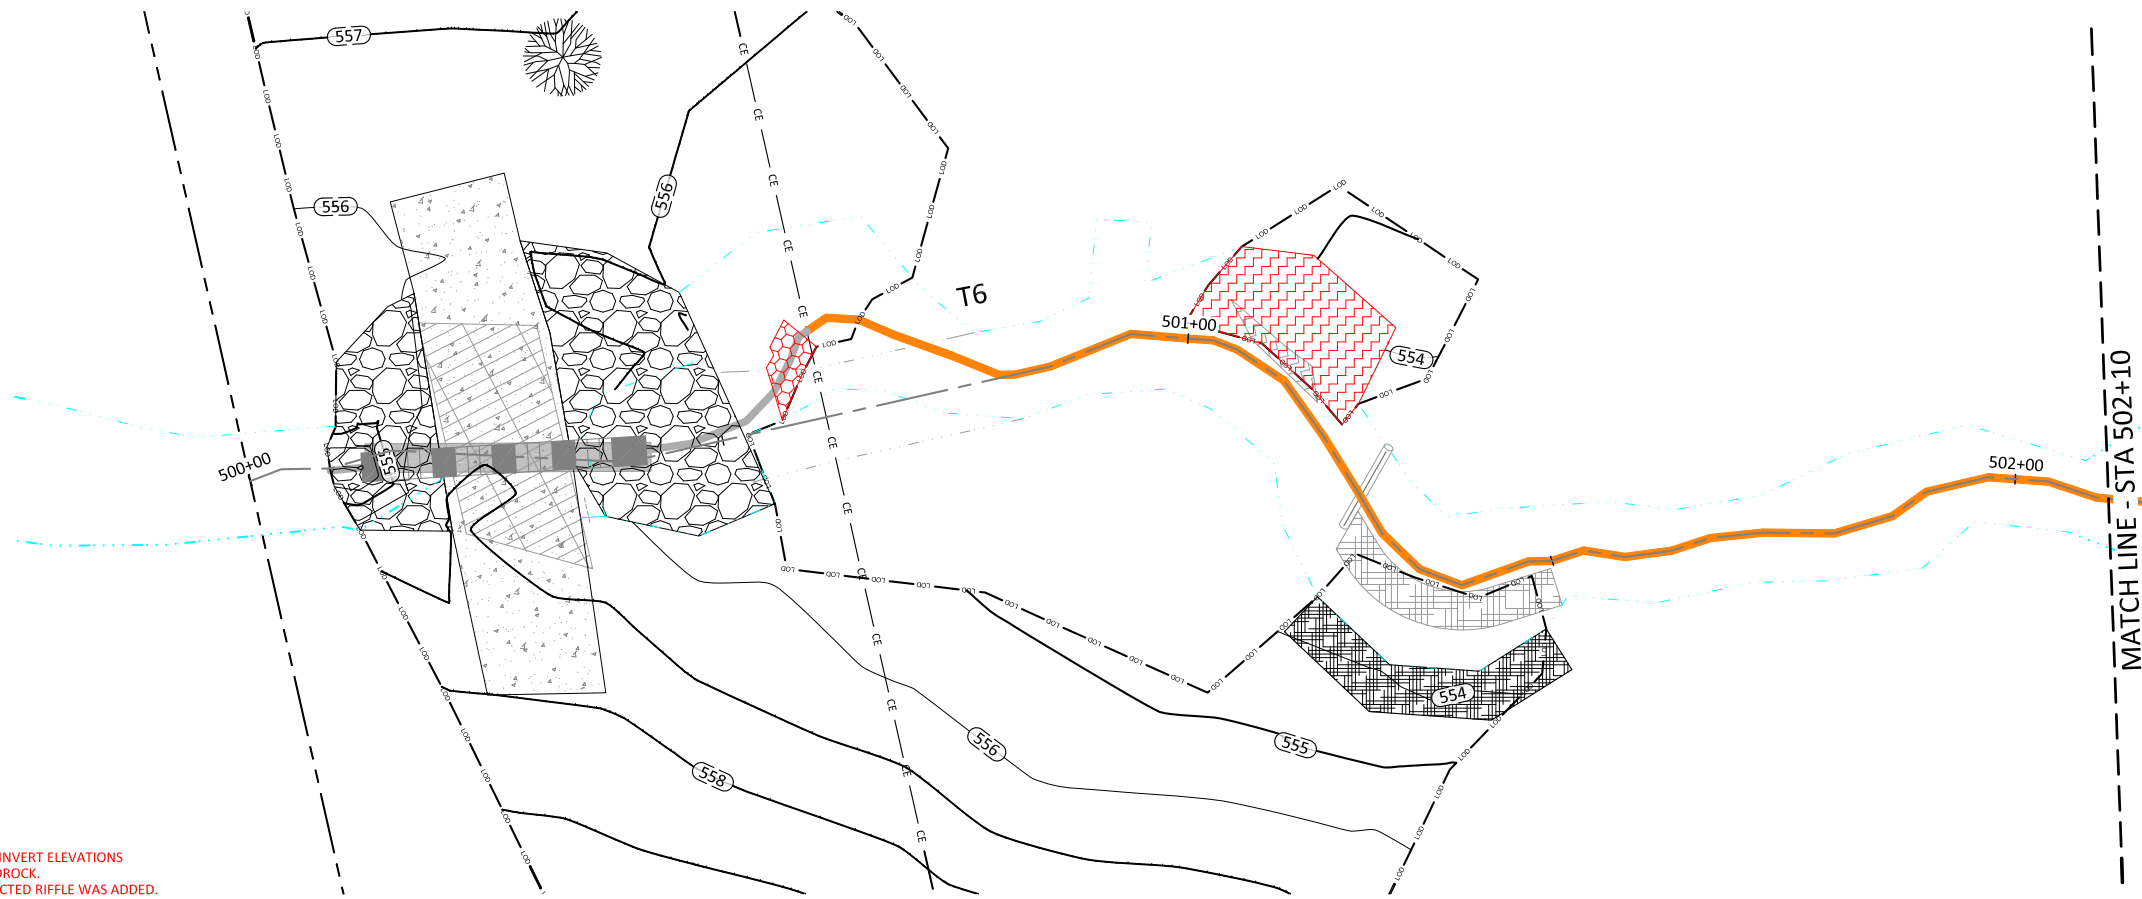
- NOTE:**
1. STA 500+27: CULVERT INVERT ELEVATIONS ADJUSTED DUE TO BEDROCK.
 2. STA 500+59: CONSTRUCTED RIFFLE WAS ADDED.
 3. STA 501+25: LOG SILL NOT INSTALLED DUE TO BEDROCK.
