**BASELINE MONITORING
DOCUMENT AND AS-BUILT
BASELINE REPORT
FINAL**

BUCKWATER MITIGATION SITE

Orange County, NC

DMS Project Number 97084

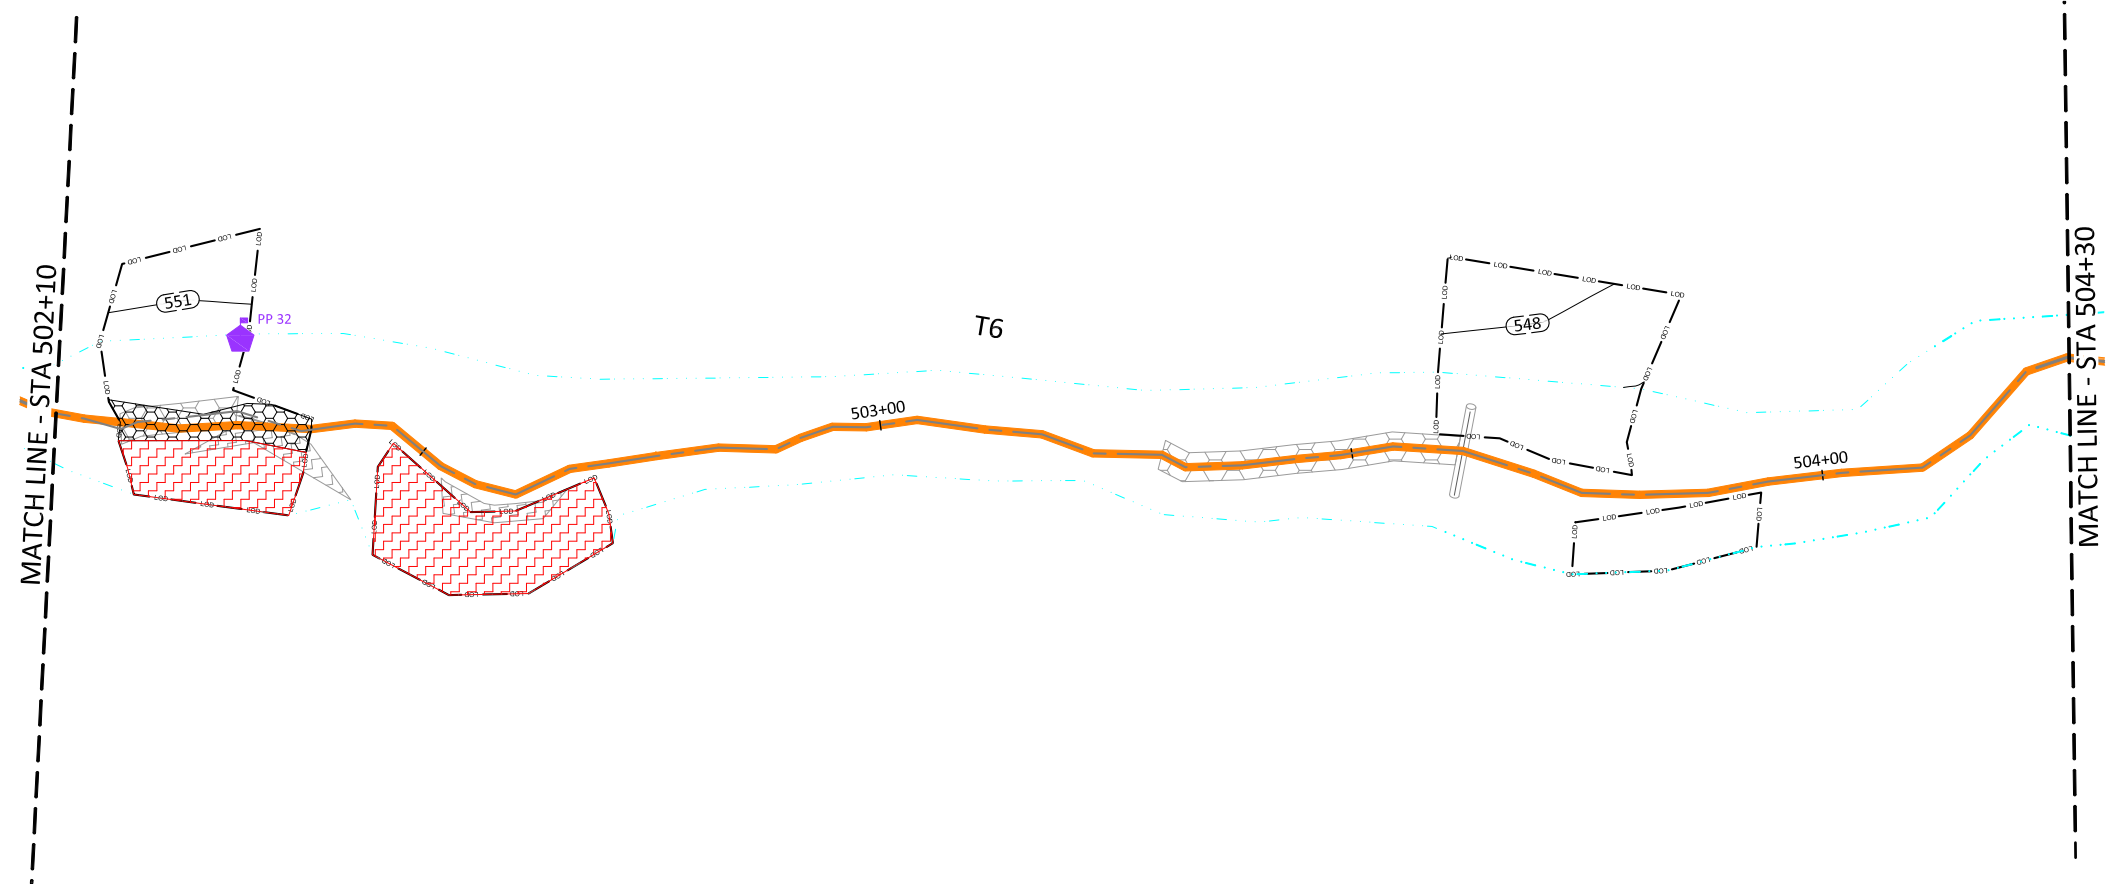
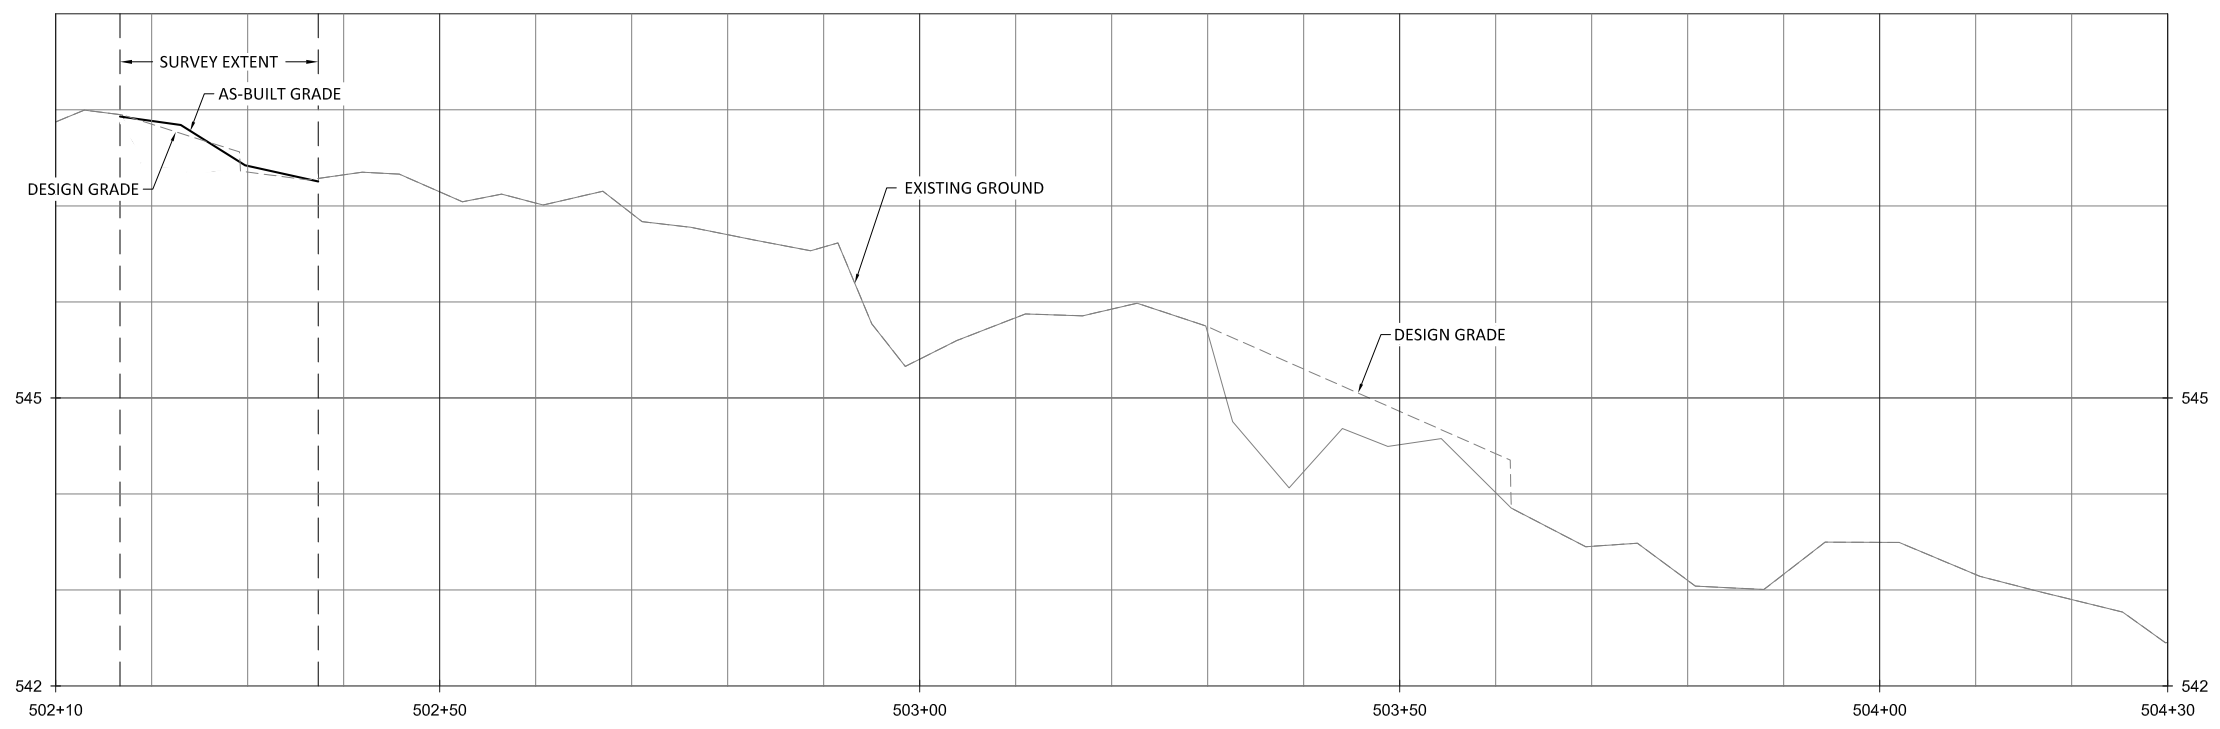
NOTE:
 1. STA 503+44: RIFFLE AND LOG SILL NOT INSTALLED DUE TO BEDROCK.

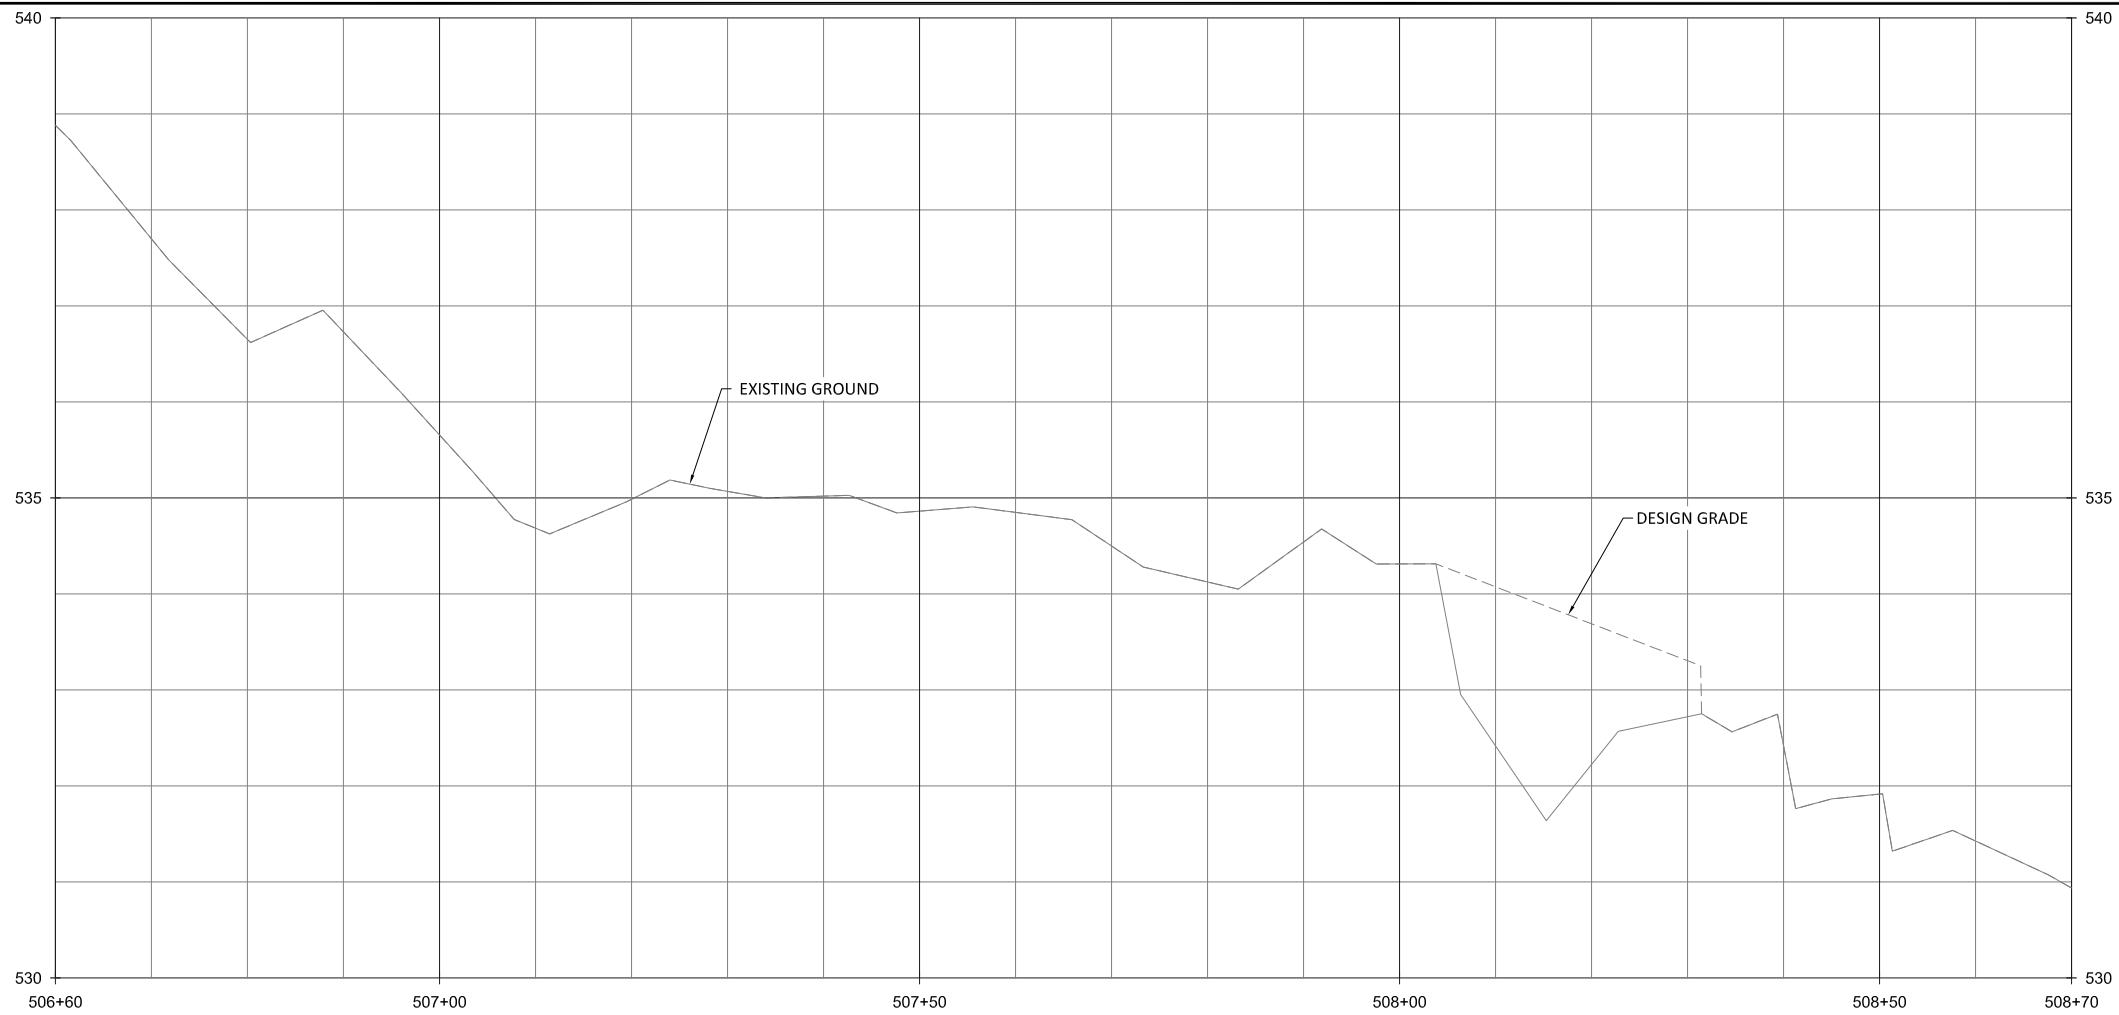
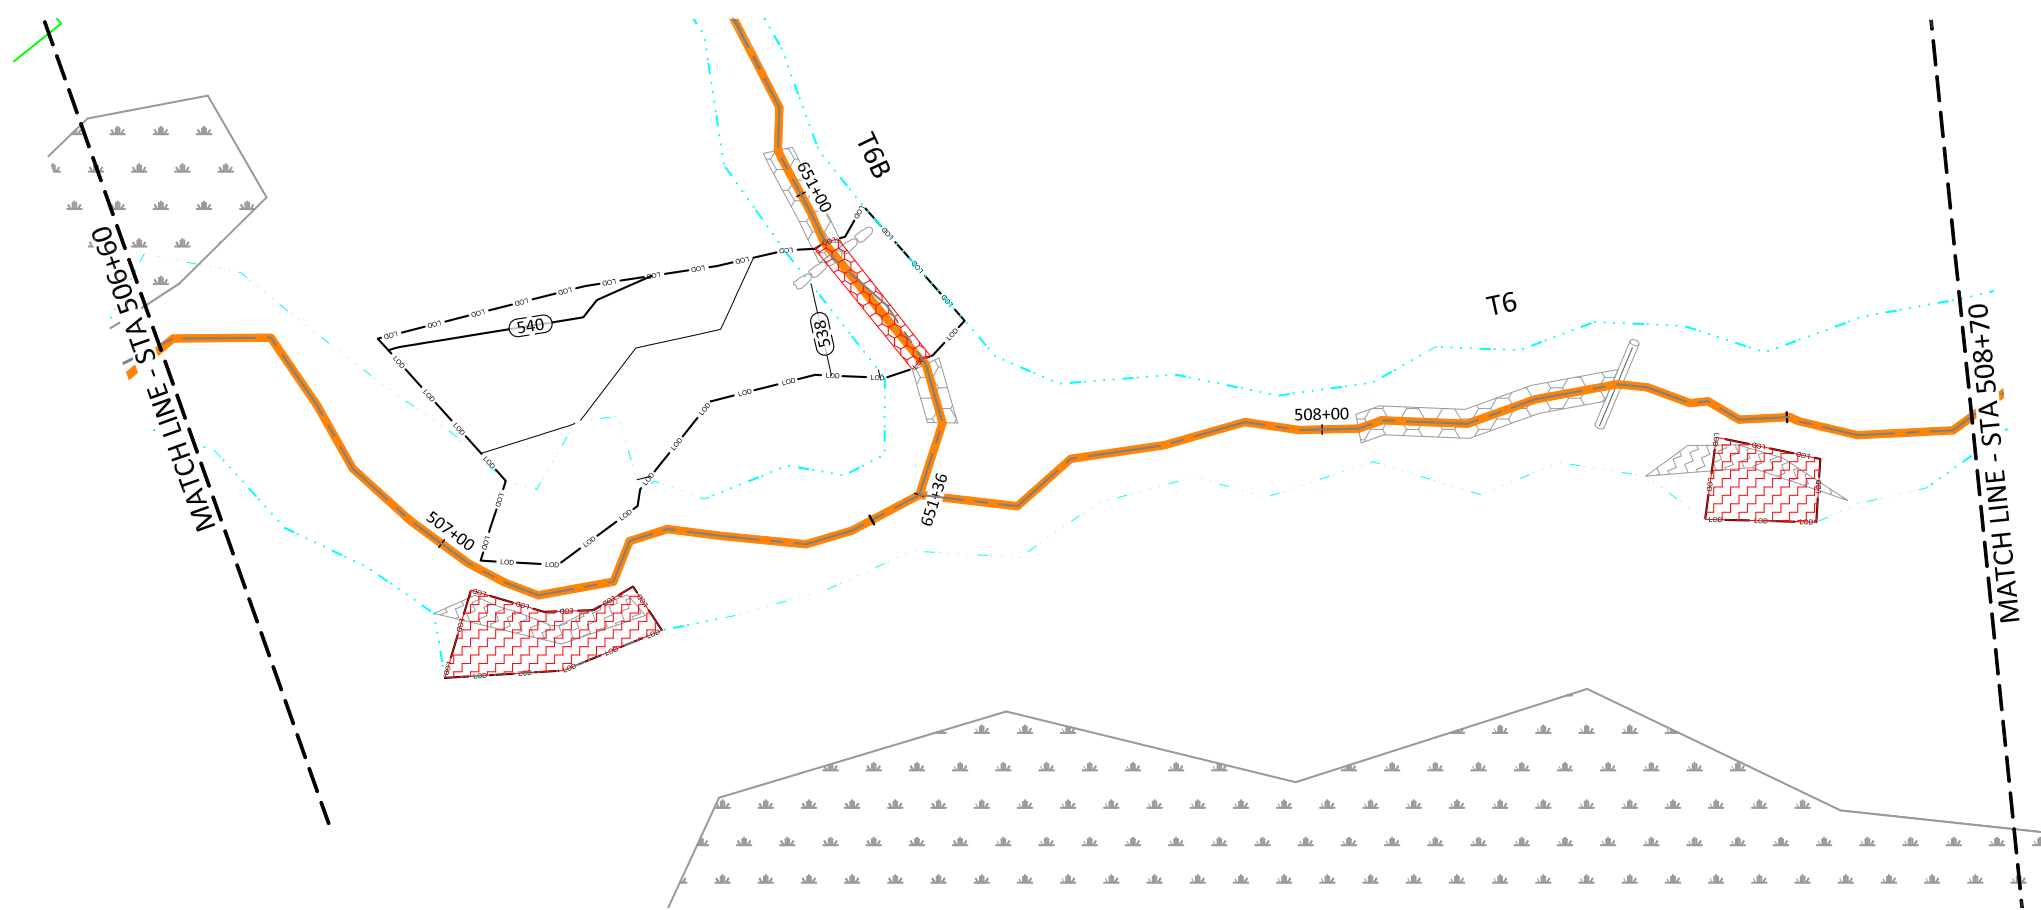
NOTE:
 1. STA 508+17: RIFFLE AND LOG SILL NOT INSTALLED DUE TO BEDROCK.

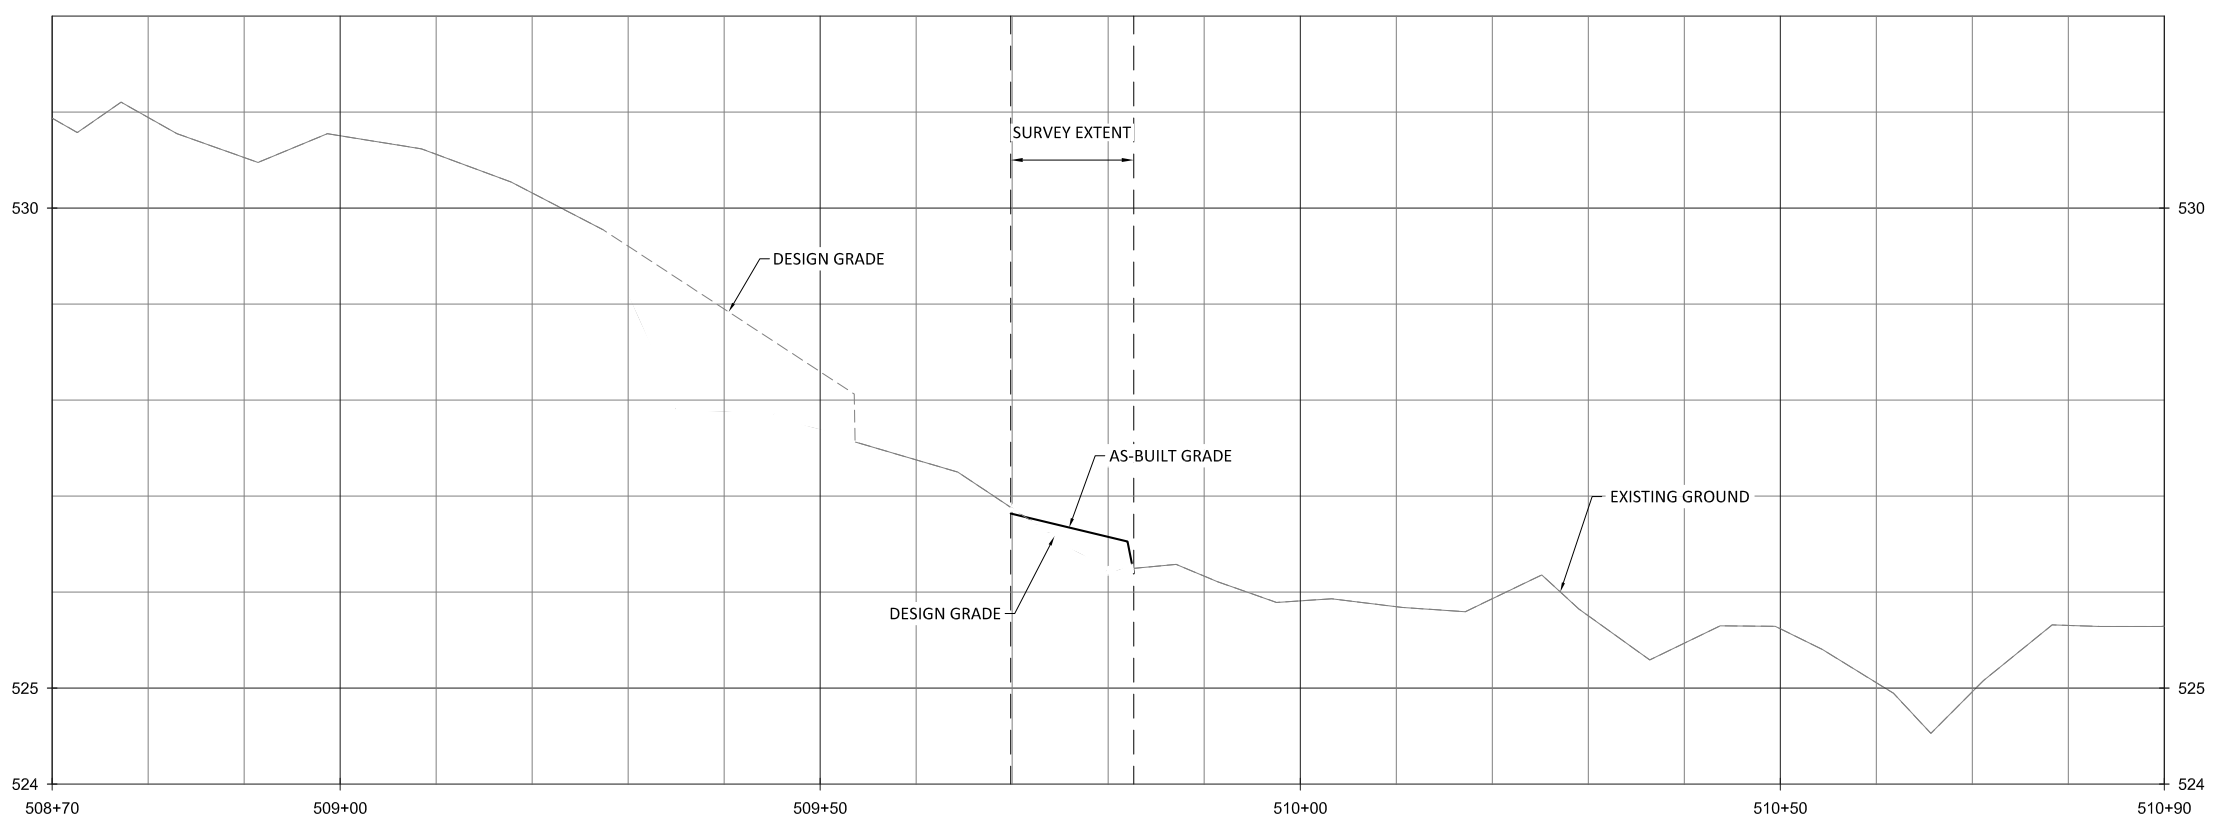
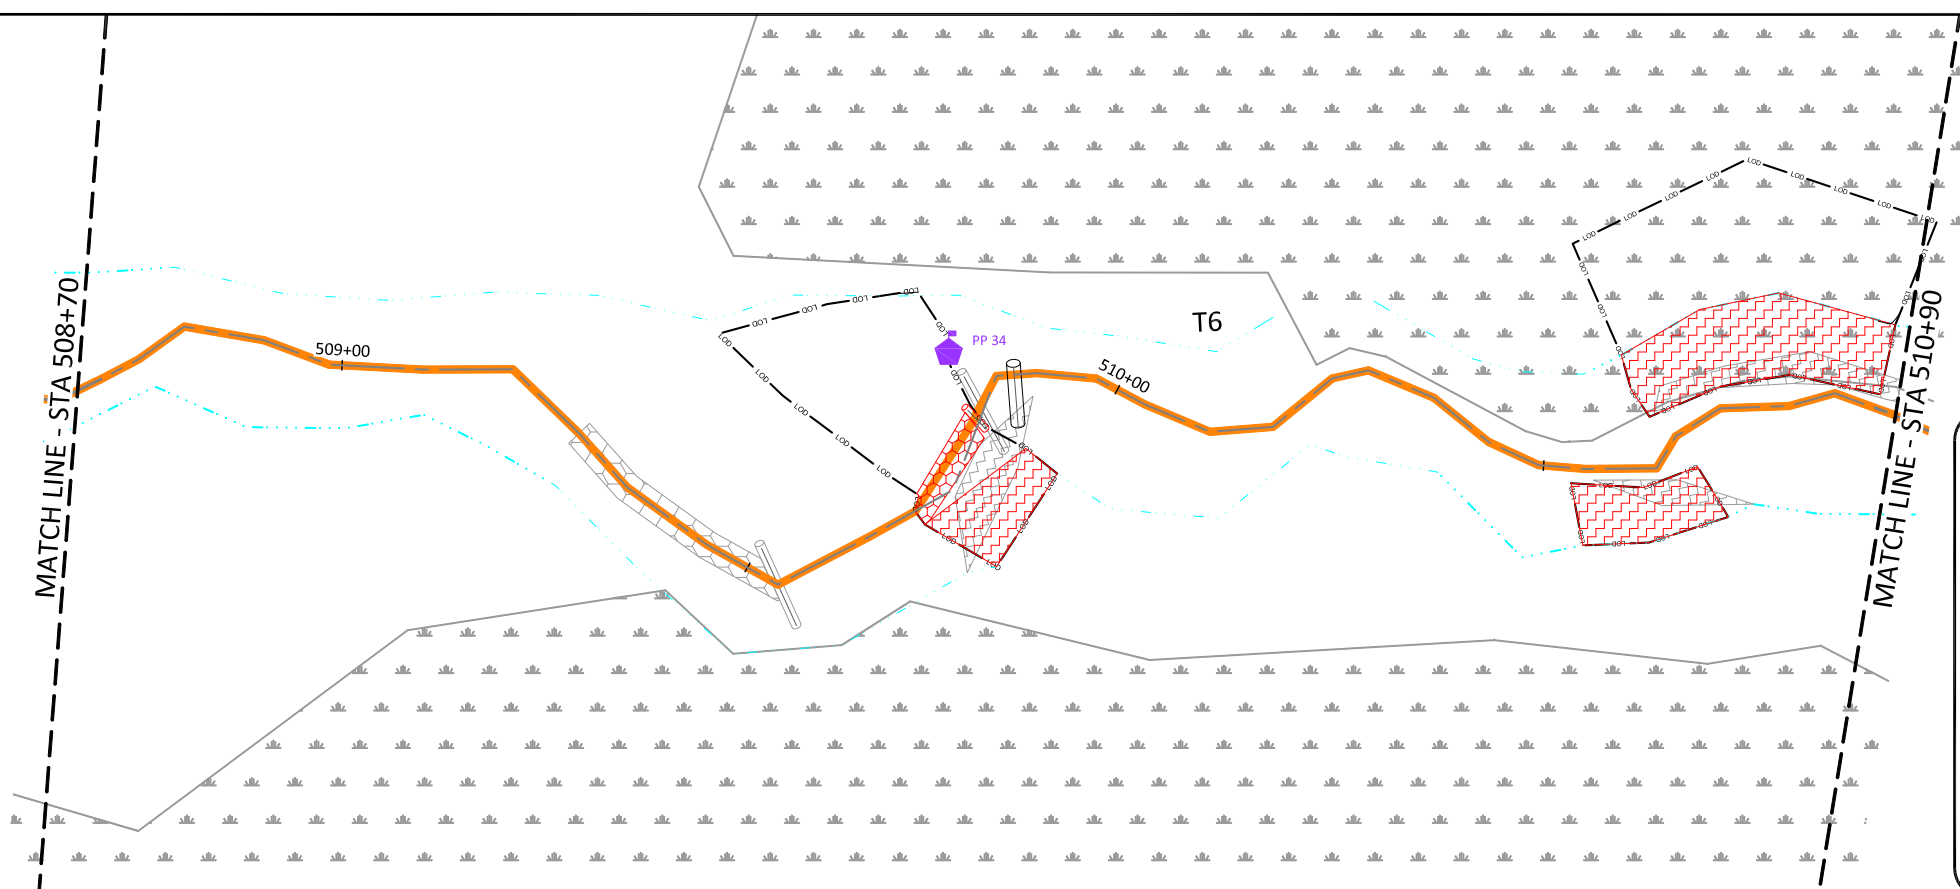
- NOTE:**
1. STA 509+40: RIFFLE AND LOG SILL NOT INSTALLED DUE TO BEDROCK.
 2. STA 509+76: RIFFLE AND LOG SILL WAS ADDED.

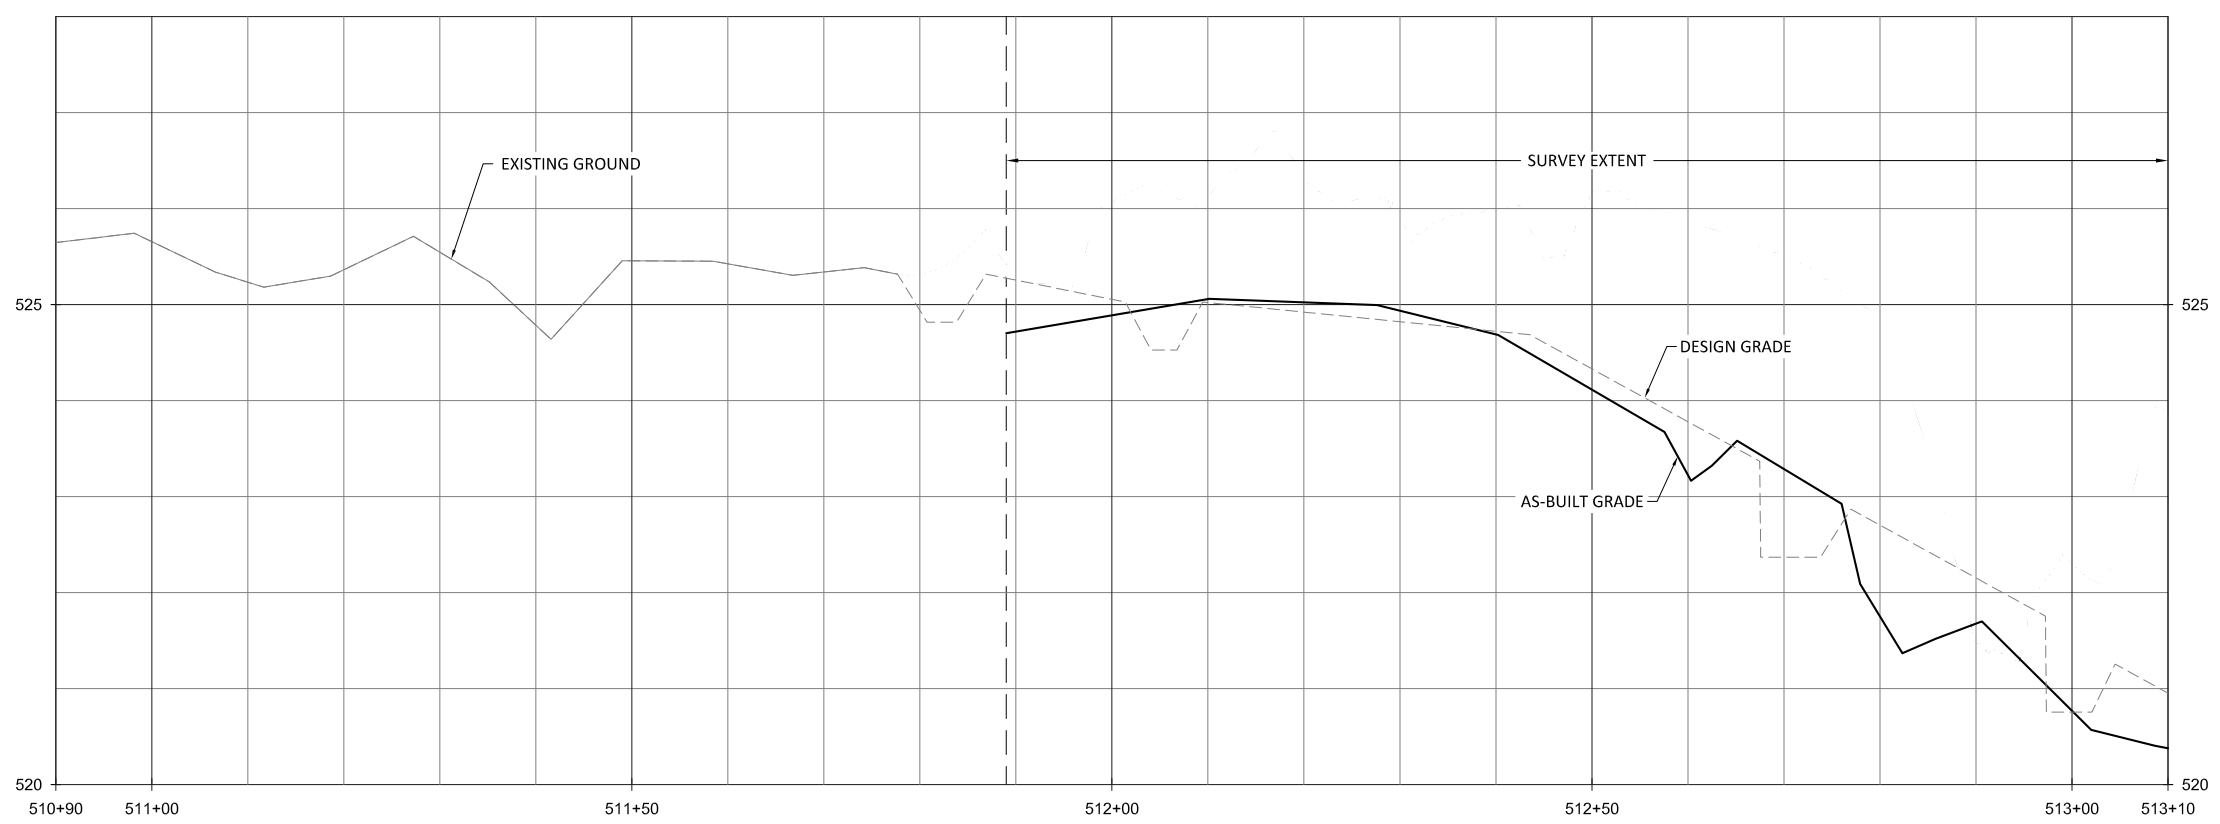
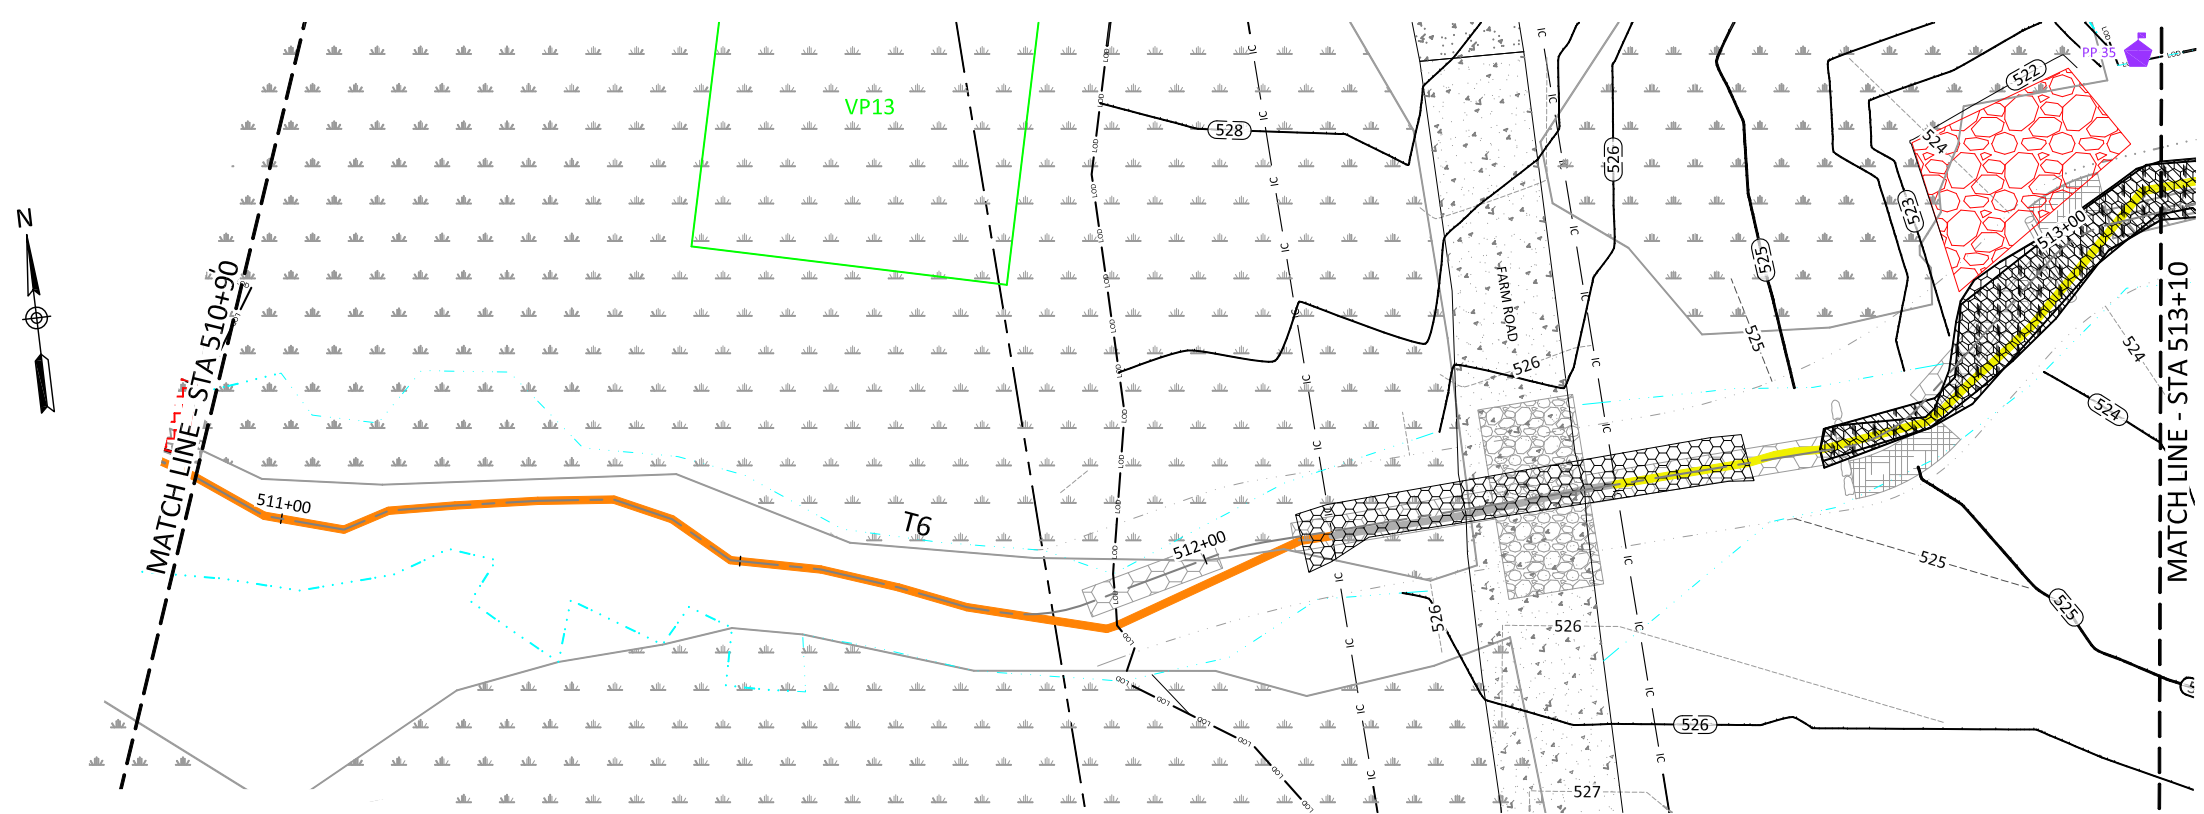
1.46

- NOTE:**
1. STA 511+94: RIFLE WAS NOT INSTALLED DUE TO FIELD CONDITIONS.
 2. STA 512+72: BOULDER SILL AND BRUSH TOE WERE NOT ADDED DUE TO BEDROCK.
 3. STA 512+97: LOG SILL NOT ADDED DUE TO BEDROCK.
 4. STA 513+00: RIPRAP ADDED.

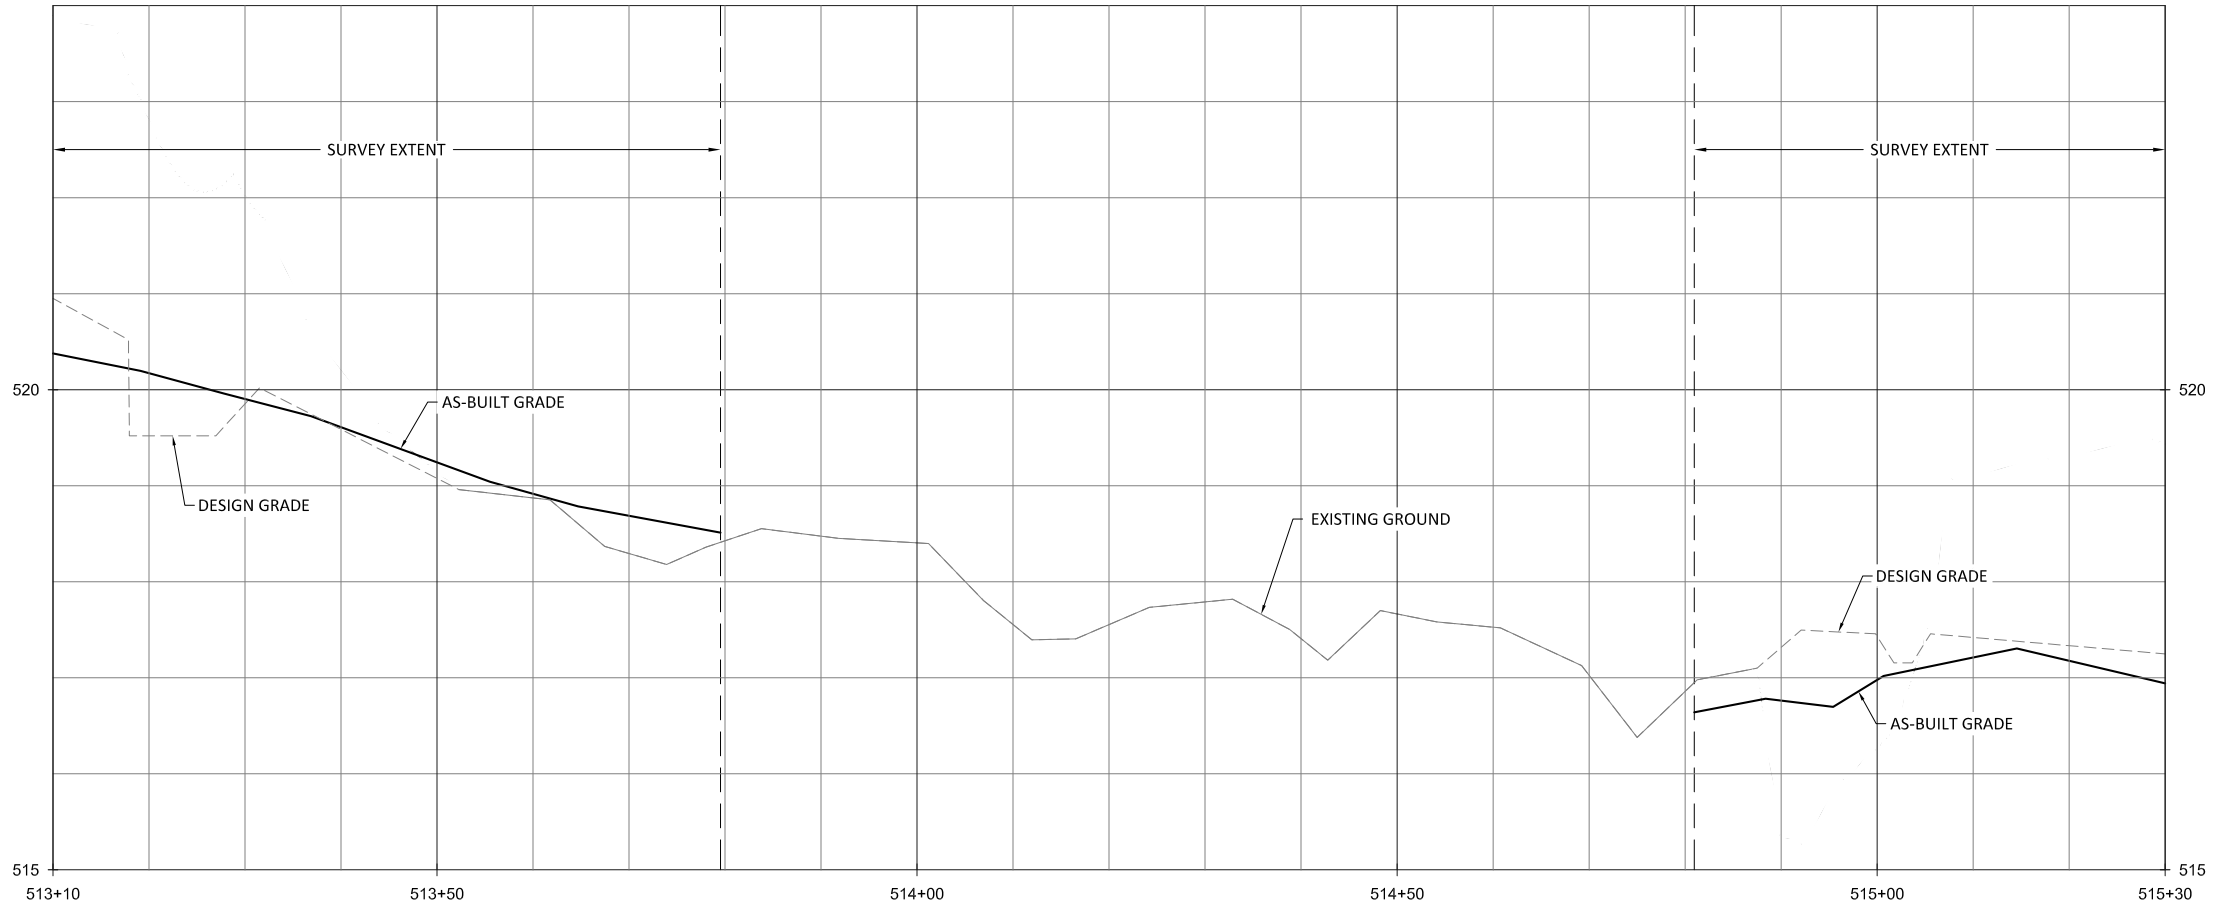
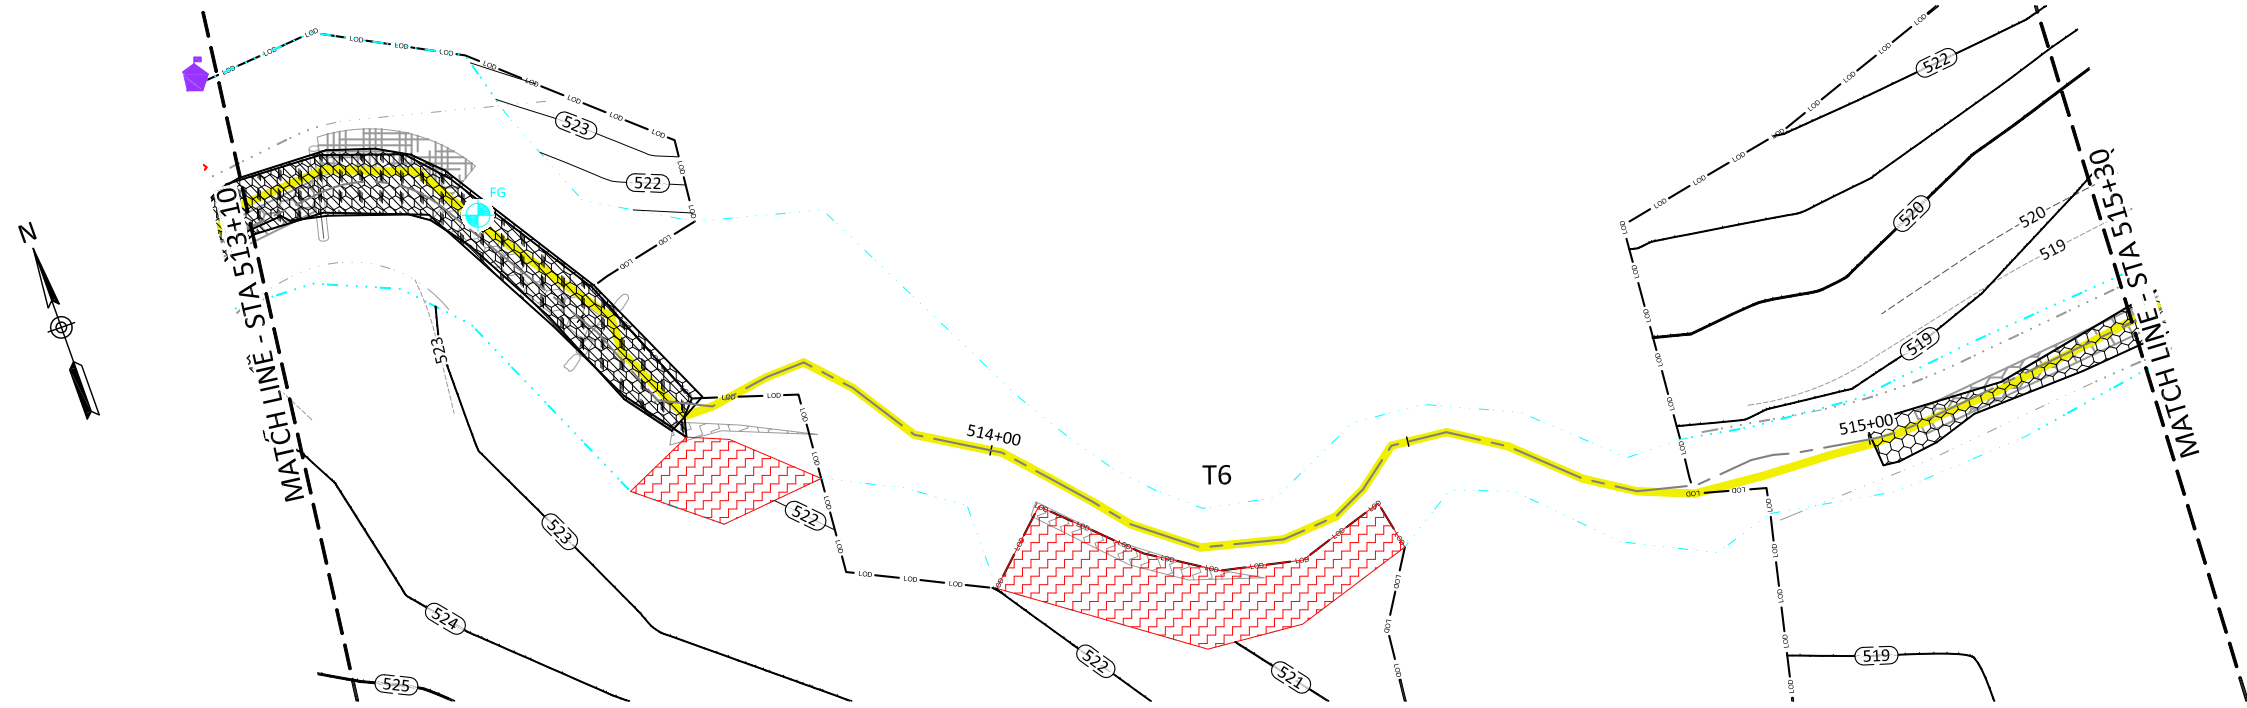
- NOTE:**
1. STA 513+18: LOG SILL NOT INSTALLED DUE TO BEDROCK.
 2. STA 513+26: BRUSH TOE NOT INSTALLED DUE TO BEDROCK.
 3. STA 513+52: BOULDER SILL NOT INSTALLED DUE TO BEDROCK.

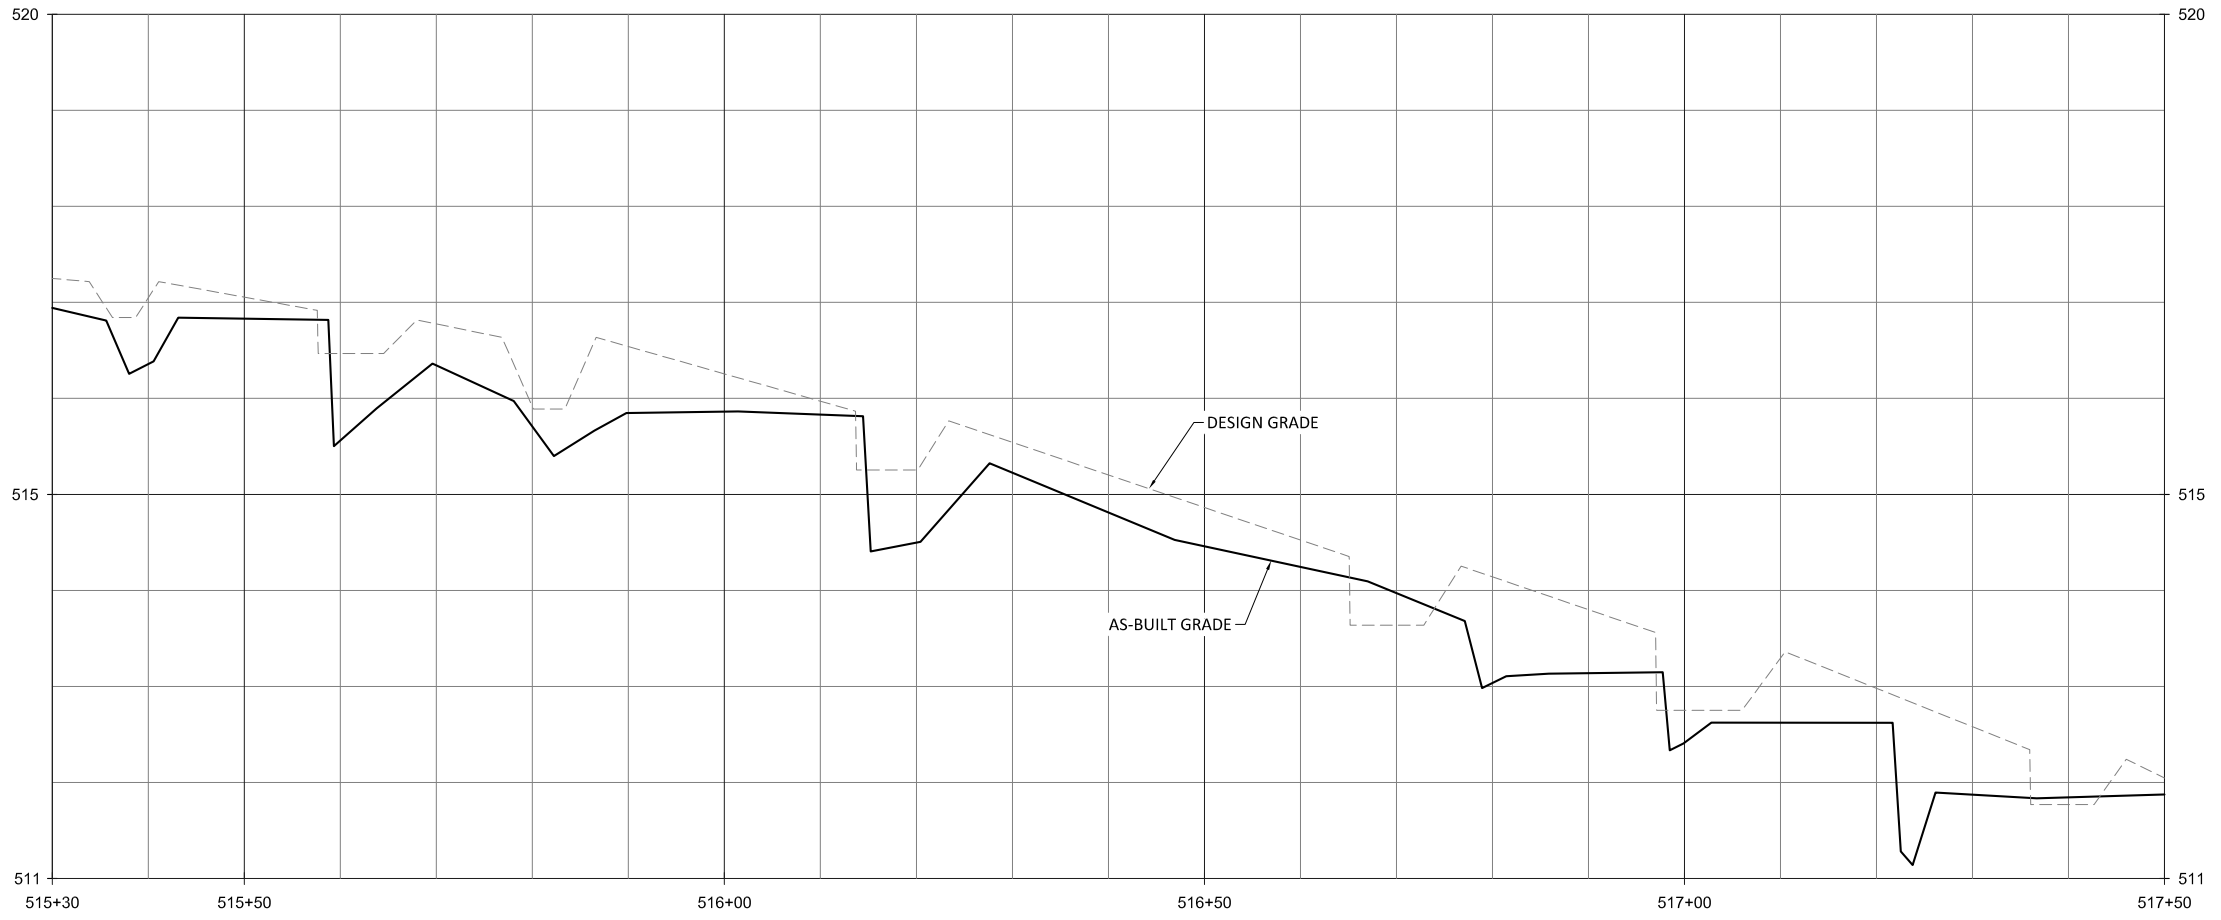
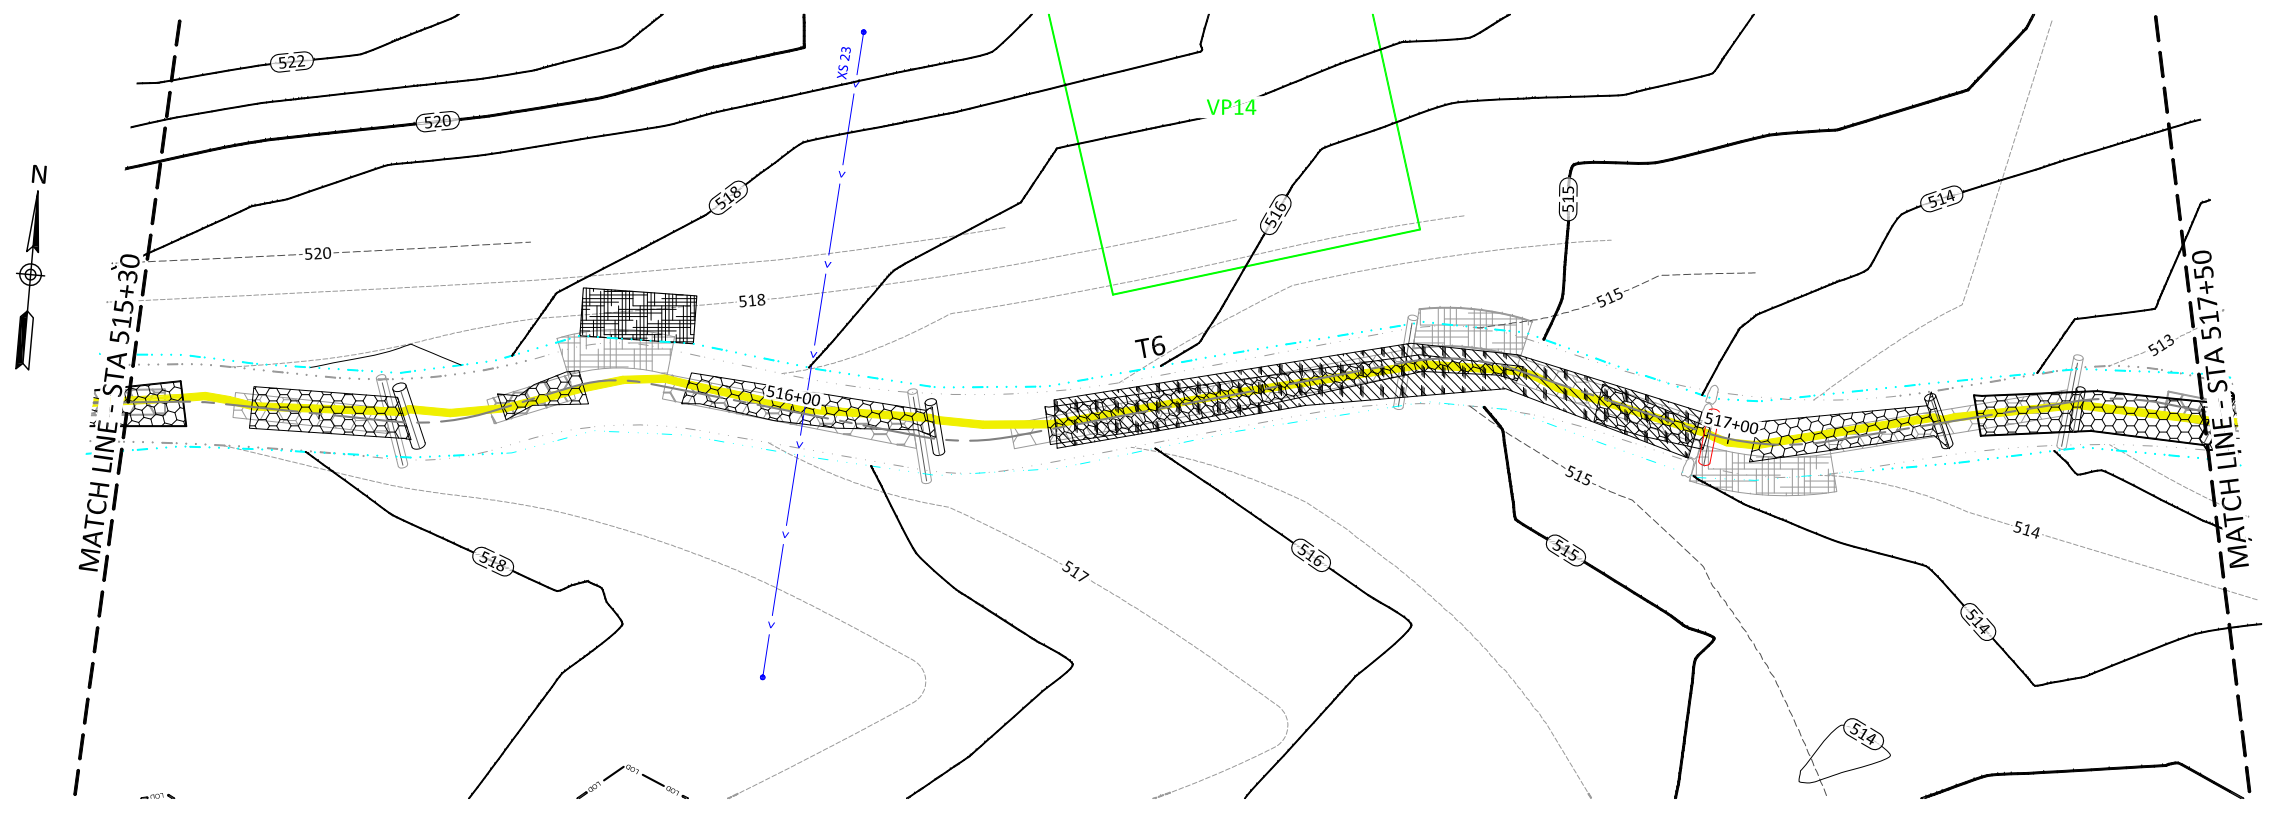
1.48

- NOTE:**
1. STA 516+65: LOG SILL NOT INSTALLED DUE TO BEDROCK.
 2. STA 516+72: BRUSH TOE NOT INSTALLED DUE TO BEDROCK.
 3. STA 516+98: A LOG SILL WAS INSTALLED INSTEAD OF A BOULDER SILL.
 1. STA 517+04: BRUSH TOE NOT INSTALLED DUE TO BEDROCK.
