**BASELINE MONITORING
DOCUMENT AND AS-BUILT
BASELINE REPORT
FINAL**

BUCKWATER MITIGATION SITE

Orange County, NC

DMS Project Number 97084

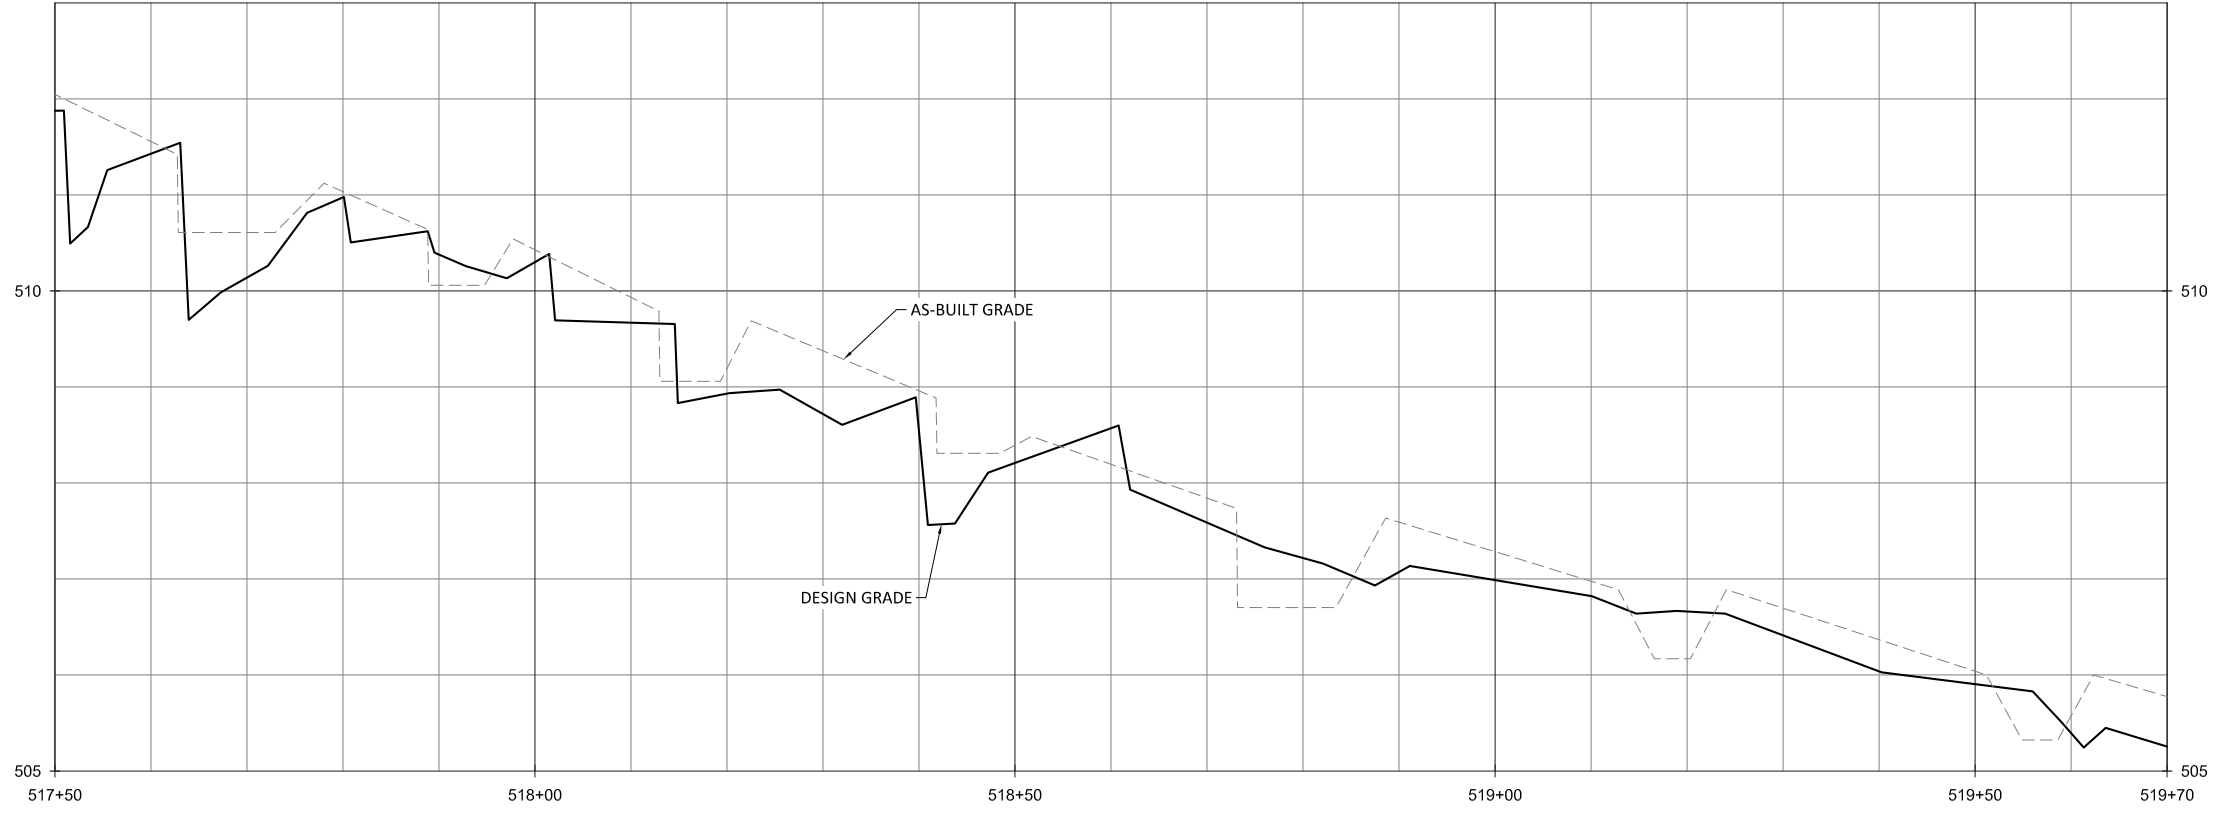
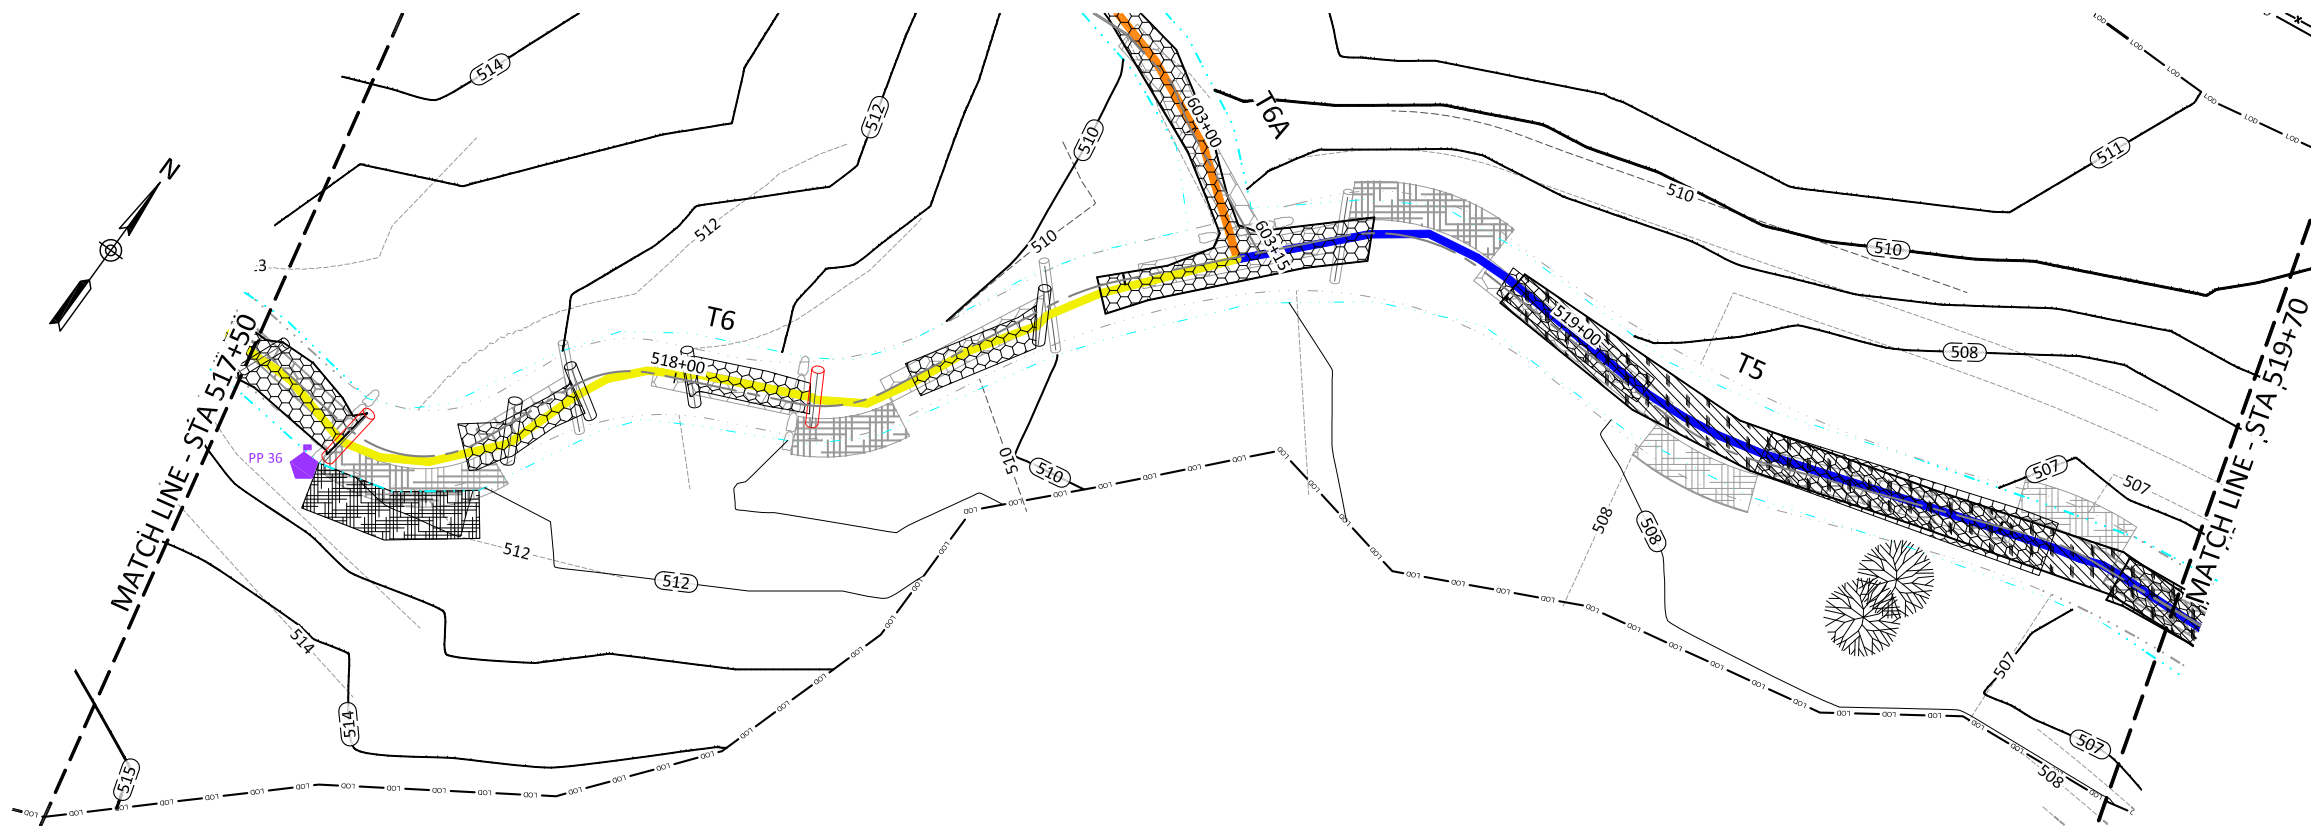
1.49

- NOTE:**
1. STA 517+73: A LOG SILL WAS INSTALLED INSTEAD OF A BOULDER SILL.
 2. STA 518+15: A LOG SILL WAS INSTALLED INSTEAD OF A BOULDER SILL.
 3. STA 518+18: BRUSH TOE WAS NOT INSTALLED DUE TO BEDROCK.
 4. STA 518+73: LOG SILL WAS NOT INSTALLED DUE TO BEDROCK.
 5. STA 518+82: BRUSH TOE WAS NOT INSTALLED DUE TO BEDROCK.
 6. STA 519+18: BRUSH TOE WAS NOT INSTALLED DUE TO BEDROCK.
 7. STA 519+57: BRUSH TOE WAS NOT INSTALLED DUE TO BEDROCK.

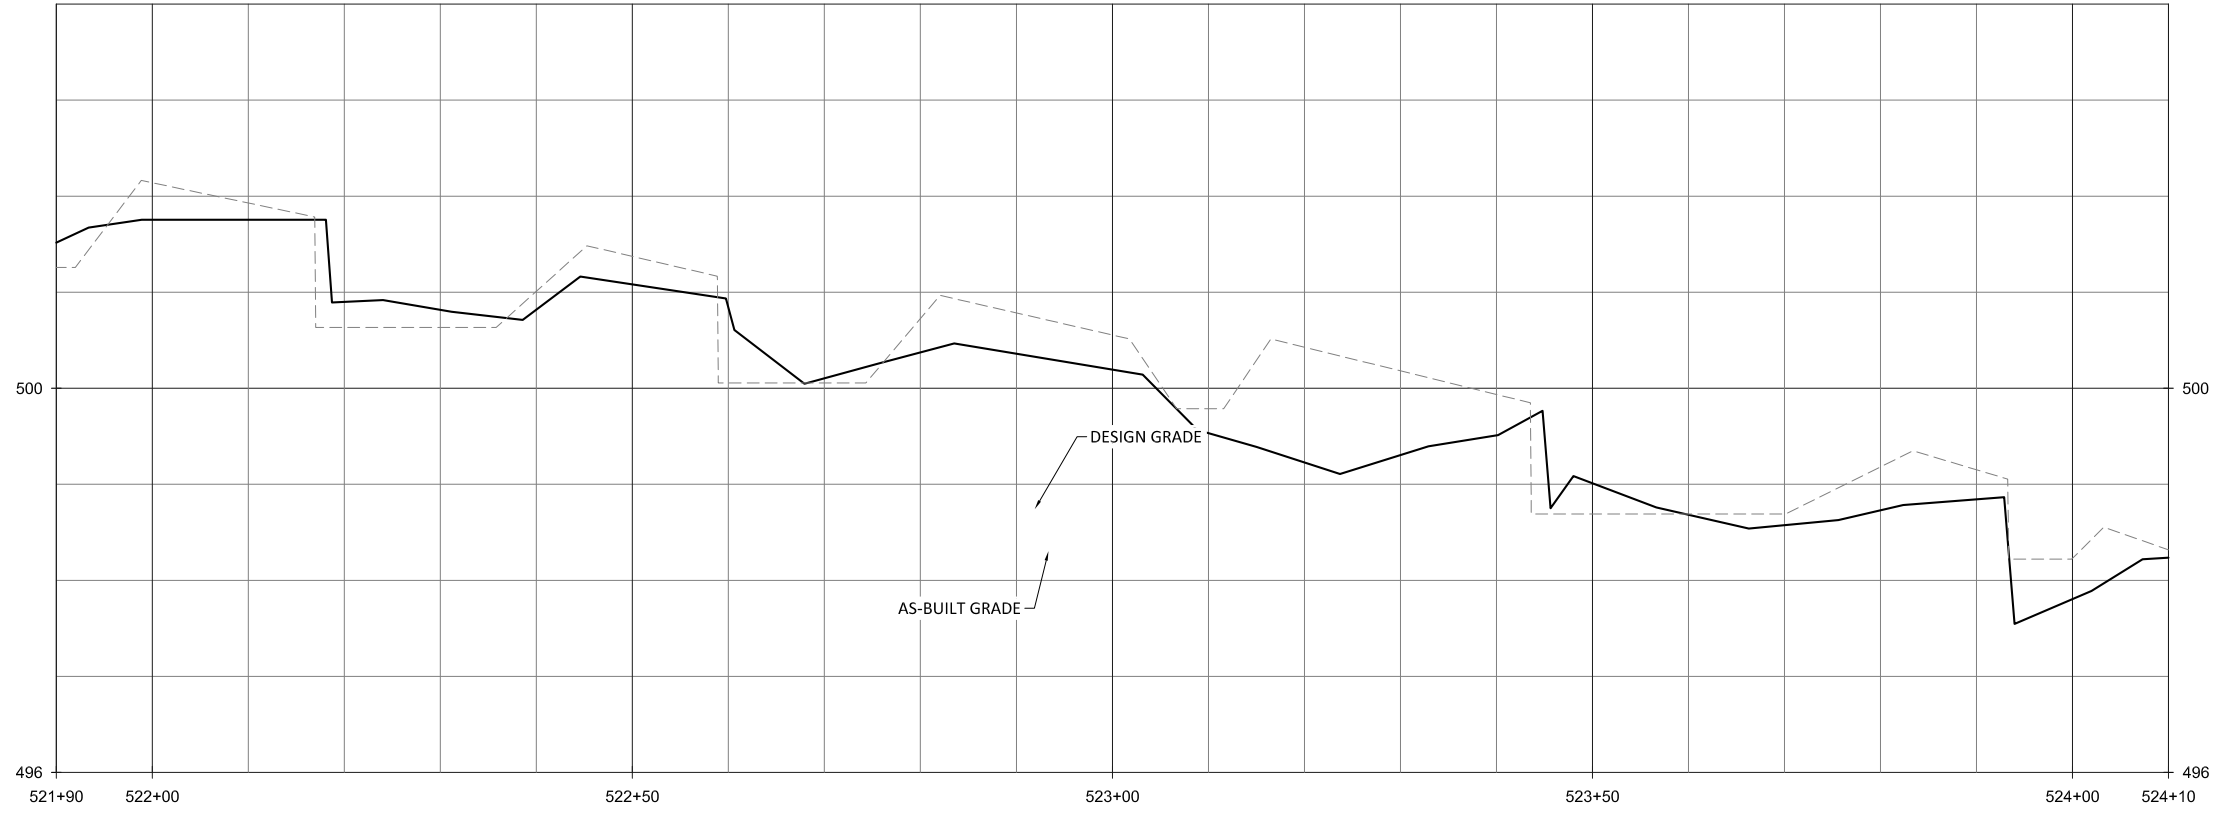
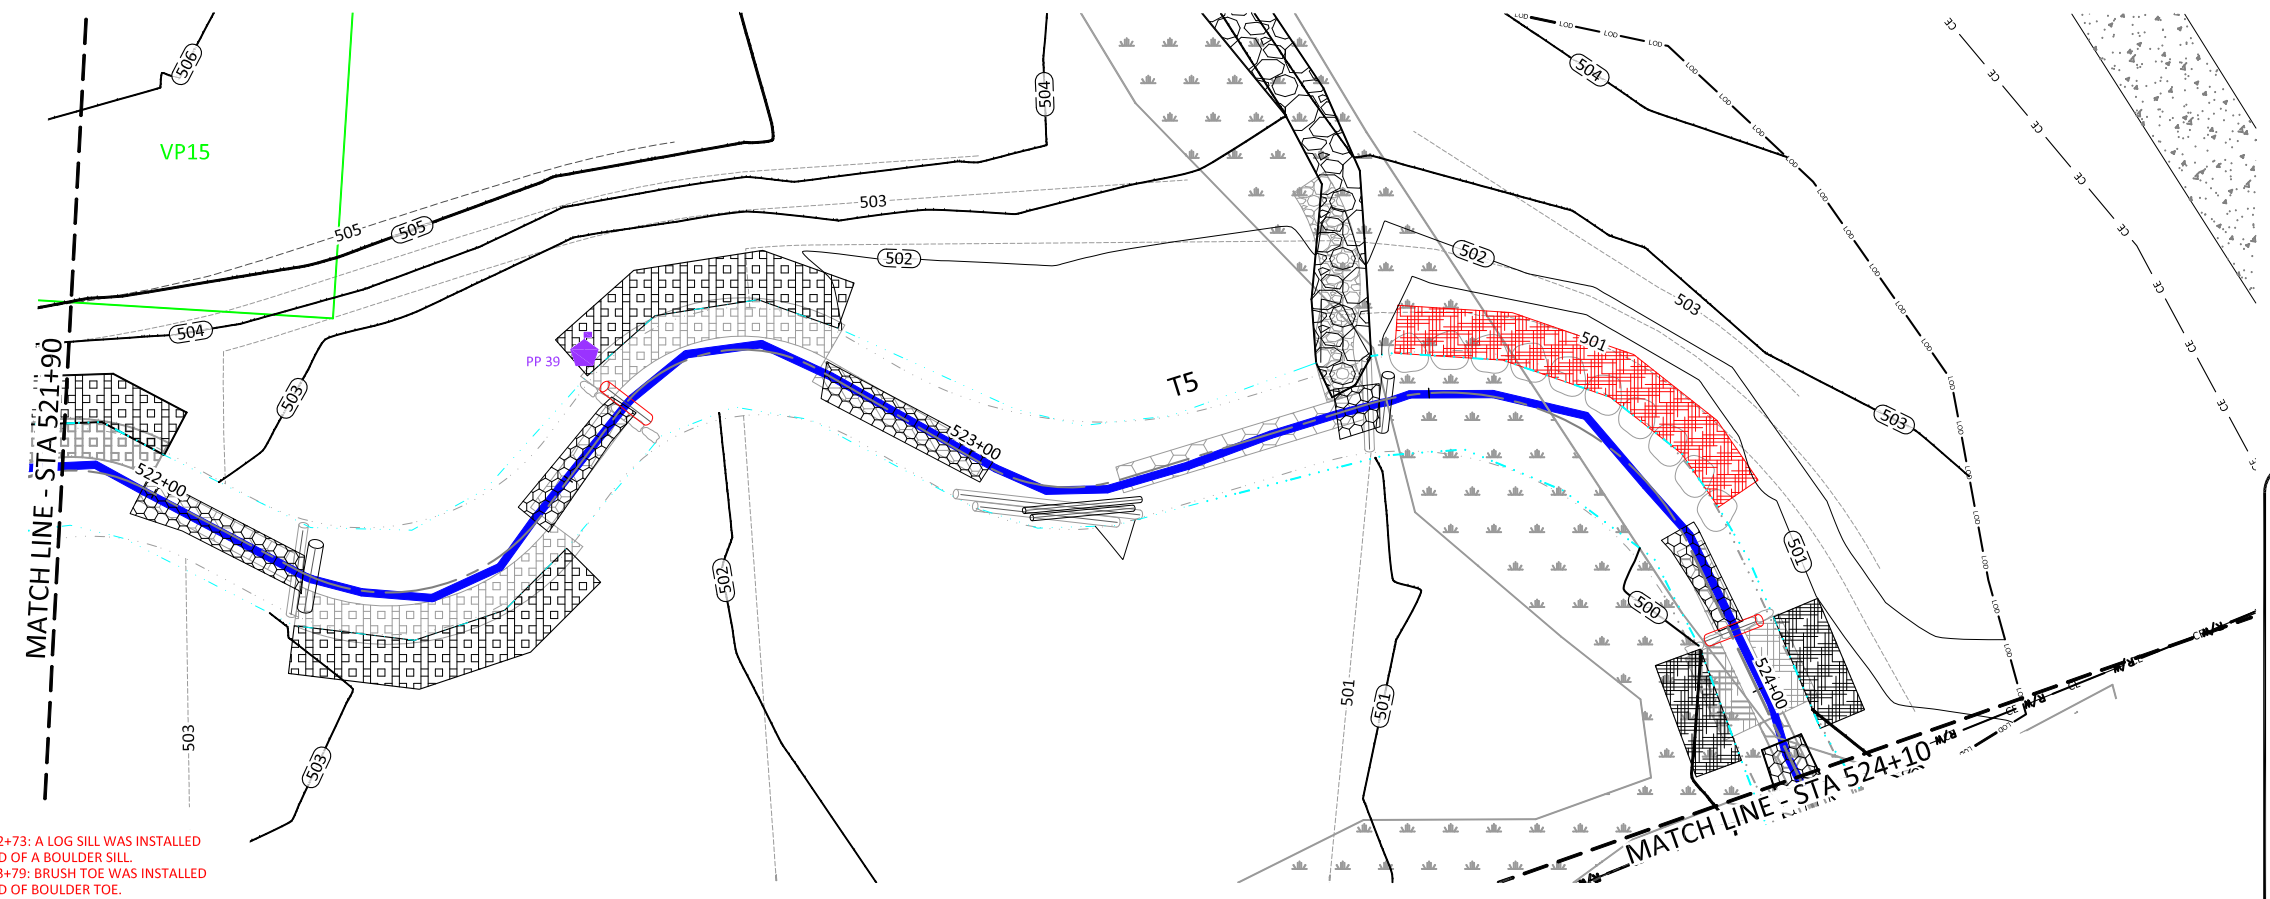
- NOTE:**
1. STA 522+73: A LOG SILL WAS INSTALLED INSTEAD OF A BOULDER SILL.
 2. STA 523+79: BRUSH TOE WAS INSTALLED INSTEAD OF BOULDER TOE.
 3. STA 524+08: A LOG SILL WAS INSTALLED INSTEAD OF A BOULDER SILL.

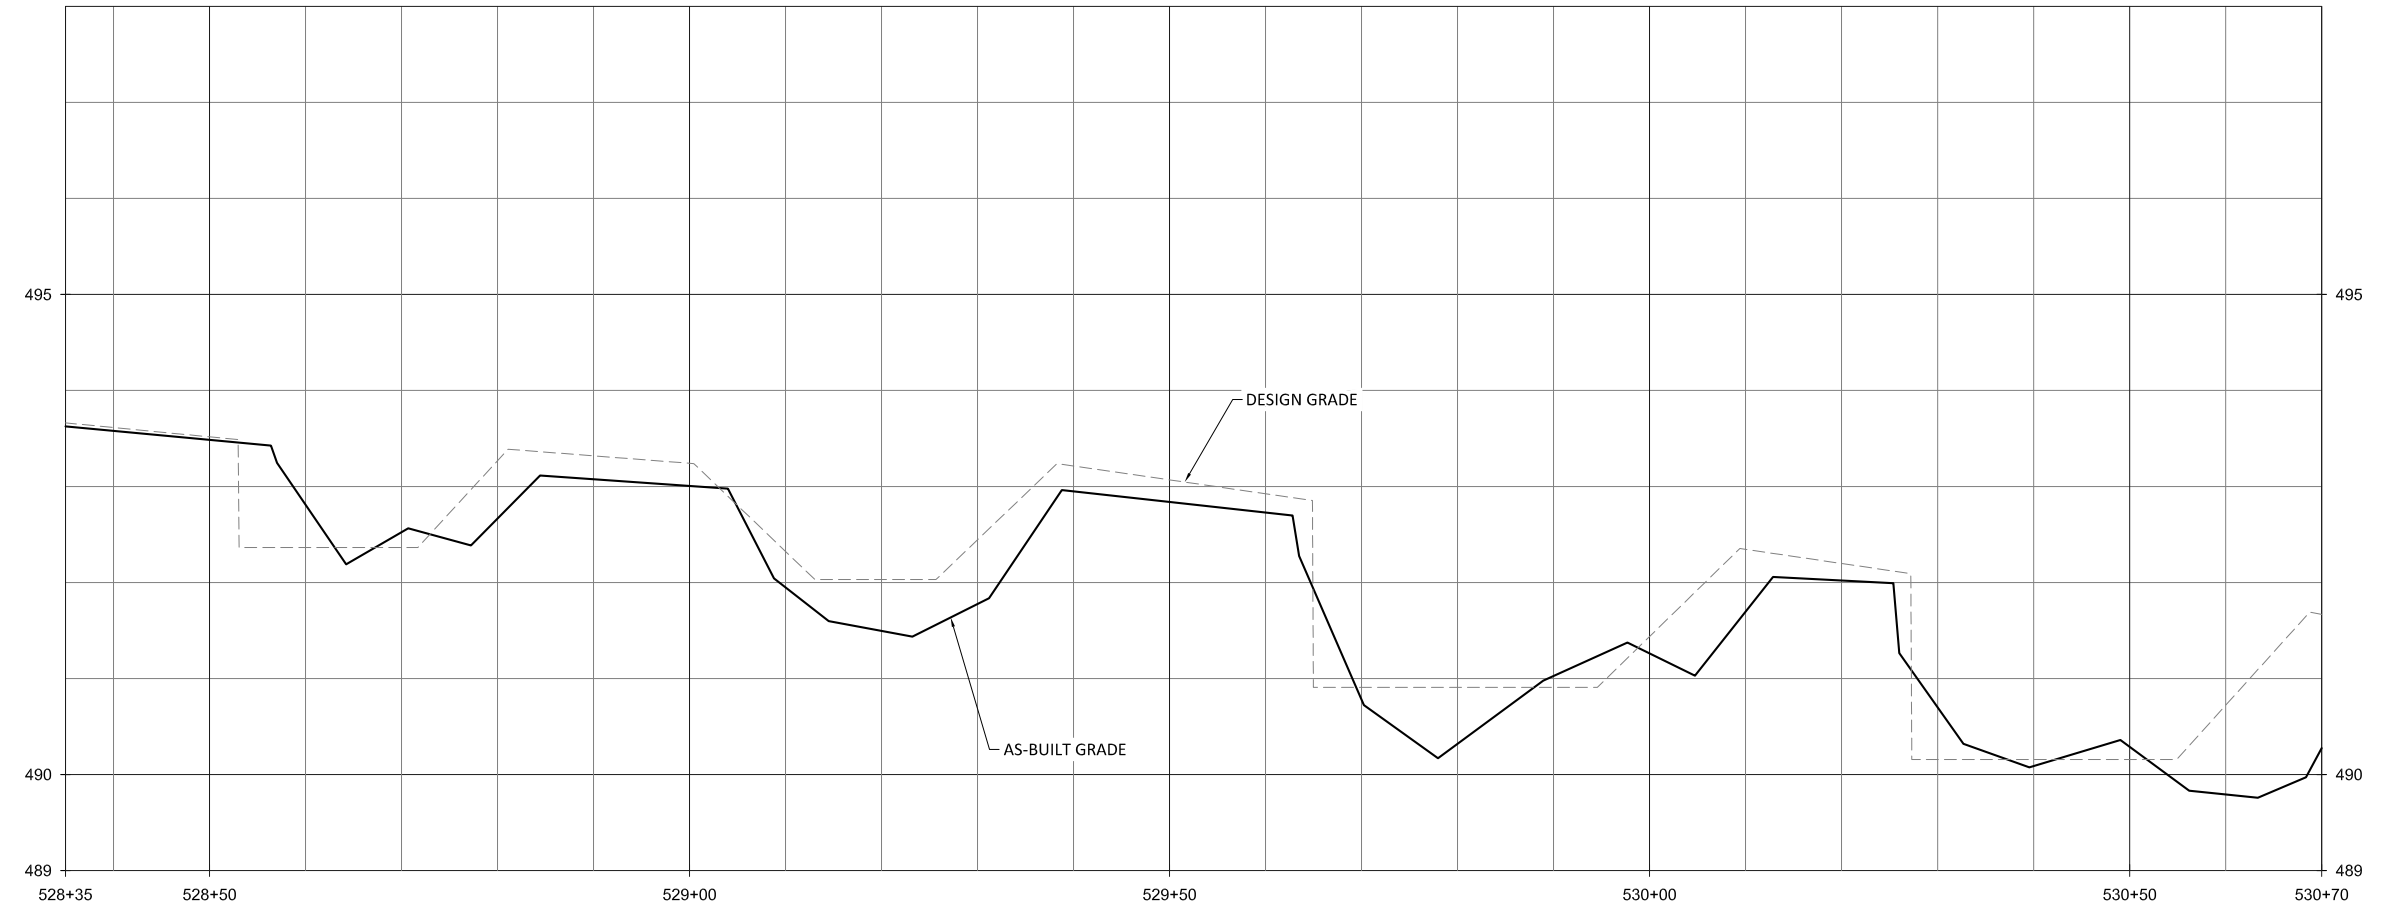
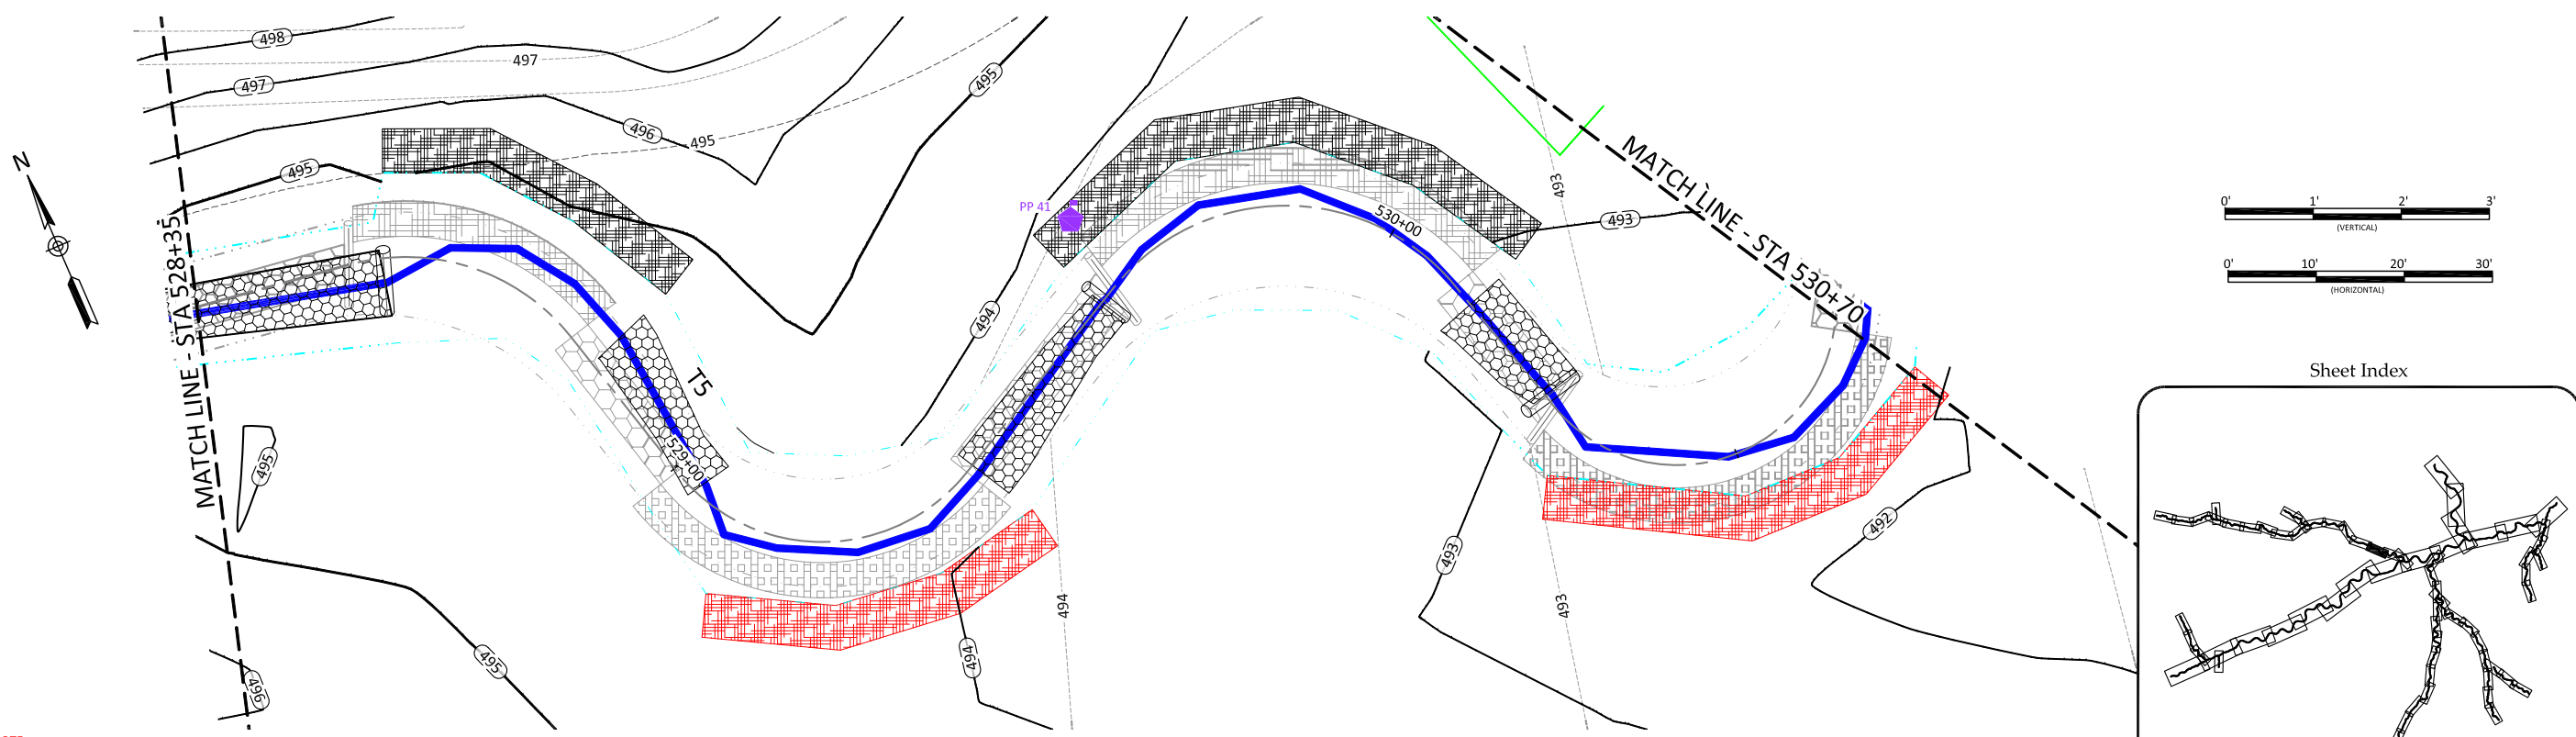
- NOTE:**
1. STA 529+46: BRUSH TOE WAS INSTALLED INSTEAD OF SOD MAT.
 2. STA 530+76: BRUSH TOE WAS INSTALLED INSTEAD OF SOD MAT.

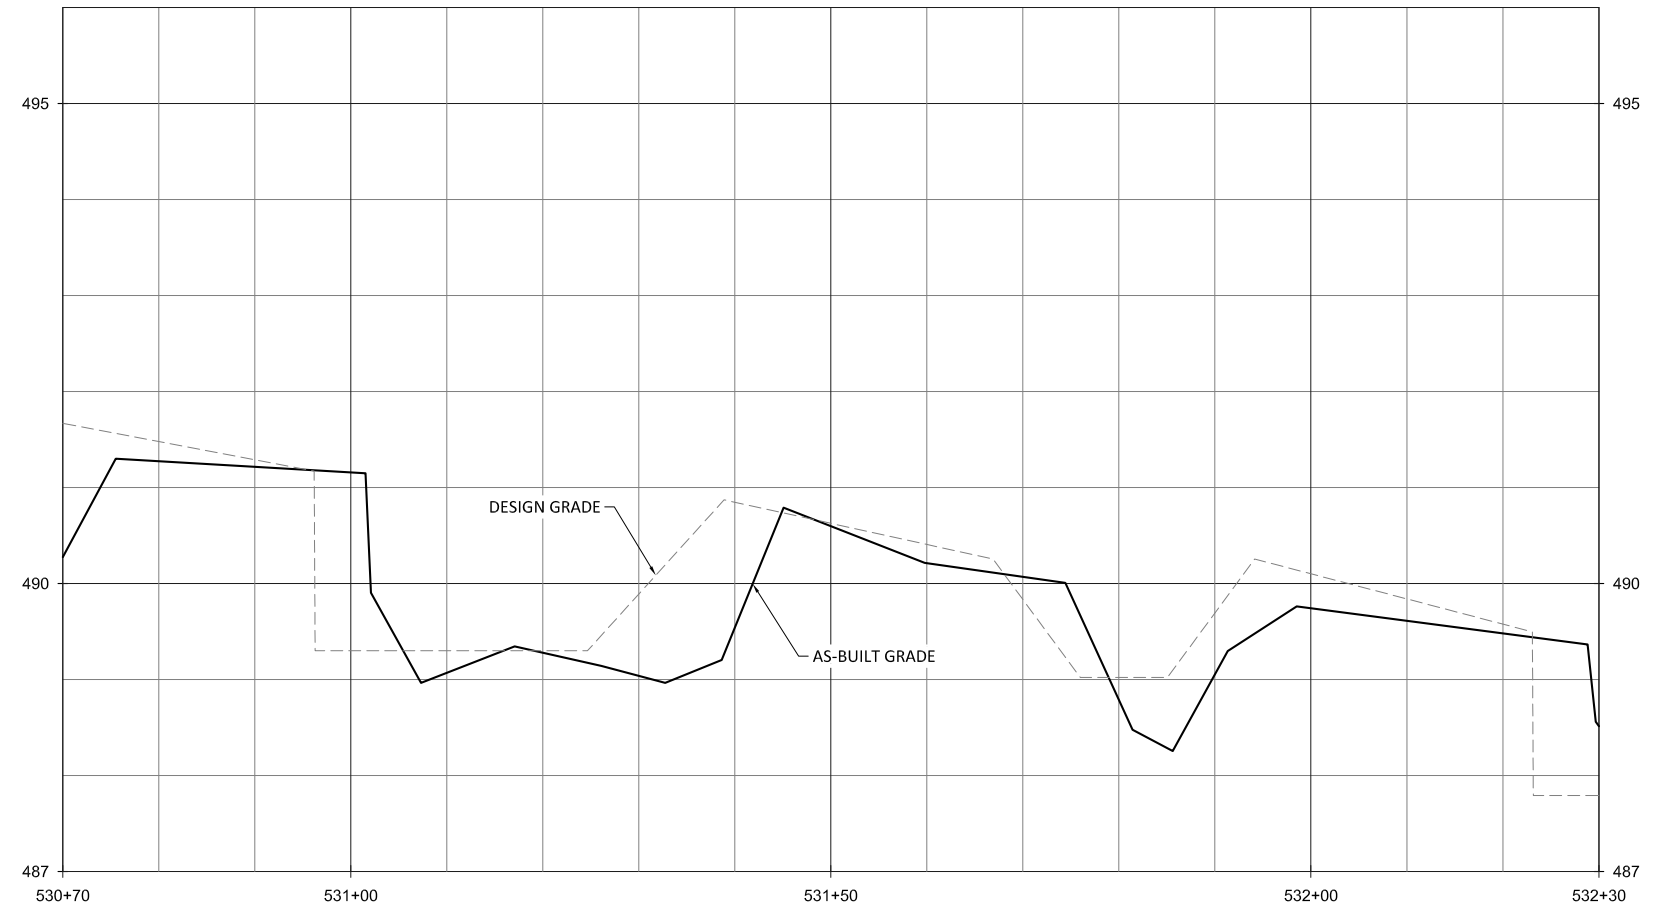
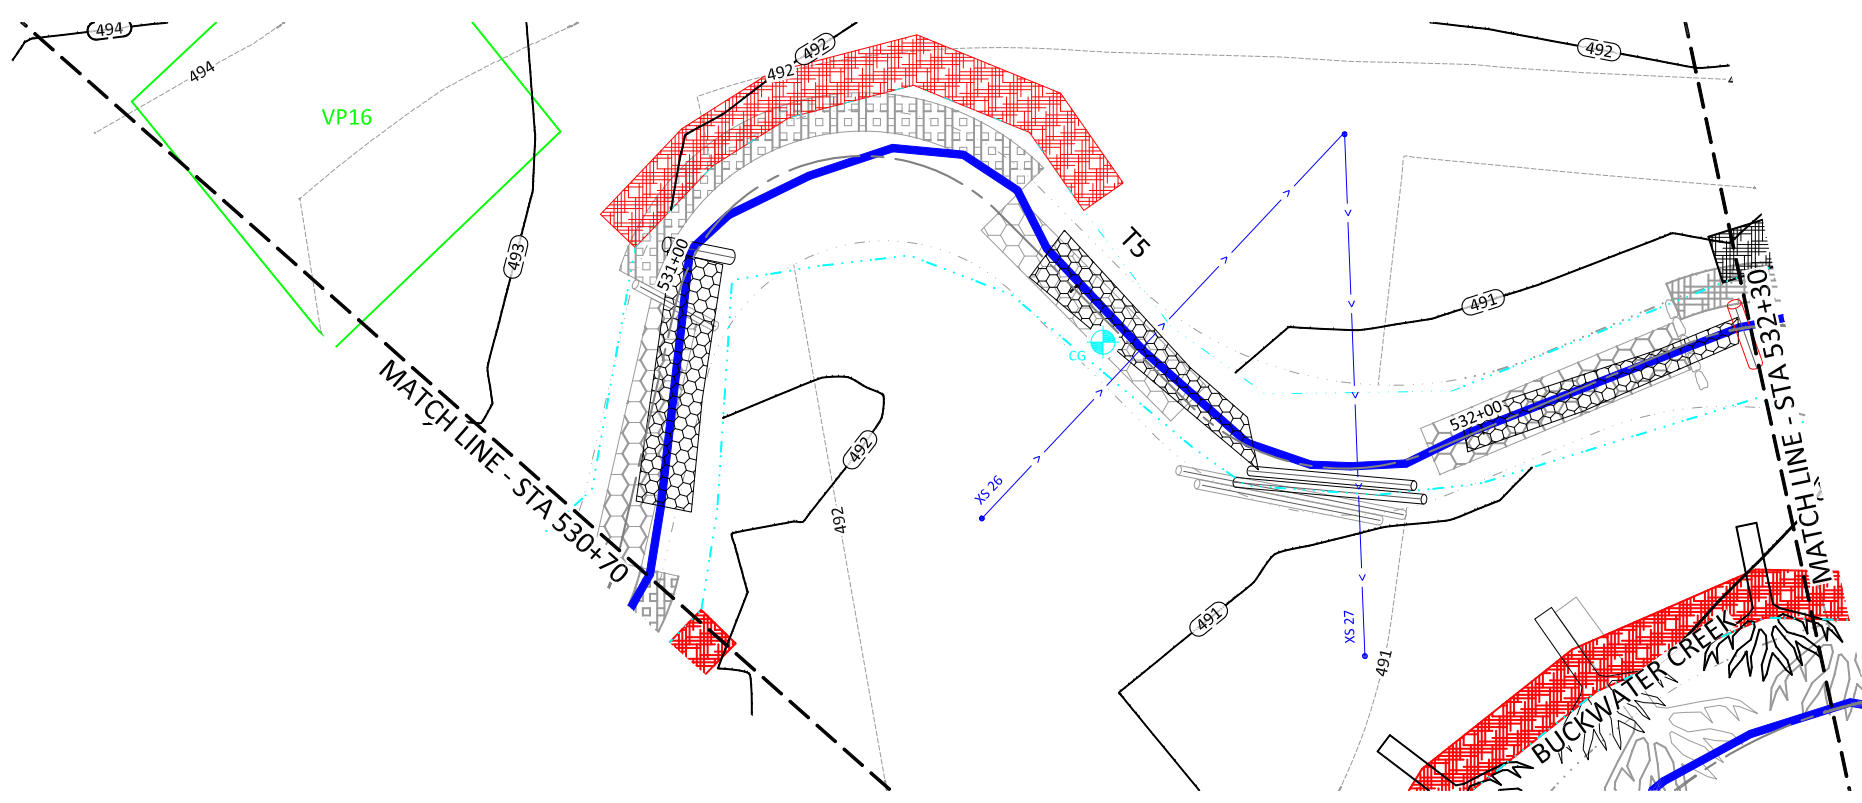
- NOTE:**
1. STA 531+51: BRUSH TOE WAS INSTALLED INSTEAD OF SOD MAT.
 2. STA 532+59: LOG SILL WAS INSTALLED INSTEAD OF BOULDER SILL.

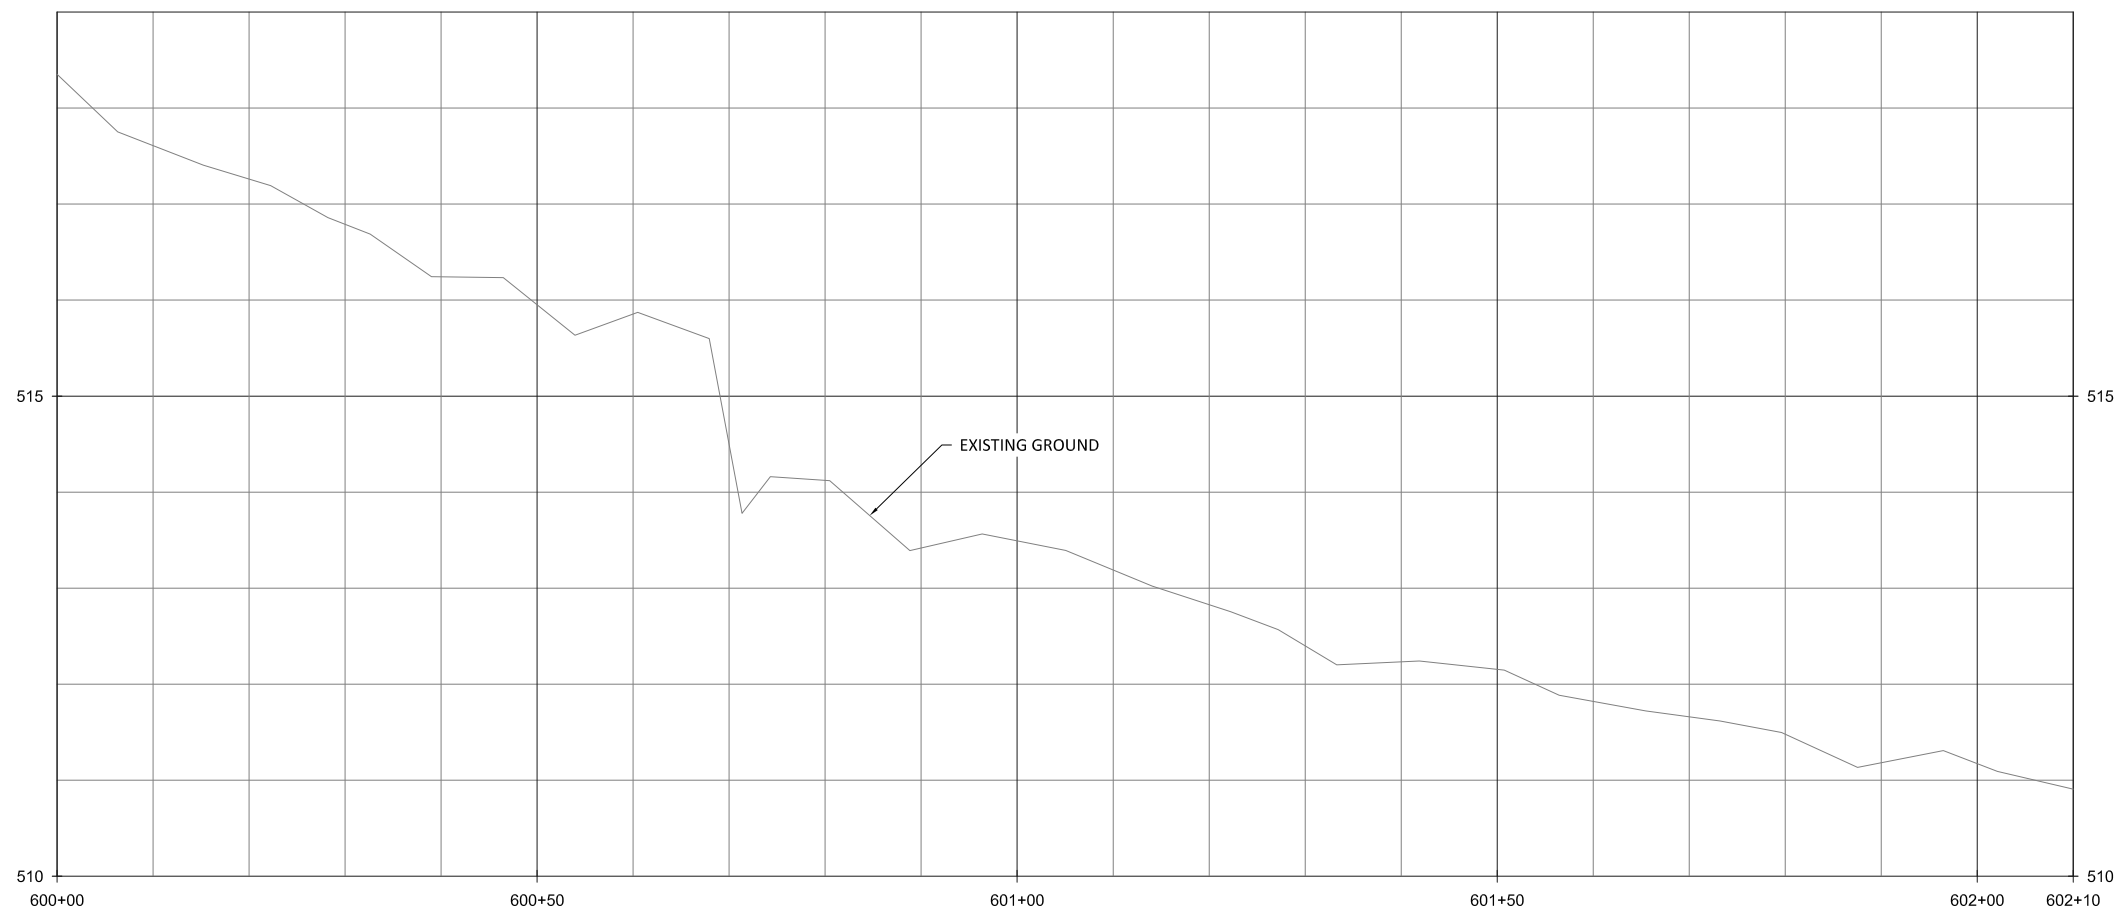
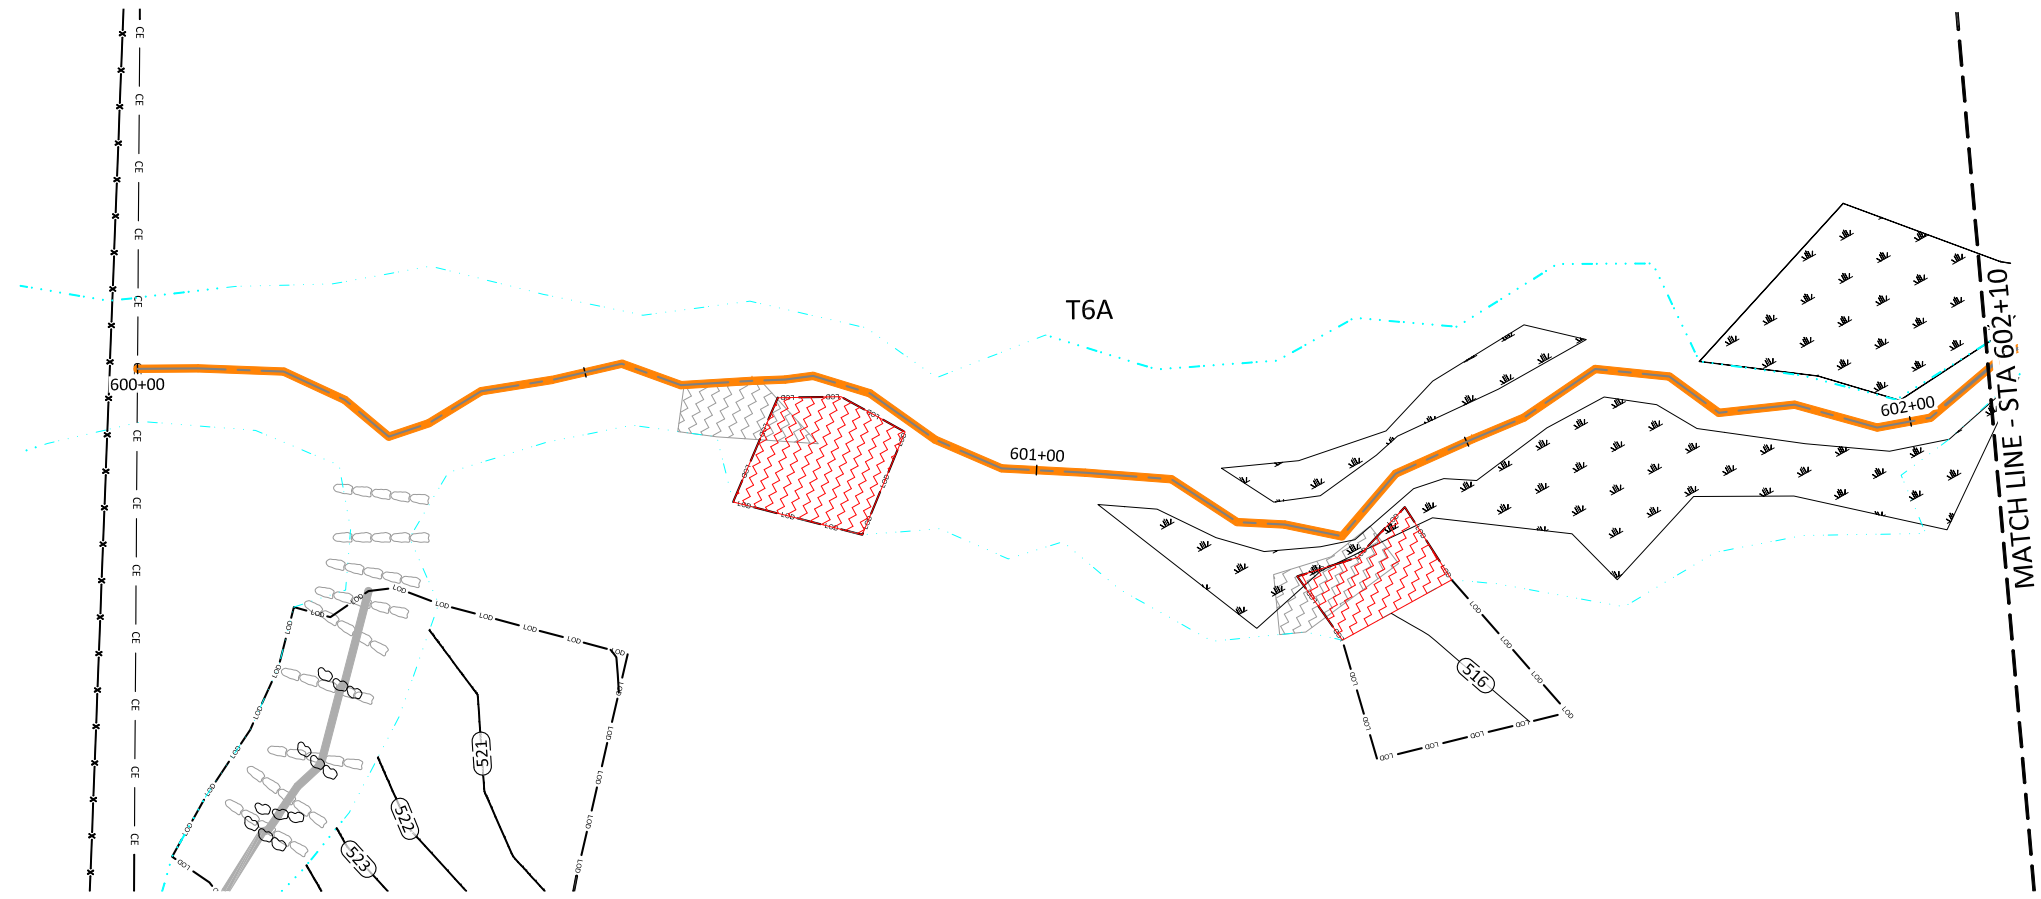
NOTE:
 1. STA 600+28: ALONG THIS SWALE, DOWNSTREAM STRUCTURES WERE NOT INSTALLED DUE TO BEDROCK.

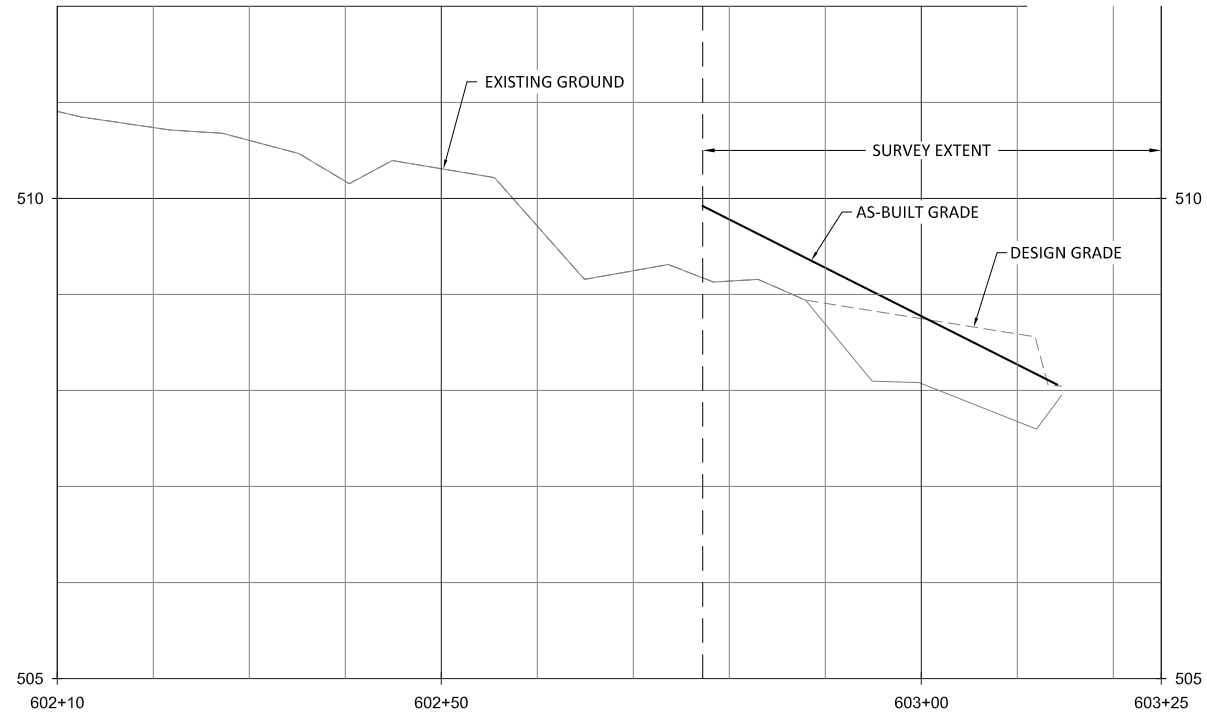
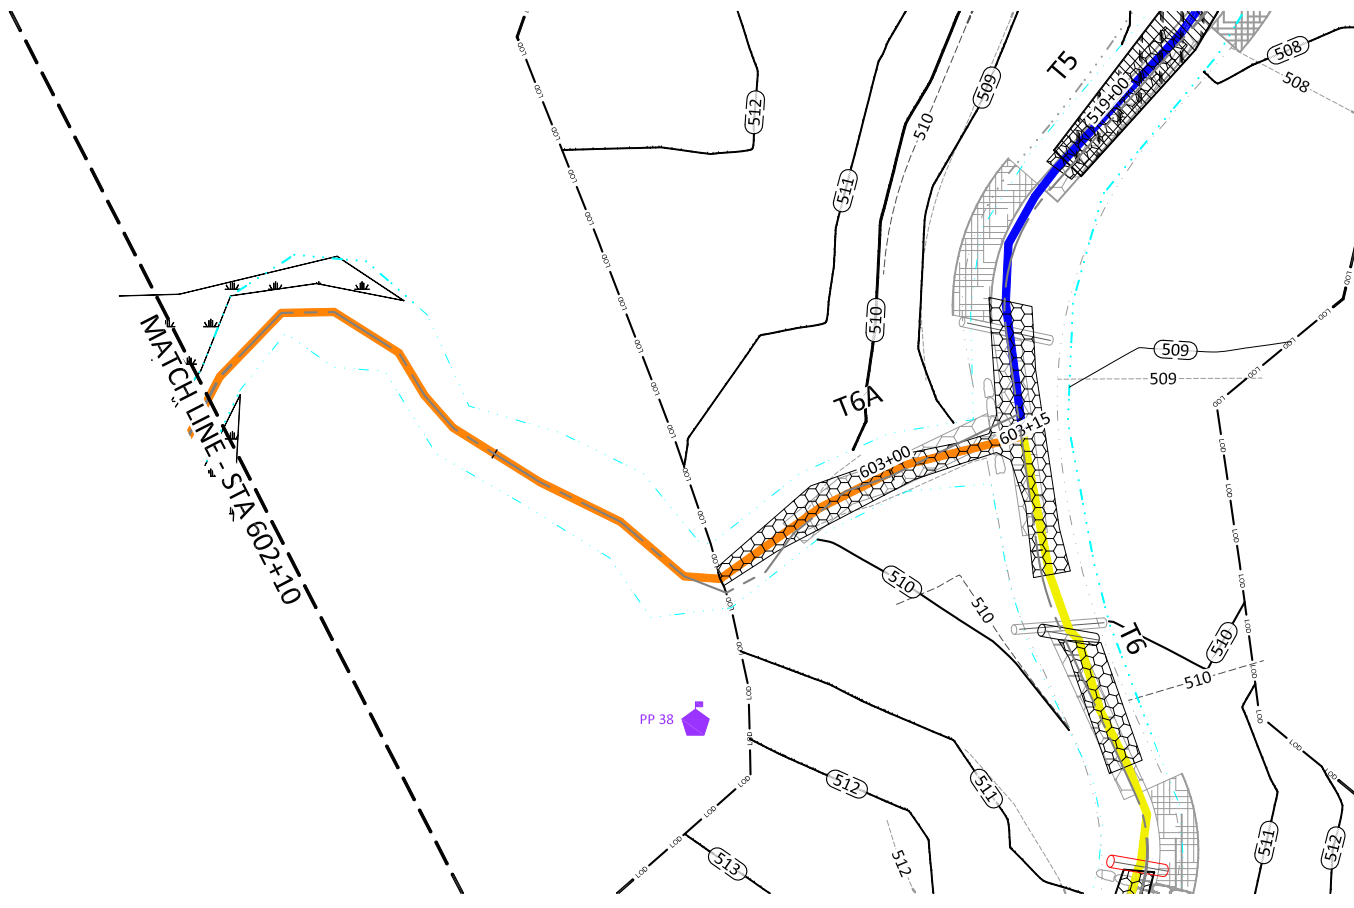
1.58

NOTE:
 1. STA 603+12: BOULDER SILL NOT INSTALLED DUE TO BEDROCK.

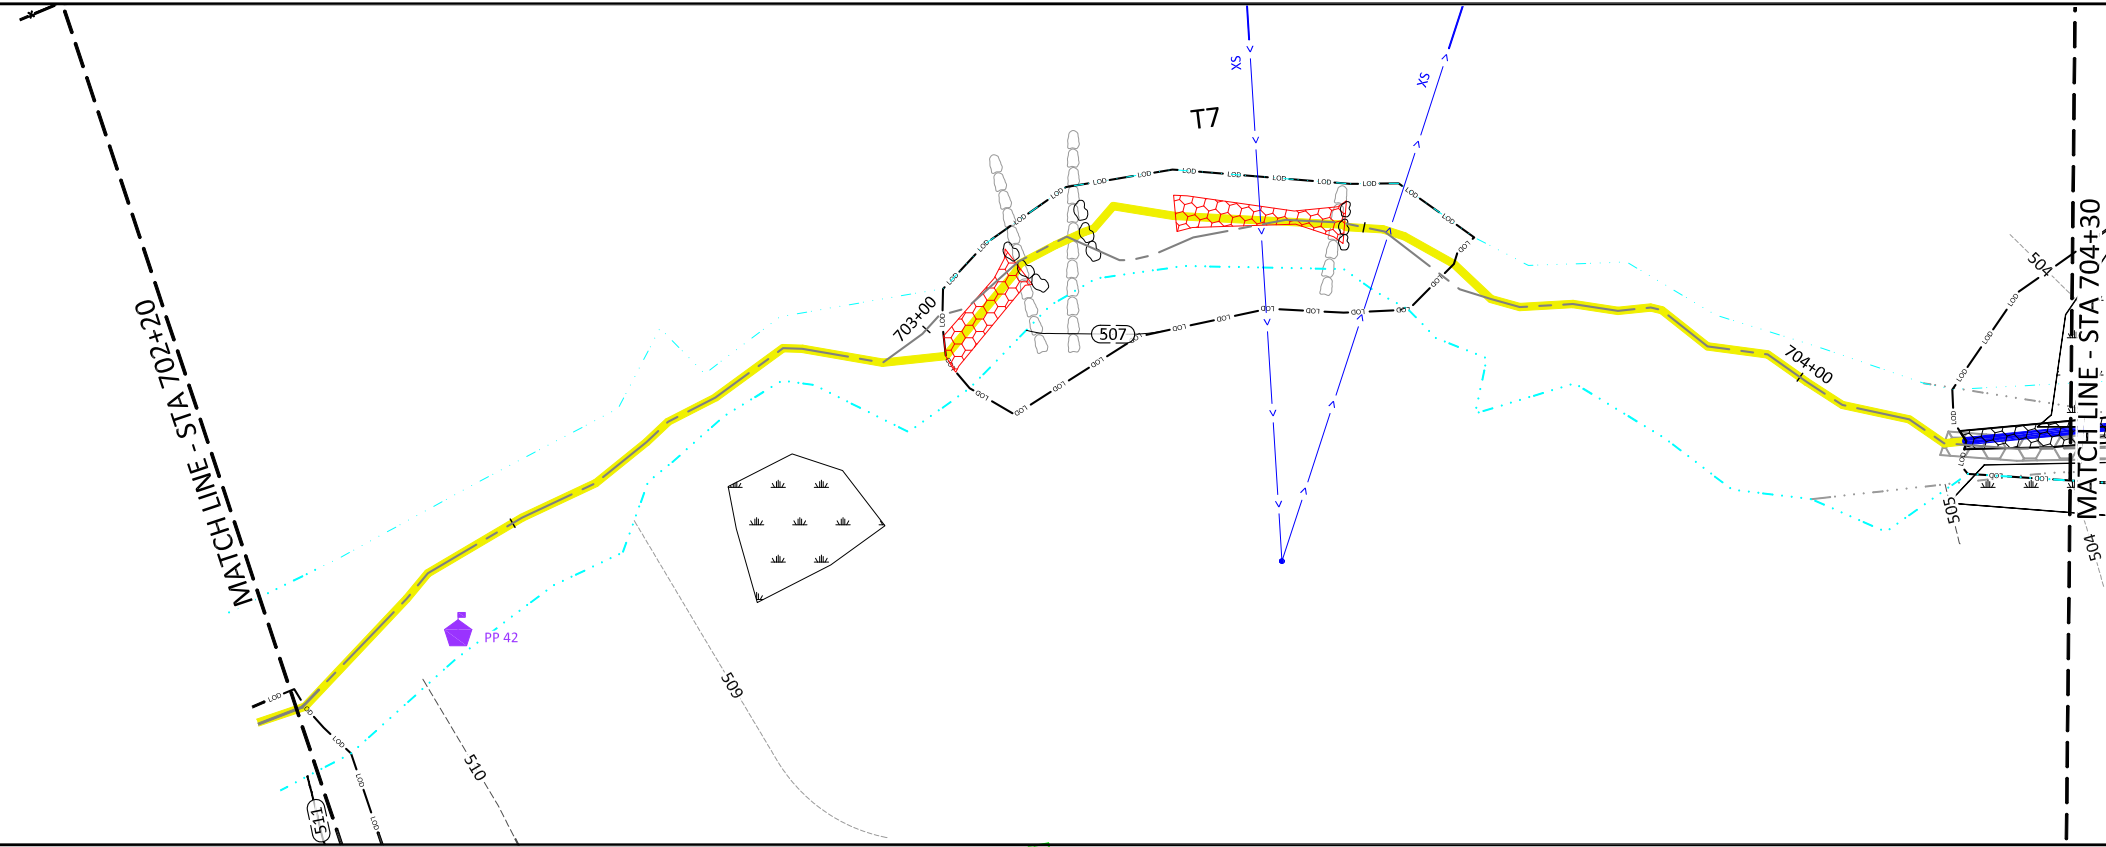
1.61

- NOTE:**
1. STA 703+04: RIFFLE ADDED.
 2. STA 703+38: RIFFLE ADDED.
