**BASELINE MONITORING
DOCUMENT AND AS-BUILT
BASELINE REPORT
FINAL**

BUCKWATER MITIGATION SITE

Orange County, NC

DMS Project Number 97084

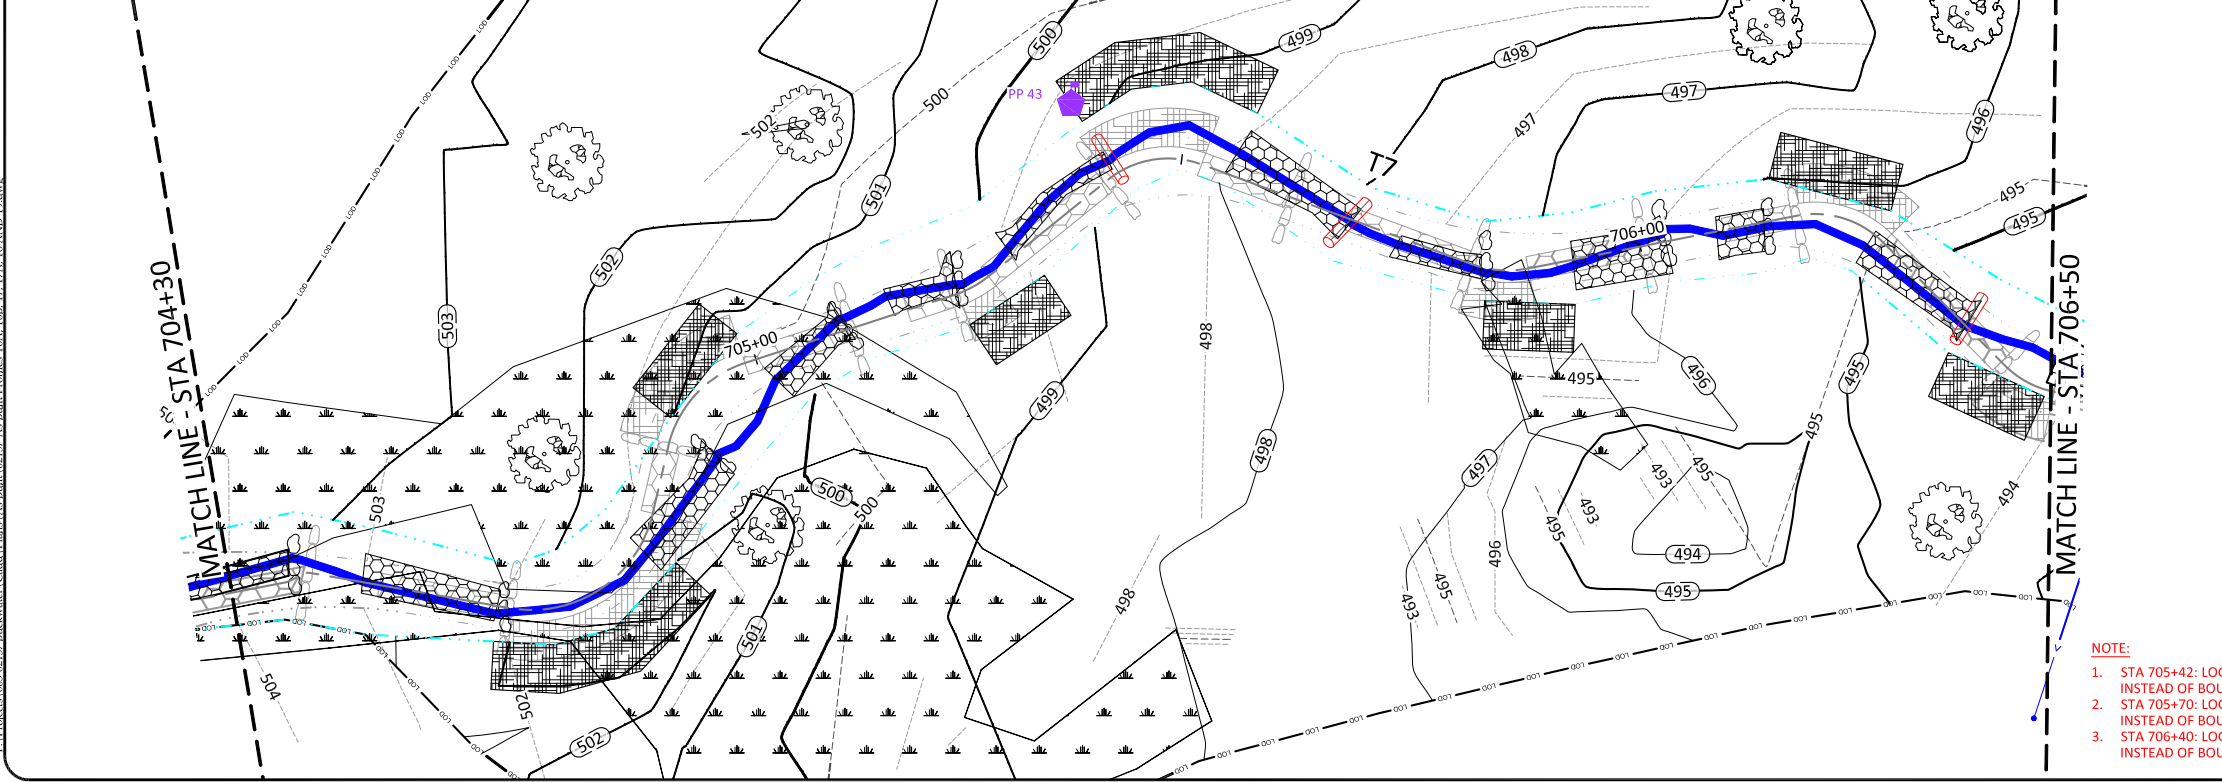
1.62

- NOTE:**
1. STA 705+42: LOG SILL INSTALLED INSTEAD OF BOULDER SILL.
 2. STA 705+70: LOG SILL INSTALLED INSTEAD OF BOULDER SILL.
 3. STA 706+40: LOG SILL INSTALLED INSTEAD OF BOULDER SILL.

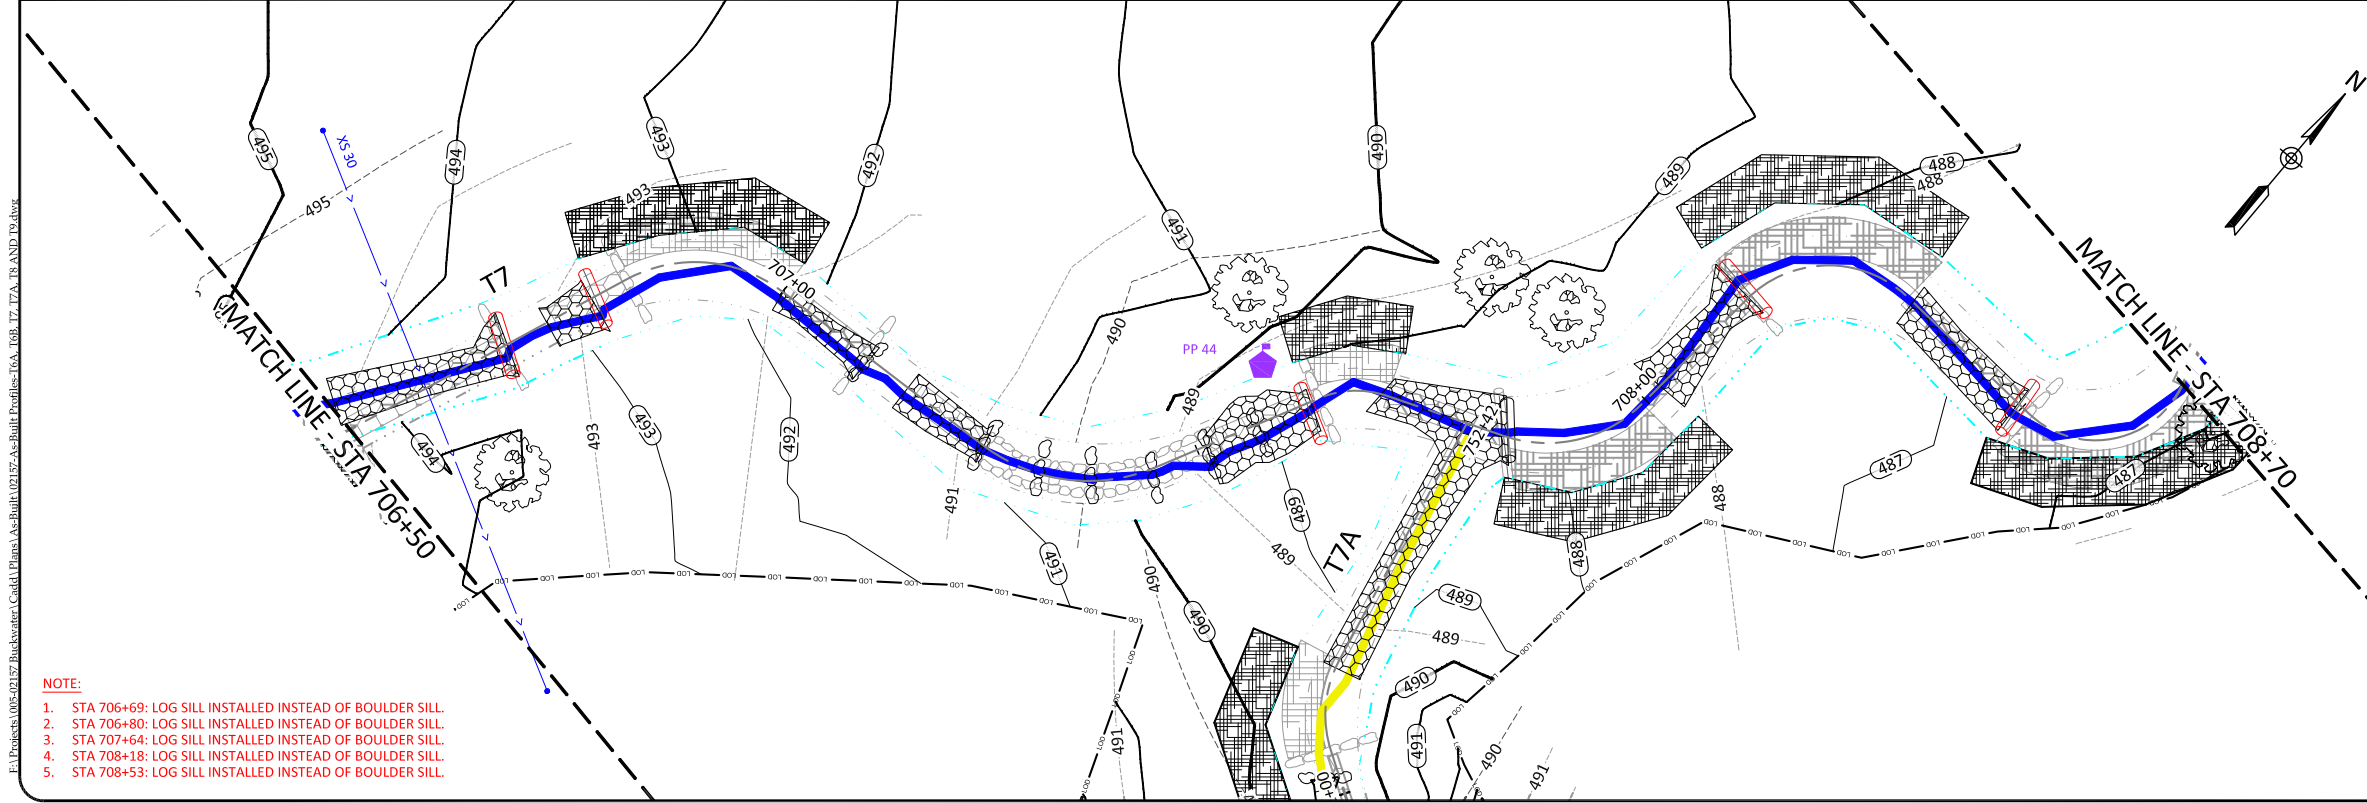
- NOTE:**
1. STA 706+69: LOG SILL INSTALLED INSTEAD OF BOULDER SILL
 2. STA 706+80: LOG SILL INSTALLED INSTEAD OF BOULDER SILL
 3. STA 707+64: LOG SILL INSTALLED INSTEAD OF BOULDER SILL
 4. STA 708+18: LOG SILL INSTALLED INSTEAD OF BOULDER SILL
 5. STA 708+53: LOG SILL INSTALLED INSTEAD OF BOULDER SILL

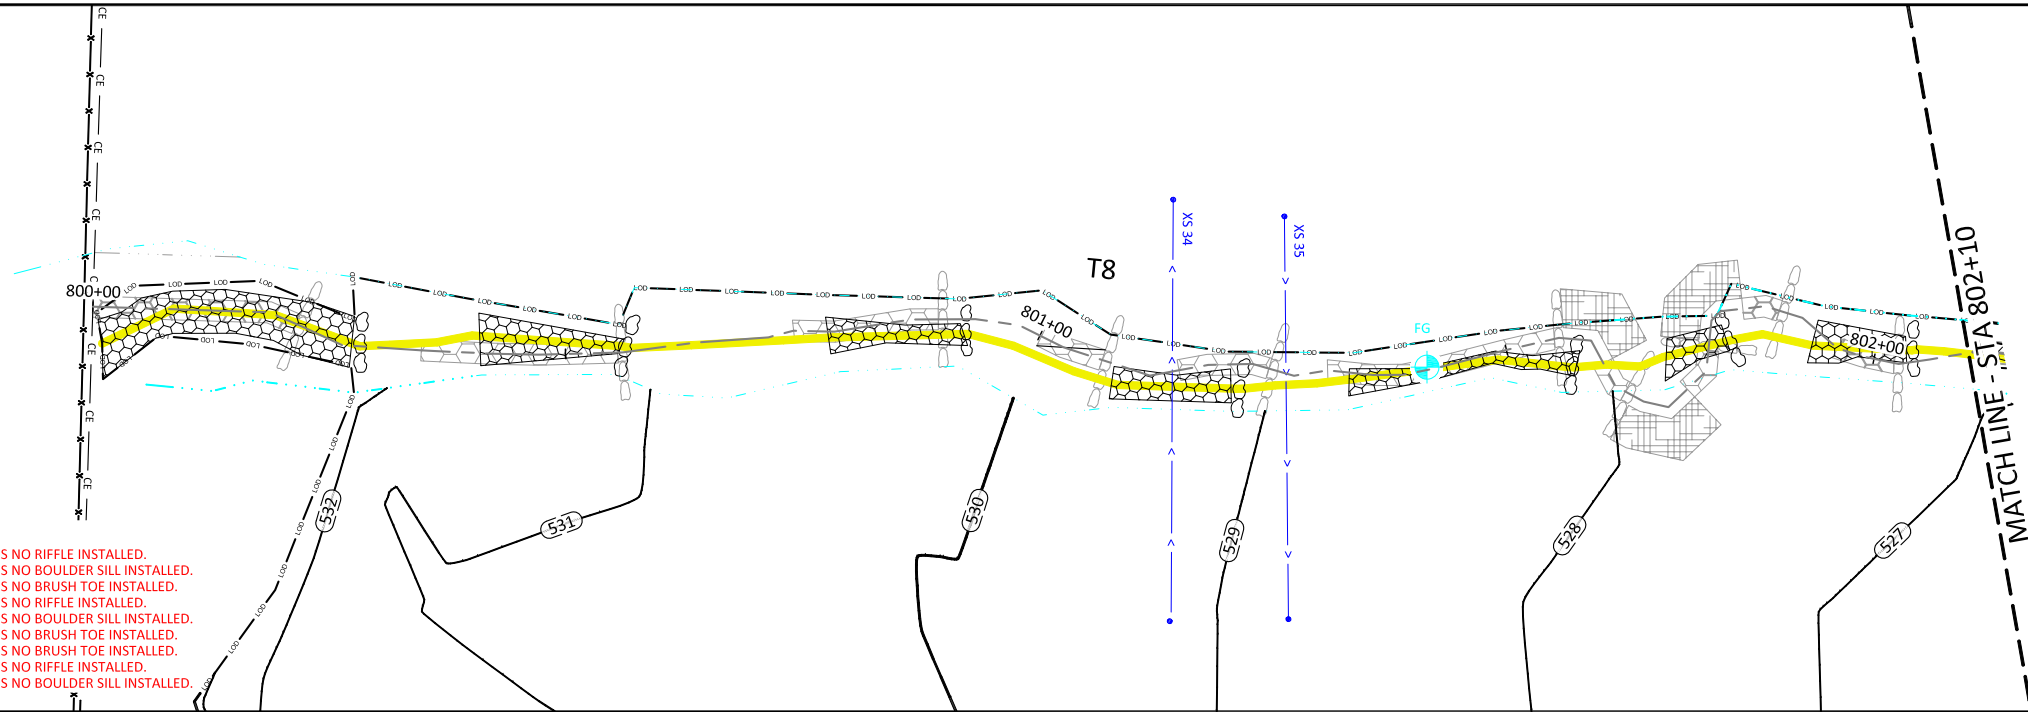
1.66

1. STA 801+04: DUE TO SITE CONDITIONS NO RIFFLE INSTALLED.
2. STA 801+07: DUE TO SITE CONDITIONS NO BOULDER SILL INSTALLED.
3. STA 801+75: DUE TO SITE CONDITIONS NO BRUSH TOE INSTALLED.
4. STA 801+63: DUE TO SITE CONDITIONS NO RIFFLE INSTALLED.
5. STA 801+66: DUE TO SITE CONDITIONS NO BOULDER SILL INSTALLED.
6. STA 801+70: DUE TO SITE CONDITIONS NO BRUSH TOE INSTALLED.
7. STA 801+82: DUE TO SITE CONDITIONS NO BRUSH TOE INSTALLED.
8. STA 801+87: DUE TO SITE CONDITIONS NO RIFFLE INSTALLED.
9. STA 801+89: DUE TO SITE CONDITIONS NO BOULDER SILL INSTALLED.

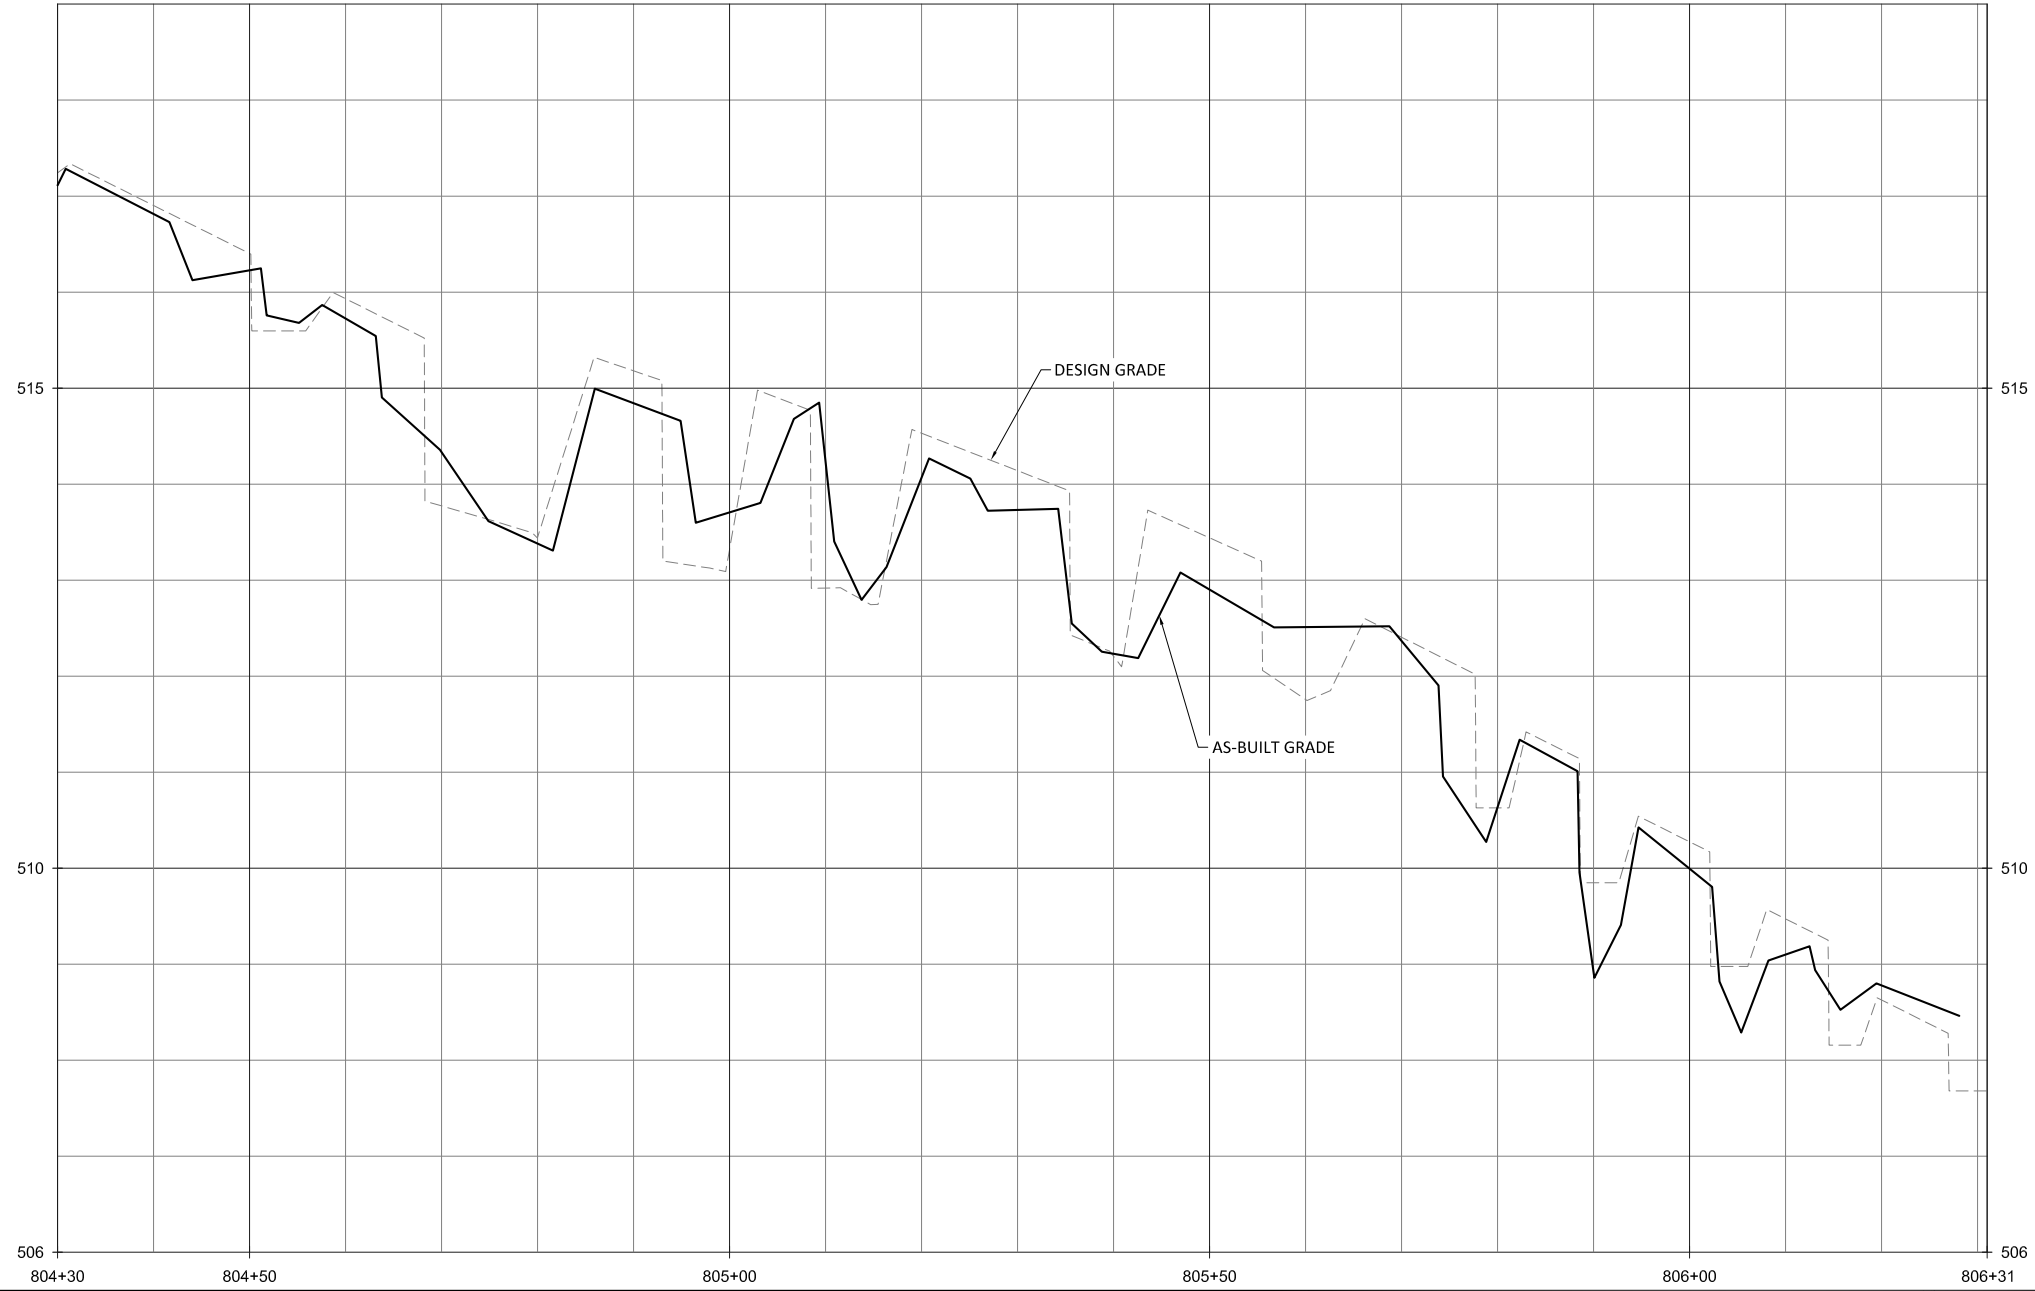
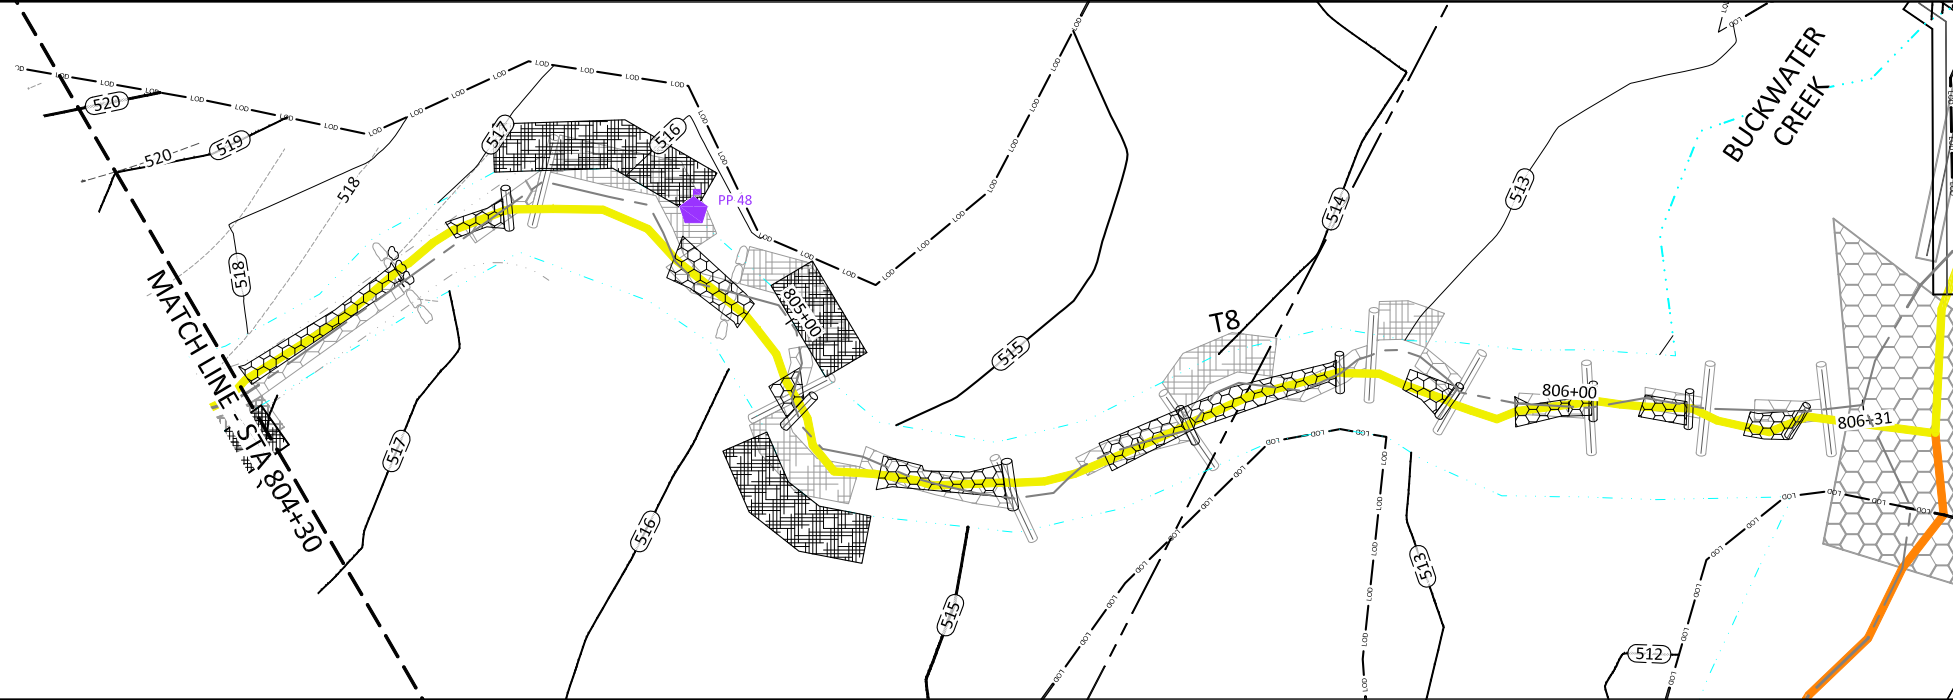
1. STA 804+93: NO BOULDER SILL INSTALLED.
2. STA 805+62: BRUSH TOE WAS NOT INSTALLED TO AVOID IMPACTING EXISTING VEGETATION.
3. STA 805+81: BRUSH TOE WAS NOT INSTALLED TO AVOID IMPACTING EXISTING VEGETATION.
