Annual Monitoring Report

**Mill Dam Creek Restoration Site
Yadkin River Basin - 03040101
Monitoring Year 01
DEQ Contract 6898
DMS Project Number 97136**

**DWR #: 18-1349
USACE Action ID: 2016-01335
Yadkin County, North Carolina**

**Data Collected: 2020
Date Submitted: January 2021**

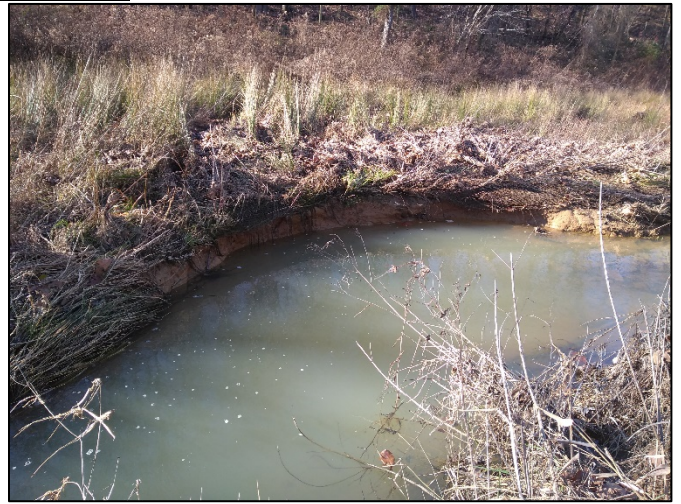
Outer bend erosion, Sta 39+50, 12/18/20

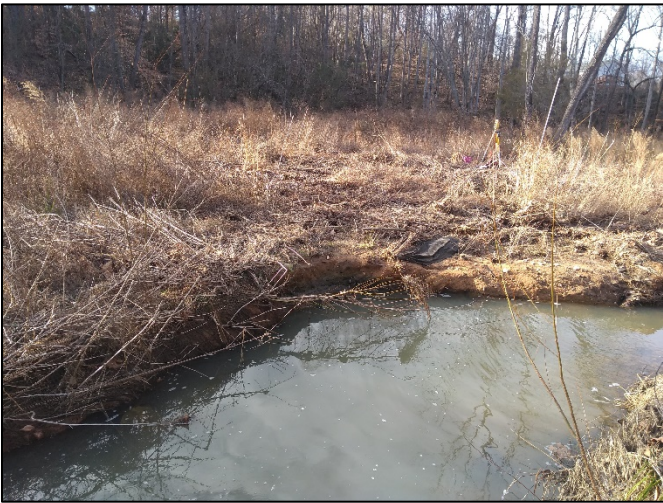
Outer bend erosion, Sta 46+25, 12/18/20

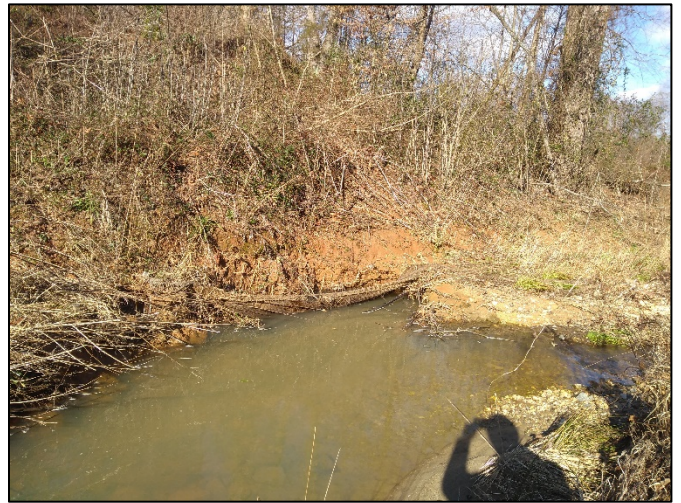
Outer bend erosion, Sta 50+75, 12/18/20

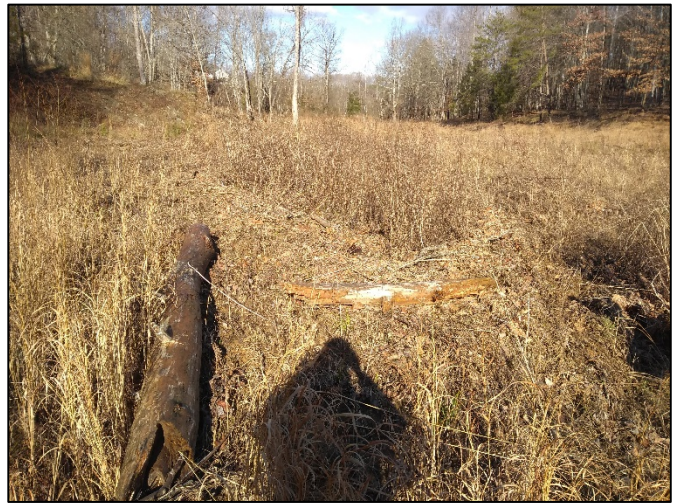
Photo 2. Wrack lines above bankfull, UTHC3 – 12/18/2020
