Thomas Creek Restoration Project

Year 1 Monitoring Report

Wake County, North Carolina

DMS Project ID Number – 96074, DEQ Contract No. 5549

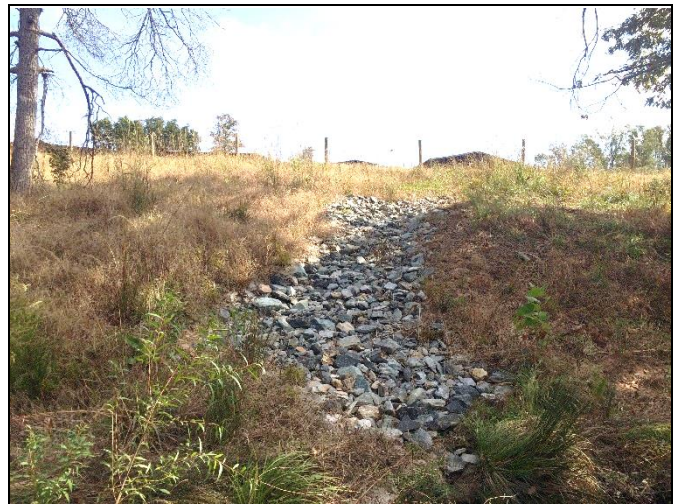
Reach 2, view of stabilized drainage on left bank at Station 20+80
