Subject: Response to DMS Comments for DRAFT Monitoring Year 2 Report
Thomas Creek Restoration Project, Wake County
DMS Project # 96074, DEQ Contract #5549, RFP# 16-005020

FINAL

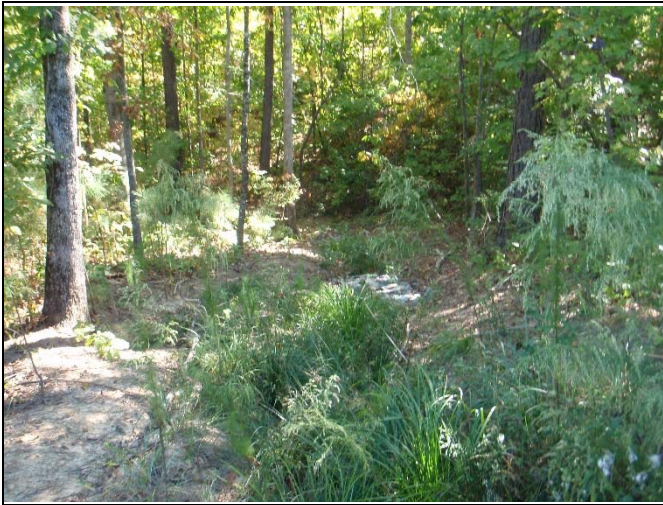
Reach 7, view of stabilized drainage at Station 13+50

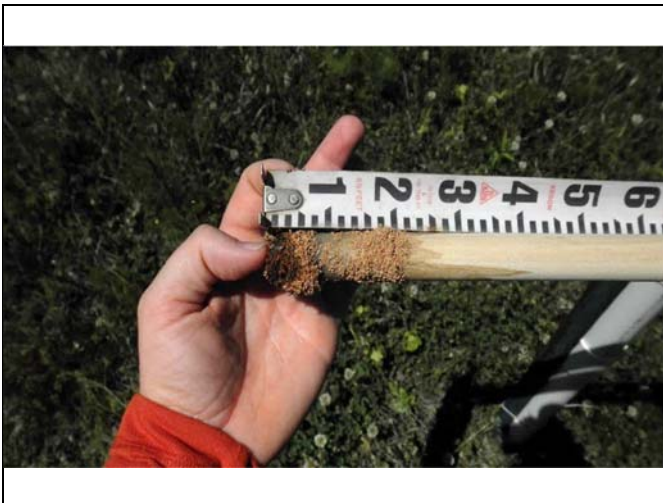
Reach 2: Crest Gauge, 0.21 ft on 5/2/17 (from 3.2" rain on 4/25/17, see associated spikes in flow gauge graphs)

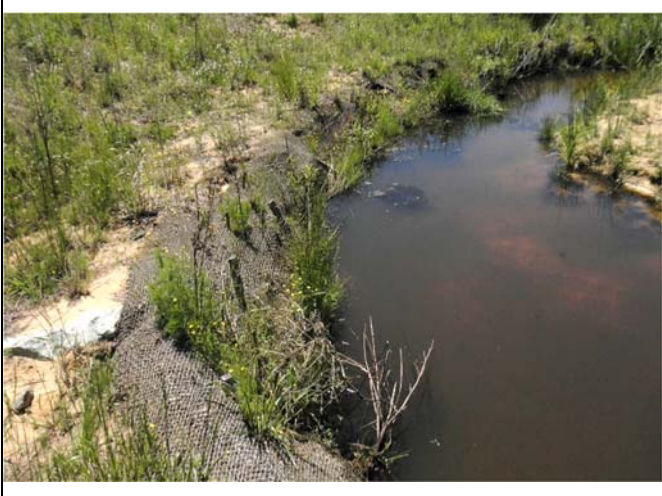
Stream Problem Area 1 (lack of woody vegetation establishment along left bank), R2 Station 32+25

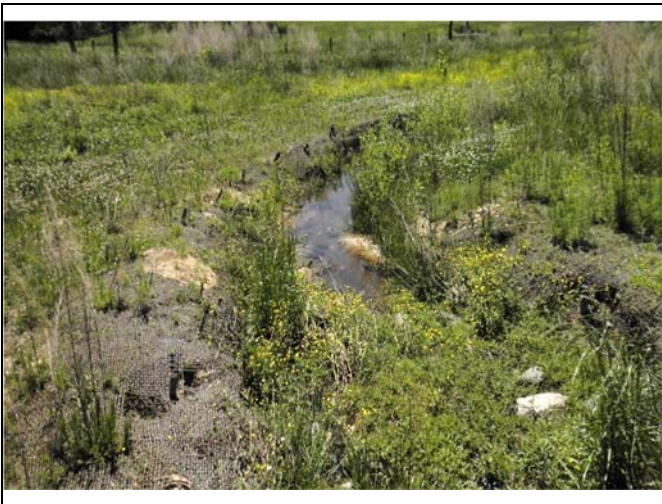
Stream Problem Area 3 (lack of woody vegetation establishment along left bank), R2 Station 35+60
