Subject: Response to DMS Comments for DRAFT Monitoring Year 3 Report
Thomas Creek Restoration Project, Wake County
DMS Project # 96074, DEQ Contract #5549, RFP# 16-005020

Figure 5 Index Map
Current Condition Plan View
Thomas Creek Site - MY3

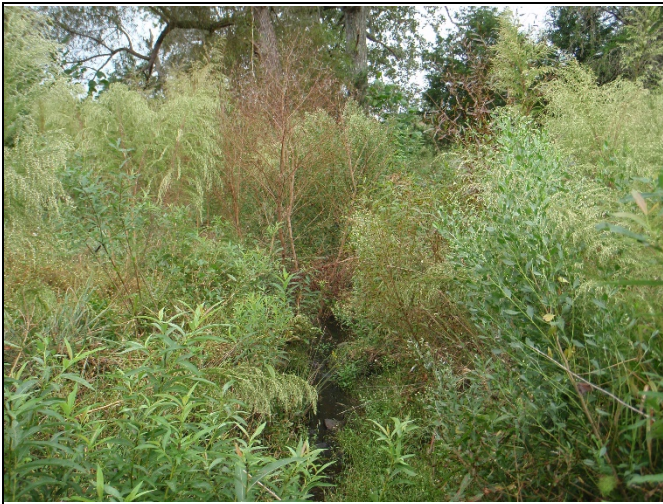
PP-29: Reach 2, view downstream at Station 36+90

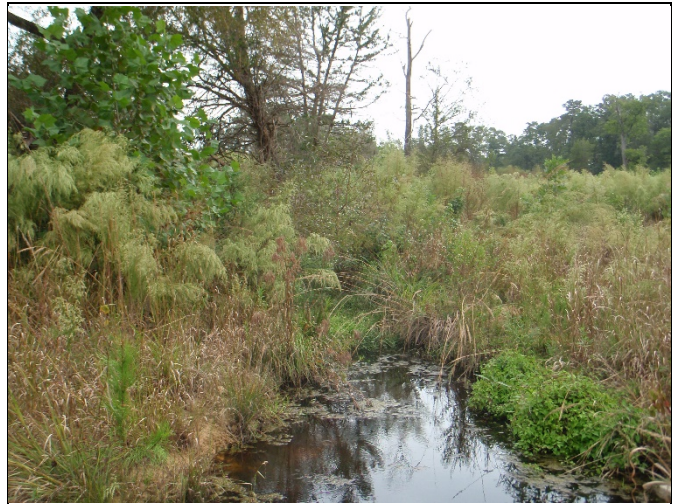
PP-30: Reach 2, view upstream at Station 38+25

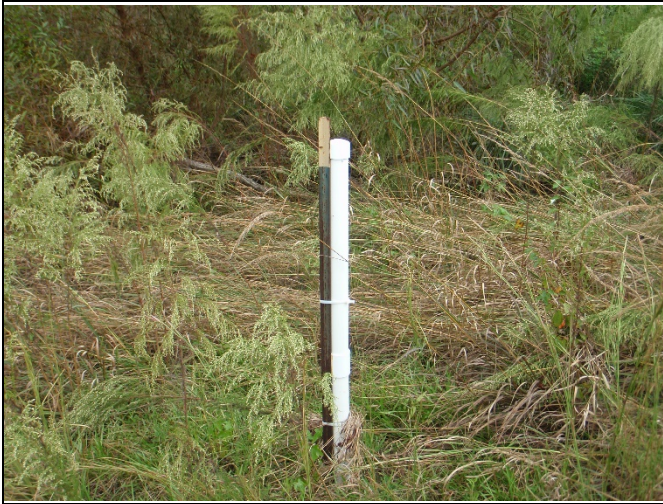
PP-31: Reach 2, Crest Gauge at Station 38+90

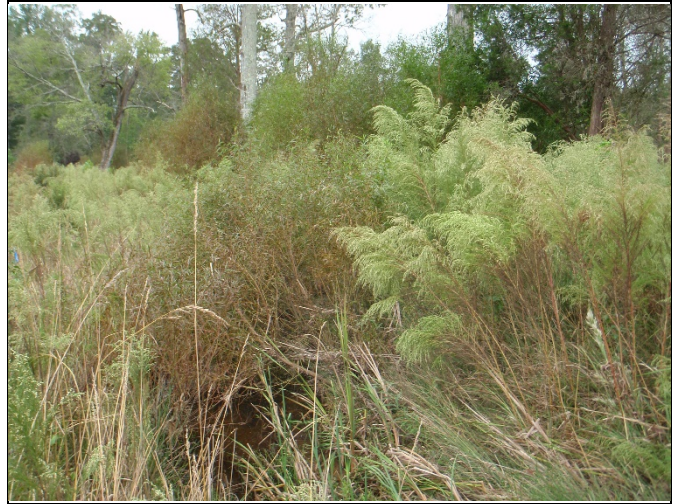
PP-32: Reach 2, view downstream at Station 39+40

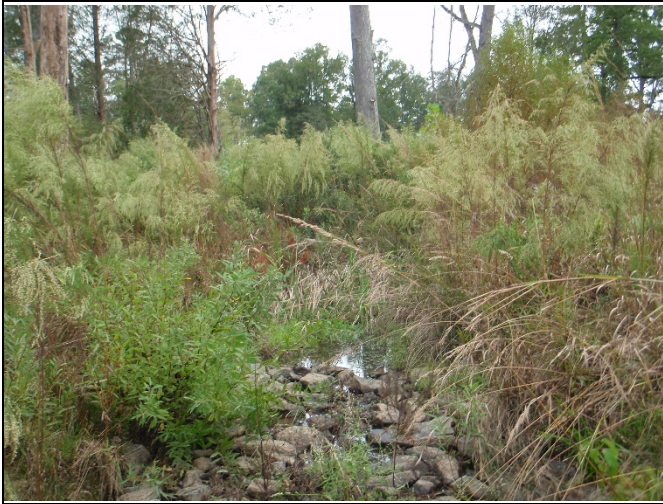
PP-33: Reach 2, view upstream at Station 41+50

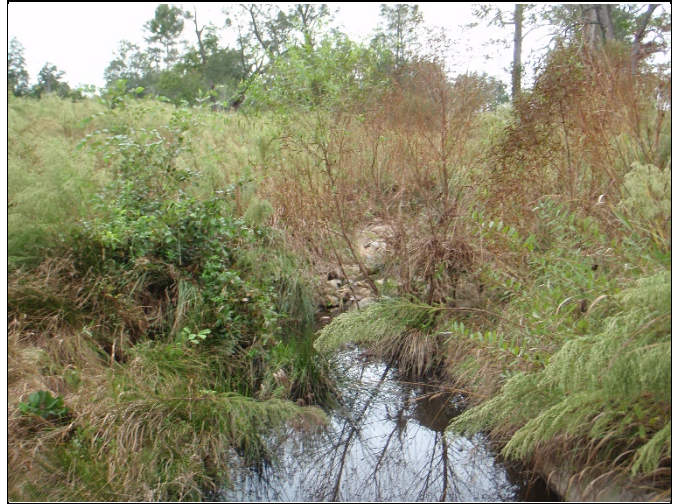
PP-34: Reach 1, view upstream at Station 42+75

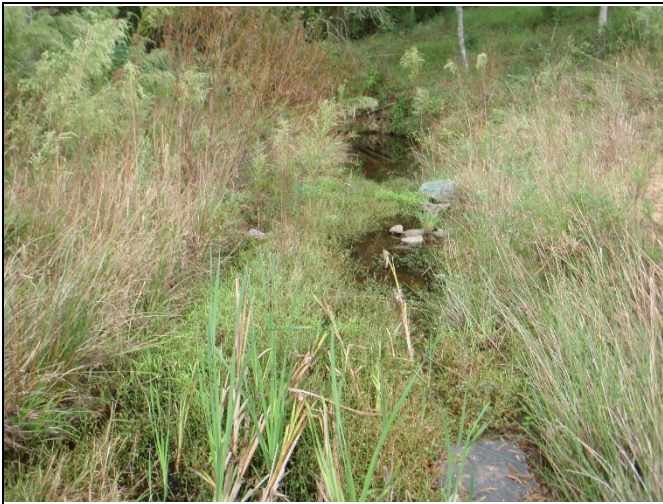
PP-35: Reach 1, view downstream at Station 43+25

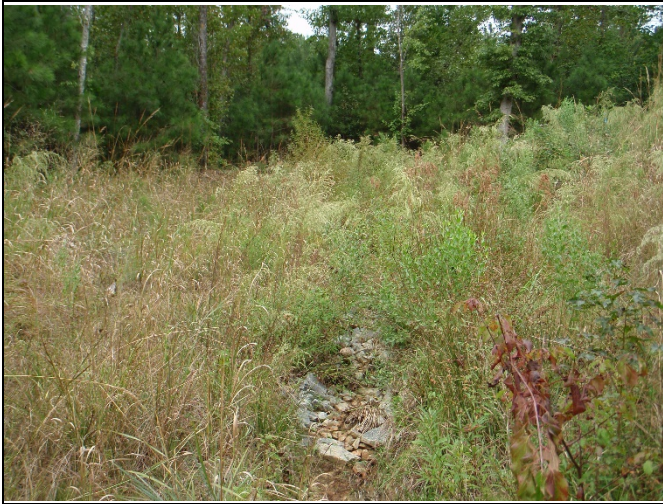
PP-37: Reach 6, view upstream at Station 10+75

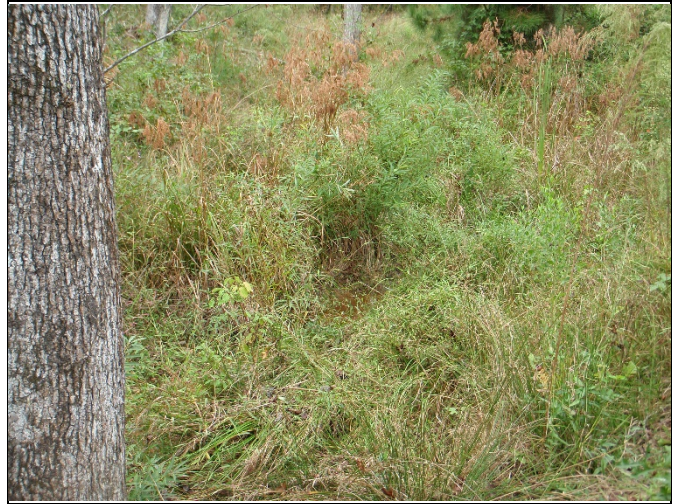
PP-38: Reach 6, view upstream at Station 11+50

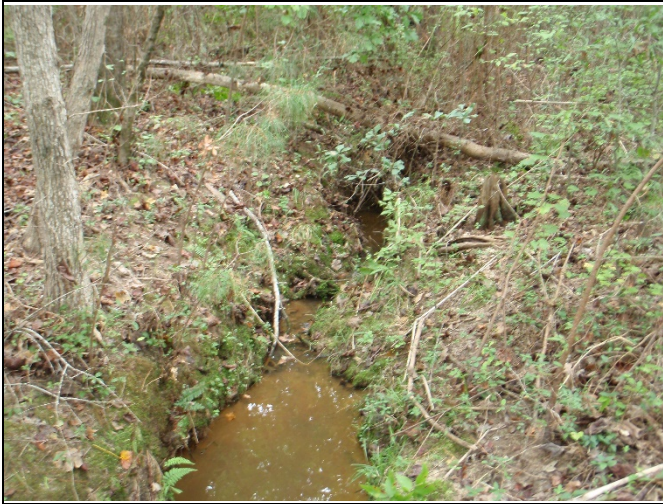
PP-39: Reach 6, view upstream at Station 15+25

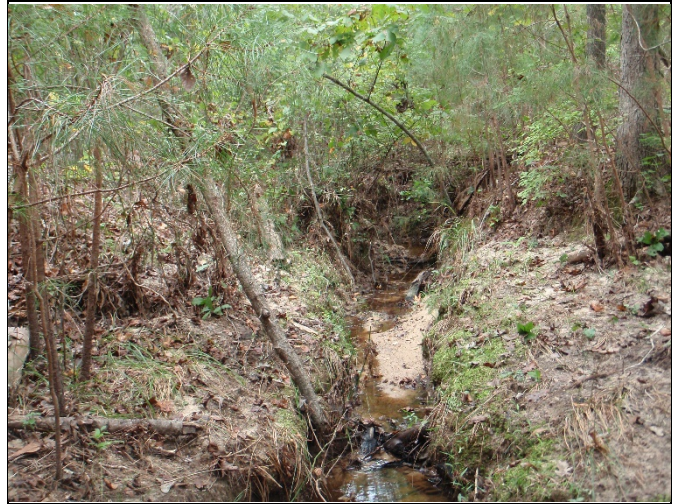
PP-40: Reach 6, view upstream at Station 18+90

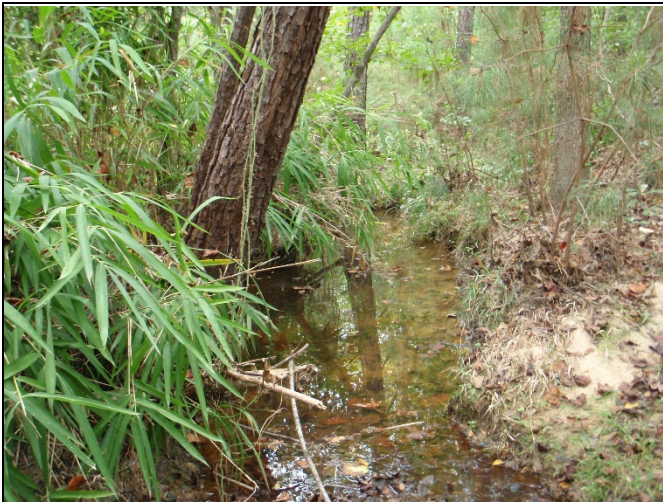
PP-41: Reach 6, view upstream at Station 25+50

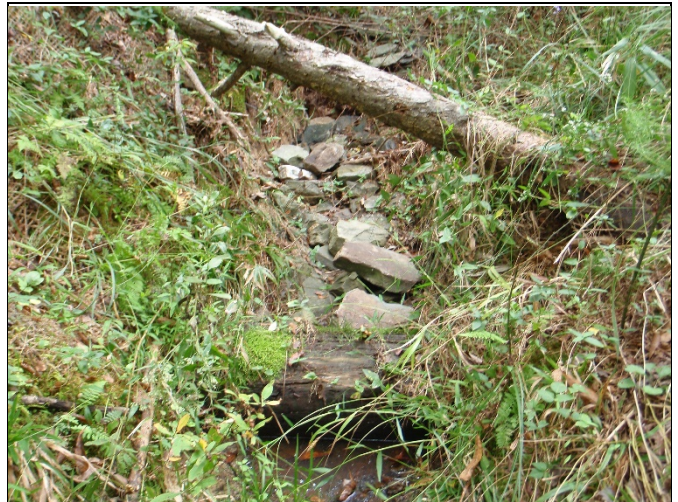
PP-42: Reach 7, view upstream at Station 10+40

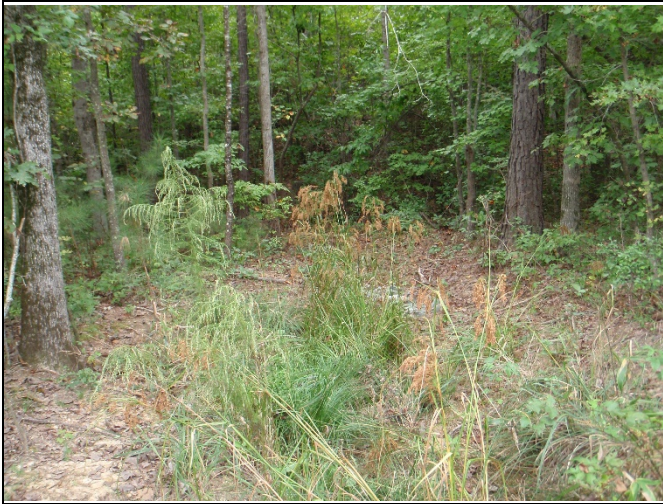
PP-43: Reach 7, view of stabilized drainage at Station 13+50

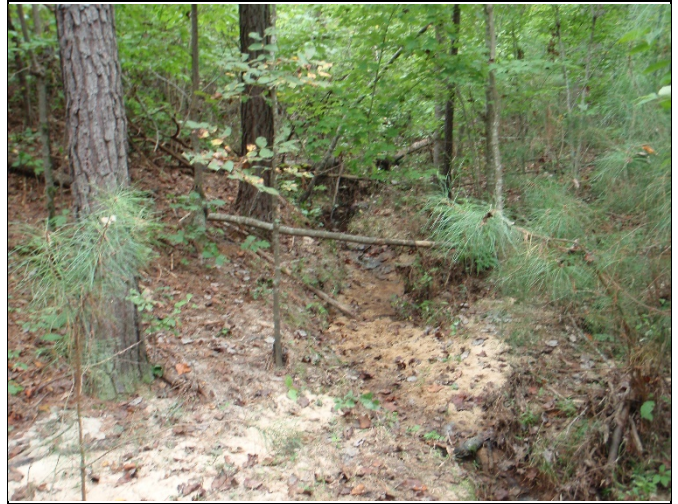
PP-44: Reach 7, view upstream at Station 15+00

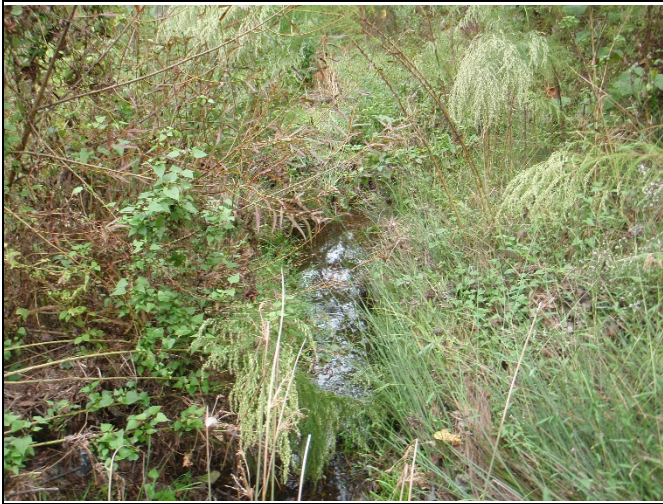
PP-45: Reach 5, view upstream at Station 30+25

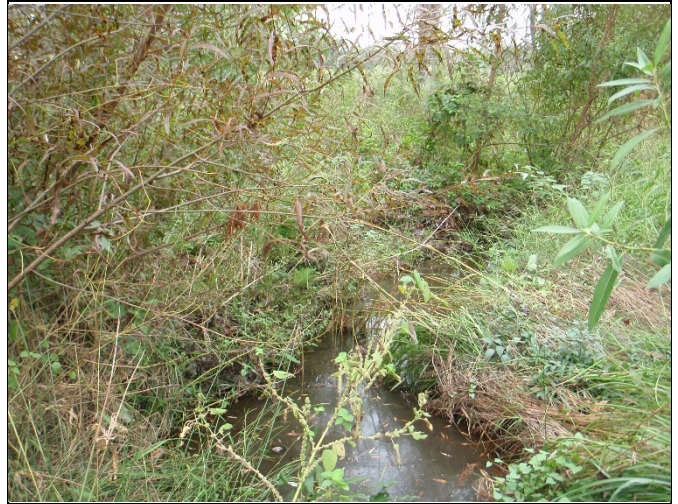
PP-46: Reach 5, view downstream at Station 30+75

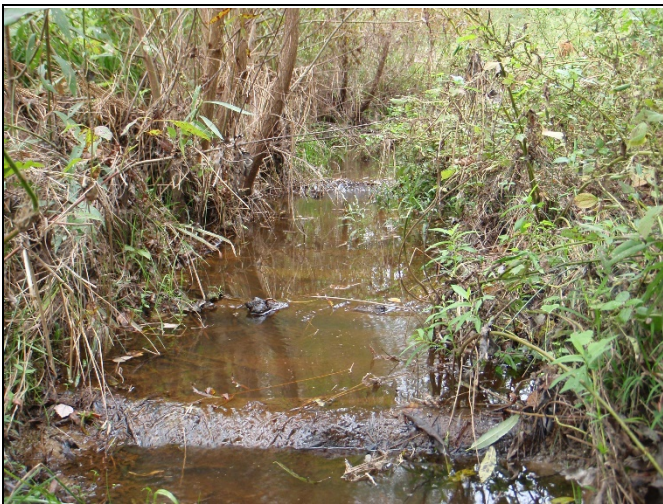
PP-47: Reach 5, view downstream at Station 31+40

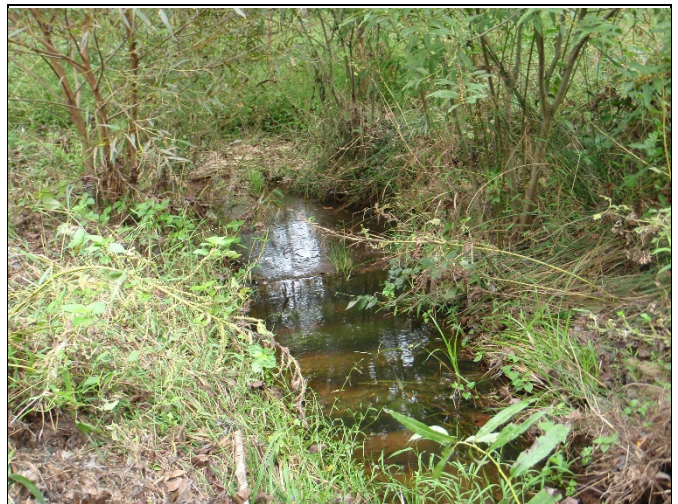
PP-48: Reach 5, view downstream at Station 32+50

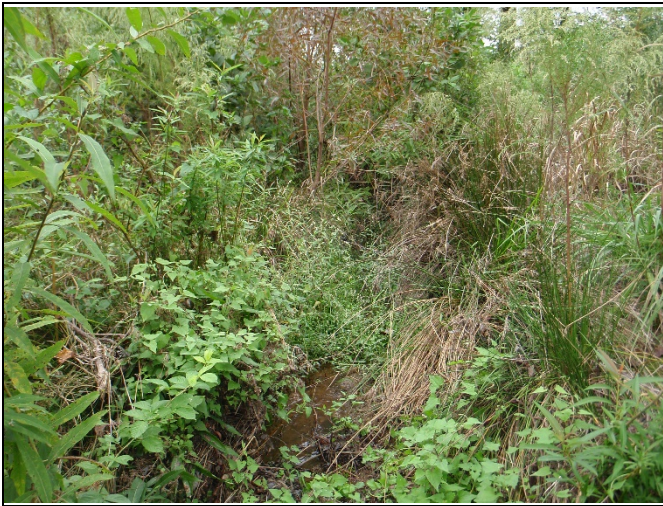
PP-49: Reach 5, view upstream at Station 33+10

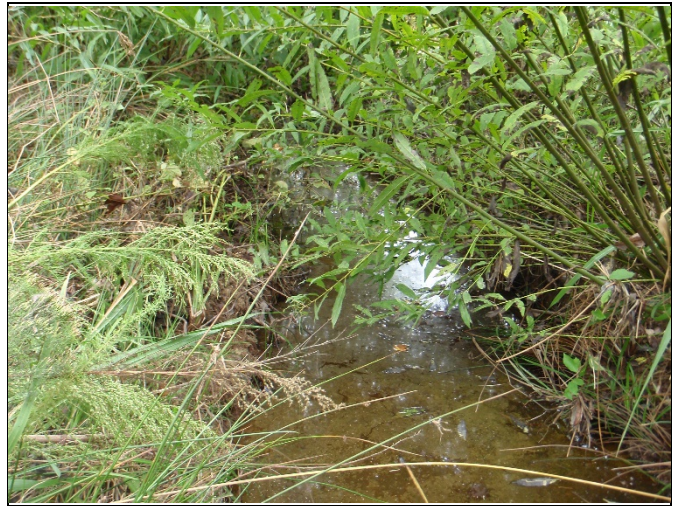
PP-50: Reach 5, view downstream at Station 33+75

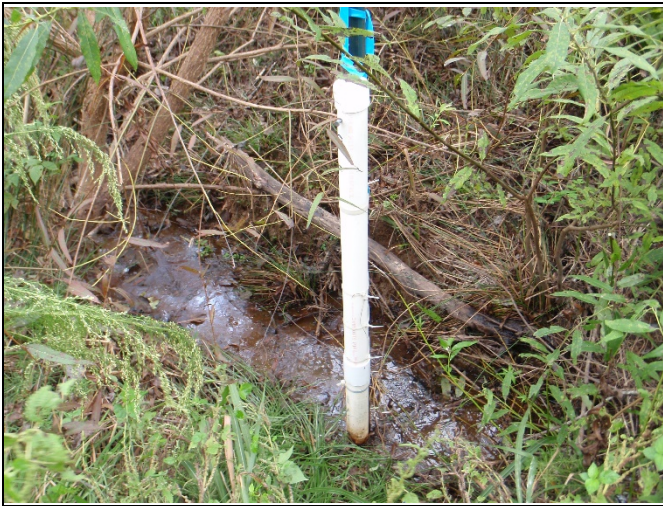
PP-51: Reach 5, Flow Gauge #2 at Station 33+90

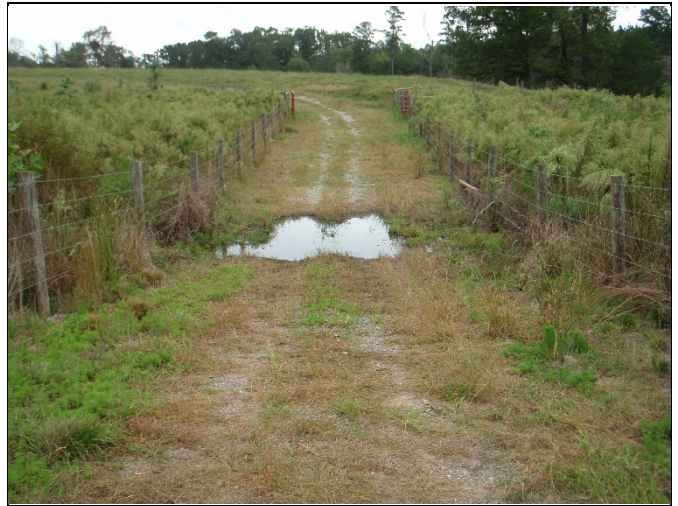
PP-52: Reach 5, view of crossing at Station 35+00

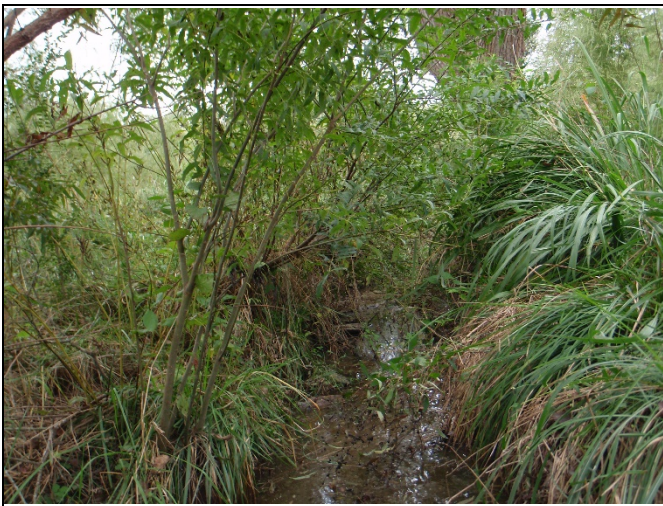
PP-53: Reach 5, view upstream at Station 36+40

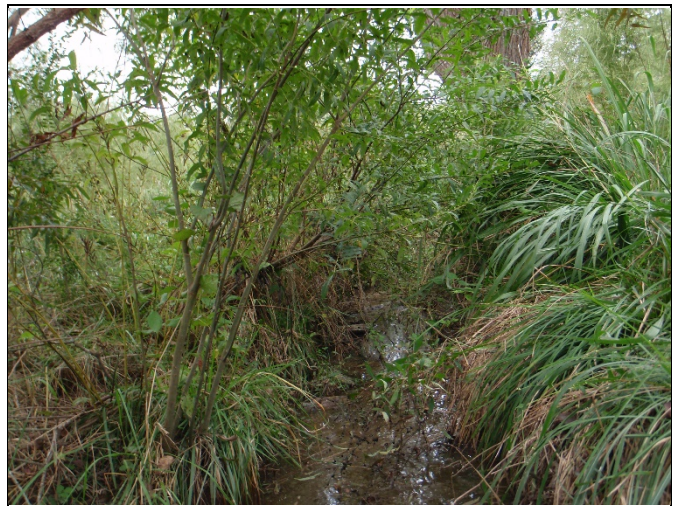
PP-54: Reach 5, view upstream at Station 36+75

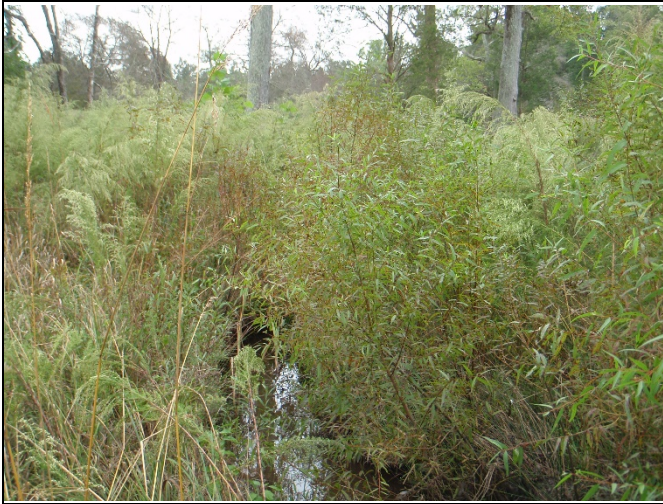
PP-55: Reach 5, view downstream at Station 37+30

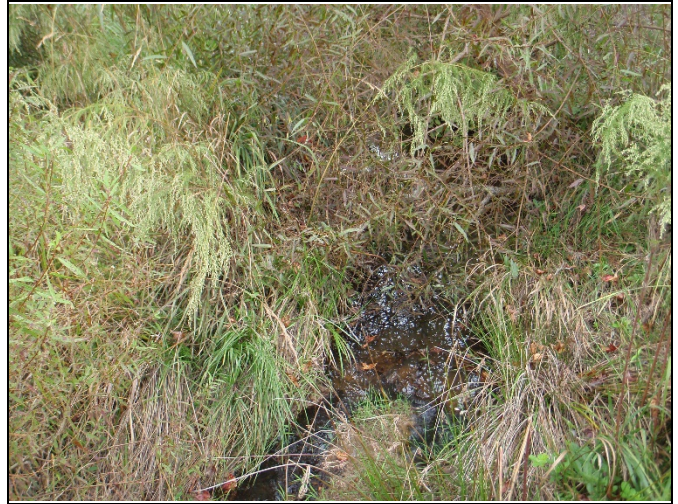
PP-56: Reach 5, view upstream at Station 38+50

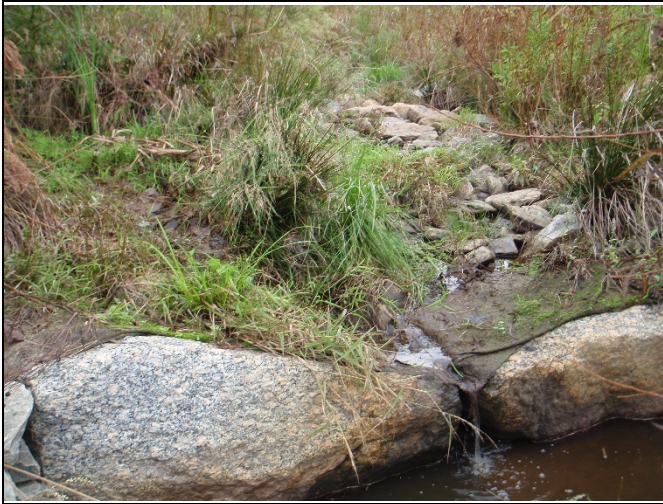
PP-57: Reach 5, view upstream at Station 39+90
(the confluence of R5 and R2)

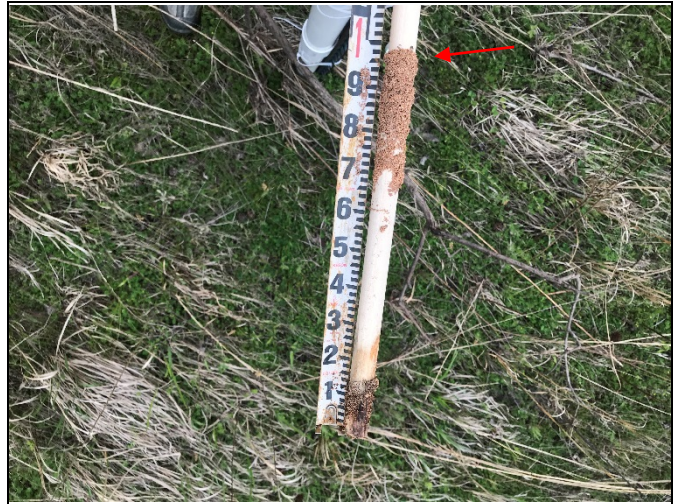
Overbank event of 0.97 ft (photo: 4/23/18)

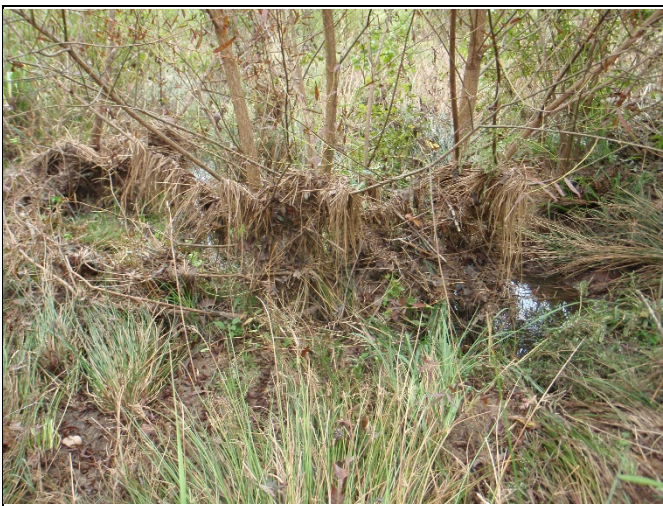
Evidence of overbank flow, Reach R3: Debris jam in the limbs of floodplain vegetation

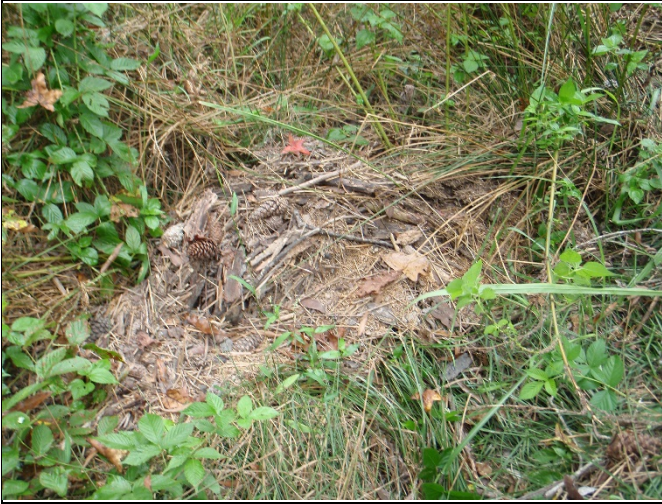
Evidence of overbank flow, Reach R5: Debris pile / wrack line in floodplain

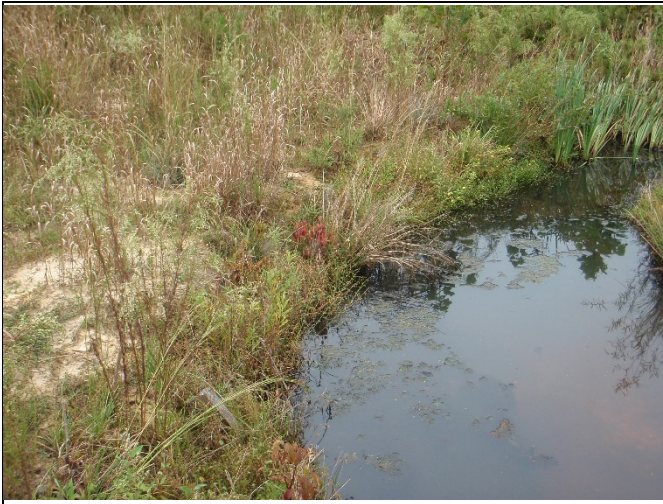
Livestakes planted in March 2018 establishing and stabilizing the left bank of R2, ~Station 32+25

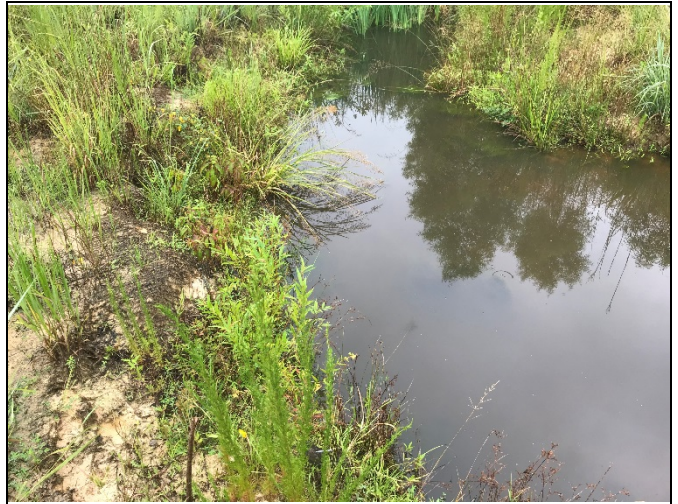
Livestakes planted in March 2018 establishing and stabilizing the left bank of R2, ~Station 34+25

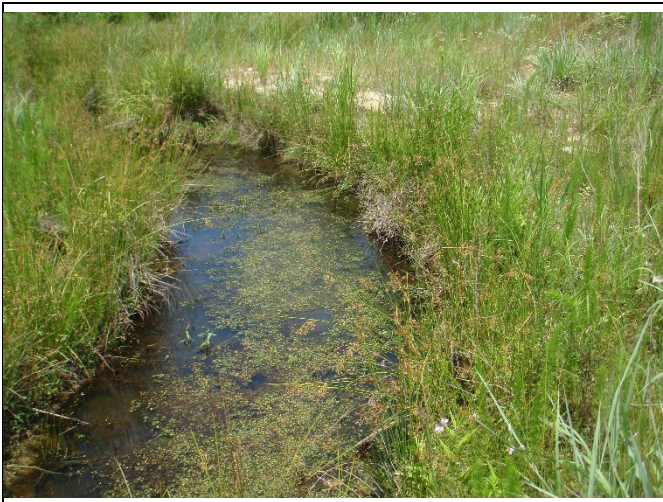
Livestakes planted in March 2018 establishing and stabilizing the left bank of R2, ~Station 35+50
